# National Transportation Safety Board

ERA22LA090

## **WRECKAGE EXAM**

Airplane: Aerofab Lake LA-4-250, N1402C

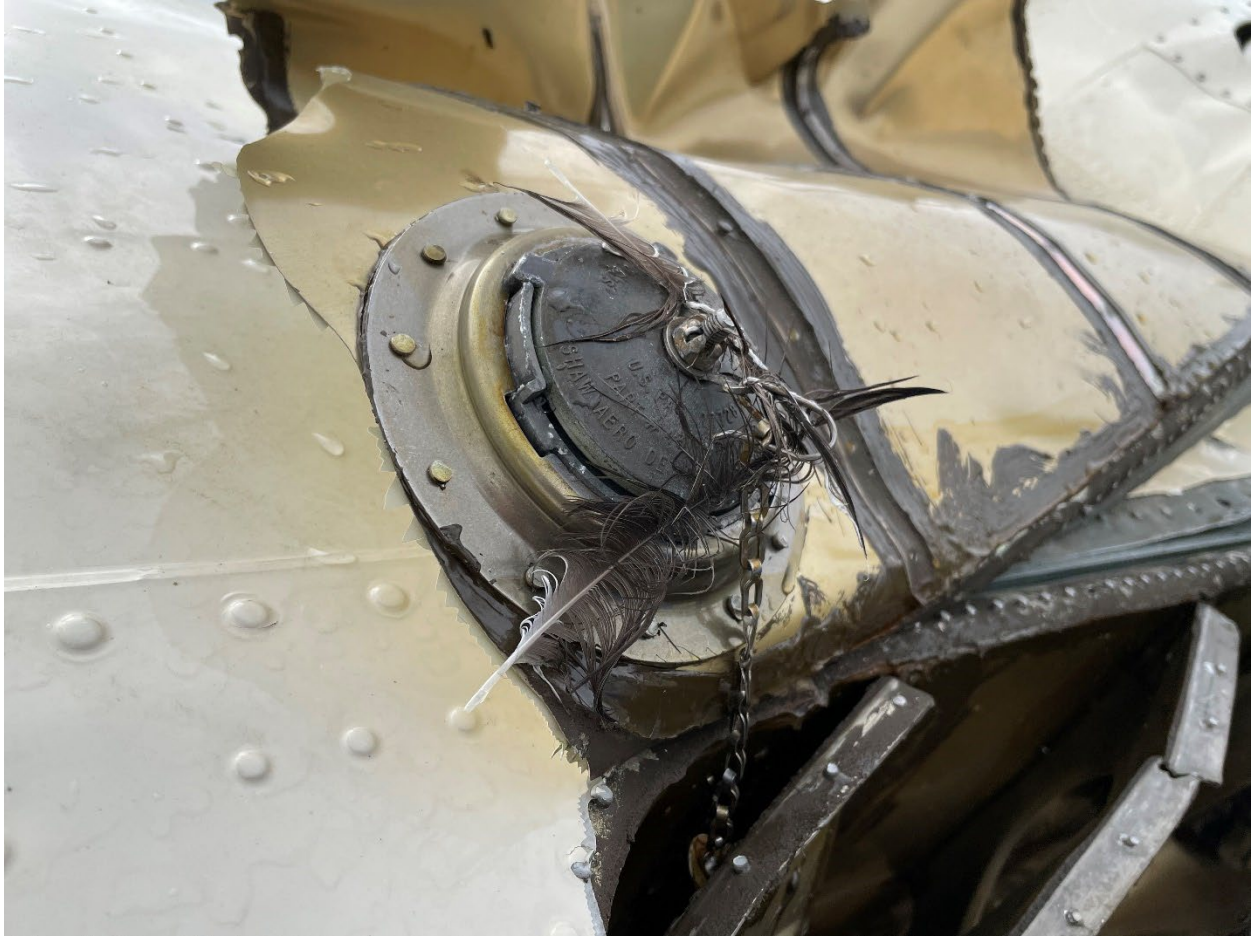
**Figure 1 - Right Wing Tank Fuel Cap / Feather Remnants**

Recovery personnel discovered feather remnants attached to the right wing fuel tank cap / filler neck area, as the airplane was lifted from the water.

The feather remnants were collected and sent to the Smithsonian Institute Feather Identification Lab in Washington, DC, for examination. The feathers were identified as being from a Turkey Vulture (*Cathartes aura*). A separate report from the Smithsonian Institute is available in the public docket. No other obvious remnants of bird were found on or in the wreckage.

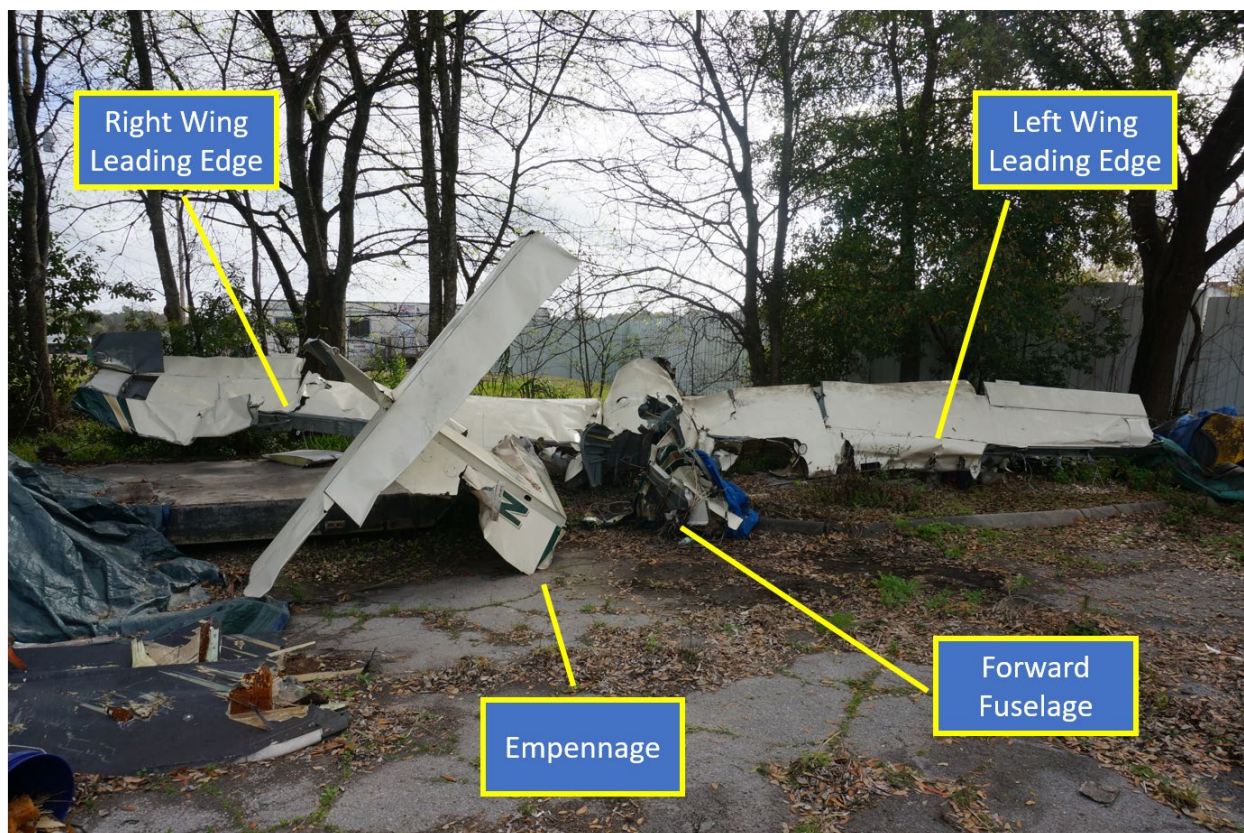
**Figure 2 - View of Wreckage at Salvage Facility**

The Fuselage significantly fragmented and damaged forward of the wing. No windscreen or any other acrylic-like remnants were separately recovered from the accident site, and none were observed in wreckage.

Wing leading edge crush/impact damage was present along entire span with many sections missing. The tail/empennage was completely separated just aft of the wing, though largely intact.

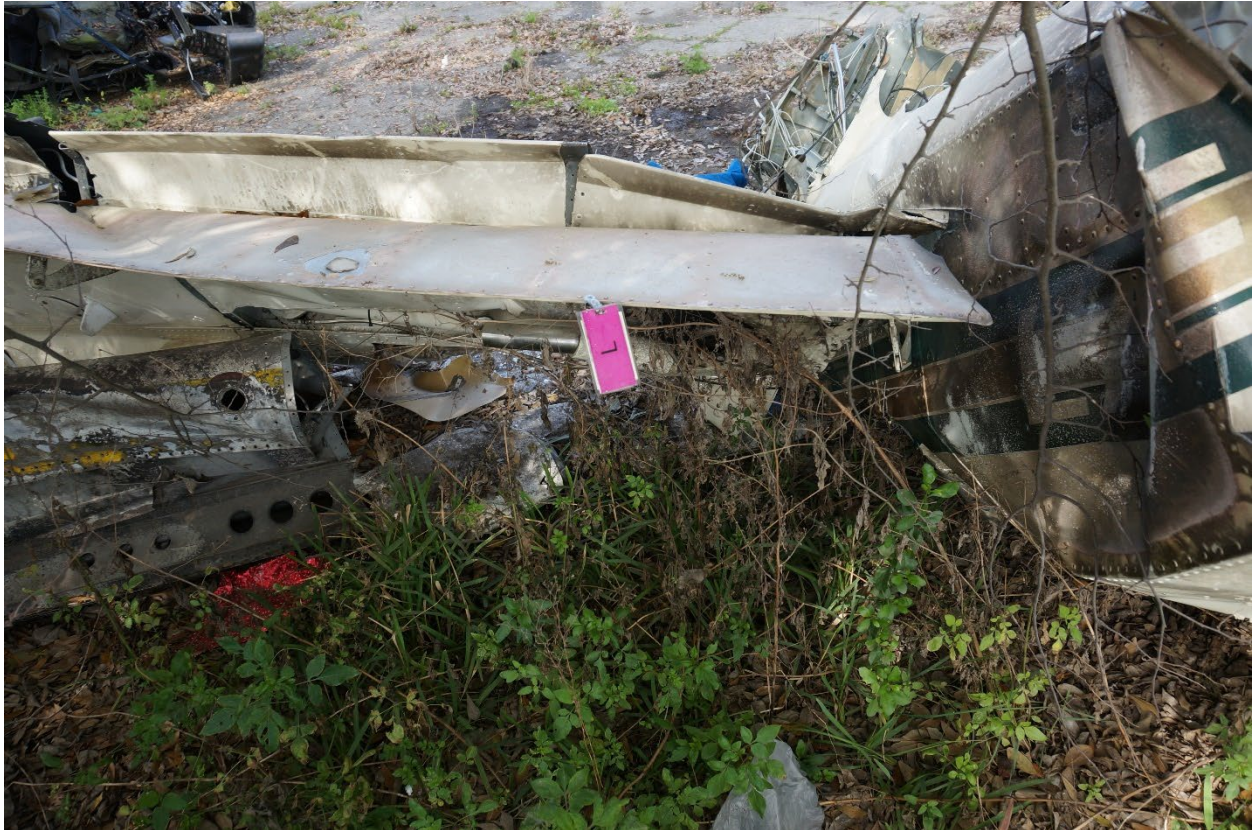
**Figure 3 - Left Inboard Wing/Flap and Left Forward Empennage**

Fire damage (soot, paint bubbling) was present on both sides of empennage, left wing/left flap, and many other small areas including cockpit upholstery.

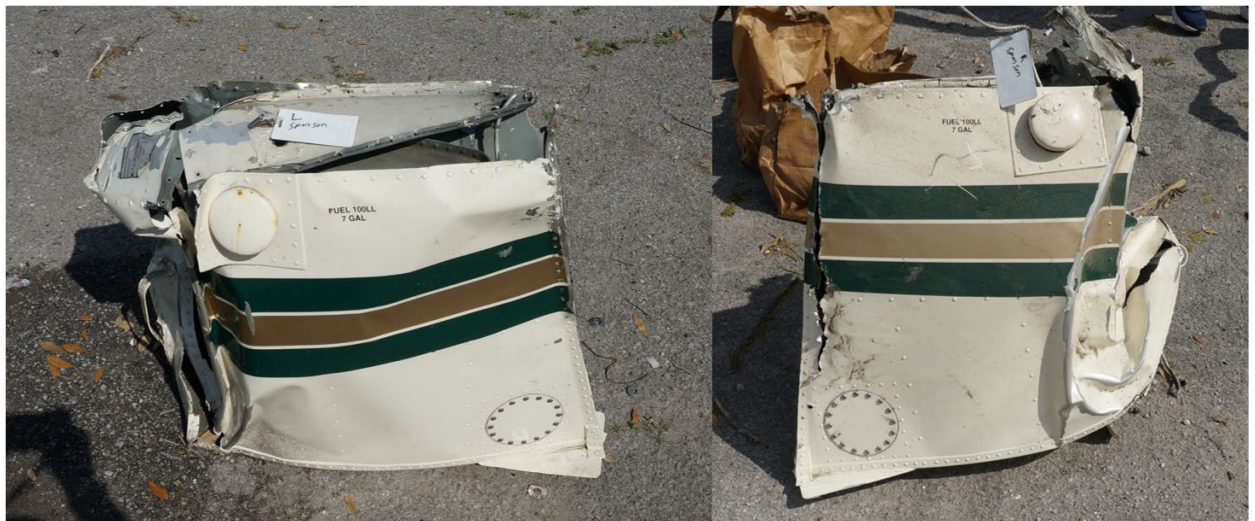
**Figure 4 - Sponsons (Left / Right)**

Both sponsons leading edge crushing along their entire forward edge.

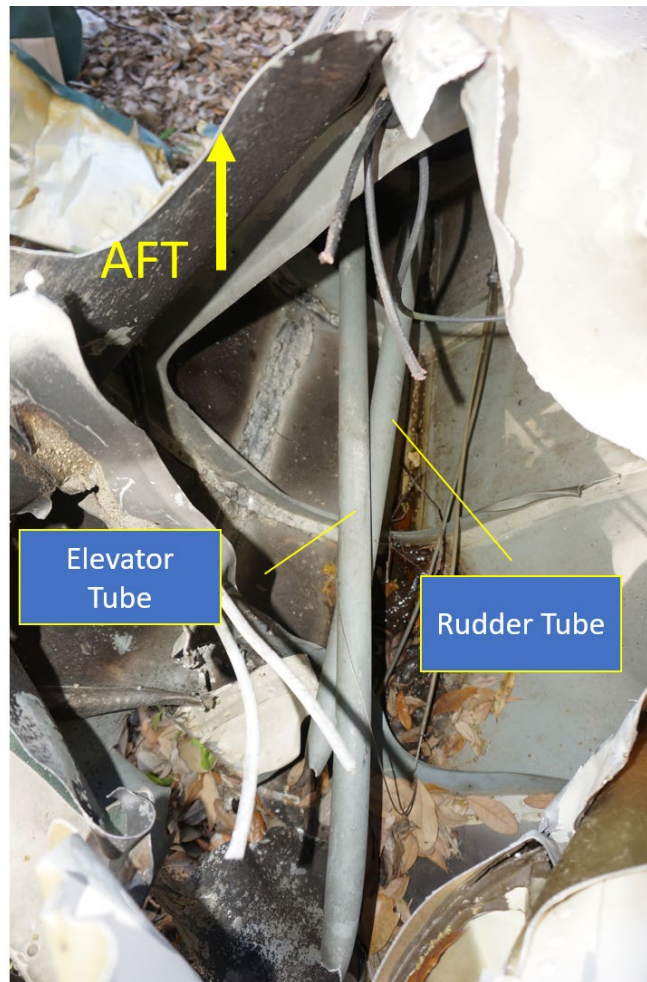
**Figure 5 - Elevator and Rudder Push/Pull Tubes in Empennage**

The elevator and rudder push pull tubes were fractured, consistent with overload, near the forward end of the empennage just below leading edge of vertical stabilizer.

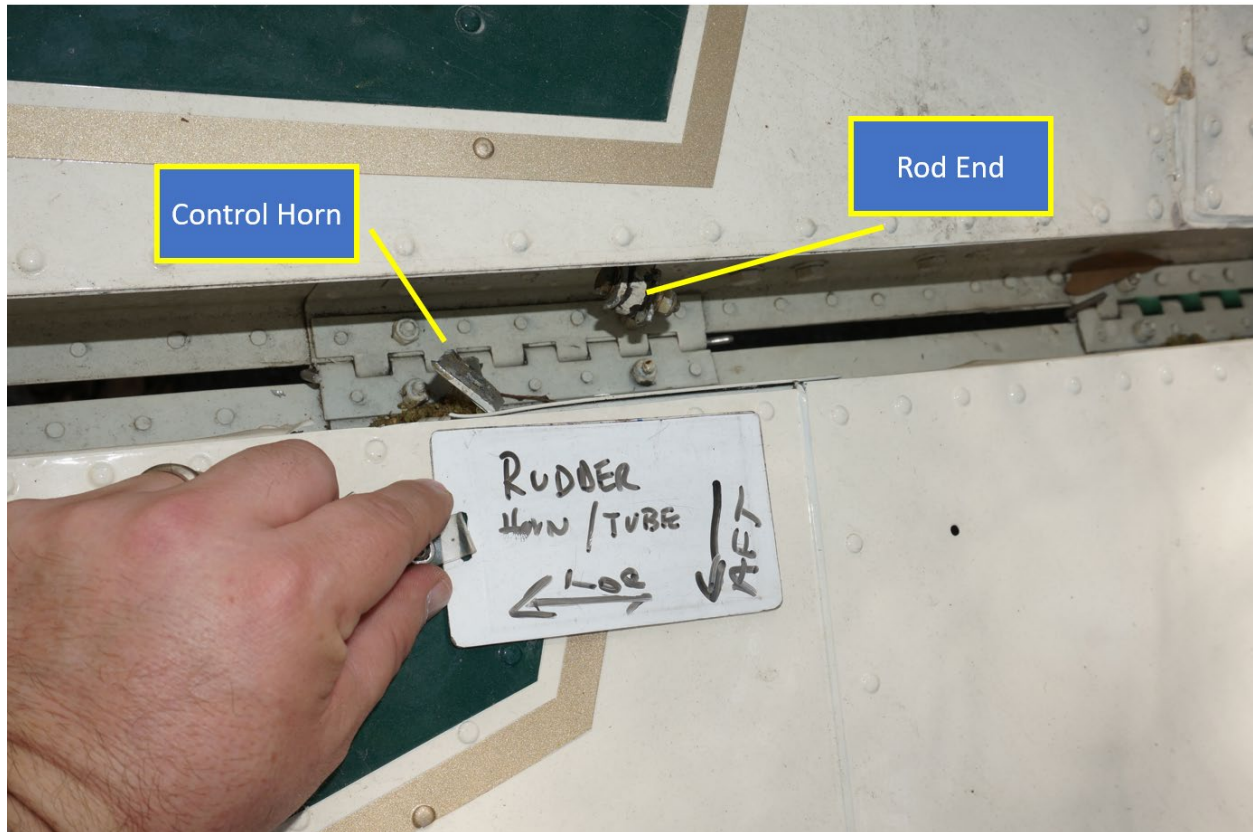
**Figure 6 - Fractured Rudder Control Horn, and Rod End**

The rudder control was continuous from this fracture to another overload fracture in the rudder control horn.

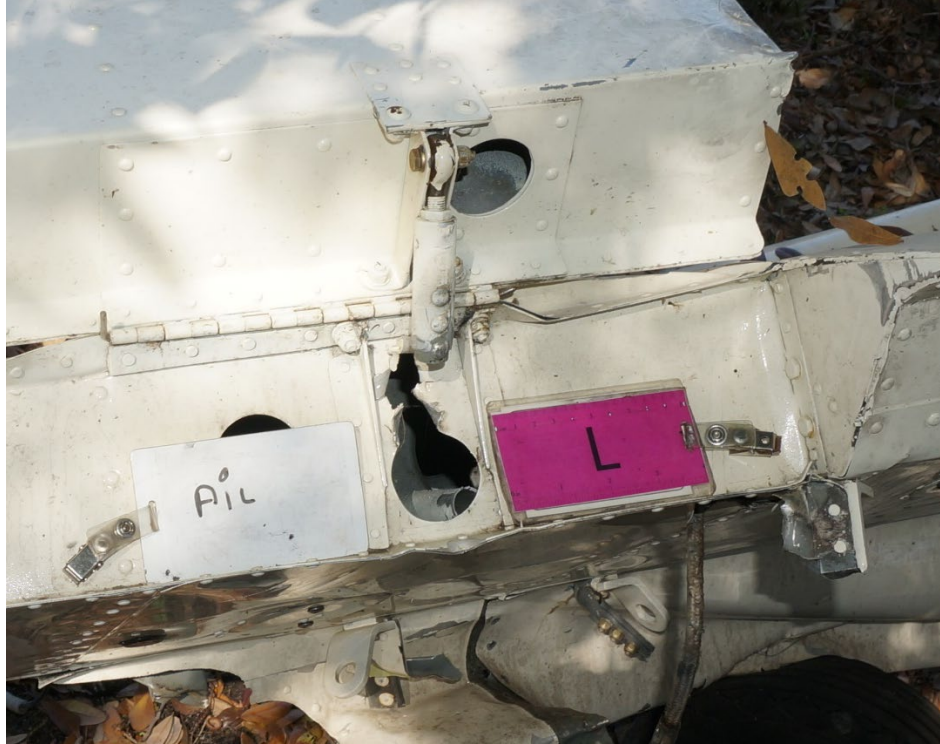
**Figure 7 - Left Aileron Fractured Push-Pull Tube at Control Horn**

Aileron continuity was established from the wing center section through an overload fracture in the push-pull tube at the left aileron control horn.

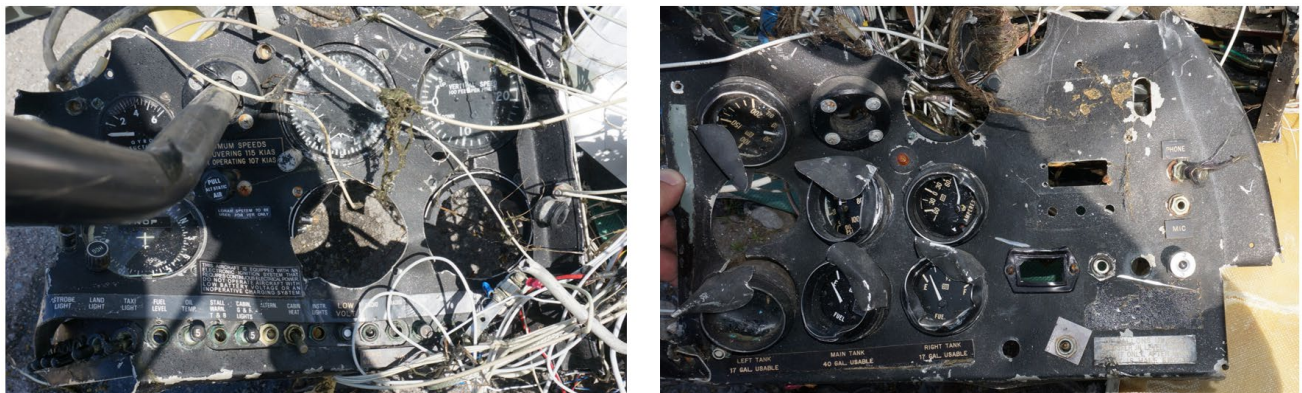
**Figure 8 - Instrument Panel Left/Right**

The instrument panel was impact damaged and some instruments were separated from the panel.

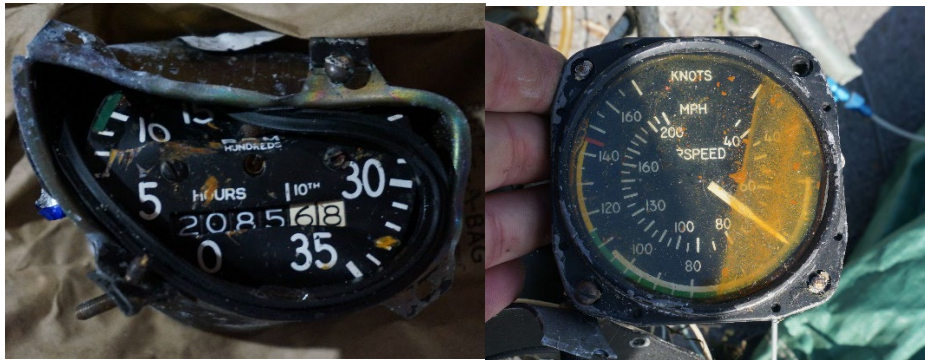
**Figure 9 - Tachometer (left) Airspeed Indicator (right)**

The recording tachometer read: 2085.68 hours.

The airspeed indicator read 62 knots.

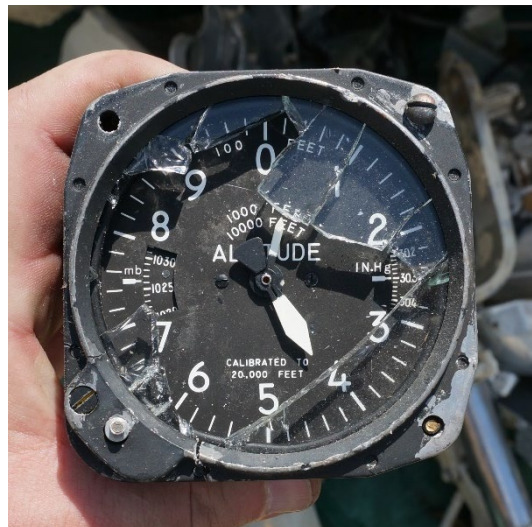
**Figure 10 - Altimeter**

The altimeter setting was 30.30, the indicated altitude was about 4,000 ft (the hundreds needle was missing).

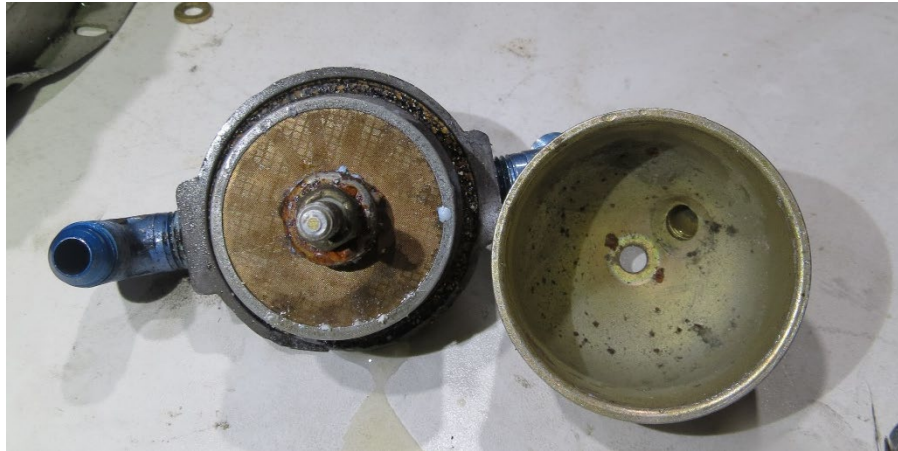
**Figure 11 - Fuel Strainer**

The fuel strainer bowl was found safety wired in place. Drops of water and minor corrosion were found inside the strainer, the screens inside were unobstructed.

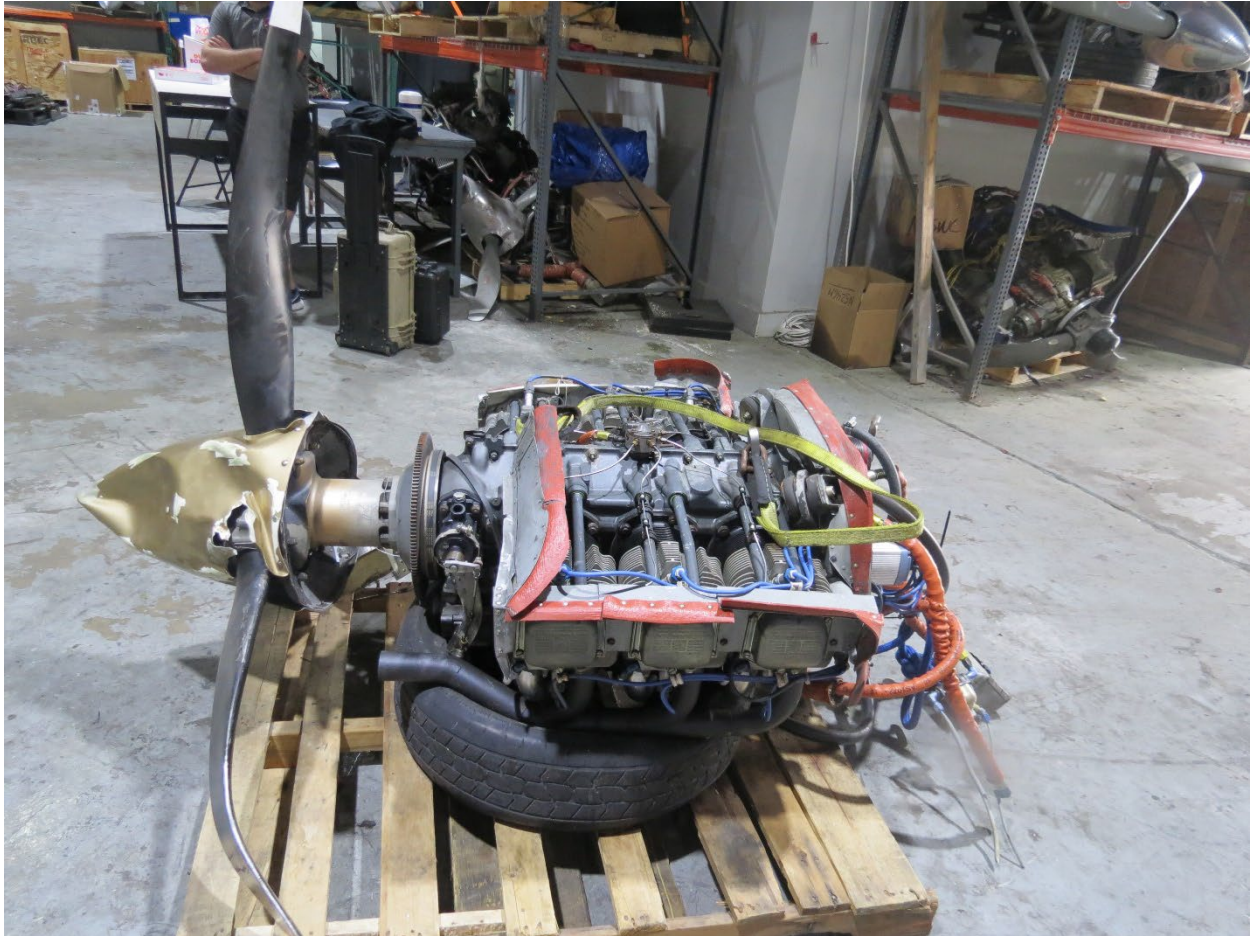
**Figure 12 - Engine**

The engine was separated from the airplane. It had been immersed in a lake during the accident and had not been preserved for the 2 months prior to the examination.

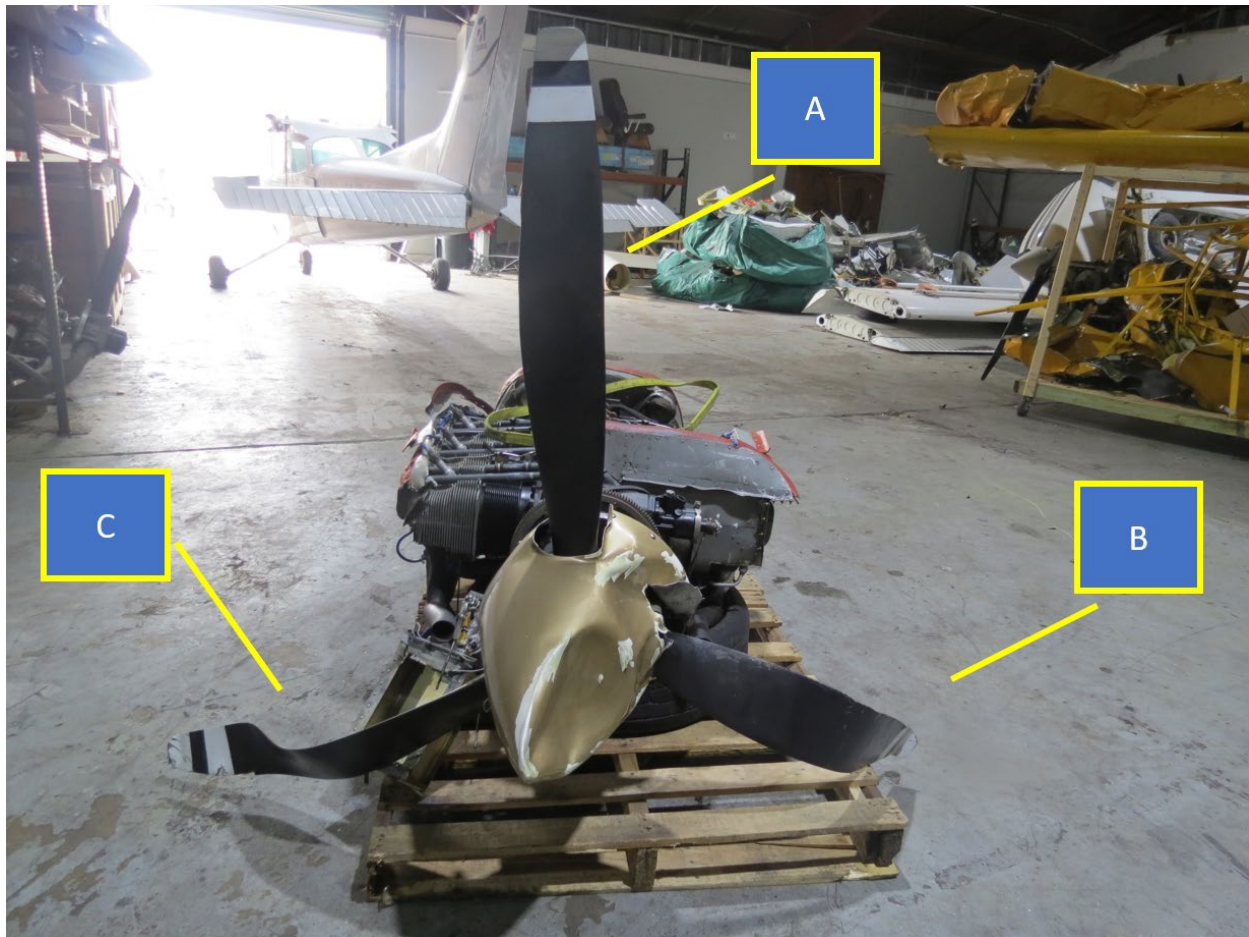
**Figure 13 - Propeller and Spinner**

The propeller remained attached to the engine crankshaft flange. The propeller spinner was partially crushed. The propeller blade labeled "A" was curved forward (toward the front of the airplane - the engine orientation as installed is with the propeller facing rearward in a pusher configuration) about 5 degrees. The blade labeled "B" was bent forward about 30 degrees at about mid-span, exhibited leading edge damage near the blade tip and chord-wise scratches. The blade labeled "C" was bent forward about 20 degrees at about  $\frac{3}{4}$  span and exhibited leading edge damage near the tip. That blade also exhibited trailing edge "S" bending from about mid-span outboard toward the tip.

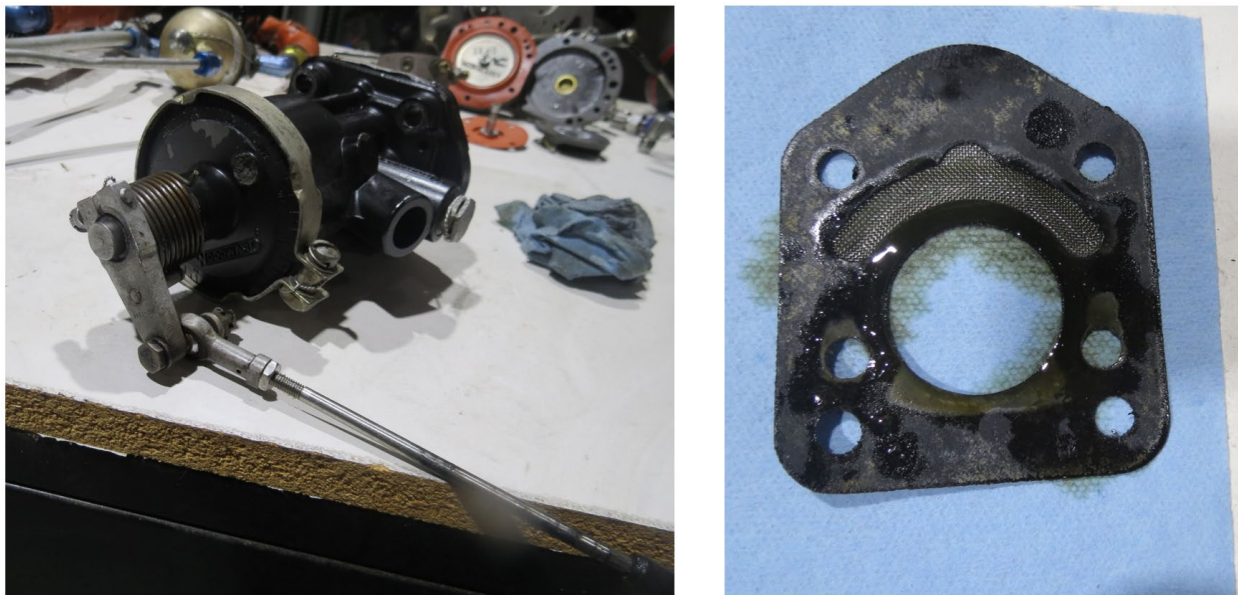
**Figure 17 - Propeller Governor (Left) and Oil Screen (Right)**

The propeller governor was removed from the engine, and rotated smoothly by hand. The oil screen was absent of debris.

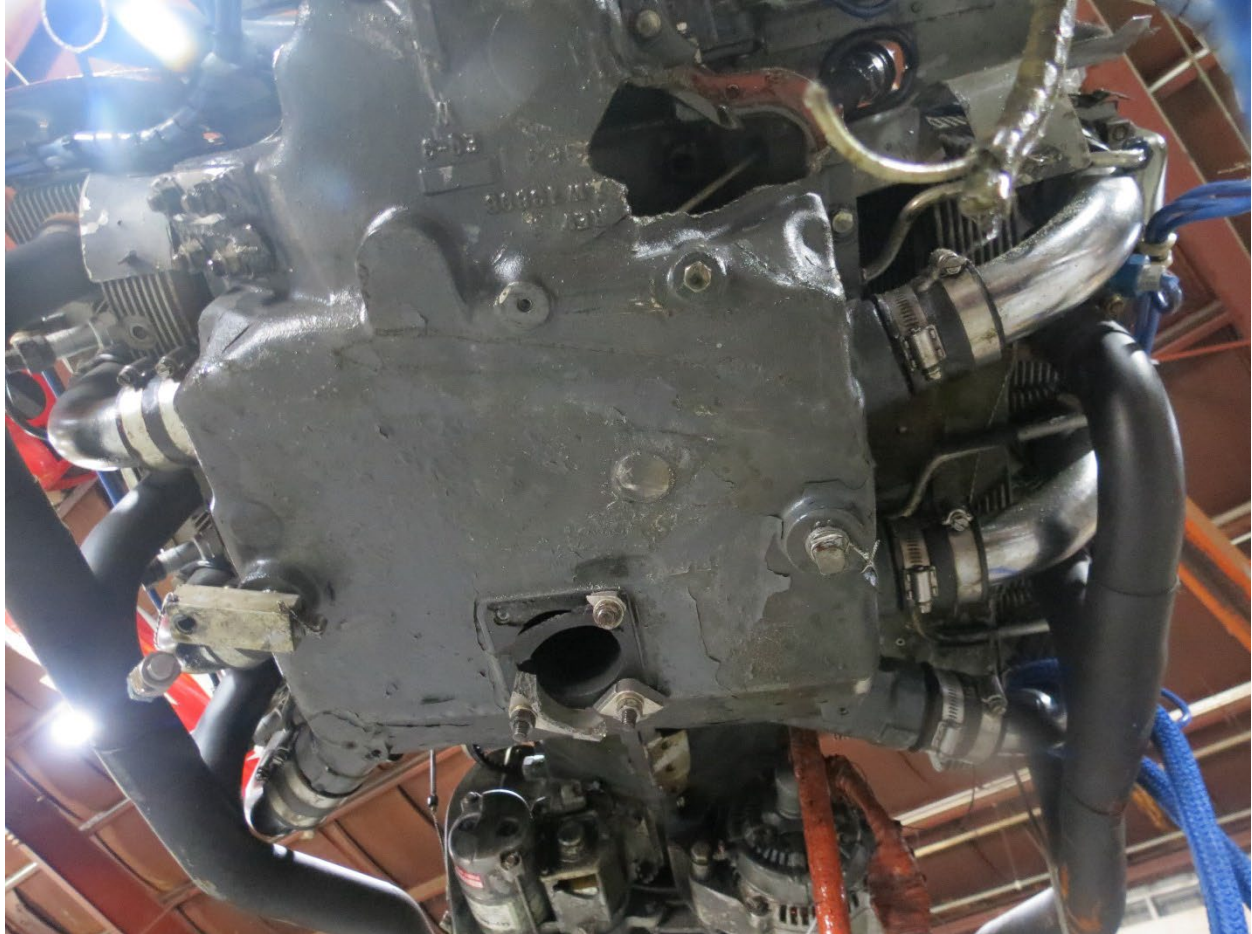
**Figure 18 - Engine Oil Sump**

The oil sump was fractured at the right rear corner, a hole about 2x3 inches was present. A borescope examination of each cylinder revealed some water and corrosion in each cylinder, with no damage observed.

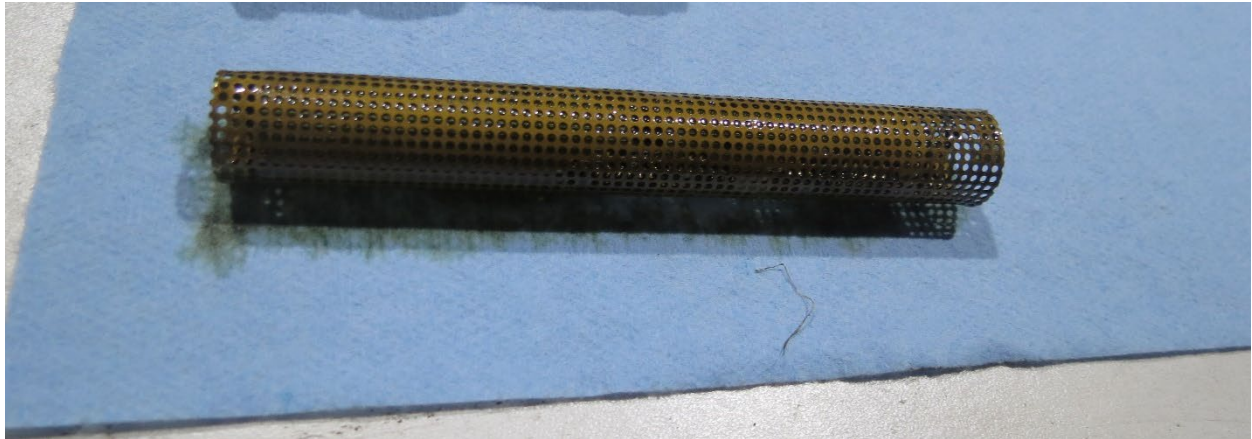
**Figure 19 - Engine Oil Suction Screen**

The crankshaft was rotated by hand at the propeller. Crankshaft and valvetrain continuity were confirmed by observing accessory section gear rotation and valve pushrod/rocker arm motion. With the spark plugs removed, water pumped out of the spark plug holes for several cylinders and the crankshaft was rotated. Water also pumped out of the exhaust manifolds. Thumb compression and suction were observed on all cylinders. The engine oil suction screen was absent of debris. The engine oil filter assembly was fracture separated from the engine and not found.

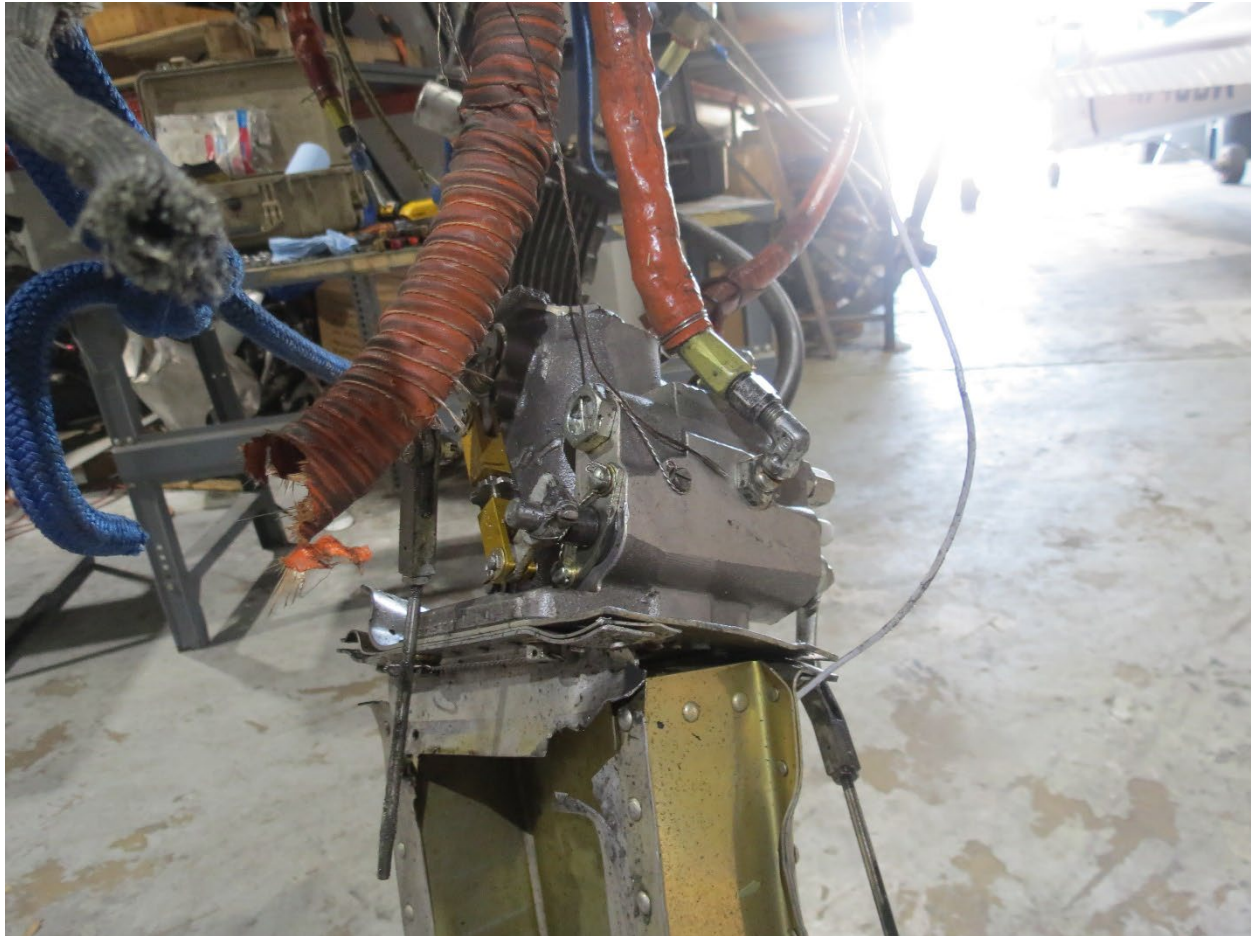
**Figure 20 - Fuel Servo**

The throttle cable and mixture cable ends remained attached to their respective control arms on the fuel servo, and were separated about 6" from the rod end connector. The fuel servo was separated from the engine and fractured across the throttle bore. The fuel lines from the servo to the engine driven fuel pump and the fuel flow divider remained in place.

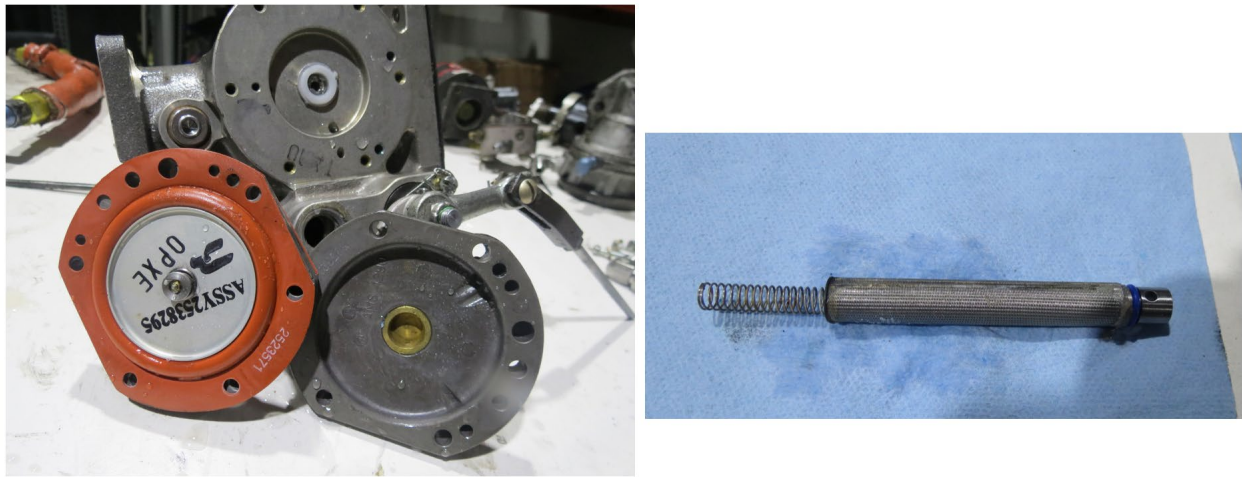
**Figure 21 - Partially Disassembled Fuel Servo (Left) and Fuel Inlet Screen (Right)**

The servo fuel regulator section was partially disassembled and no damage to the rubber diaphragms or other internal components observed. The regulator cover brass plug was secure. The servo fuel inlet screen was unobstructed.

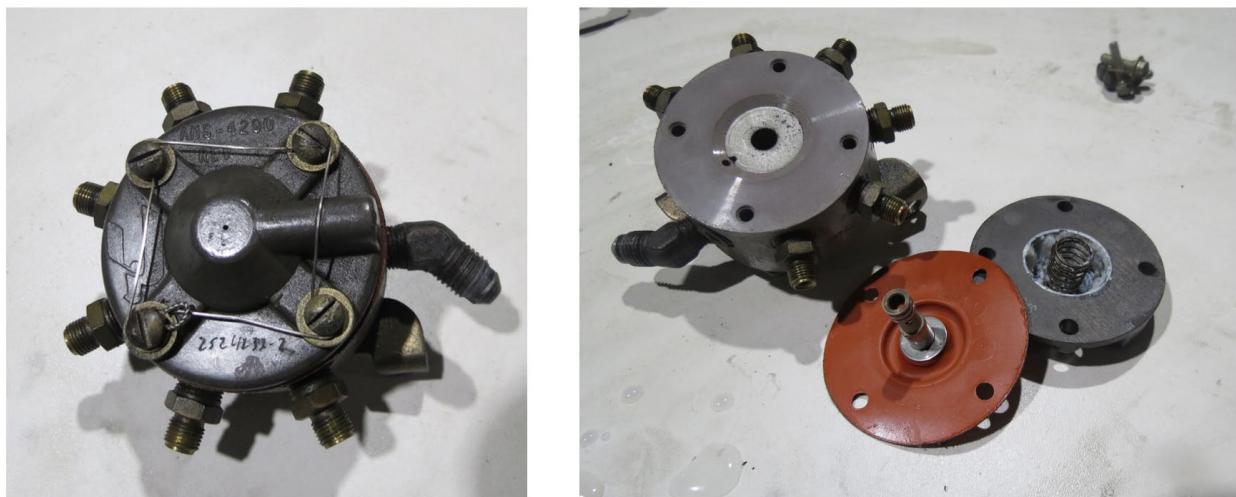
**Figure 22 - Fuel Flow Divider - Intact (Left) Partially Disassembled (Right)**

The fuel flow divider remained attached to the engine and no damage was noted. The associated fuel hose and fuel injector lines were secure. The flow divider was partially disassembled, and no obstructions observed. The rubber diaphragm was intact.

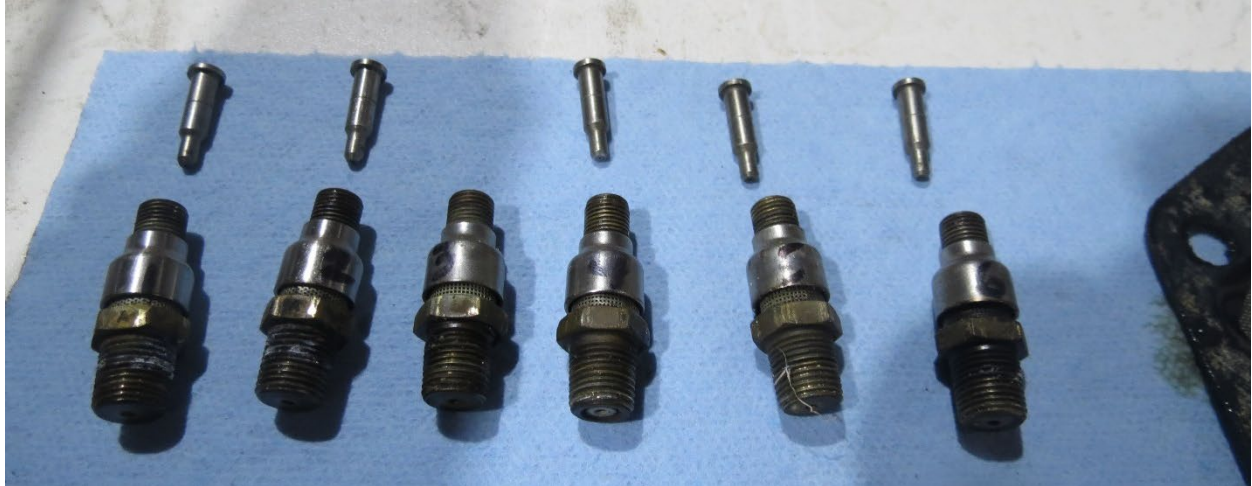
**Figure 23 - Fuel Injector Nozzles**

The fuel injector nozzles remained attached to the engine and no damage was noted. The #1, #2, #4, #5 and #6 nozzles were of a two-piece design. The #3 nozzle was of a 1-piece design. All the nozzles were unobstructed.

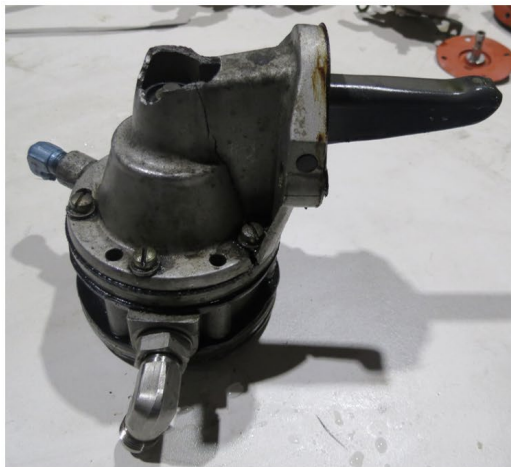
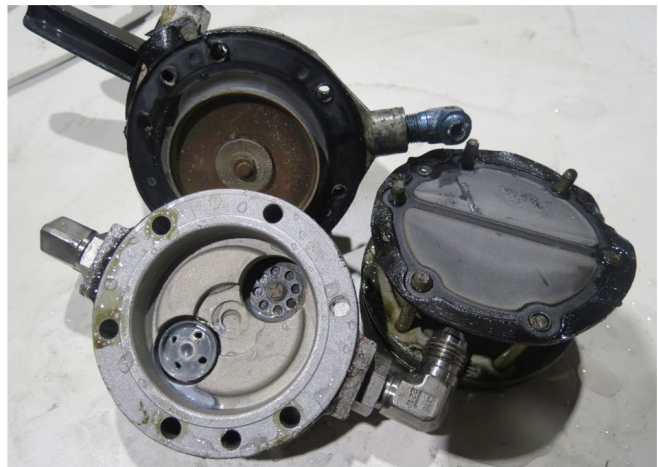
**Figure 24 - Engine Driven Fuel Pump - Intact but Damaged (Left) Partially Disassembled (Right)**

The engine driven fuel pump remained attached to the engine and was impact damaged. The pump was actuated by hand and produced air at the outlet port. The pump was partially disassembled and no damage to the rubber diaphragms or internal check valves noted. Corrosion was observed on the check valves.

Water and liquid with an odor consistent with aviation gasoline was observed in the fuel injector servo and in the engine driven fuel pump.

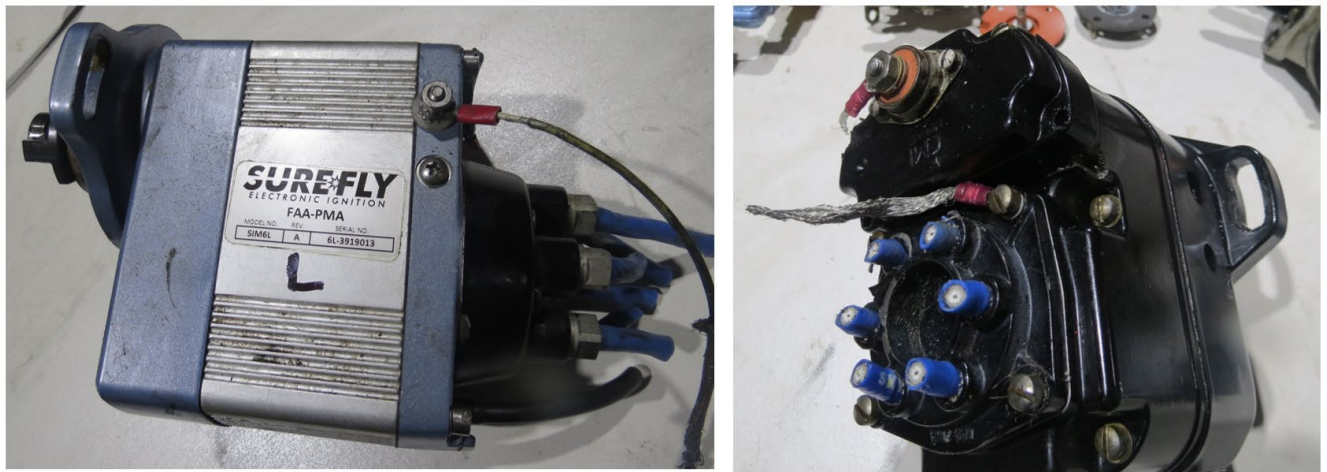
**Figure 25 - Left Magneto (Left) and Right Magneto (Right)**

There was some damage to the ignition harness however the leads remained attached to the spark plugs and the magnetos. Both magnetos remained intact, in place and were undamaged. The left magneto was an aftermarket electronic unit. Water drained from the left magneto when a plug was removed from the housing. When rotated, the left magneto did not produce spark (it likely may require electrical power to function, which was not applied). The right magneto produced spark on all 6 ignition leads when rotated with an electric drill.

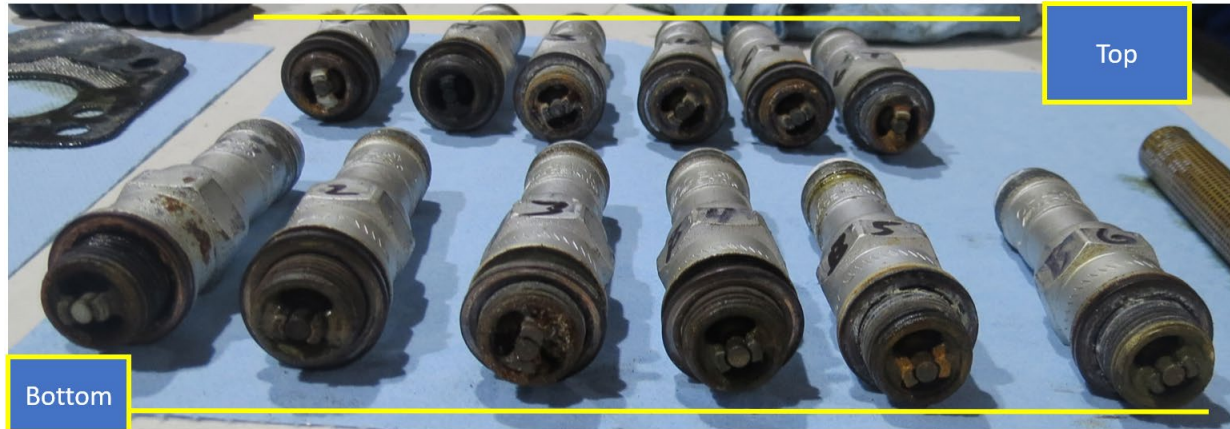
**Figure 26 - Spark Plugs - No. 1 through 6 Left to Right**

All spark plugs exhibited some water and/or corrosion products. None of the electrodes were damaged, and all appeared "worn-normal" as compared to a Champion check-a-plug chart.
