# NATIONAL TRANSPORTATION SAFETY BOARD

## MATERIALS LABORATORY FACTUAL REPORT

Report No. 22-070

Place : Marathon, Florida  
Date : December 29, 2021  
Vehicle : Cessna 207, N1596U  
NTSB No. : ERA22LA097  
Investigator : Adam Gerhardt, AS-ERA

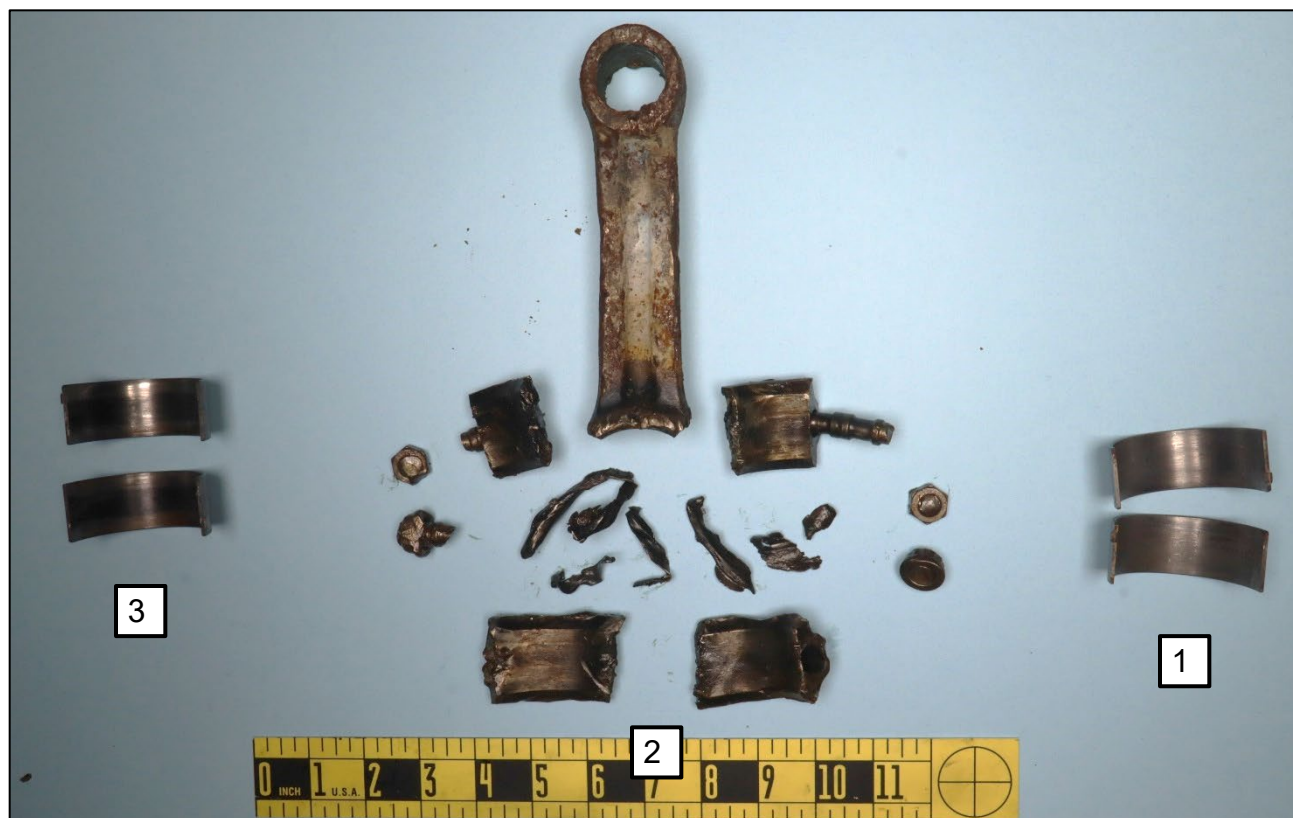
An overall view of the submitted number 2 connecting rod assembly and bearing pieces and bearings from the numbers 1 and 3 connecting rods are shown in figure 1. The number 2 connecting rod assembly was fractured in multiple locations at the big end of the assembly. The bearing halves for the number 3 connecting rod were darkened near the middle of the bearing around the circumference, and displaced and smeared babbitt material was observed on the interior surfaces. The bearing halves for the number 1 connecting rod had a nominal appearance with no indication of abnormal wear or damage.

Figure 1. Overall view of the submitted number 2 connecting rod and bearing pieces and bearings from the numbers 1 and 3 connecting rods.

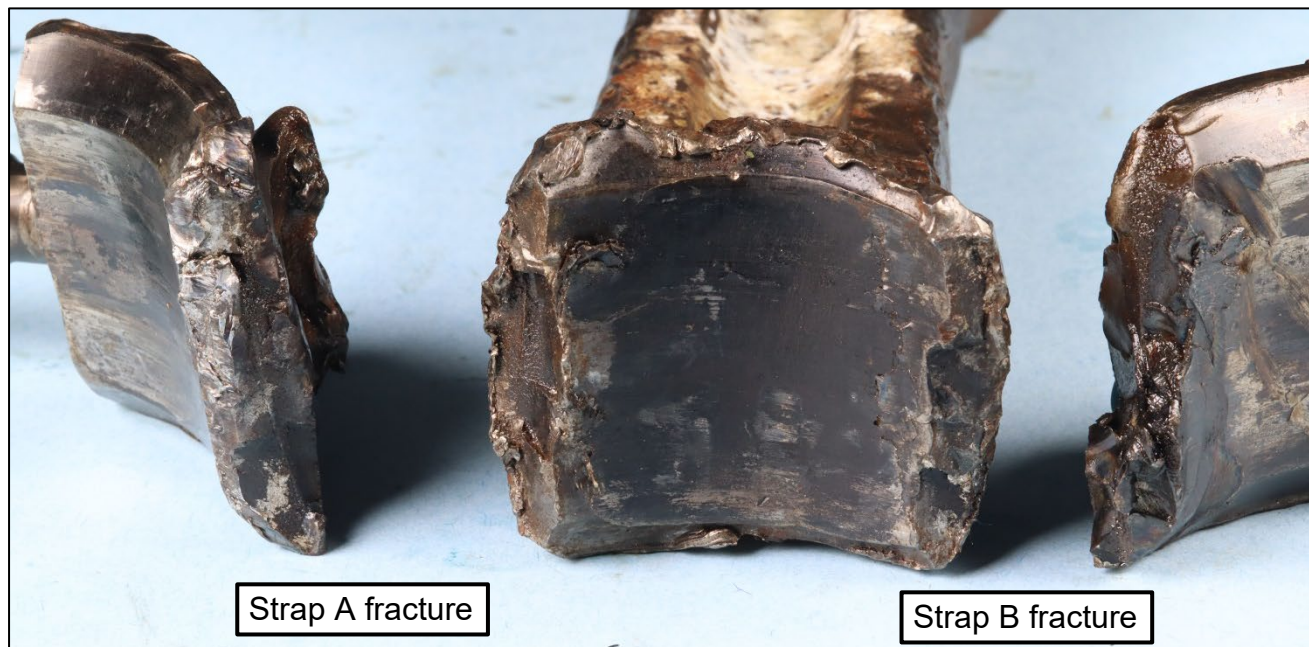
The number 2 connecting rod beam and small end portions had a mix of white and orange deposits and oxides on the surfaces consistent with exposure to sea water.<sup>1</sup> However, the big end of the connecting rod was tinted black consistent with exposure to high heat during operation. The number 2 bearing was mostly missing, and the submitted recovered pieces were thinned, fractured, and severely deformed with dark heat tinting. The interior faces at the big end of the connecting rod were tinted a dark color, particularly on the beam side of the surfaces, and showed circumferential scoring and smeared metal (see figures 2 and 3).

The connecting rod was also fractured through the straps on either side of the beam. The straps were arbitrarily labeled "A" and "B" as indicated in figure 2. Mating sides of the strap A fracture are shown in figure 5. Both sides of the fracture were substantially damaged by post fracture impacts. However, remaining fracture features showed flat fractures with curving arrest lines, features consistent with fatigue. Fatigue features emanated from multiple origins on the interior surface and from at least one origin area on the exterior surface. Unlabeled arrows in figure 5 indicate approximate locations of fatigue origins, including damaged areas where the origin location was estimated based on features observed on the mating fracture face. The fatigue cracks emanating from the interior and exterior surfaces appeared to intersect near the middle of the strap cross-section through the thickness at the location indicated with a dashed line. The entire extent of the fatigue boundary and other likely origin areas were obliterated by post fracture damage to both sides of the fracture.

Figure 2. Interior surfaces at the big end of the number 2 connecting rod.

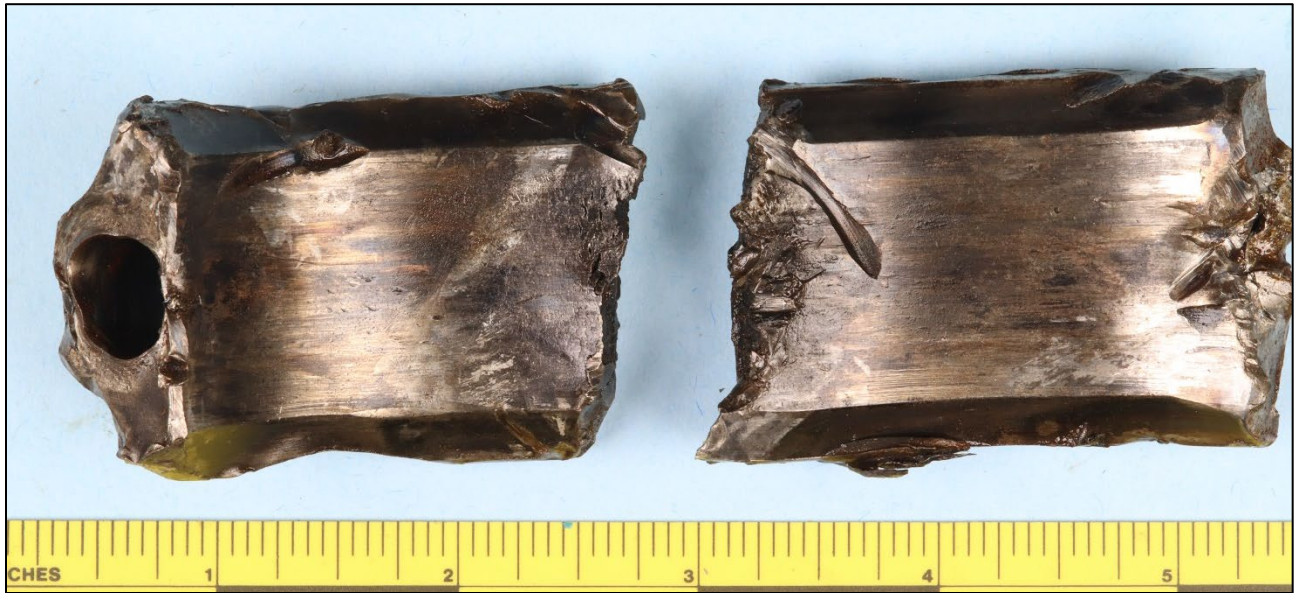
The cap fractured into two pieces as shown in figure 3. Much of the fracture surfaces were damaged by post fracture contact, and most of the remaining surface had rough features consistent with ductile overstress fracture. However, one area had relatively flat features with a smoothly curving boundary as shown in figure 4, features consistent with fatigue. The fatigue features emanated from a relatively broad origin area at the interior surface as shown in figure 4. The dashed line in figure 4 indicates the fatigue boundary, and the total area of the fatigue region represented less than 5 percent of the total cross-sectional area.

Figure 3. Interior surface of the fractured number 2 connecting rod cap.

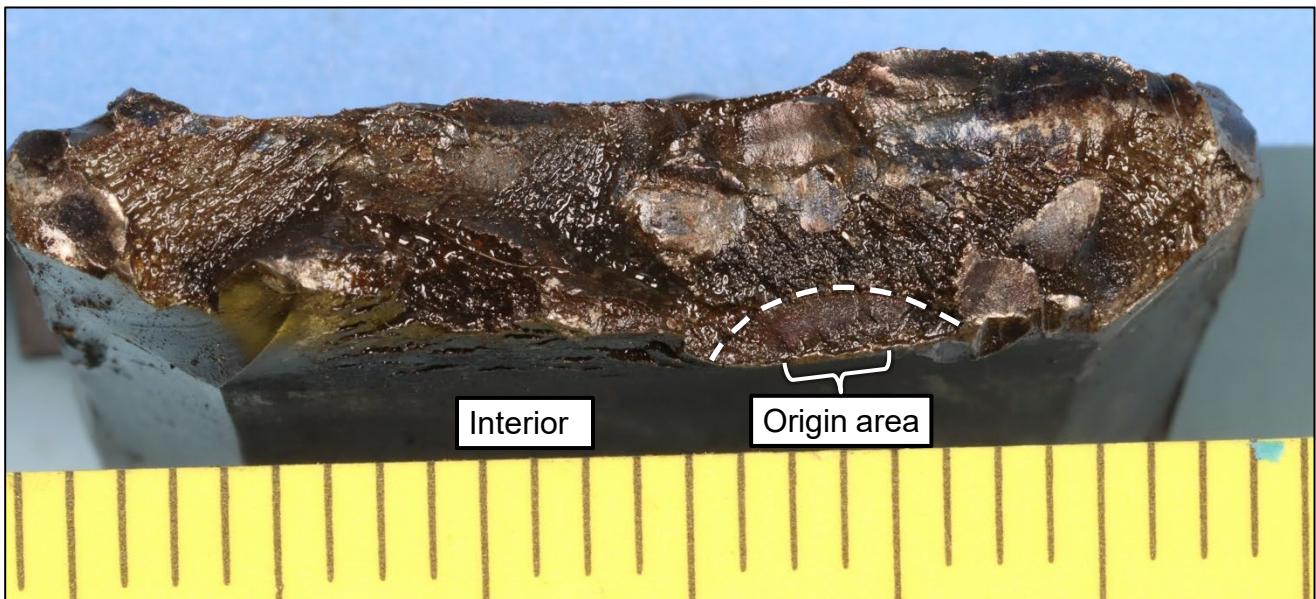
Figure 4. Fracture surface of the number 2 connecting rod cap. A dashed line indicates the boundary of a fatigue region.

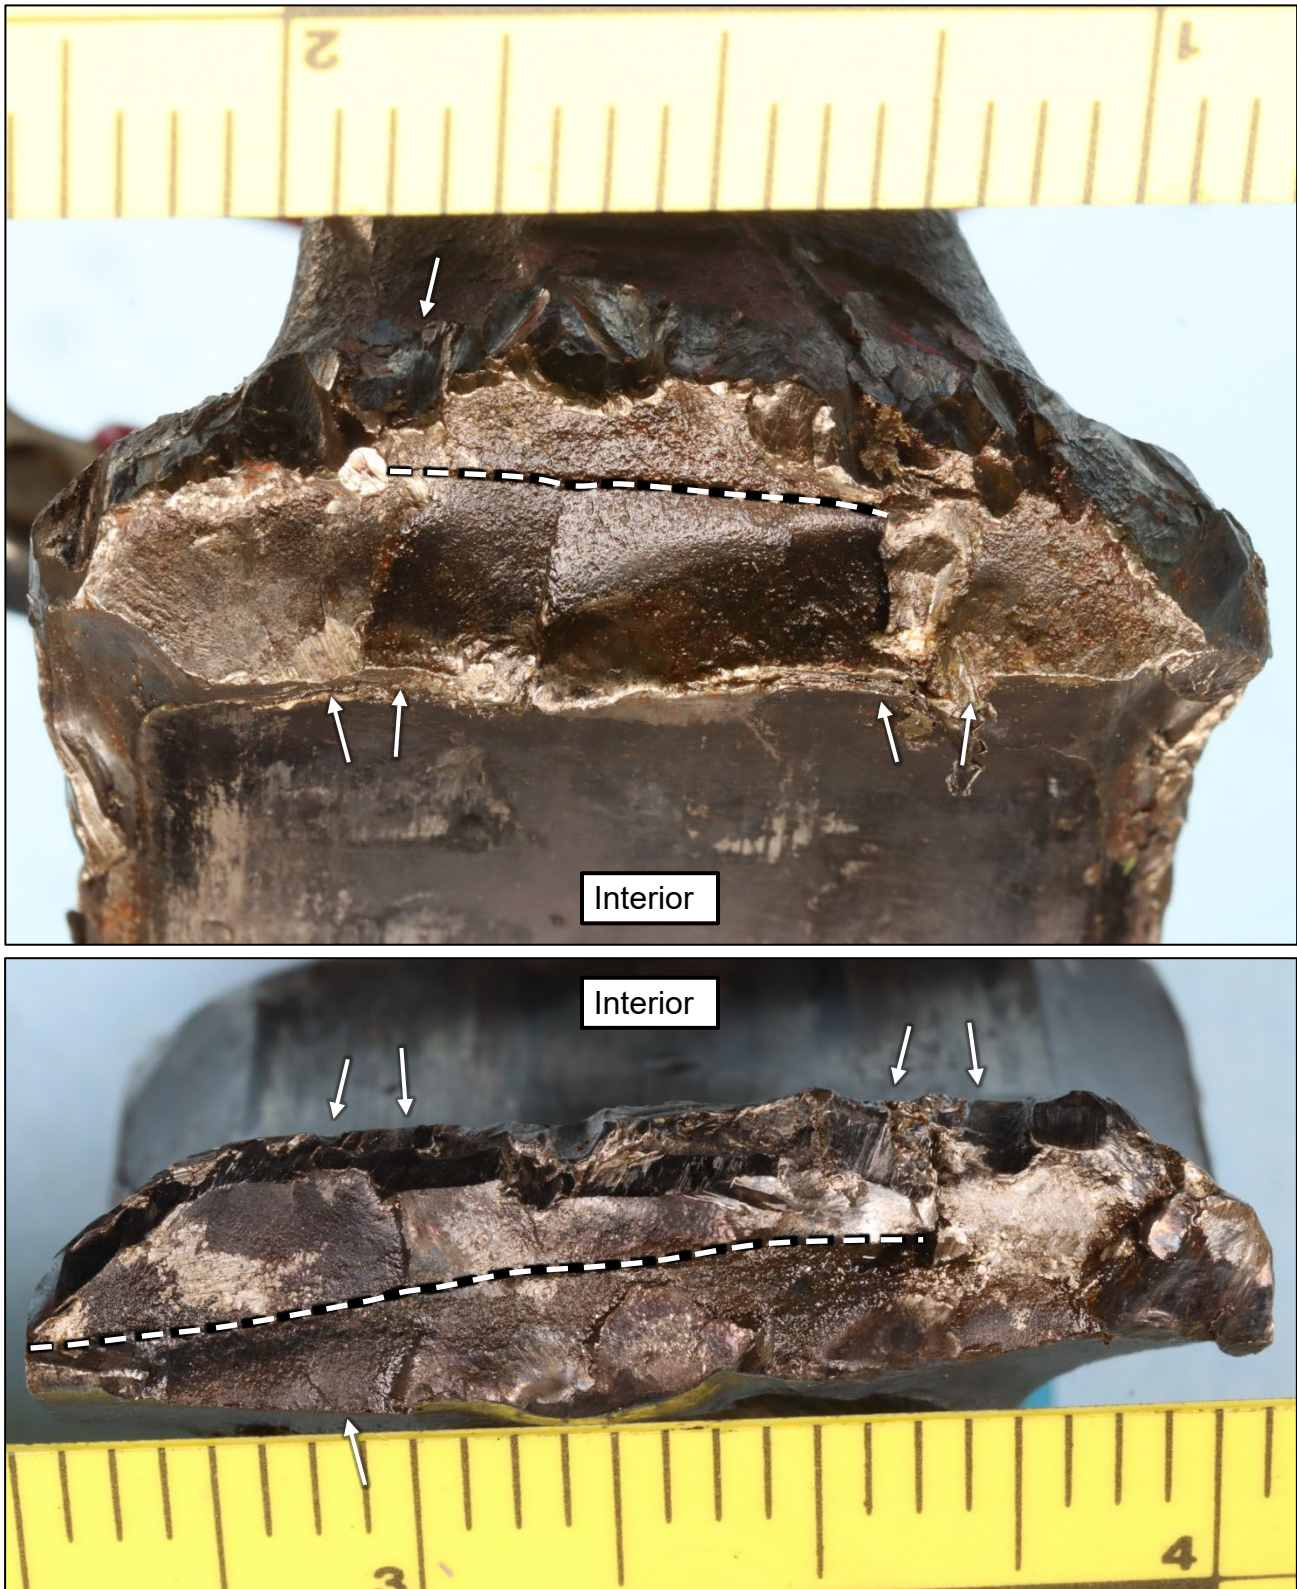
Figure 5. Mating fracture faces on strap A of the number 2 connecting rod. Dashed lines indicate partial fatigue boundaries, and arrows indicate approximate origin areas.

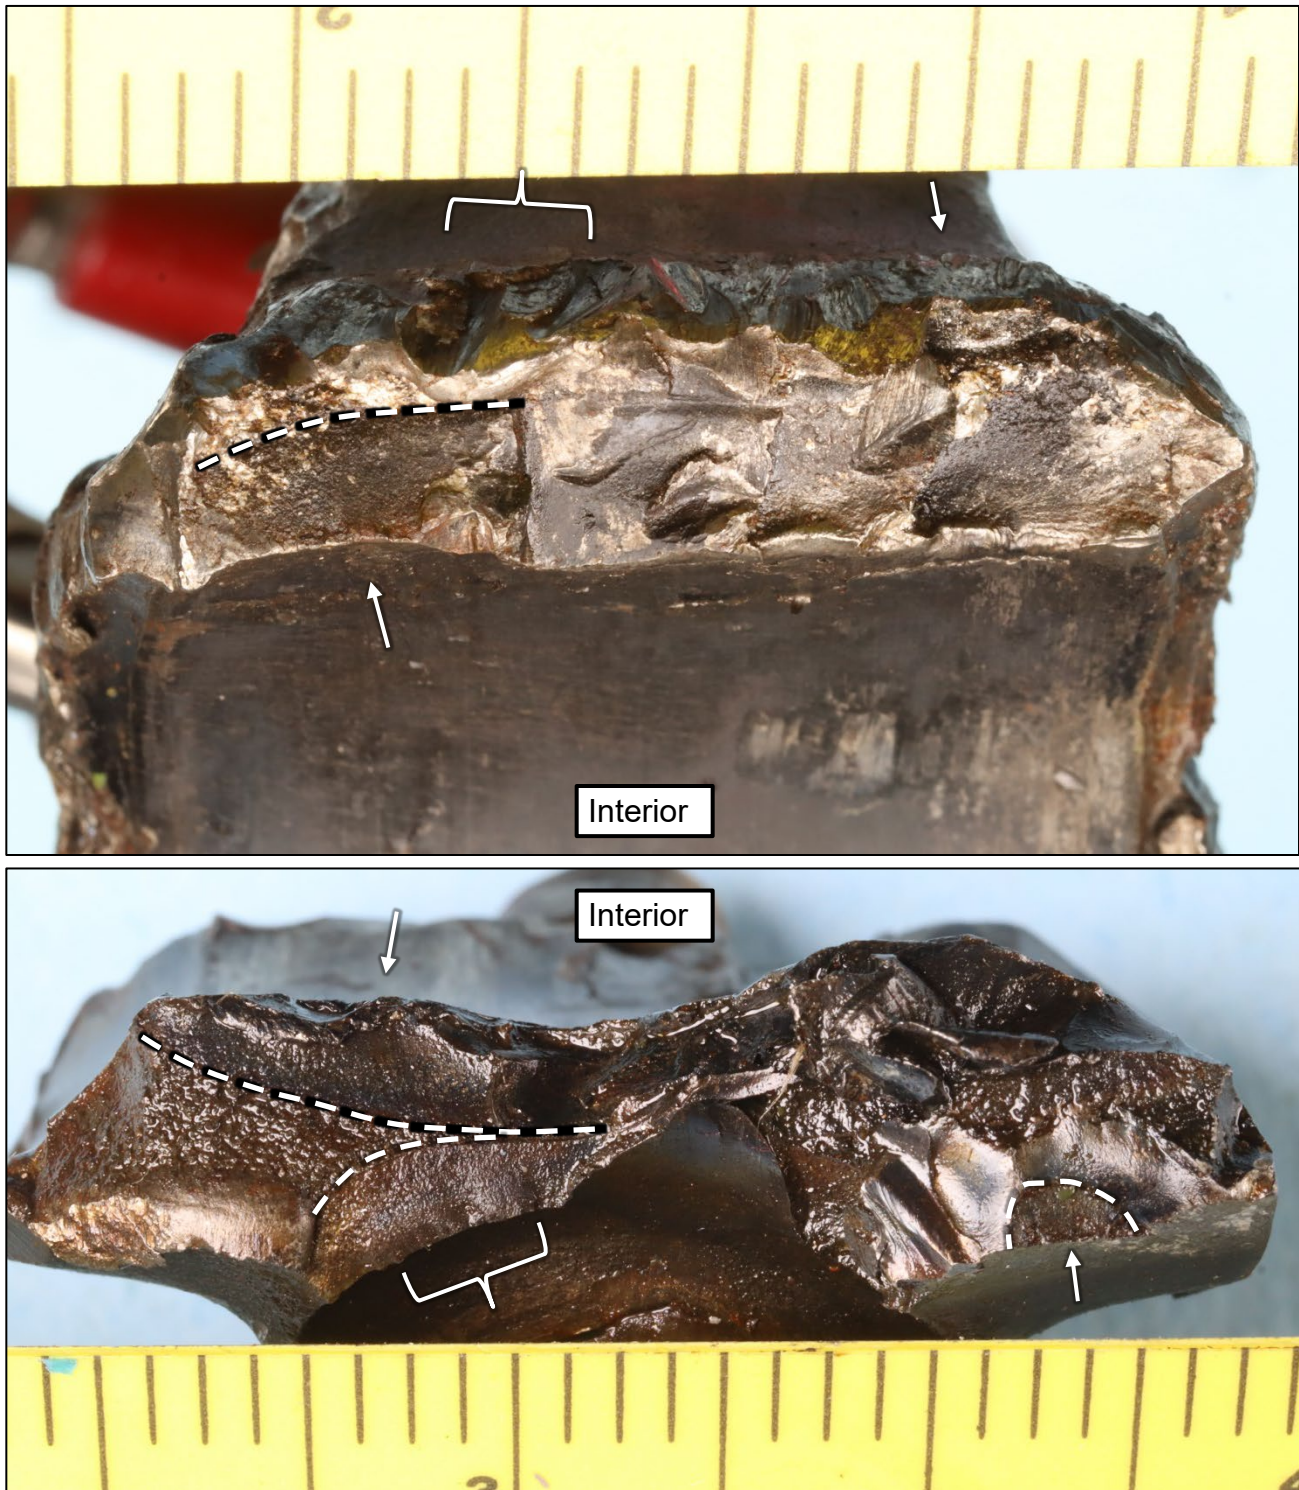
Mating sides of the strap B fracture are shown in figure 6, where features similar to the strap A fracture were observed. Both sides of the fracture were substantially damaged by post fracture impacts. However, remaining fracture features showed areas with flat fractures with curving boundaries, features consistent with fatigue. Fatigue features emanated from at least one origin on the interior surface and from multiple origins on the exterior surface. Unlabeled arrows and brackets in figure 6 indicate approximate locations of fatigue origins, including damaged areas where the origin location was estimated based on features observed on the mating fracture face. The fatigue cracks emanating from the interior and exterior surfaces intersected near the middle of the strap cross-section through the thickness, but rougher features were observed near the outer edges consistent with ductile overstress fracture of the remaining ligament. The entire extent of the fatigue boundaries and other likely origin areas were obliterated by post fracture damage to both sides of the fracture.

Figure 6. Mating fracture faces on strap B of the number 2 connecting rod. Dashed lines indicate partial fatigue boundaries, and arrows and brackets indicate approximate origin areas.
