**NTSB ERA22LA097**

N1596U, Cessna 207

Photo Array

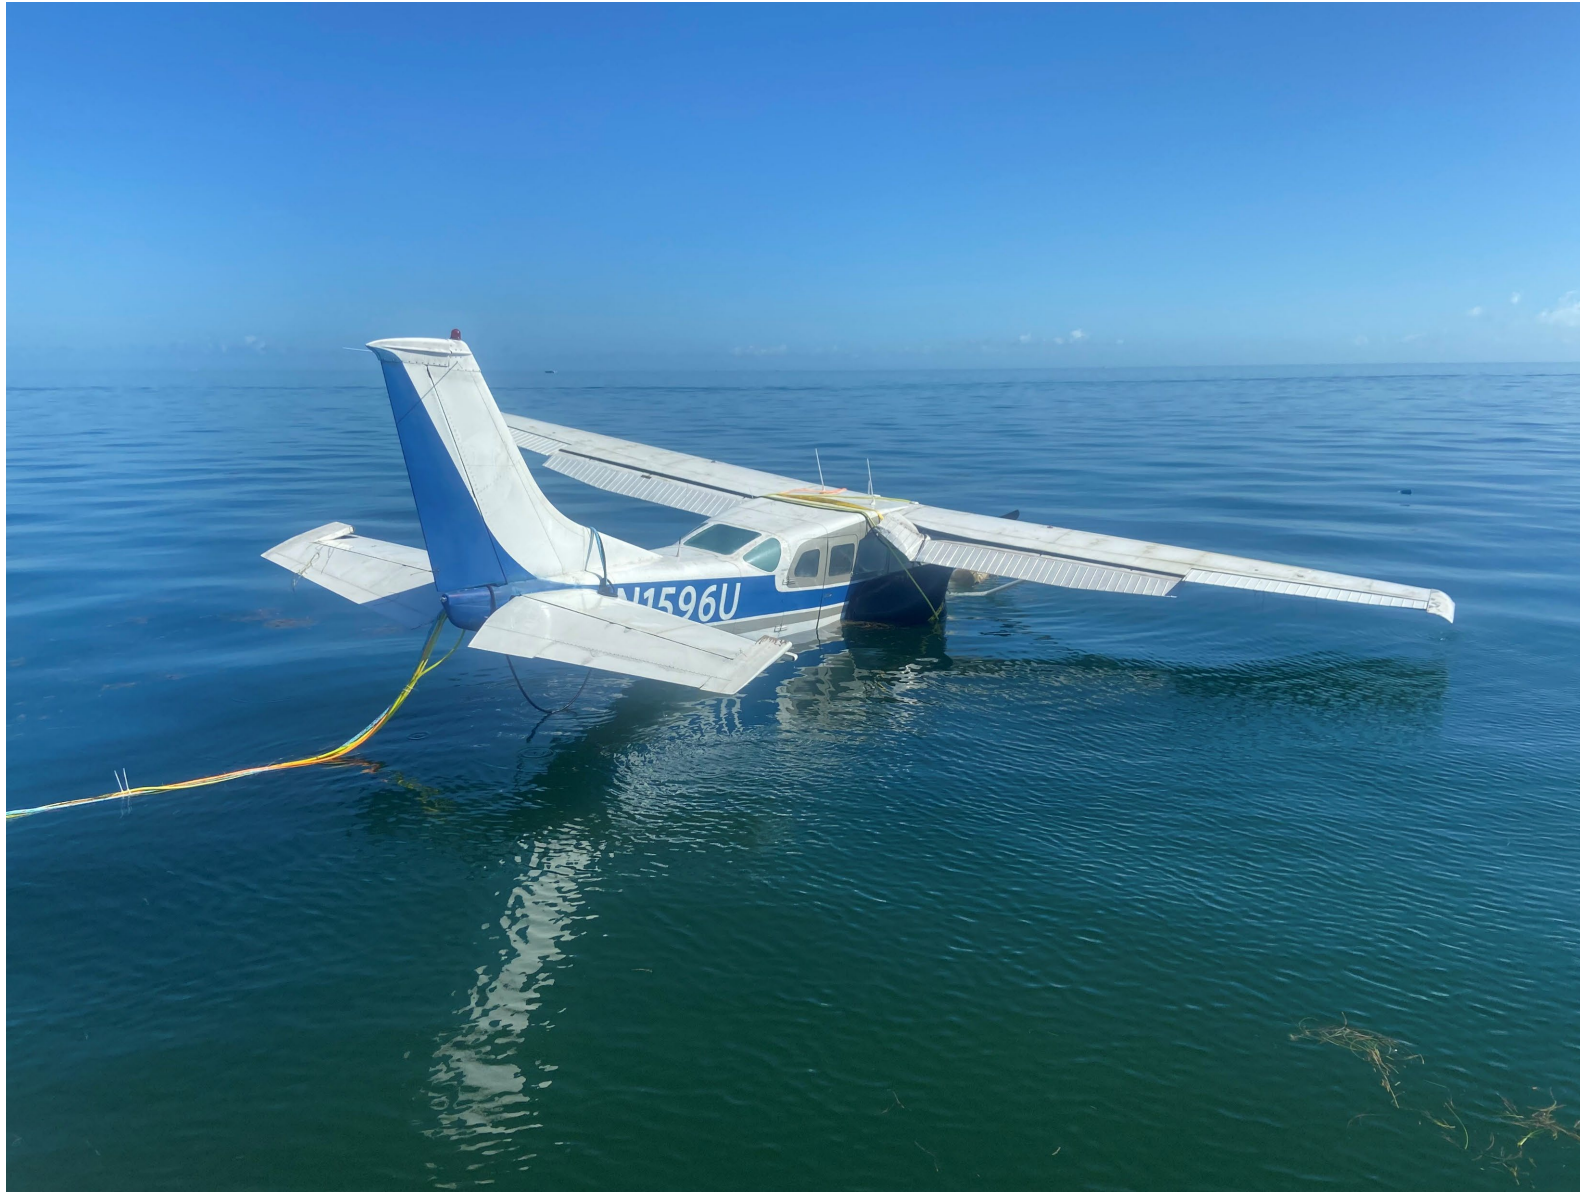
Photo 1: Overview of the airplane partially submerged in water as viewed during the recovery operations  
(Photo Courtesy of Florida Air Recovery)

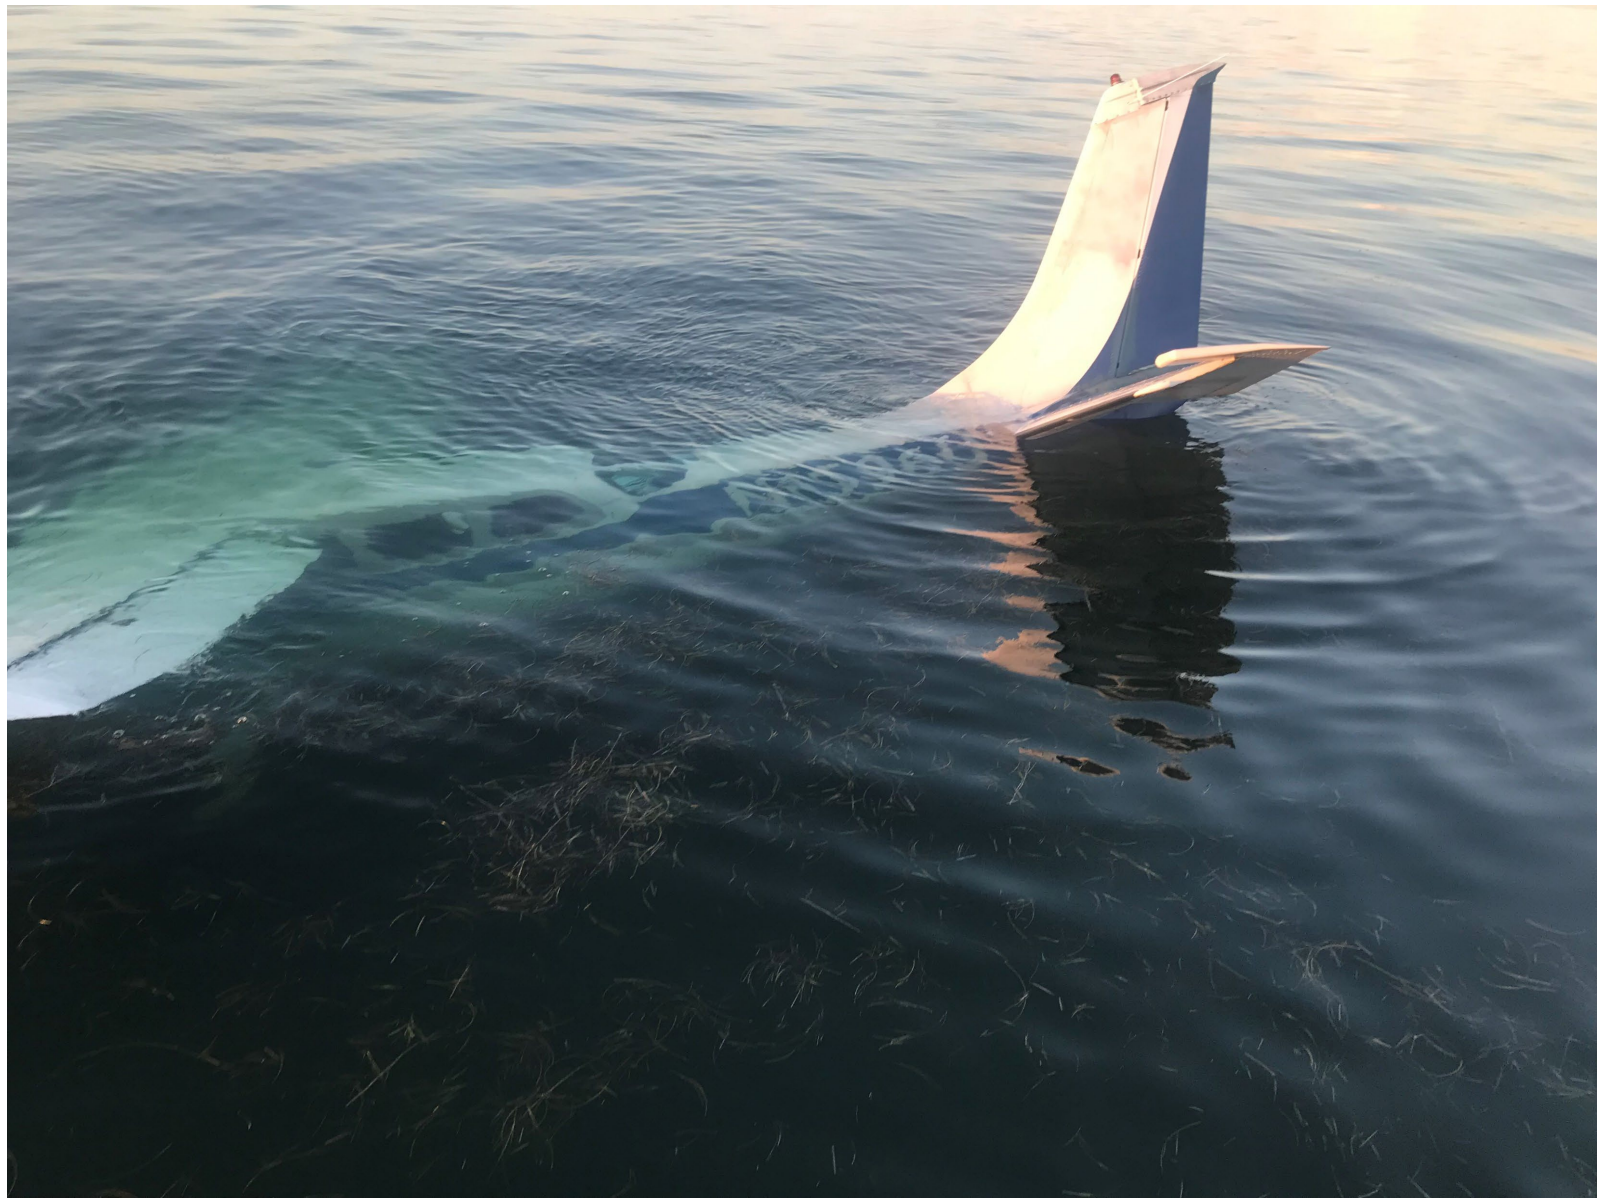
Photo 2: Overview of the airplane mostly submerged underwater at the accident site (Photo Courtesy of Florida Air Recovery)

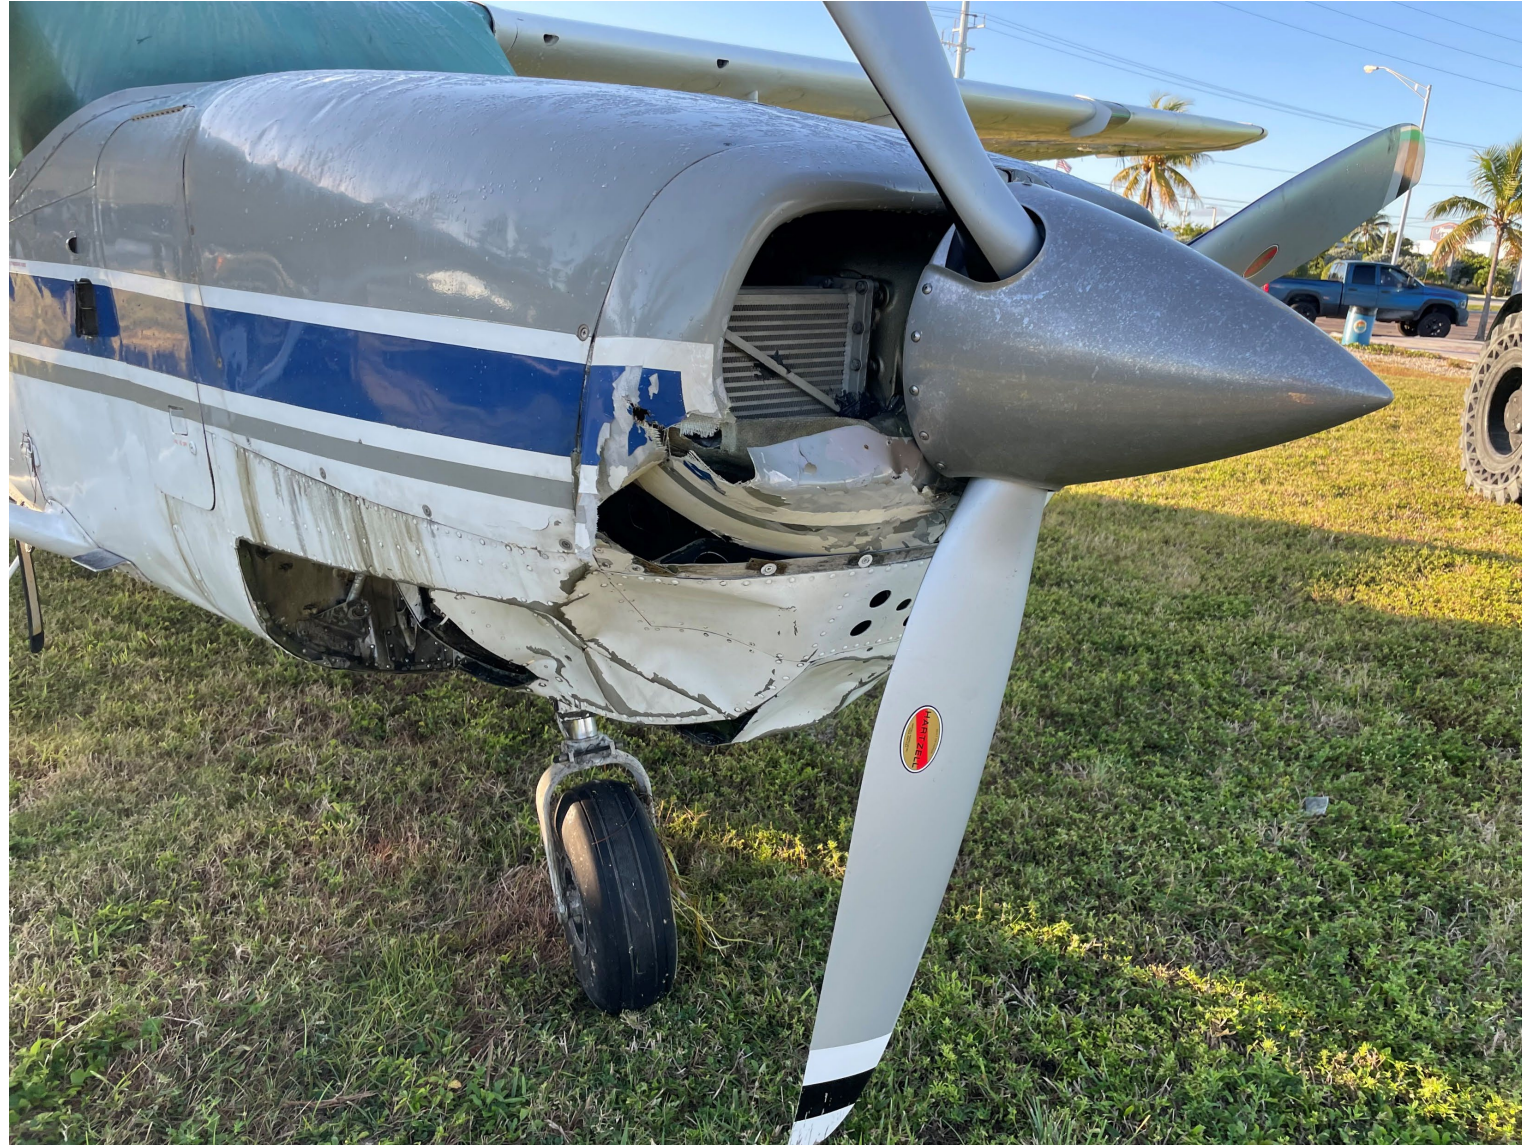
Photo 3: Overview of the cowling and engine area after the airplane had been recovered to shore (Photo Courtesy of FAA)

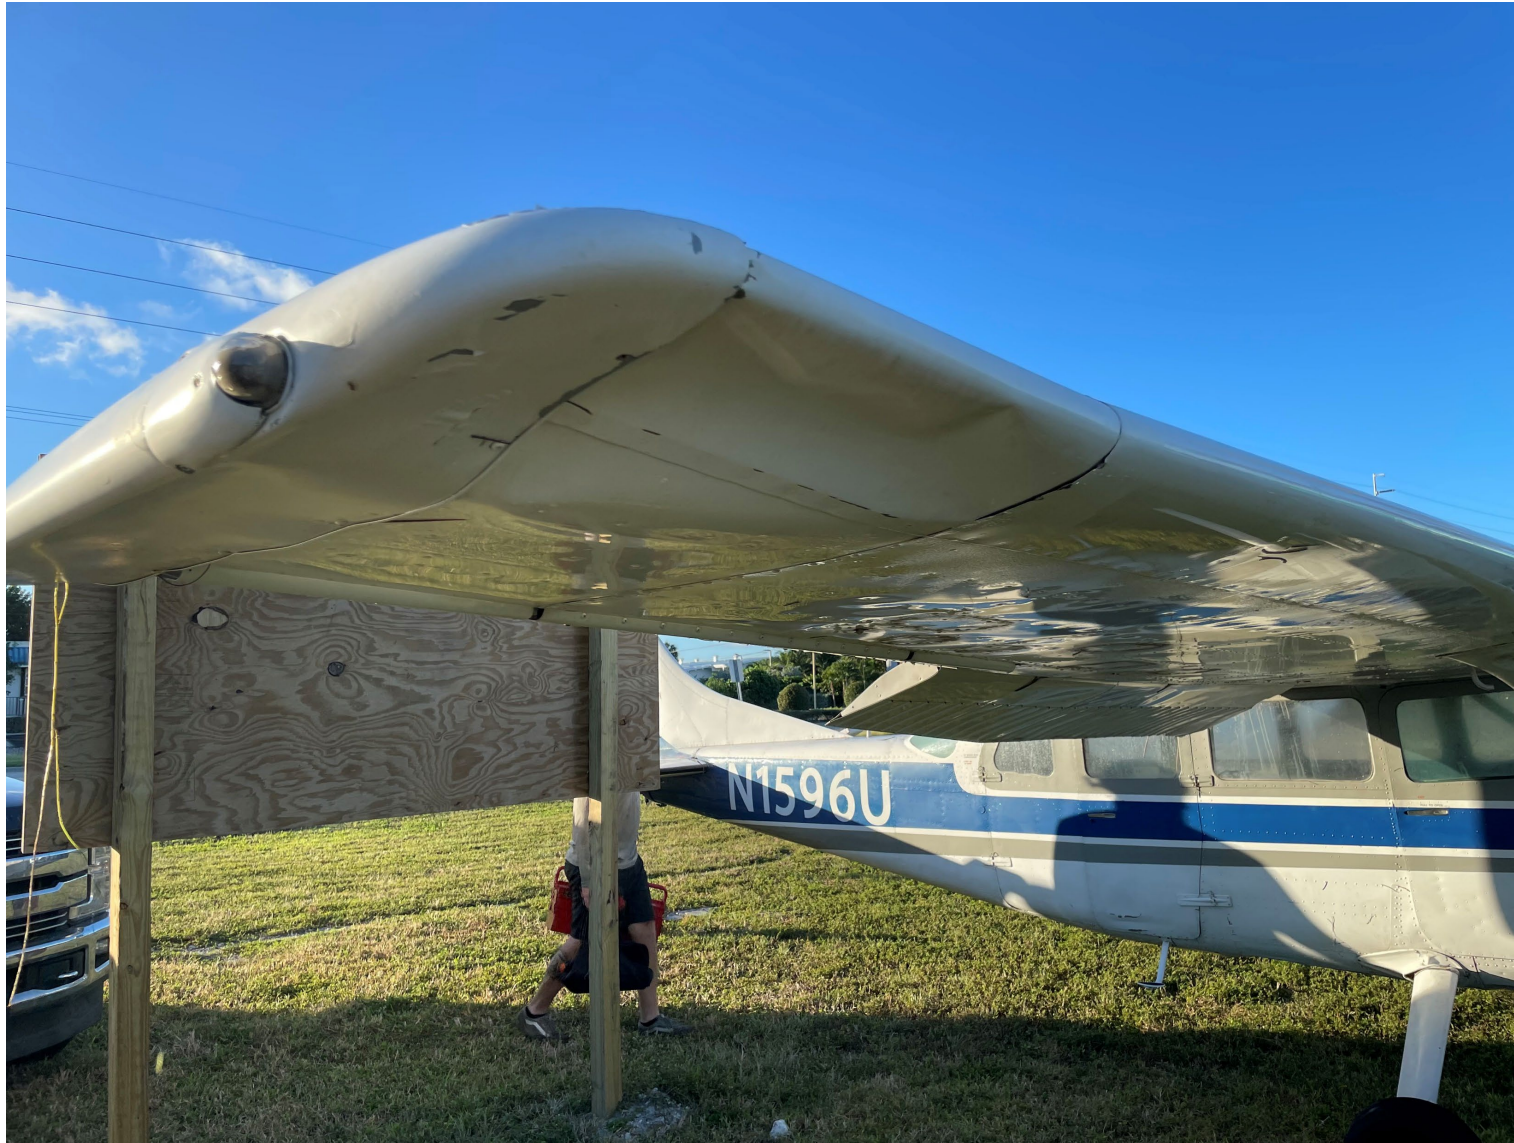
Photo 4: Overview of the right wing (Photo Courtesy of FAA)

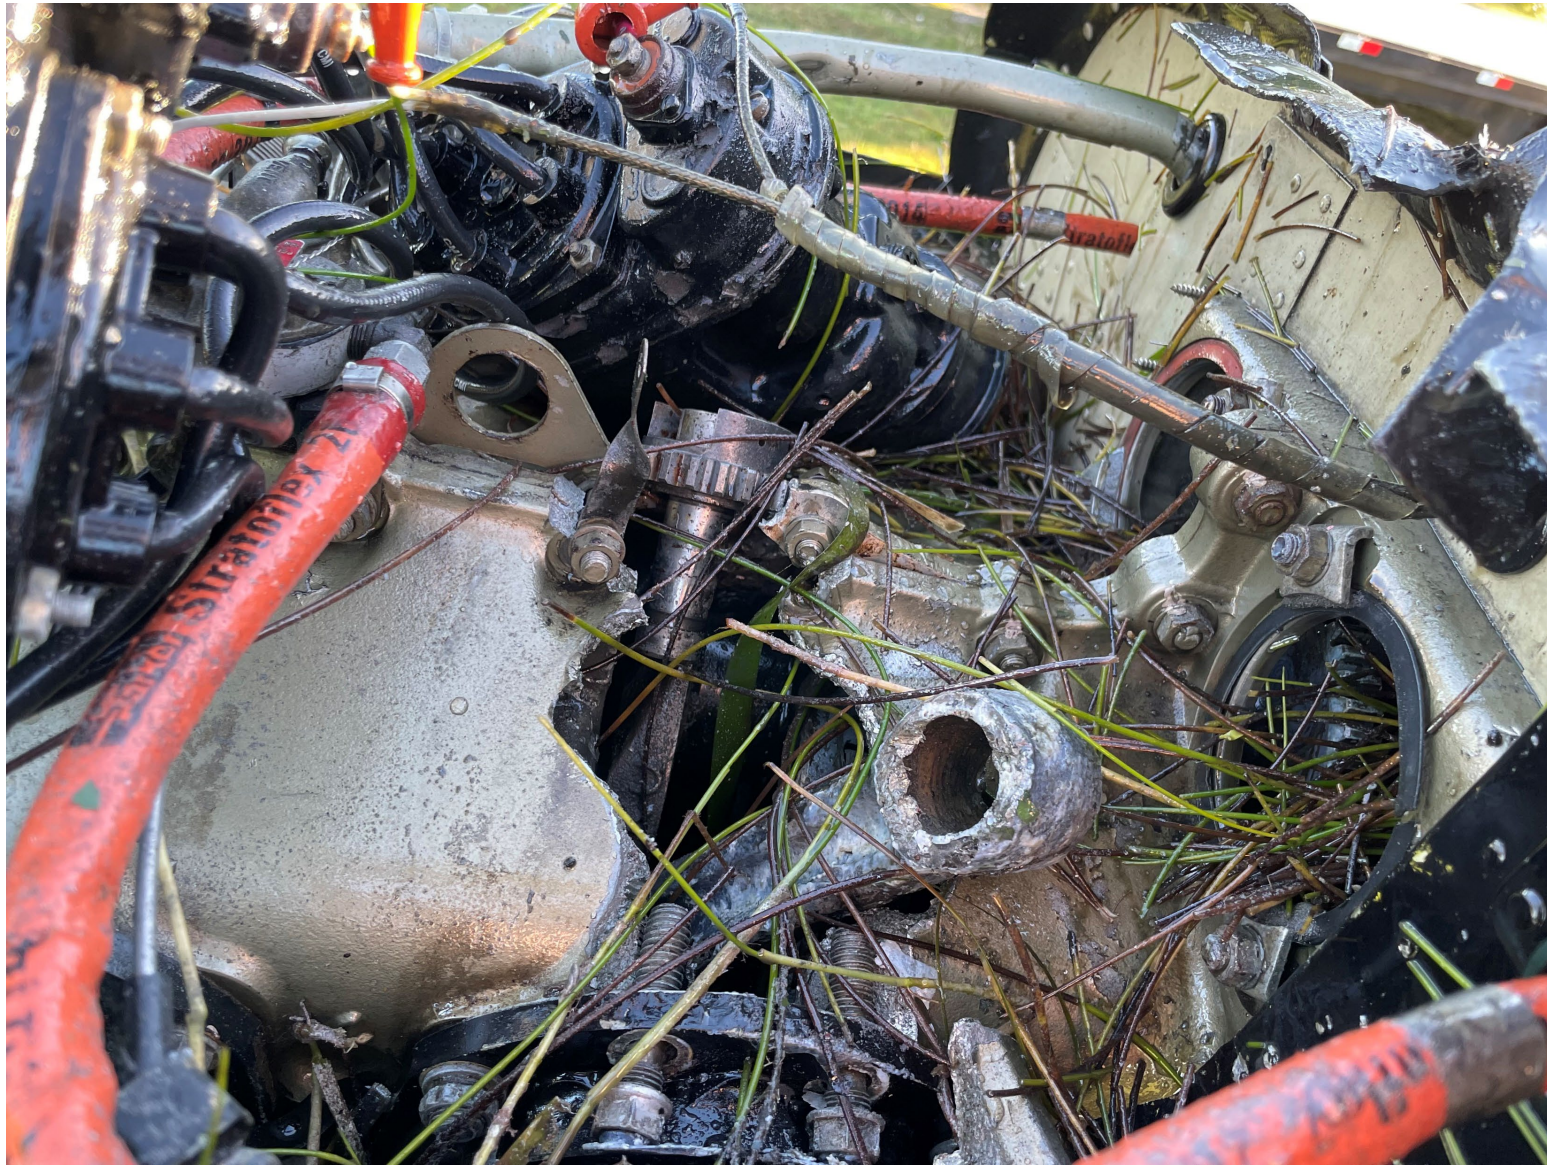
Photo 5: Overview of the engine damage near the No. 2 Cylinder (Photo Courtesy of FAA)

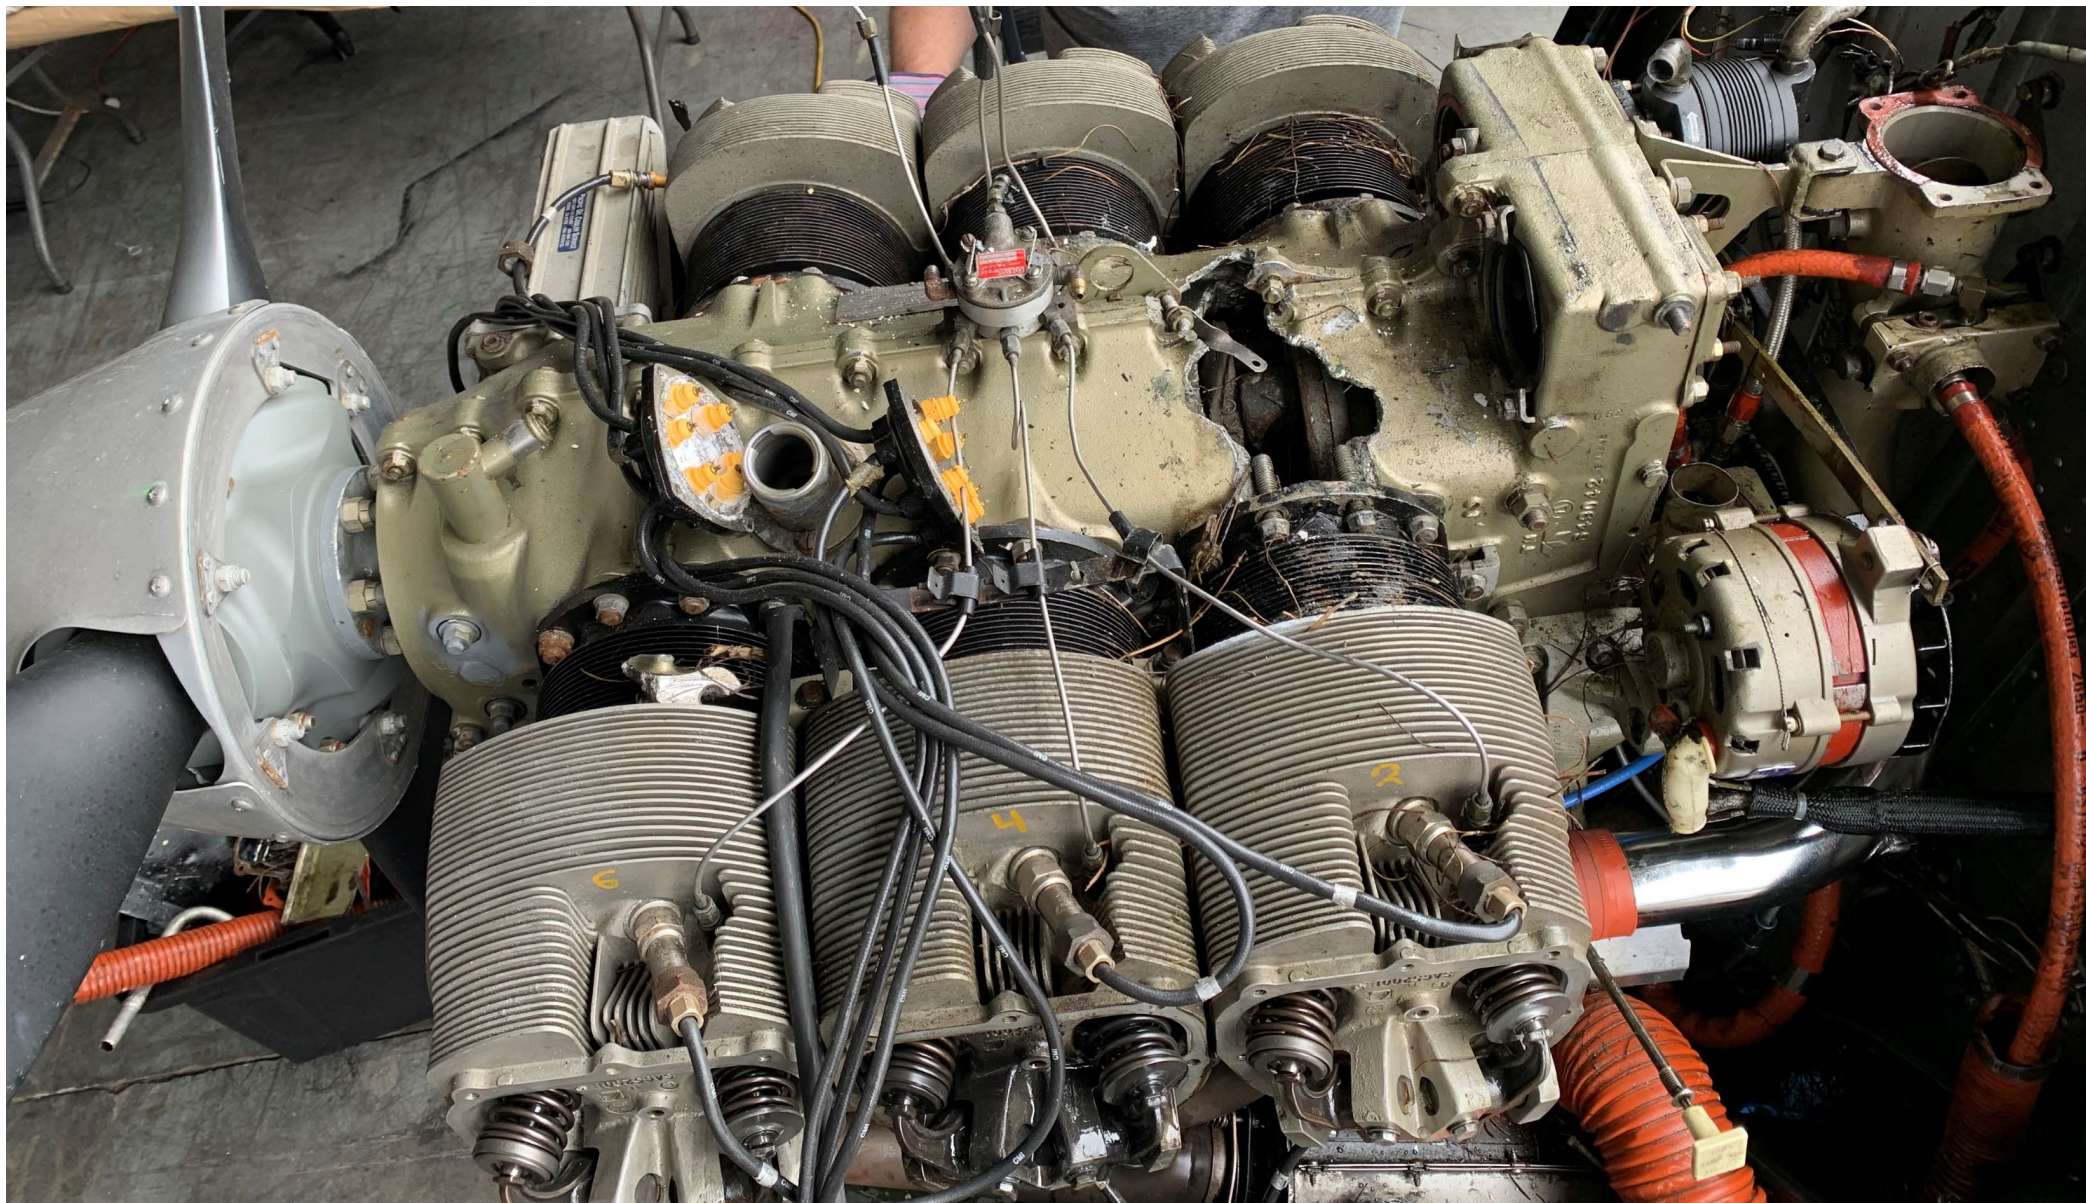
Photo 6: Overview of engine and damage near its aft end, concentrated near the No. 2 Cylinder (NTSB Photos)

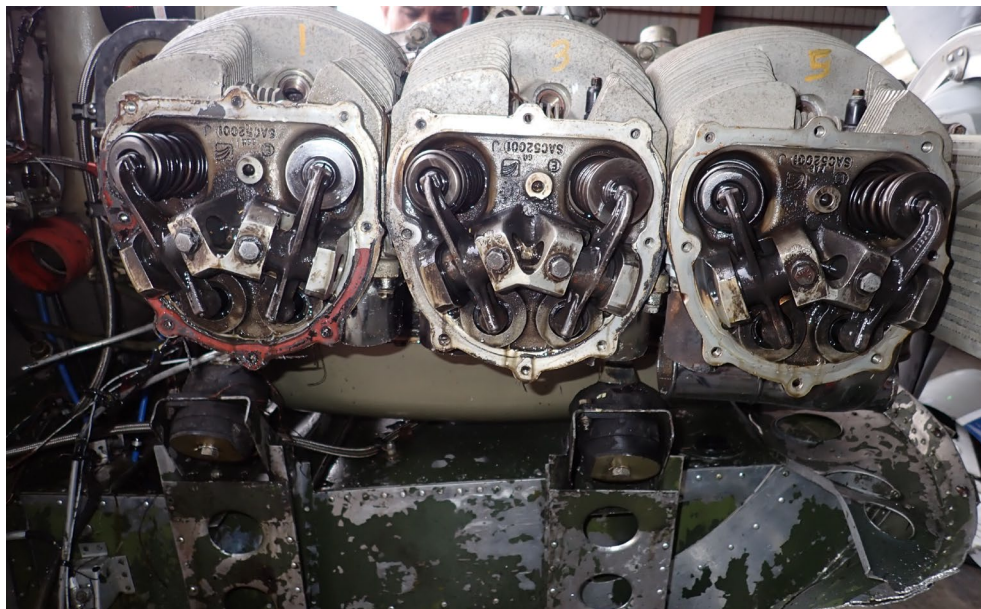
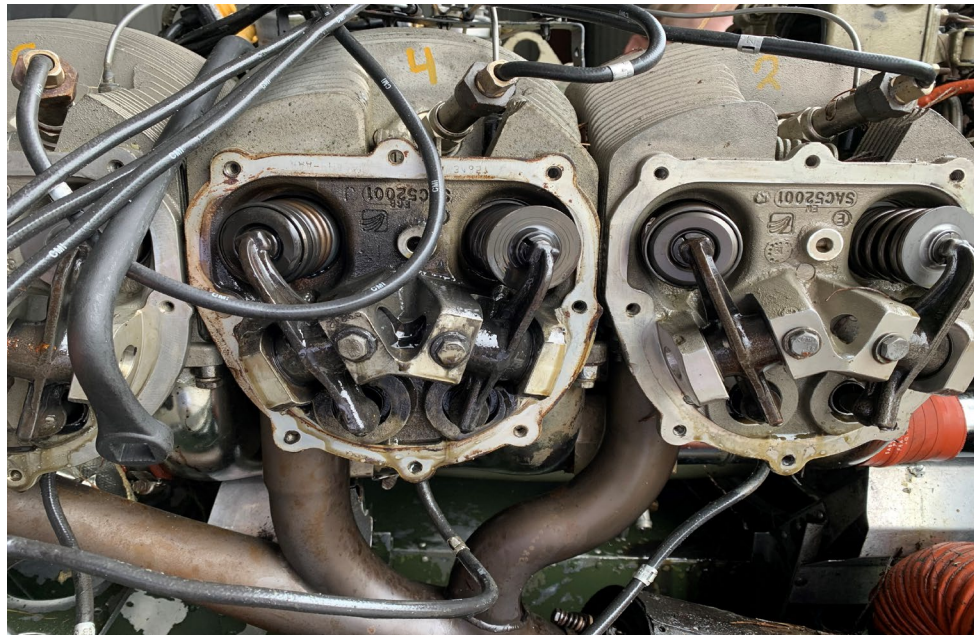
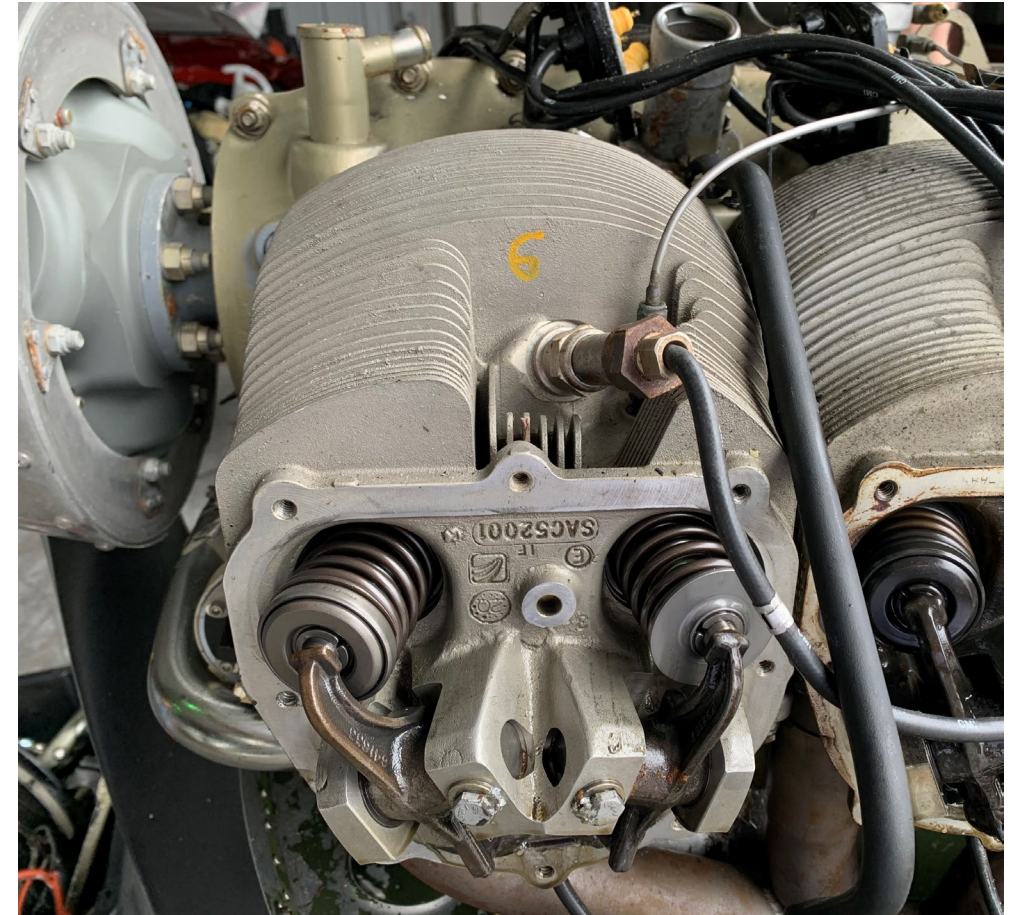
Photos 7, 8, 9: Overview of each cylinder (NTSB Photo)

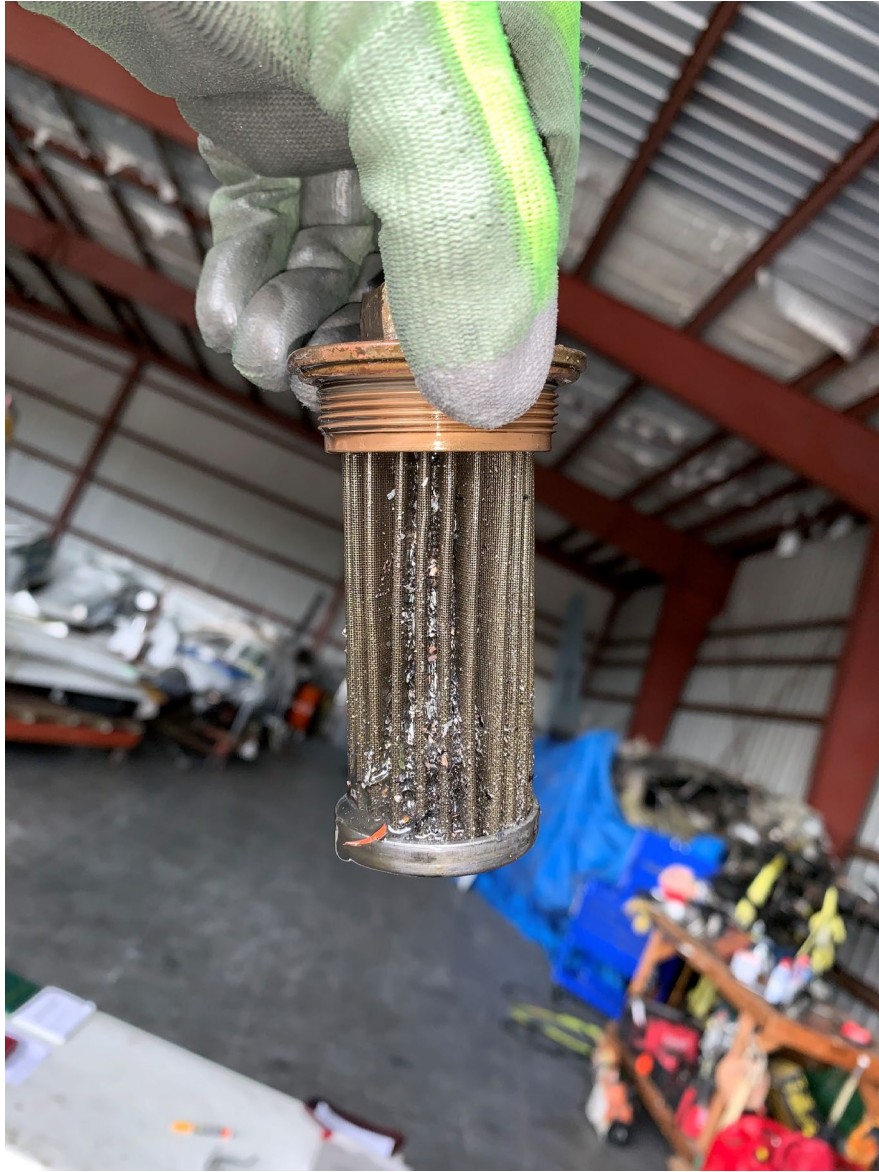
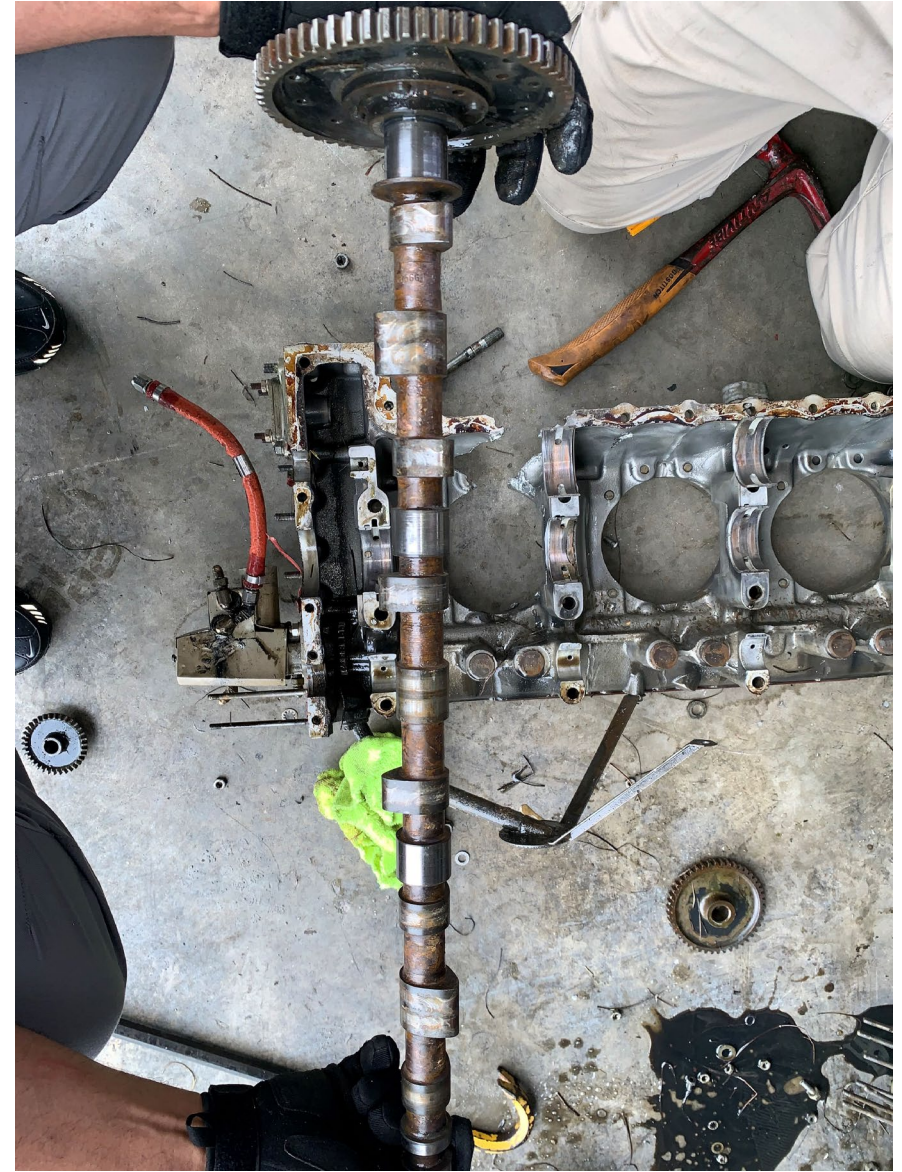
Photos 10, 11: Overview of the oil filter and the camshaft disassembled (NTSB Photo)

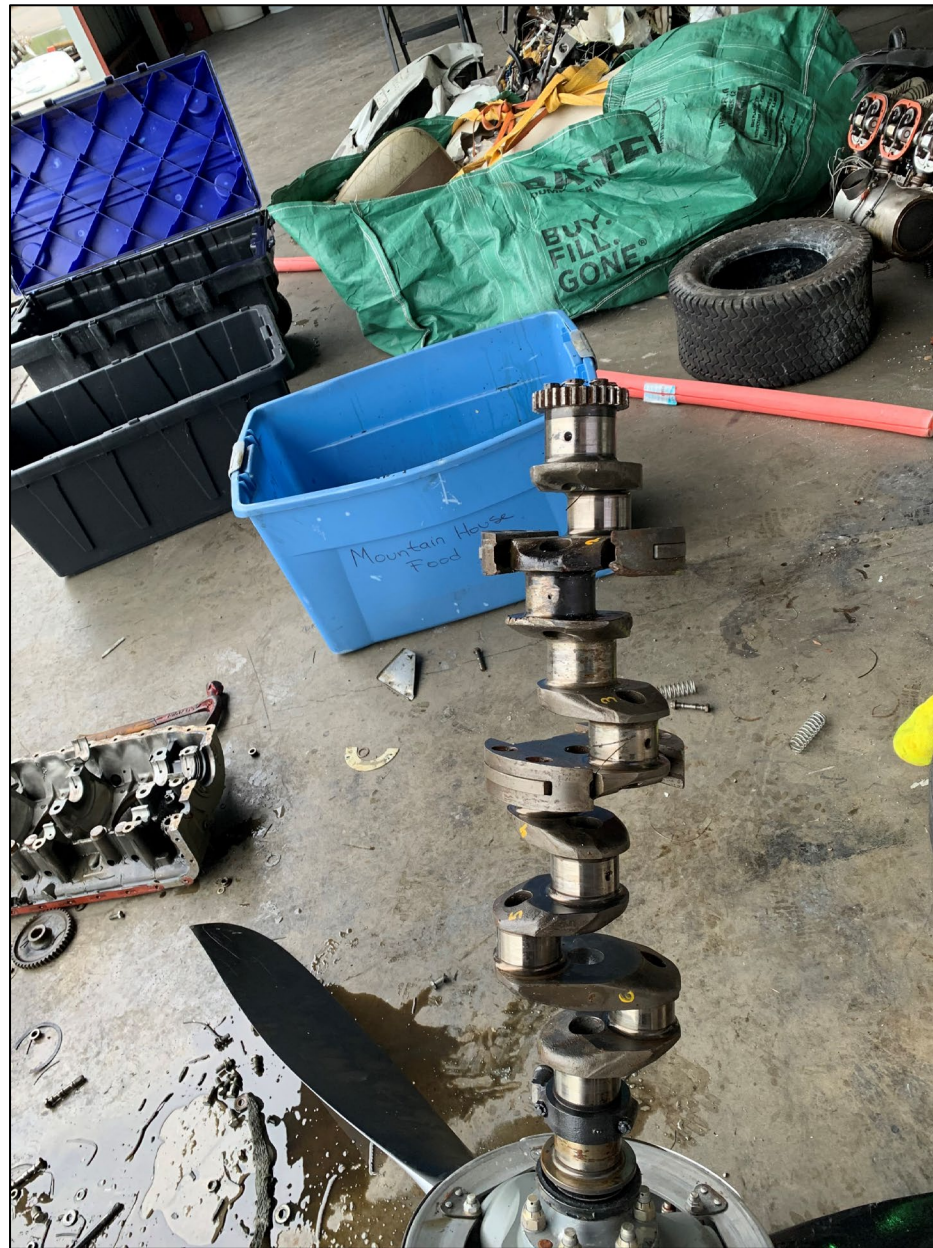
Photo 12: Overview of the crankshaft post disassembly (NTSB Photo)
