# Figures from Report

NTSB Investigation: ERA22LA097

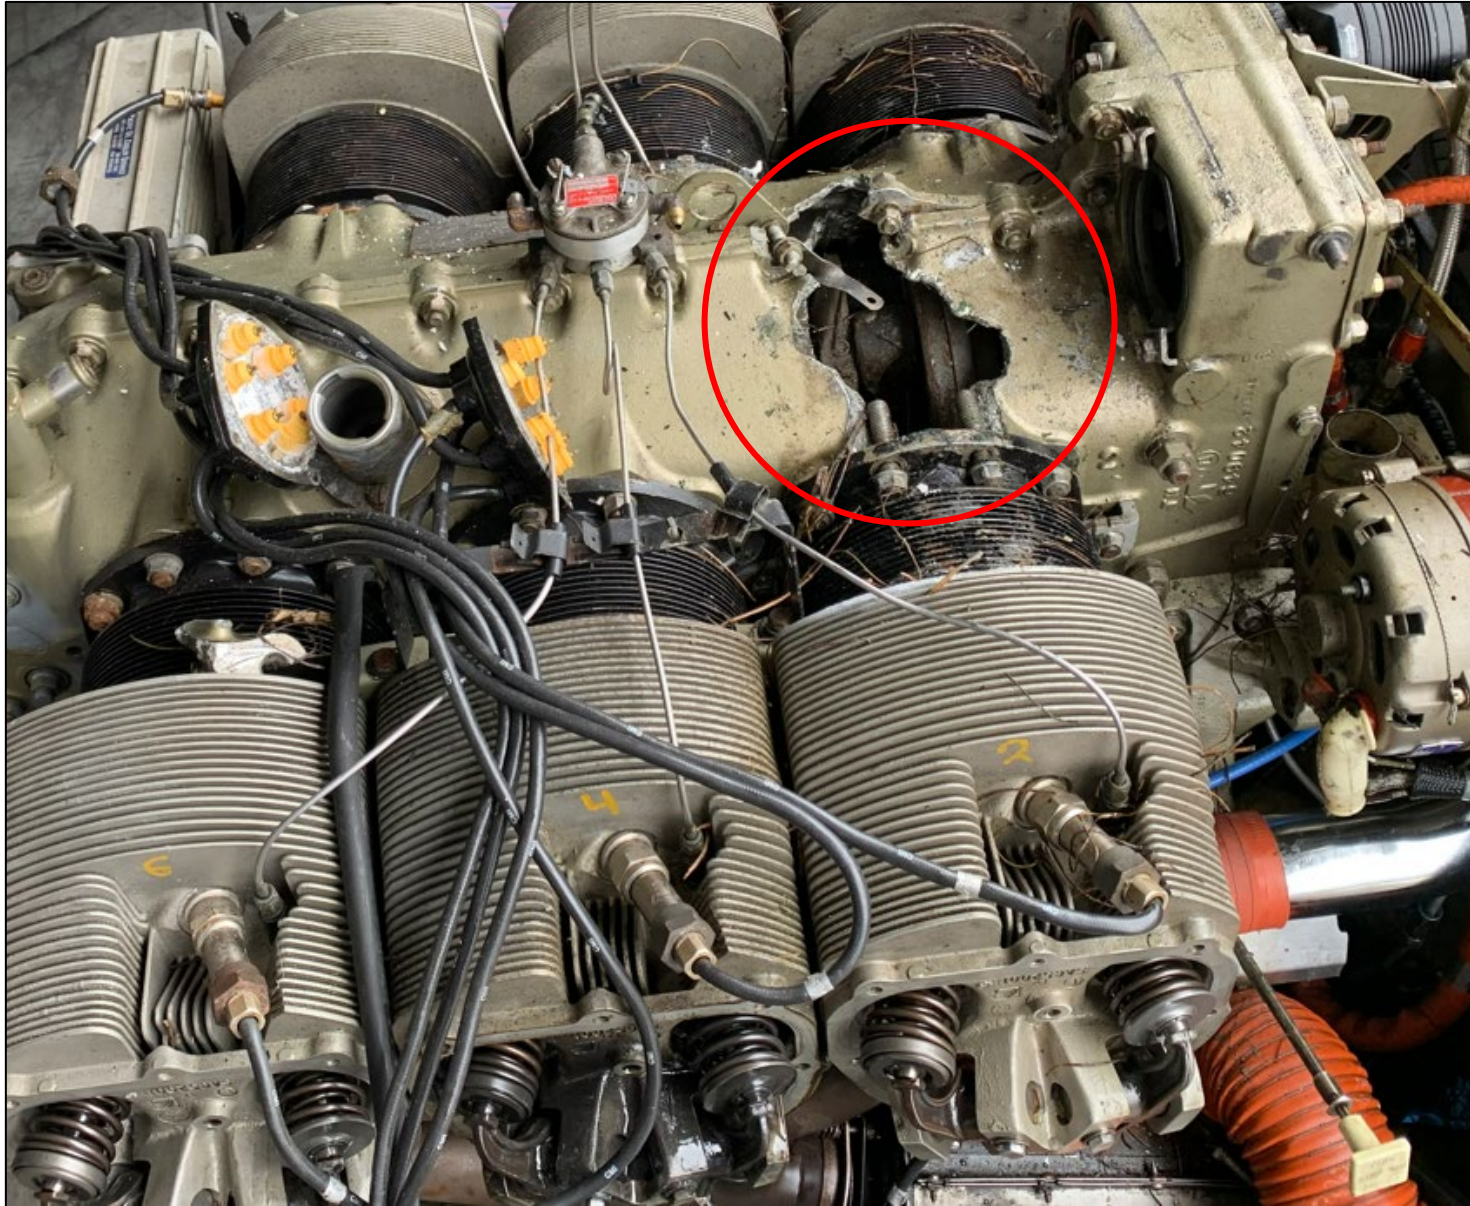
Figure 1: View of the engine damage originating at the No. 2 cylinder area (NTSB Photo)

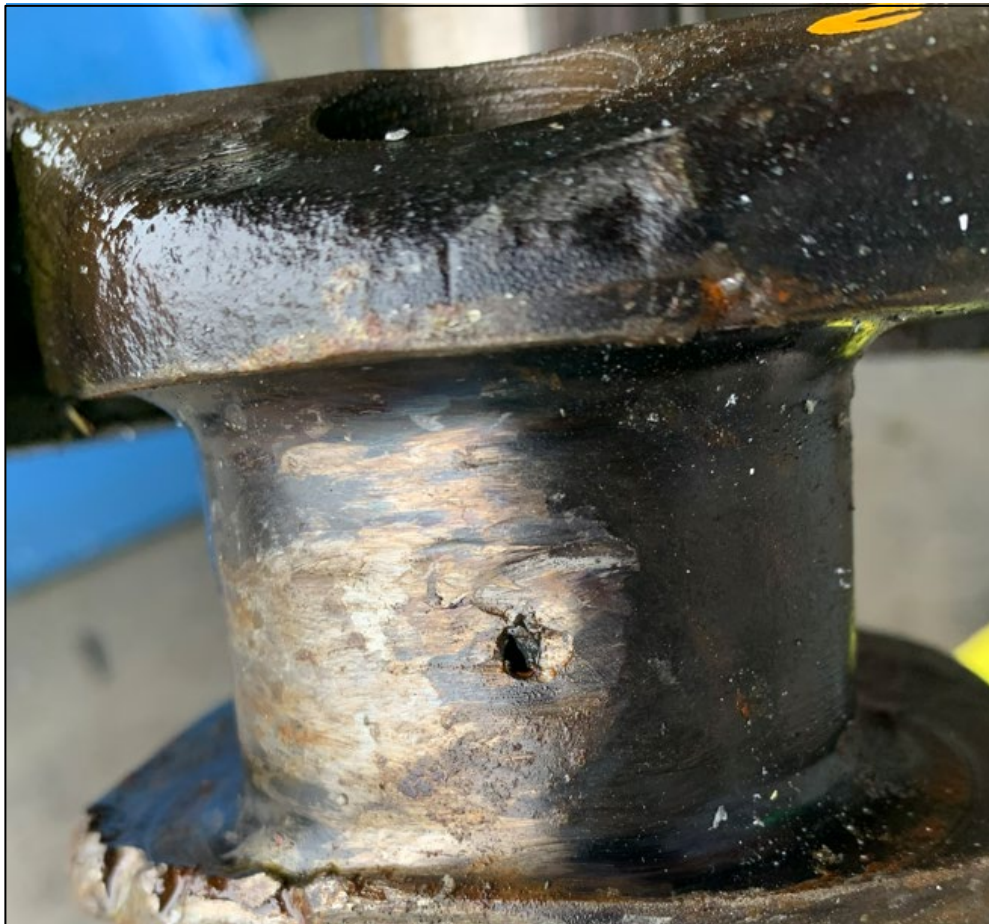
Crankshaft oil transfer hole at the No. 2 connecting rod attachment area.

Figure 2: View of the crankshaft oil transfer hole at the No. 2 connecting rod/ bearing attachment area and view of the No. 2 connecting rod and Nos. 1 & 3 connecting rod bearings (NTSB Photos)

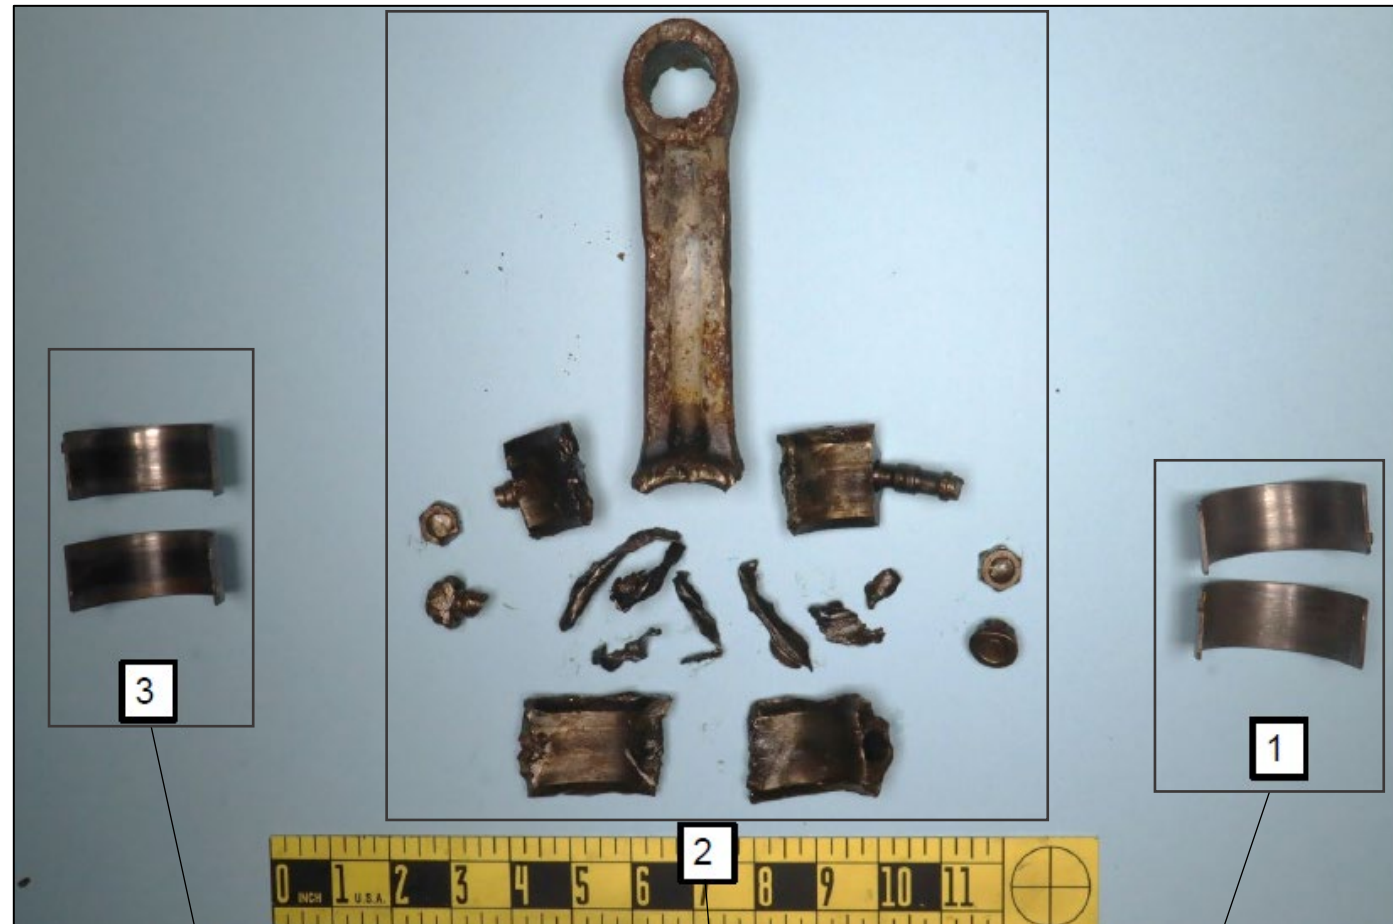
No. 3 connecting rod bearings.

No. 2 connecting rod & its bearing and bolt fragments.

No. 1 connecting rod bearings.
