# National Transportation Safety Board

ERA22LA097

## **AIRFRAME AND ENGINE EXAMINATION FACTUAL REPORT**

Location: Marathon, Florida  
Date: December 29, 2021  
Time: 1622 Local  
2122 UTC  
Airplane: Cessna 207, N1596U

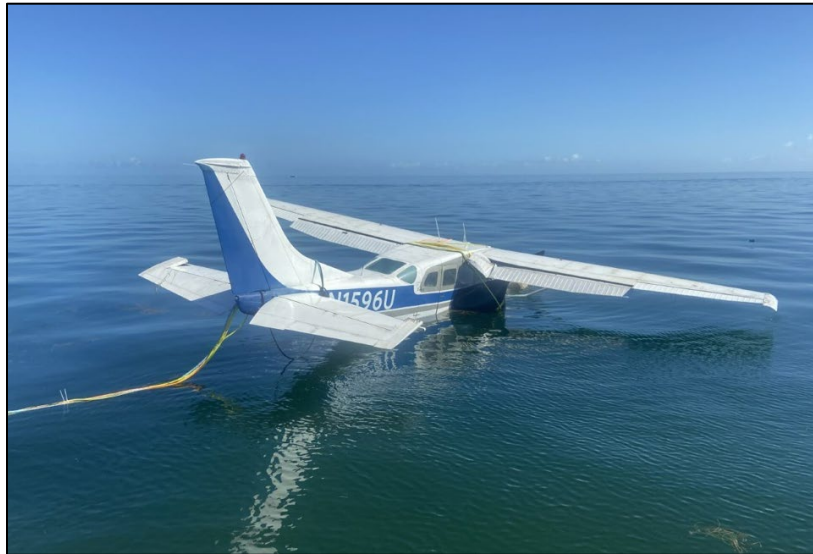
**Figure 1: View of the accident airplane partially submerged in the Florida Bay as viewed during recovery operations.**

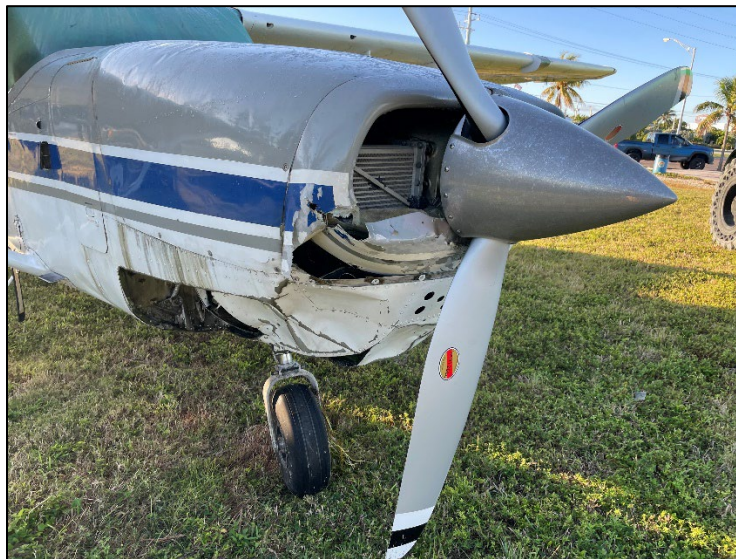
**Figure 2: View of the engine area and propeller post-recovery**

The engine remained attached to its engine mounts and sustained minor impact damage. A large fracture hole was present at the No. 2 cylinder with internal core engine components protruding through the fracture hole. The engine contained several gallons of saltwater due to its multiple day submersion in the Florida Bay. The water was drained from the oil quick drain, where water and oil were observed to empty from the engine. Saltwater corrosion was present throughout several components and surfaces.

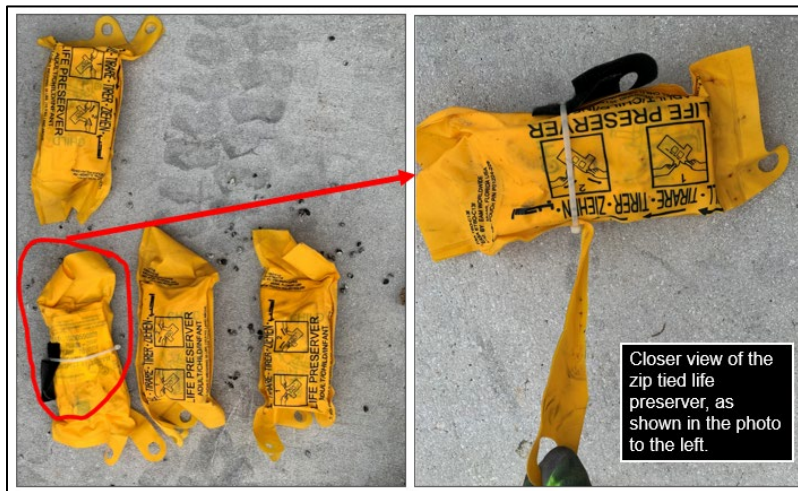
Under the passenger seats and loose within the wreckage, four life preservers were found. One life preserver was found to have a zip tie placed around the package,

which restricted the ability to tear it open. The figure below shows the life preservers, as recovered by this investigation.

**Figure 3: View of the four life preservers found in the cabin and an additional view of the zip tied life preserver (NTSB Photo)**

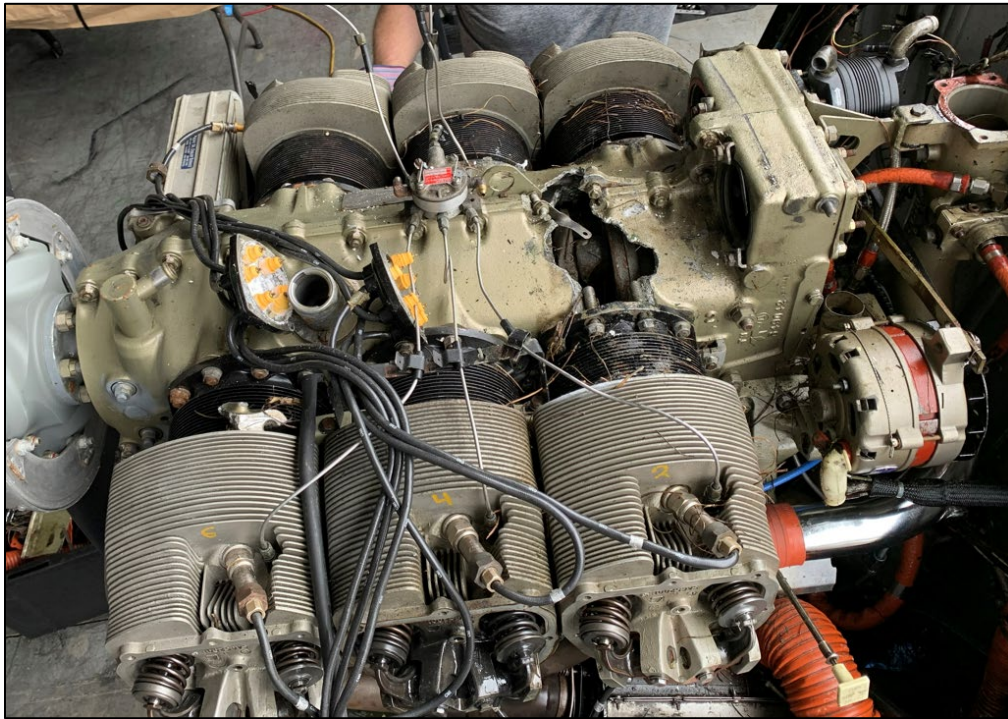
**Figure 4: Overview of the engine post-recovery**

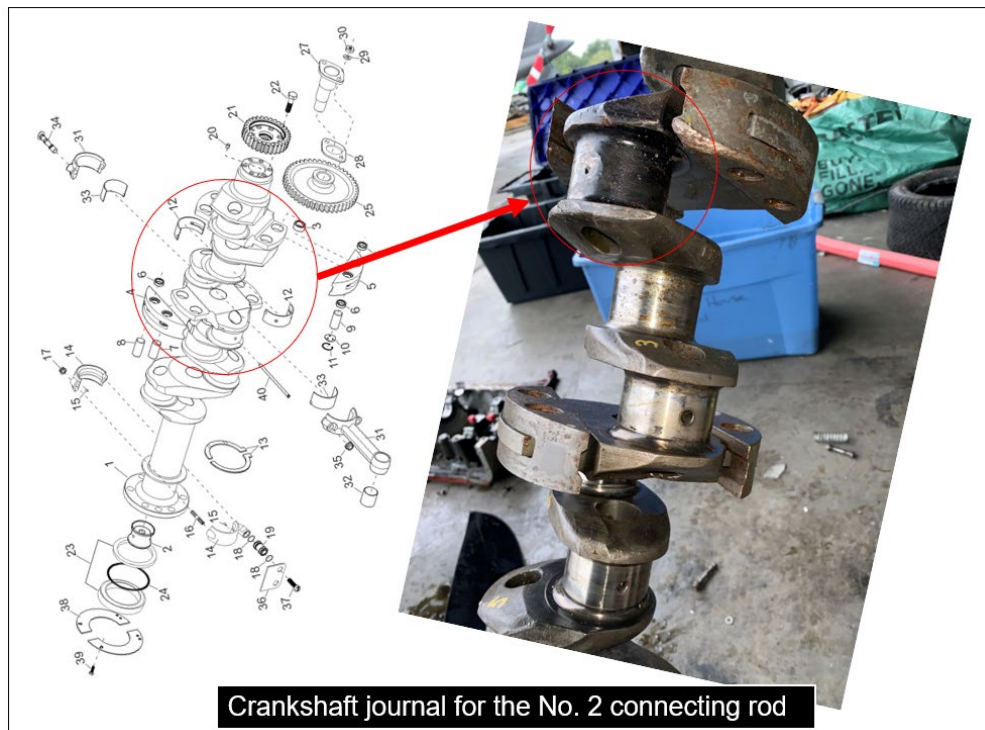
**Crankshaft journal for the No. 2 connecting rod**

The crankshaft journal for the No. 2 connecting rod and its oil transfer hole displayed wear marks, heat transfer, and deformation of the oil transfer hole. There was a small fragment of debris located in the oil transfer hole that was consistent in color to the fragmented bearing material located in the oil pan. This oil transfer hole displayed no other deformation or blockage at the other end of the oil entry hole.

**Figure 5: View of the crankshaft with the No. 2 journal circled in red and compared to the Continental Motors engine drawing.**

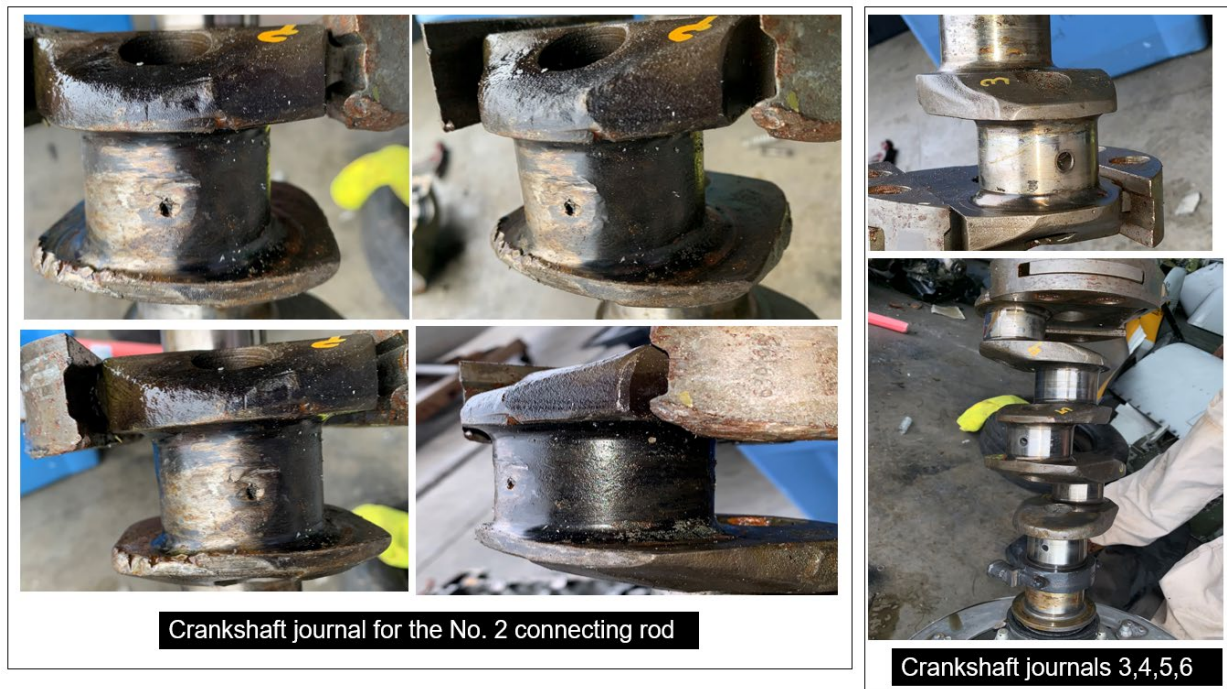
All other oil transfer holes along the crankshaft appeared normal without deformation and were clear of debris.

**Figure 6: Photographs showing the crankshaft journals, with detailed photos showing the No. 2 journal.**

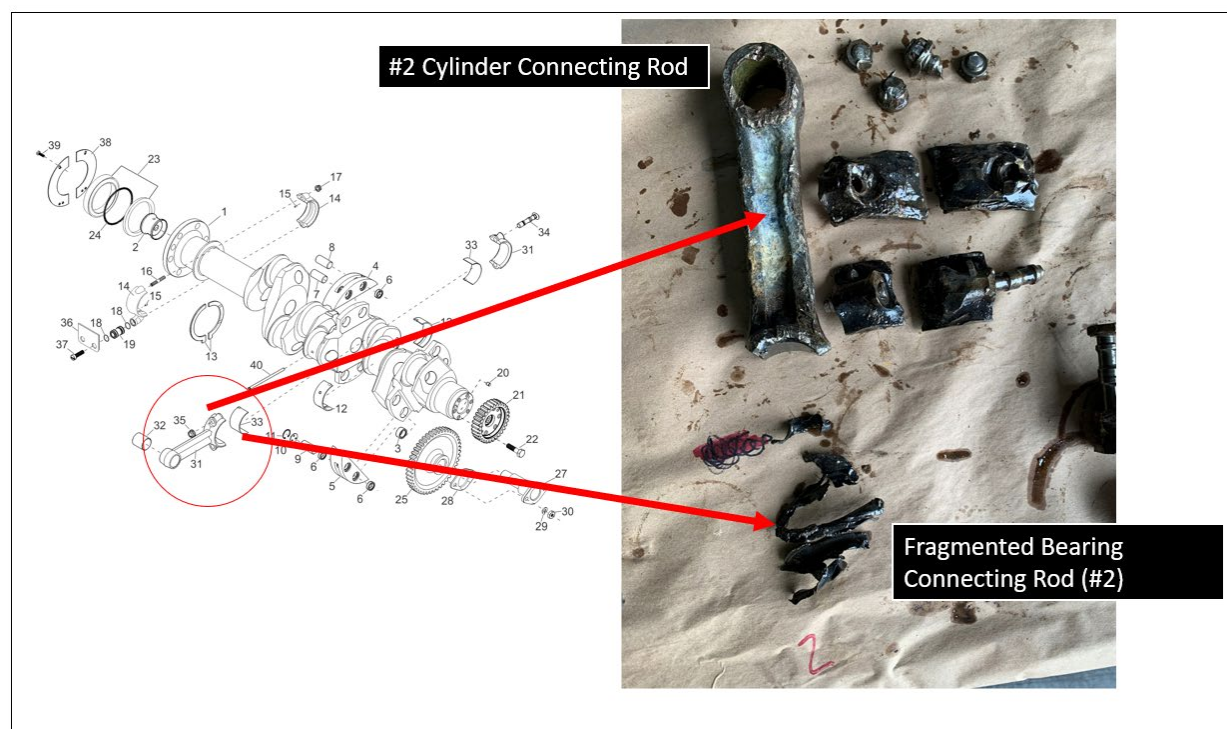
The No. 2 cylinder connecting rod crankshaft end was heavily fragmented and had fractured. The piston pin had separated and was found intact in the bottom of cylinder 3. Several fragments of the connecting rod were located in the oil pan. Presumed bearing material belonging to the No. 2 cylinder connecting rod attachment area was located in the oil pan as well. It appeared severely worn, thin, and displayed evidence of heat transfer.

**Figure 7: Overview of the No. 2 cylinder connecting rod and bearing fragments.**

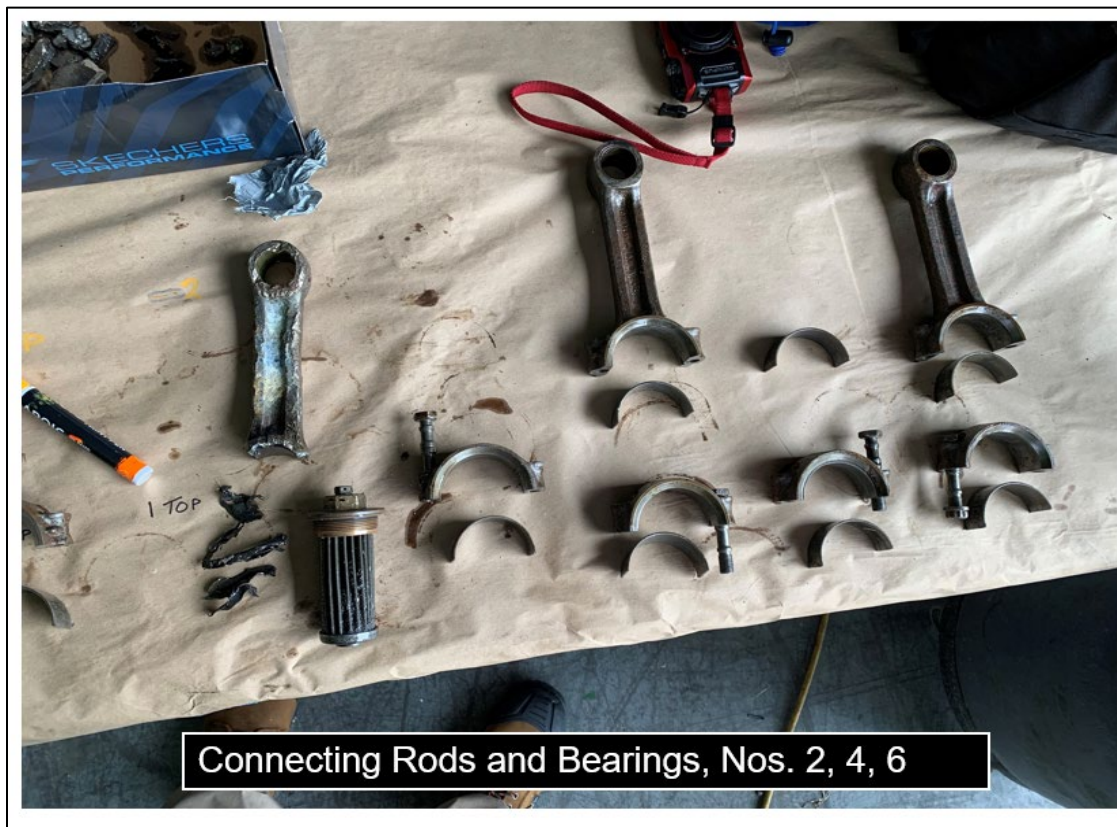
All connecting rods (with exception to the No. 2) appeared normal and their associated connecting bolts were tight when removed. They all also did not display heat discoloration (except No. 2).

**Figure 8: Connecting rods No. 2, 4, and 6 as viewed from left to right.**
