[ERA22LA104]

## INVESTIGATION EXAM PHOTOGRAPHS

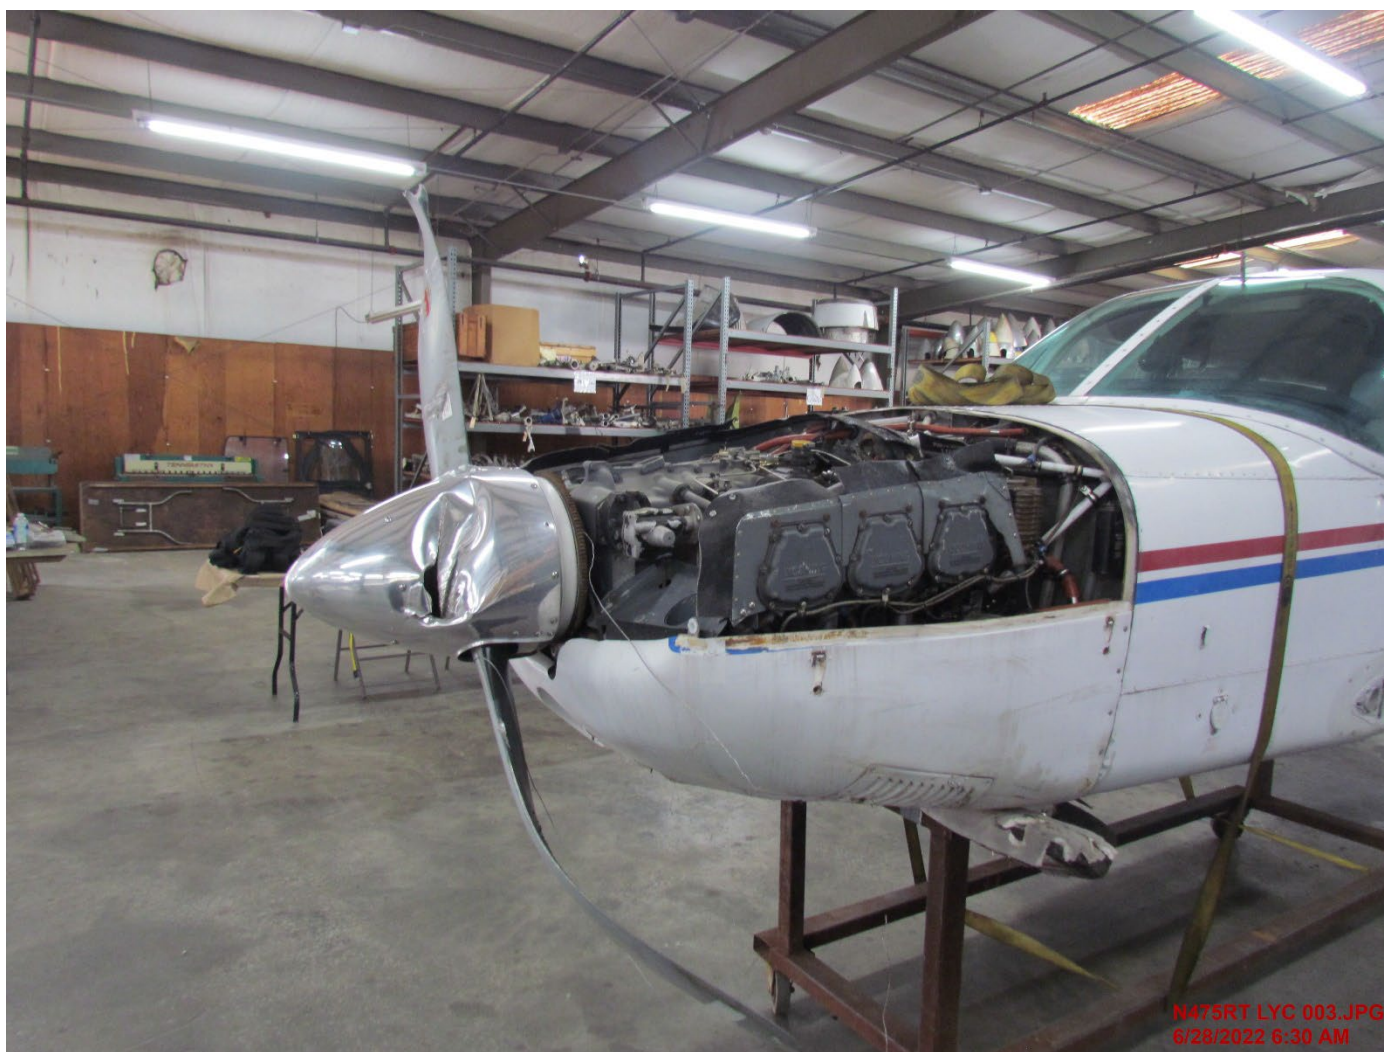
**Photograph 1 - View of engine compartment prior to disassembly. (Courtesy of Lycoming)**

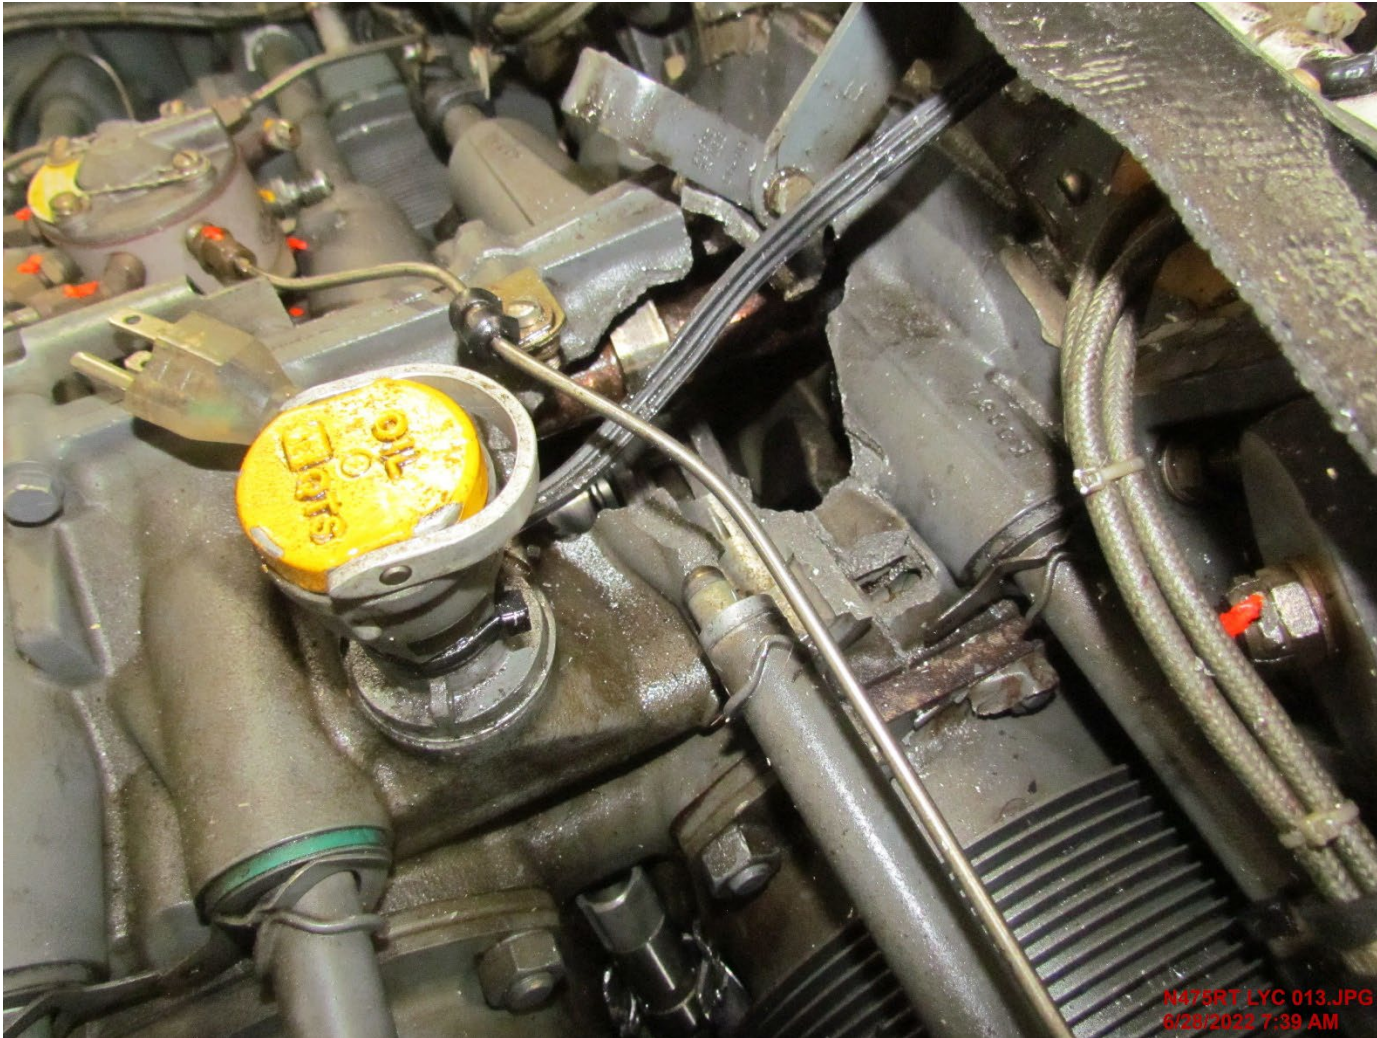
**Photograph 2 - Closeup view of hole in engine case. (Courtesy of Lycoming)**

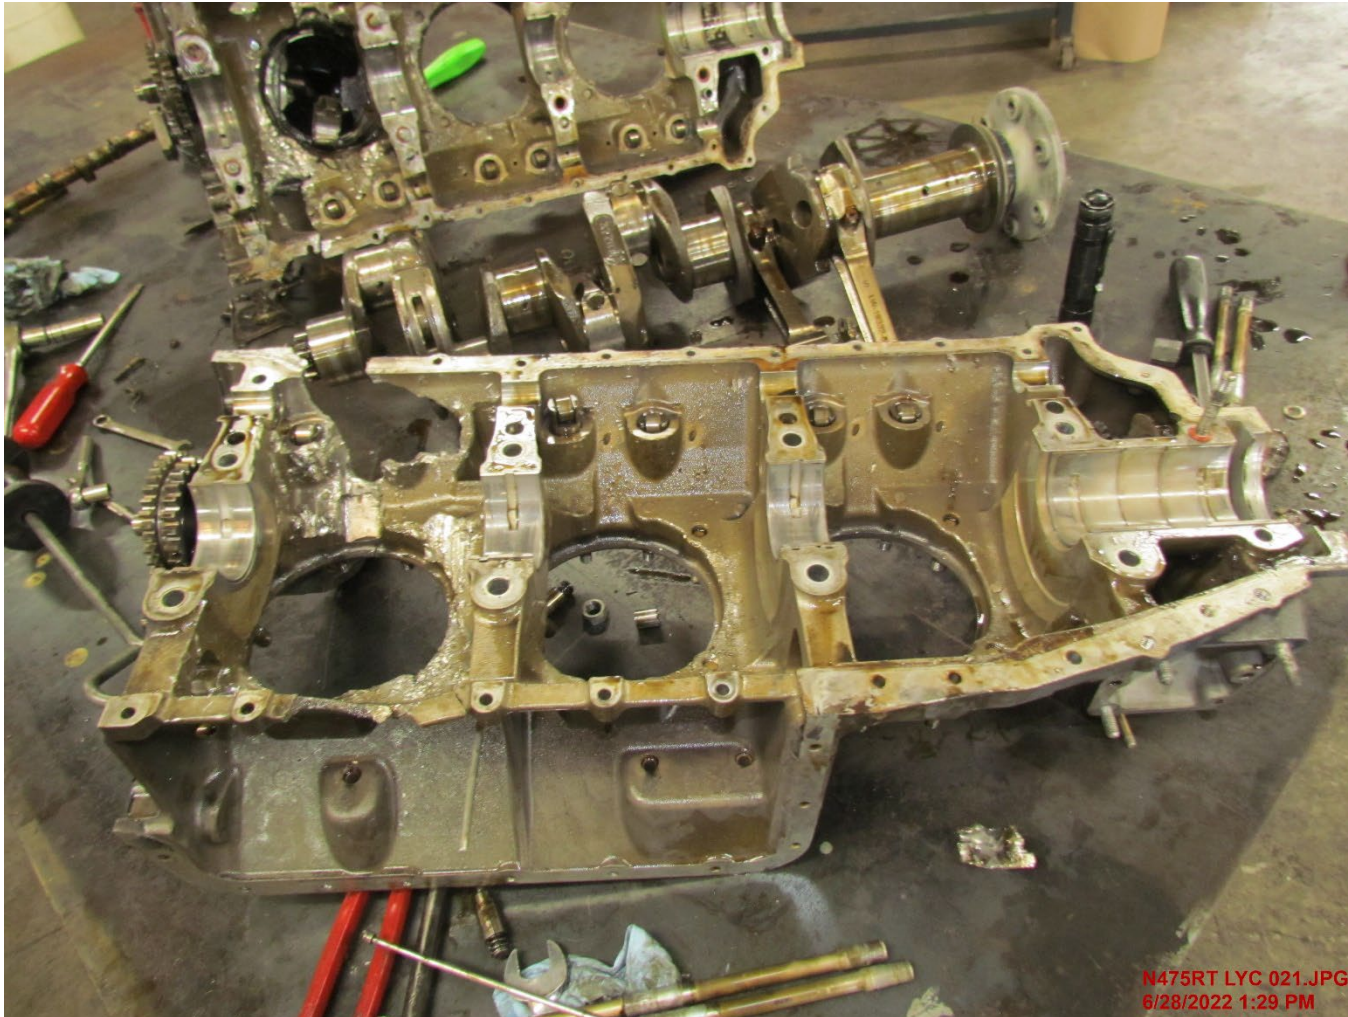
**Photograph 3 - Engine crankcase halves separated. (Courtesy of Lycoming)**

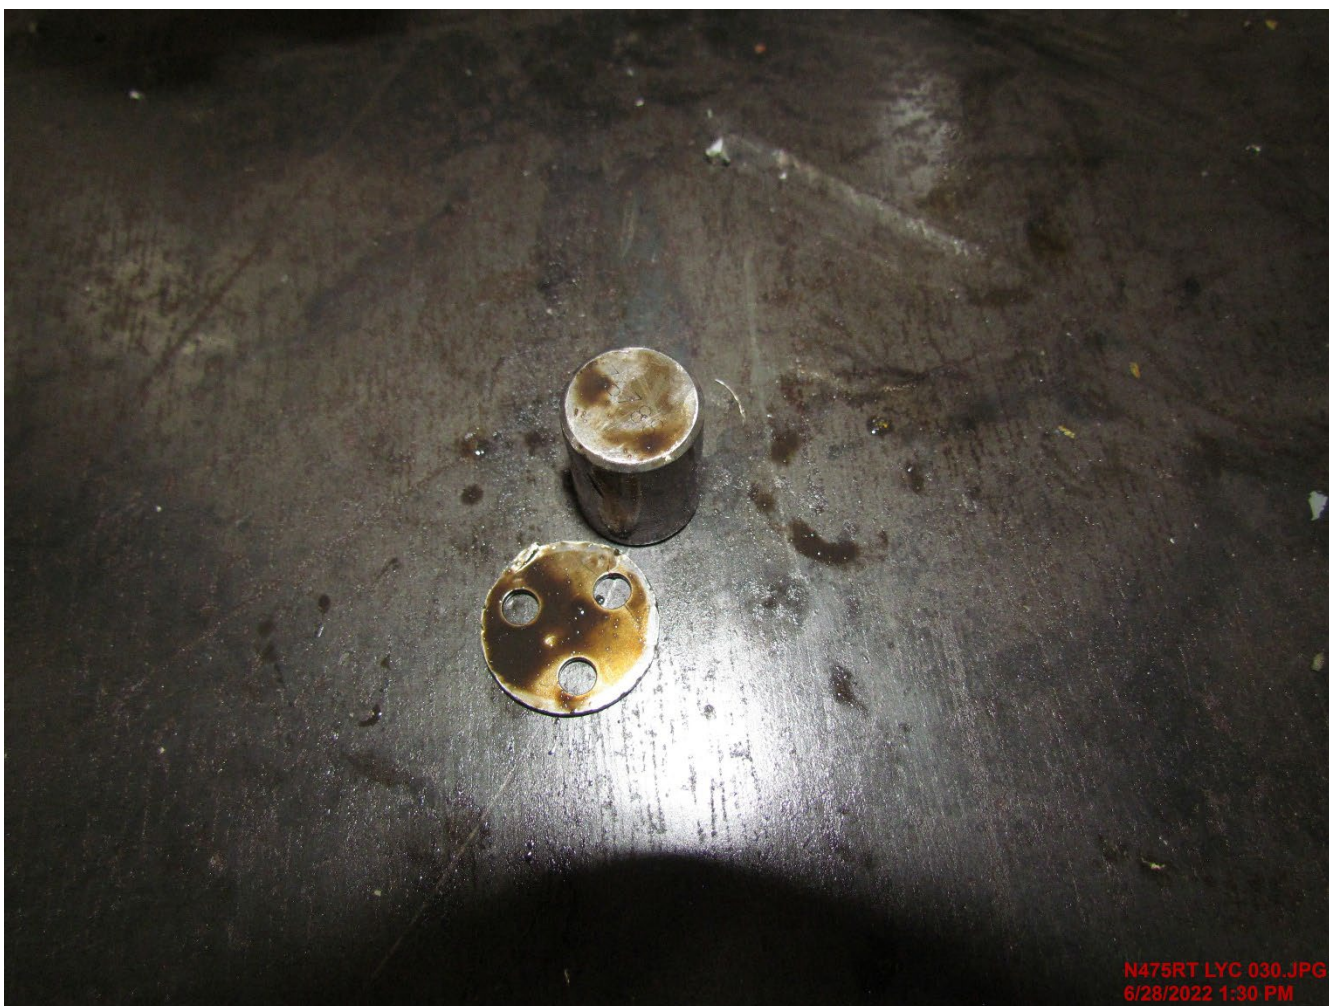
**Photograph 4 - Counterweight roller and washer ejected. (Courtesy of Lycoming)**

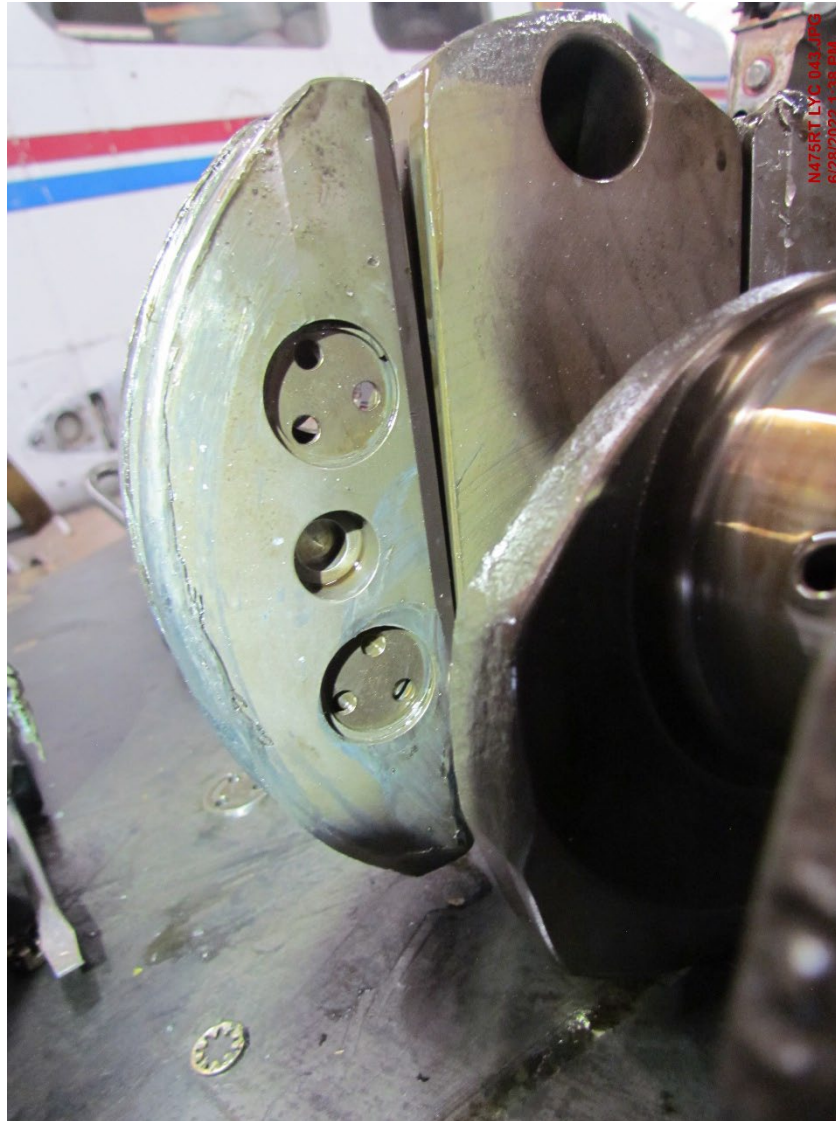
**Photograph 5 - Counterweight, washer, and circlip. Note circlip with broken eyelets. (Courtesy of NTSB)**

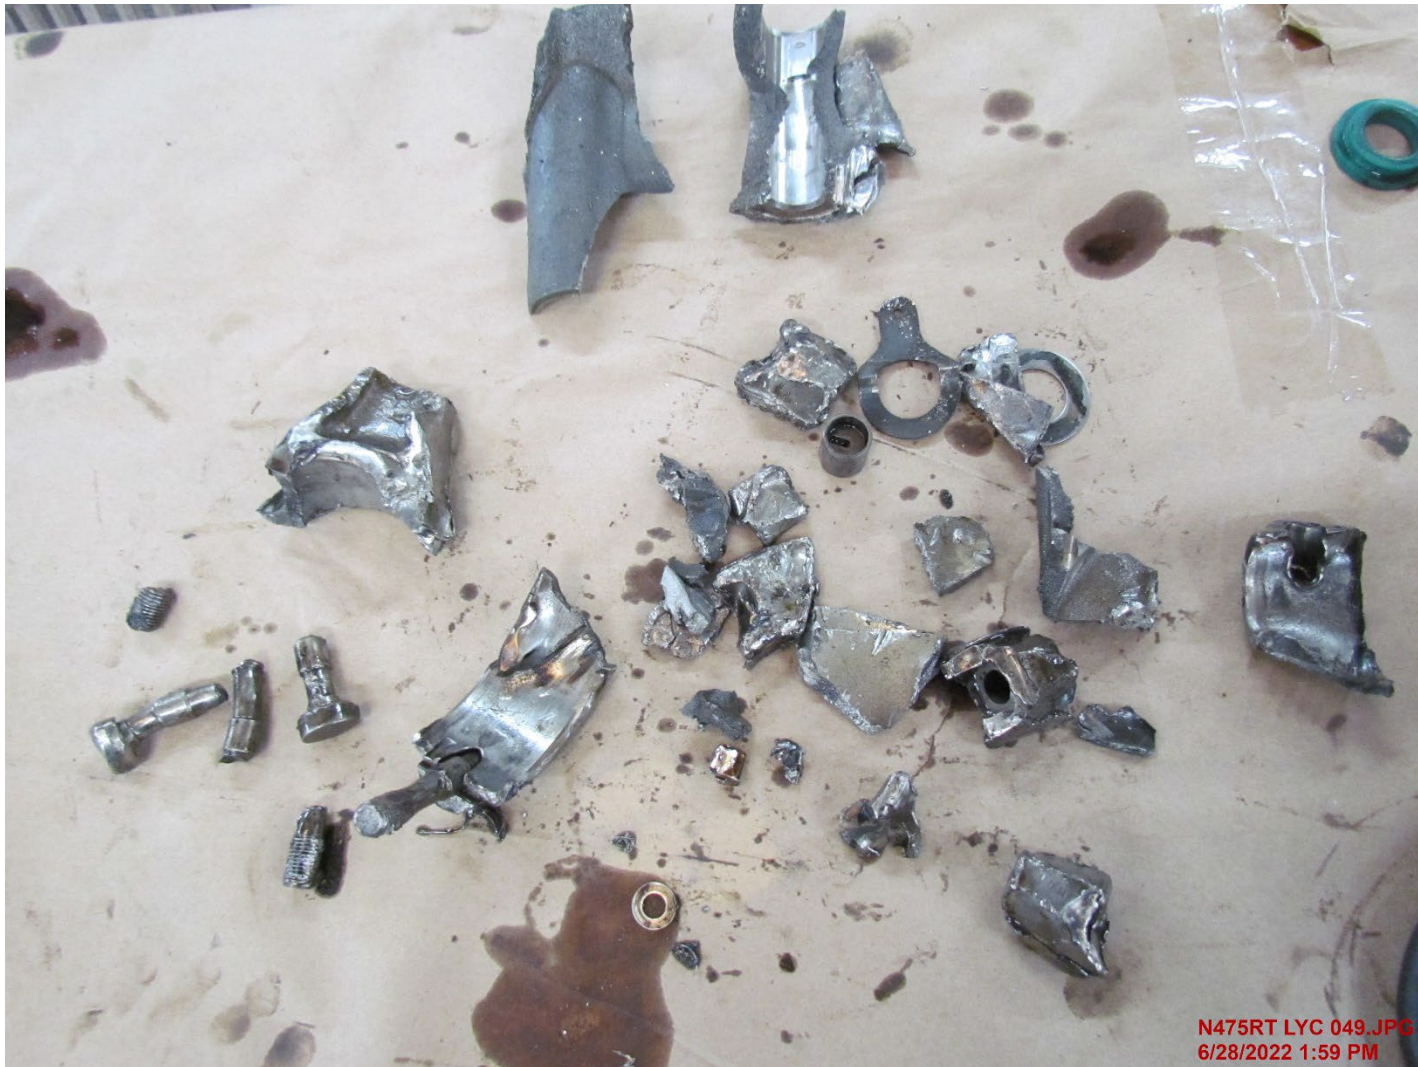
**Photograph 6 - Fractured bearings, rods and rod bolts. (Courtesy of Lycoming)**
