### MATERIALS LABORATORY INVESTIGATION REPORT

TYPE: IO-540-K1A5

NAME: Crankshaft, #5 and #6 conn  
rods, and counterweights

Analyze crankshaft/counterweights/#5 and #6 connecting rods to find potential causes of failure.

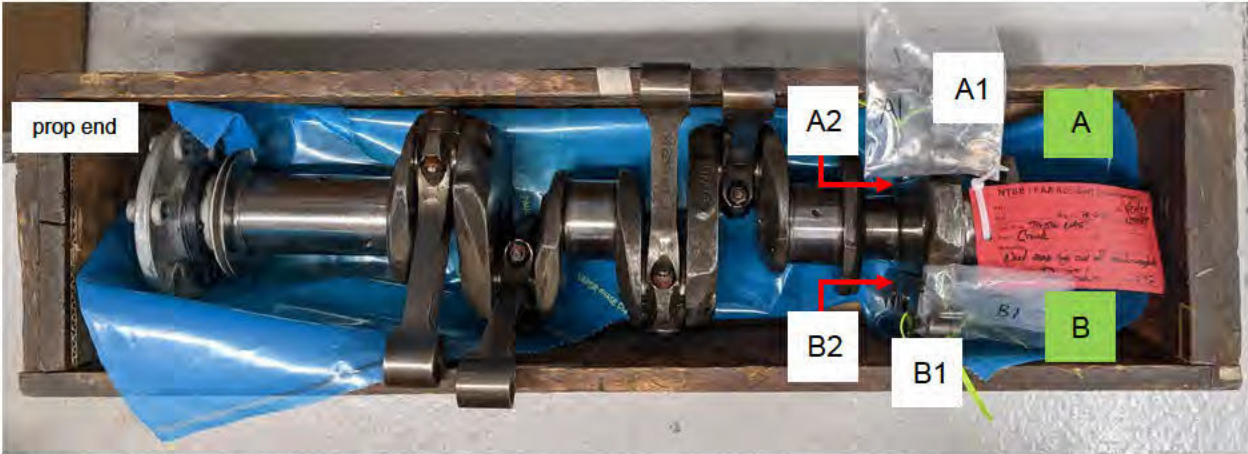
The hardware from the crankshaft counterweights (rollers, circlips, and washers) arrived in the Materials Lab in bags that were zip-tied to the counterweights and still attached to the crankshaft, as shown in Figure 1. The crankshaft itself was not examined in detail for this investigation since the relevant damage was sustained on the crankshaft counterweights, the counterweight hardware, and the connecting rods.

**Figure 1.** Image of the crankshaft with counterweights and hardware of interest attached in the as-received condition. The green labels A and B identify the two crankshaft counterweights and the white labels A1, A2, B1, and B2 identify the four sets of counterweight hardware (rollers, circlips, and washers).

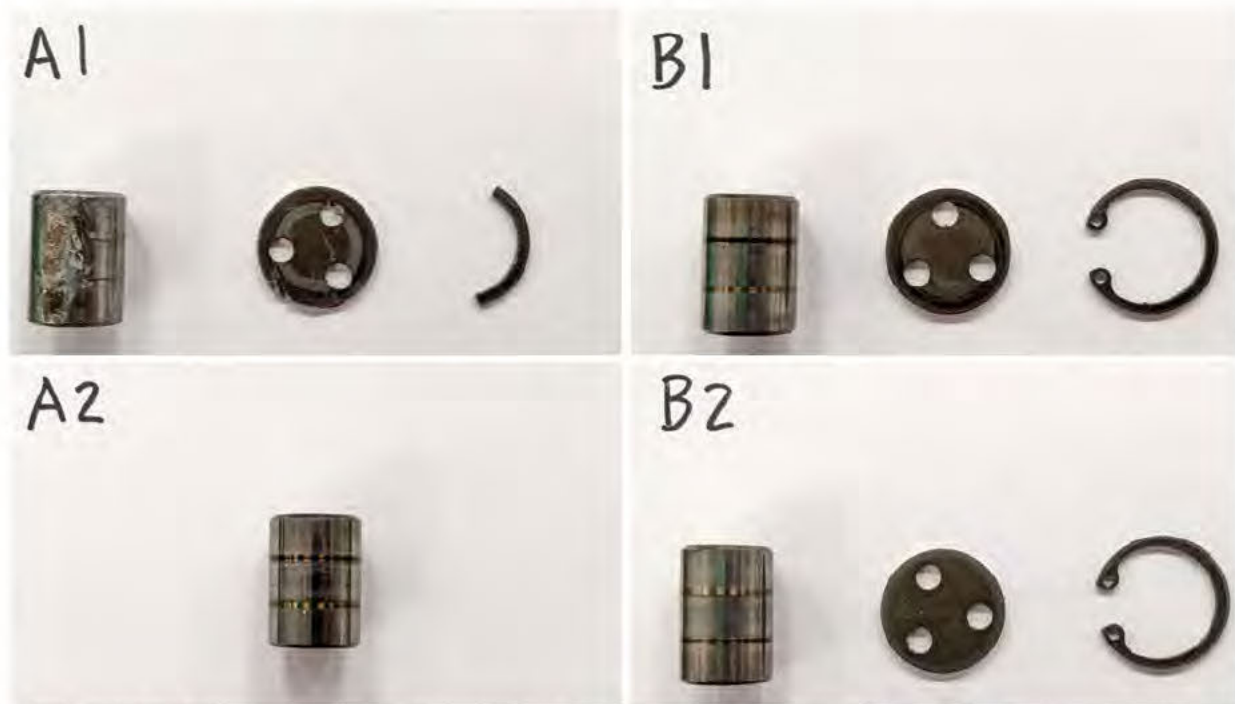
The counterweight hardware pieces that arrived in the lab already out of the crankshaft/counterweight assembly are shown with labels in Figure 2. In addition to what is shown in Figure 2, a bag of (fractured) washer pieces was sent to the lab. These washer pieces

Figure 2. Crankshaft counterweight hardware, labeled as bagged and identified in Figure 1.

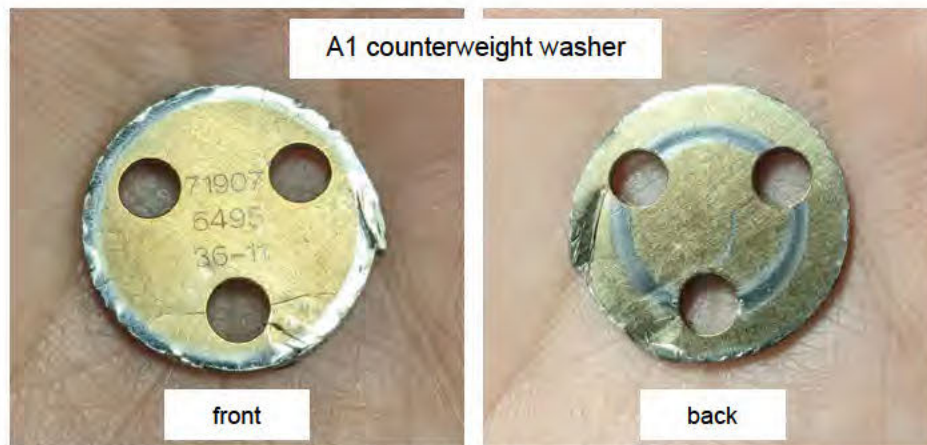
The roller, partial circlip, and washer that are labeled A1 are the ones described on page 8 of 10 of the Appendix A report. As shown in Figure 3 and noted in Appendix A, the A1 counterweight washer shows cracks emanating from one of its three central holes and a crack around its circumference. It also shows wear marks on its part-marked (front) face from contact with the circlip. The back surface of the washer shows heavy wear from contact with the counterweight roller. As noted in Appendix A, all washers from the A counterweight showed some evidence of fracture.

**Figure 3.** Close-up image of washer shown in the A1 panel of Figure 2.

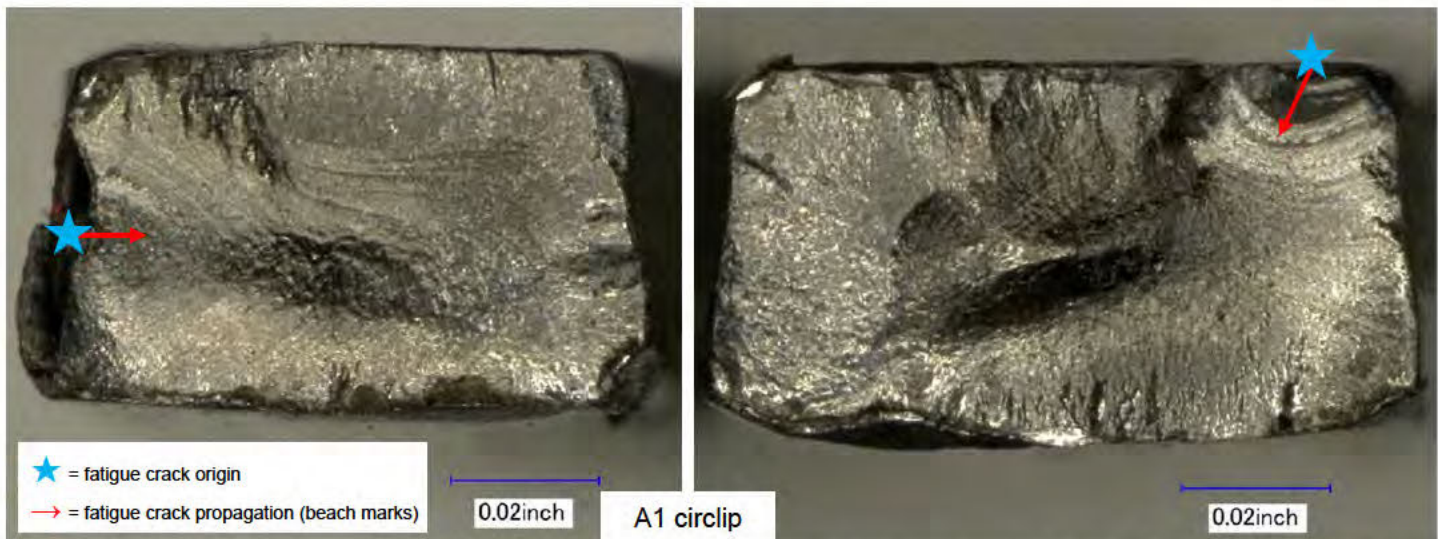
Both fractured ends of the circlip section show evidence of fatigue failure in the form of beach marks, as shown in Figure 4. The blue stars on both fracture surfaces mark the crack origin, as identified by the beach marks emanating away from those locations (beach mark propagation direction shown by red arrows in Figure 4). Beach marks on a fracture surface are created from irregular periods of loading during fatigue and typically propagate away from the crack origin and are curved, with the center of the curvature at the crack origin.

**Figure 4.** Images of both fracture surfaces (both ends) of the A1 partial circlip shown in Figure 2. Both fracture surfaces show evidence of fatigue (beach marks).

It is possible that the failure of the A1 circlip shown in Figures 2 and 4 initiated the failure of the engine by allowing the A1 roller to be ejected from the A counterweight, which caused further destruction inside the engine, including the breaking of the #5 and #6 connecting rods.

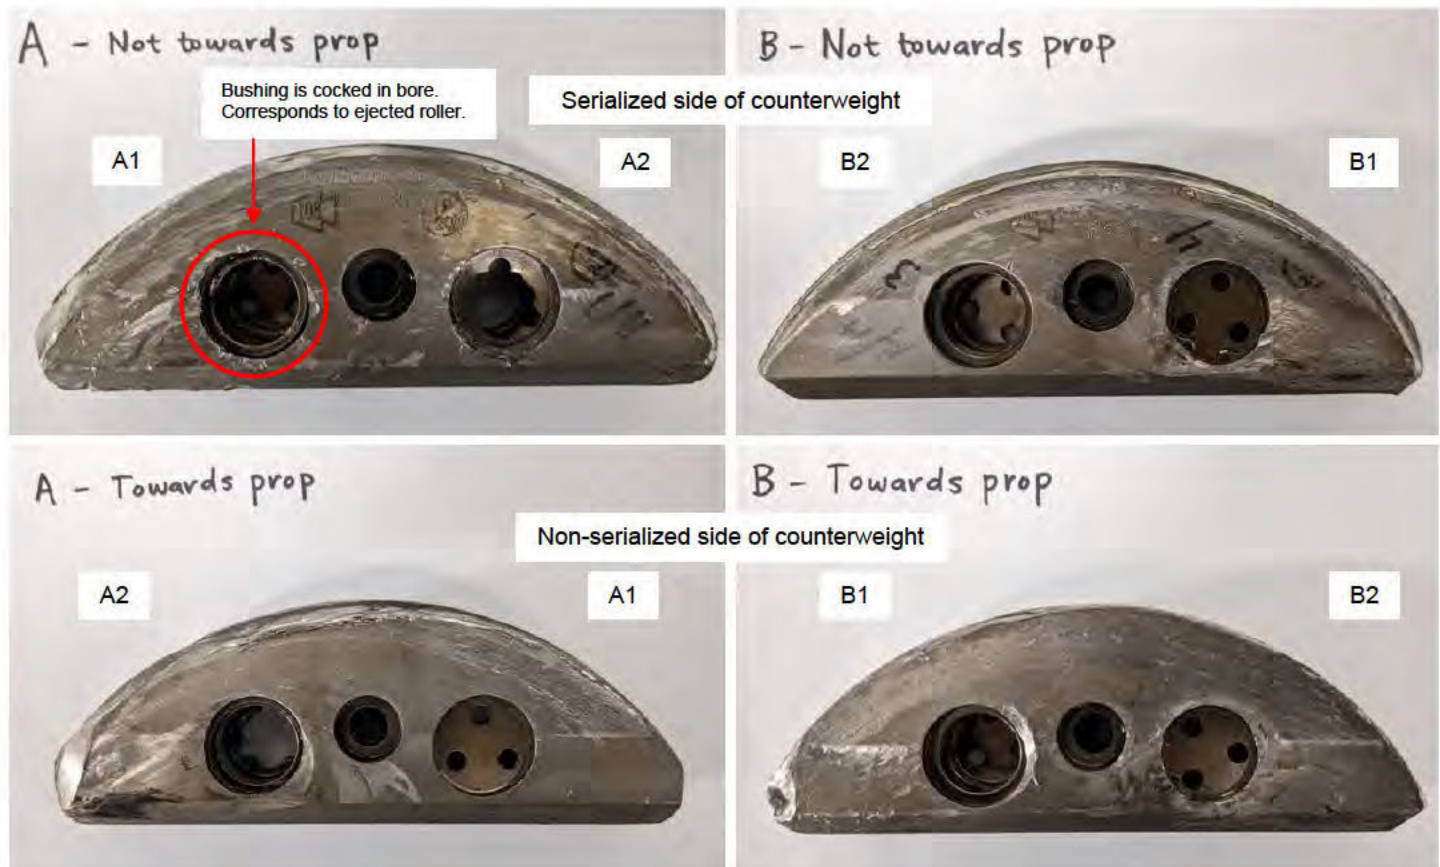
As shown in Figure 1, the two counterweights were identified and labeled as A and B. Both sides of both counterweights are shown in Figure 5. The counterweight identified and labeled as A is hand-labeled with "L/H" and the counterweight identified and labeled as B is hand-labeled with "R/H."

**Figure 5.** Images of both side of both counterweights A and B. Locations of hardware that is identified in Figures 1 and 2 are labeled. The side of each counterweight that was not towards the propeller flange (prop) included part number and identification markings, and the side that was towards the propeller did not include part numbers and identification markings. The red circled bushing is cocked sideways in the counterweight bore. This bushing corresponds to the counterweight roller that was ejected from the crankshaft assembly.

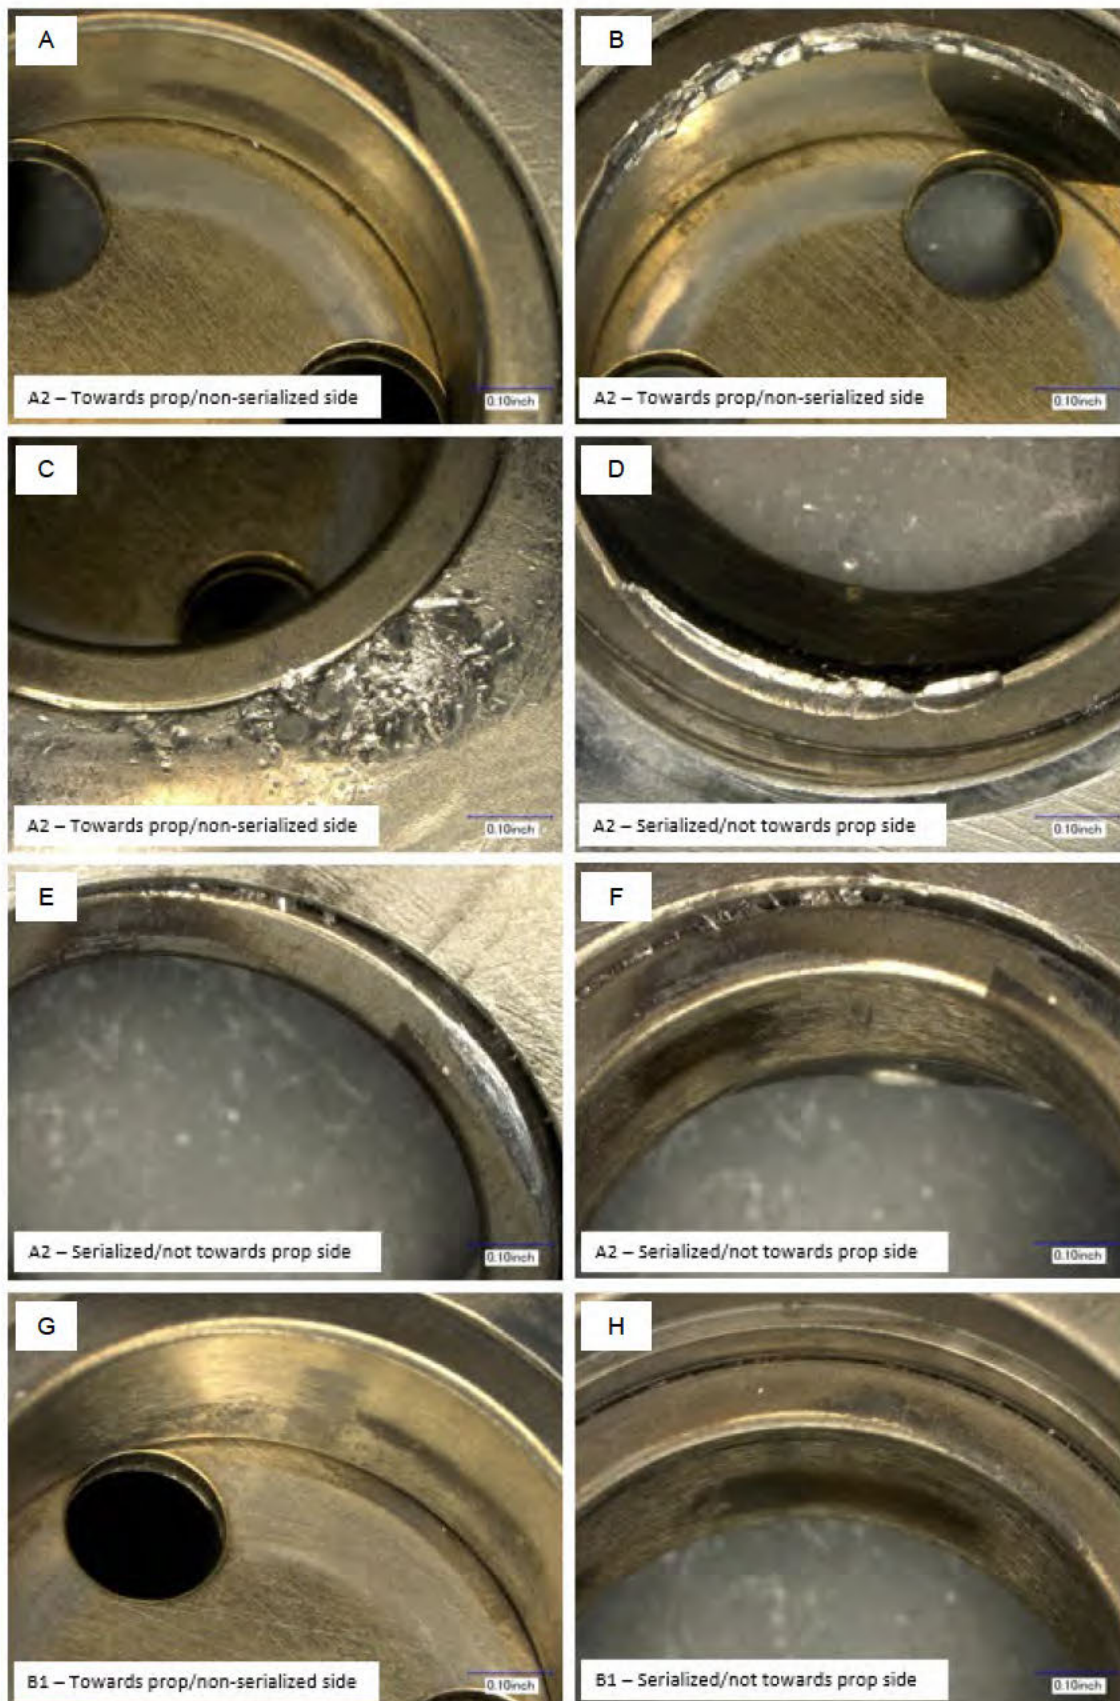
Selected images of some of the bushings are shown in Figure 6. None of the bushing IDs showed anything alarming or unusual. The dark marks on the IDs in the images labeled A, F, G, and H of Figure 6 are embedded oil/debris that was able to be removed with rigorous scrubbing using ethanol and a cotton swab. Images A through D of Figure 6 show the A2 bushing on the propeller side of the A counterweight, and there is visible impact damage to both the ID corner of the bushing and the counterweight surface adjacent to the bushing.

**Figure 6.** Images of counterweight bushing inner diameters and surrounding counterweight surfaces.

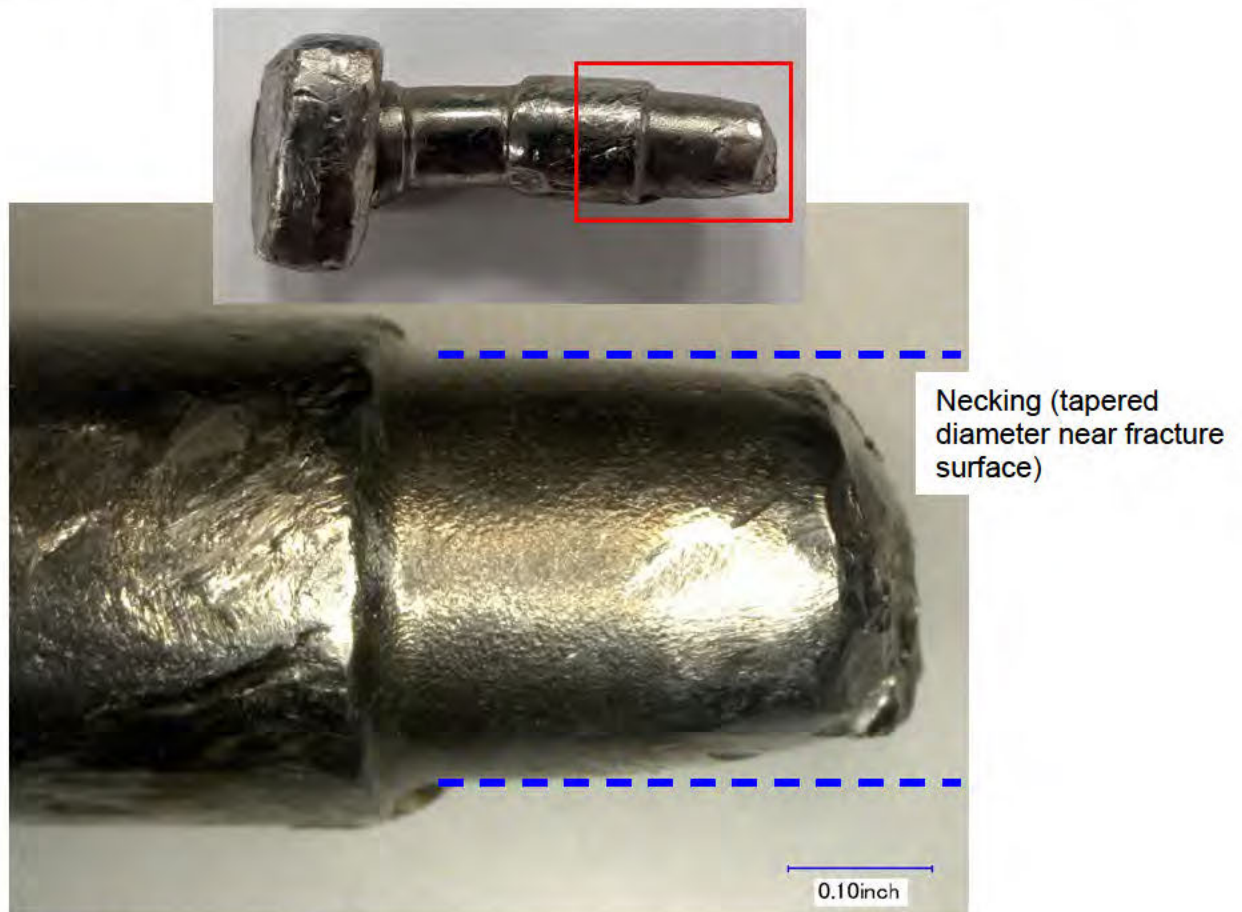
| Piece ID | Description (based on labeled bag the piece was delivered to the lab in) | Post-cleaning observations |
|---|---|---|
| F | Connecting rod bolt – Head section | This section of a connecting rod bolt was badly beaten up. The non-threaded part of the shank was visibly bent, and the unthreaded part of the shank near the fracture surface shows necking, indicative of <b>failure by overload</b> . There is blue heat tint on a small part of the fracture surface. See Figure 9. |

Piece F is shown in Figure 9. The tapered end containing the fracture surface shows necking, evidence of failure by overload.

**Figure 9.** Image of Piece F showing necking.

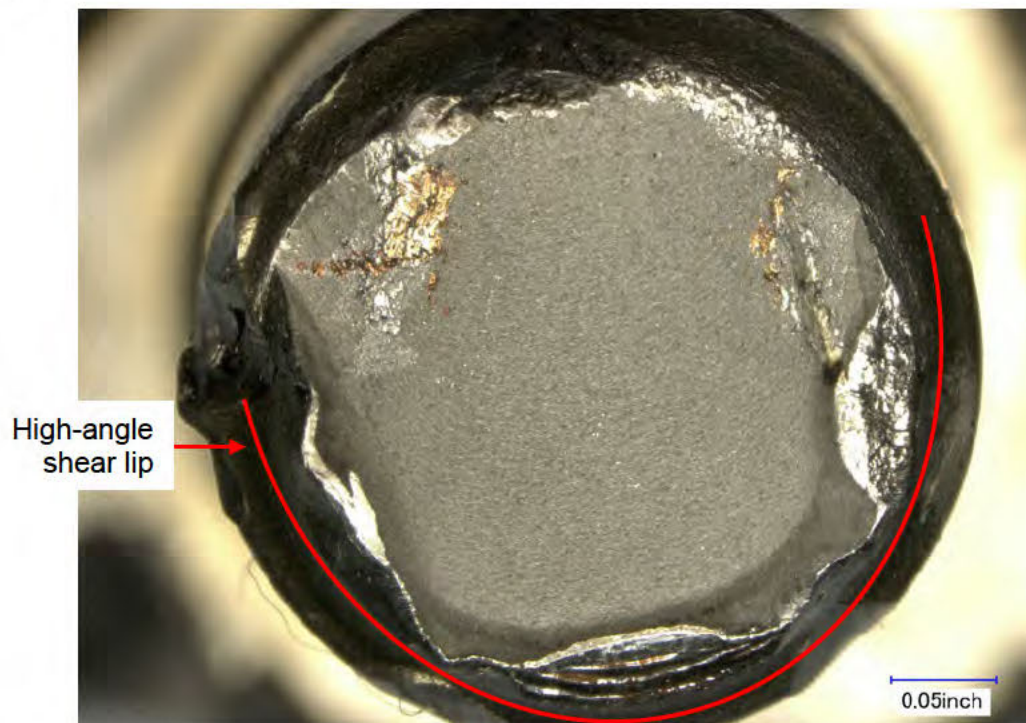
| Piece ID | Description (based on labeled bag the piece was delivered to the lab in) | Post-cleaning observations |
|---|---|---|
| G | Connecting rod bolt – Head section | Fracture surface appears to be the cup end of a cup-and-cone fracture (indicative of <b>failure by overload</b> ) with a high-angle lip that spans about 50% of the circumference of the bolt with some smashing. Embedded material from being tossed around in engine. See Figure 10. |

Figure 10 shows Piece G. The fracture surface has a cup-and cone appearance and a high-angle shear lip that spans about 50% of the circumference of the bolt, all consistent with sudden overload. Some areas of the surface are smashed and there is some embedded material from the bolt being tossed around in the engine.

**Figure 10.** Image of Piece G showing cup-and-cone fracture with a high-angle lip.

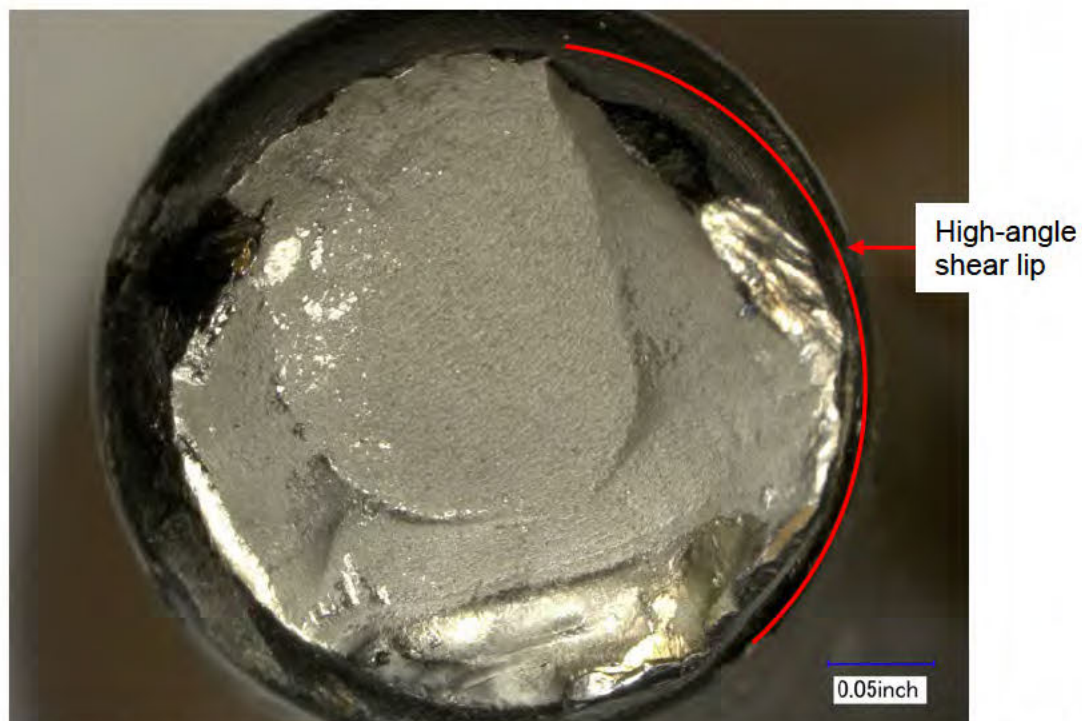
Figure 11 shows the unthreaded end Piece H. The fracture surface has a cup-and-cone appearance and a very high-angle shear lip, all consistent with sudden overload.

**Figure 11.** Image of the unthreaded end of Piece H showing cup-and-cone fracture surface and very high-angle shear lip.

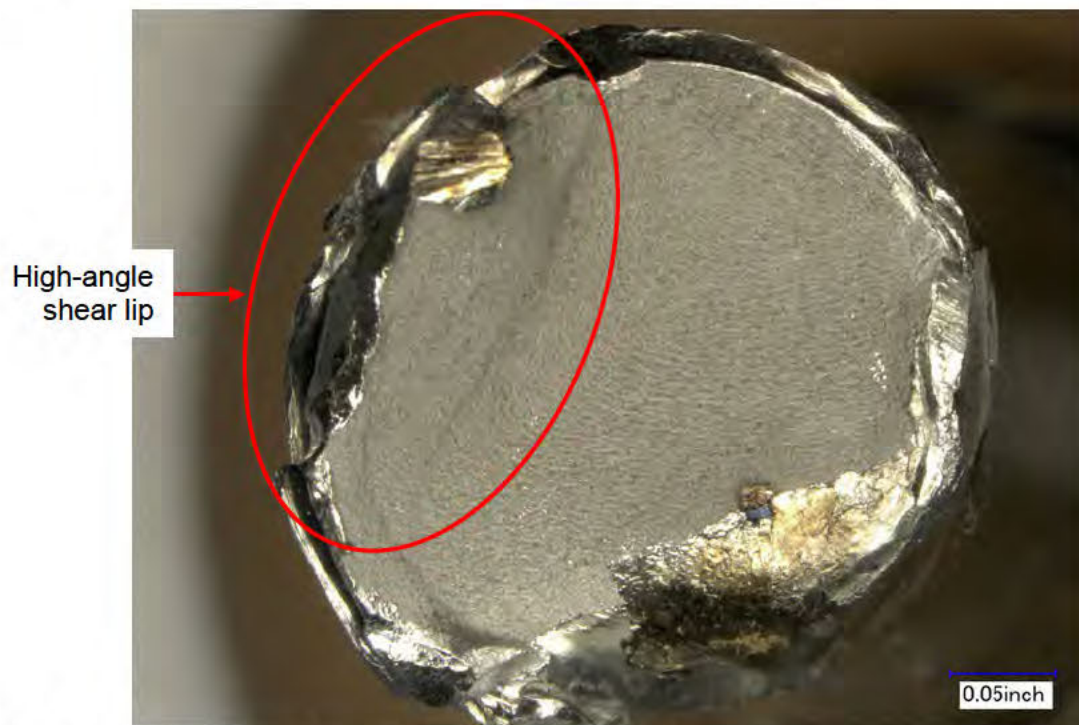
| Piece ID | Description (based on labeled bag the piece was delivered to the lab in) | Post-cleaning observations |
|---|---|---|
| H | Connecting rod bolt – Unthreaded section | Unthreaded end of this section has a shear lip and looks like a cup-and-cone fracture (indicative of <b>failure by overload</b> ) with some smashing. The threaded end has a large shear lip and appears to be the cup end of a cup-and-cone fracture (indicative of <b>failure by overload</b> ). This end tore in the first few threads. See Figures 11 and 12. |

Figure 12 shows the threaded end of Piece H. There is a high-angle shear lip and the surface is smashed around its circumference.

**Figure 12.** Image of the threaded end of Piece H showing a high-angle shear lip and smashing around the circumference.

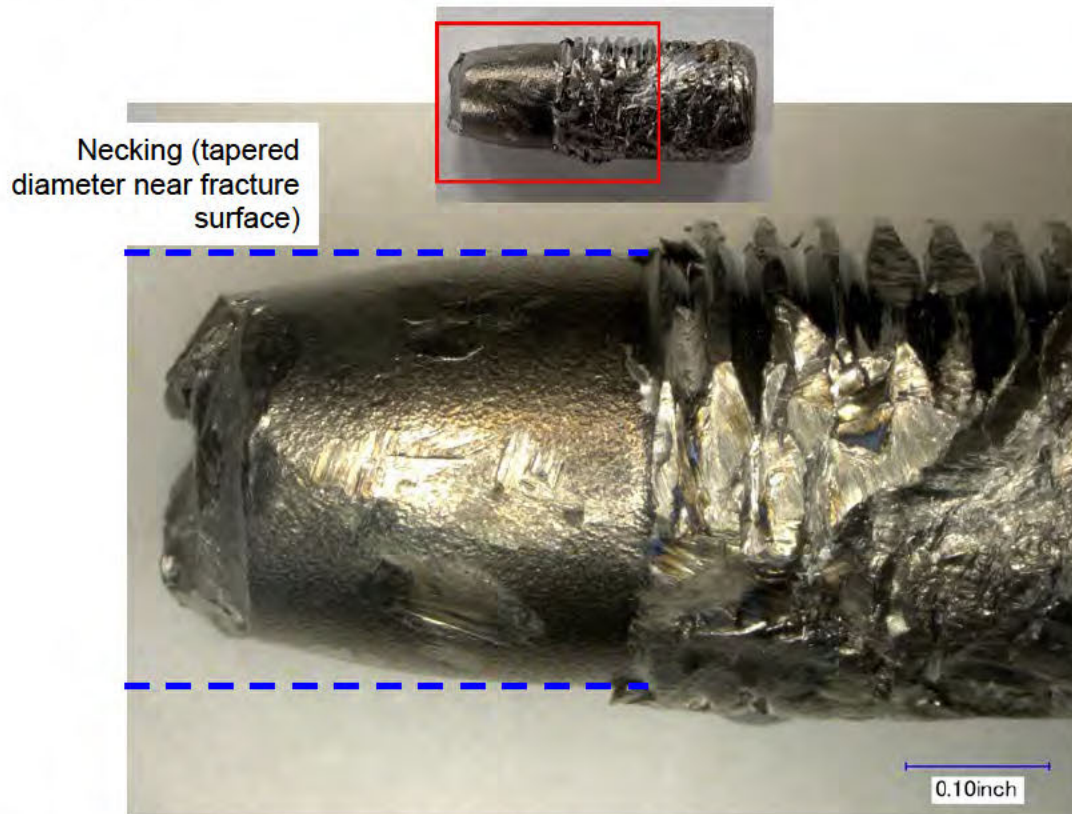
| Piece ID | Description (based on labeled bag the piece was delivered to the lab in) | Post-cleaning observations |
|---|---|---|
| I | Connecting rod bolt – Threaded section | Threads are severely damaged, and the fracture surface is smashed. The shank shows necking, indicative of <b>failure by overload</b> . There is a small spot of blue heat tint on the base of the threaded end. See Figure 13. |

Figure 13 shows Piece I. The bolt is necked, and the threads experienced significant smashing. The fracture surface is smashed and provided no useful information about failure mode; however, the necking clearly indicates ductile overload failure.

**Figure 13.** Image of Piece I showing necking and smashed threads.

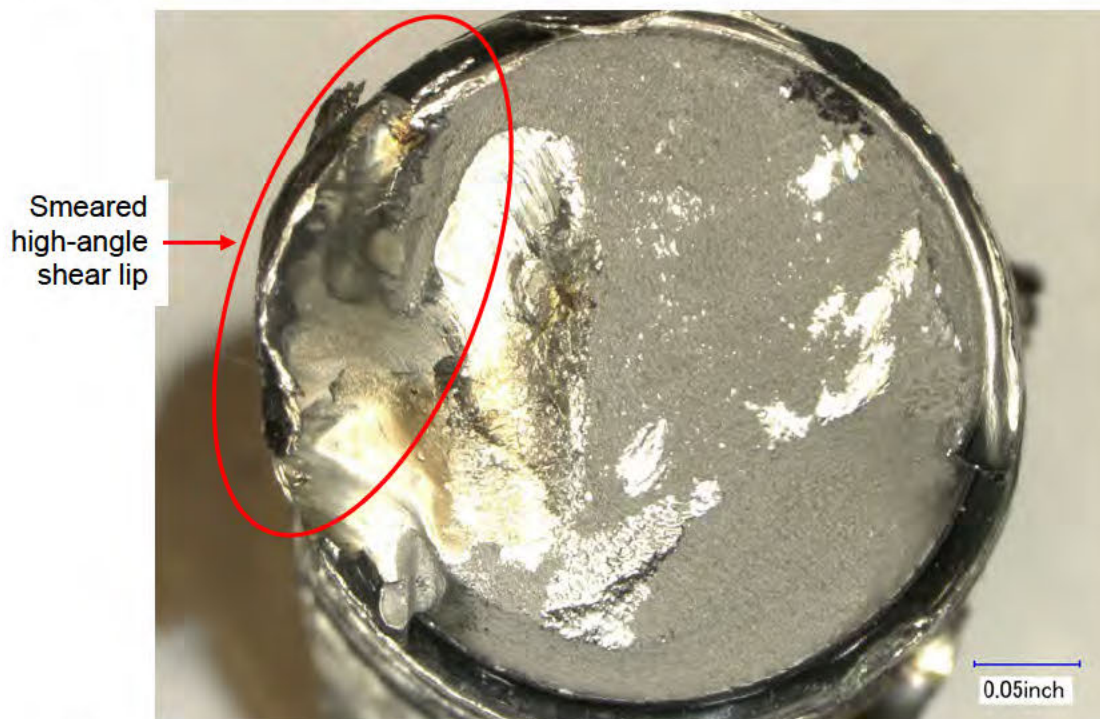
| Piece ID | Description (based on labeled bag the piece was delivered to the lab in) | Post-cleaning observations |
|---|---|---|
| J | Connecting rod bolt – Threaded section | The fracture surface appears to be the cup end of a cup-and-cone fracture (indicative of <b>failure by overload</b> ) and shows smashing. There is what appears to be a shear lip that is severely smashed. Threads are severely damaged. See Figures 14 and 15. |

Figure 14 shows the fracture surface of Piece J. It is the cup end of a cup-and-cone fracture and shows smashing. There is also a severely smeared high-angle shear lip.

**Figure 14.** Image of fracture surface of Piece J showing a smeared shear lip and cup-and-cone fracture.

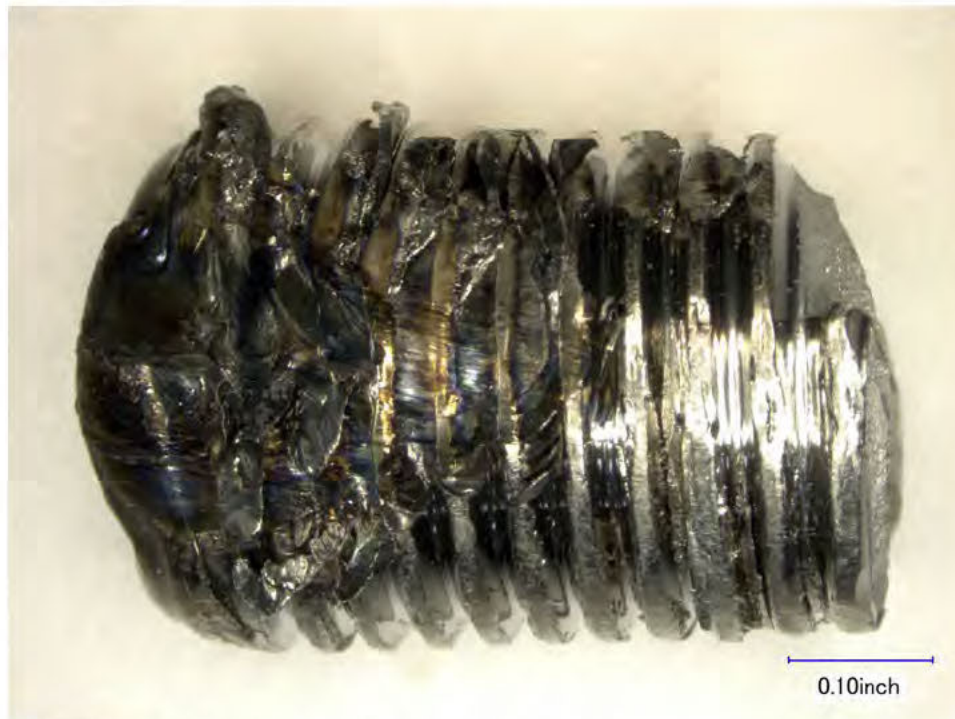
Figure 15 shows the smashed threads of Piece J.

**Figure 15.** Image showing smashed threads of Piece J.

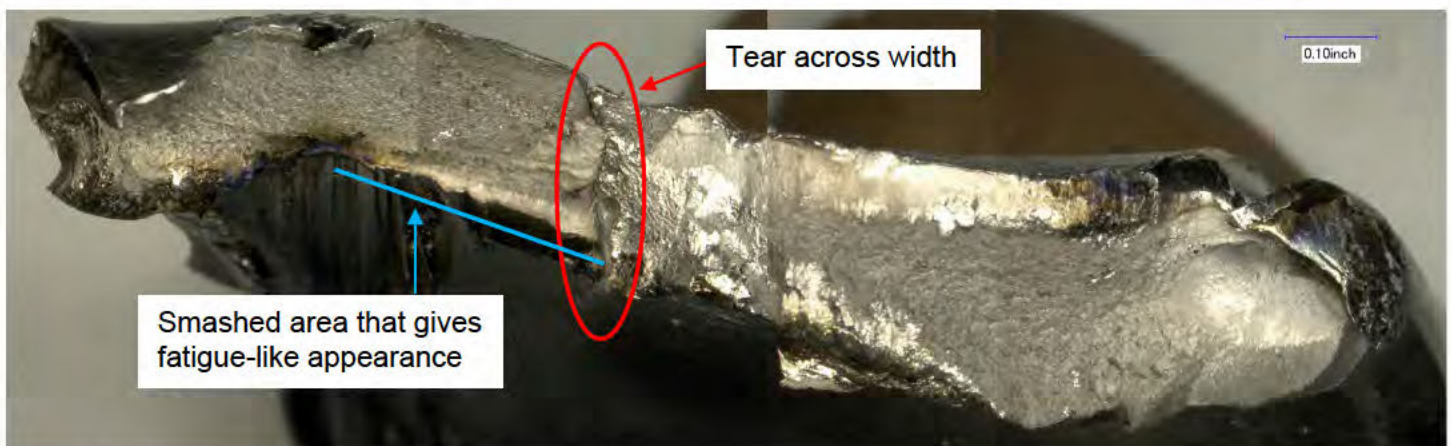
| Piece ID | Description (based on labeled bag the piece was delivered to the lab in) | Post-cleaning observations |
|---|---|---|
| M | #5 connecting rod cap chunk with connecting rod bolt hole | Fracture surface is jagged and smashed. There is clear evidence of severe damage, including a tear across the width of the connecting rod cap and physical distortion of the part. Macroscopically, part of the fracture surface appears woody and part of it appears to show microvoid coalescence (MVC), indicative of <b>failure by overload</b> . There is an area that looks like it could have been fatigued but based on the severe damage and distortion of the part and that particular area, it is likely that the fatigue-appearing region was smashed into the pattern it shows. See Figure 16. |

Figure 16 shows the fracture surface of Piece M. There is clear evidence of severe damage, including impact-induced waviness of the part and a tear across its width, indicating failure by overload. The fracture surface has areas that appear woody and ones that appear to show microvoid coalescence (MVC). There is an area (pointed out with a blue line in Figure 16) that looks like it could be fatigue, but given the level of damage the part sustained, it is more likely that the region was smashed into the pattern it shows.

**Figure 16.** Image showing fracture surface of Piece M.

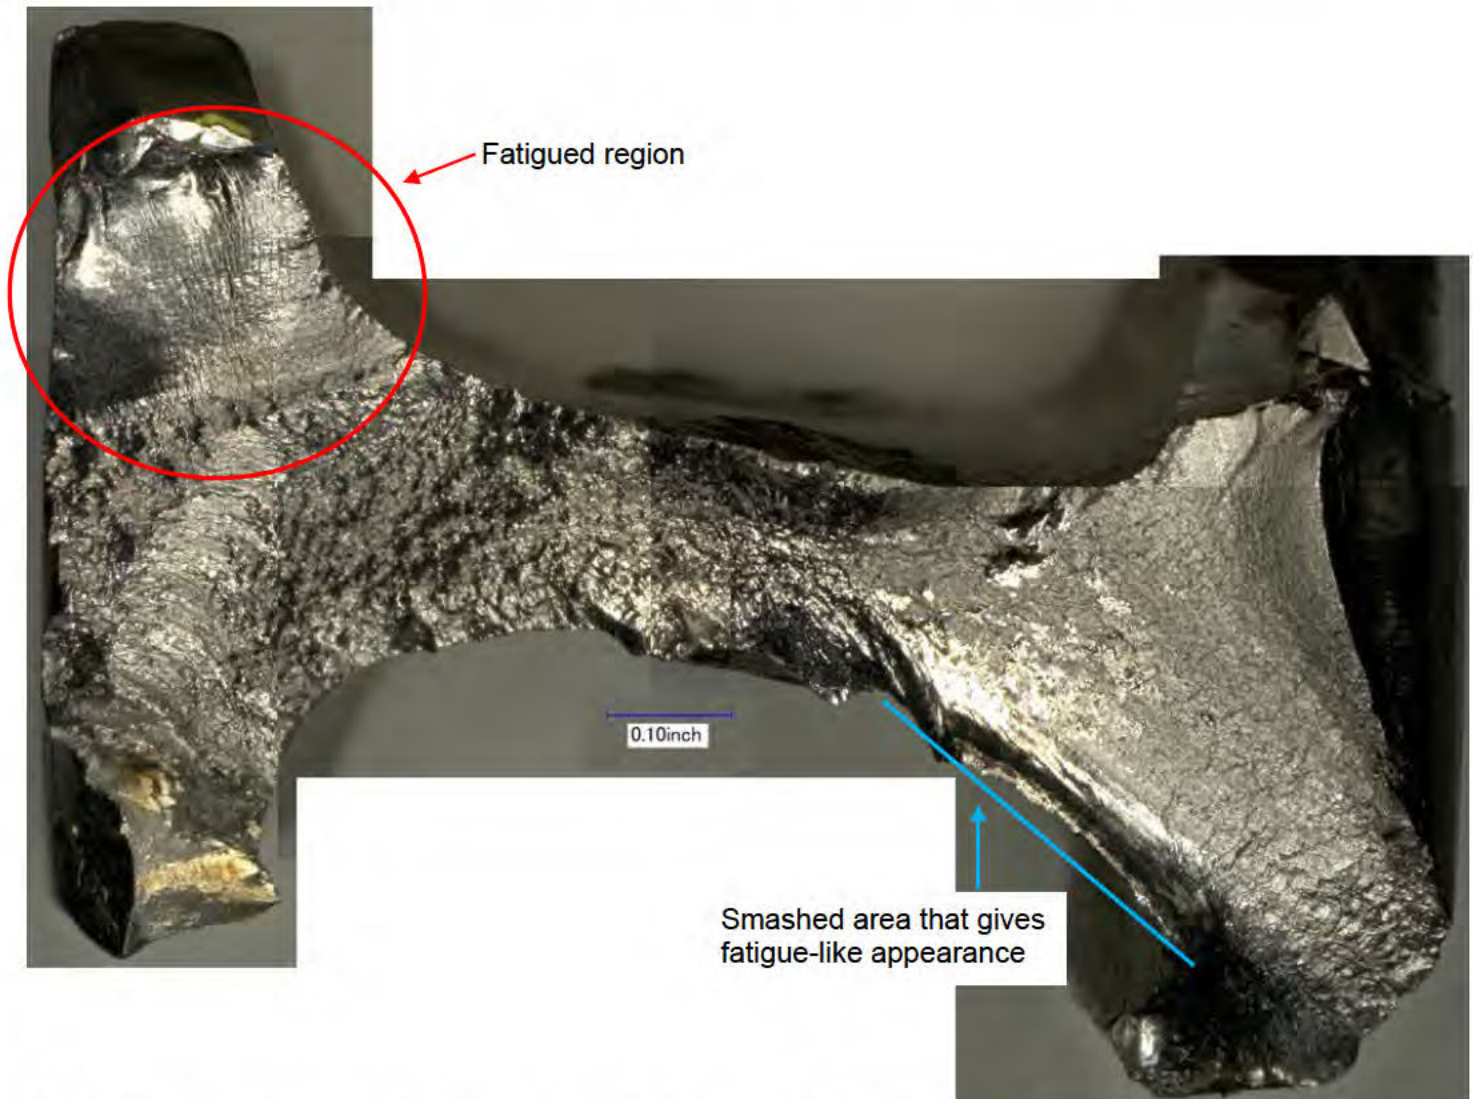
| Piece ID | Description (based on labeled bag the piece was delivered to the lab in) | Post-cleaning observations |
|---|---|---|
| N | #6 connecting rod main body, excluding bearing end | Mating surface with part O. Fracture surface is flat and shiny in some areas and textured and shiny in others. Shows <b>fatigue</b> and evidence of smashing. The piston pin end shows severe heat tinting. See Figures 17 and 18. |

Figure 17 shows the fracture surface at the bearing end of the #6 connecting rod, Piece N. The rod fractured where the I-beam of the rod transitions to the bearing end of the rod. This fracture surface is the mating surface to one of the fracture surfaces of Piece O. It shows fatigue and evidence of smashing. Like Piece M, there is a region pointed out with a blue line that looks like it could be fatigued or could have been smashed into that pattern from impact in the damaged engine.

**Figure 17.** Image showing the fracture surface at the bearing end of the #6 connecting rod, Piece N.

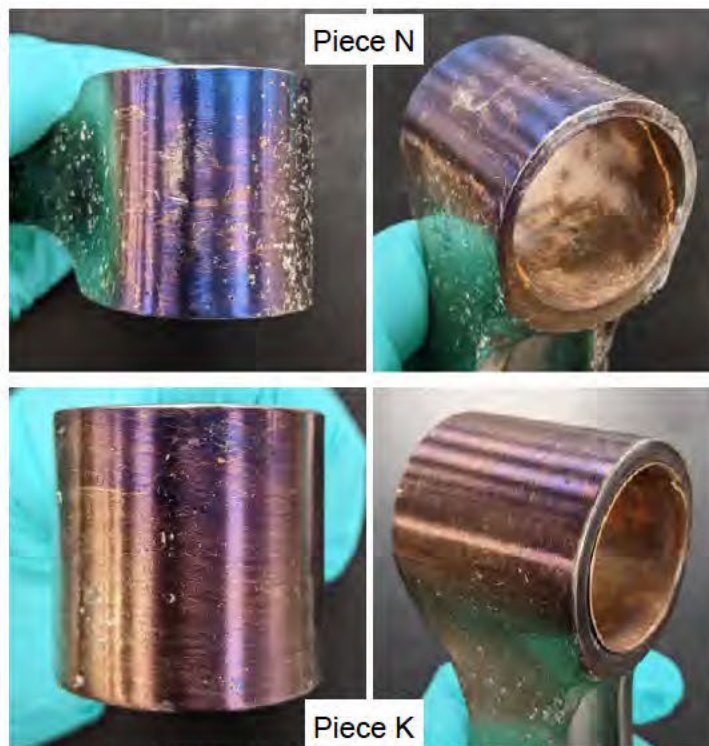
Once the combustion/detonation debris was ultrasonically cleaned off Piece N (#6 connecting rod main body, excluding bearing end) it became clear that the piece saw high service temperatures, based on the heat coloring on the piston pin end. Piece K (#5 connecting rod main body, including bearing end), although its fracture surfaces were deemed to be too damaged to be salvageable, was also cleaned to examine its piston pin end for similar heat coloring. As shown in Figure 18, both Pieces N and K show a deep purple/bright blue coloration, which corresponds to operating temperatures in the (approximate) 540°F to 590°F range.

**Figure 18.** Image showing heat tinting of pieces N and K.

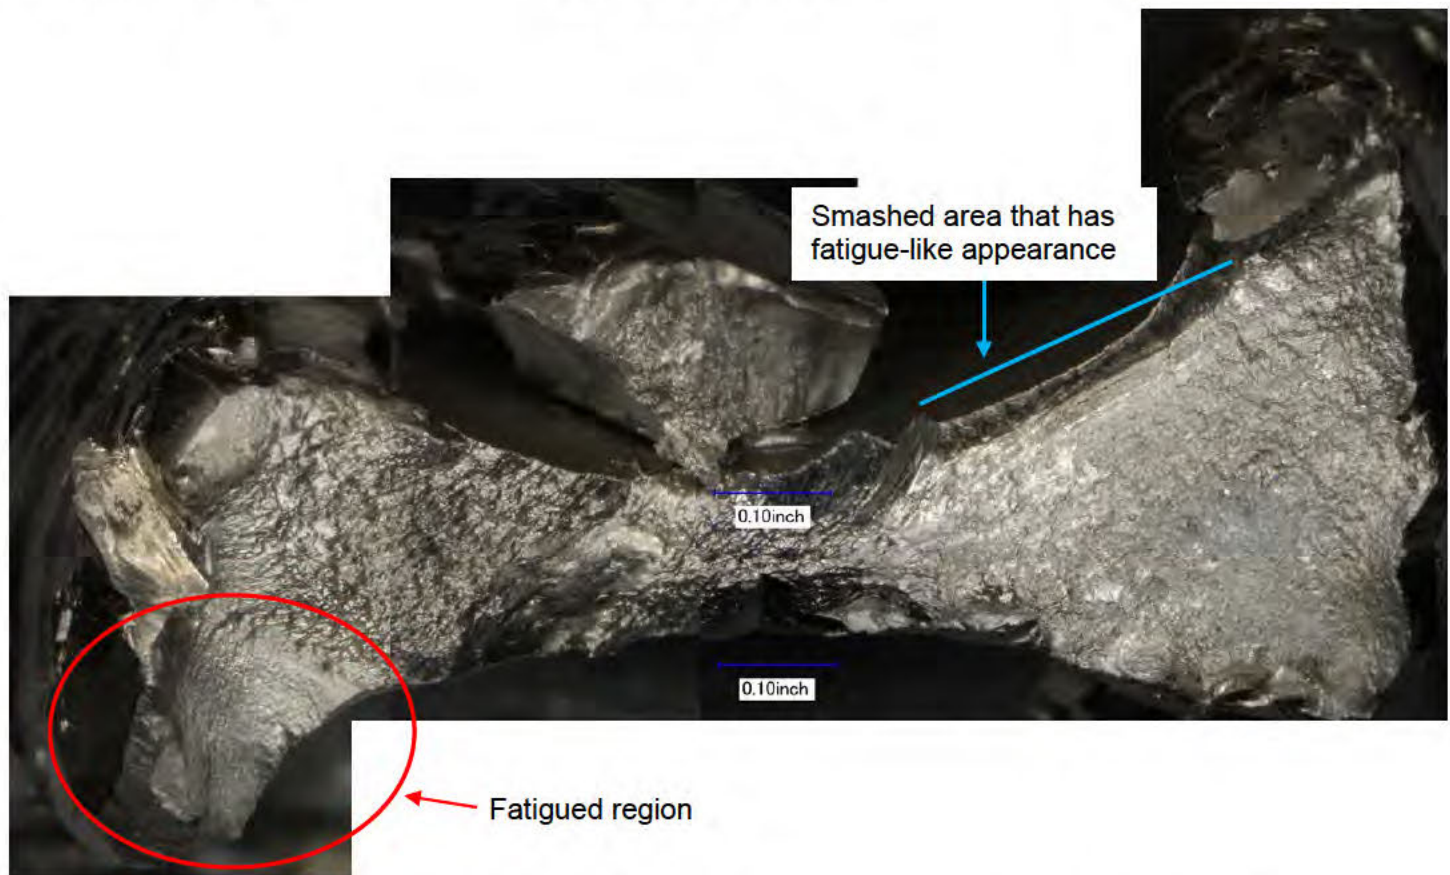
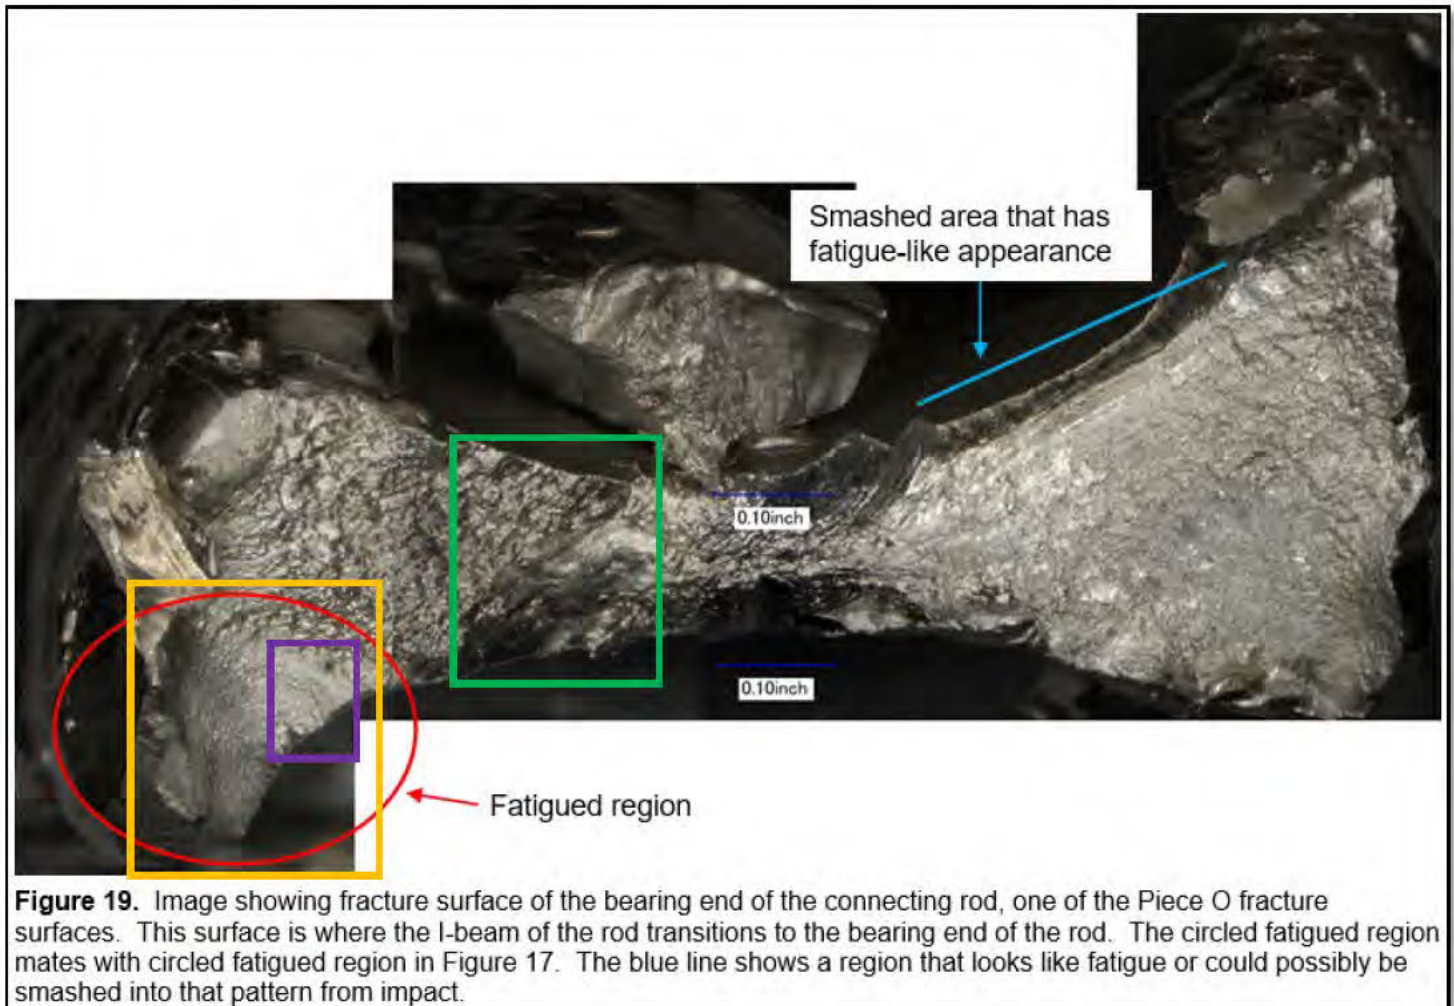
| Piece ID | Description (based on labeled bag the piece was delivered to the lab in) | Post-cleaning observations |
|---|---|---|
| O | #6 connecting rod main body, bearing end only | Has three fracture surfaces (one where I-beam of rod transitions to bearing end of rod, and two each end of the connecting rod bearing end where the bolt hole is). The mating surface with part N shows some smashing and evidence of <b>fatigue</b> . There are two ends that mate with the connecting rod cap—one end (with wave-shaped curl) shows evidence of fatigue, some smashing, and a woody section. The other end is completely smashed and will provide no useful information. See Figures 19-21 and Appendix B Figures i-ix. |

**Figure 19.** Image showing fracture surface of the bearing end of the connecting rod, one of the Piece O fracture surfaces. This surface is where the I-beam of the rod transitions to the bearing end of the rod. The circled fatigued region mates with circled fatigued region in Figure 17. The blue line shows a region that looks like fatigue or could possibly be smashed into that pattern from impact.
