### MATERIALS LABORATORY INVESTIGATION REPORT

TYPE: IO-540-K1A5

NAME: Crankshaft, #5 and #6 conn  
rods, and counterweights

Analyze crankshaft/counterweights/#5 and #6 connecting rods to find potential causes of failure.

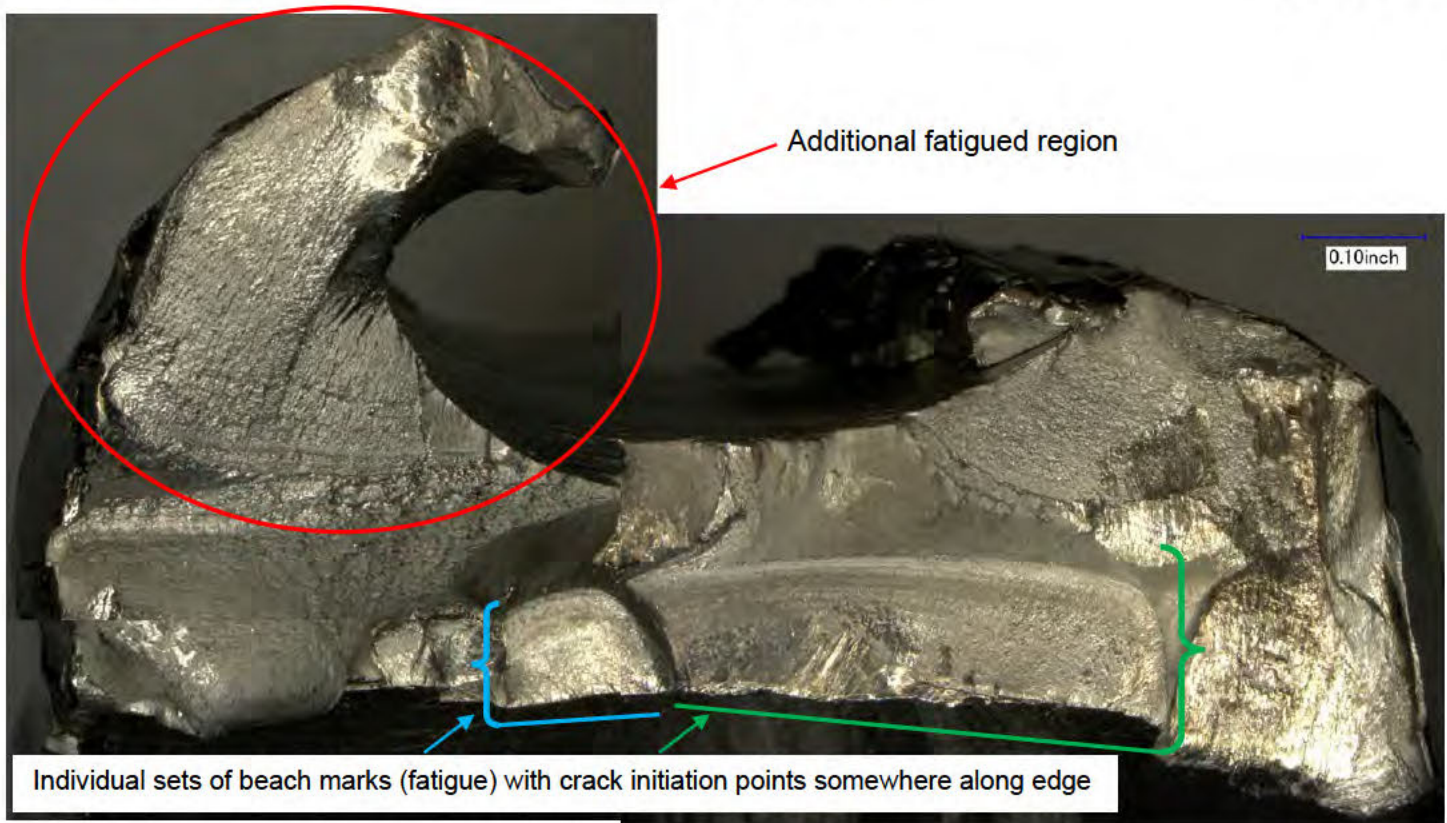
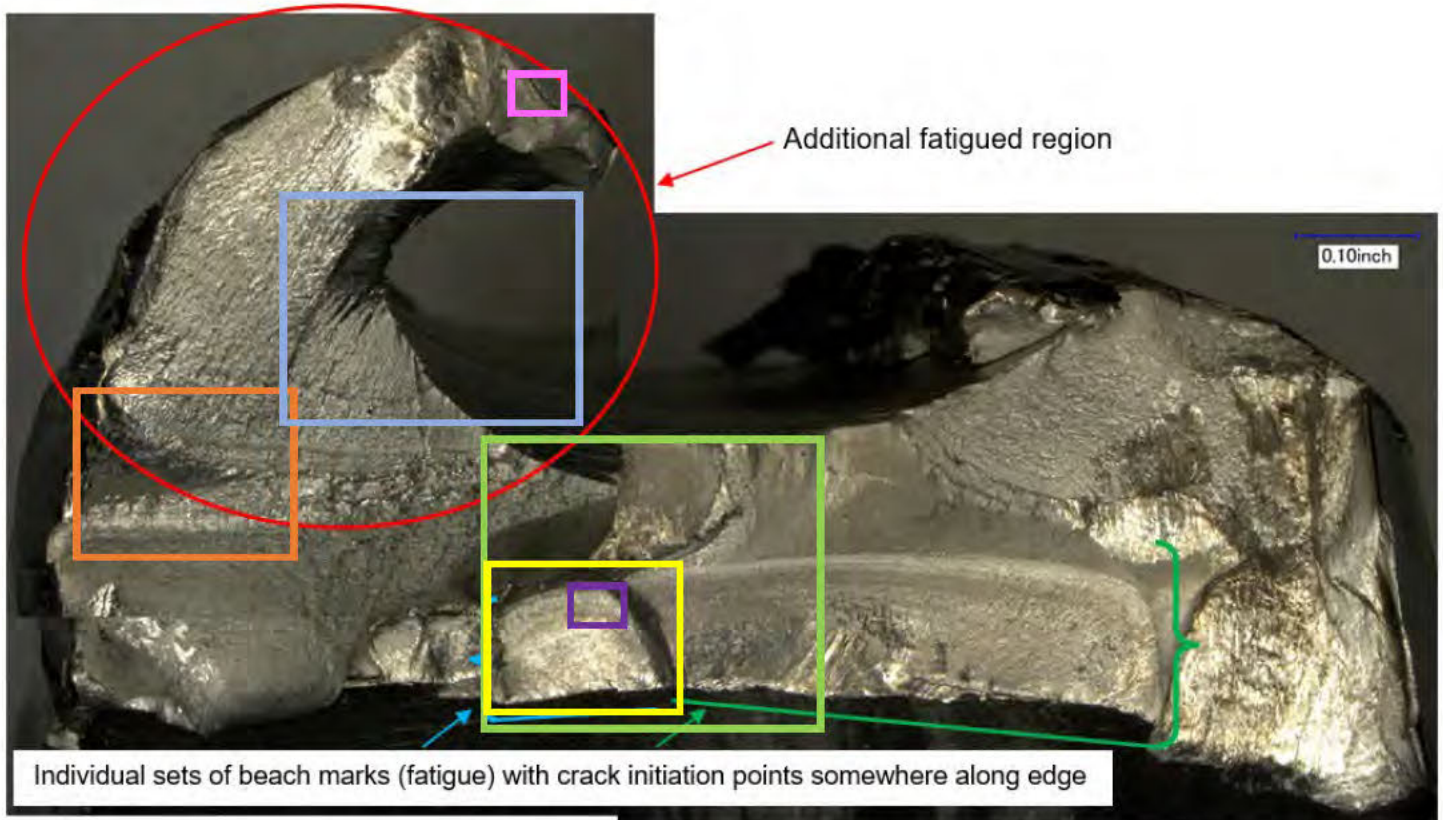
**Figure 20.** Image of one of the bolt hole ends of the #6 connecting rods, Piece O. There is clear evidence of fatigue, with multiple sets of beach marks and crack initiation sites.

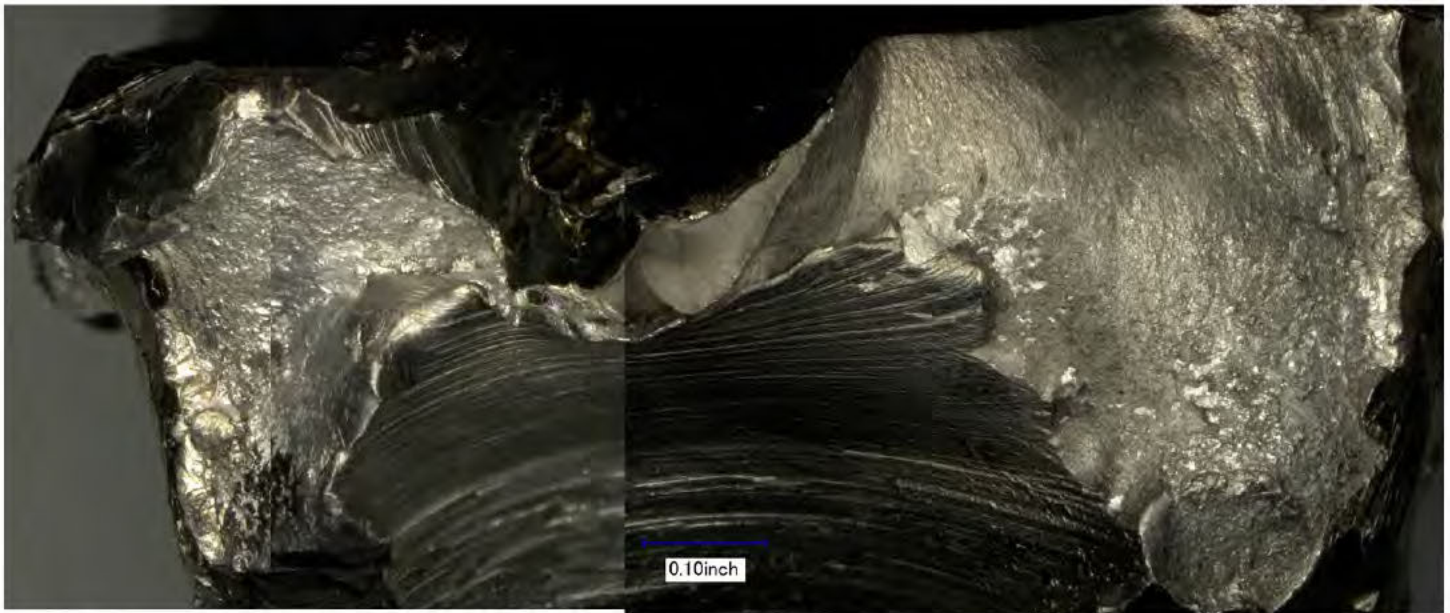
The other bolt hole end of the #6 connecting rod (Piece O) is shown in Figure 21. This fracture surface is very damaged and will not provide any useful fracture information.

**Figure 21.** Image of one of the bolt hole ends of the #6 connecting rods, Piece O. There surface is very damaged and will not provide useful information about failure mode.

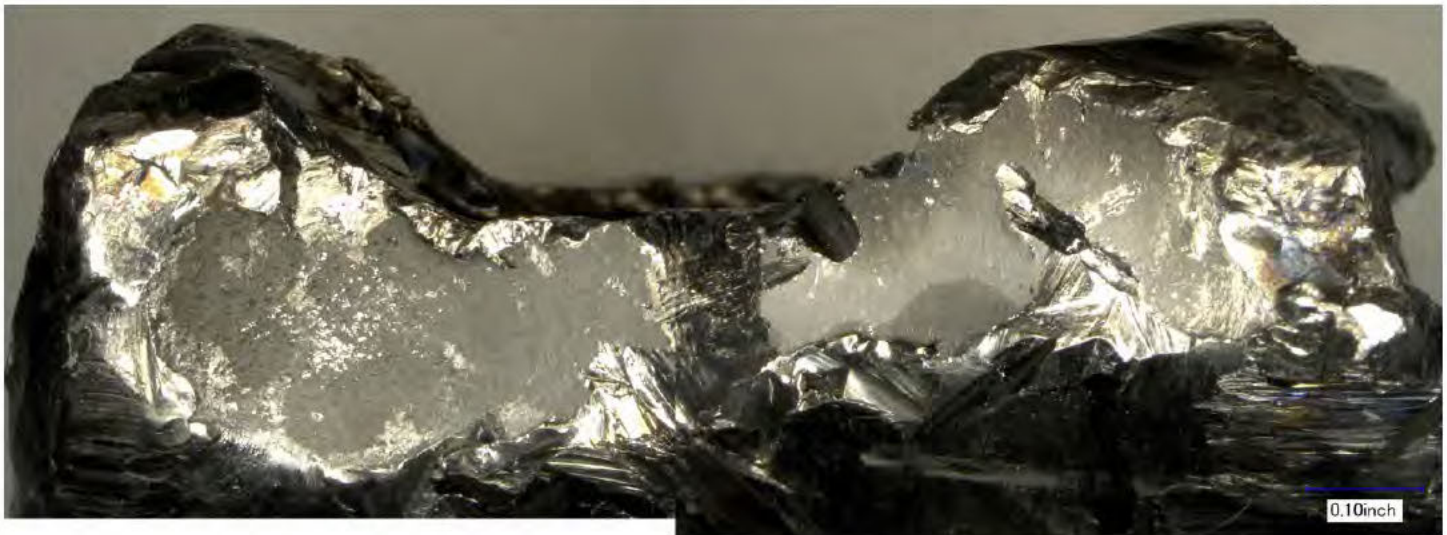
| Piece ID | Description (based on labeled bag the piece was delivered to the lab in) | Post-cleaning observations |
|---|---|---|
| P | #6 connecting rod cap chunk with connecting rod bolt hole | Fracture surface is smashed and smeared. Surface appears dark gray and not shiny. Provides no useful information about failure mode. See Figure 22. |

Figure 22 shows the fracture surface of Piece P. The fracture surface is very damaged and provides no useful information.

**Figure 22.** Image of fracture surface of Piece P. Provides no useful failure information.

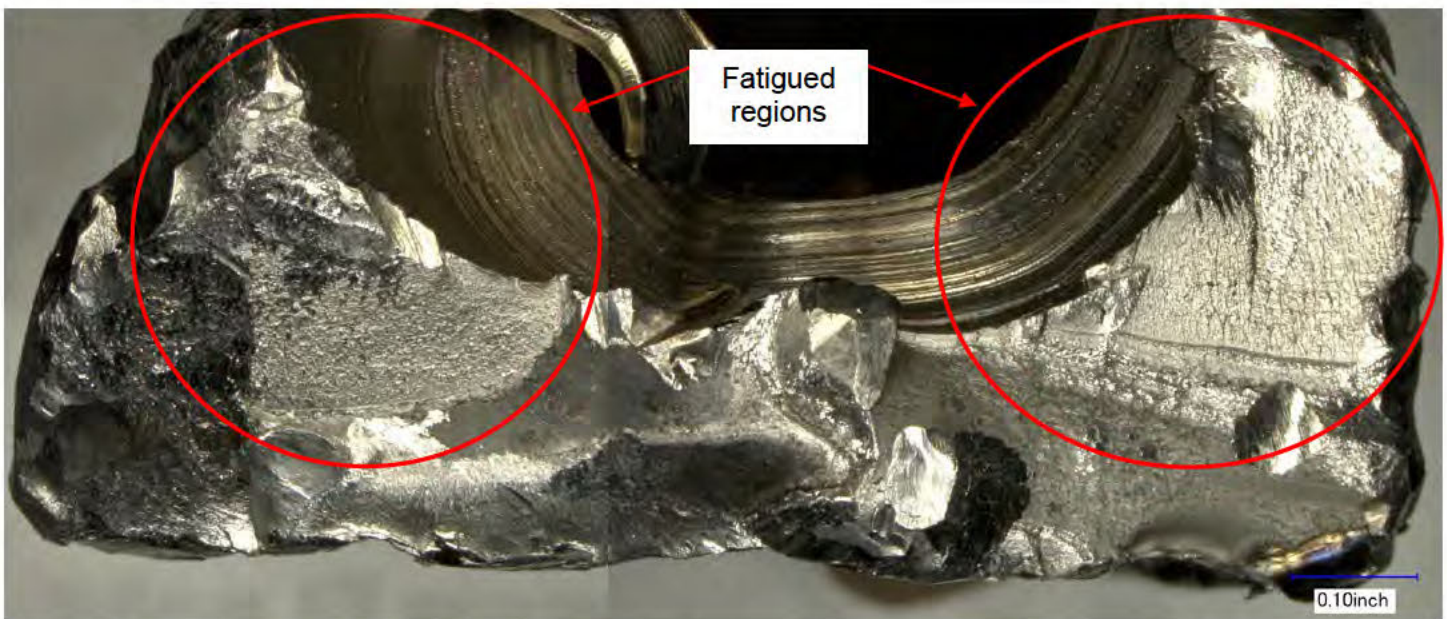
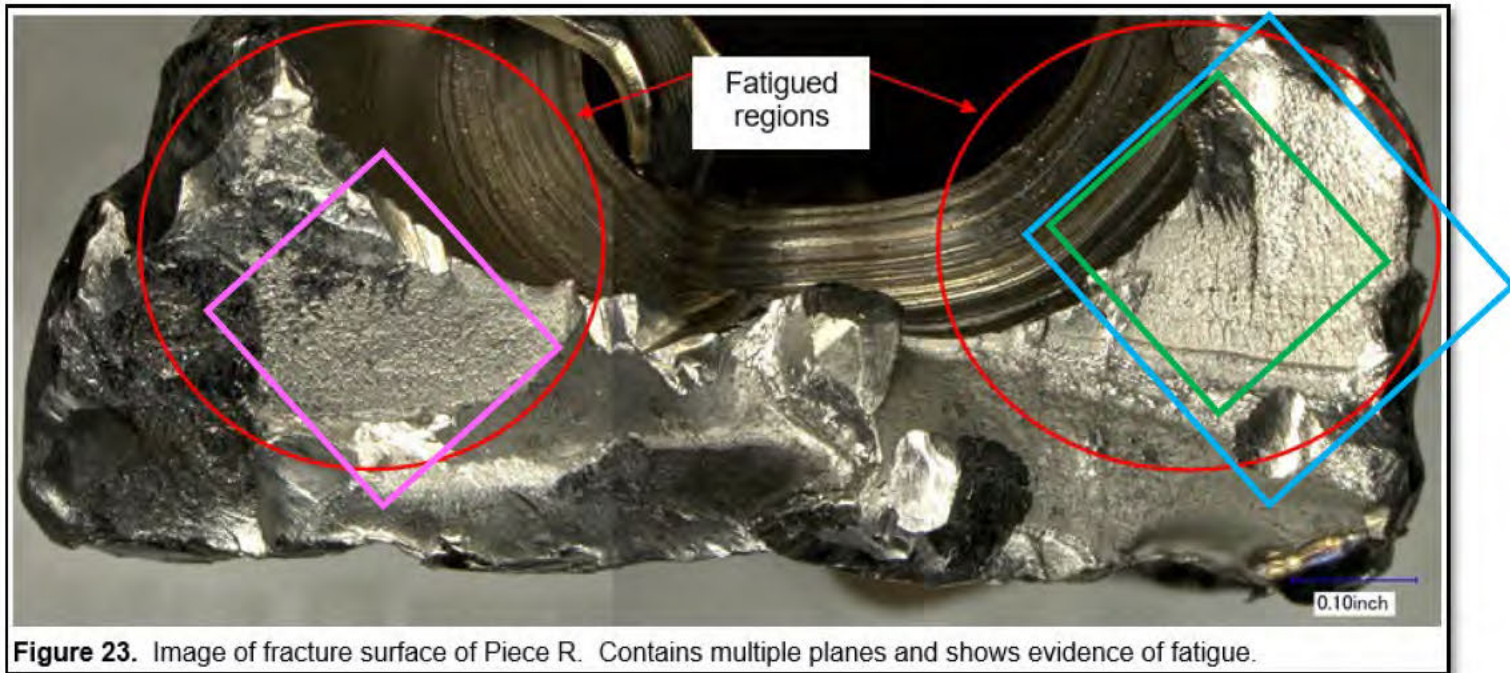
Figure 23 shows the fracture surface of Piece R. The piece has multiple planes, some that meet at 90° angles, and shows evidence of fatigue. Additional micrographs of this surface taken using the SEM are available in Appendix B, Figures x-xii.

**Figure 23.** Image of fracture surface of Piece R. Contains multiple planes and shows evidence of fatigue.

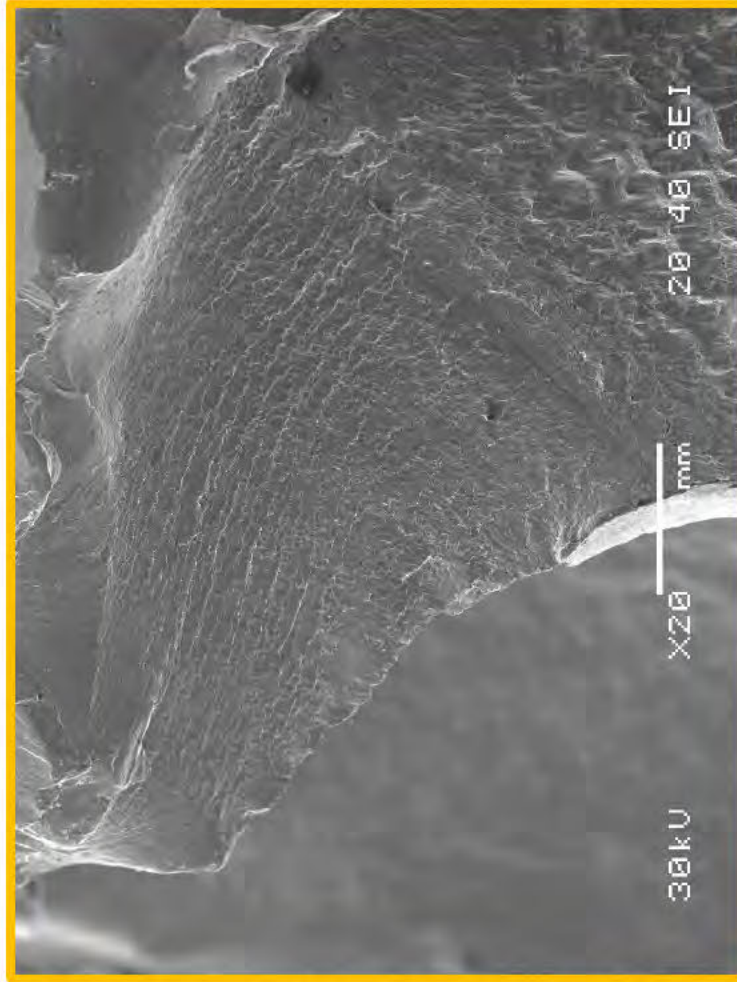
**Figure i.** SEM micrograph of Piece O, mating surface with connecting rod, where I-beam end of rod transitions to the bearing end of the rod. Region shows evidence of fatigue crack growth.

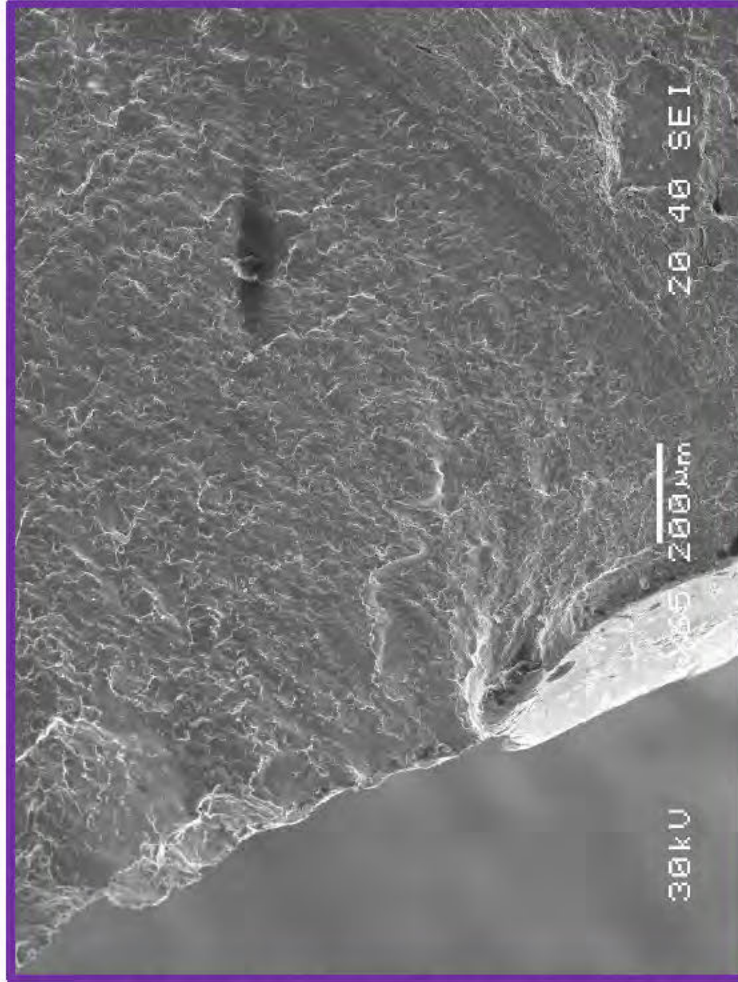
**Figure ii.** SEM micrograph of Piece O, mating surface with connecting rod, where I-beam end of rod transitions to the bearing end of the rod. Higher magnification image of Figure i. Region shows evidence of fatigue crack growth.

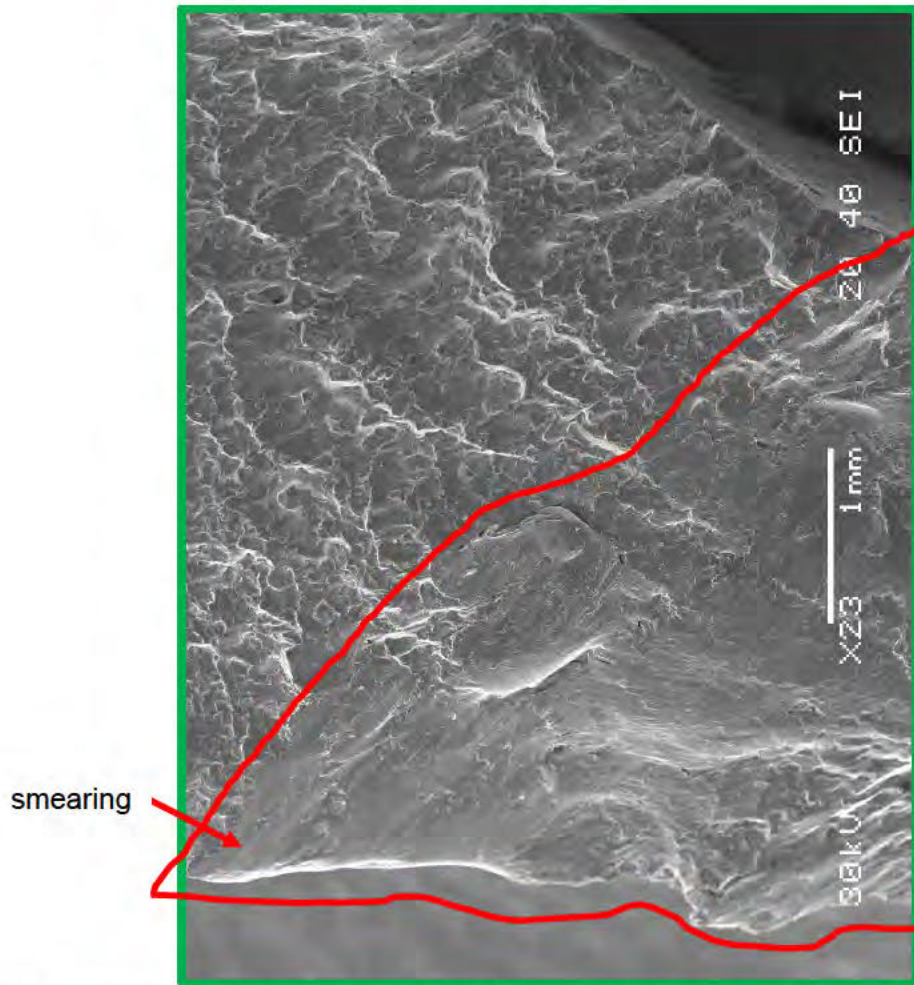
**Figure iii.** SEM micrograph of Piece O, mating surface with connecting rod, where I-beam end of rod transitions to the bearing end of the rod. Region near exact center of cross-section. There is a region of severe smearing outlined in red. Outside of the severely smeared region there is another damaged region that may show rough ductile tearing, possibly with some shear-type directionality, which is consistent with overload.

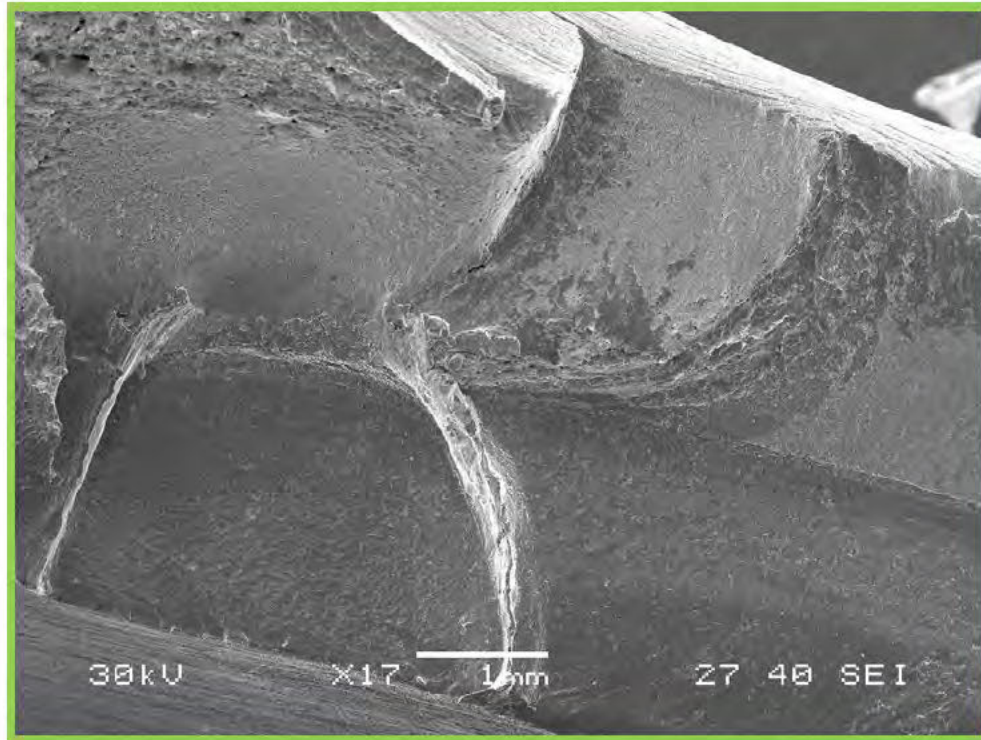
**Figure iv.** SEM micrograph of Piece O, bolt hole end. Region shows the convergence of multiple individual areas of fatigue crack growth.

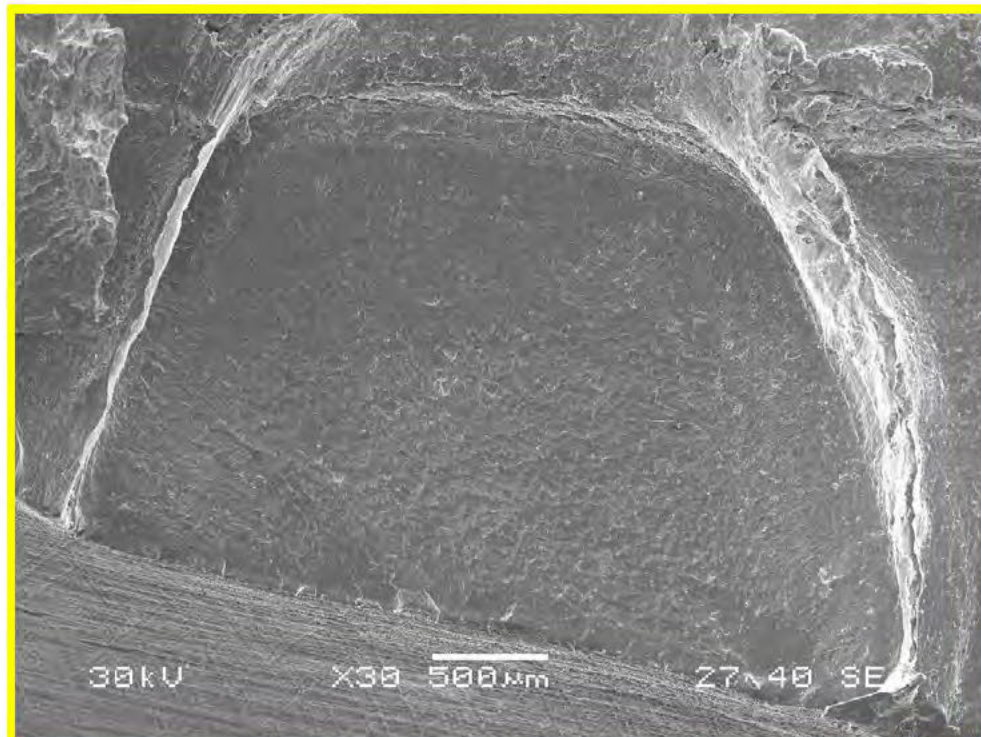
**Figure v.** SEM micrograph of Piece O, bolt hole end. Region shows a recessed area of fatigue crack growth, a closer view of a part of Figure iv.

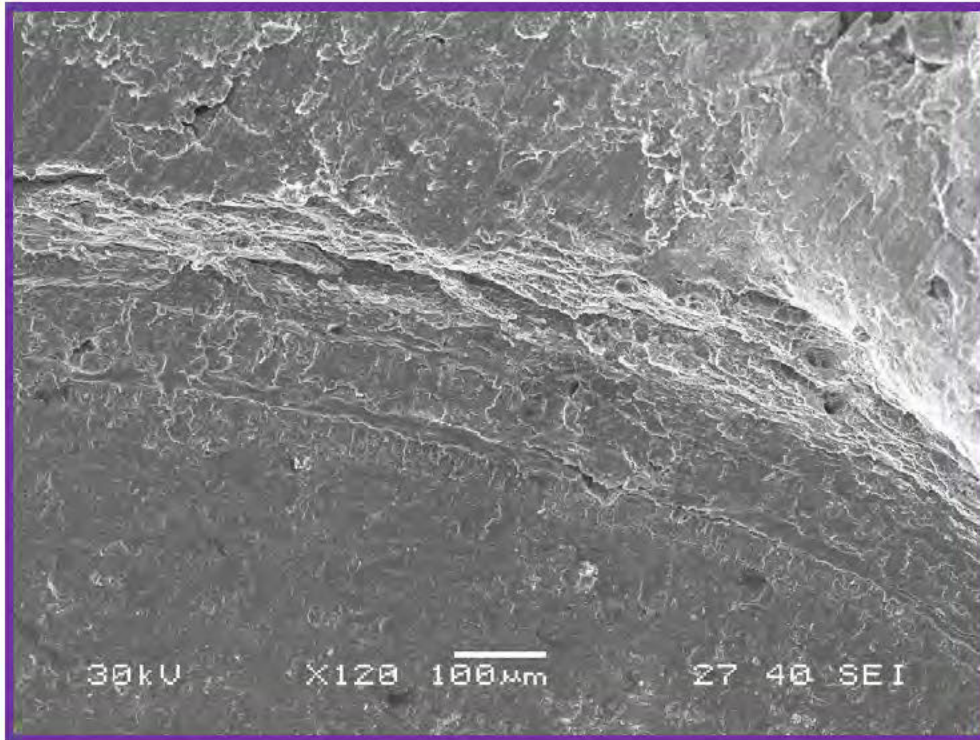
**Figure vi.** SEM micrograph of Piece O, bolt hole end. Region shows a closer view of the recessed area of fatigue crack growth in Figure v.

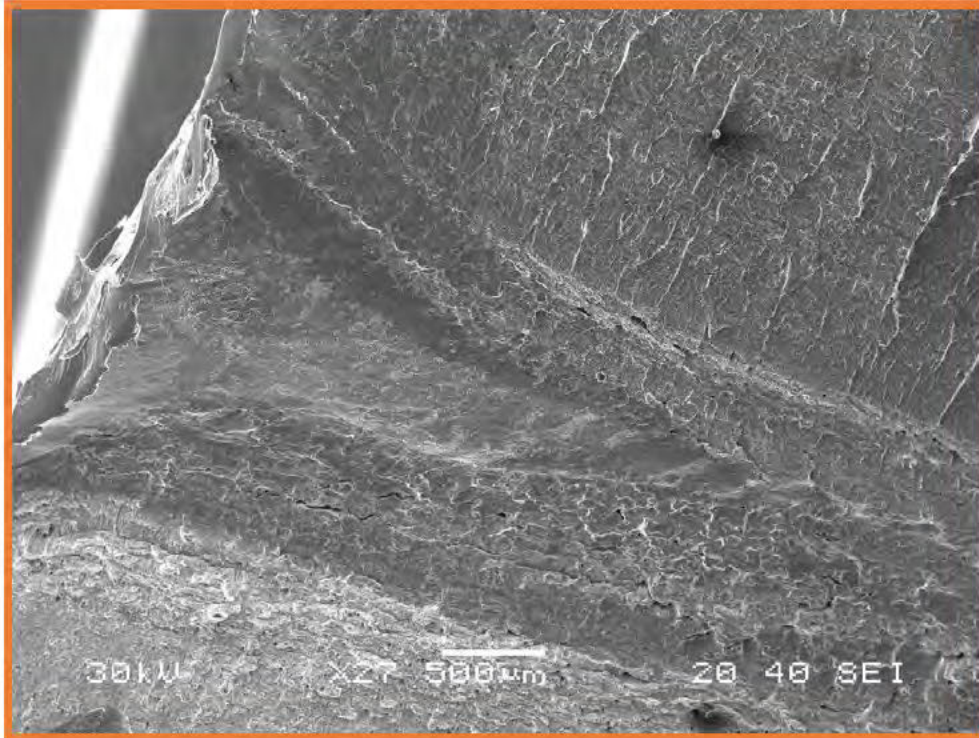
**Figure vii.** SEM micrograph of Piece O, bolt hole end. Region shows evidence of fatigue crack growth.

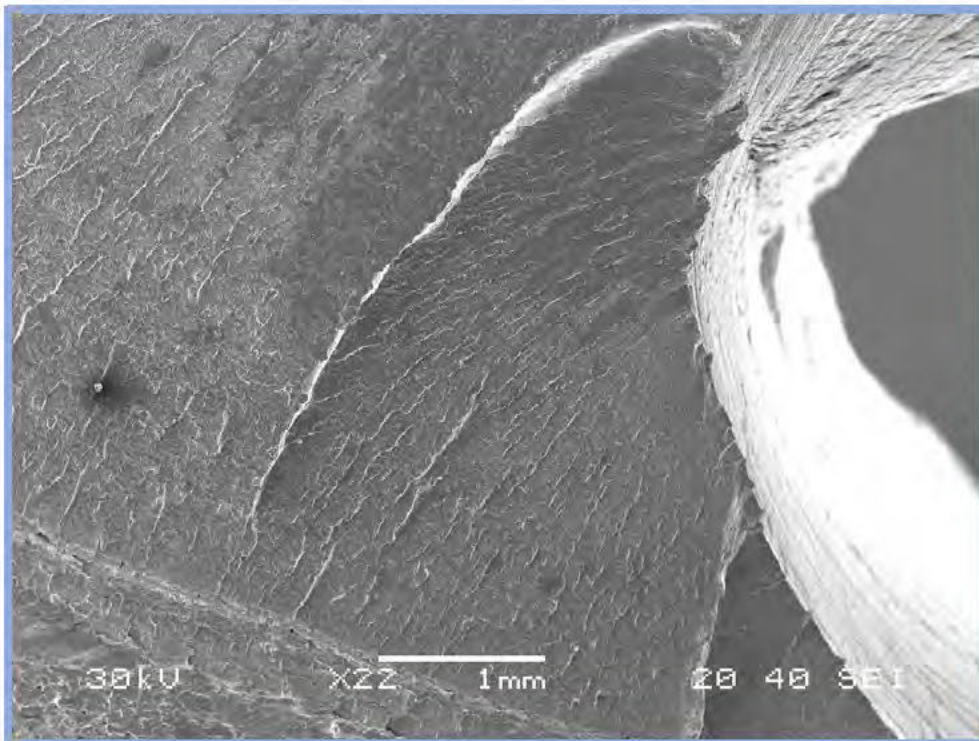
**Figure viii.** SEM micrograph of Piece O, bolt hole end. Region shows evidence of fatigue crack growth.

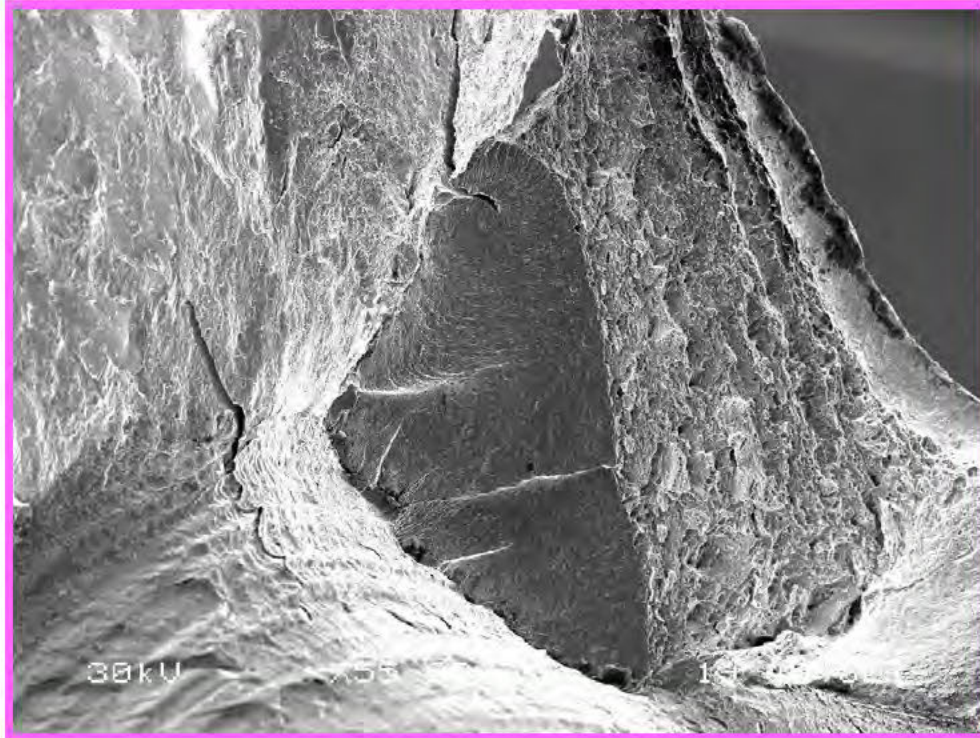
**Figure ix.** SEM micrograph of Piece O, bolt hole end. Region shows a recessed area with evidence of fatigue crack growth.

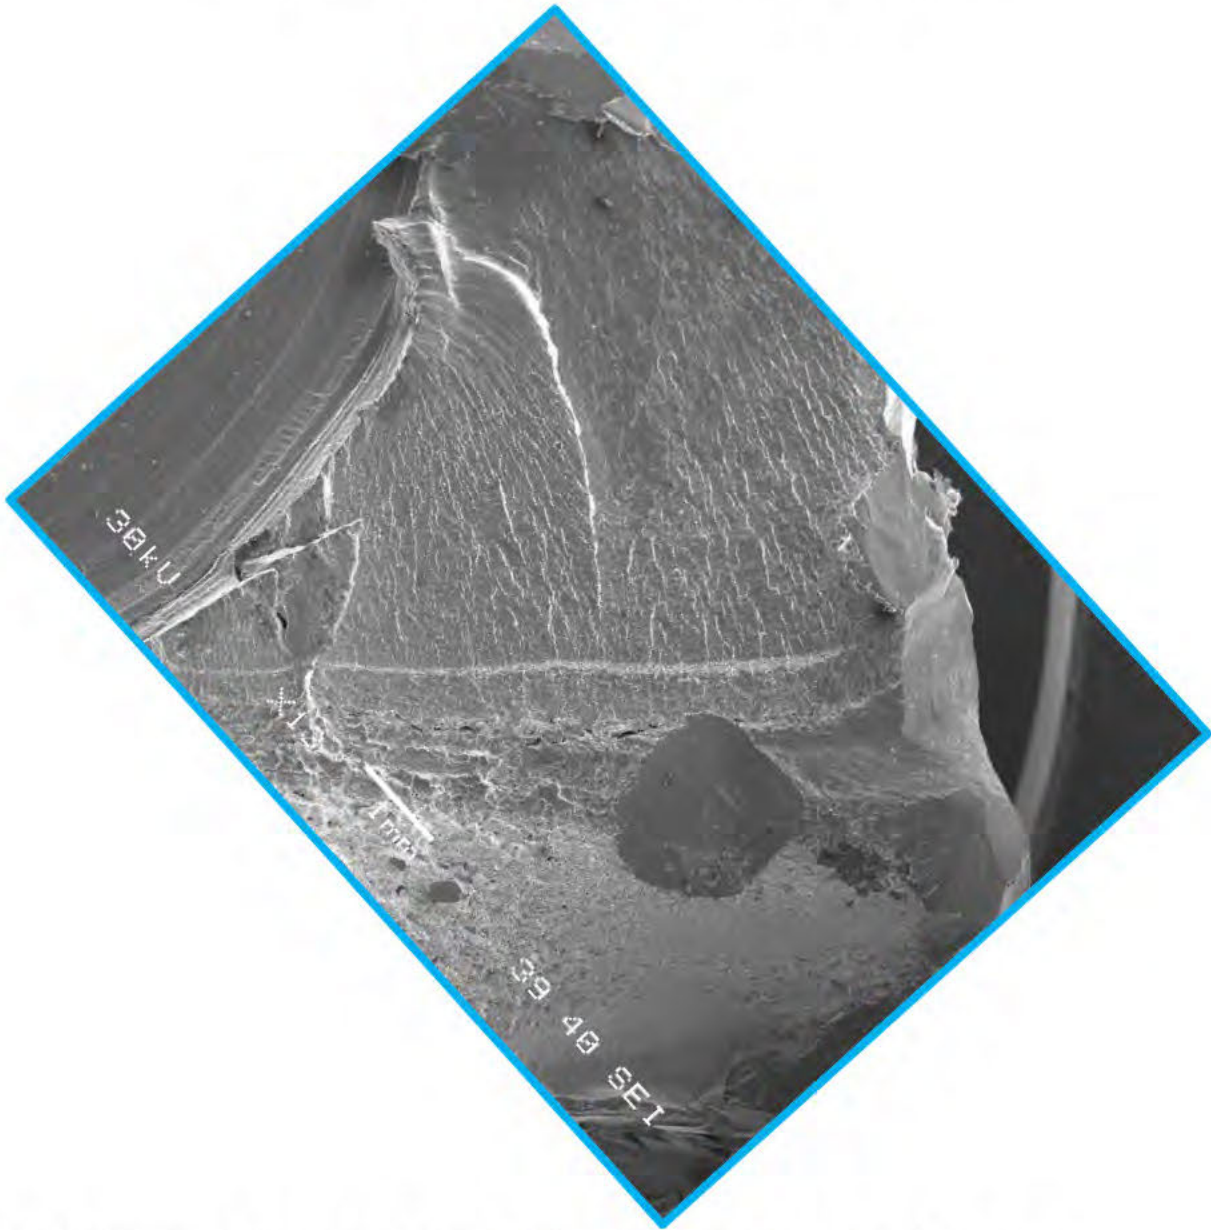
**Figure x.** SEM micrograph of Piece R. Region shows evidence of fatigue crack growth.

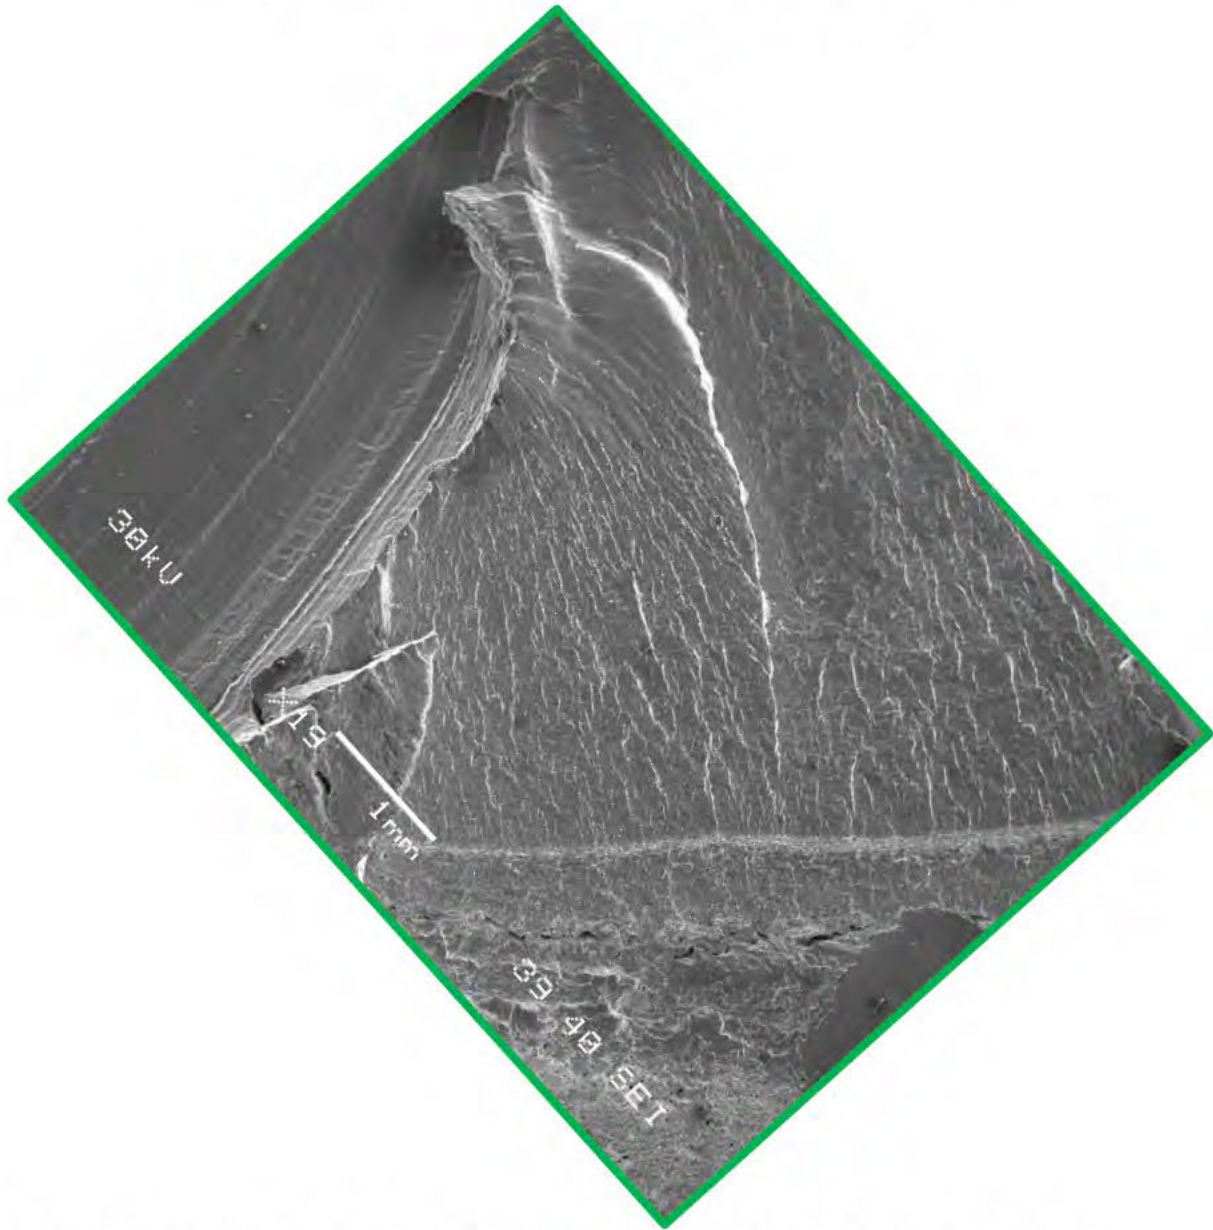
**Figure xi.** SEM micrograph of Piece R. Region shows evidence of fatigue crack growth.

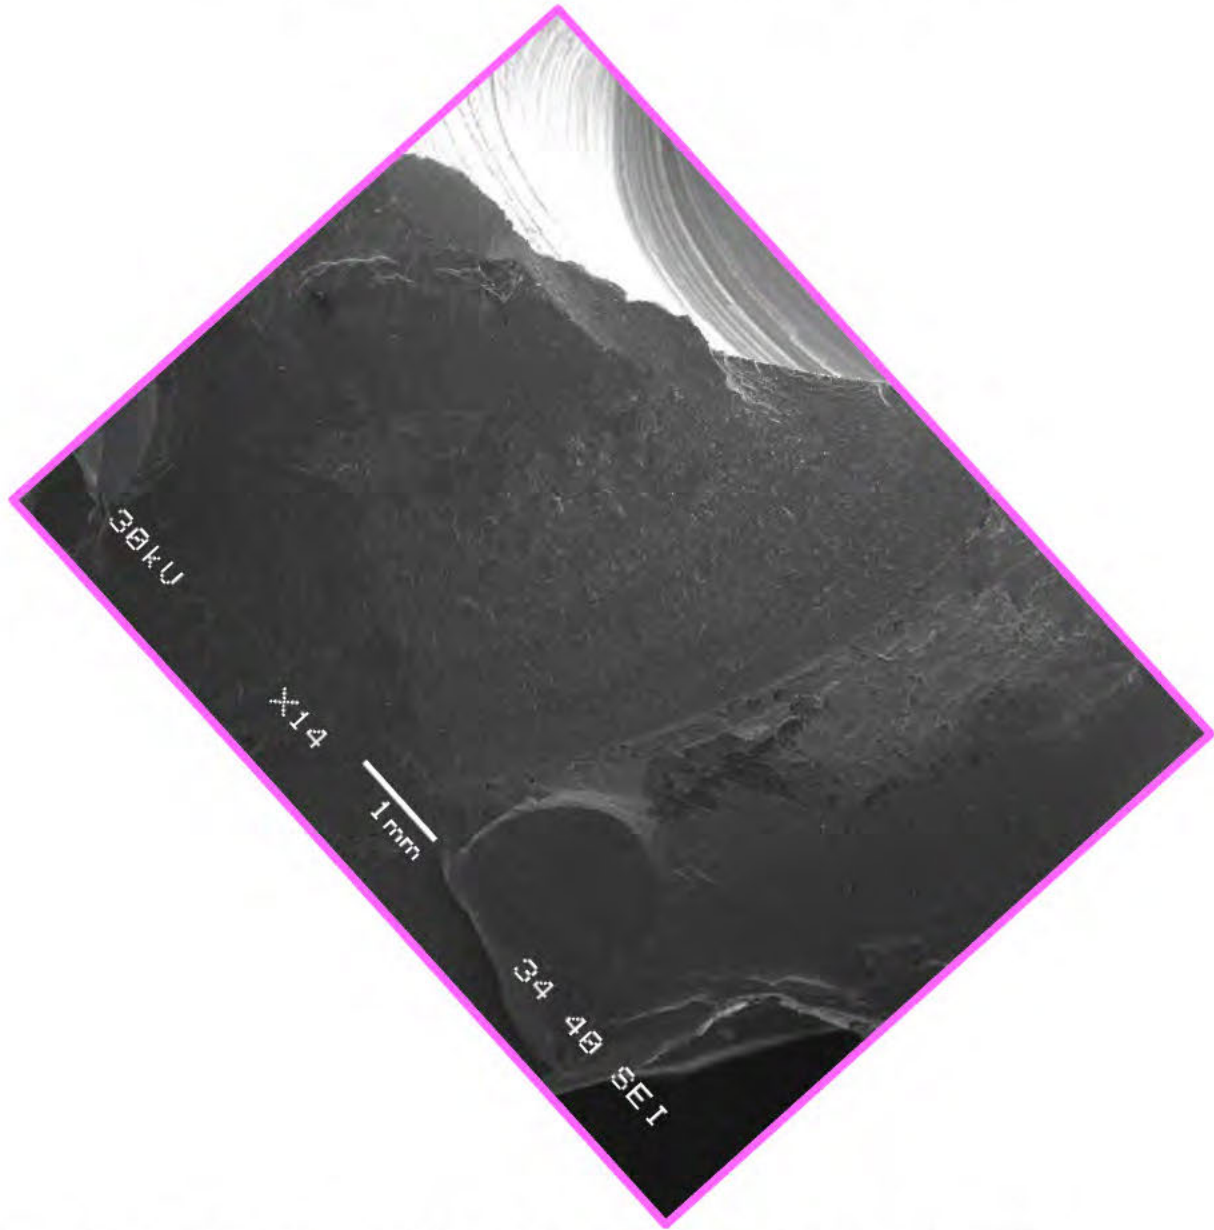
**Figure xii.** SEM micrograph of Piece R. Region shows evidence of fatigue crack growth.
