## **NATIONAL TRANSPORTATION SAFETY BOARD**

# **EXAMINATION SUMMARY**

**ERA22LA107**

Location: Winter Haven, Florida  
Date: January 12, 2022  
Time: 1427 EST  
Airplane: Piper J3-C65, N88509

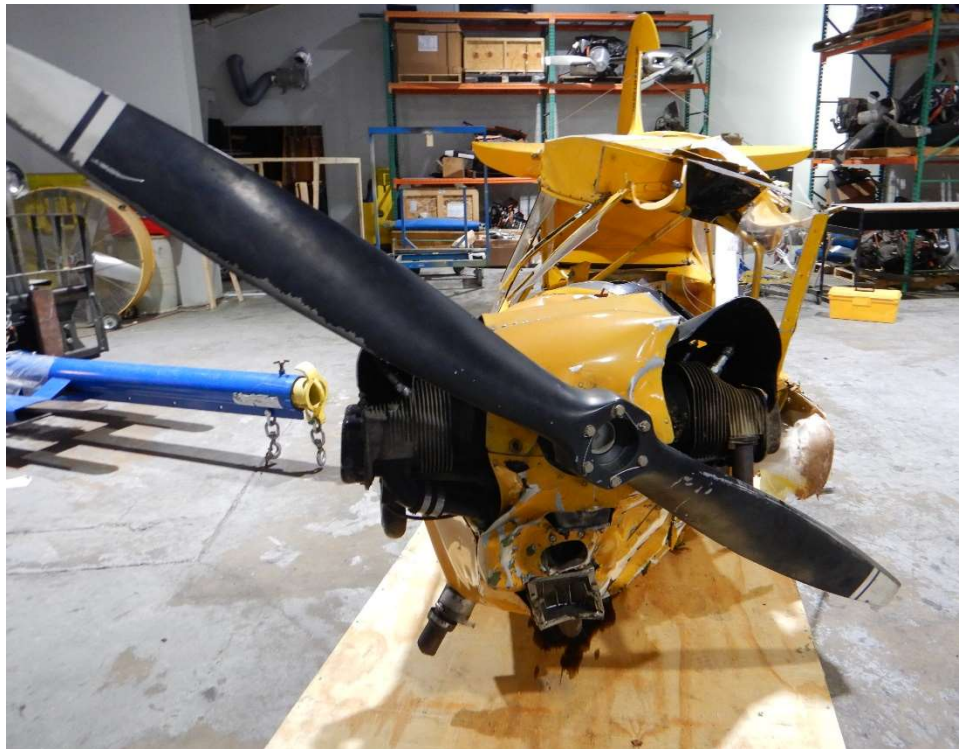
- Blades 1 & 2 – leading edge abrasion; no twisting, bending or rotational scoring

*Photo 1- View of propeller and cowled engine prior to examination*

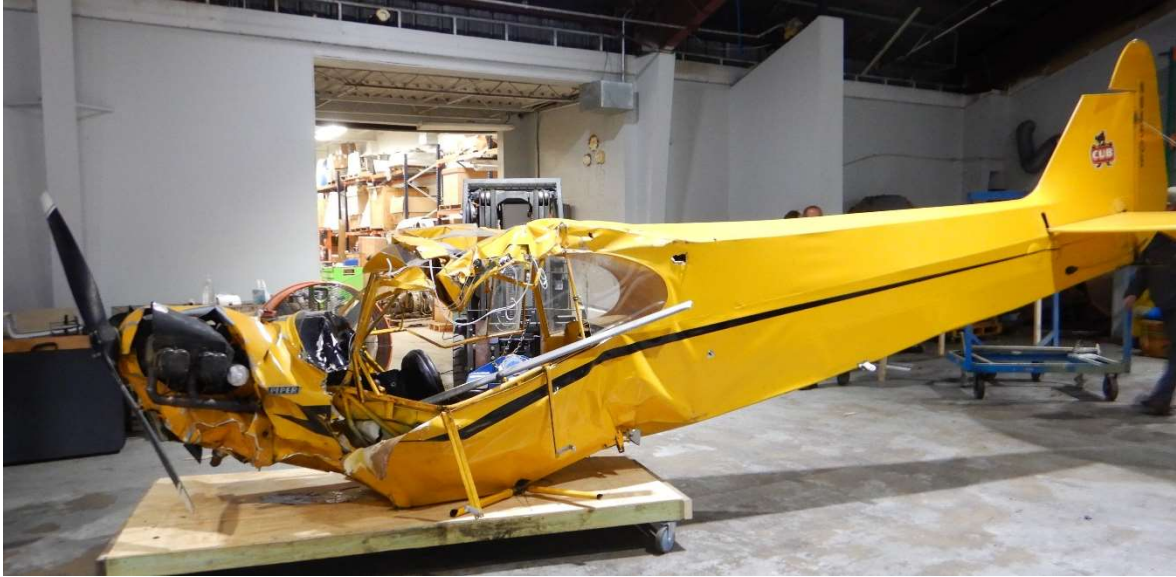
*Photo 2 - Photo of wreckage from left (wings removed for recovery)*

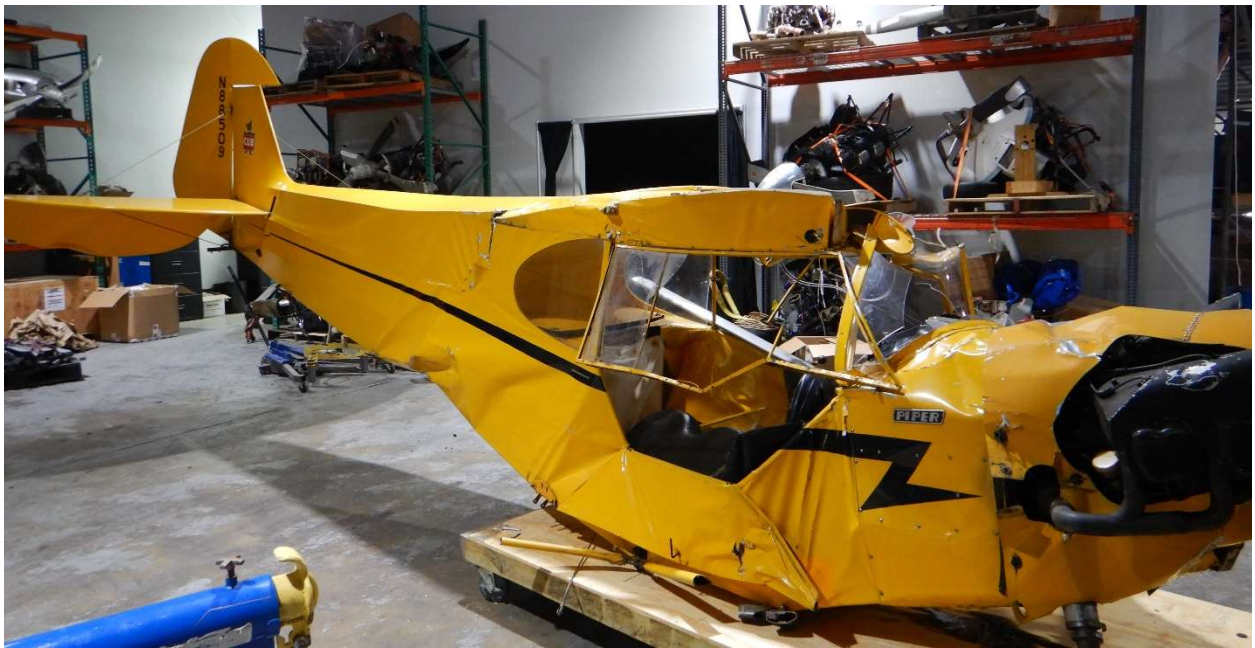
*Photo 3- Photo of wreckage from right (wings removed for recovery)*

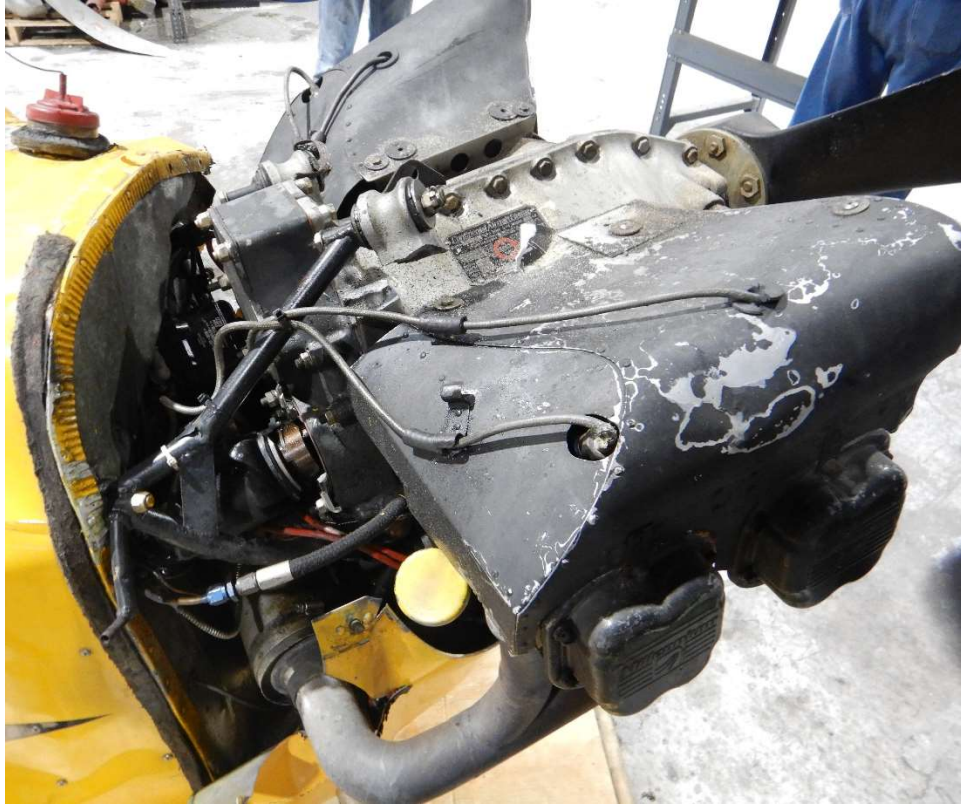
*Photo 4 - Engine with cowling removed*

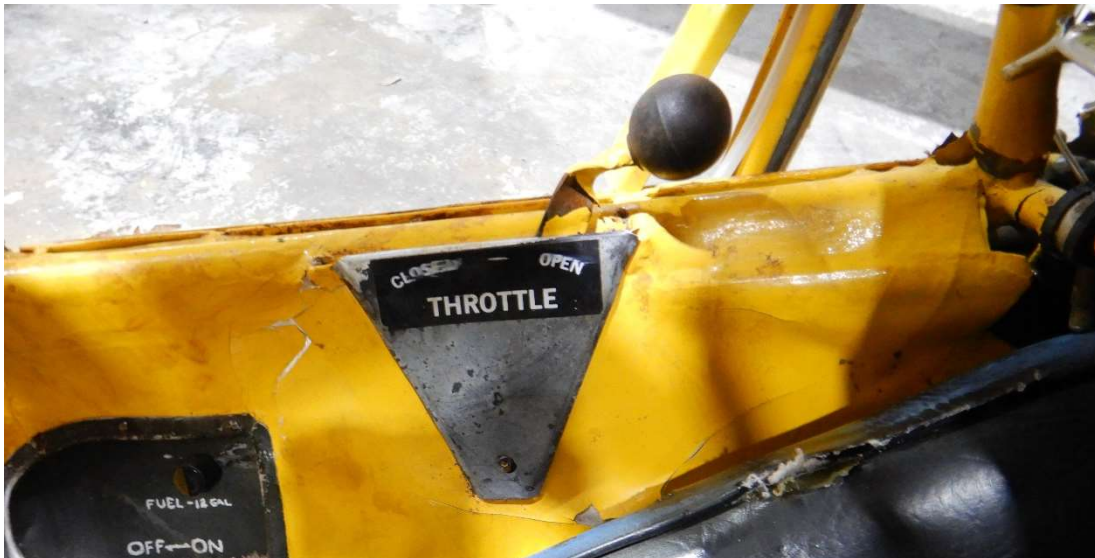
*Photo 5 - Throttle control*

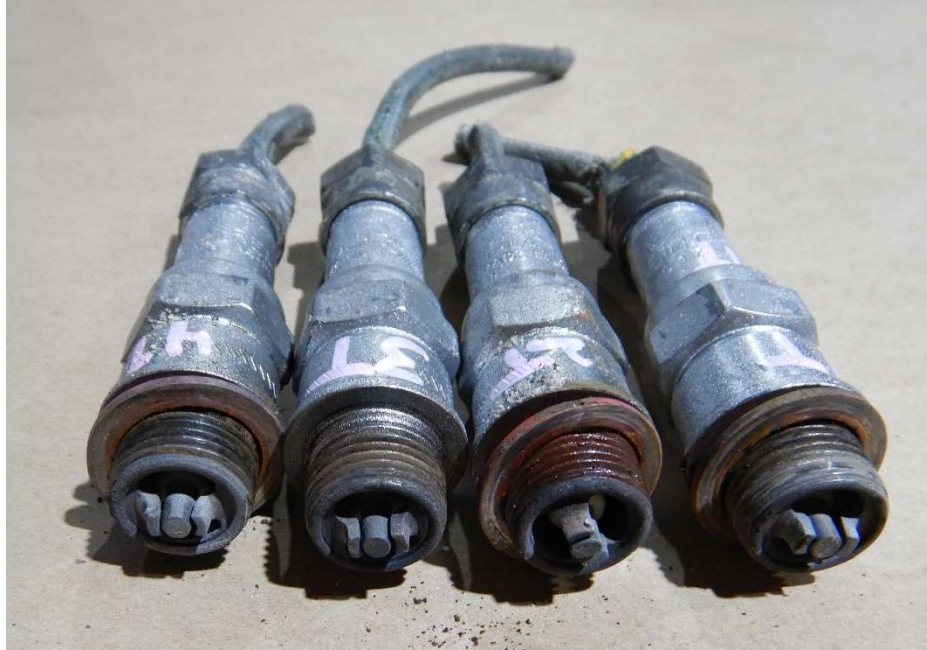
- Continuity of crankshaft & camshaft confirmed when propeller rotated by hand
- Spark plugs, top – Worn-out to normal based on Champion Aviation check-A-Plug Guide

*Photo 6 - Top spark plugs*

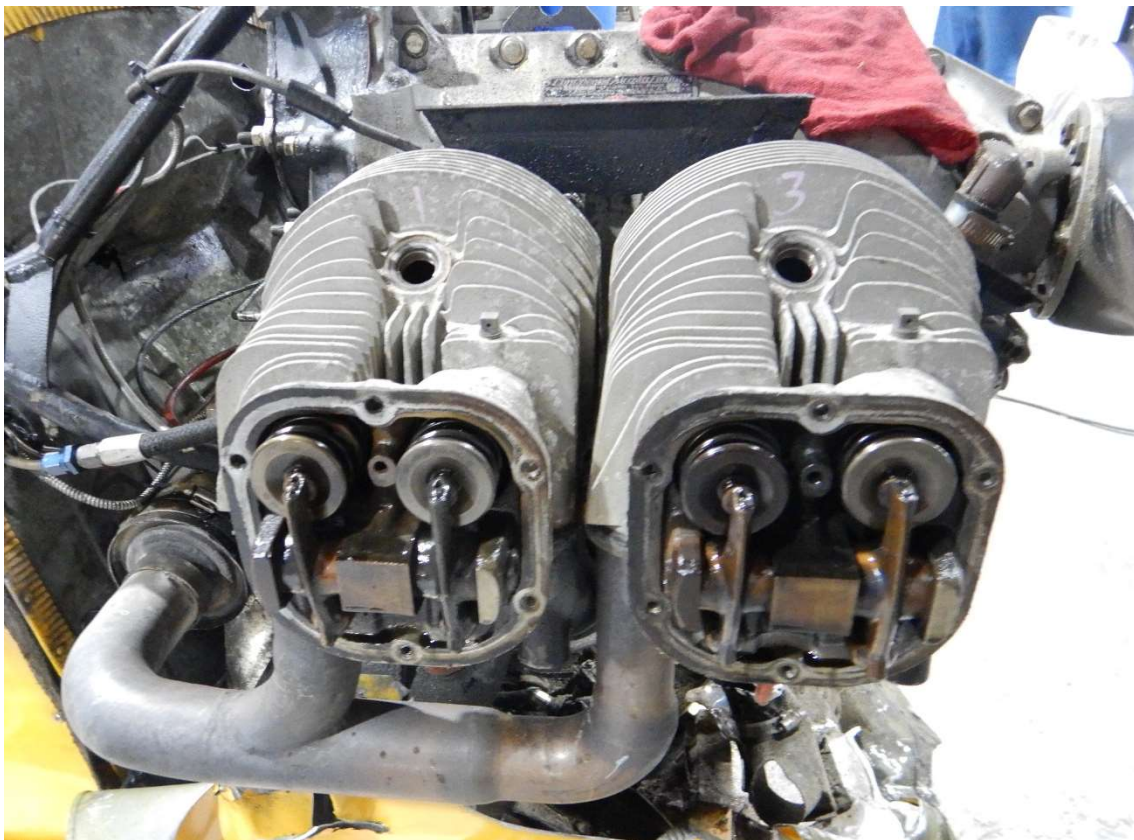
- Right magneto fractured off at impact; sparked strongly at all leads
- Left magneto sparked strongly at all leads
- Borescope examination of all cylinders revealed carbon deposits consistent with rich mixture and/or automotive fuel use

*Photo 7 - Cylinder Nos. 1 and 3 with spark plugs and rocker covers removed*

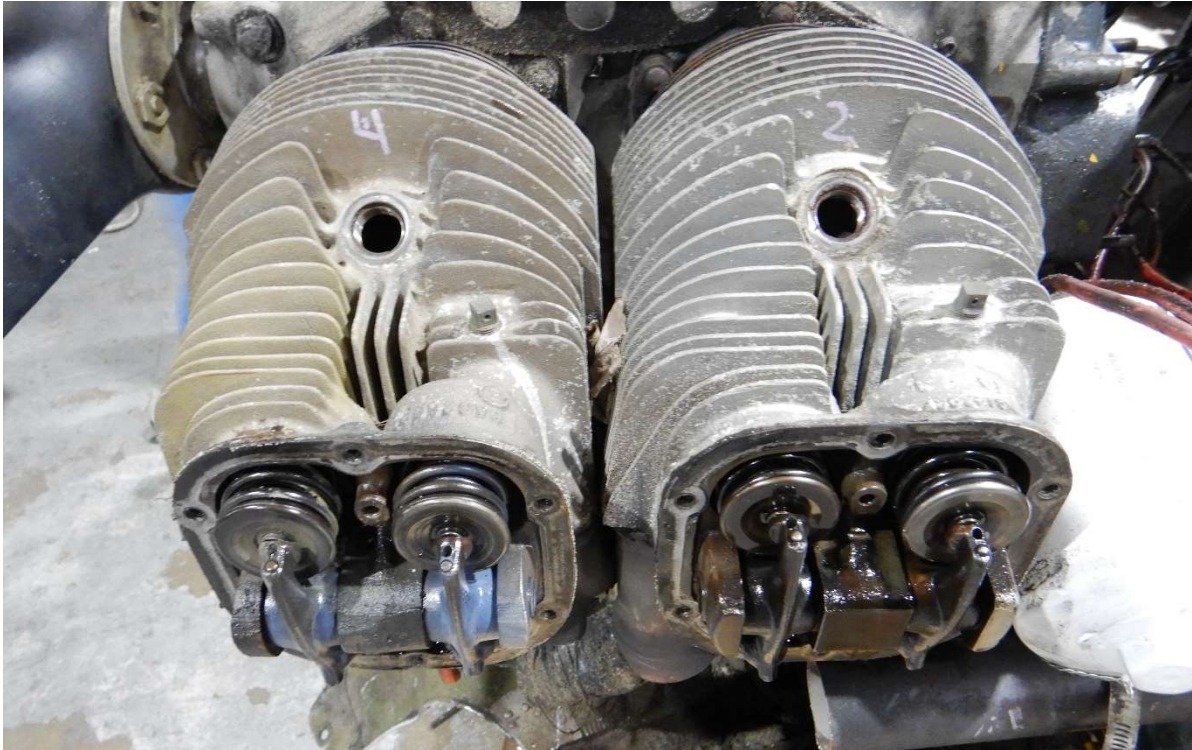
*Photo 8 - Cylinder Nos. 2 and 4 with spark plugs and rocker covers removed*

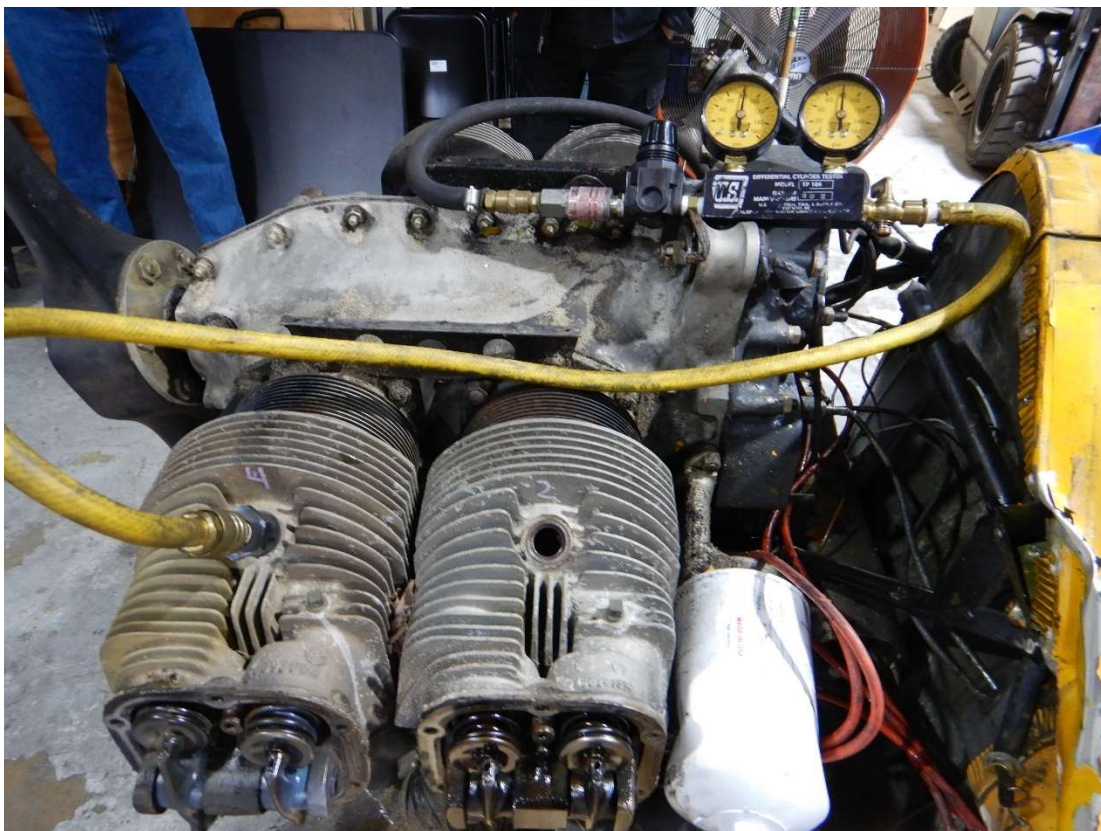
- Cylinder compression check – all cylinders passed cold
- Carburetor was partially fractured off engine and removed
- The fuel shut-off on the carburetor was safety wired to “ON” position

*Photo 9 - Compression test of cylinder No. 4*
