Office of Aviation Safety  
Eastern Region

**Photo Array**

**ERA22LA109**

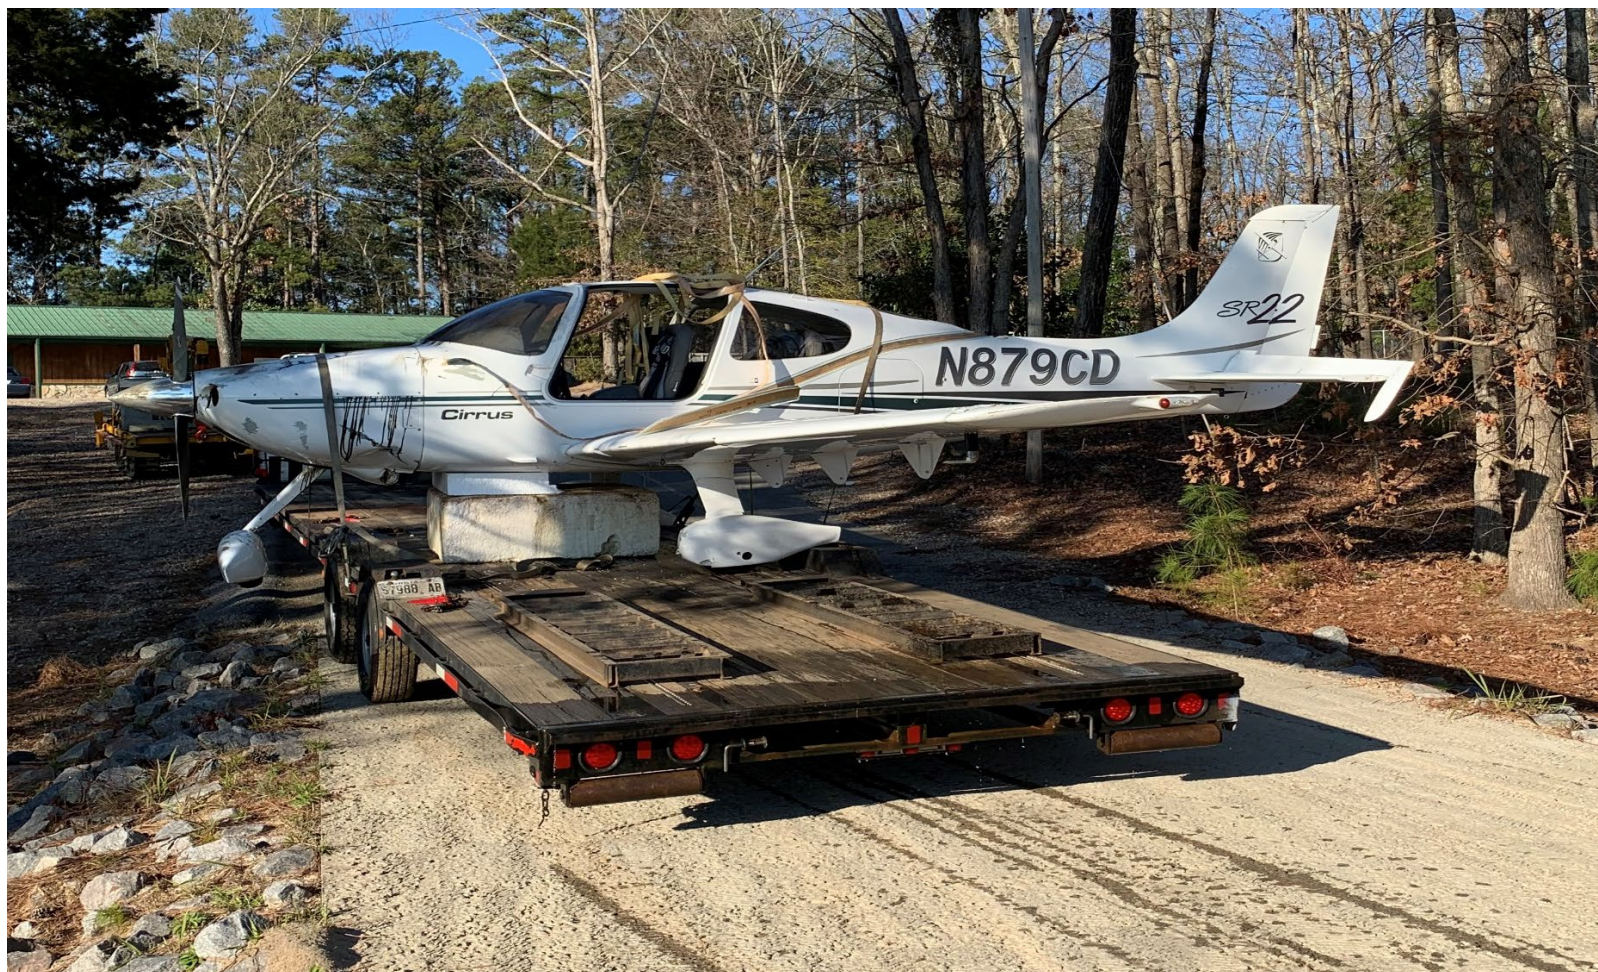
**Photo 1 – View of airplane from left wing after recovery (Photo Courtesy of FAA)**

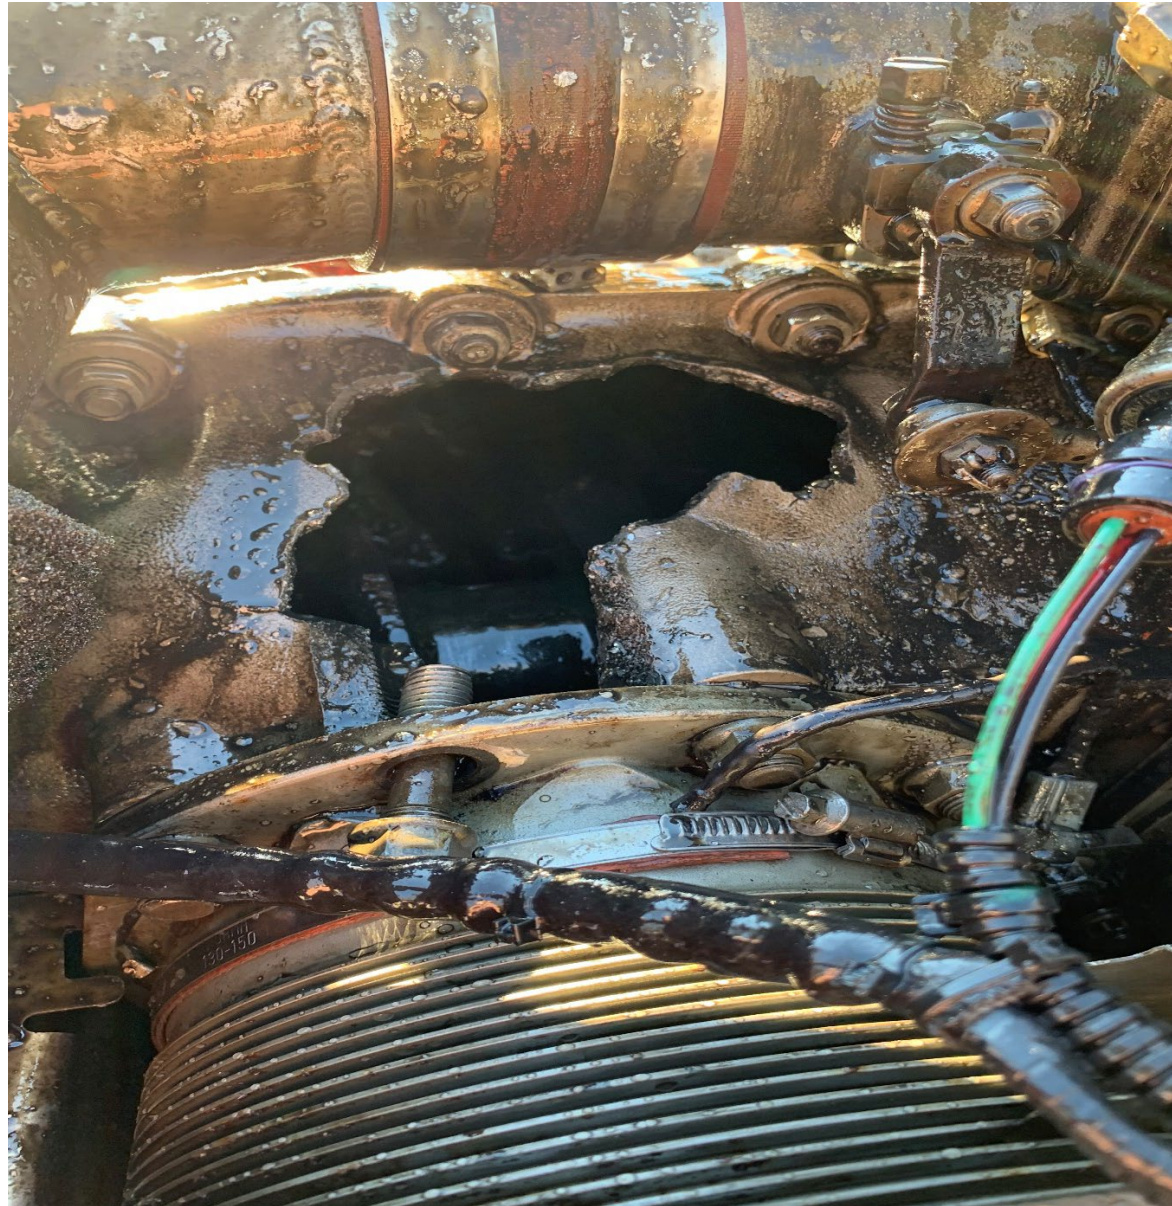
**Photo 2 – View of damage to crankcase at cylinder No. 6 (Photo Courtesy of FAA)**

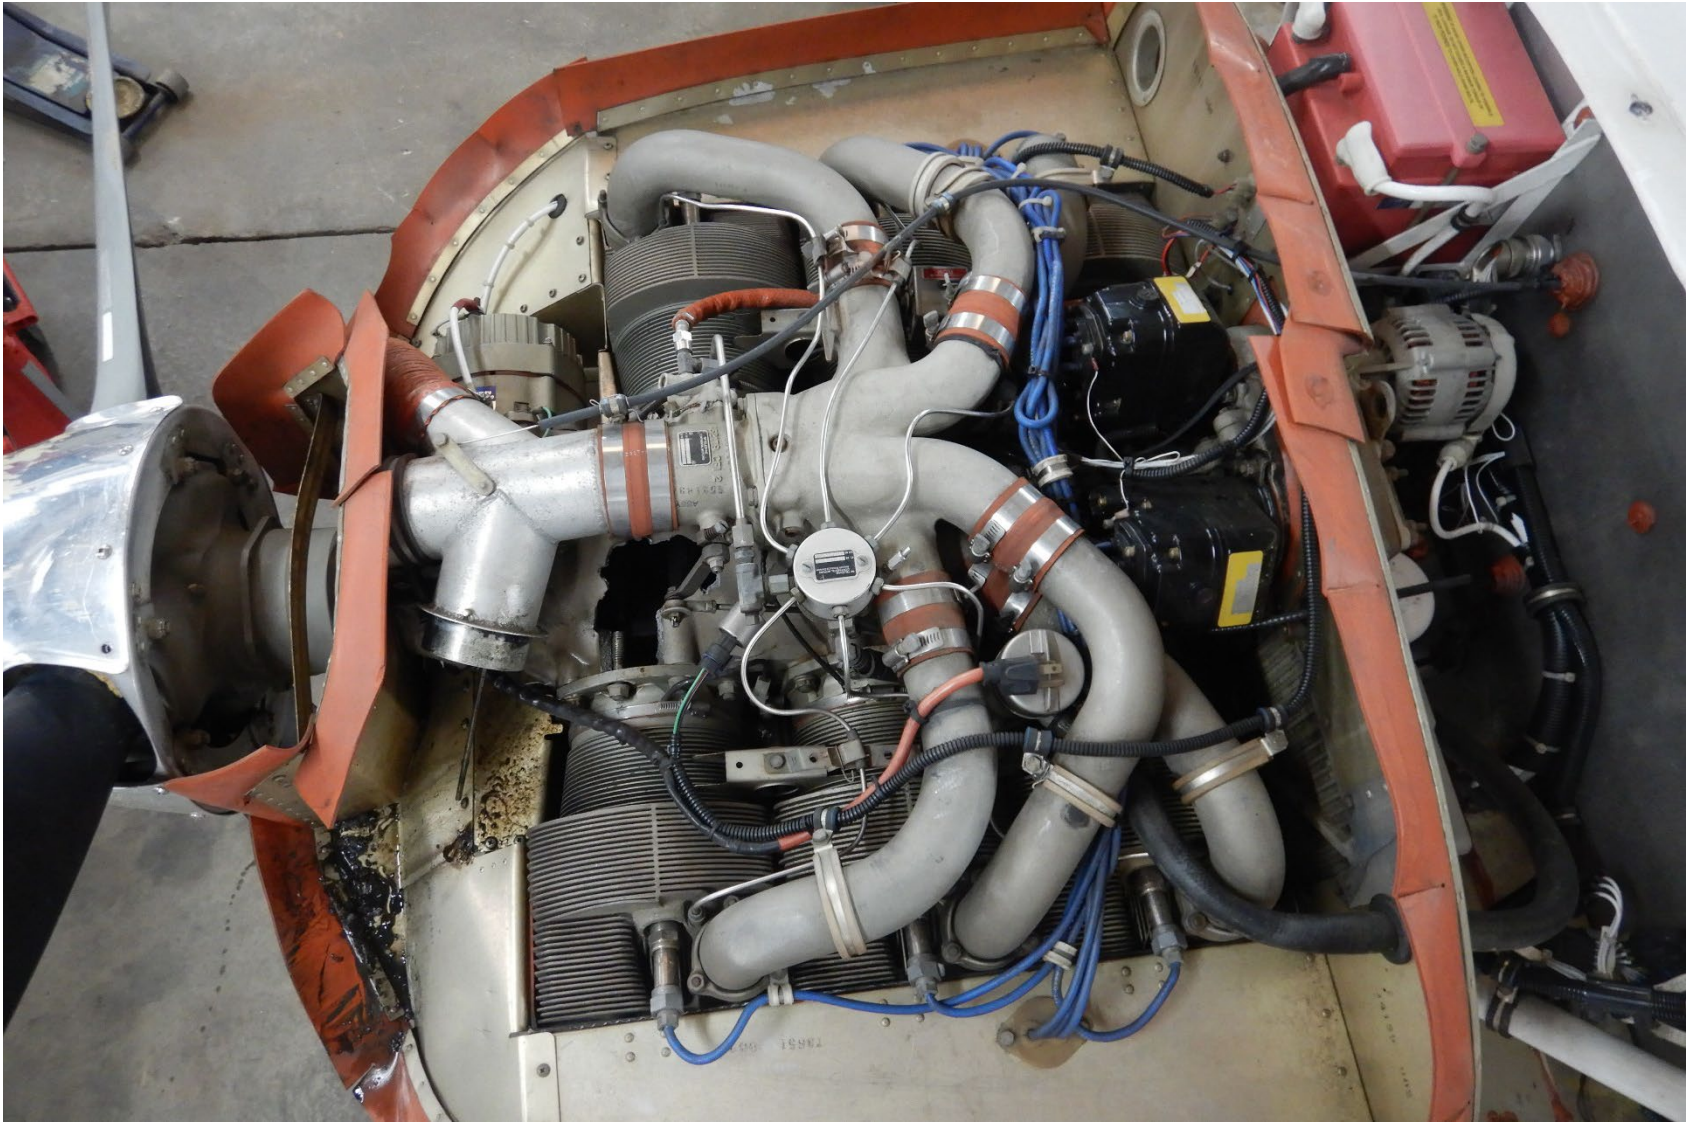
**Photo 3 – View of engine from above before initial examination.**

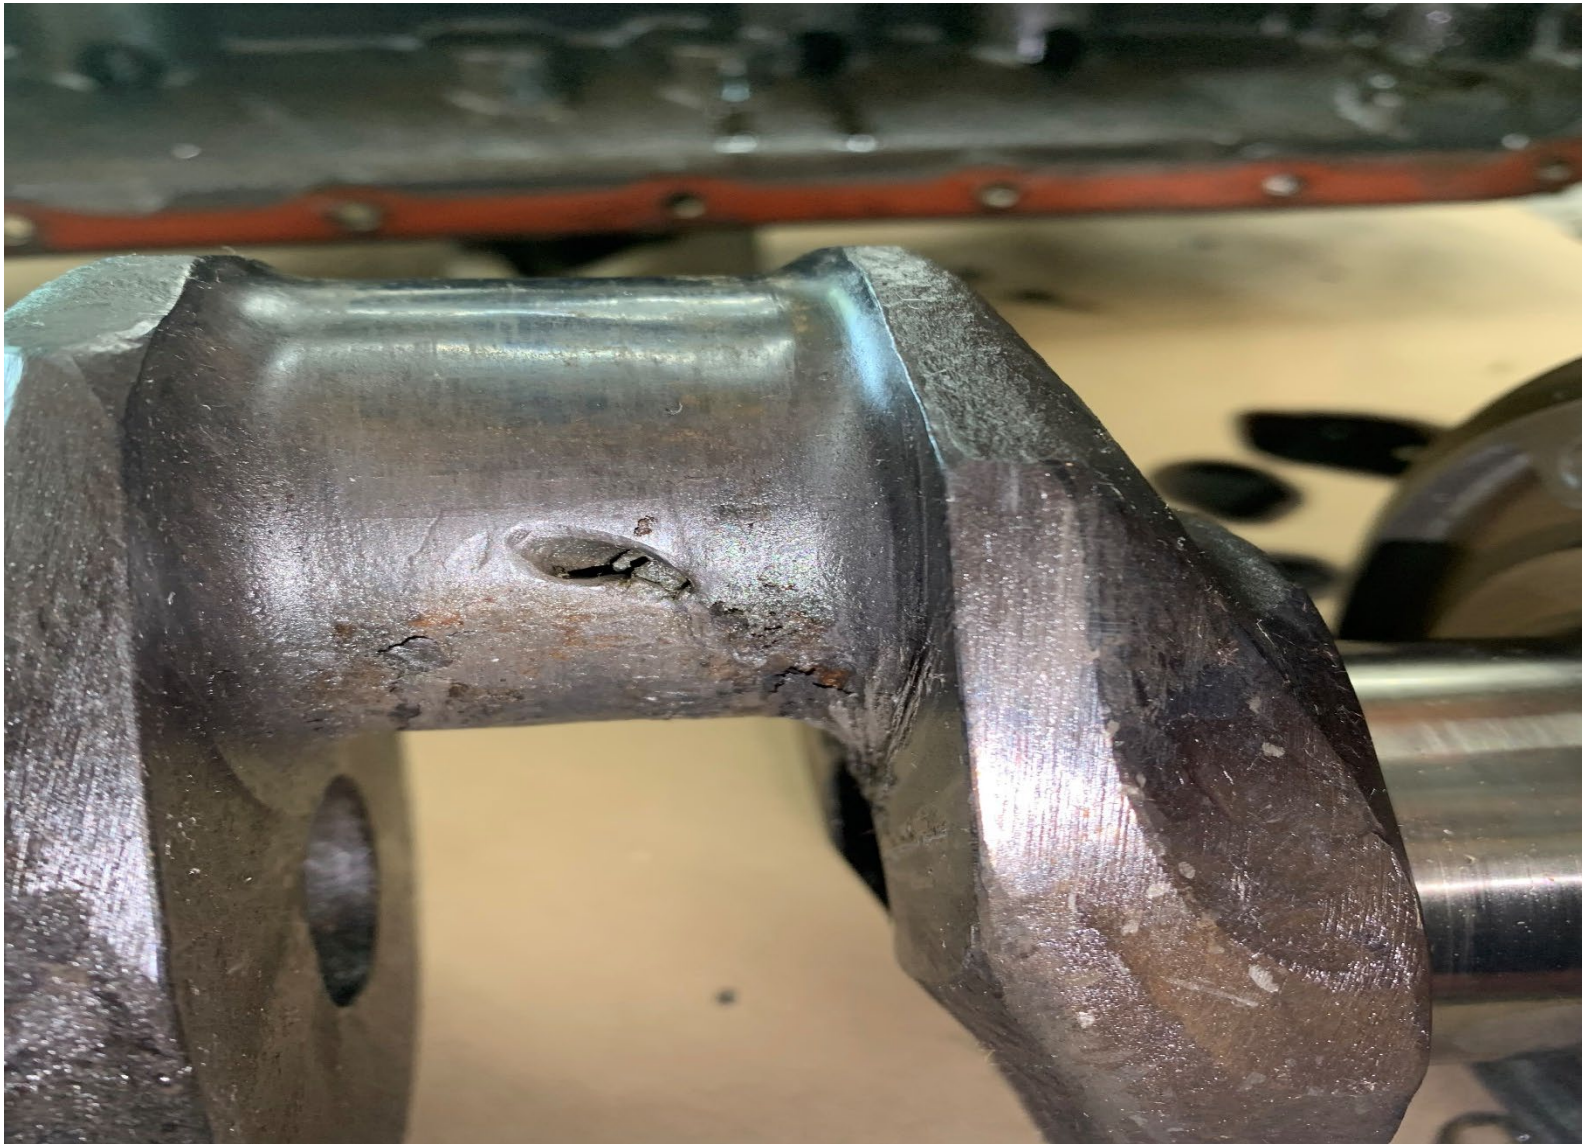
Photo 4 - View of the No. 6 connecting rod bearing fused to the crankshaft journal.

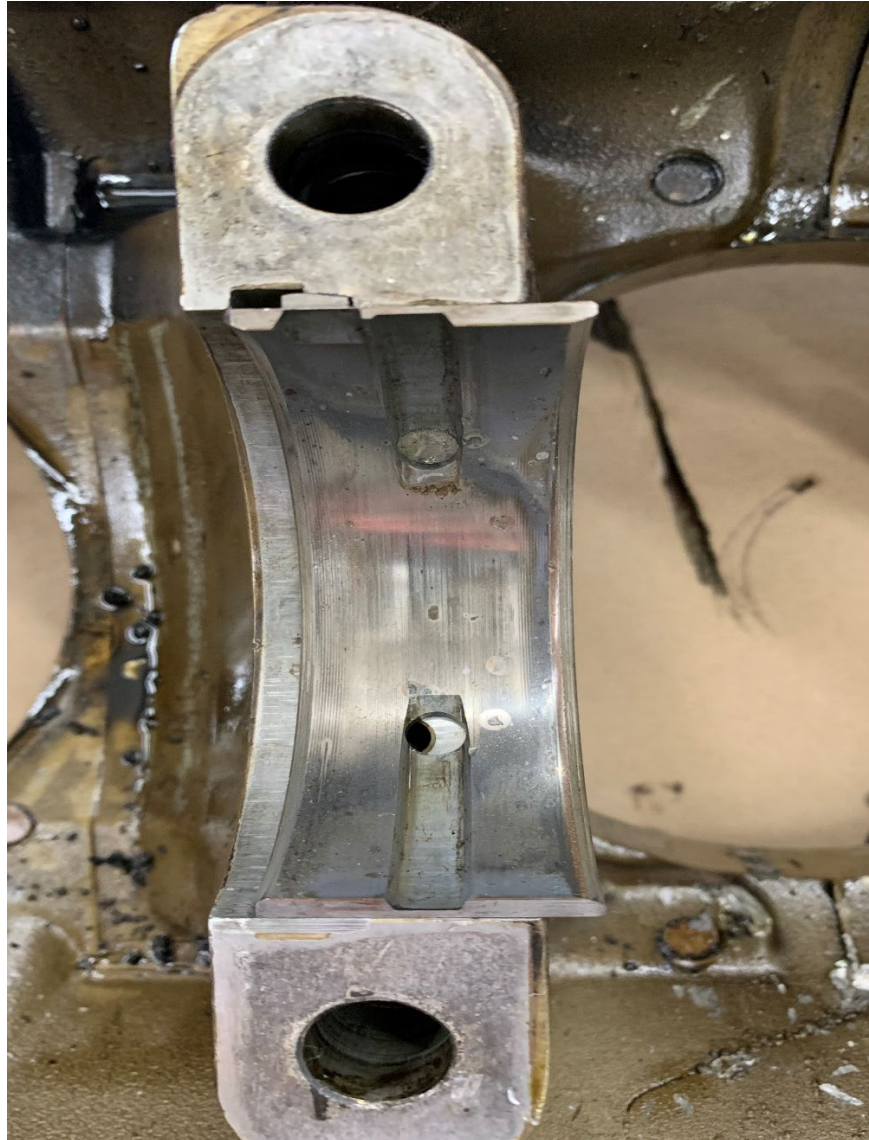
**Photo 5 – View of No. 3 main journal bearing as seated in right side of crankcase, blocking the oil port.**
