# National Transportation Safety Board

ERA22LA109

## ENGINE EXAMINATION

N879CD, Cirrus SR-22

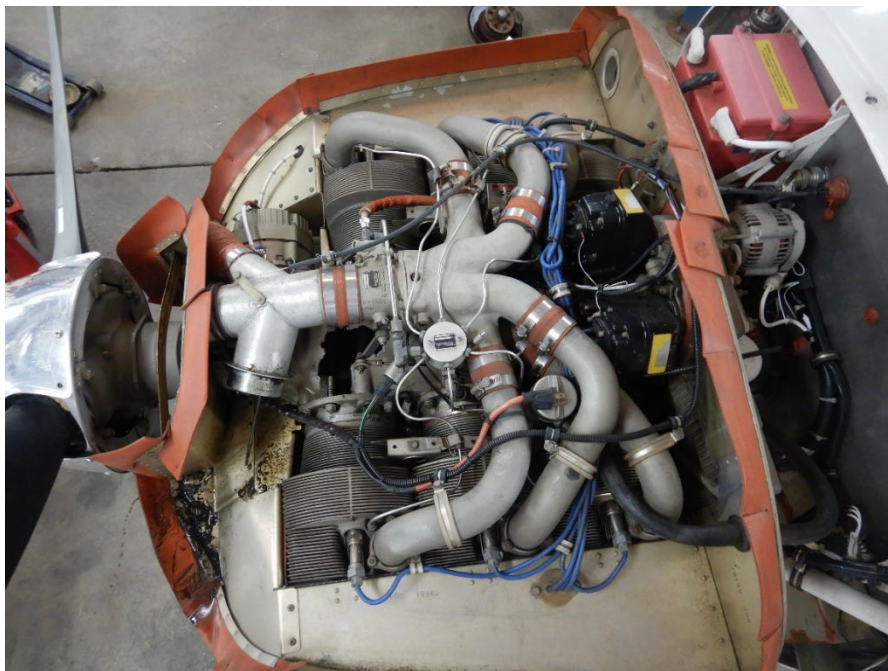
descended to the water. A post-accident examination of the airplane by a Federal Aviation Administration inspector revealed substantial damage to the fuselage and left elevator. Additionally, the engine exhibited a hole on the top of the case near the No. 6 cylinder. An examination was completed April 6, 2022; however, notes of that exam were never located. Therefore, this follow-up exam was performed.

Photo 1 - Engine as observed from above with a hole in the crankcase above cylinder No. 6.

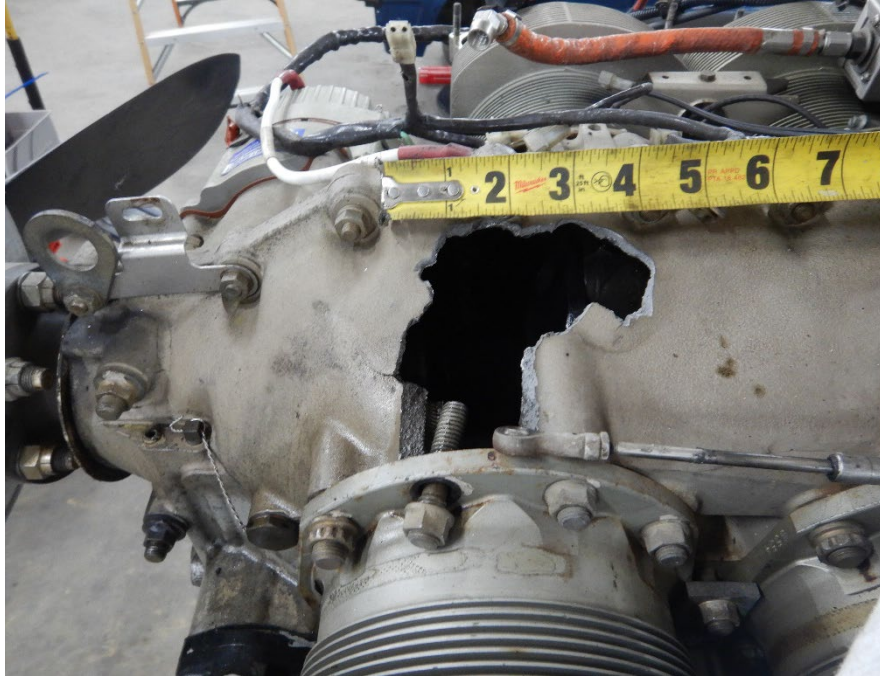
Photo 2 - Close-up view of crankcase hole.

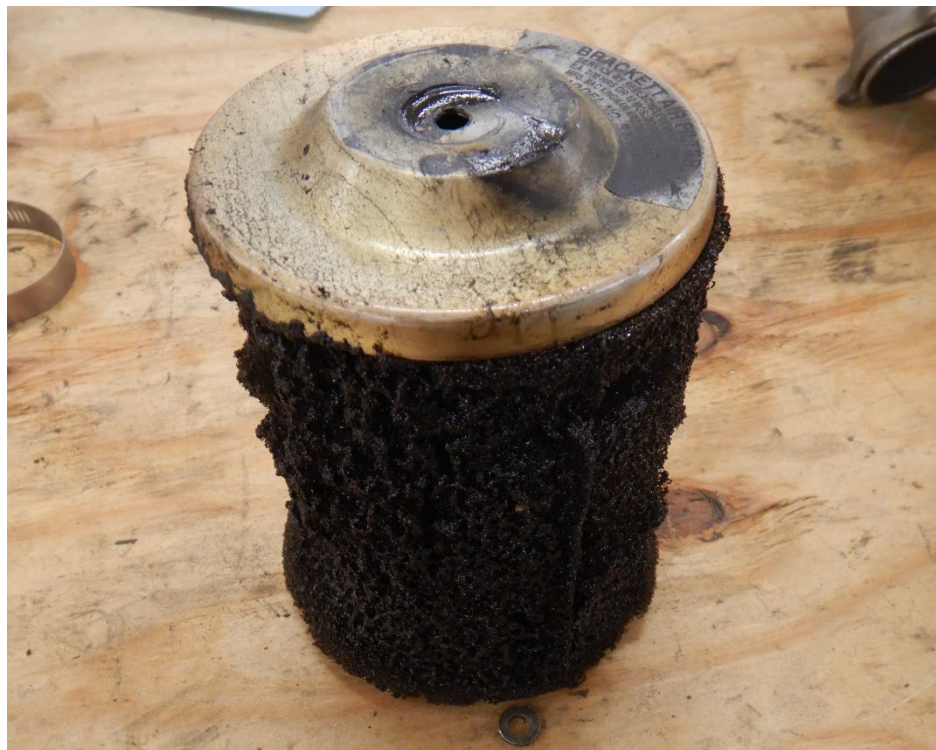
Photo 3 - View of air filter.

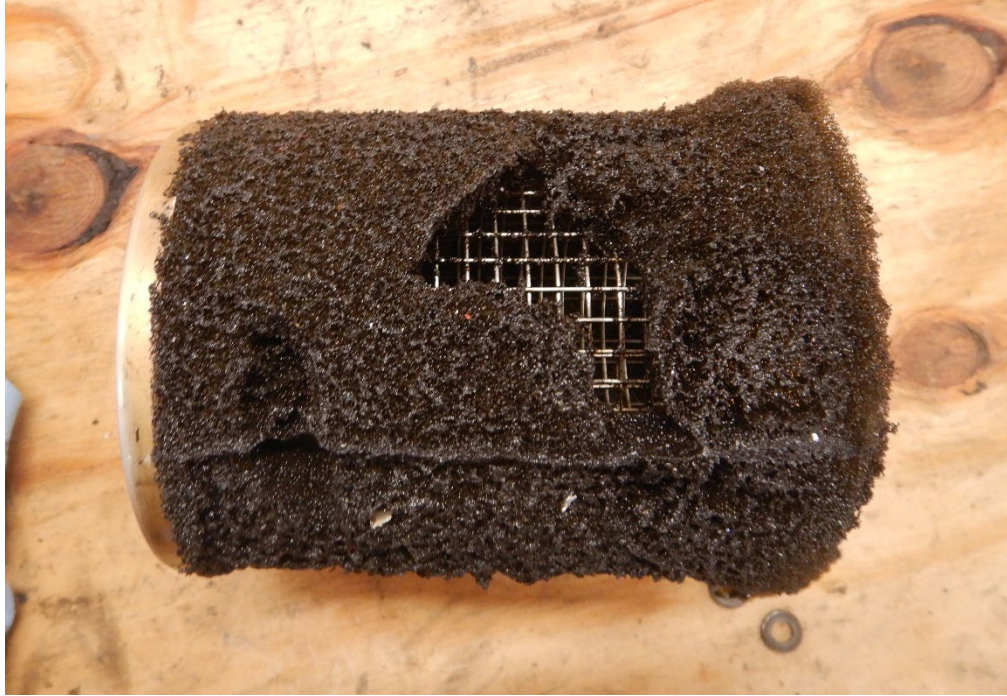
Photo 4 - Side view of air filter.

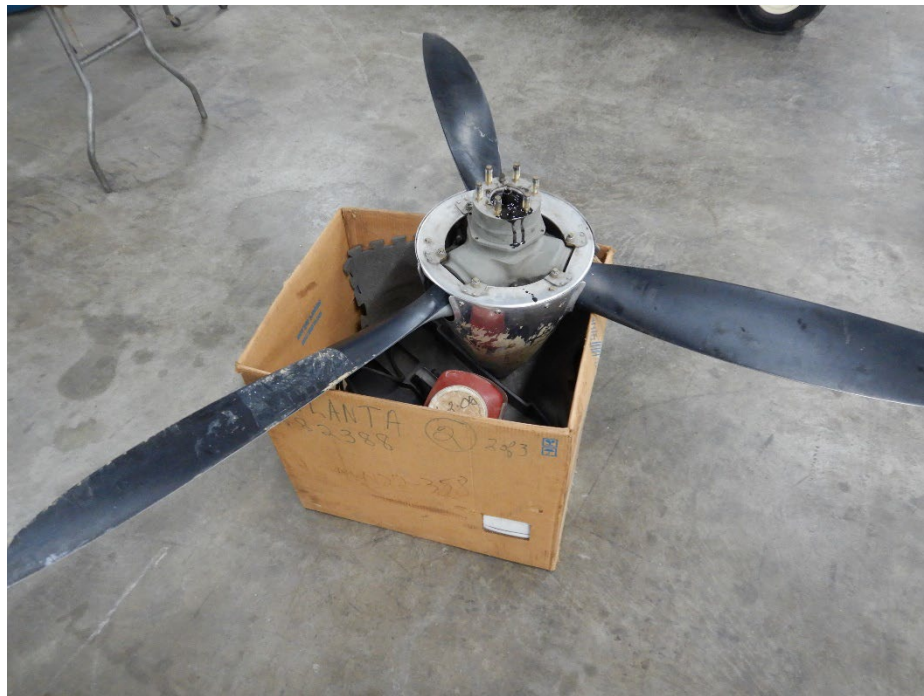
Photo 5 - View of propeller with blades attached.

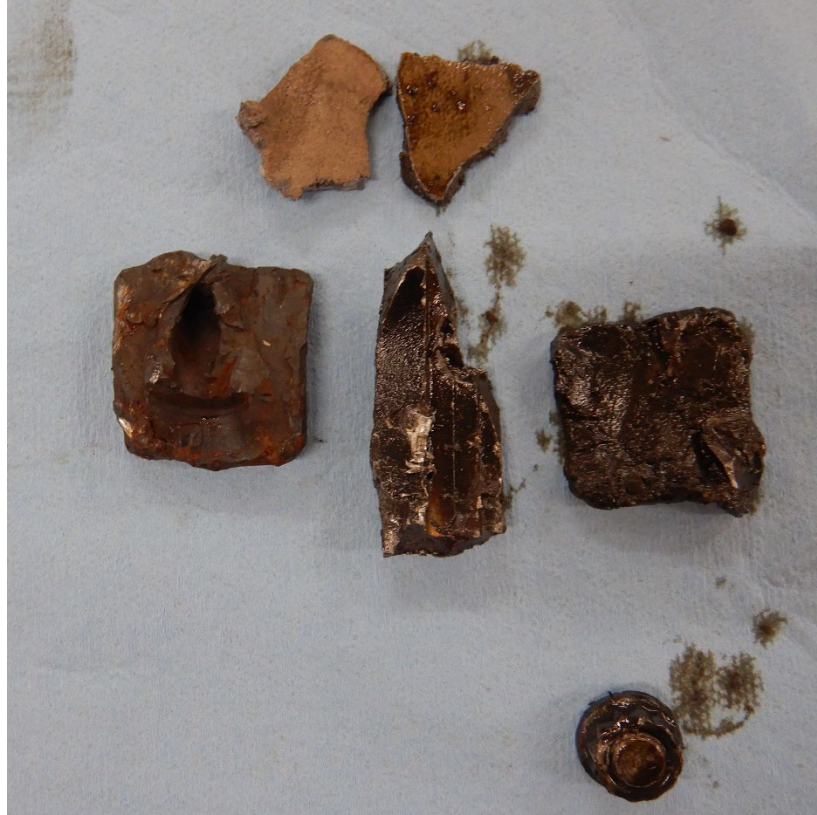
Photo 6 - View of recovered metal debris.

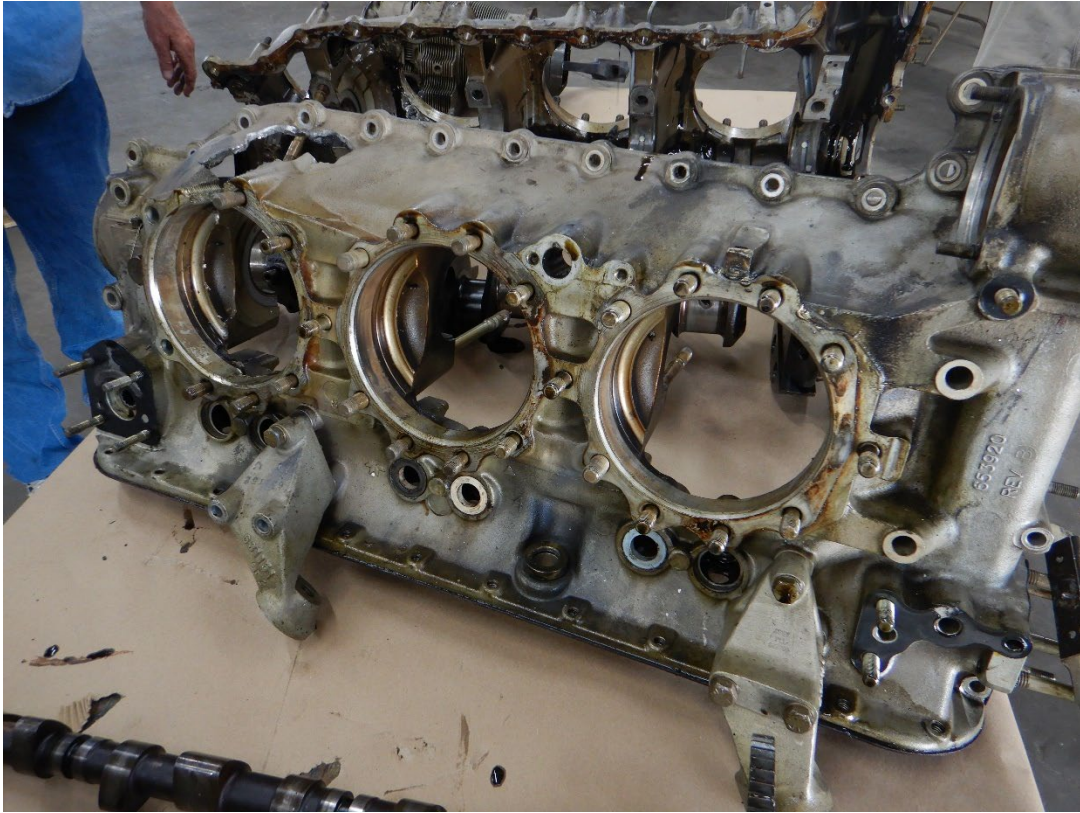
Photo 7 - View of left side of split crank case showing hole above cylinder No. 6.

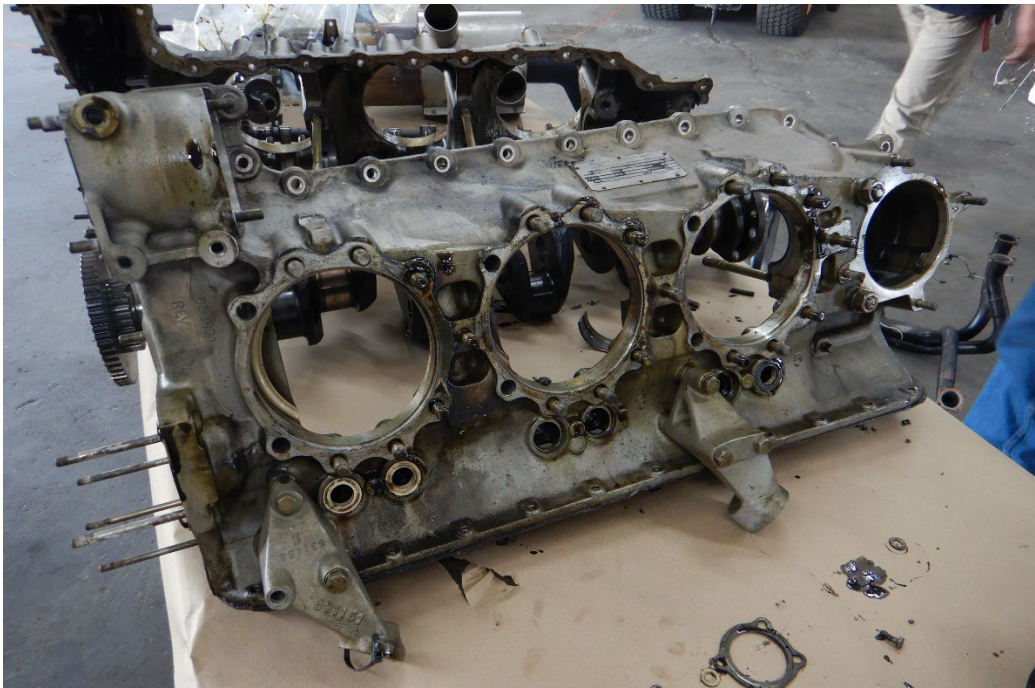
Photo 8 - View of right side of split crankcase

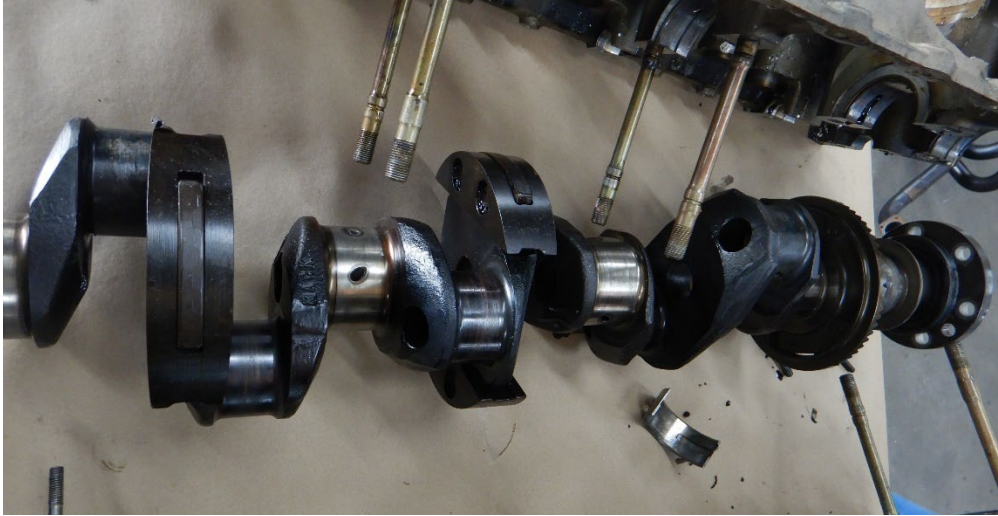
As first viewed, the engine had been completely dismantled, with the crankcase split, and the camshaft, crankshaft and all cylinders removed. Examination of the engine revealed that all crankshaft connecting rod journals showed evidence of lubrication distress. Additionally, the No. 3 main journal bearing had shifted, resulting in the blockage of the oil ports. The crankcase exhibited lock slot elongation as a result of the bearing shift. The No. 6 connecting rod bearing showed evidence of spinning and was fused to the crankshaft journal. The cylinder No. 1 connecting rod bearings were fused together on the crankshaft, and the bearing surface was smeared and torn. The bearing metal had melted and re-solidified along the edges.

Photo 9 - View of crankshaft with burnt connecting rod journals.

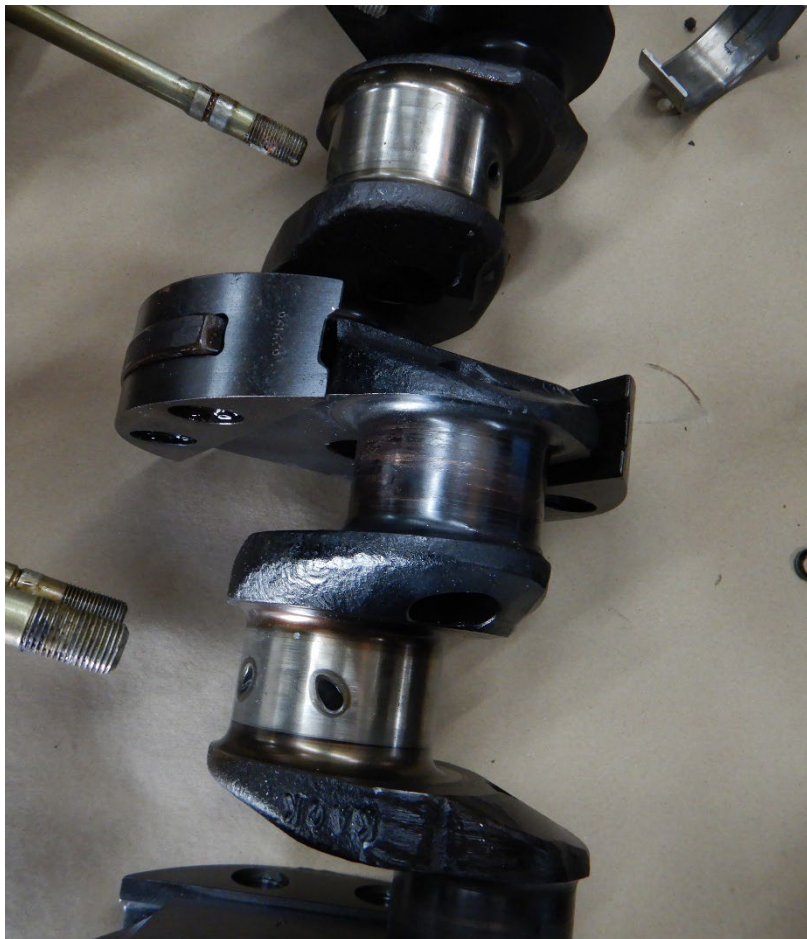
Photo 10 - Close-up view of burnt connecting rod journal.

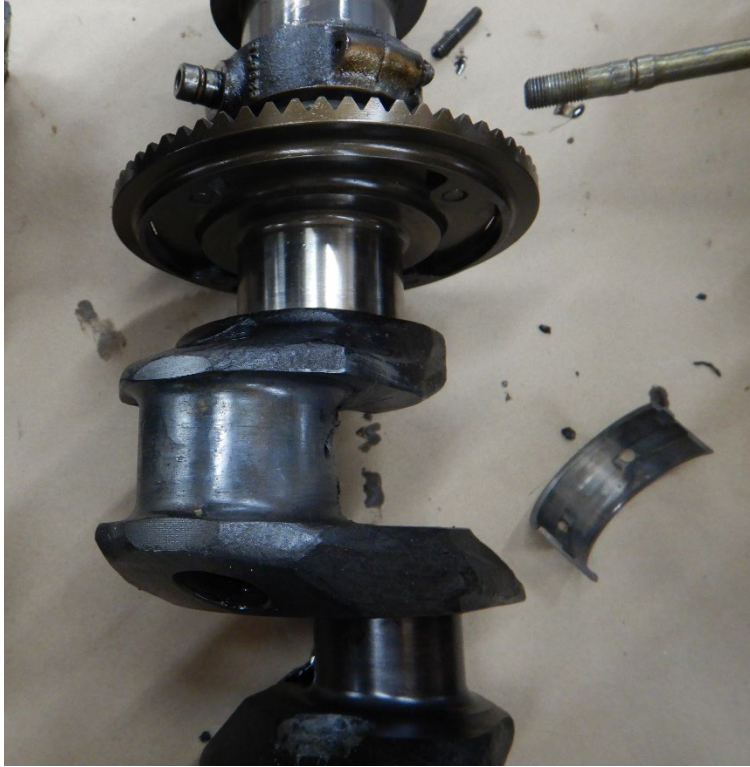
Photo 11 - Close-up view of burnt connecting rod journal.

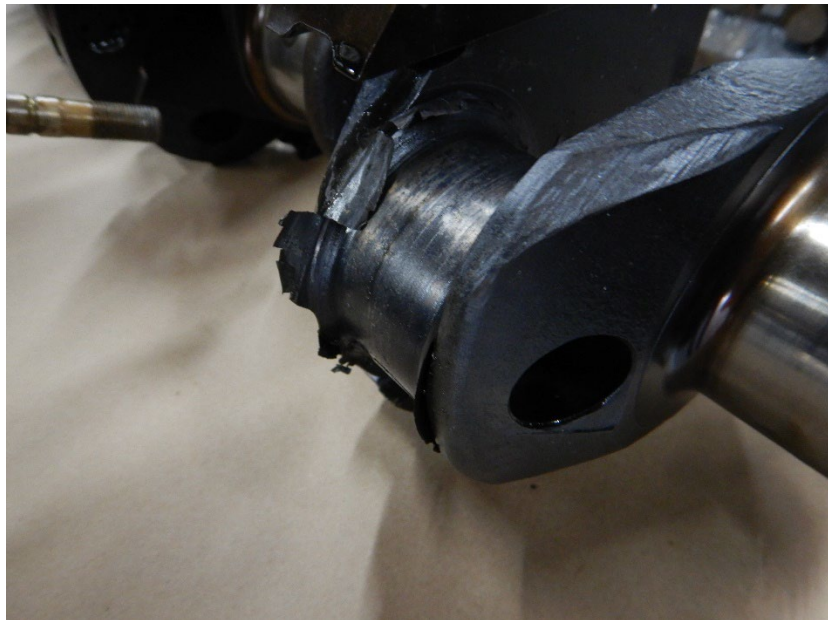
Photo 12 - View of spalling of fused bearing on cylinder No. 1.

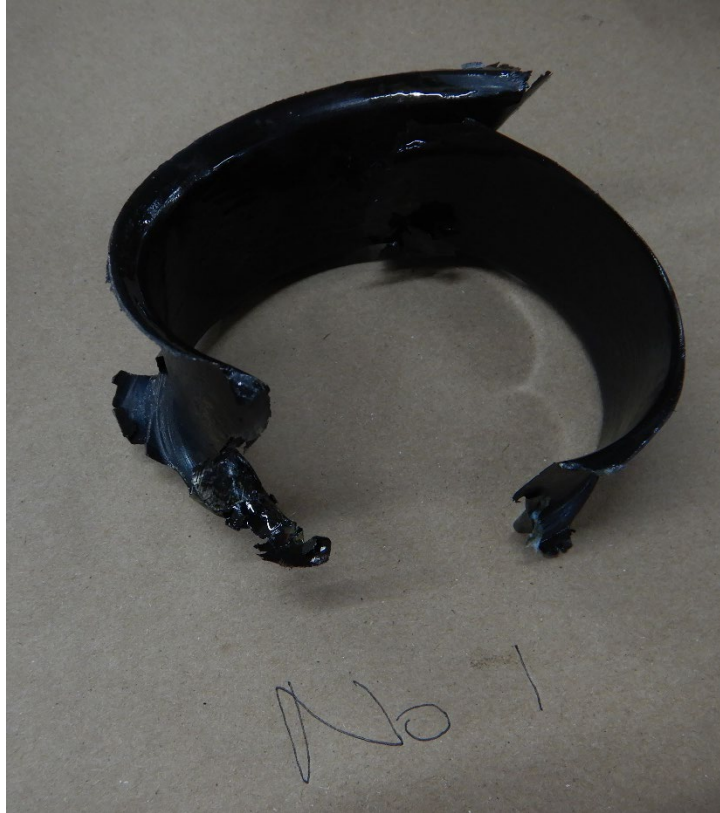
Photo 13 - View of removed fused bearing from cylinder No. 1.

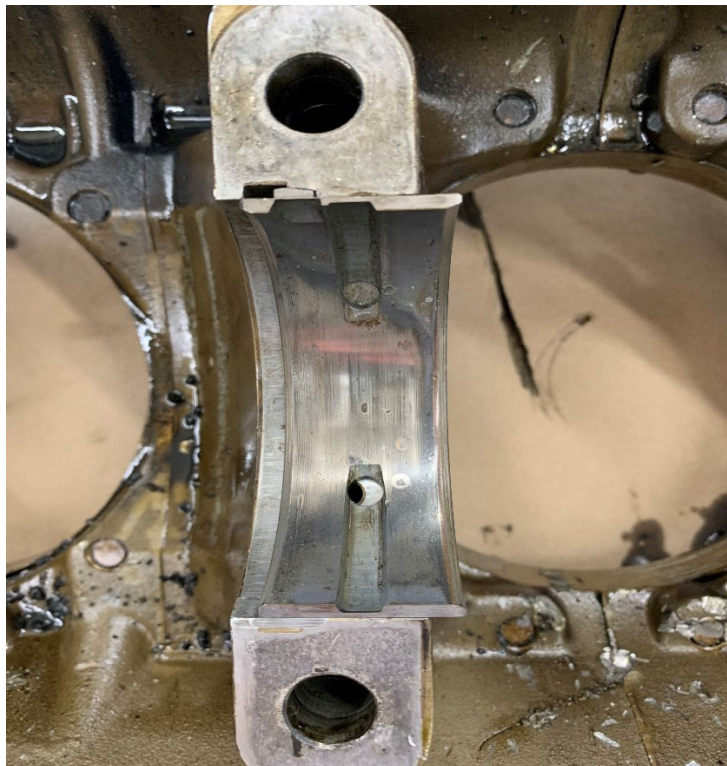
Photo 14 - View of No. 3 main journal bearing as seated in right side of crankcase, blocking the oil port.

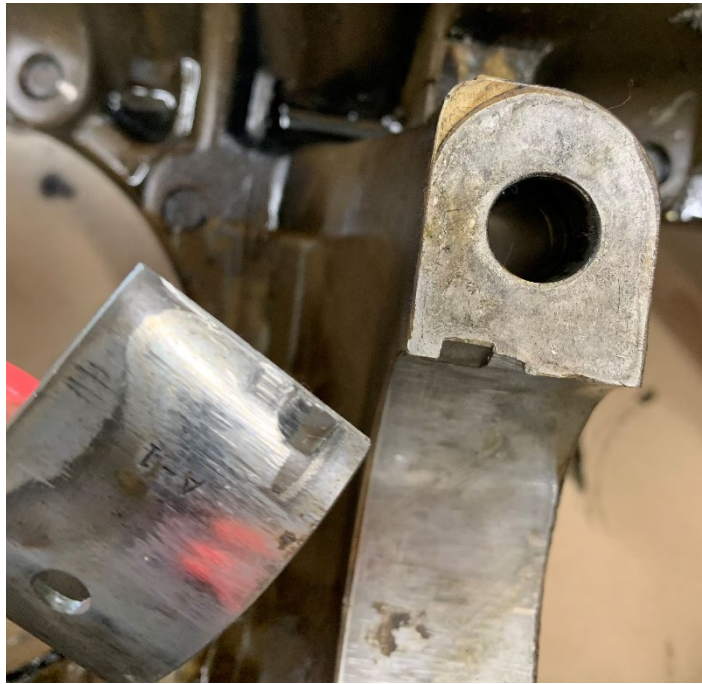
Photo 15 - Close-up view of damaged bearing and No. 3 main journal with damage on right crankcase.

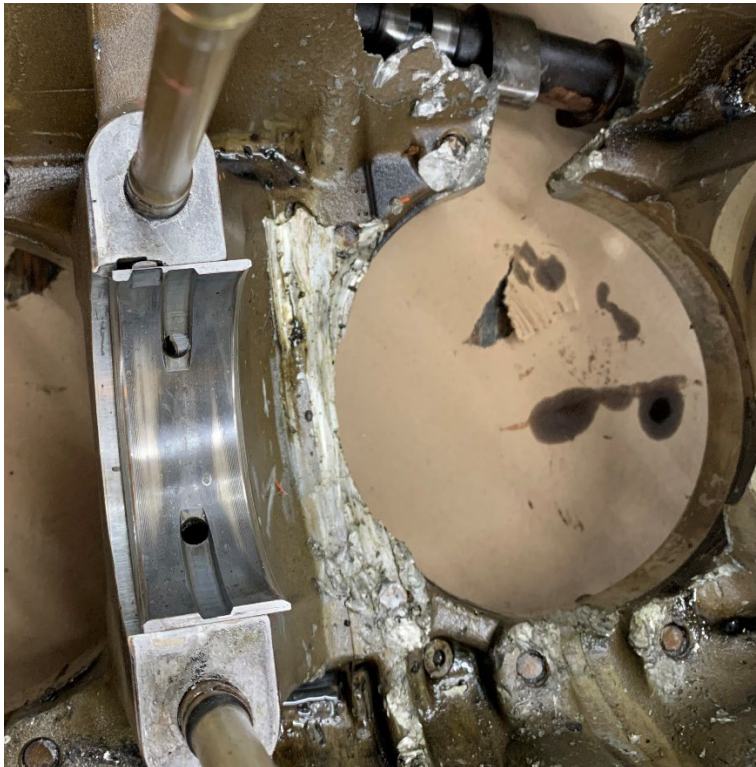
Photo 16 - View of damaged bearing and No. 3 main journal with damage on left crankcase.

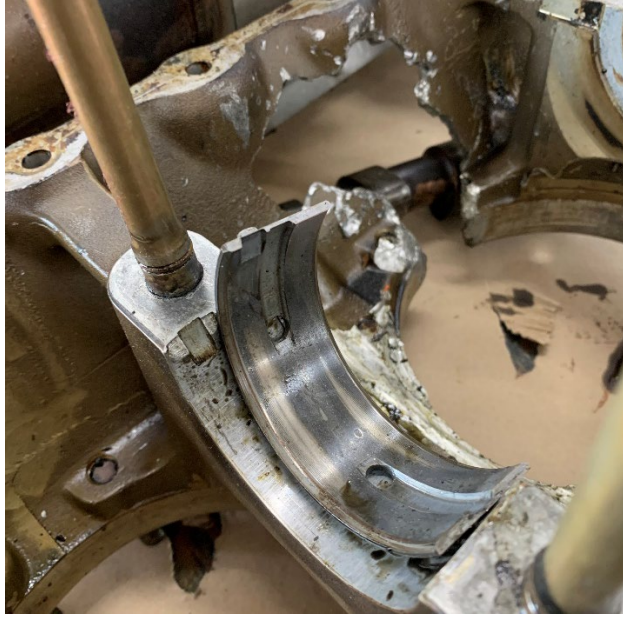
Photo 17 - Close-up view of bearing and No. 3 main journal damage on left crankcase

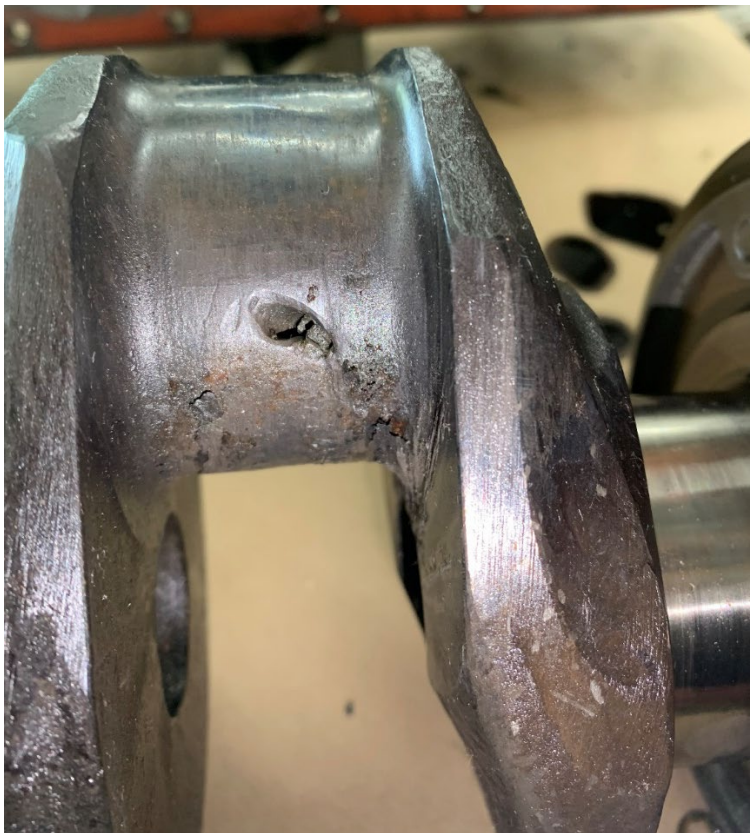
Photo 18 - View of portions of the No. 6 connecting rod bearing fused to the crankshaft journal.
