ERA22LA121

## INVESTIGATION PHOTOGRAPHS

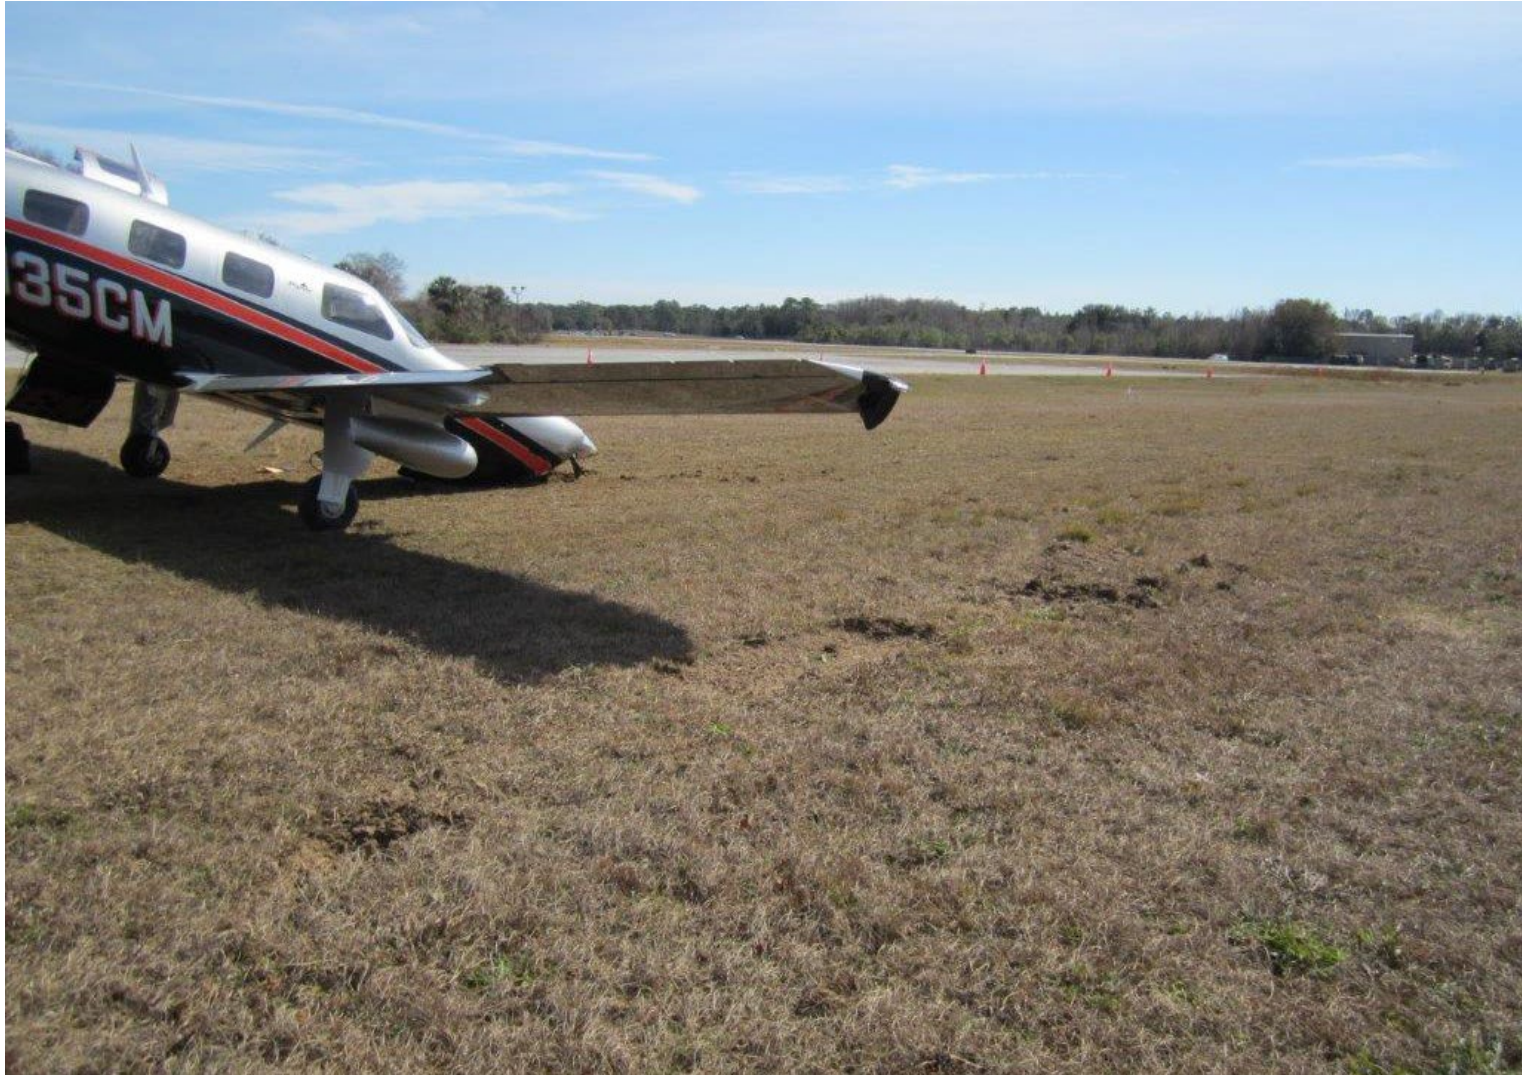
**Photograph 1 - View of Airplane from Right Side (Courtesy FAA)**

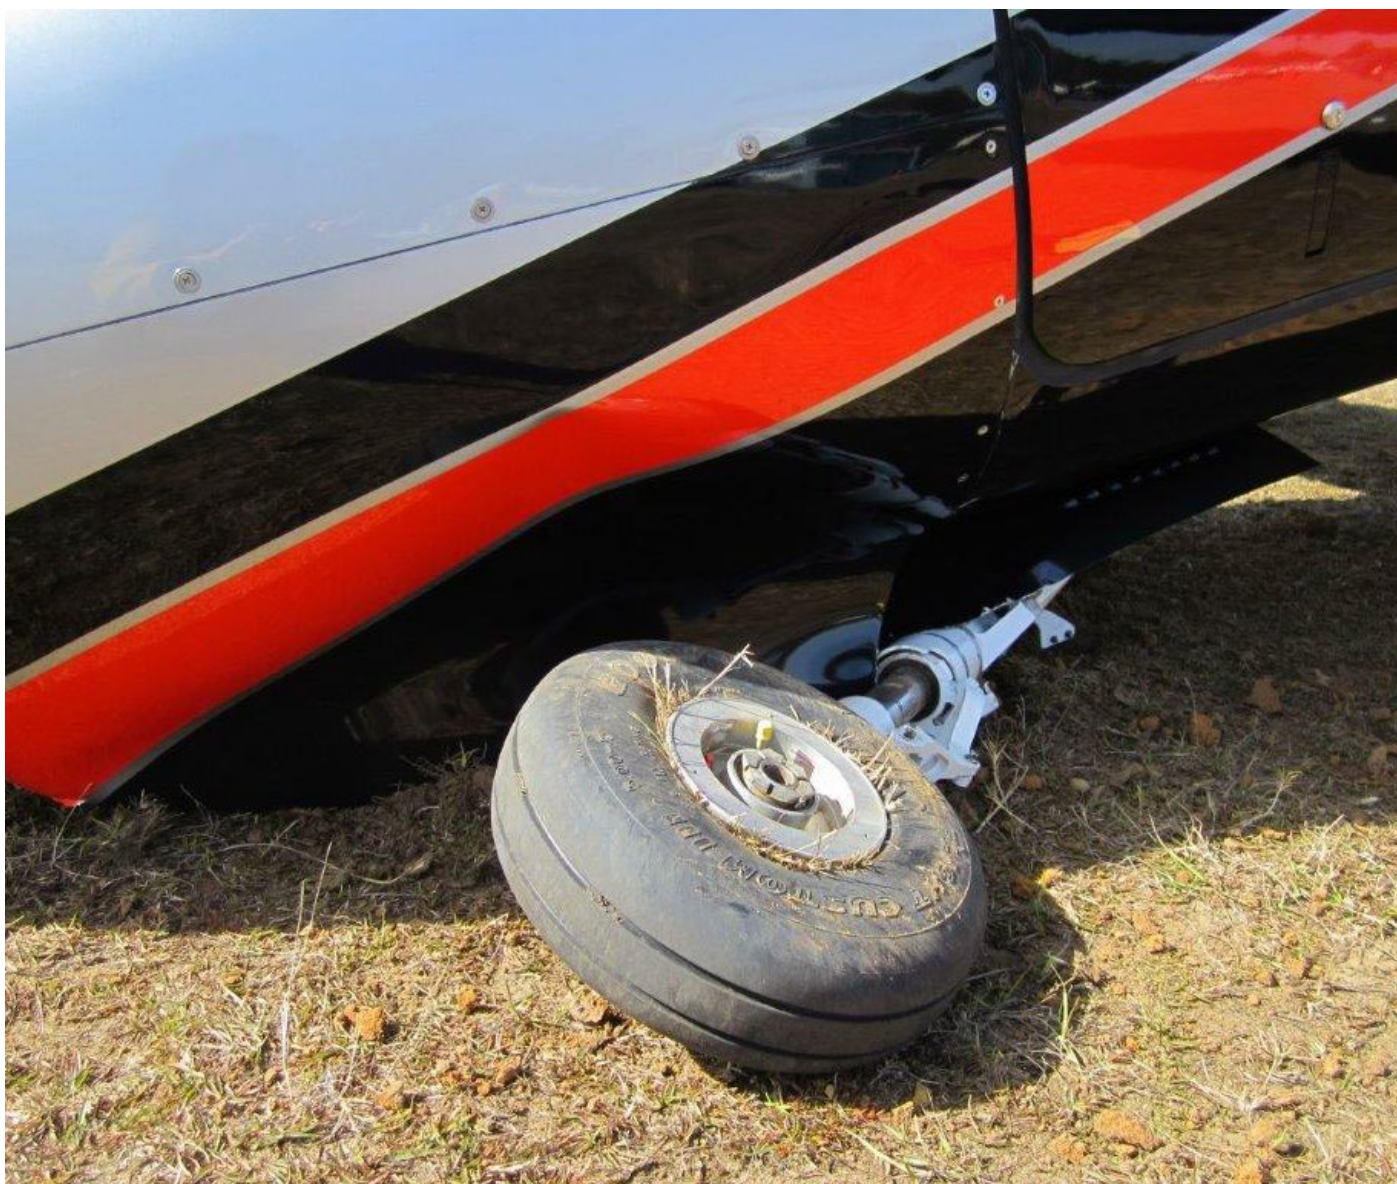
**Photograph 2 - View of Nose Landing Gear Wheel (Right Side Facing UP, Courtesy FAA)**

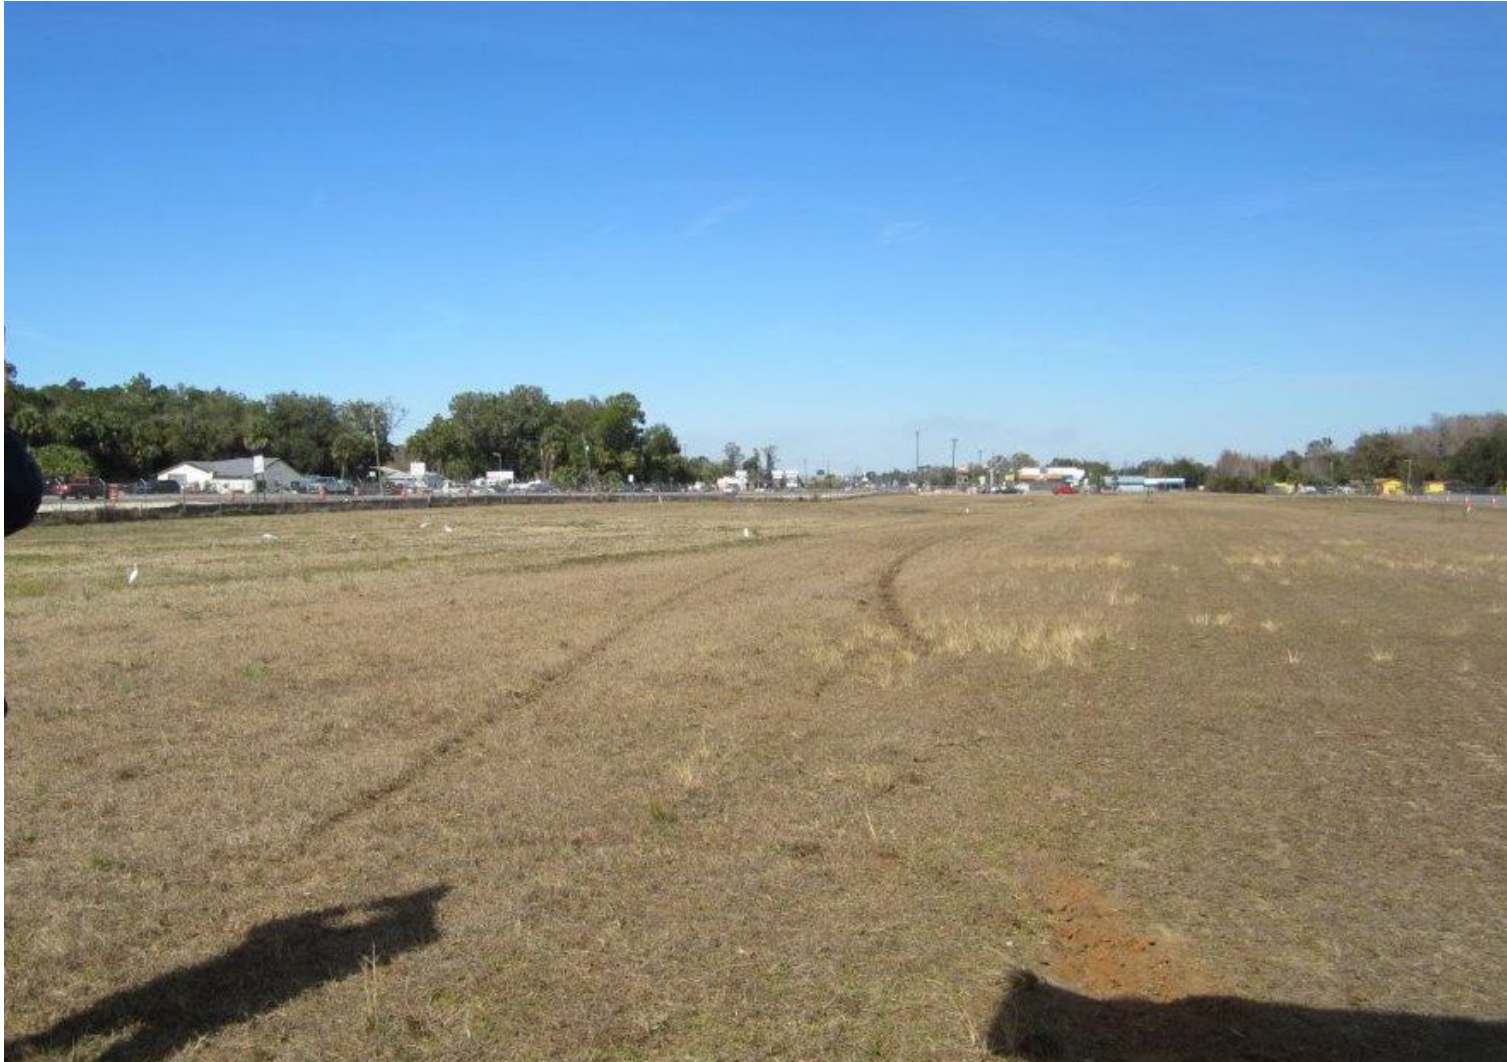
**Photograph 3 - Tire Marks Near End of Rollout - Direction of Travel- Toward Camera (Courtesy FAA)**

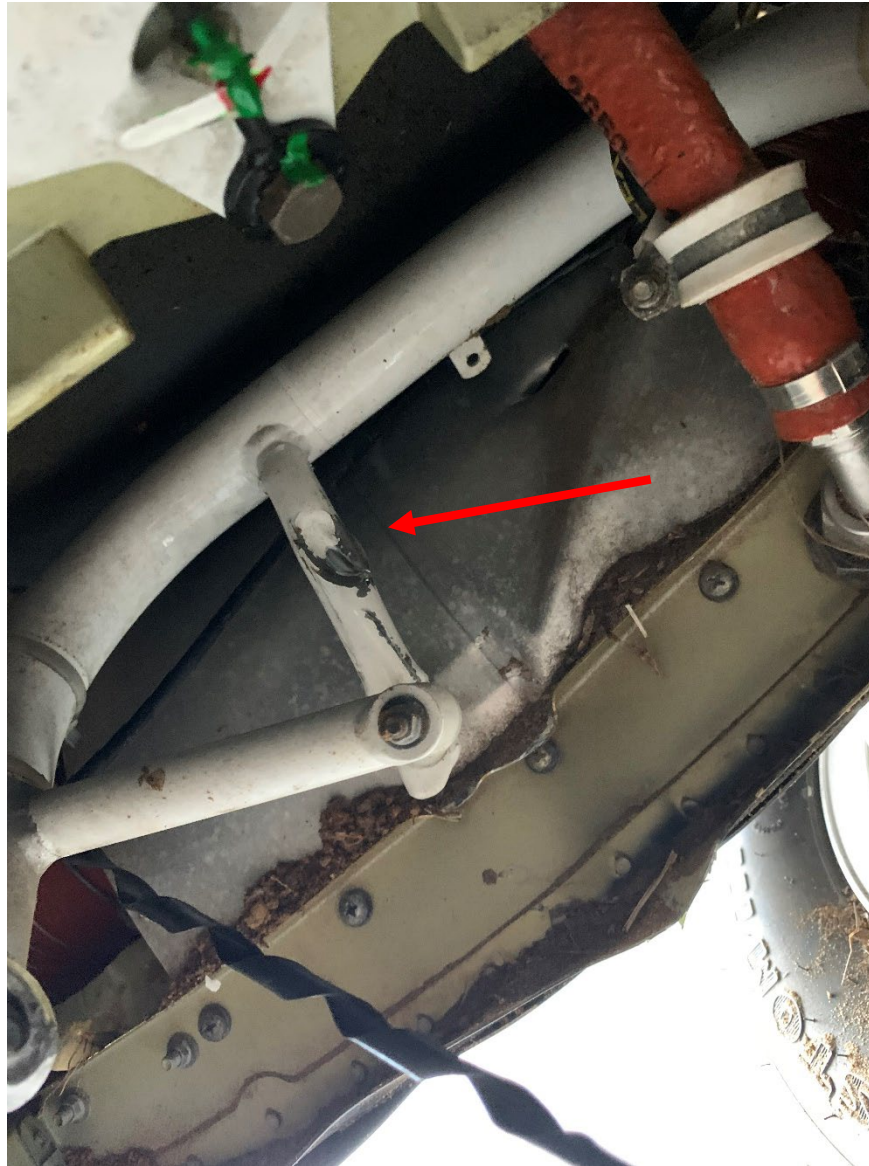
**Photograph 4 - Damage to Engine Mount Structure (Courtesy FAA)**

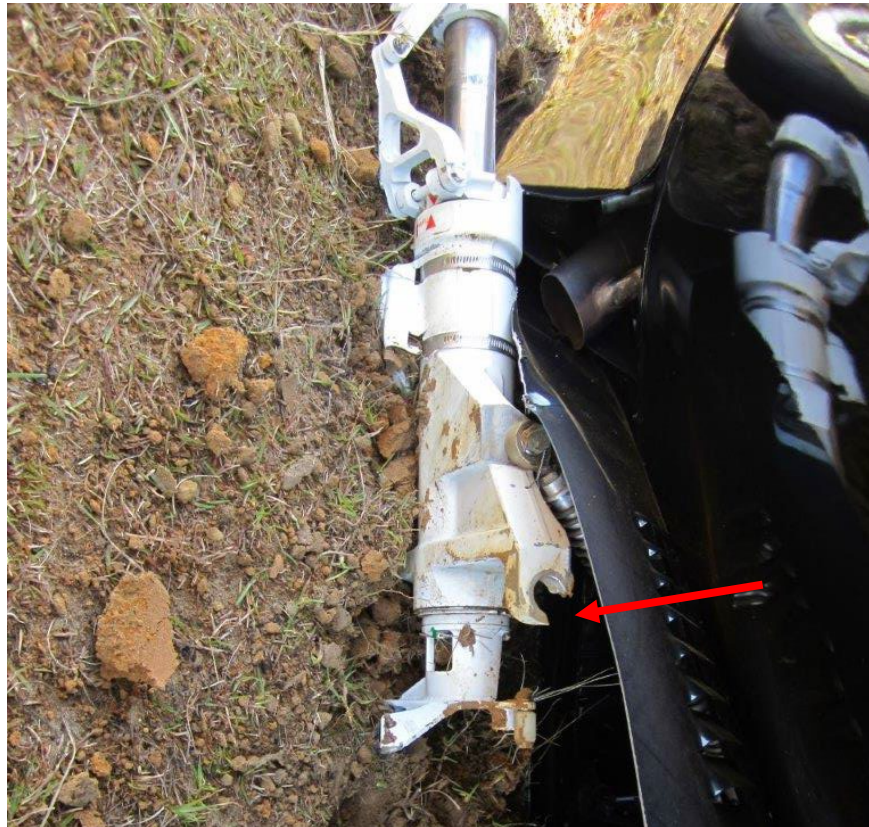
**Photograph 5 - Fractured Landing Gear Trunnion (Courtesy FAA)**

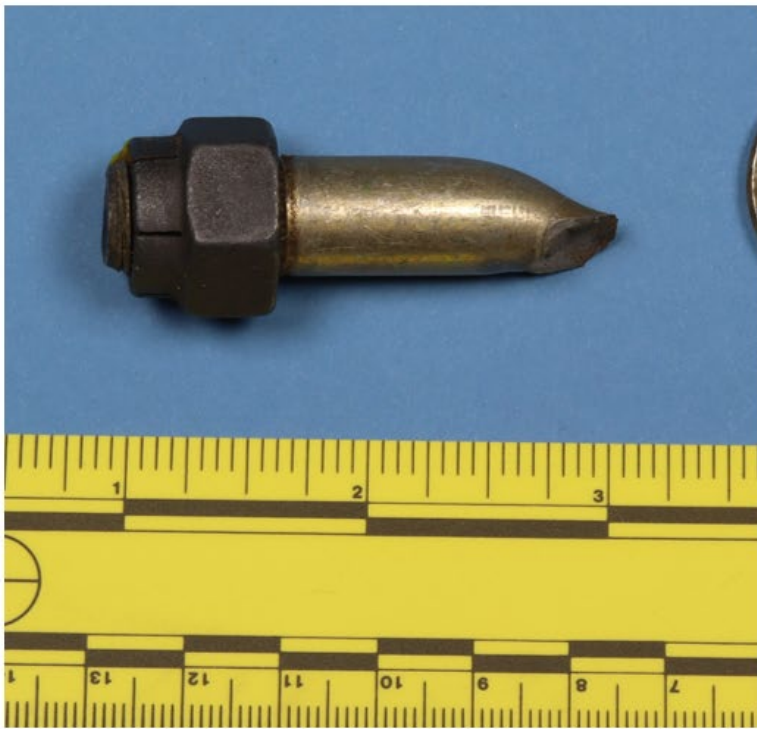
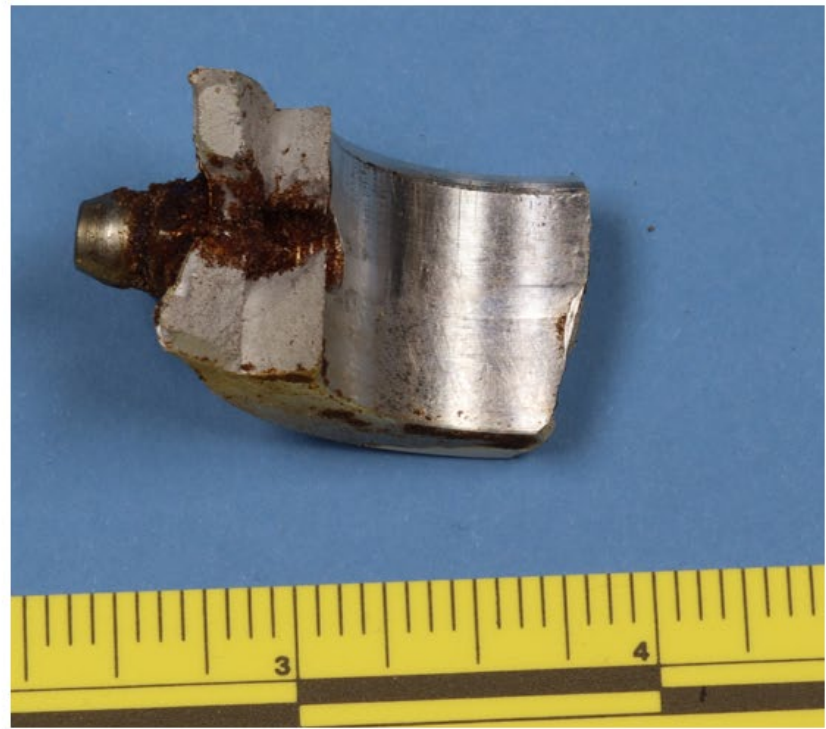
**Photograph 6 - Fractured Trunnion Bolt (left) and Fitting (Right)**
