**From:** [Fox Matthew](#)  
**To:** [Read Leah](#)  
**Subject:** ERA22LA134 - Sarasota, FL - Lab examination complete  
**Date:** Friday, April 8, 2022 4:56:47 PM  
**Attachments:** [IMG\\_2558.JPG](#)  
[image001.png](#)

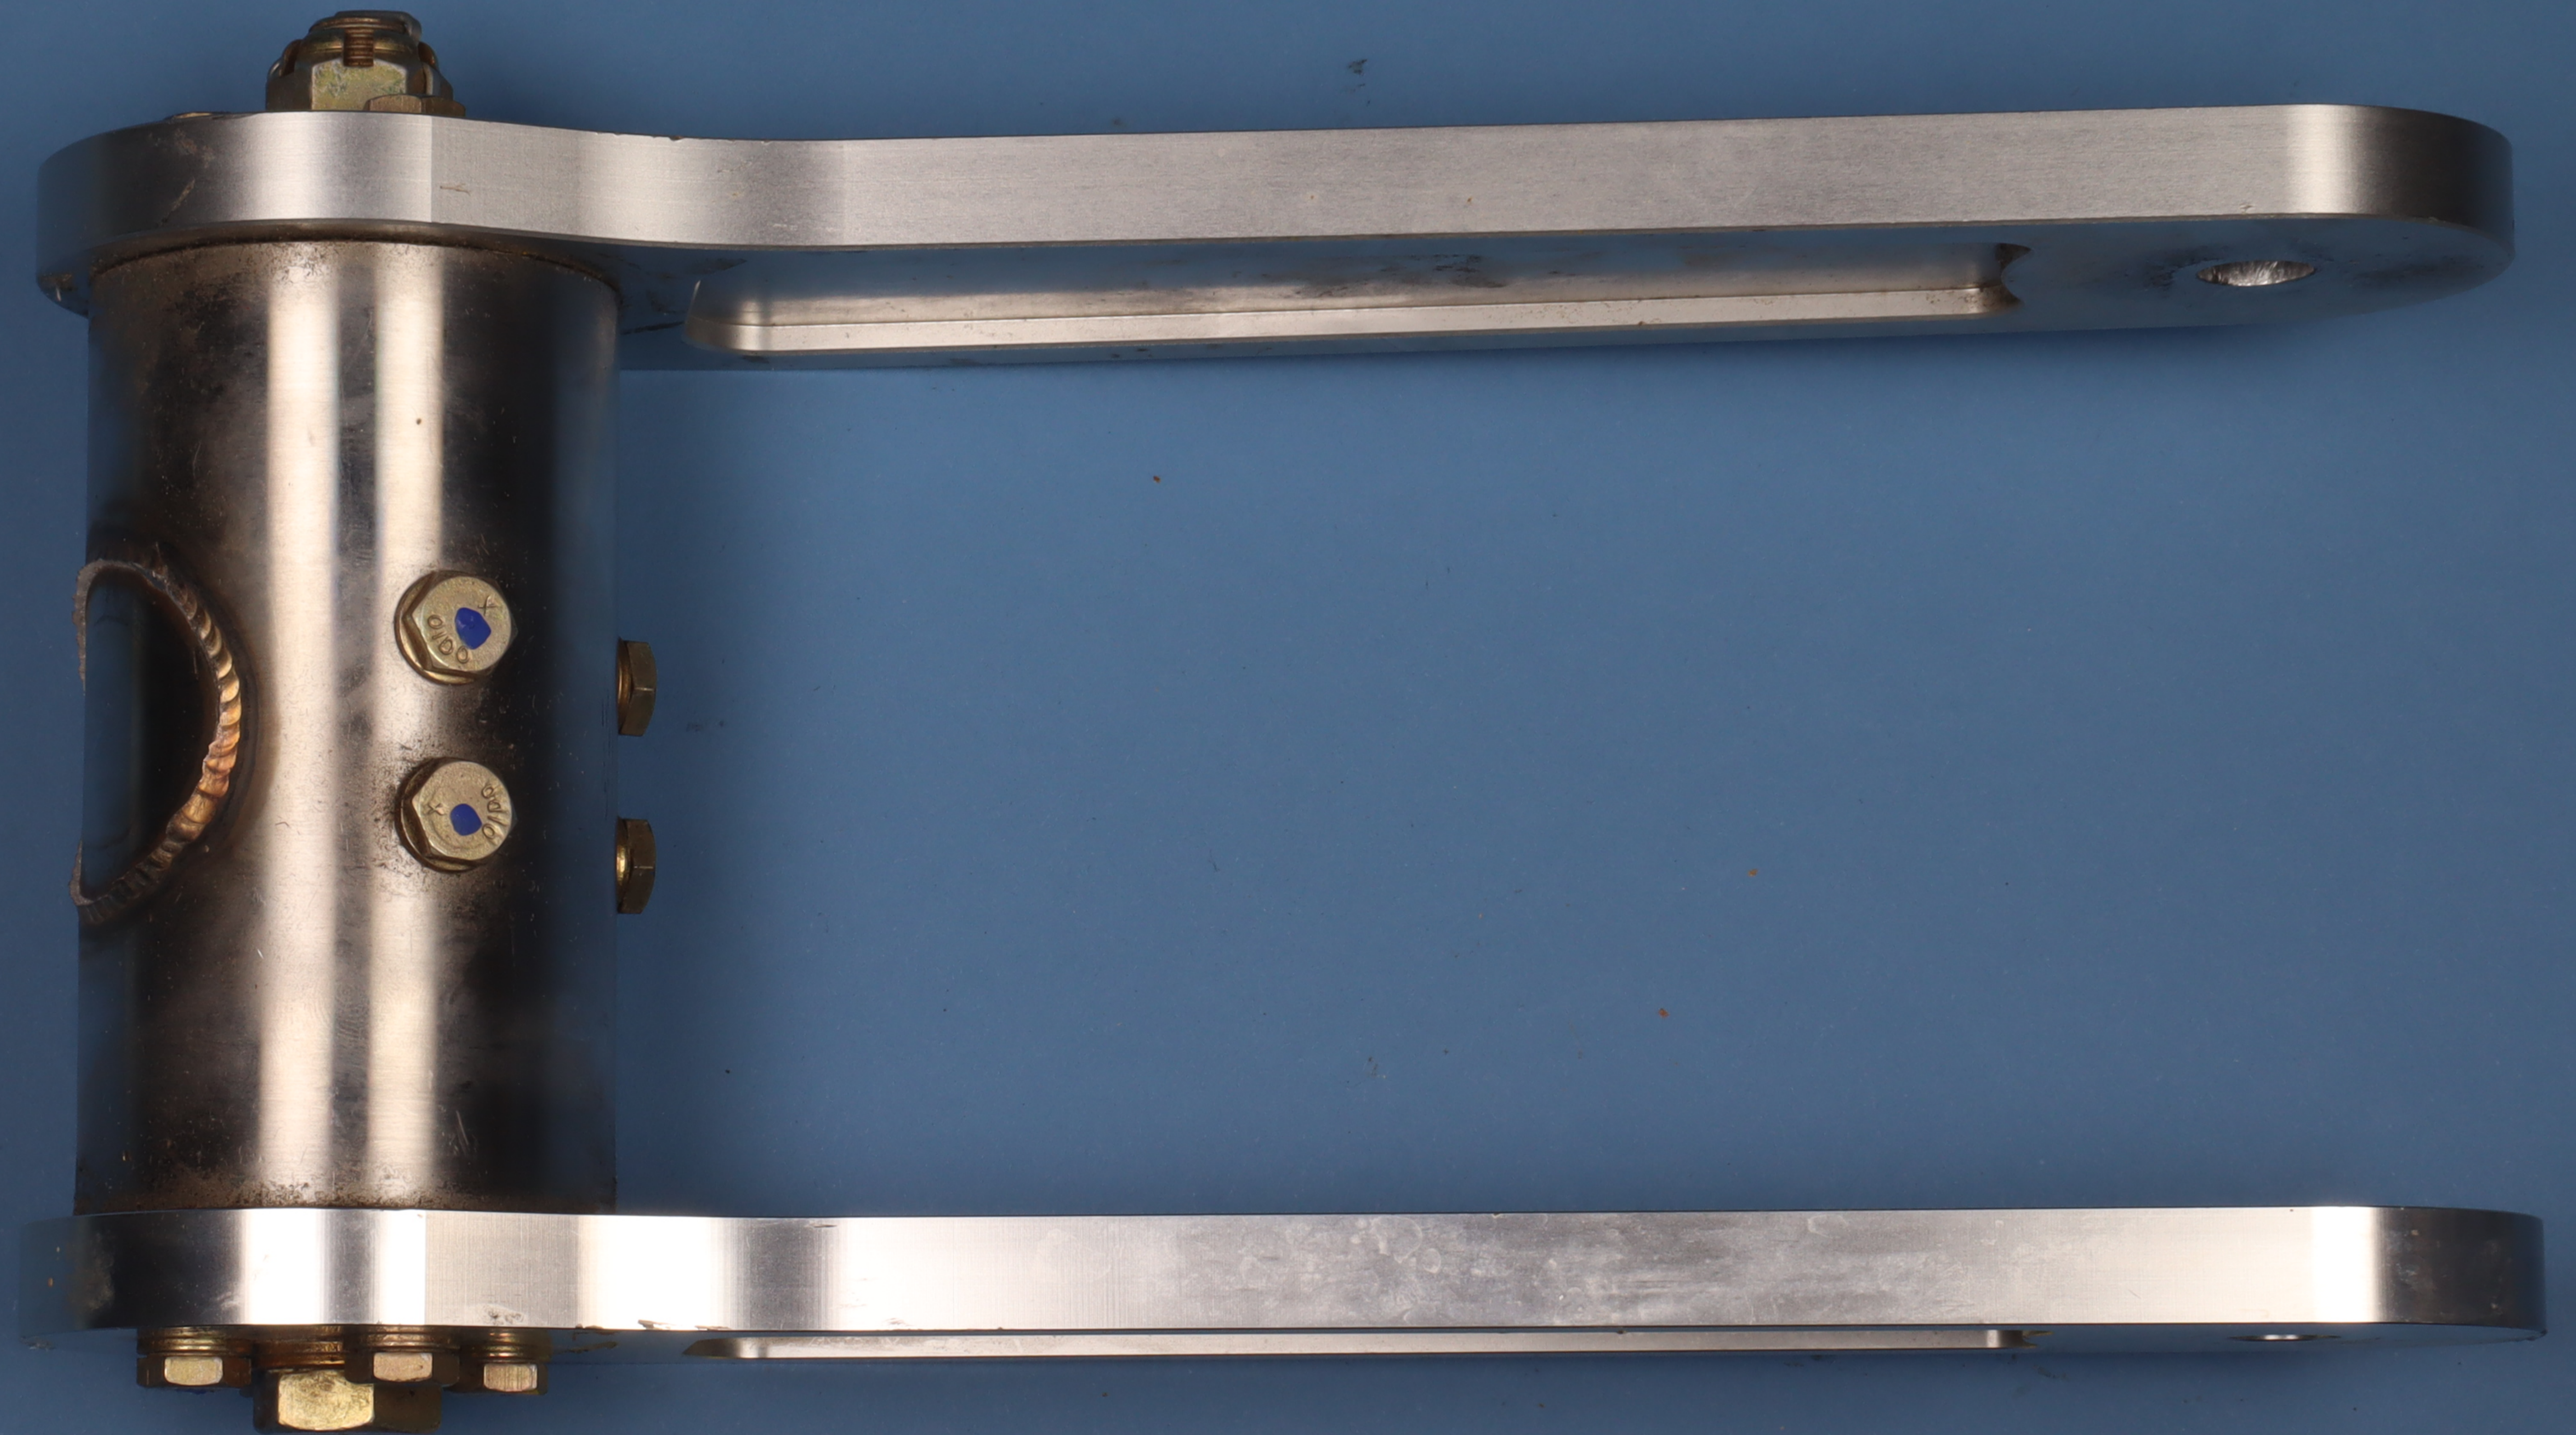
The nose wheel fork assembly shown in the attached image was examined visually and with a stereo microscope. According to a representative of SilverLight Aviation, the cross-tube assembly at the upper end of the nose wheel fork for the aircraft in the subject investigation was manufactured with a vertical tube that was welded to the upper side of the transverse tube. The submitted cross-tube assembly was fractured at the weld between the transverse tube and the vertical tube. The vertical tube was not included in the submitted components.

The fracture at the upper side of the cross tube appeared to be through the weld at or near the vertical leg of a fillet weld around the circumference of the vertical tube. The fracture surfaces had a mix of rough irregular features and flat smeared features consistent with ductile overstress shear fracture. No evidence of fatigue was observed.

As measured from the transverse tube surface, the vertical length of the fracture measured 0.048 inch, 0.025 inch, 0.057 inch, and 0.030 inch at the left, aft, right, and forward sides of the fracture, respectively. The outside diameter of the weld at the transverse tube surface (weld toe on the horizontal leg) measured 1.678 inch and 1.645 inch in the transverse and longitudinal directions, respectively.

According to scale drawings provided by SilverLight Aviation, the vertical tube has an outer diameter of 1.54 inch and a wall thickness of 0.25 inch. As measured on the submitted assembly, the transverse tube had a thickness of 0.127 inch. The representative for Silverlight Aviation reportedly stated that they strive for 70% penetration on welds. The inside diameter was measured where the fracture surface intersected the upper surface of the transverse tube, and the distance measured 1.455 inch in the transverse direction and 1.449 inch in the longitudinal direction. Assuming the vertical tube had an outer diameter in accordance with the drawing, the depth of penetration at the joint interface was approximately 0.046 inch  $(1.54/2 - 1.449/2)$ . This represents 18% of the thickness of the vertical tube and 36% of the thickness of the transverse tube.
