## **NATIONAL TRANSPORTATION SAFETY BOARD**

**Photo Array**

**ERA22LA139**

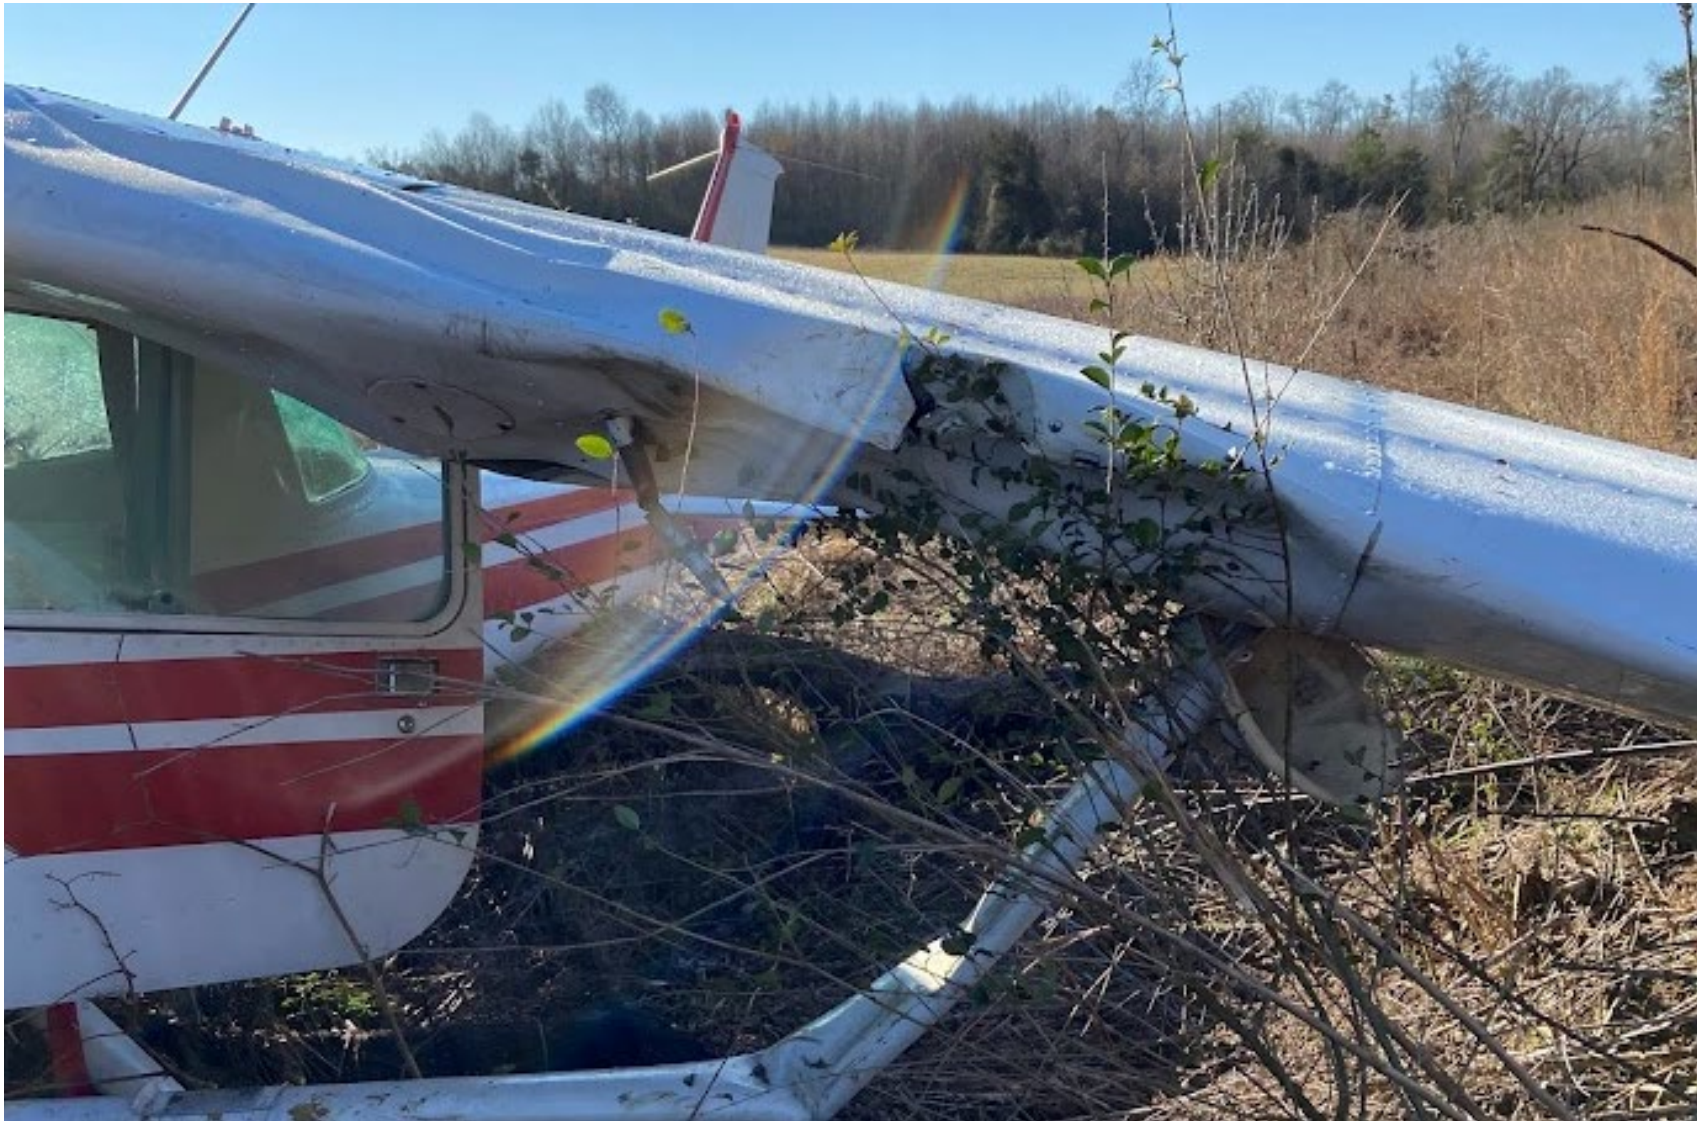
**Photo 1 – View of left wing (Photo Courtesy of FAA)**

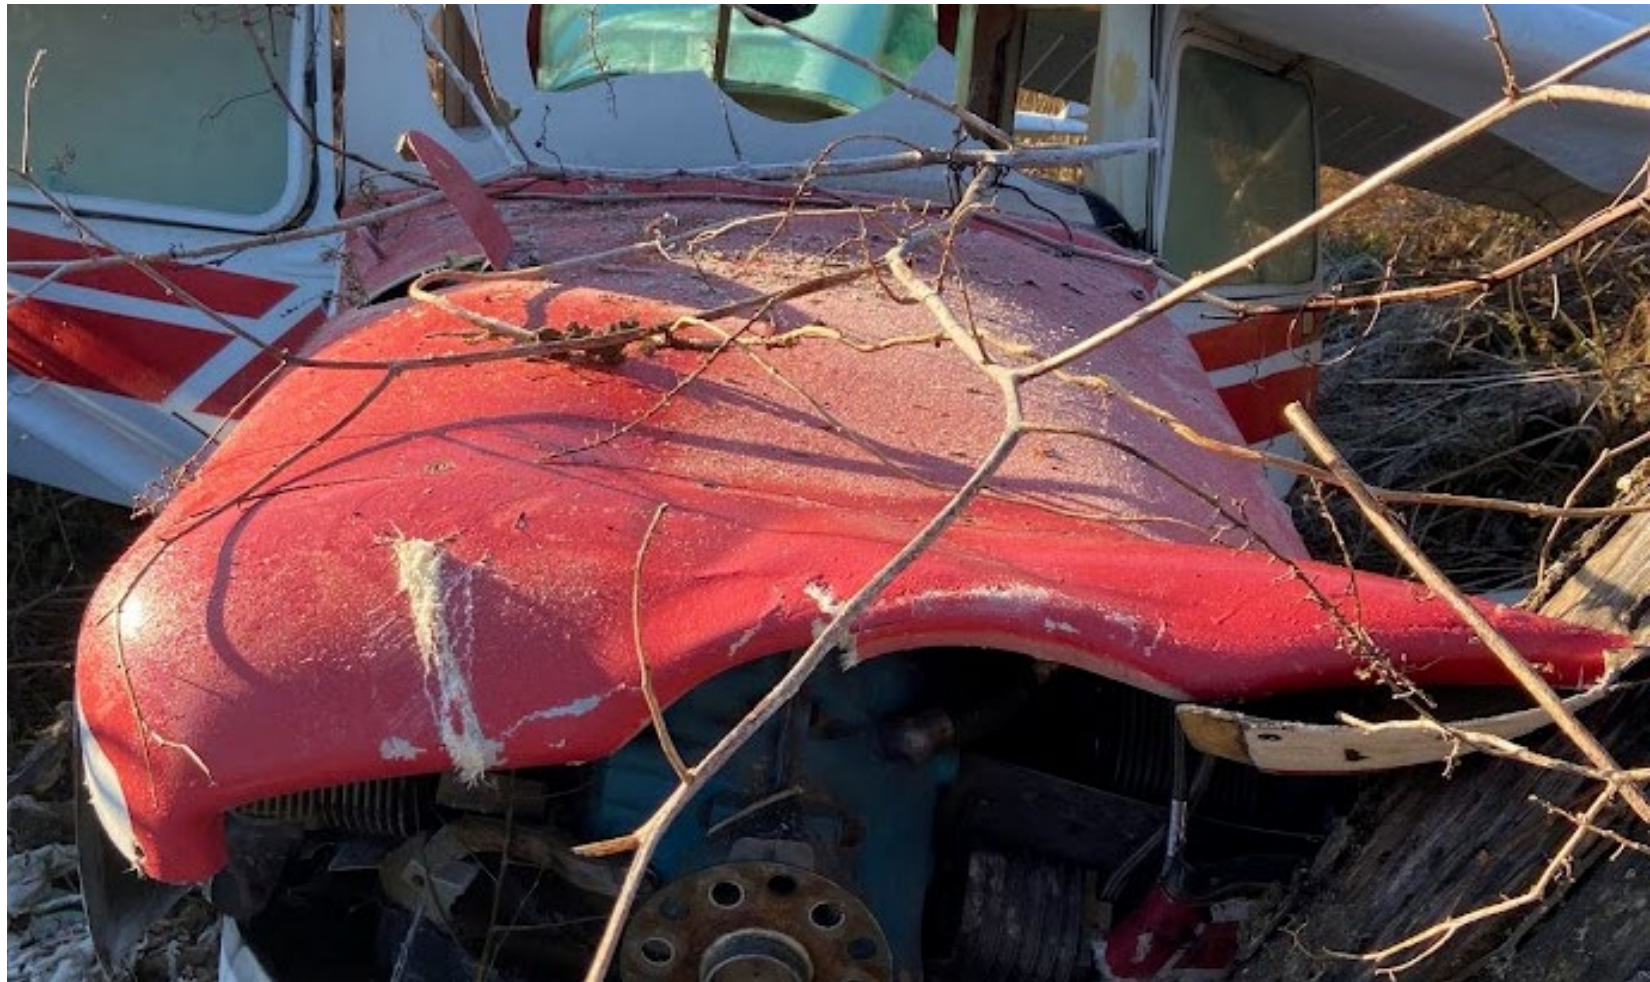
**Photo 2 – View of airplane from the front looking aft (Photo Courtesy of FAA)**

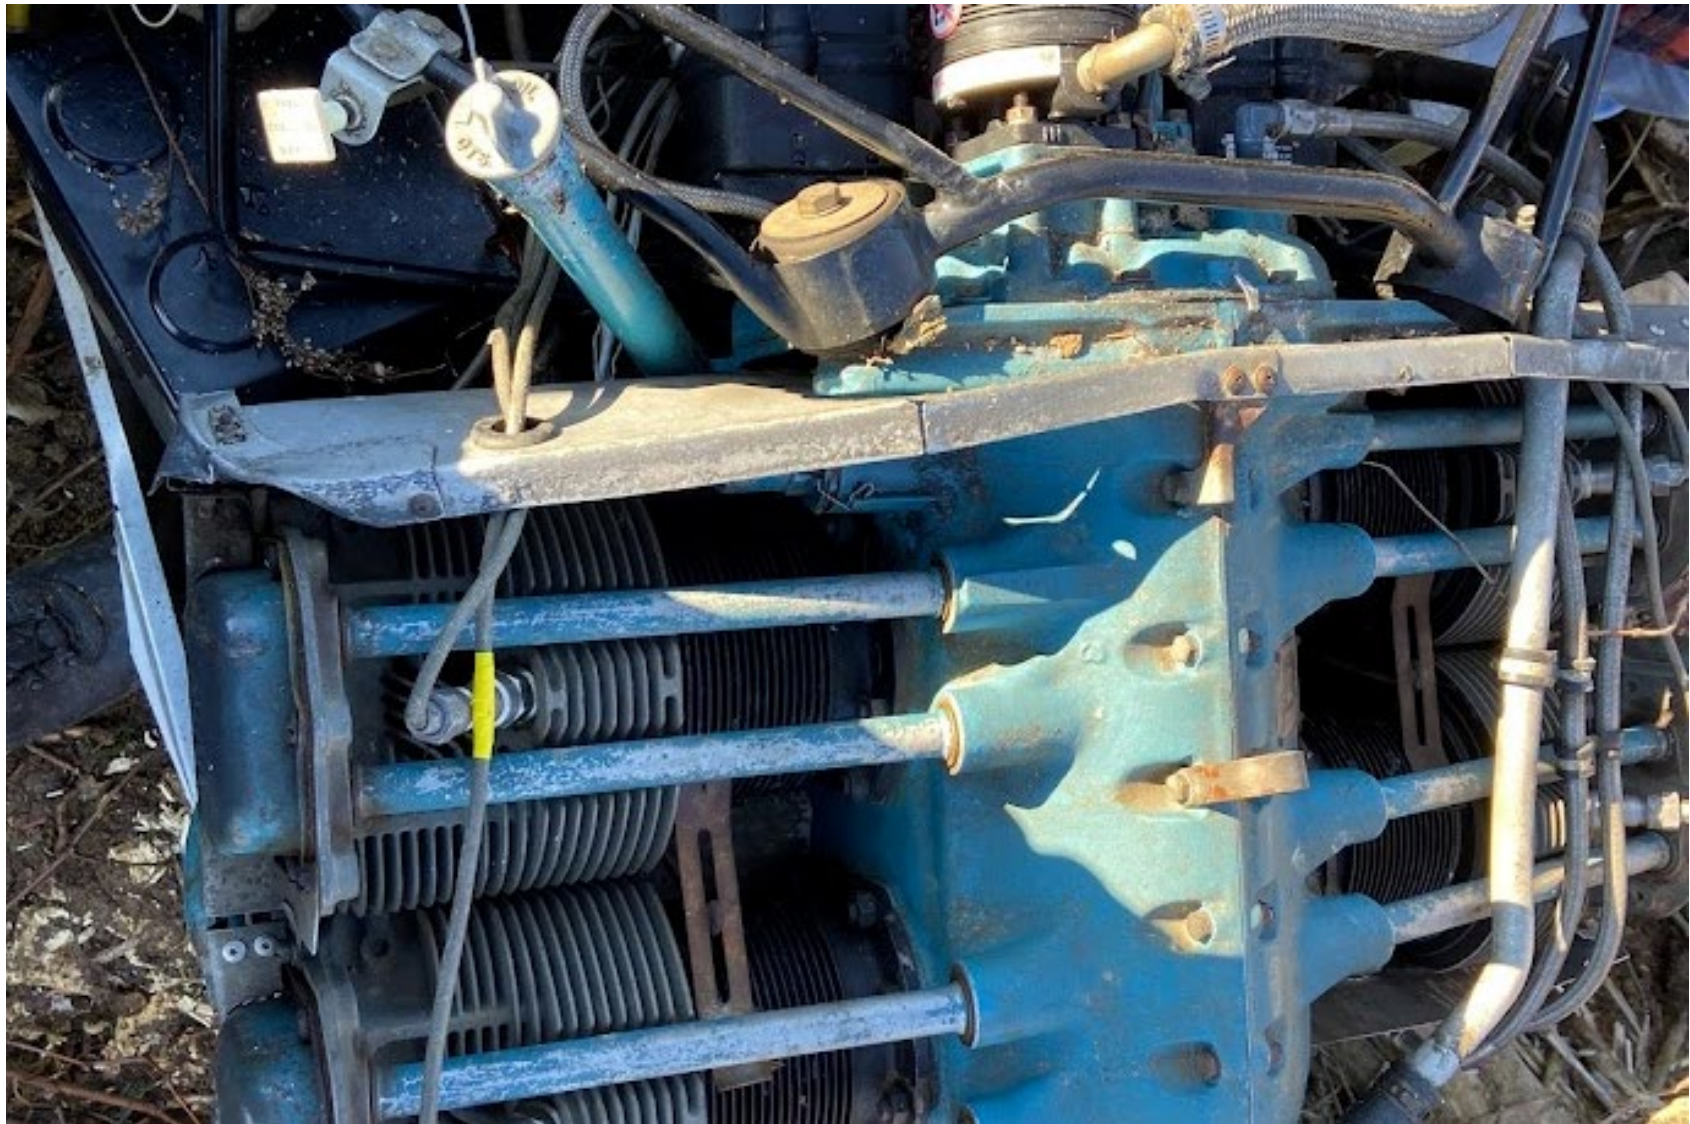
**Photo 3 – View of engine with the cowling removed in the field where it came to rest. (Photo Courtesy of FAA)**
