ERA22LA148

## INVESTIGATION PHOTOGRAPHS

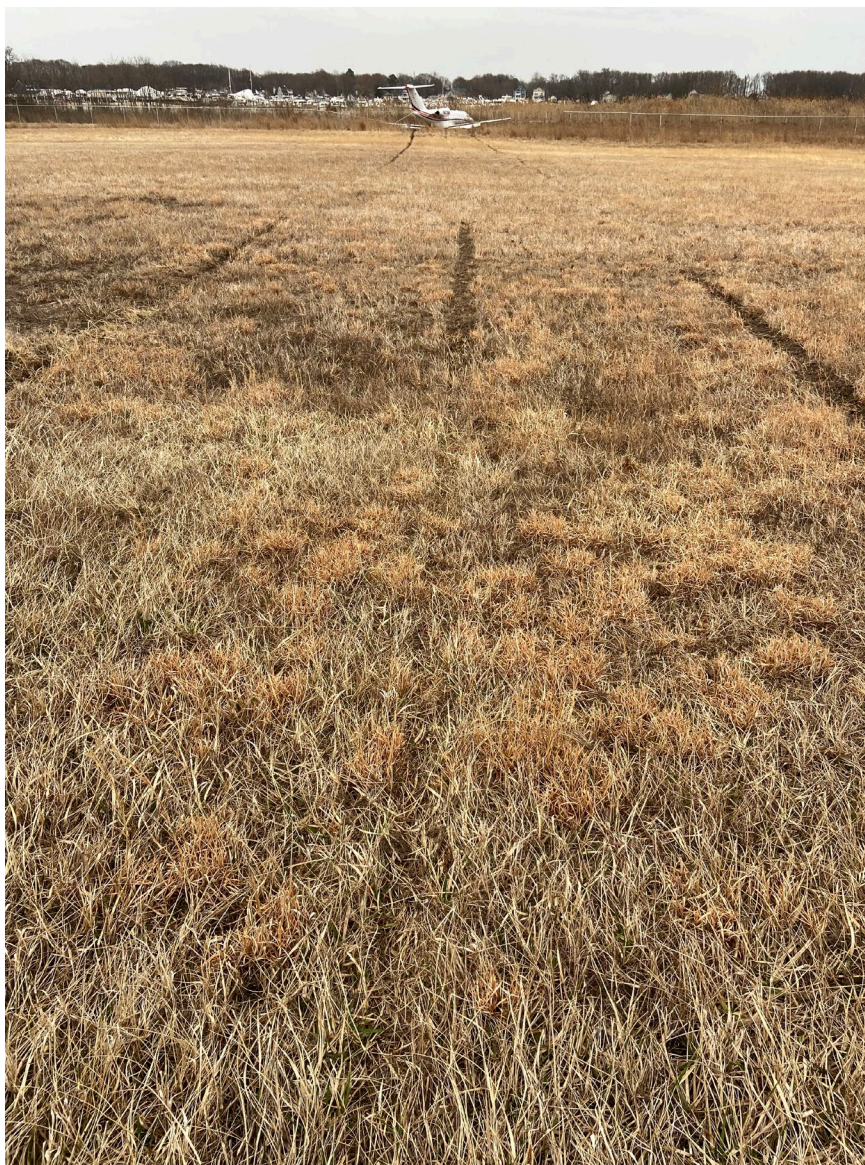
**Photograph 1 - Tire grooves in ground leading up to wreckage. (Courtesy of MTN Airport)**

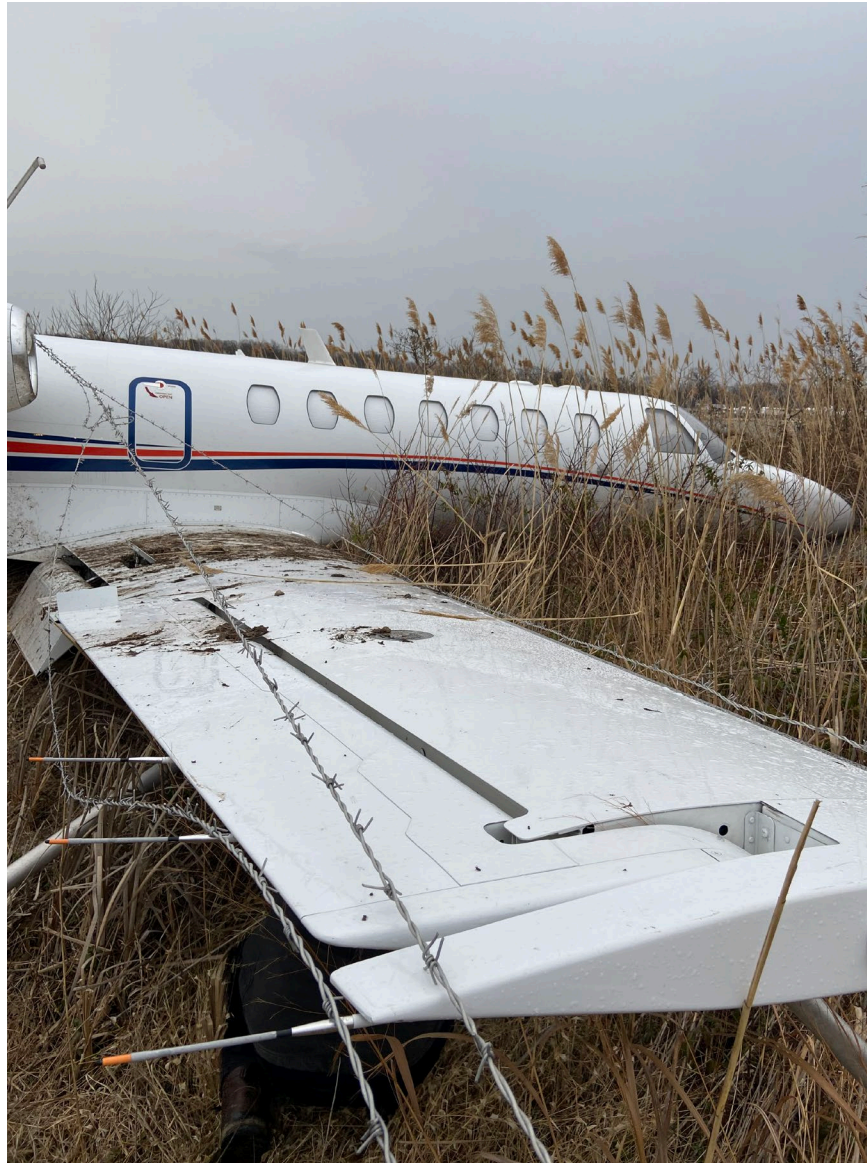
**Photograph 2 - View of right side of airplane. (Courtesy of MTN Airport)**

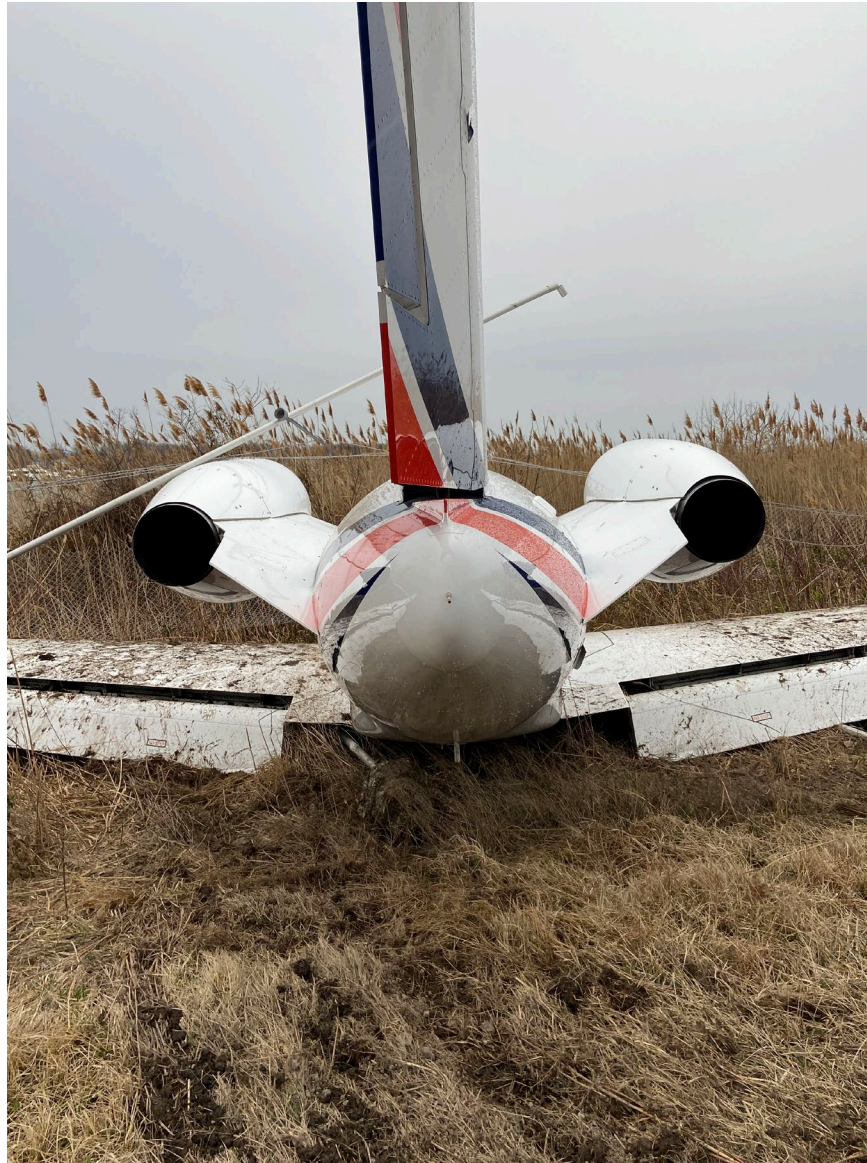
**Photograph 3 - Aft view of airplane looking forward. (Courtesy of MTN Airport)**

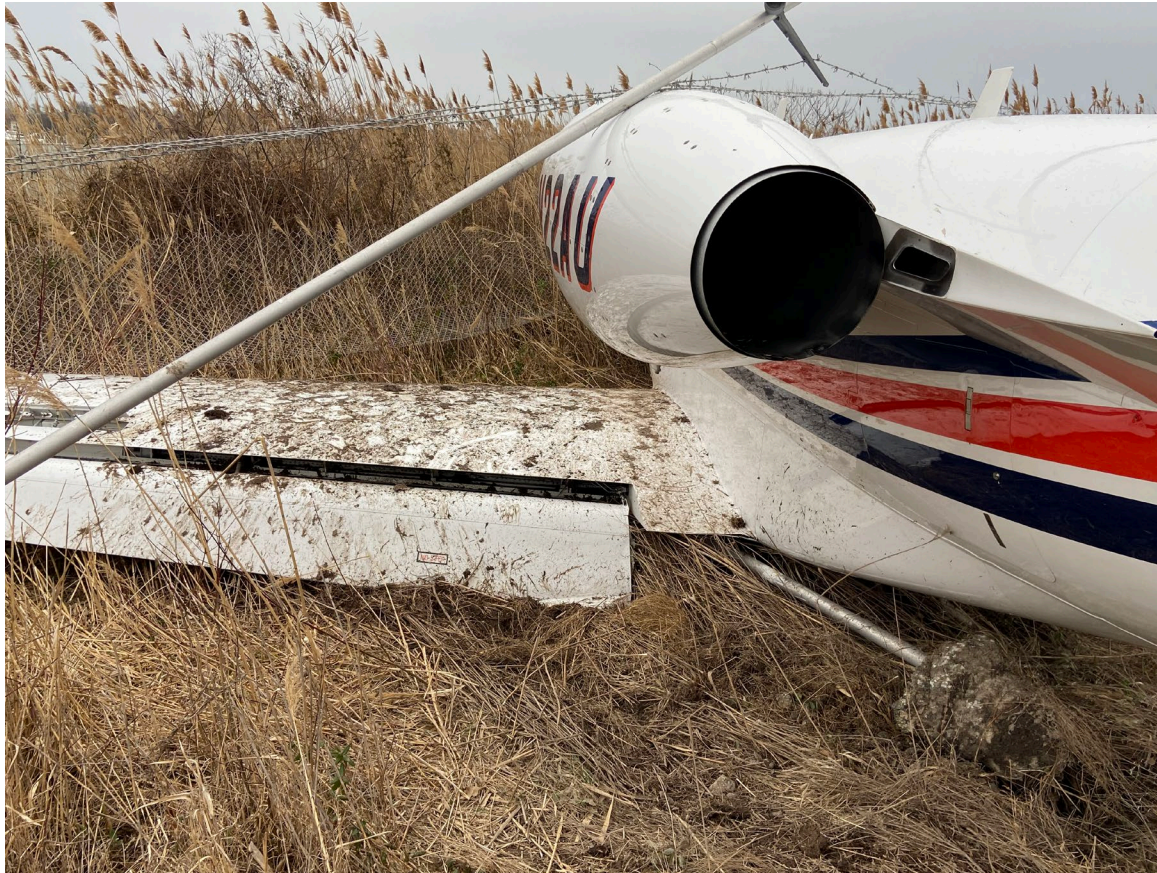
**Photograph 4 - View of left wing flap damage. (Courtesy of MTN Airport)**

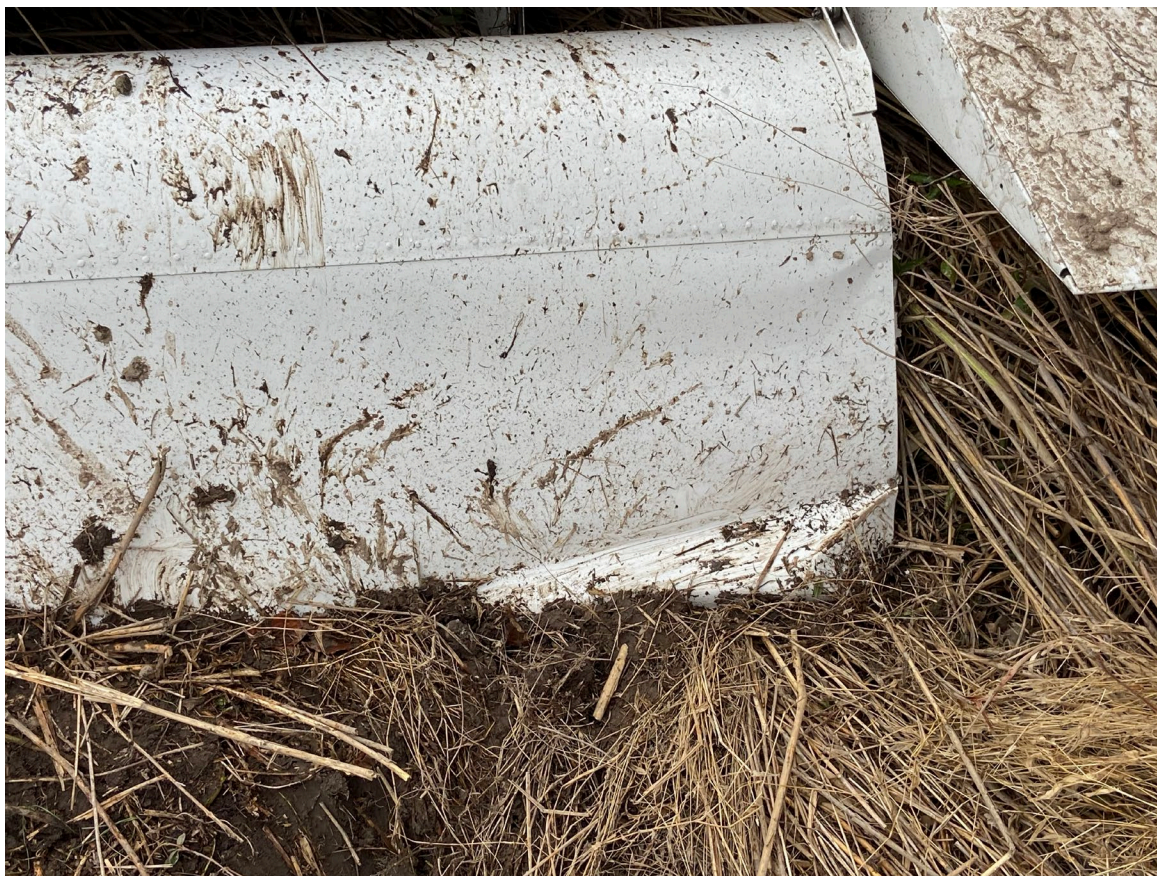
**Photograph 5 - Closeup view of left flap damage. (Courtesy of MTN Airport)**

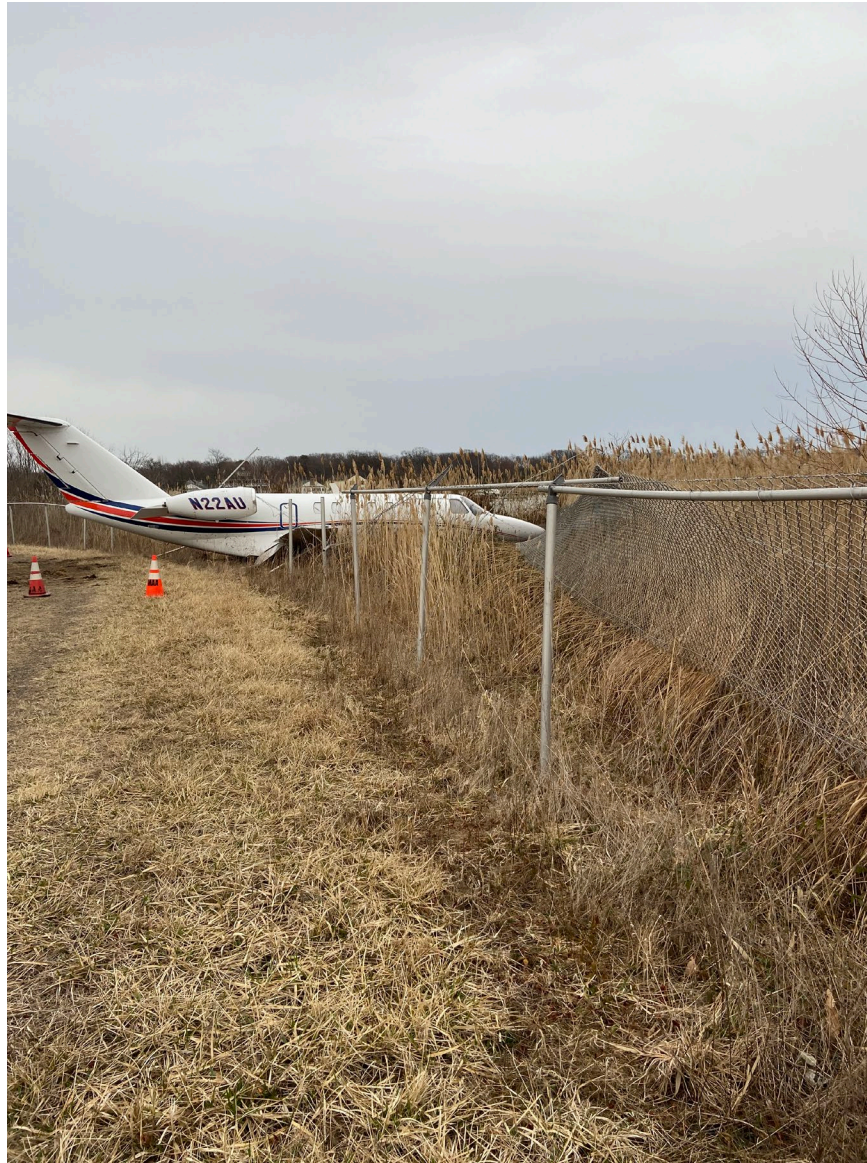
**Photograph 6 - View of airplane through security fence. (Courtesy of MTN Airport)**

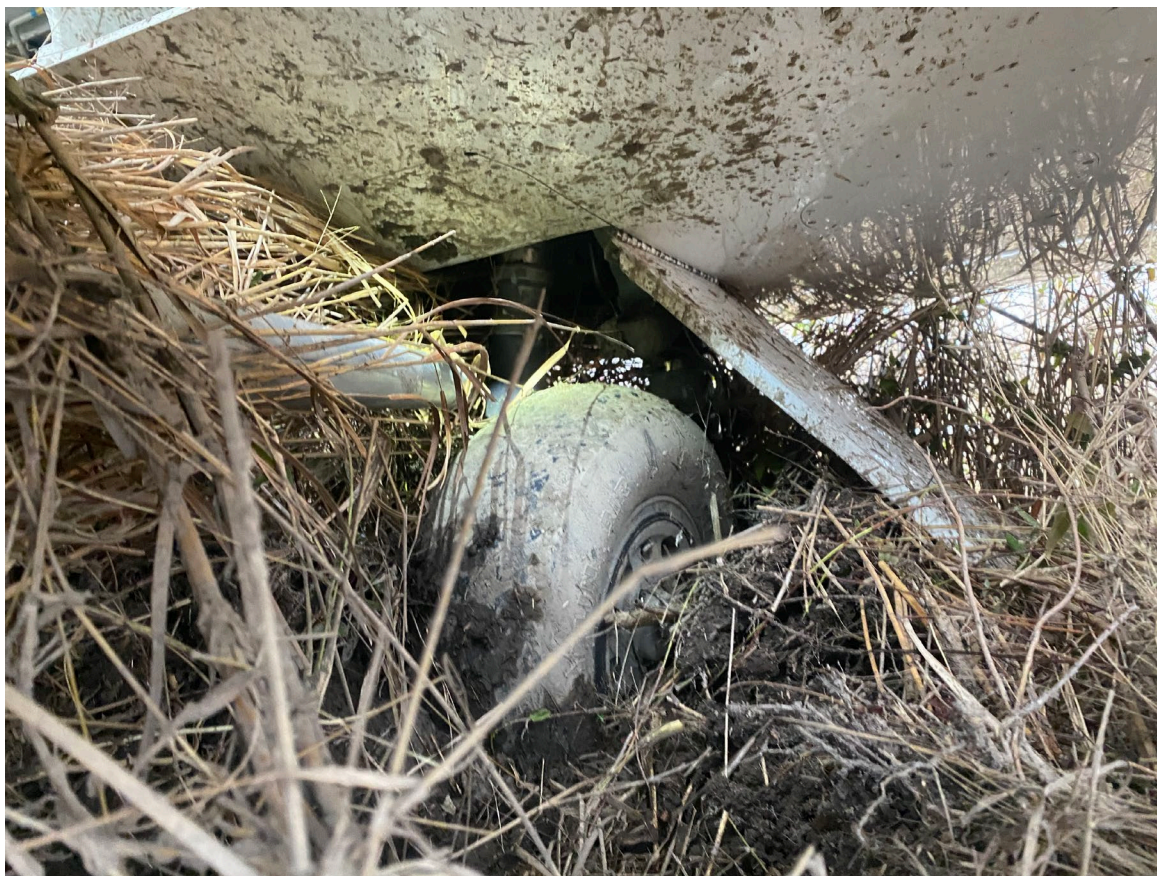
**Photograph 7 - View of landing gear in mud. (Courtesy of MTN Airport)**
