Inspector statement: 03/11/2022

March 10, 2022

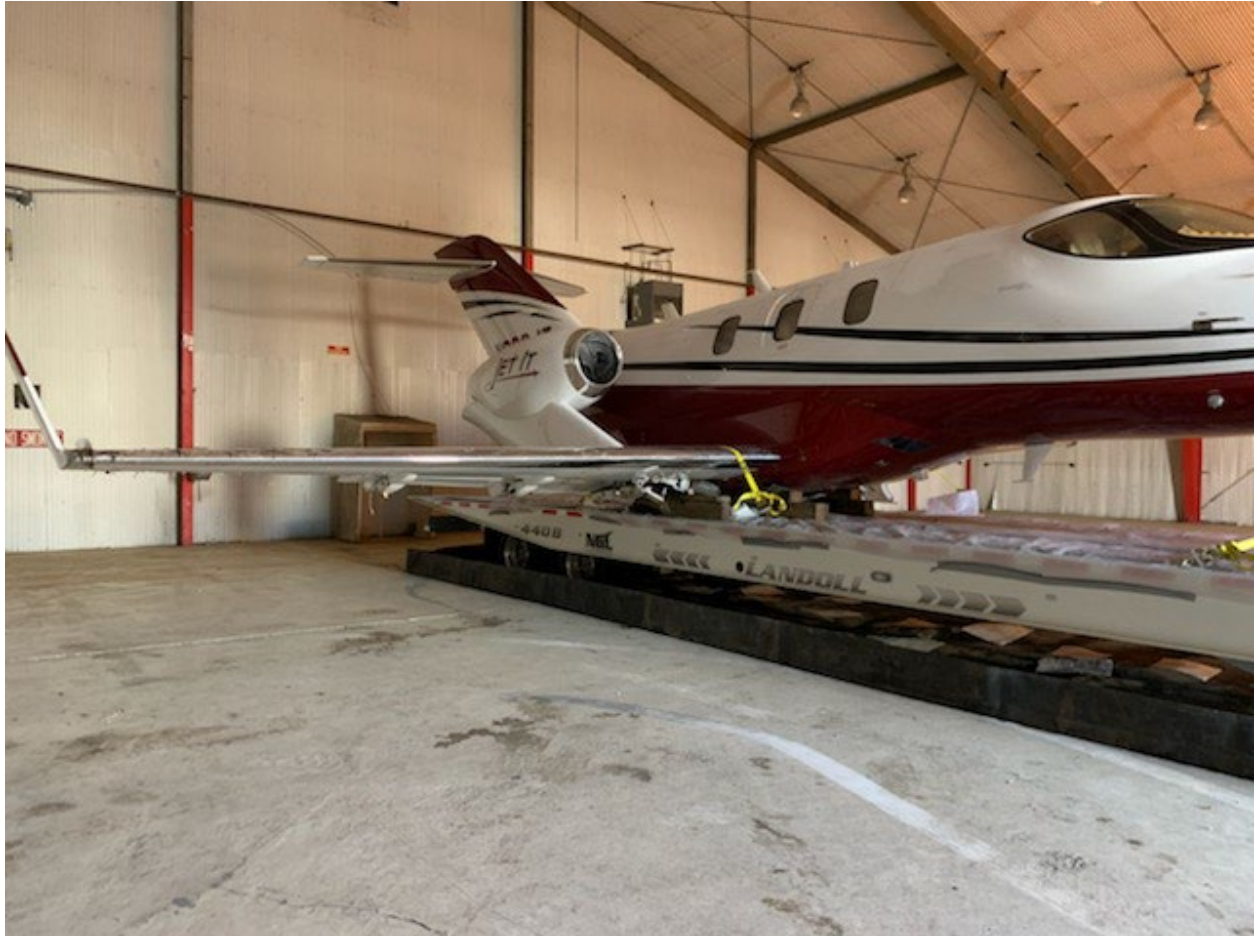
- Removed FDR from aircraft N903JT. Removed pilot personal luggage as permitted by NTSB authorization. Pilots provided a copy of the medical and pilot certificate as requested by the Ops inspector. Aircraft was located at AGC hangar 22, and was on a trailer at the time.

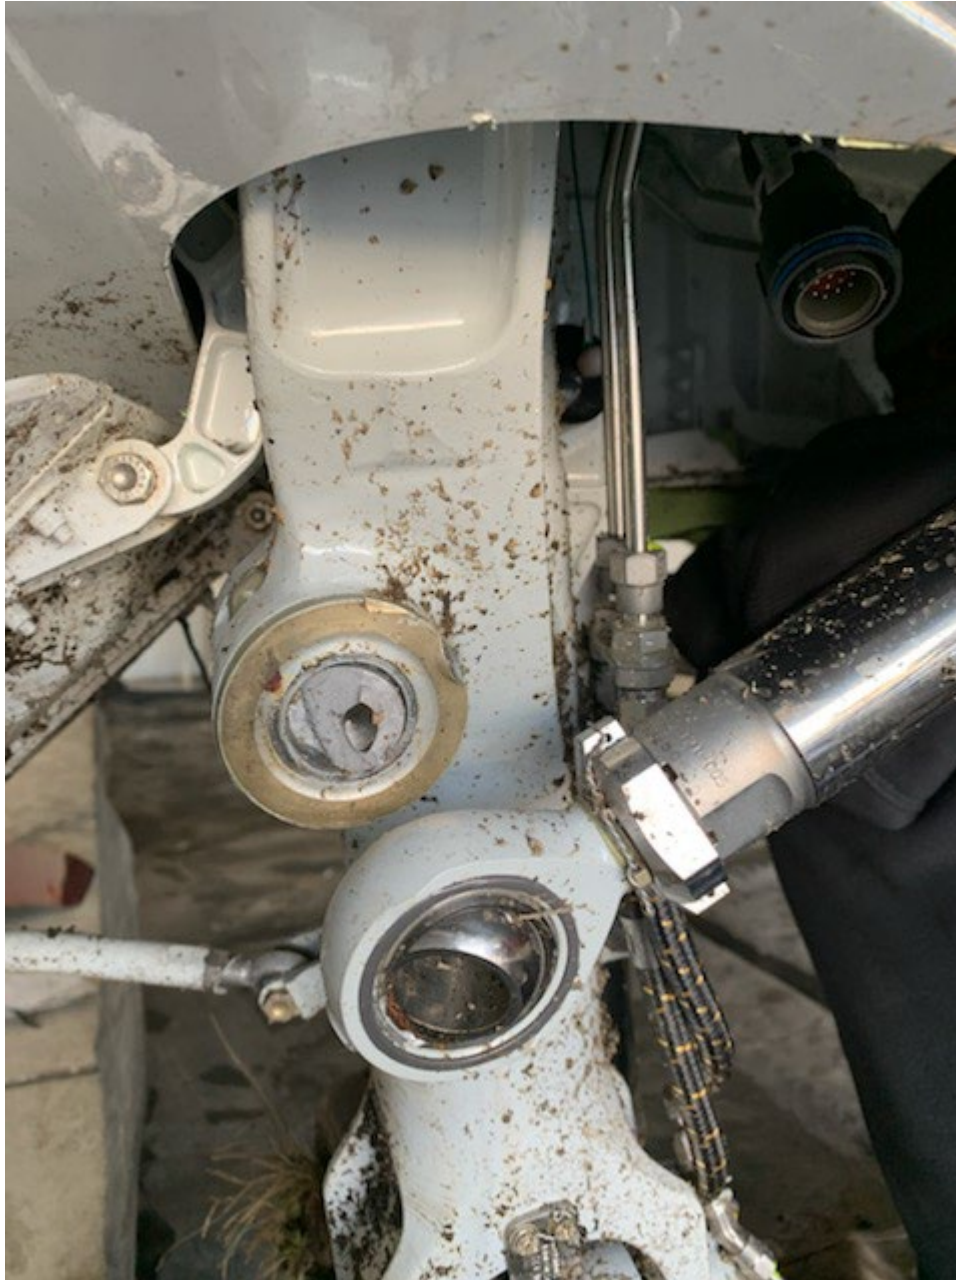
Aircraft was removed from the trailer, placed on Jacks. During the walk around the following items were noted. RMLG Was collapsed. The down lock actuator attach point (Pin) in the landing gear strut was sheared off. According to the Honda Jet maintenance personnel, The pin is designed as a weak point not to destroy the trunnion area.

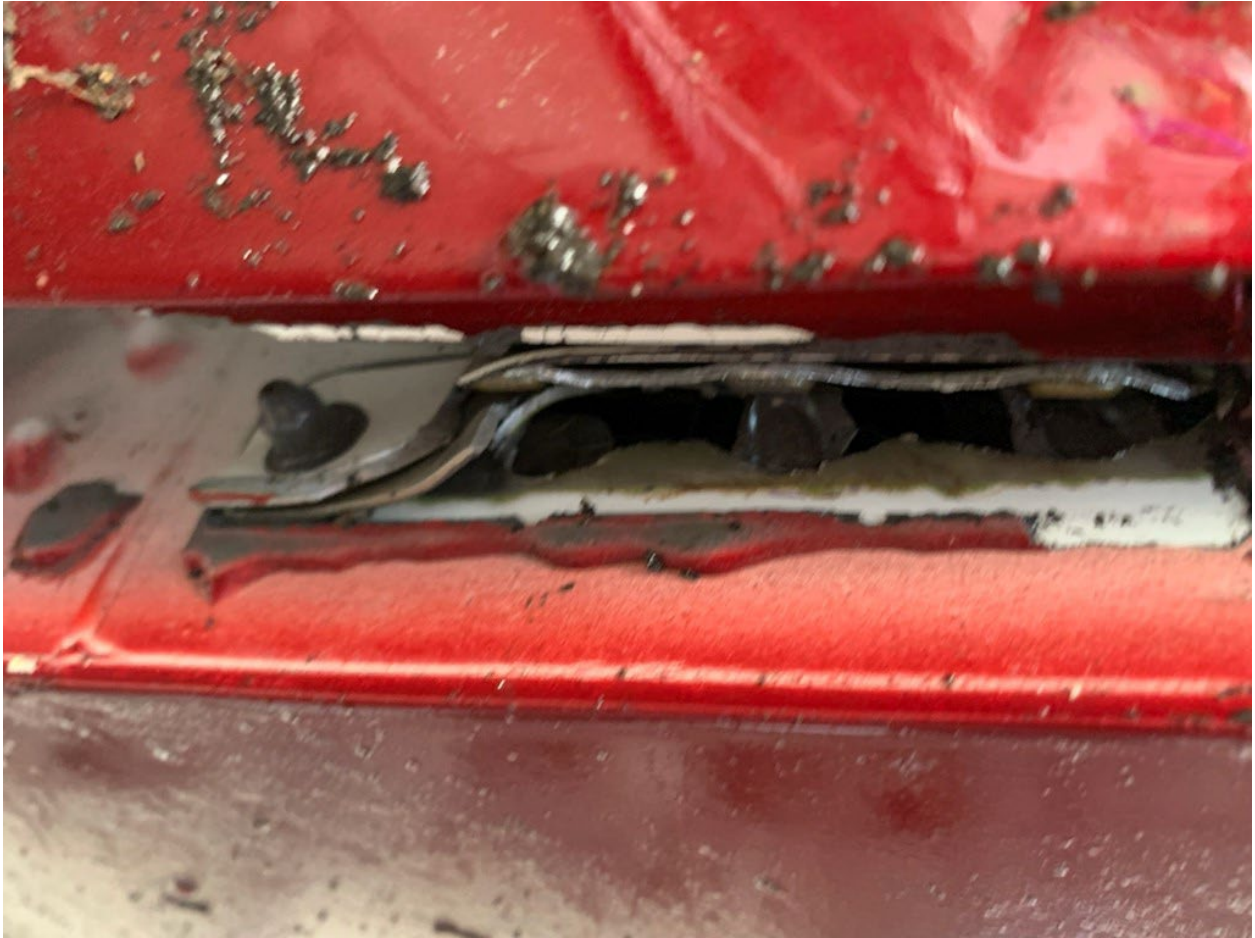
- Both MLG tires were shredded from sliding and the emergency brake was set to the on position, Brakes were set (No movement).
- Fuel leak from the center tank was evident. Center fuel tank was found to have the right Inbd gear door, Aft hinge point torn from the fuel tank wall and created a fuel leak

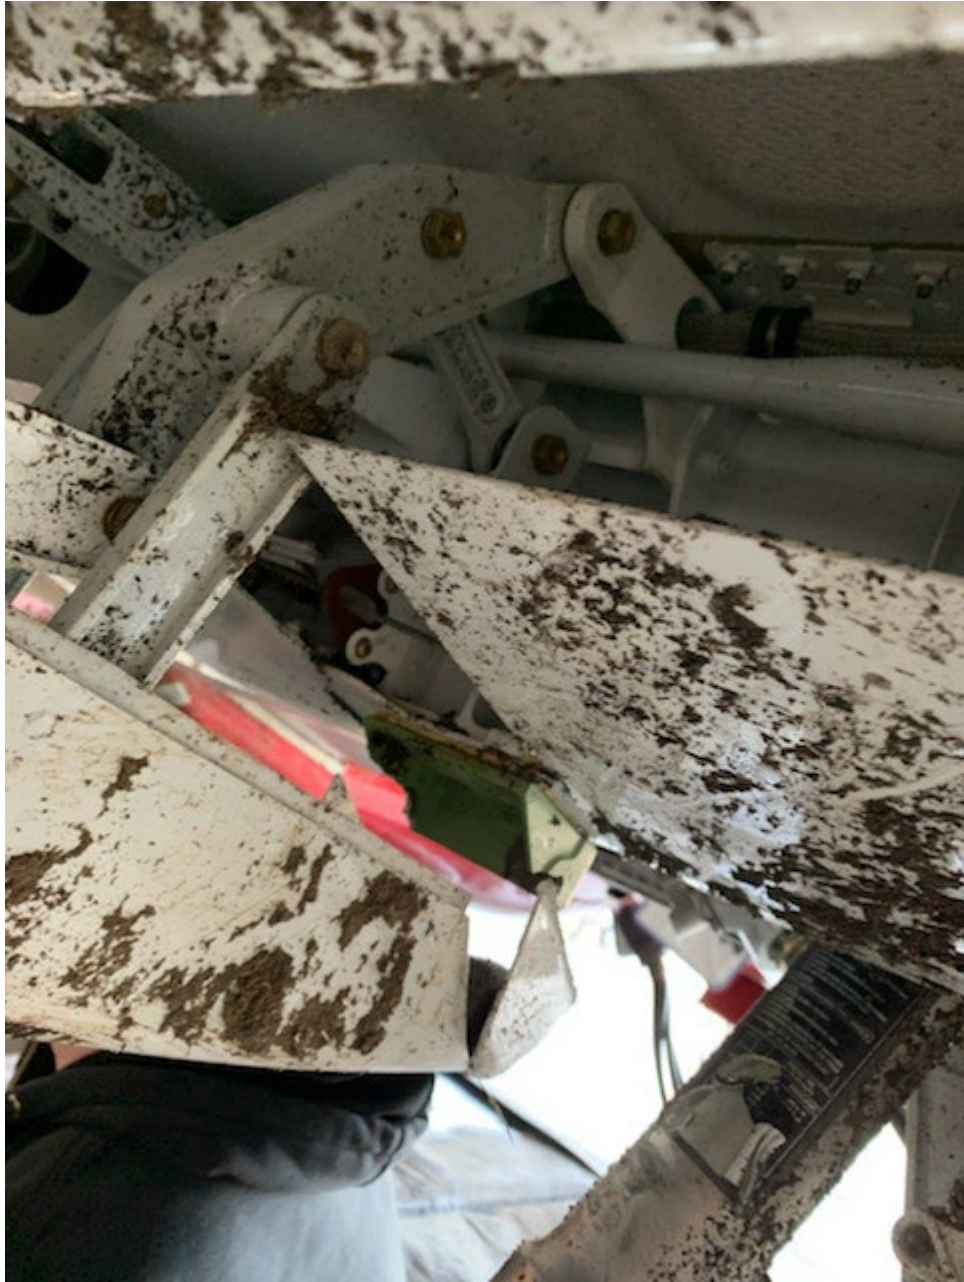
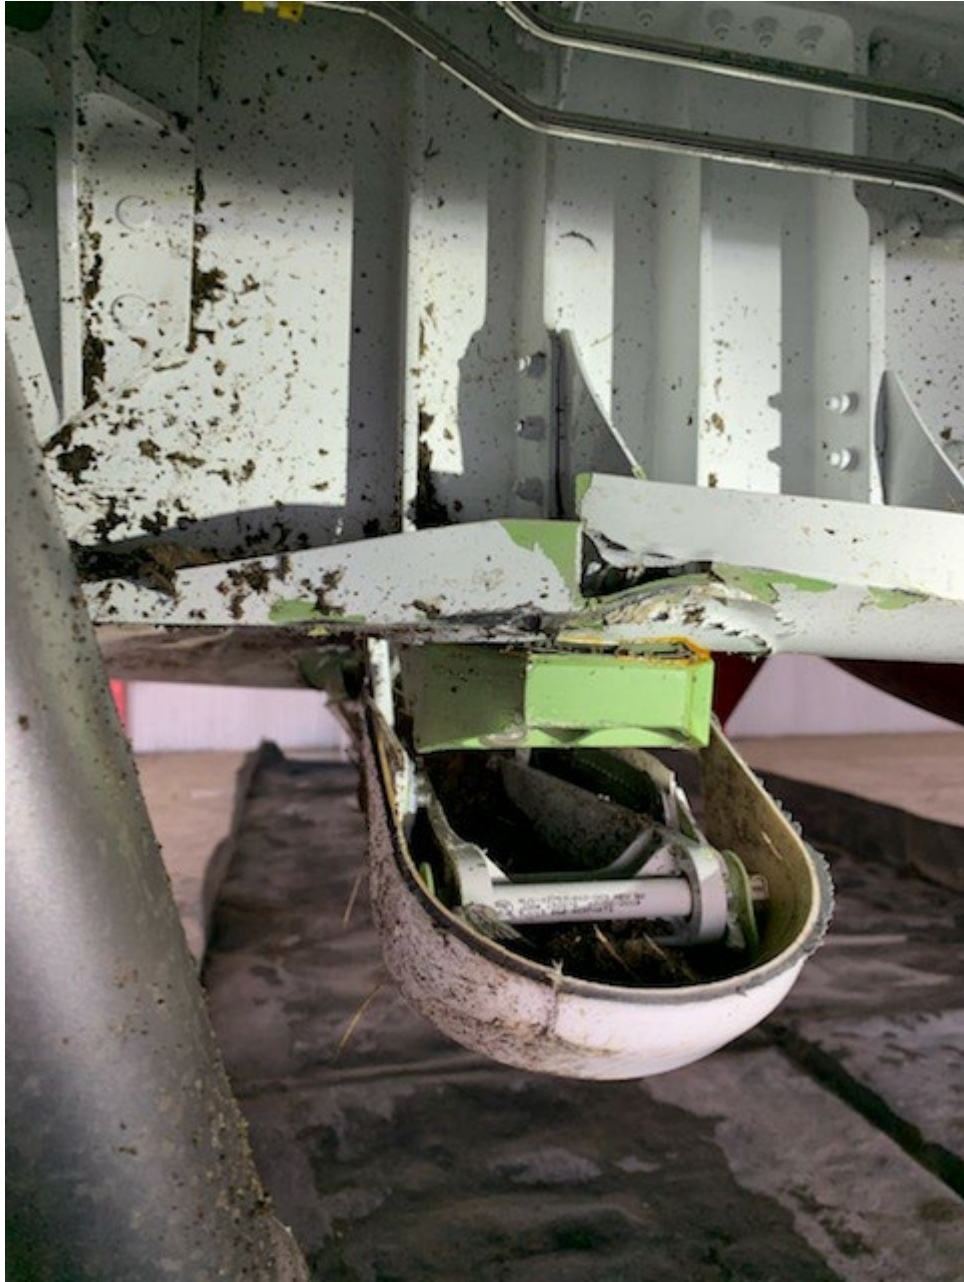
-Both inboard Flaps have damage

- Rt Flap Inbd Mount has severe damage, Torn wing skin as hinge attach point broke.

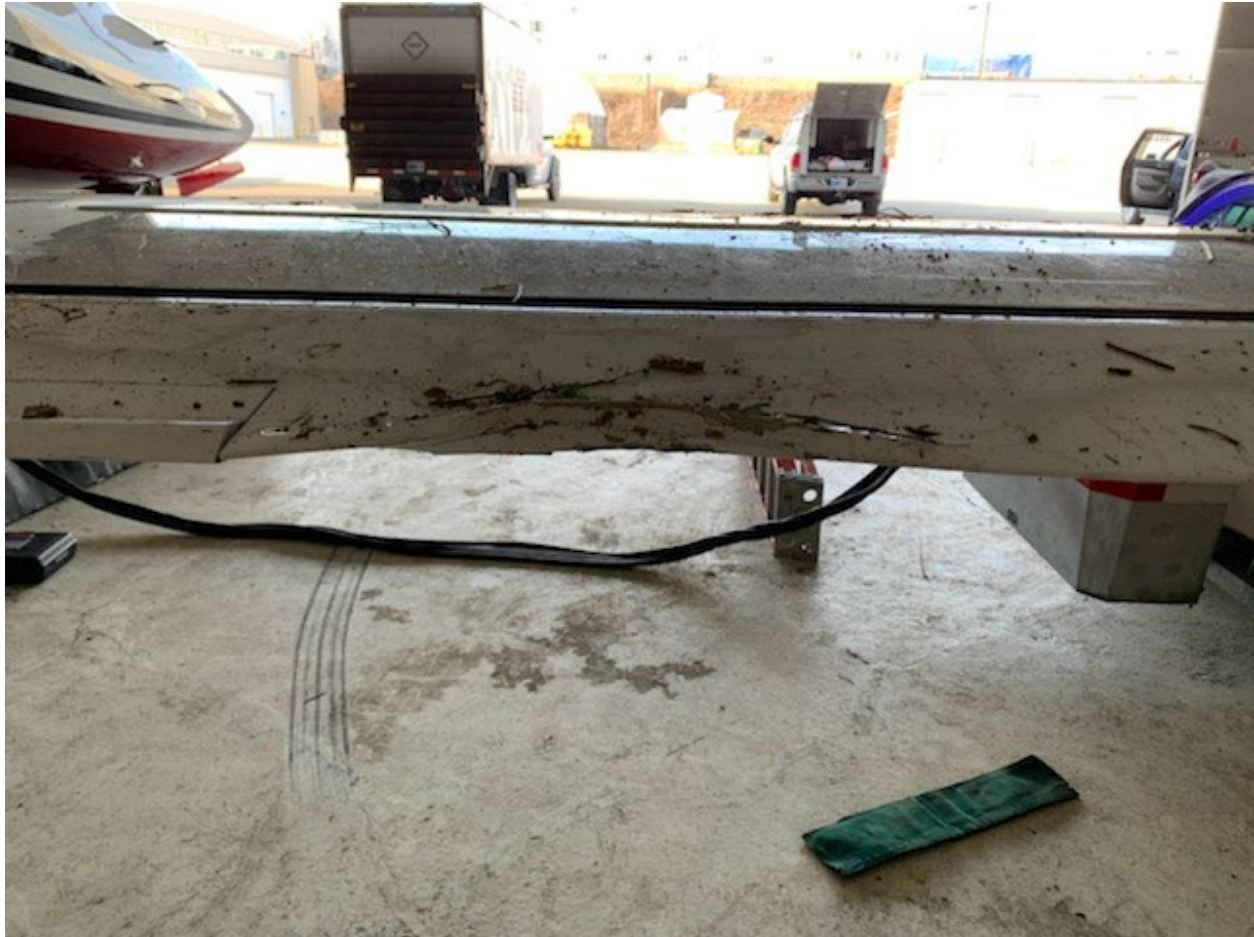
-Rt Aileron is damaged at both trailing edge and leading edge, push pull rod attach point.
