ERA22LA150

## INVESTIGATION PHOTOGRAPHS

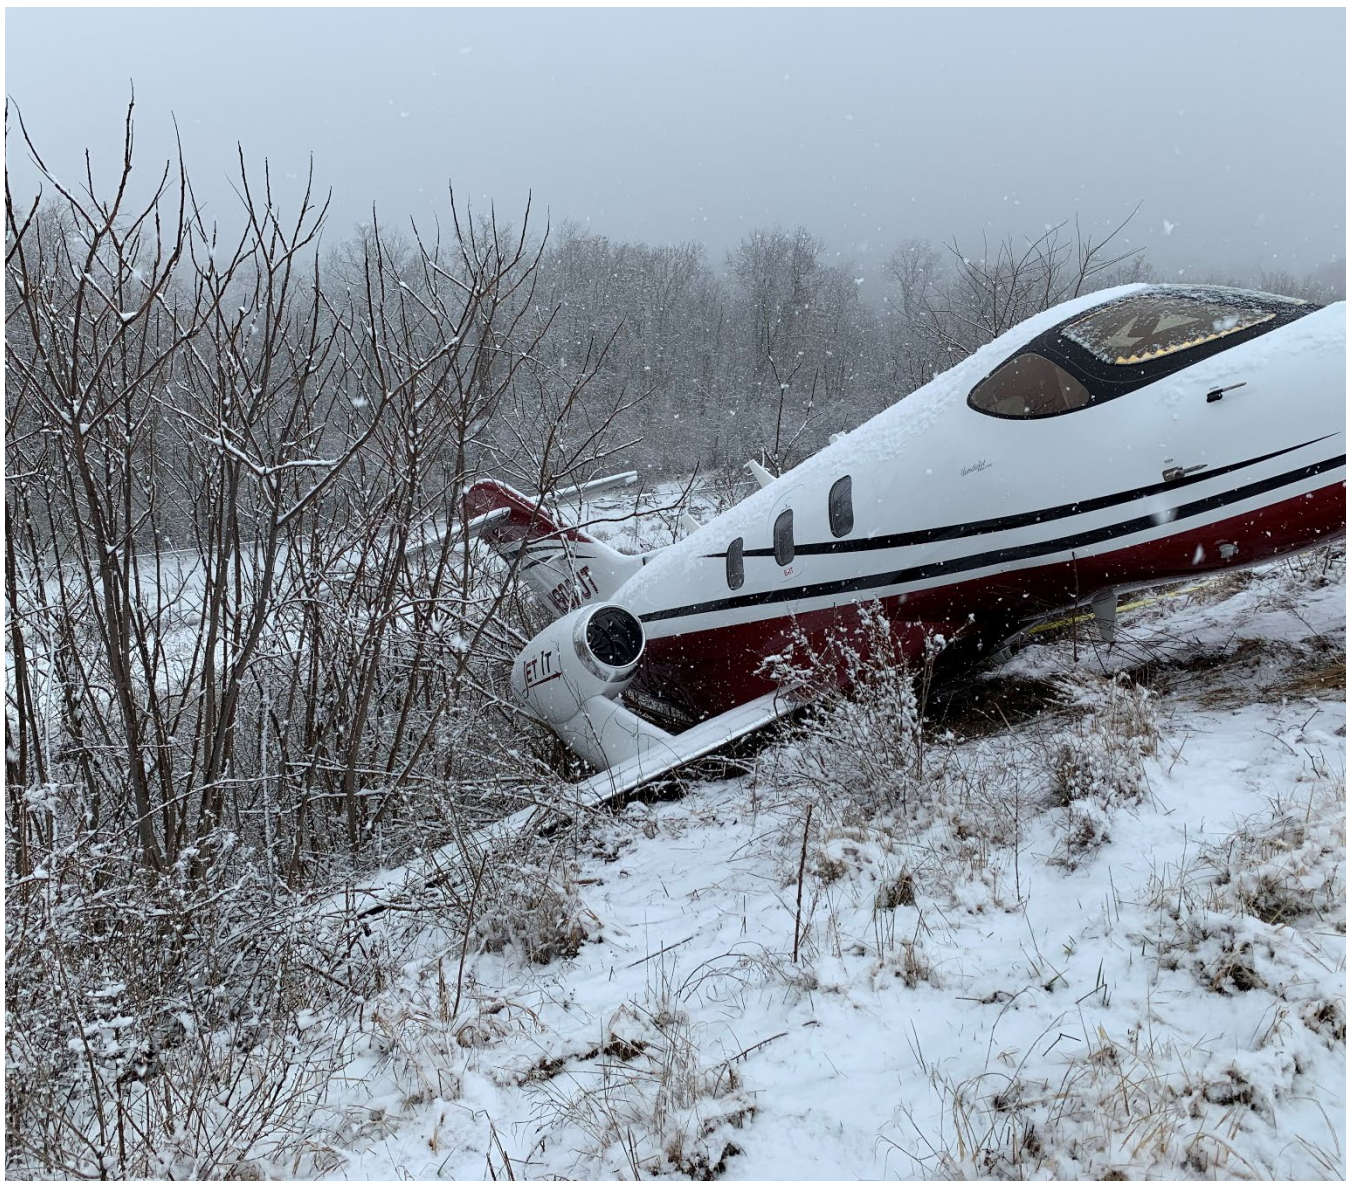
**Photograph 1 - View of airplane from right wing before recovery. (Courtesy of FAA)**

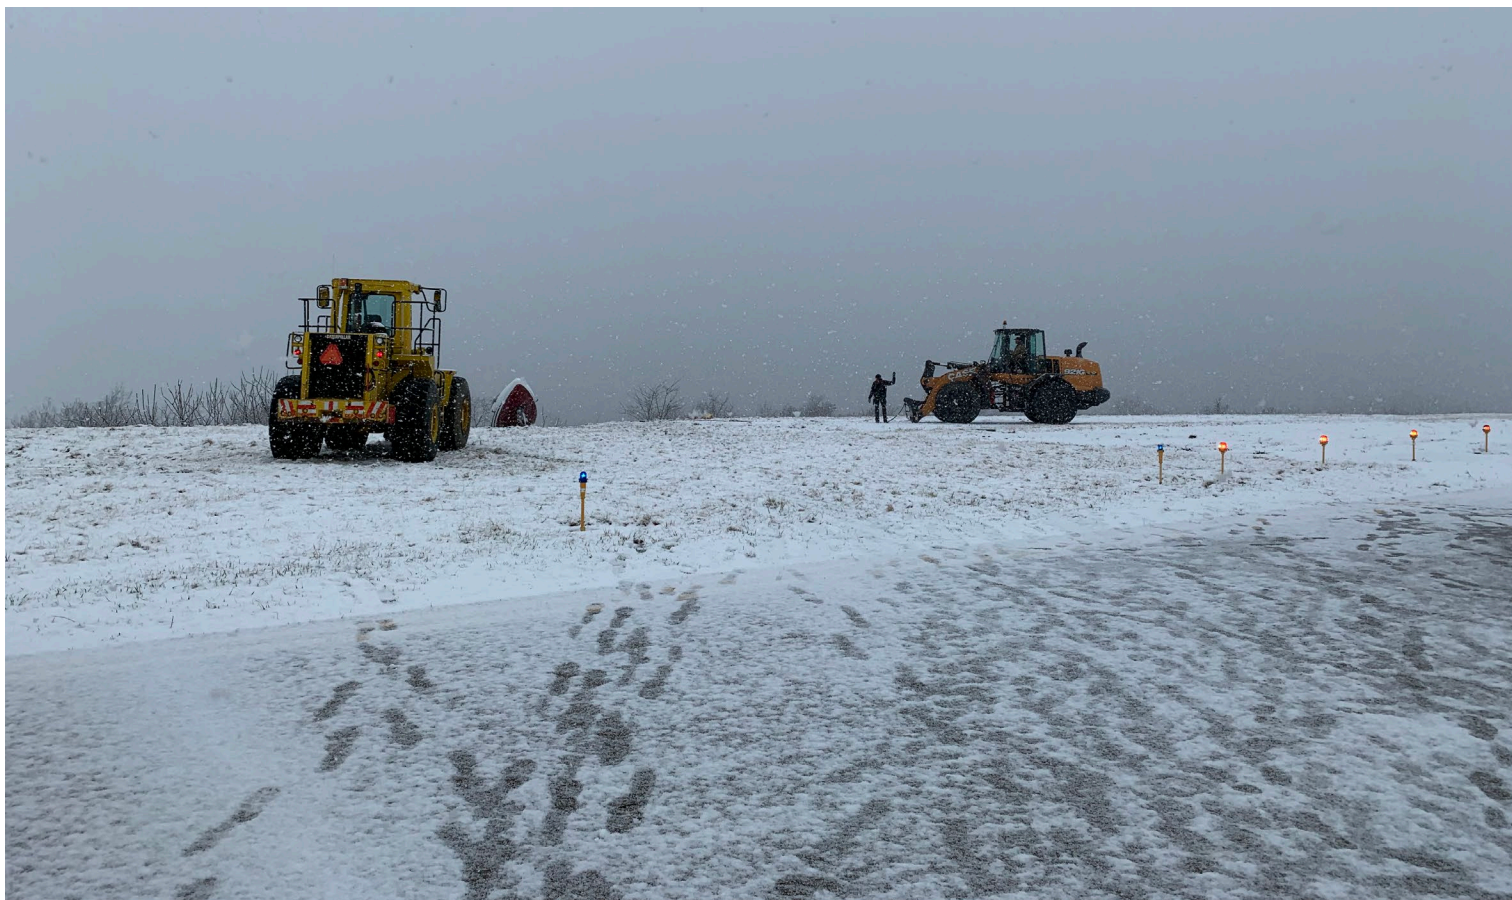
**Photograph 2 - View of airplane nose and snow-covered runway before recovery. (Courtesy of FAA)**

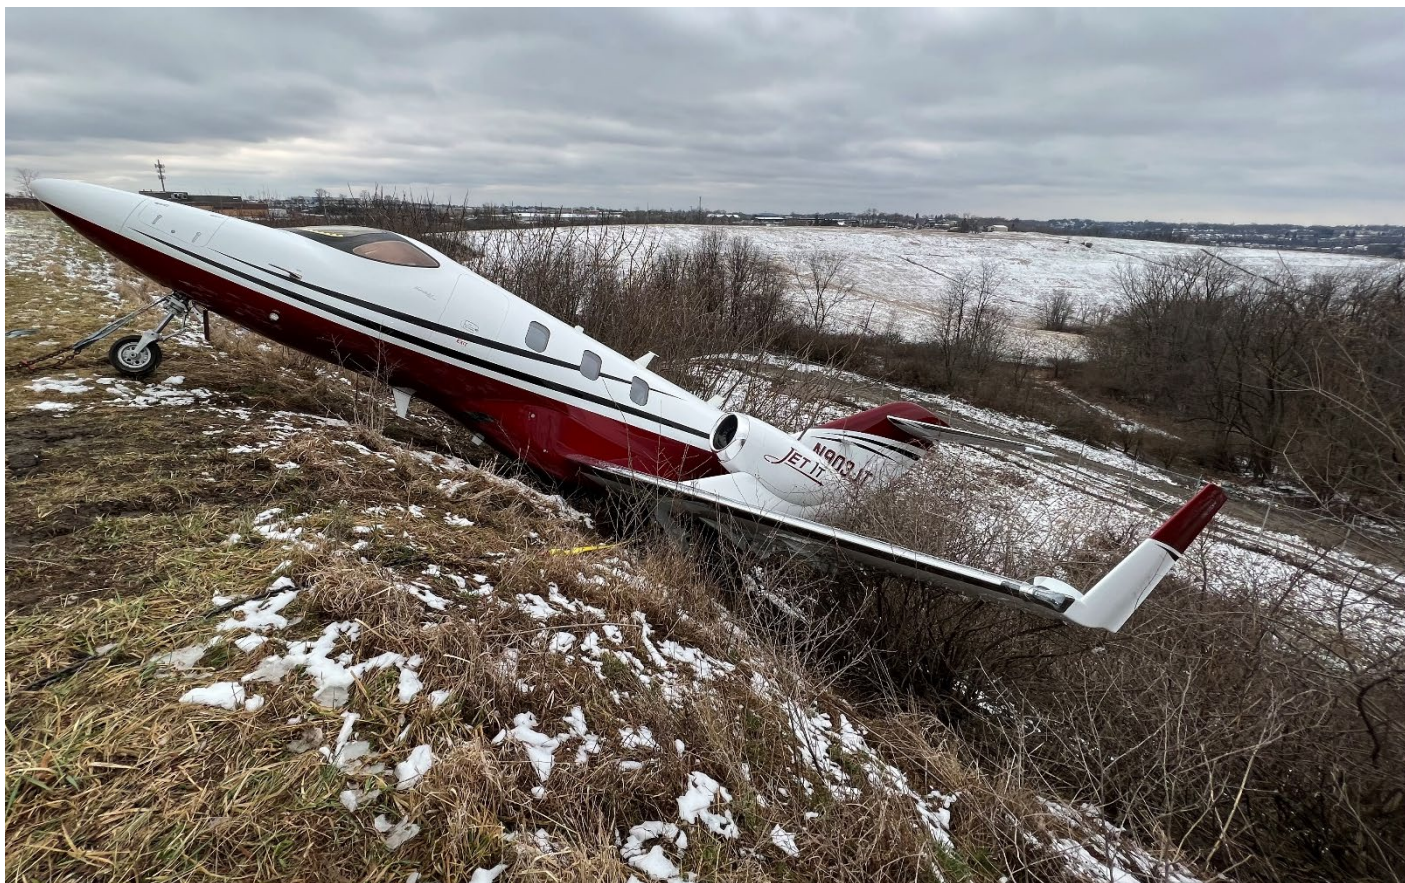
**Photograph 3 - View of airplane from right before recovery. (Courtesy of Honda Jet)**

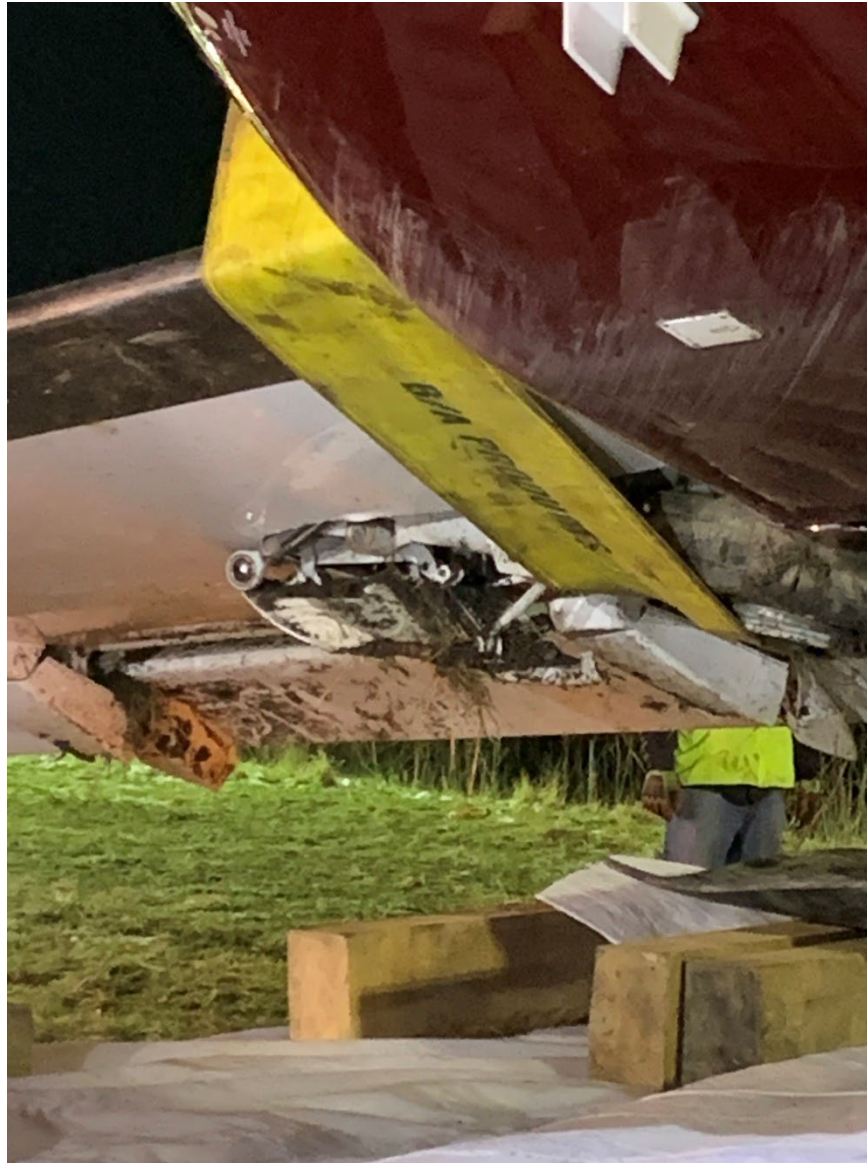
**Photograph 4 - View of lower fuselage and wing damage. (Courtesy of FAA)**

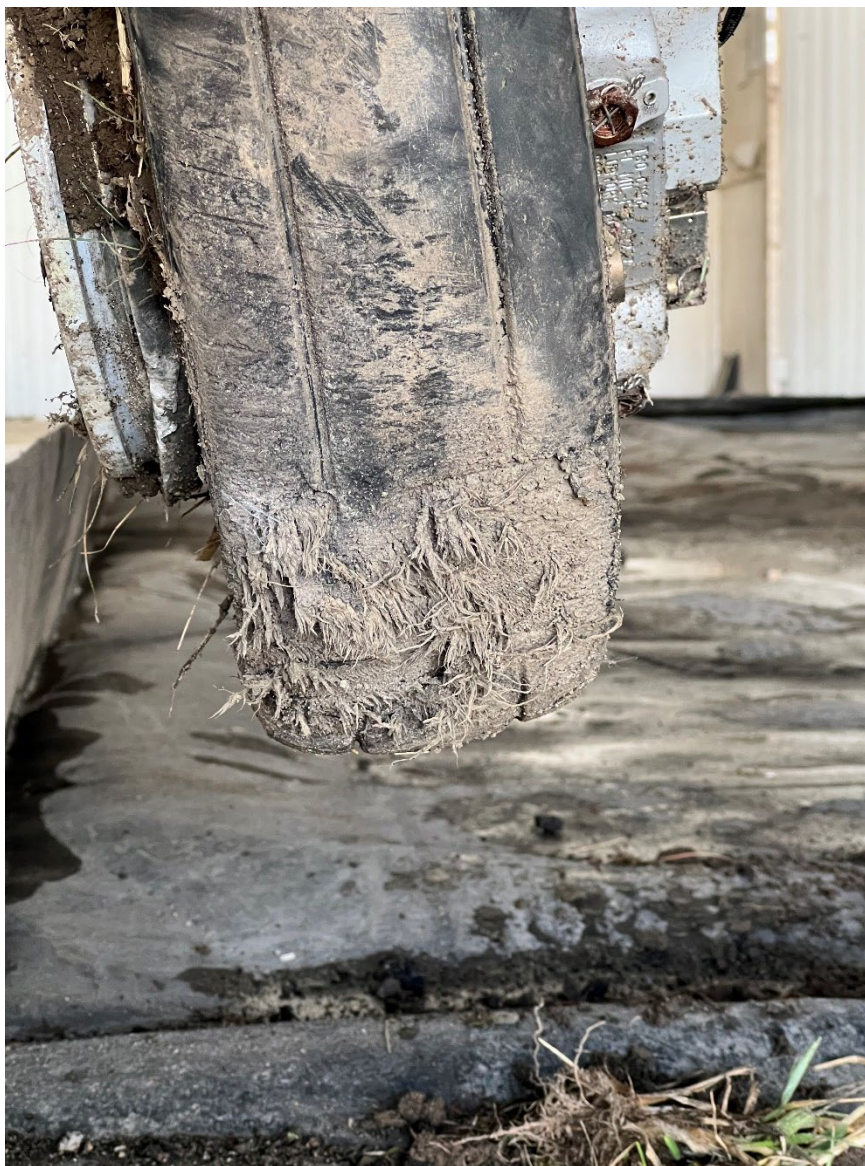
**Photograph 5 - View of right main landing gear tire. (Courtesy of HondaJet)**

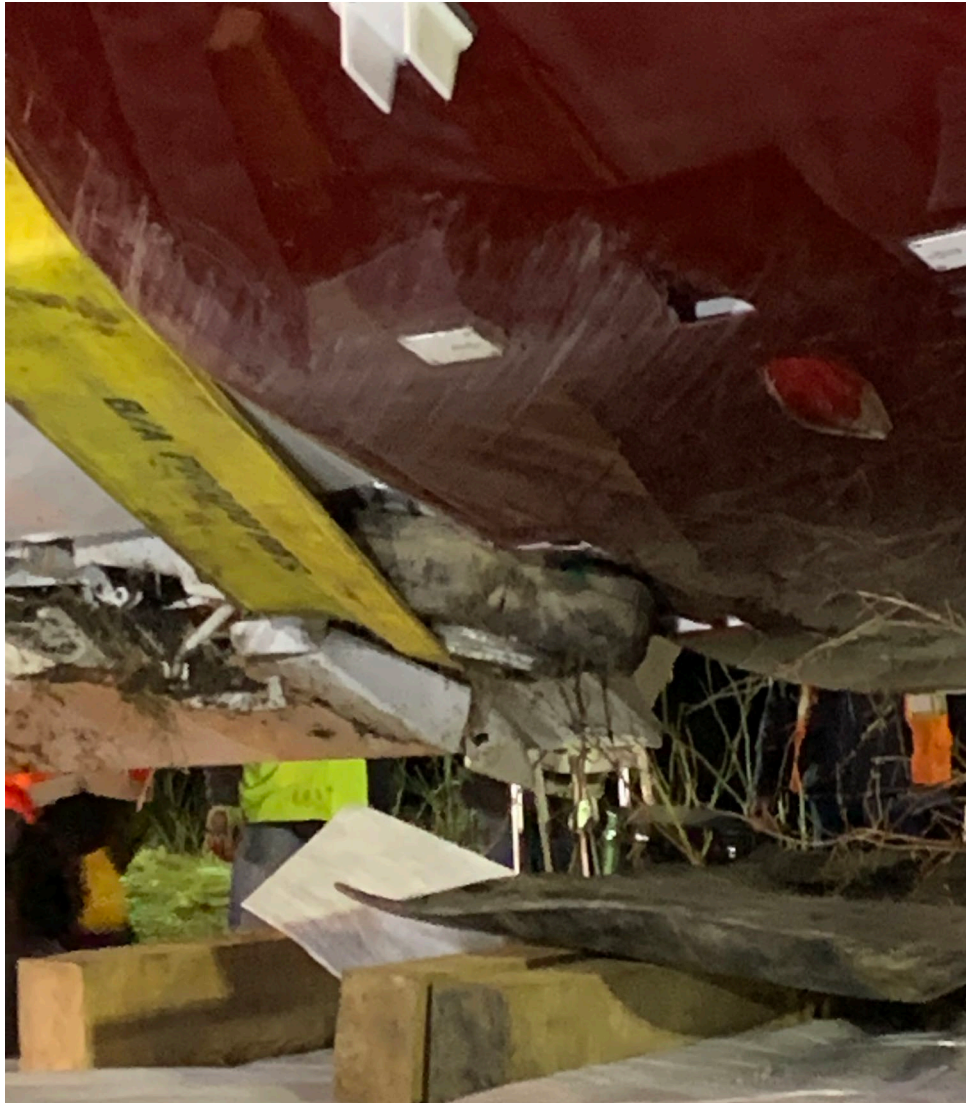
**Photograph 6 - View of impact damage as viewed at recovery. (Courtesy of FAA)**

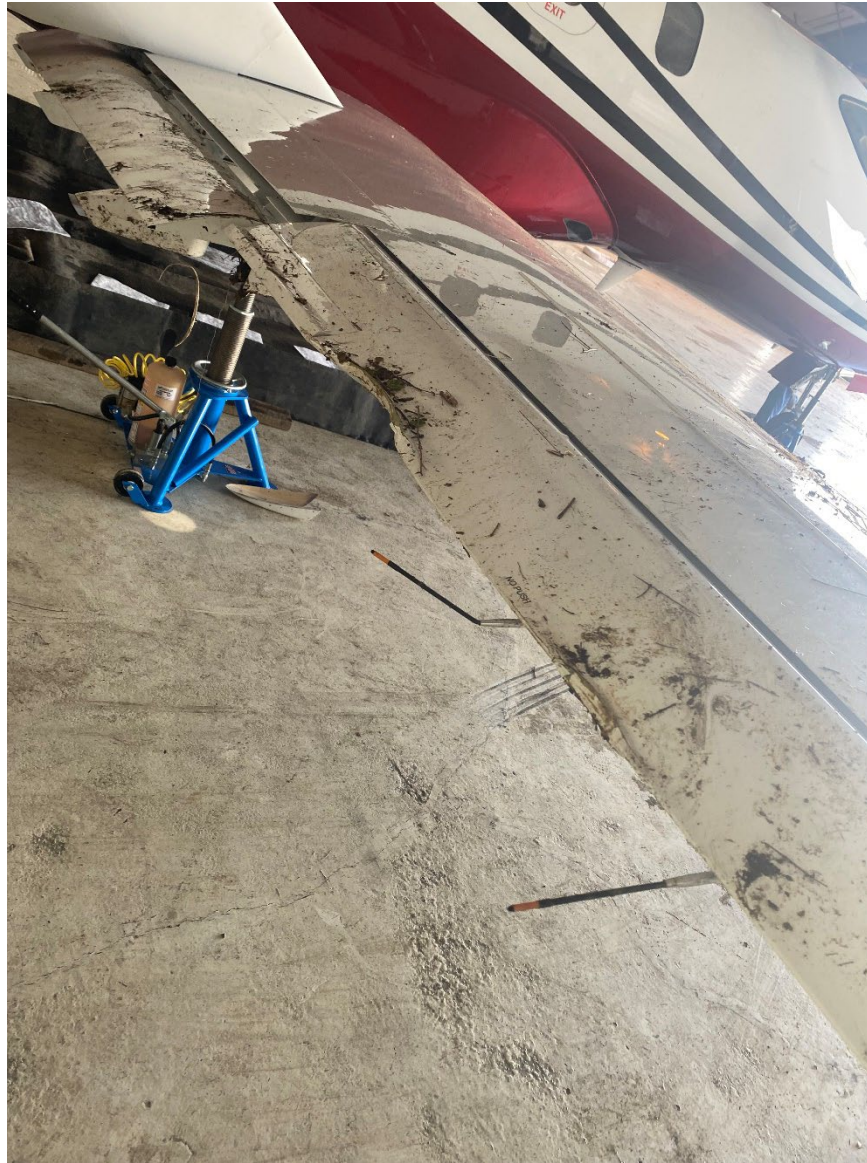
**Photograph 7 - View of right aileron damage. (Courtesy of Airport Manager)**

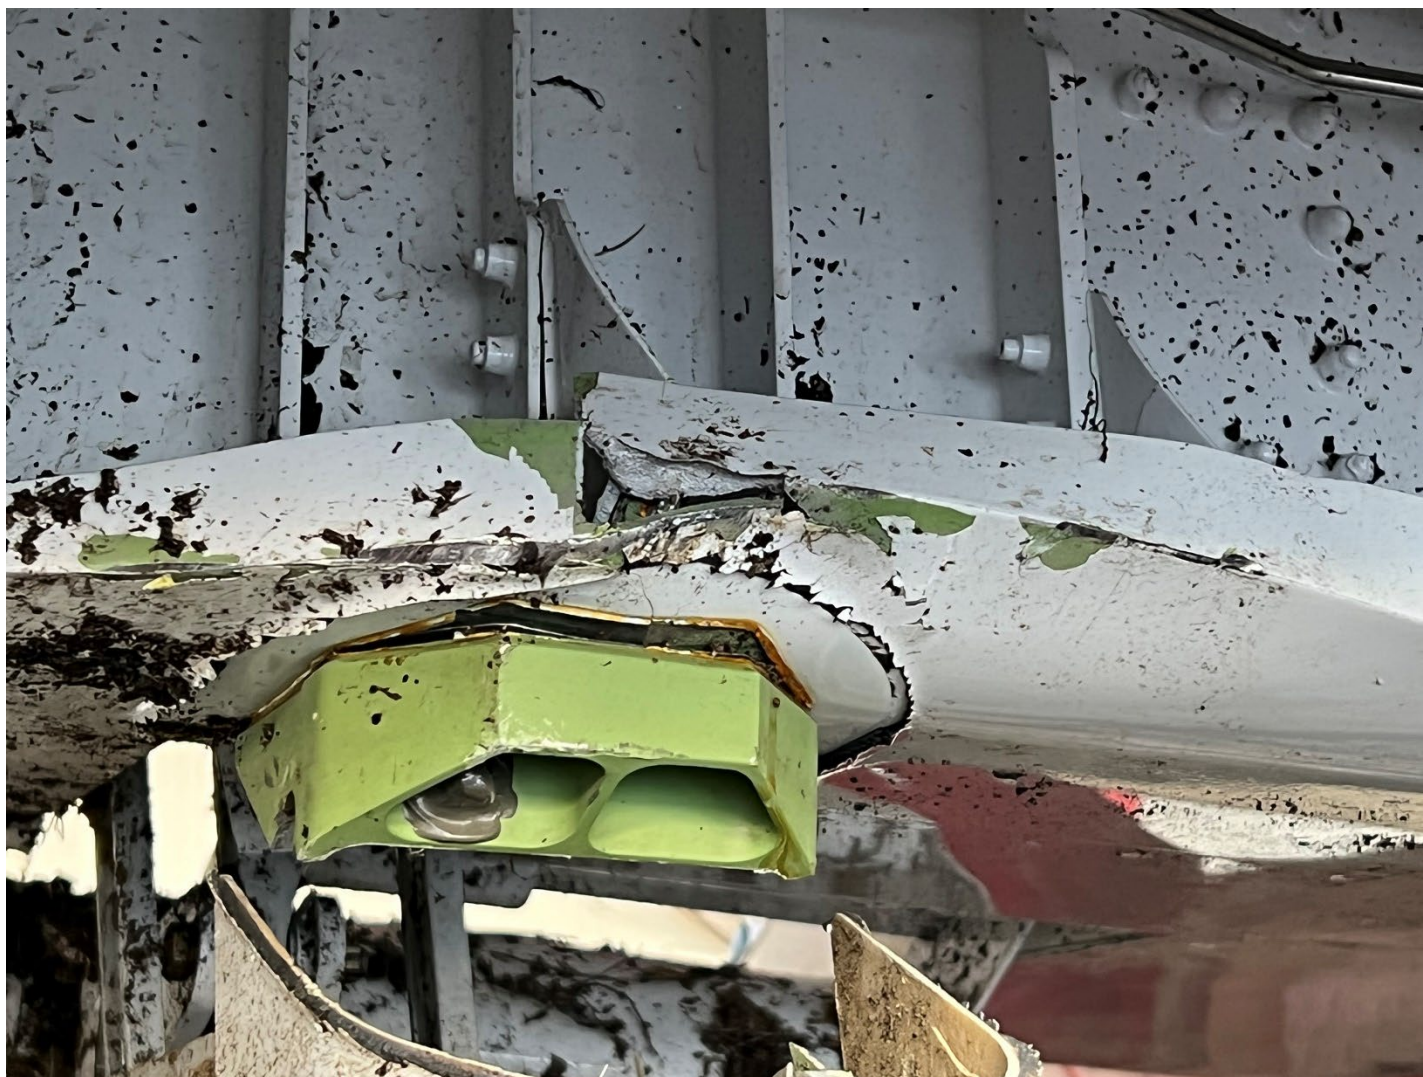
**Photograph 8 - View of damage above left main landing gear. (Courtesy of HondaJet)**
