# National Transportation Safety Board

ERA22LA150

## COCKPIT VOICE RECORDER

Specialist's Factual Report

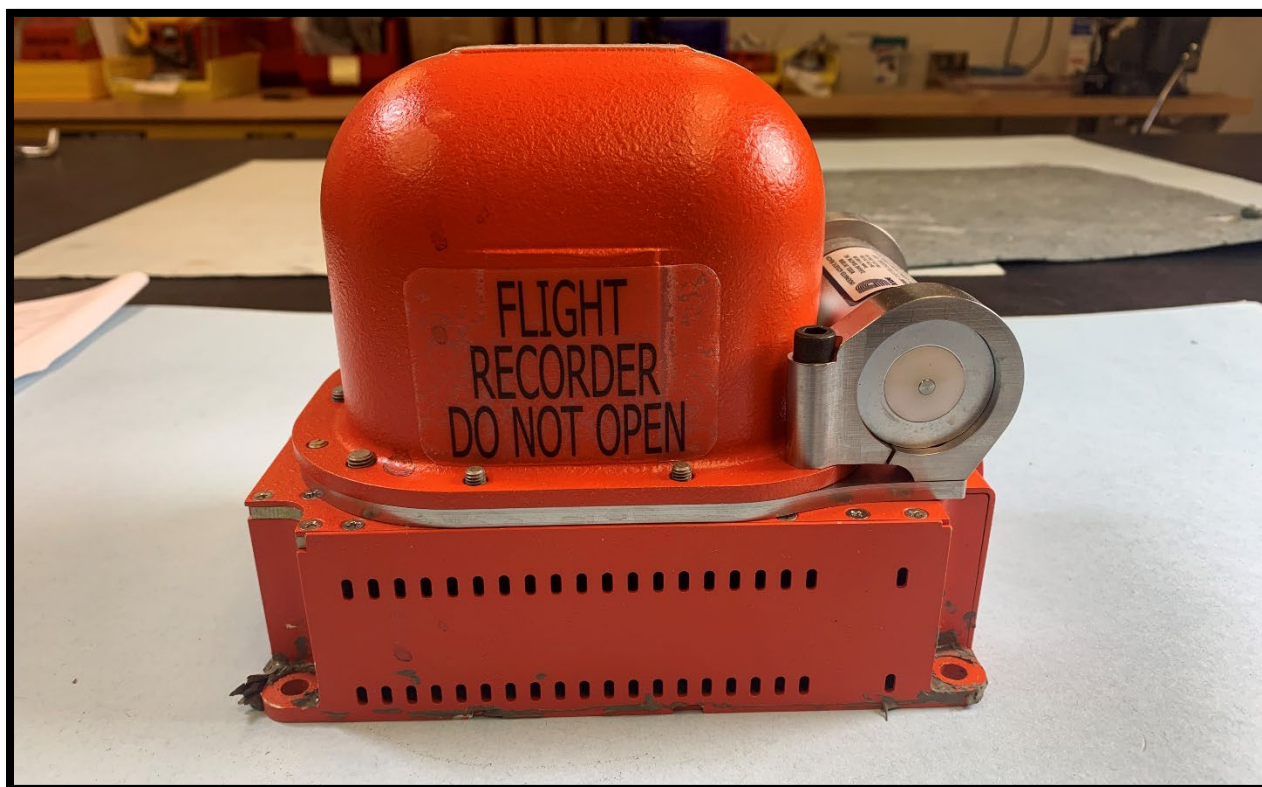
Upon arrival at the laboratory, it was evident that the CVR had not sustained any heat or structural damage, and the audio information was extracted from the recorder normally, without difficulty.

**Figure 1.** CVR, as received.
