## **MEMORANDUM FOR RECORD**

Investigative Photographs  
ERA22LA151

**Peter Wentz**  
**Air Safety Investigator**  
**Eastern Region Aviation**

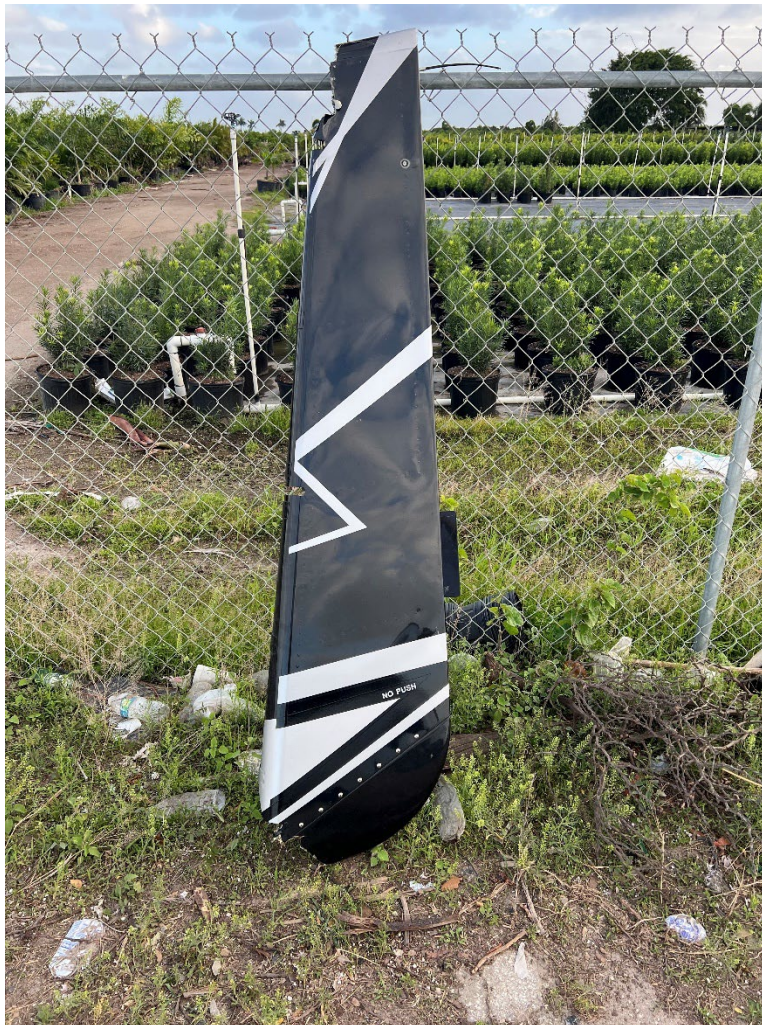
**Photograph 1 – SR-22 separated rudder.**

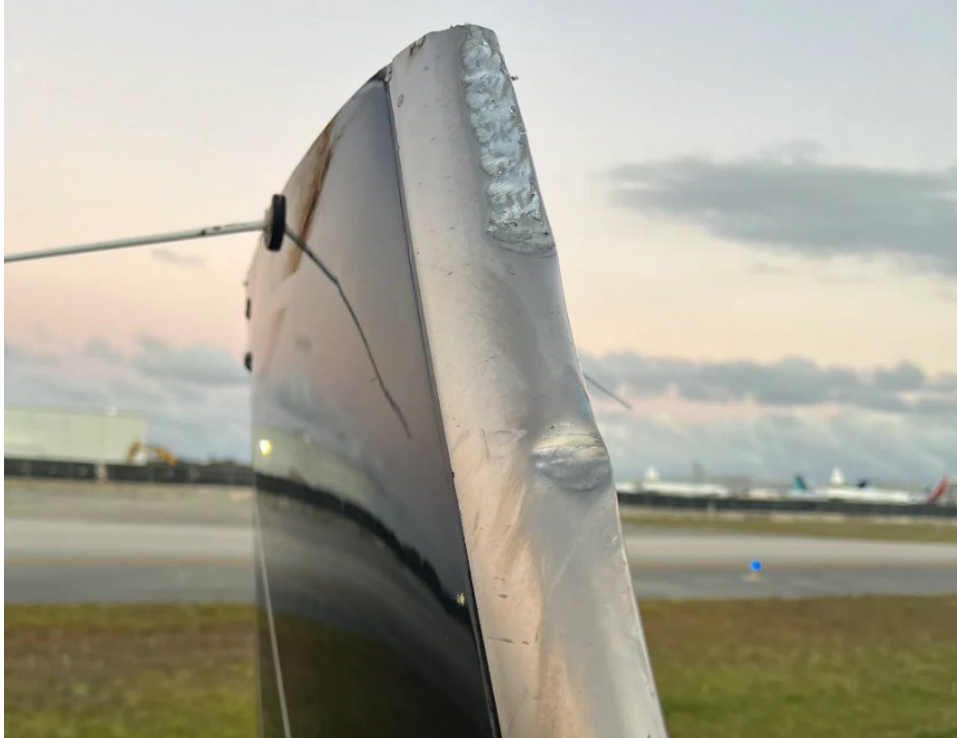
**Photograph 2 – SR-22 vertical stabilizer damage.**

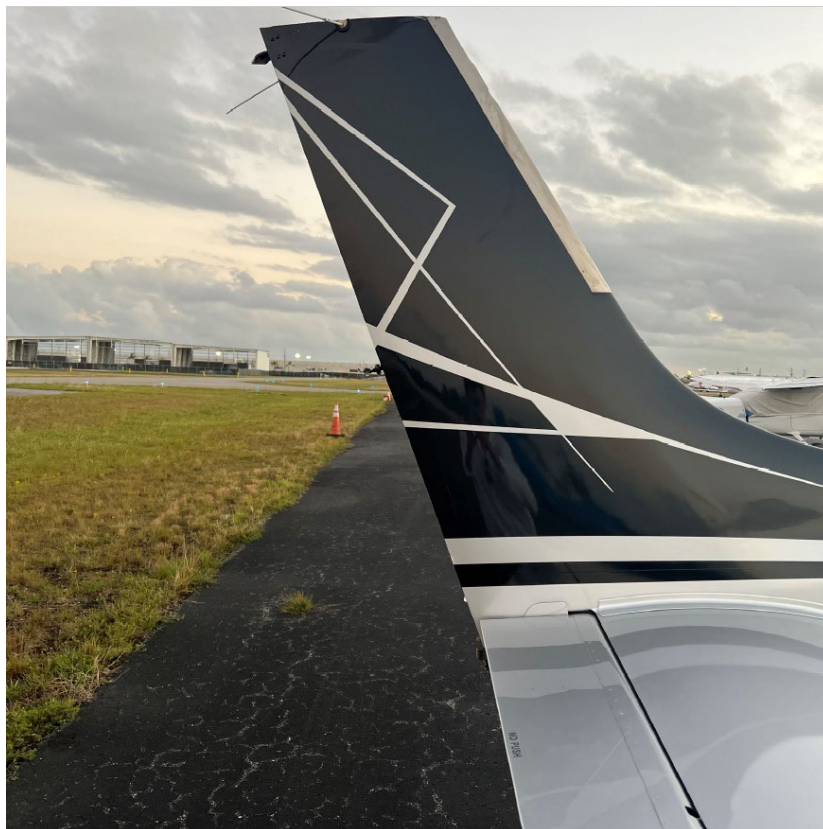
**Photograph 3 – SR-22 vertical stabilizer with missing rudder.**

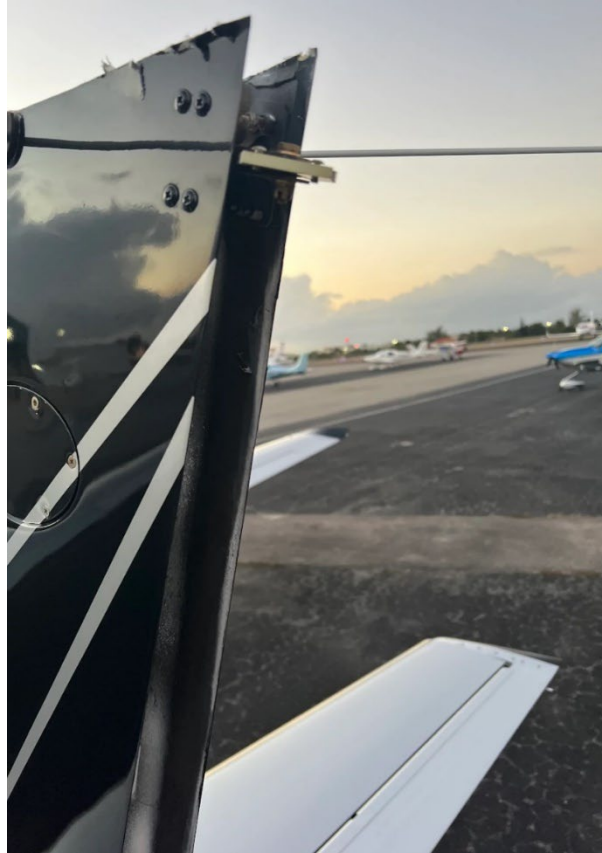
**Photograph 4 – SR-22 rudder attach point (top).**

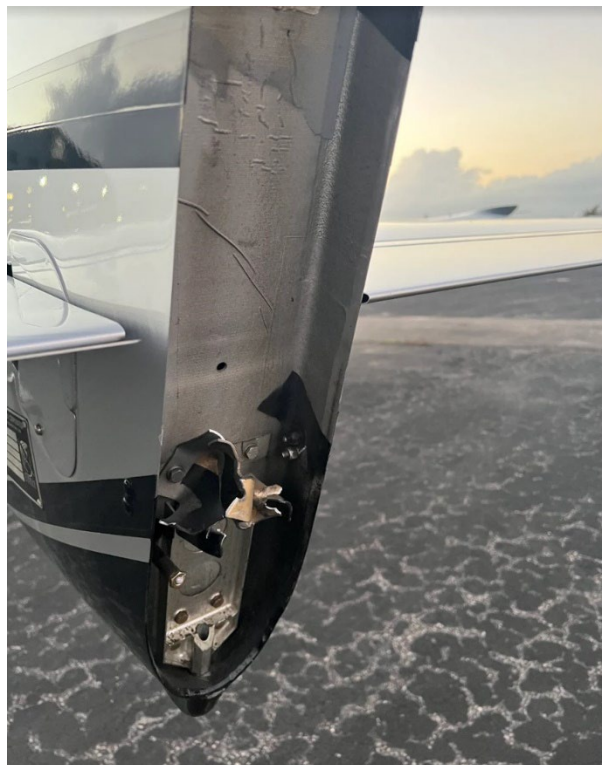
**Photograph 5 – SR-22 rudder attach point (bottom).**
