# National Transportation Safety Board

ERA22LA159

## **MATERIALS LABORATORY**

Factual Report 22-091

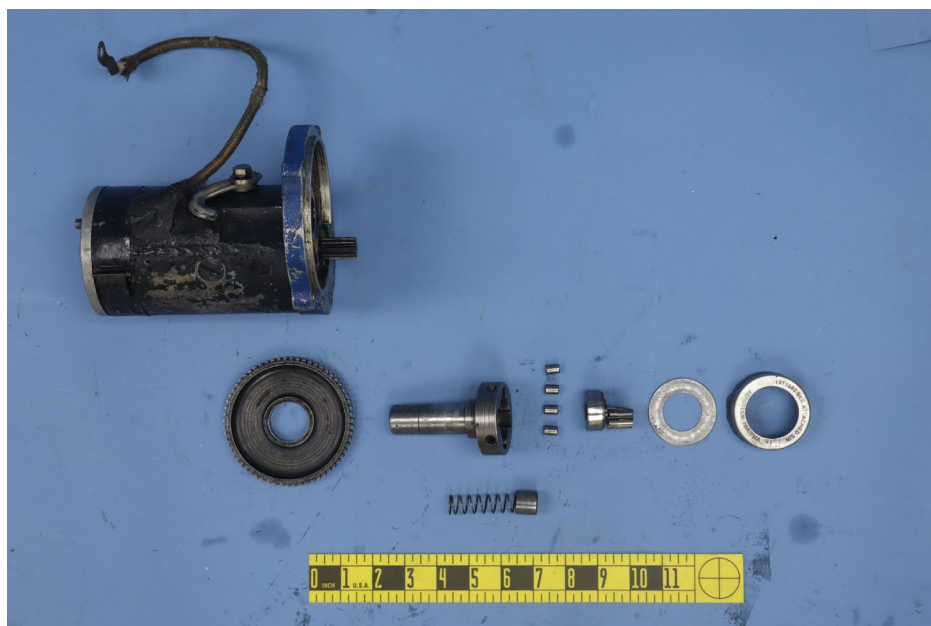
Starter motor with clutch assembly and fractured pinion gear (Figure 1)

**Figure 1.** Starter motor and clutch assembly components as received.

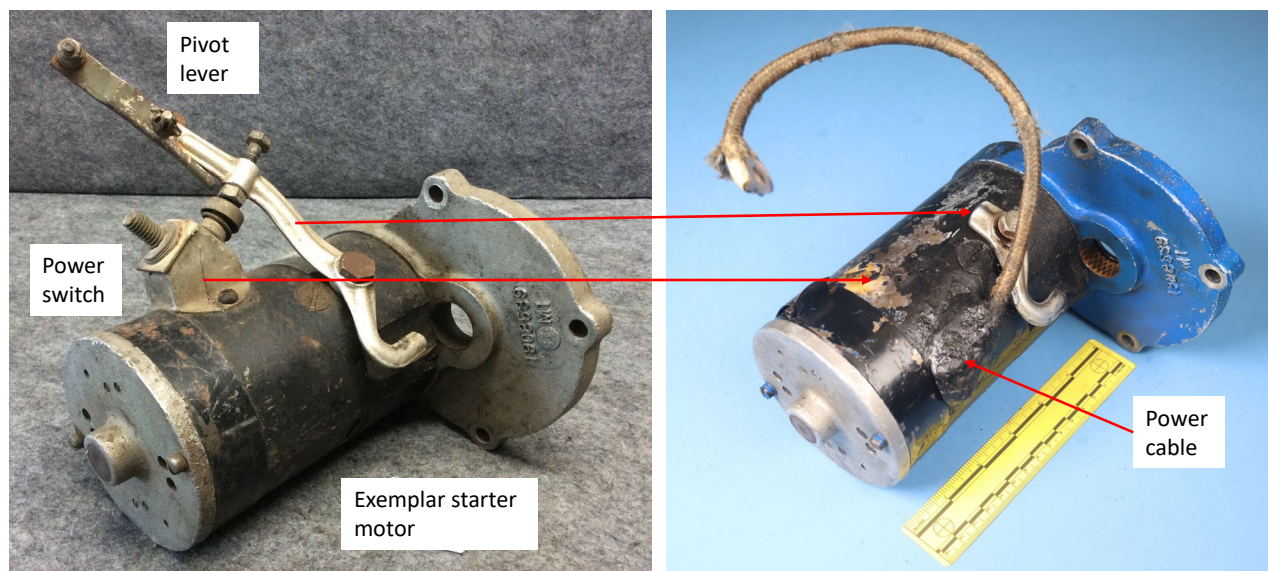
A starter motor with a clutch assembly and fractured pinion gear were submitted for examination. The starter motor exhibited modifications that deviated from the original design. These modifications included a missing starter motor power switch, a shortened pivot lever and a relocated power cable (Figure 2). It is unclear how this starter motor was being used without the pivot lever and power switch. The pivot lever controls the inward motion of the clutch and pinion gear and activates the power switch once the pinion gear and crankshaft gear are properly engaged.

**Figure 2.** Deviations from original design. Exemplar on the left, incident starter on the right.

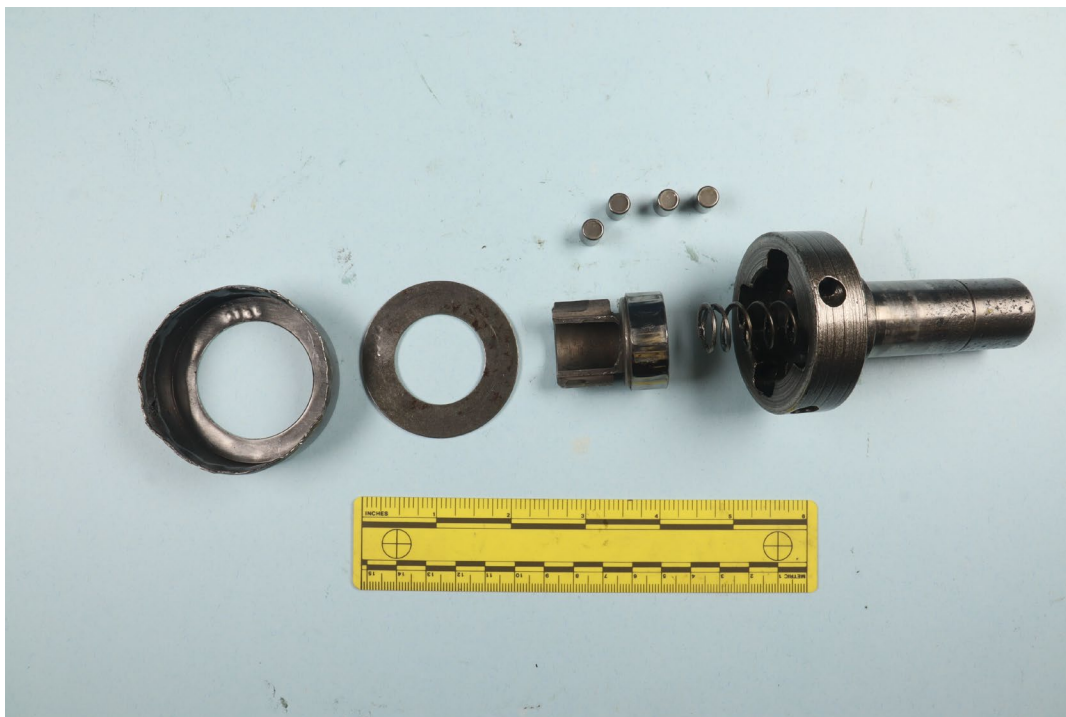
**Figure 3.** Clutch assembly components.

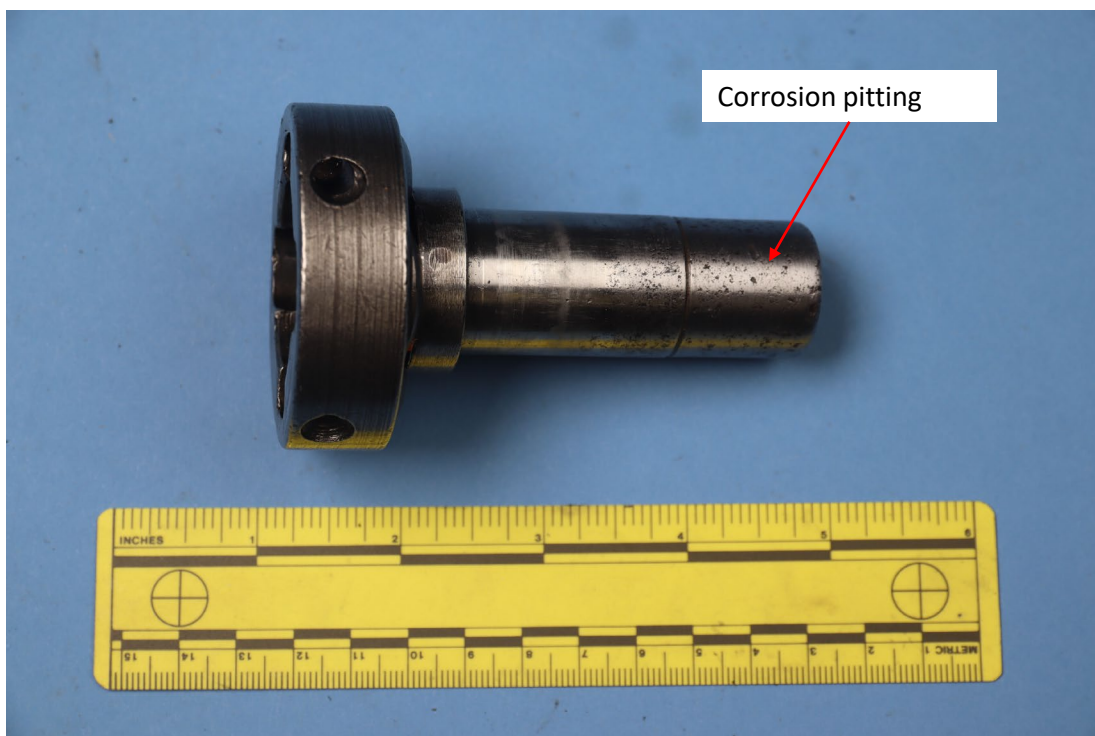
The clutch assembly (Figure 3) consisted of an overriding type of clutch mechanism. The clutch carrier would move the pinion gear forward to mesh with the crankshaft gear under the force of the pinion lever. The clutch carrier body exhibited corrosion pitting on the shaft portion (Figure 4) and deformation and raised burrs on the bearing pockets of the clutch carrier head (Figure 5) where the pinion gear would be held. The head and shaft portions of the clutch carrier body were off axis by approximately 0.015 inch.

**Figure 4.** Clutch carrier body exhibiting corrosion pitting on the shank.

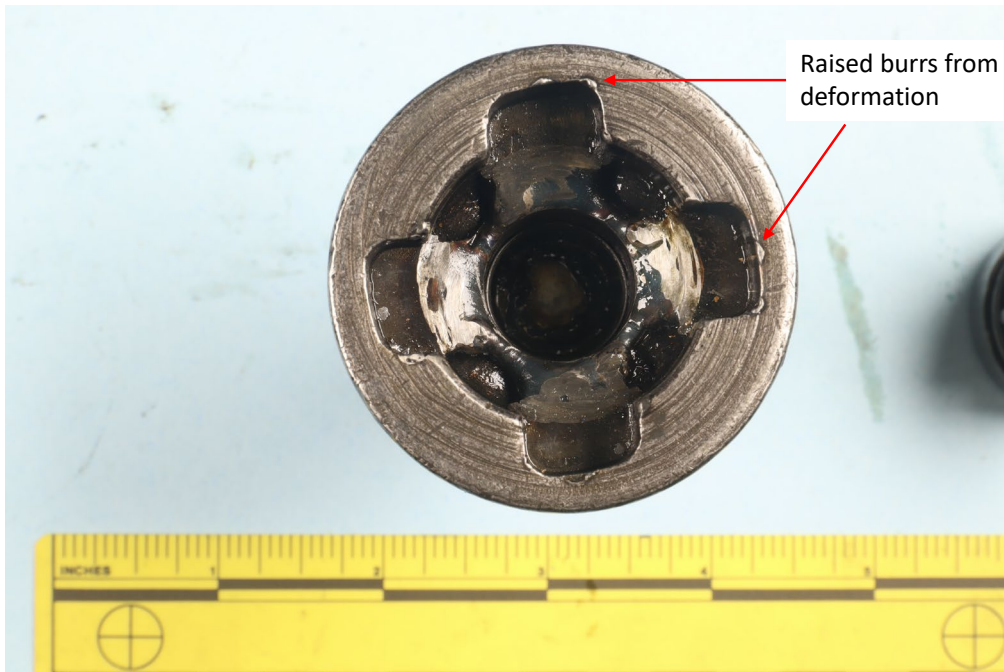
**Figure 5.** Clutch carrier body exhibiting raised burrs on the bearing pockets.

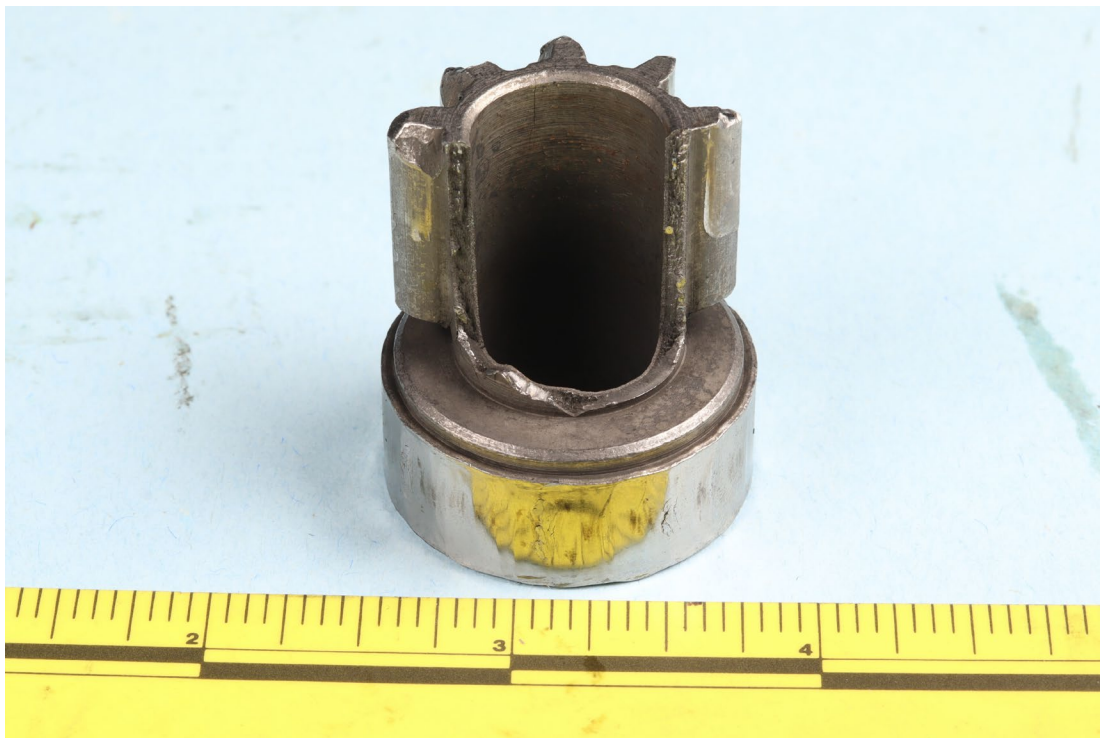
The pinion gear was fractured with approximately half of the gear teeth still present (Figure 6). The teeth that were still present exhibited fractured edges and indentations from the crankshaft gear. The indentations from the crankshaft gear teeth onto the pinion gear teeth exhibited only partial depth of engagement. The fracture surface of the missing portion of the pinion gear was consistent with overstress. The bearing race at the base of the pinion gear exhibited brinelling and case cracking (Figure 7). The damage to the pinion gear was not consistent with a sudden failure but instead the result of prolonged abuse.

**Figure 6.** Pinion gear with missing portion of gear teeth and overstress fracture.

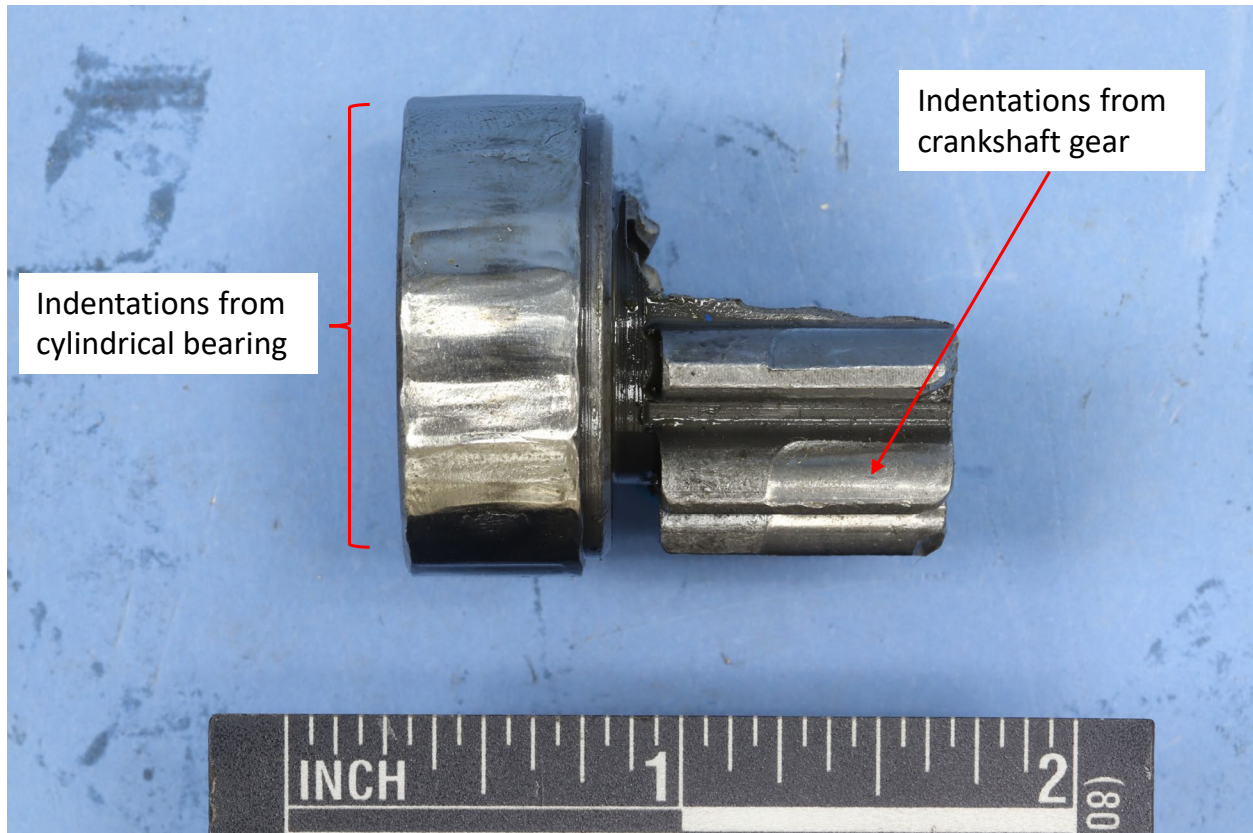
**Figure 7.** Pinion gear bearing race exhibiting indentations and case cracking from brinelling.
