# National Transportation Safety Board

ERA22LA167

## **MATERIALS LABORATORY**

Specialist's Factual Report 22-073

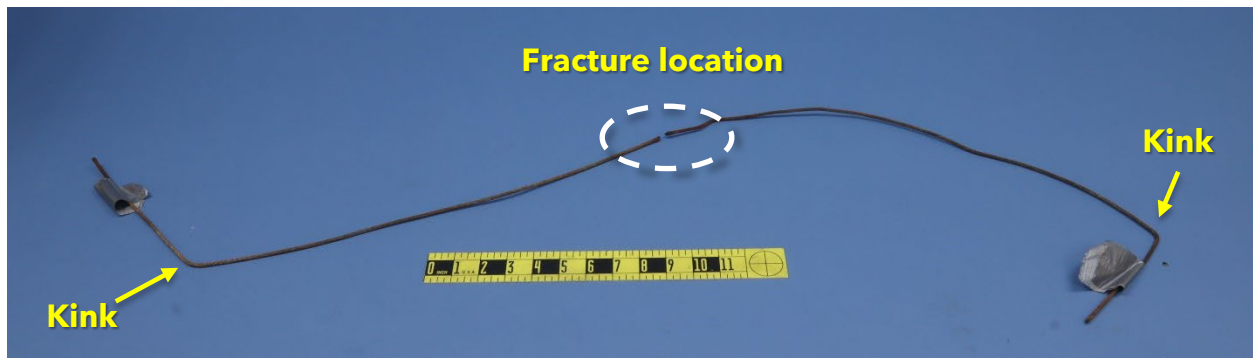
Figure 1 shows the two remnants of the aileron cable, as received. For the purposes of this report, the cable remnants were labeled as 'left' and 'right' side remnants. The left side remnant was measured as 25.5 inches in length, and the right side one was 24.75 inches in length. Each cable remnant exhibited an approximately 90° kink, as labeled in Figure 1. The kink was located approximately 17.5 inches from the fracture on the left side, and 13.5 from the fractures on the right side.

**Figure 1.** The two remnants of the fractured aileron cable, positioned with the fracture surfaces facing each other.

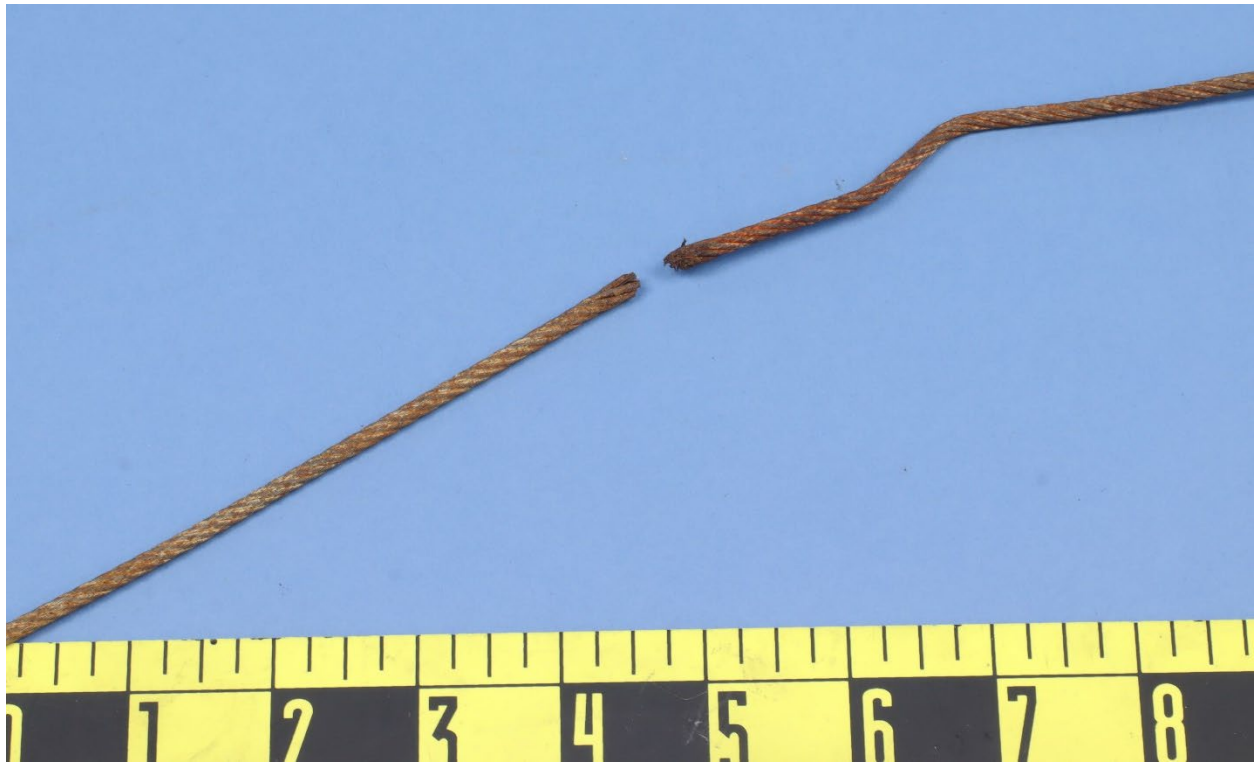
The mating sides of the cable fracture surfaces are shown in Figure 2 and Figure 3. As shown in these figures, the general orientation of the strand fractures was flat, with some of the wires in the strands having tapered to a flat point. There was little macroscopic difference in the locations of the individual wire fractures. Also, as shown in the figures, the surfaces of the cable wires exhibited a reddish-brown or

**Figure 2.** Closer view of the fractured region of the aileron cable.

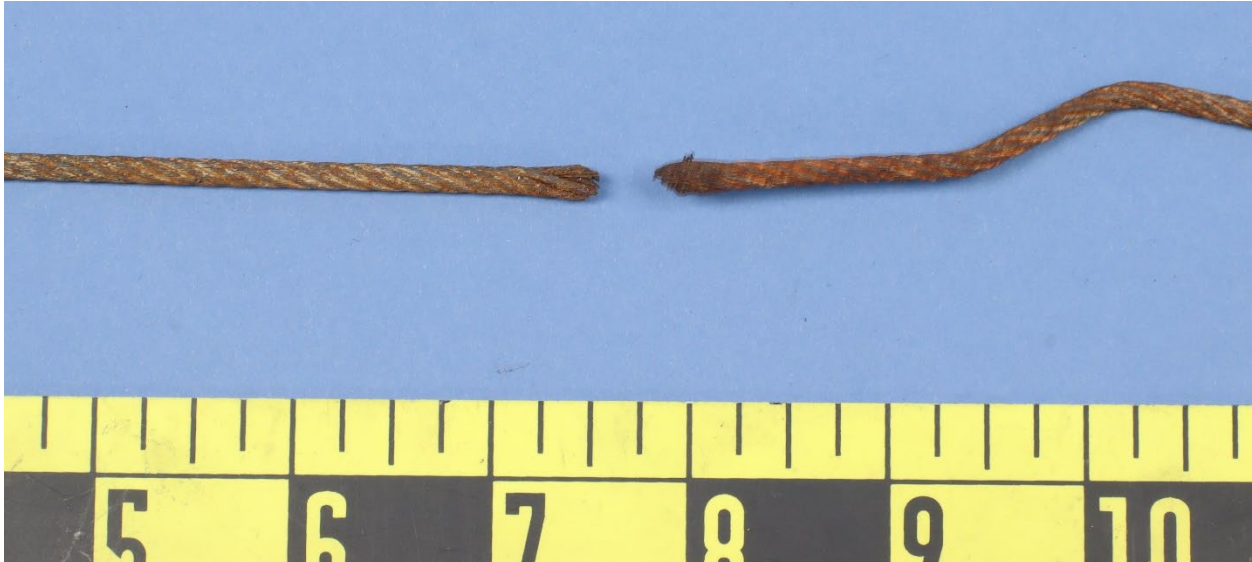
**Figure 3.** View of the fractured aileron cable ends, positioned to face each other, as received.

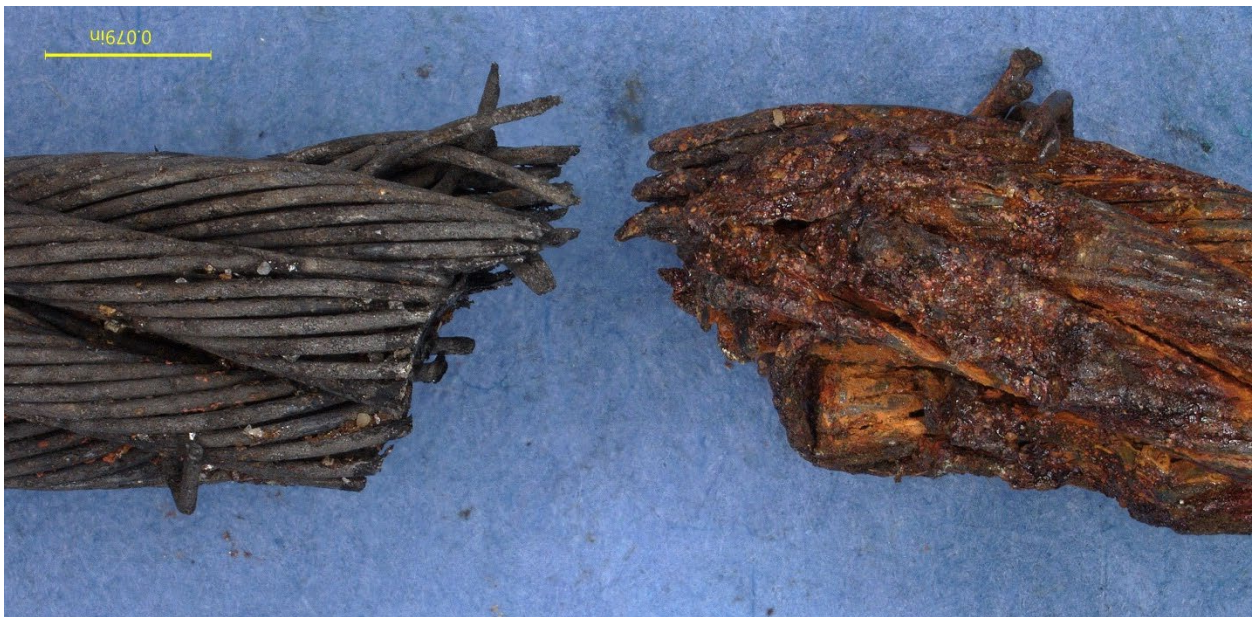
maroon hue, with indications of flaky compounds. This surface material was consistent with rust or surface iron oxides, exemplified on the right side of Figure 4.

To examine the cables and the underlying fracture surfaces, the cable remnants were sectioned approximately 2 inches from their fracture surfaces. The sections with the fracture surfaces were then sequentially and repeatedly cleaned in an ultrasonic bath with an Evapo-Rust solution.<sup>1</sup> This cleaning procedure slowly removed the surface oxidation, as exemplified in Figure 4.

During the repeated cleaning process, the morphology of the cable fracture surfaces was revealed, as shown in Figures 4 and 5. Each fracture exhibited a slanted morphology on one side, with frayed and fractured wires on the other. The cable arrangement was consistent with a six-strand cable with a core strand. Two of the strands exhibited wire pullout and local elongation, whereas the rest exhibited a slanted or angled orientation. The fracture surfaces mated as illustrated in Figures 4 and 5, with the elongated and frayed wire strands mating, and the angled strands forming a V-shaped gap.

**Figure 4.** The fractured ends of the left cable remnant (left side, post-cleaning) and the right cable remnant (right side, as-received).

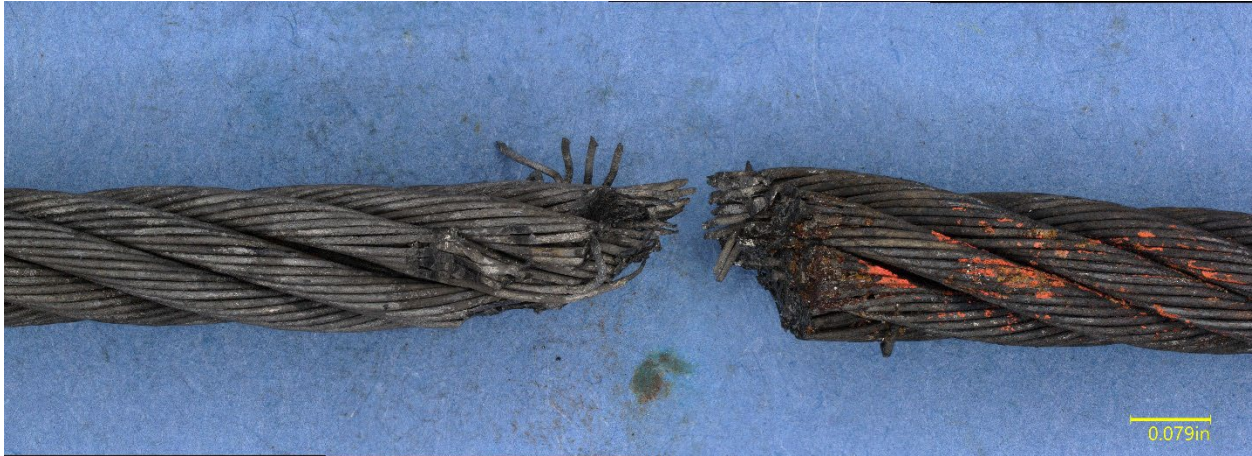
**Figure 5.** View of the fractured ends of the aileron cable, positioned in the location consistent at fracture, post-cleaning of both sides.

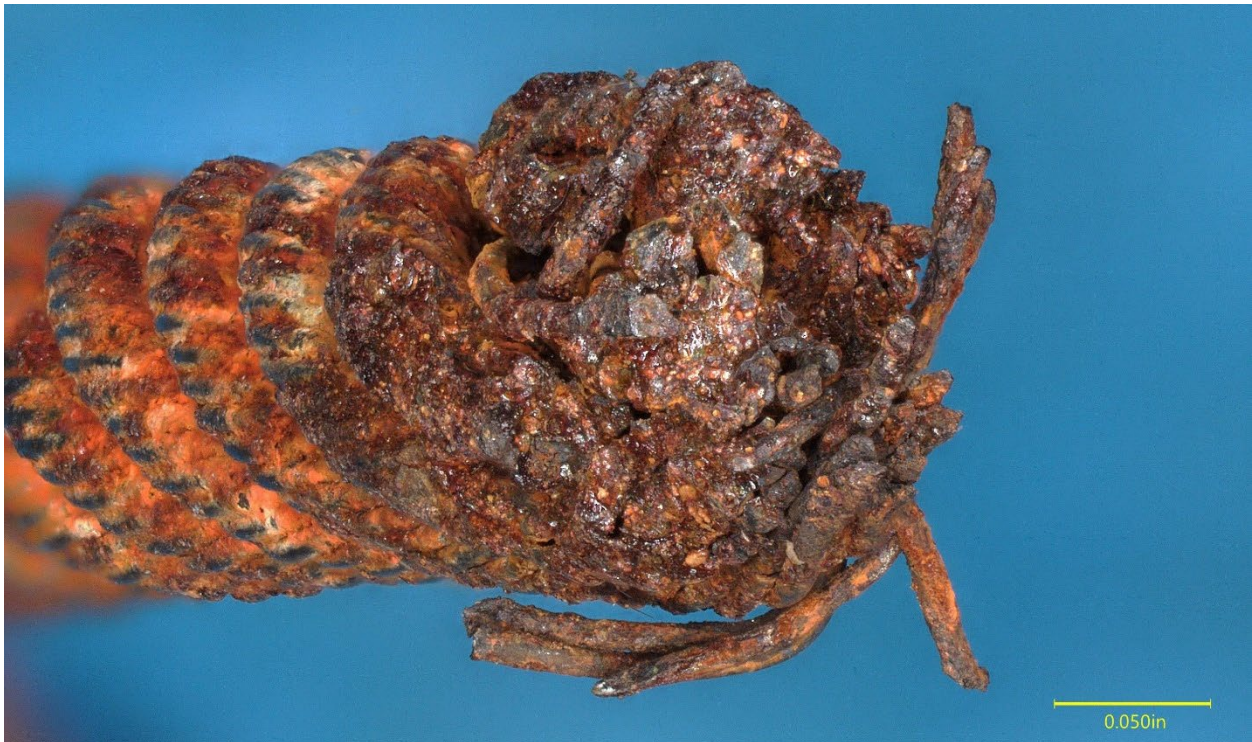
The fracture surfaces themselves were examined using optical microscopy and a field-emission scanning electron microscope (SEM). Figure 6 shows the as-received fracture surface of the right-side cable remnant. This surface exhibited enough surface oxidation to completely obscure most of the underlying features of the wires.

**Figure 6.** View of the right side cable remnant fracture surface, as received.

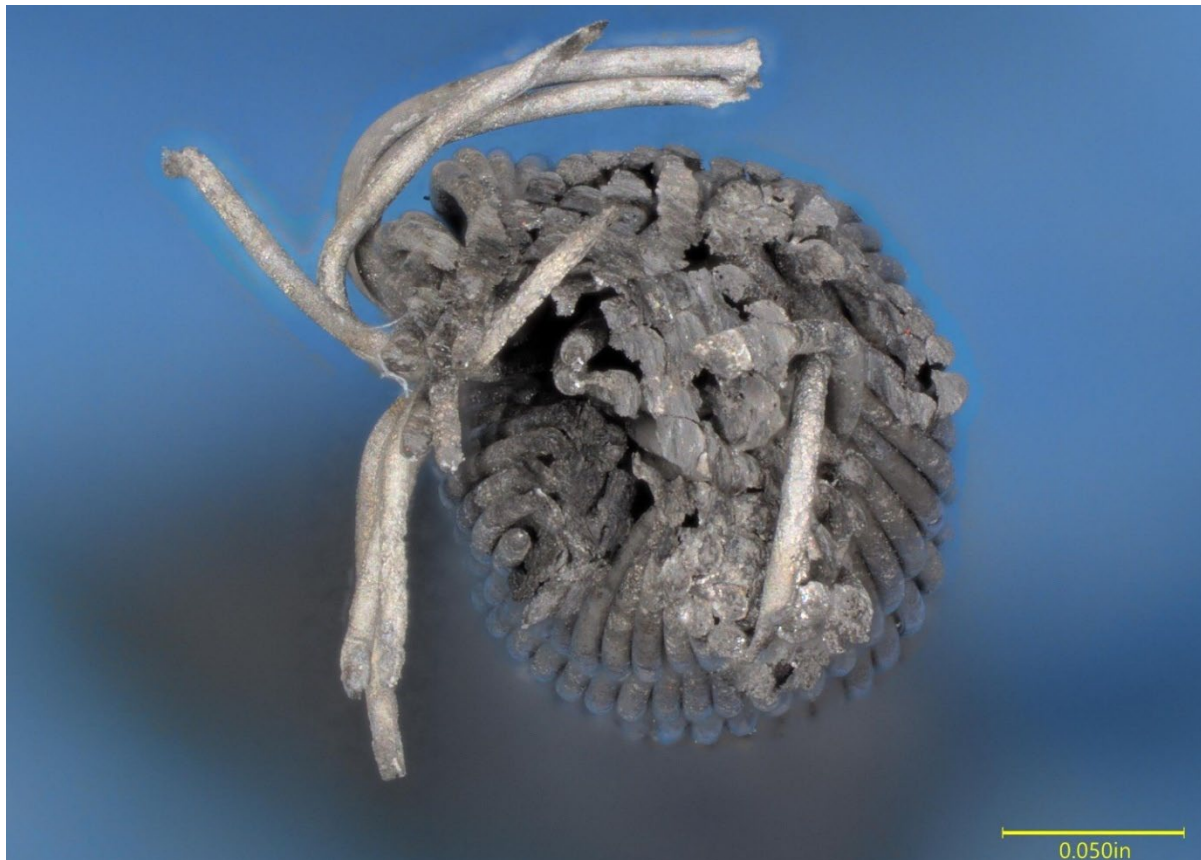
Figure 7 shows the right-side cable remnant fracture surface, after cleaning most of the surface oxidation compounds off the wires. This surface exhibited about 10 wires elongated past the fracture surface, exhibiting erratic deformation directions. These wires exhibited angled fracture surfaces, or localized necking near the fractures. Many of the other broken wires, particularly in the core and upper right of Figure 7, exhibited flat surfaces, with smearing or wear lines. The direction of these smearing lines was consistent across multiple wires, generally oriented in the vertical direction of Figure 7.

**Figure 7.** View of the right side cable remnant fracture surface, after cleaning.

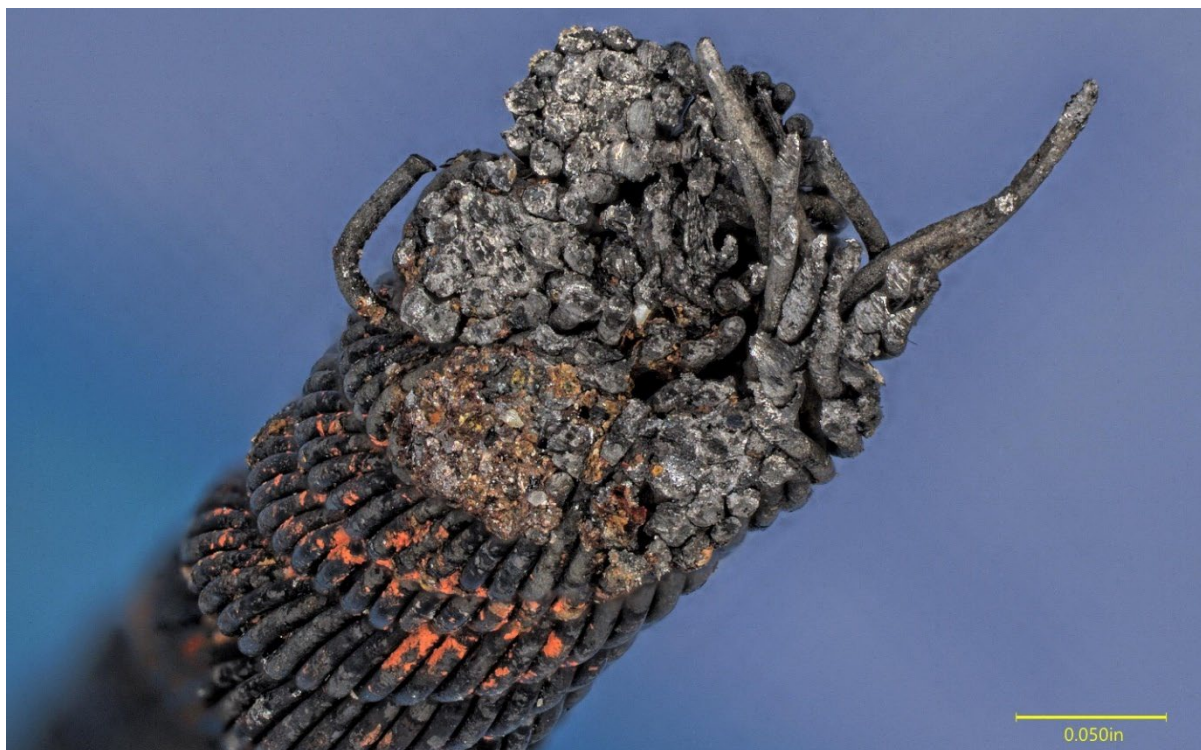
Figure 8 shows the mating left-side cable remnant fracture surface, after cleaning enough to remove some, but not all, of the surface oxidation. A flatter wire strand area in the lower left of the figure still contained some rust-colored compounds. The strands on the left exhibited consistent flat surfaces, though they were located about the still-corroded strand in the lower left. The wires in the strands on the upper right exhibited elongation and deformation, consistent with the mating wires on the right-side fracture surface illustrated in Figure 7.

The wires also exhibited a cylindrical surface layer, exhibiting a columnar grain structure where fractured. Figure 18 shows a closer view of some of this surface material, which had surrounded the center wire where it was not spalled. Examination of this layer using energy-dispersive x-ray spectroscopy (EDS) found it to be consistent with an iron oxide. These compounds appeared visually black in color, as shown on the sides in Figure 8.

**Figure 8.** View of the left side cable remnant fracture surface, after first cleaning.

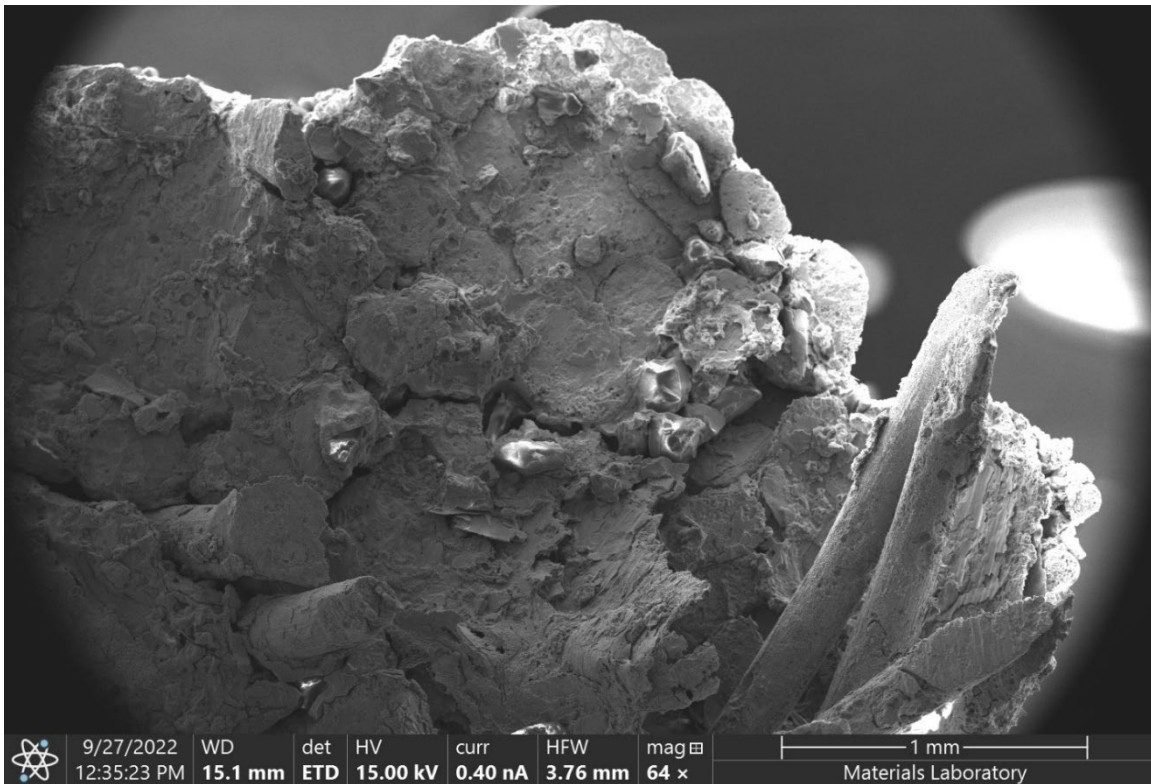
Figure 9 shows a closer view of the strand from the left-side cable fracture surface in Figure 8 when still covered in corrosion compounds, demonstrating the extent of the layering and compound intrusion between the individual wires. Figure 10 shows two of the strands with pulled out or elongated wires. Many of these fracture wires exhibited slanted fracture surfaces, with parallel streaks consistent with smearing and witness marks of wear.

**Figure 9.** Secondary electron (SE) micrograph of the flatter area of the cable fracture.

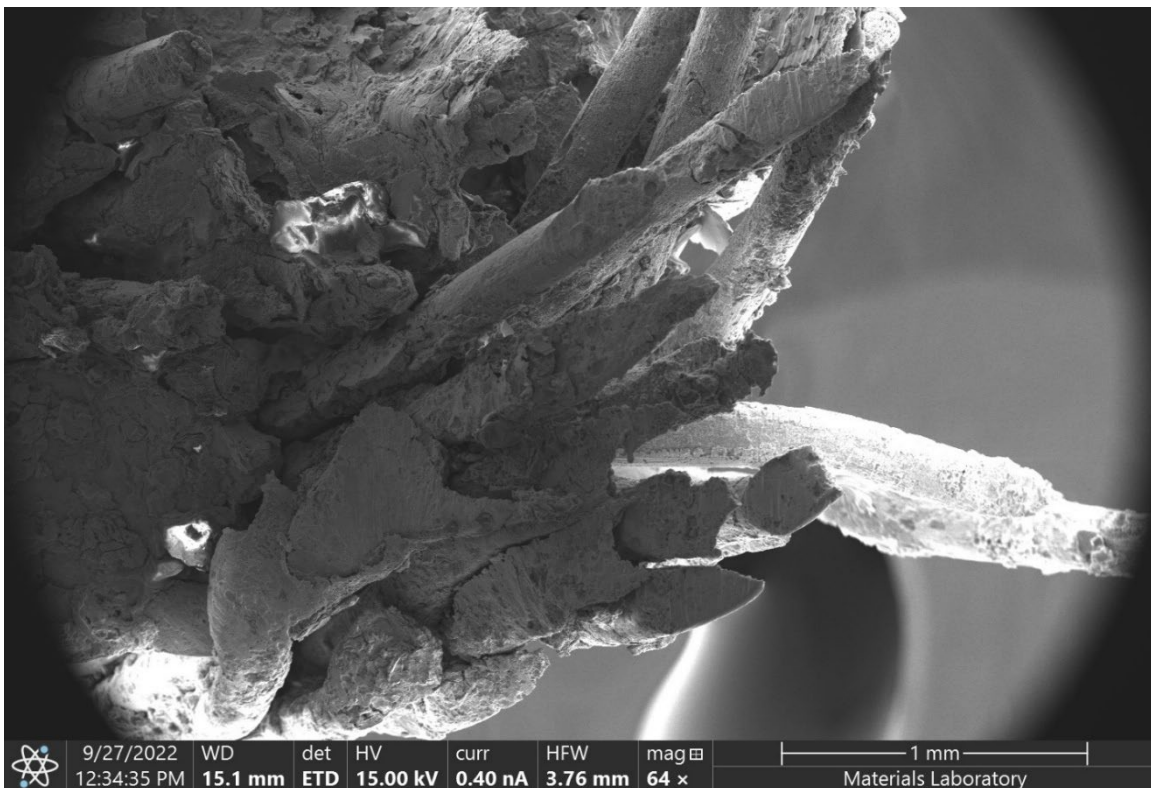
**Figure 10.** SE micrograph of the wire pullout area of the cable fracture.

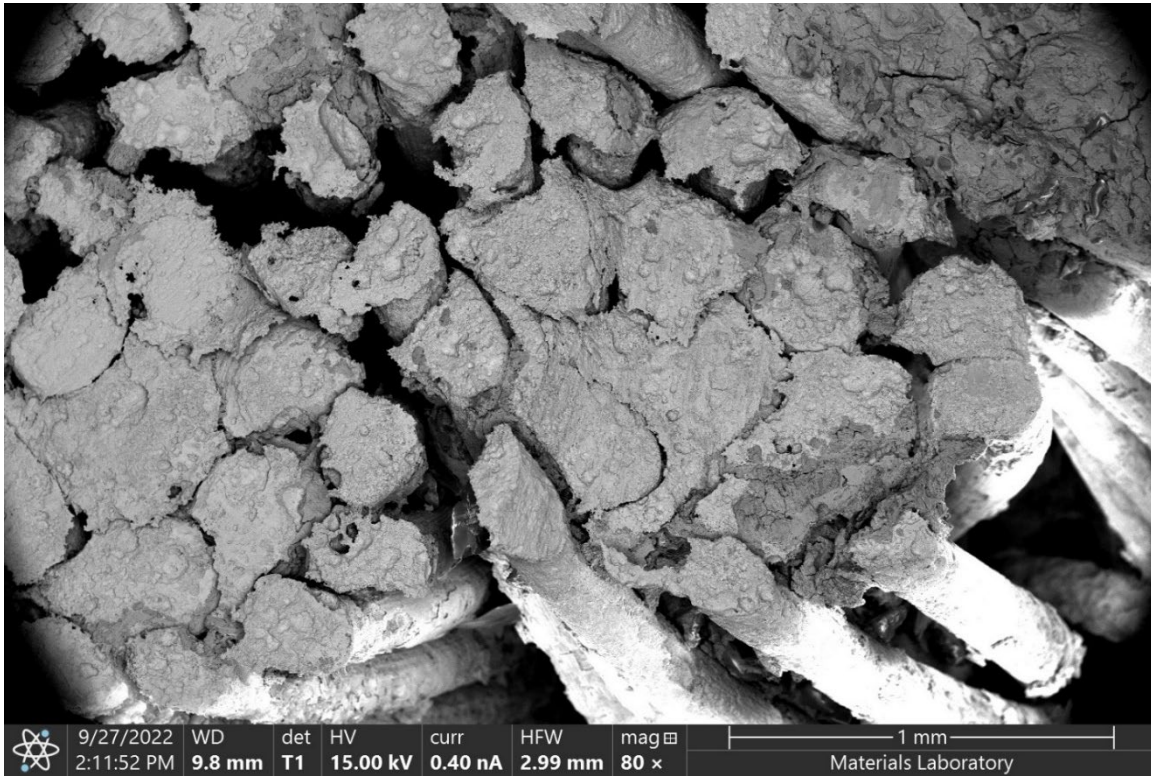
The left side fracture surface was cleaned repeatedly until almost all the surface oxidation was removed. Figure 11 shows a typical view of the flatter wires, after this process. Many of the wires exhibited pock-marked features and missing material, consistent with the remainder of the underlying metal material after removal of the surface corrosion compounds.

**Figure 11.** Backscattered electron (BE) micrograph of Figure 9, after successive cleaning.

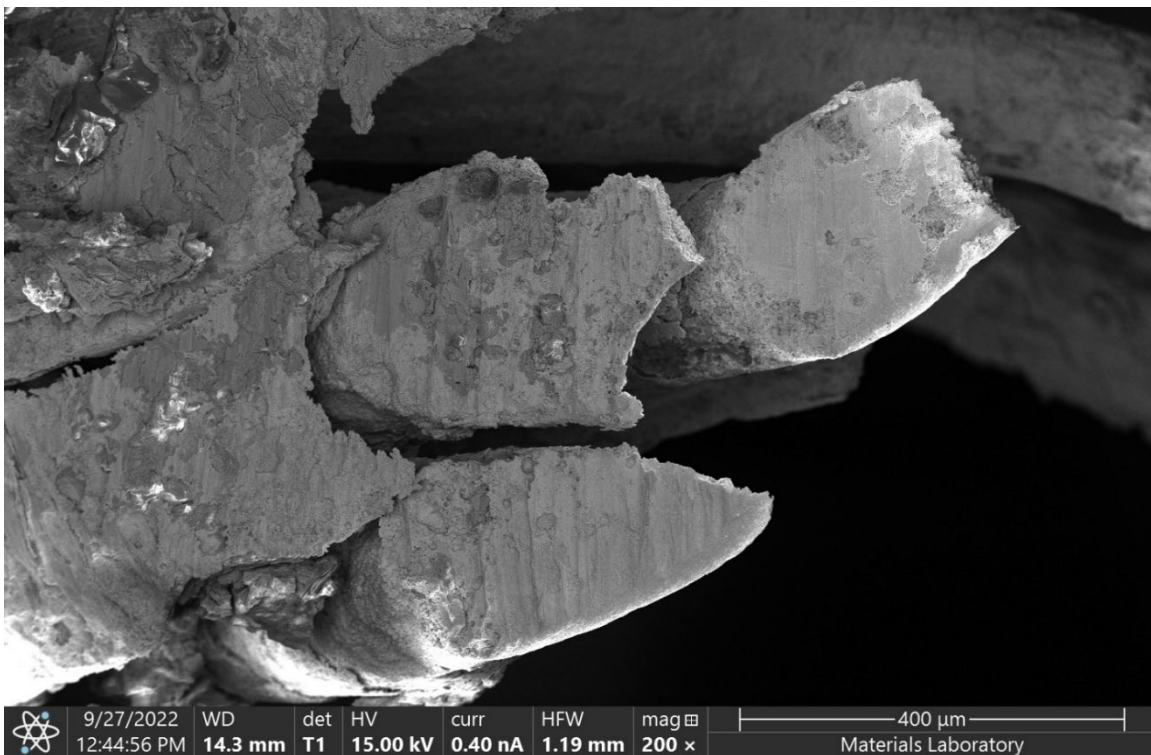
A closer view in Figure 12 shows a closer view of some of the flatter wires that had exhibited relatively less surface corrosion damage. These wires exhibited an angled and flat surface orientation, with parallel streaks, consistent across the adjacent wires. In Figure 12, these streaks were oriented vertically. In addition, there were areas of deformed and thinned material (on the right side of the wires in Figure 12).

**Figure 12.** BE micrograph of the wire surfaces of the flat cable strand region.

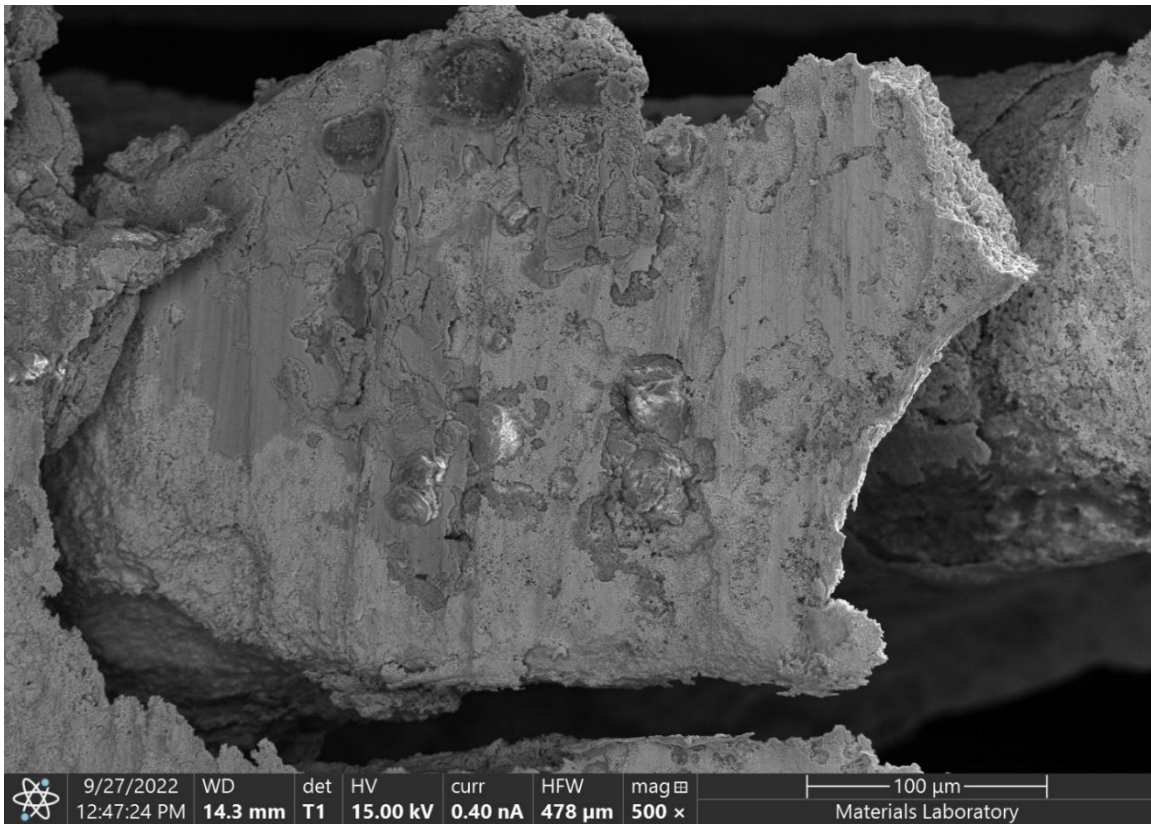
Figure 13 shows a closer view of one of these wires. While some of the surface material had been consumed by corrosion (and some corrosion products were still present, colored darker grey in backscattered electron mode), the parallel streaks were still present.<sup>2</sup> In addition, the deformed areas on the right exhibited rough features, consistent with the remainders of dimpled rupture—a feature consistent with overstress fracture of this localized area.

**Figure 13.** BE micrograph highlighting the surface of one wire in Figure 12.

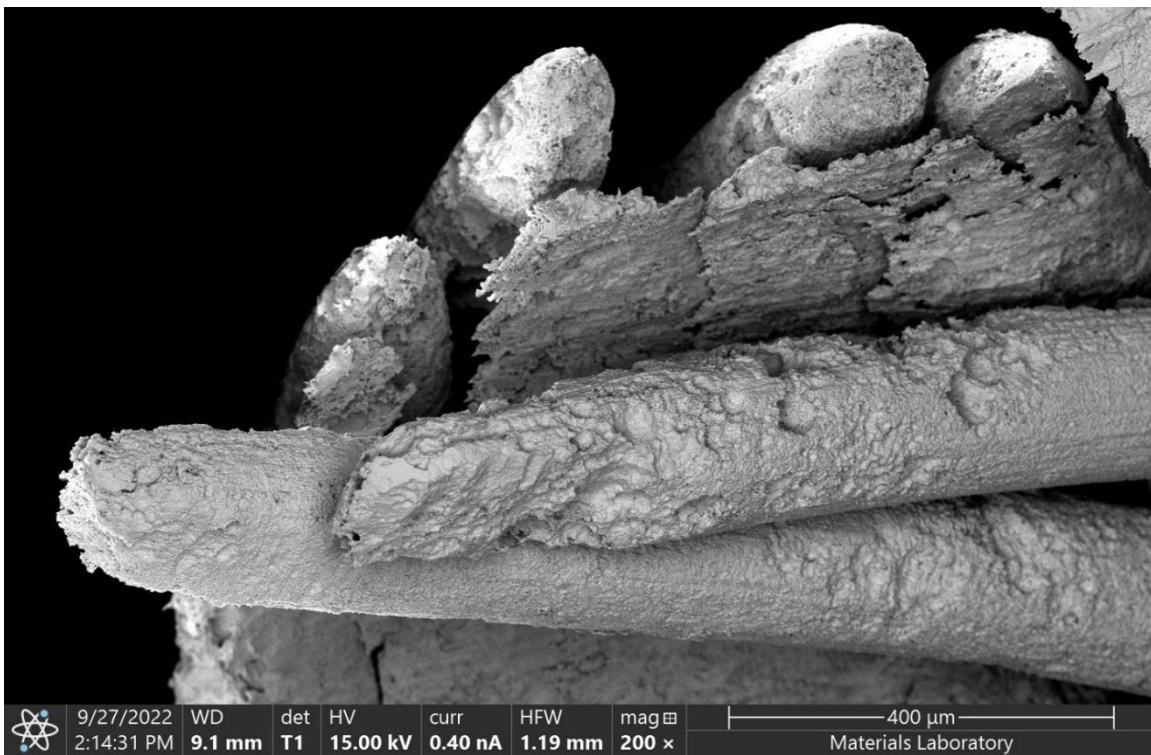
Some of the elongated wires, absent flat angled surfaces, are shown in Figure 14. Several of the wires had thinned erratically and exhibited pockmarks on all the surfaces—these features were consistent with corrosive attack of the wire metal. The damage was extensive enough on these wires that no discernible fracture features could be observed. Several of the other wires, like in Figure 15, did exhibit localized deformation in the form of necking near the fracture surface. In Figure 15, the wire exhibited tapering to a point, along with splitting of the wire material away from the fracture. The wire illustrated in Figure 16 exhibited a fracture surface with a classical cup shape. This fracture surface morphology, and the underlying dimple-like features, were consistent with tensile overstress fracture.

**Figure 14.** BE micrograph of elongated wires on the cable fracture.

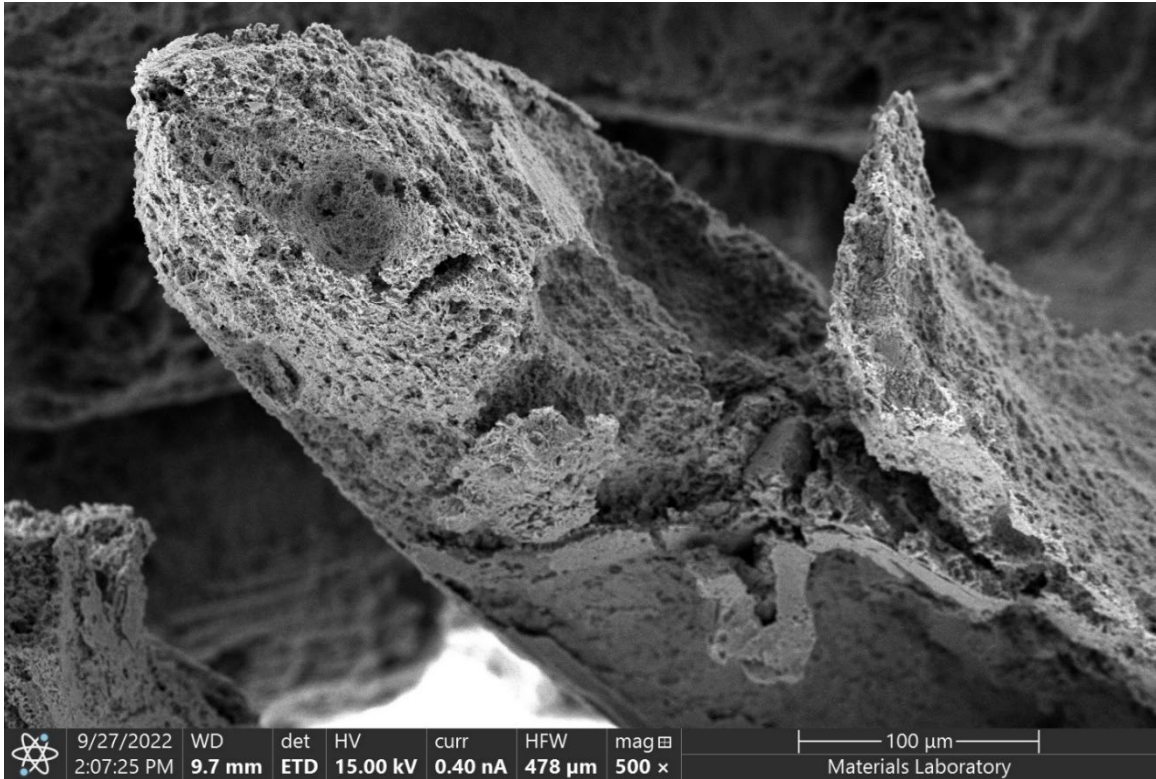
**Figure 15.** SE micrograph of a split wire that had necked near its fracture surface.

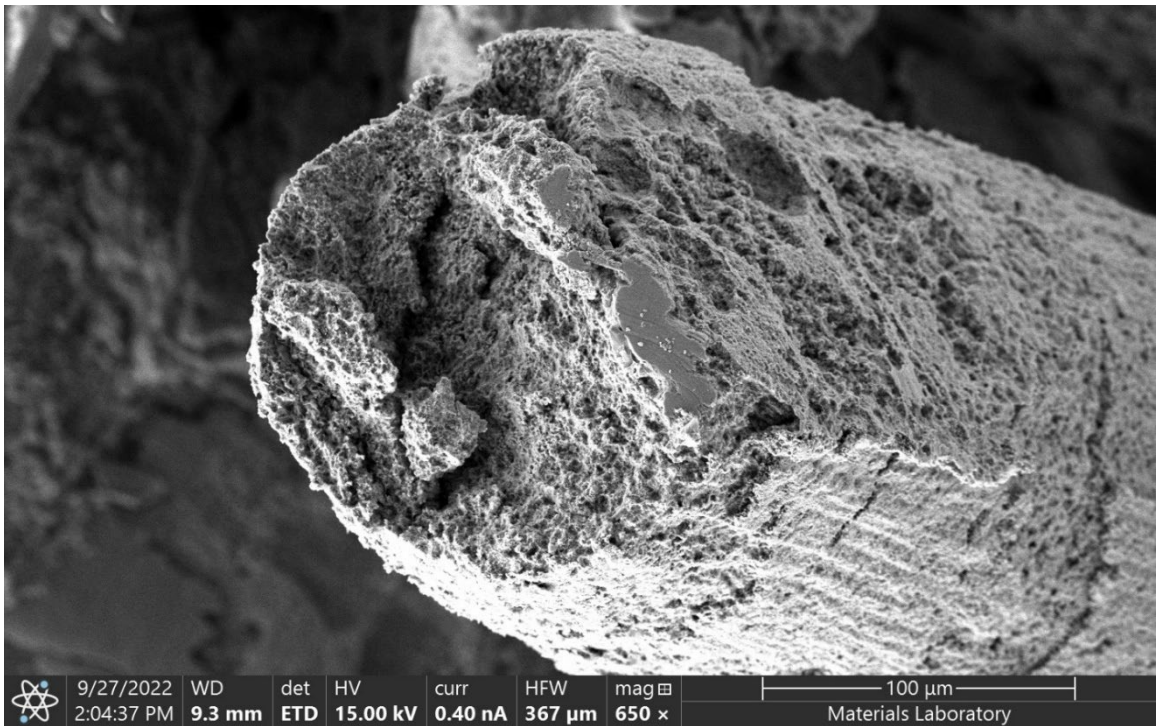
**Figure 16.** SE micrograph of cup-shaped wire fracture surface.

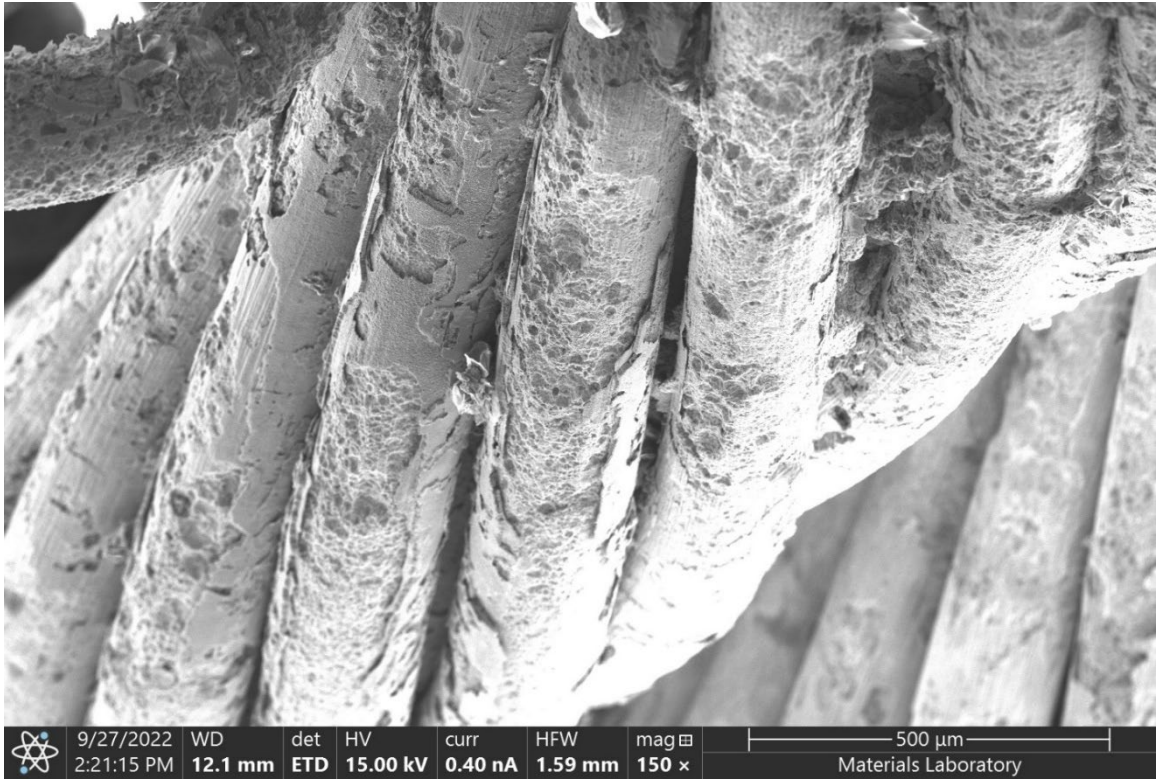
The corrosive attack to the wires was also present along the length of the cable and individual strands. Figure 17 shows an area of widespread attack on several strands of the left-side cable remnant. These wires exhibited material loss, spalling, and

deposits of corrosion compounds. The wire surfaces were often pock-marked, consistent with corrosive attack of the wire material, made bare after cleaning and removal of much of the surface oxide (Figure 18).

**Figure 17.** SE micrograph of the sides of several wires in a strand near the fracture surface.

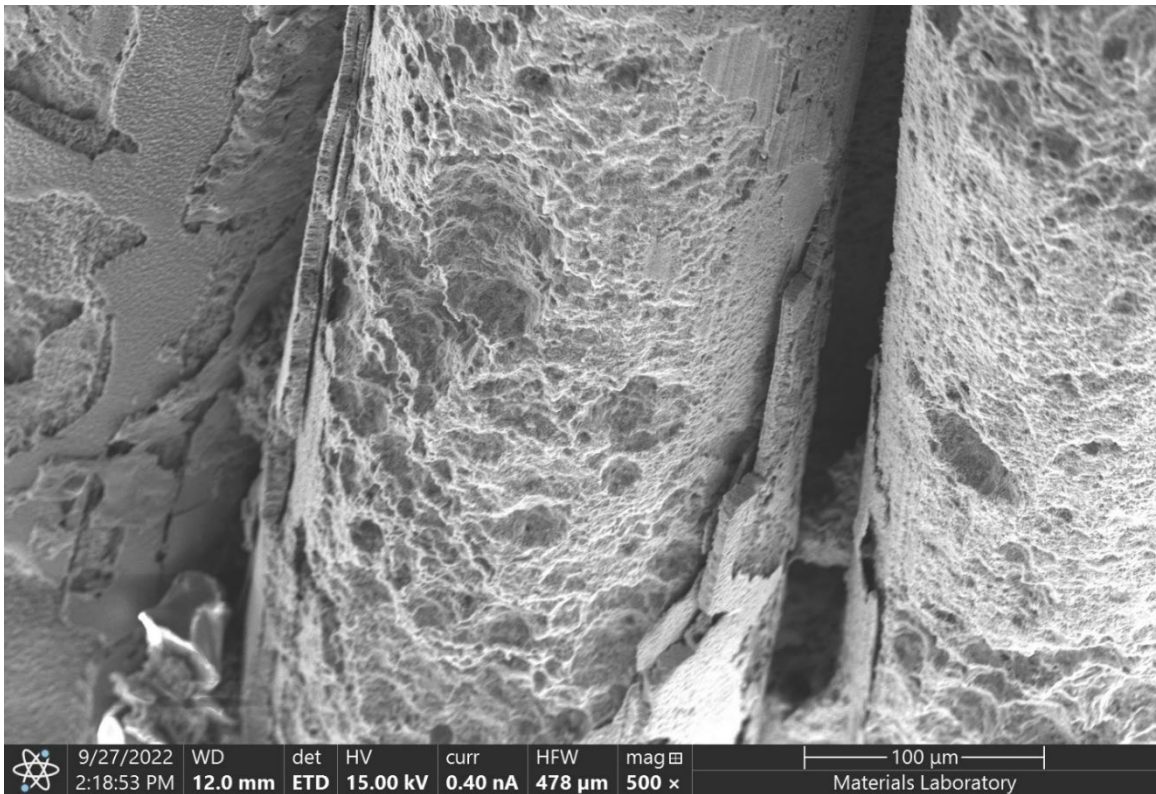
The composition of the wires was also examined using EDS, in an area absent corrosion. The core of the wires was consistent with carbon steel, and the surface exhibited high levels of zinc. These data were consistent with galvanized steel. The columnar-grained surface oxidation shown in Figure 18 was absent detectable levels of zinc.

**Figure 18.** SE micrograph of corrosion and surface scale of a wire in Figure 17.

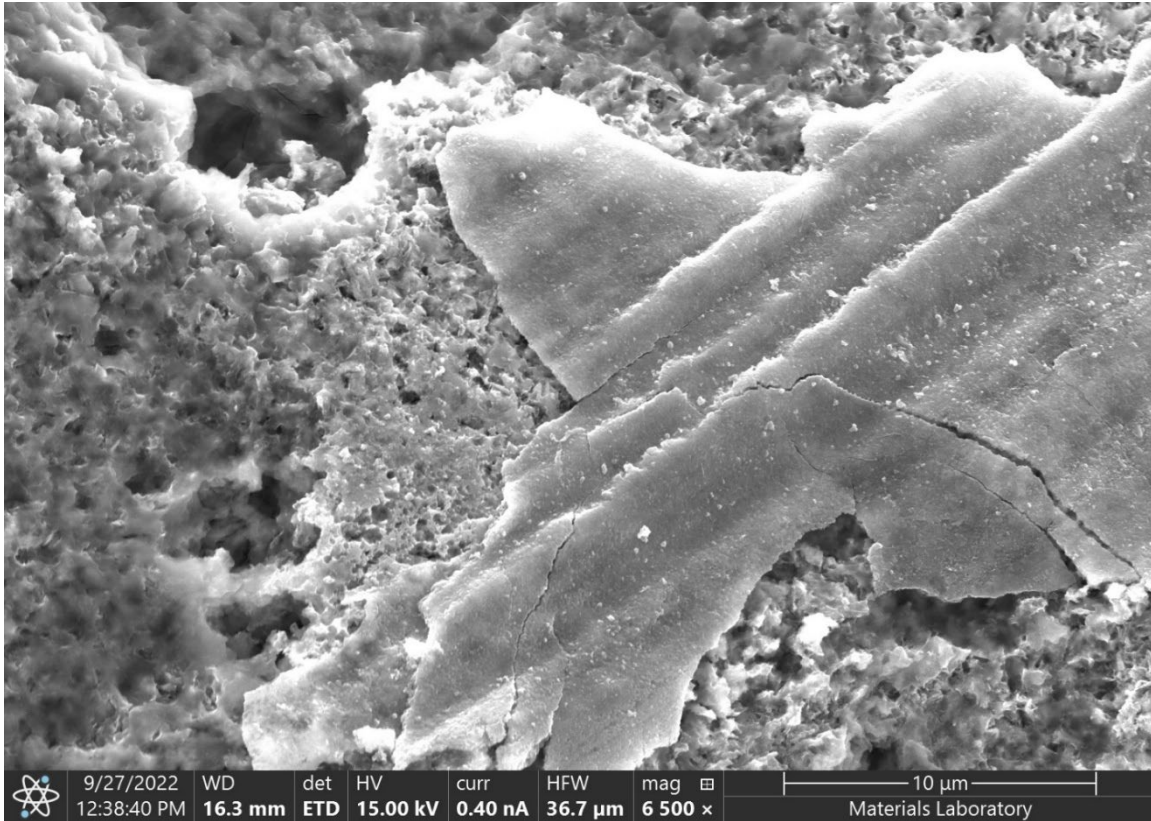
**Figure 19.** SE micrograph of a wire side surface, showing surface scale and an underlying surface with missing material.
