Heidi Kemner  
Eastern Region Aviation  
Senior Air Safety Investigator

**Subject:** ERA22LA167 - Wreckage Examination Summary

**Contact:** Andrew Hall - Textron Aviation - Air Safety Investigator

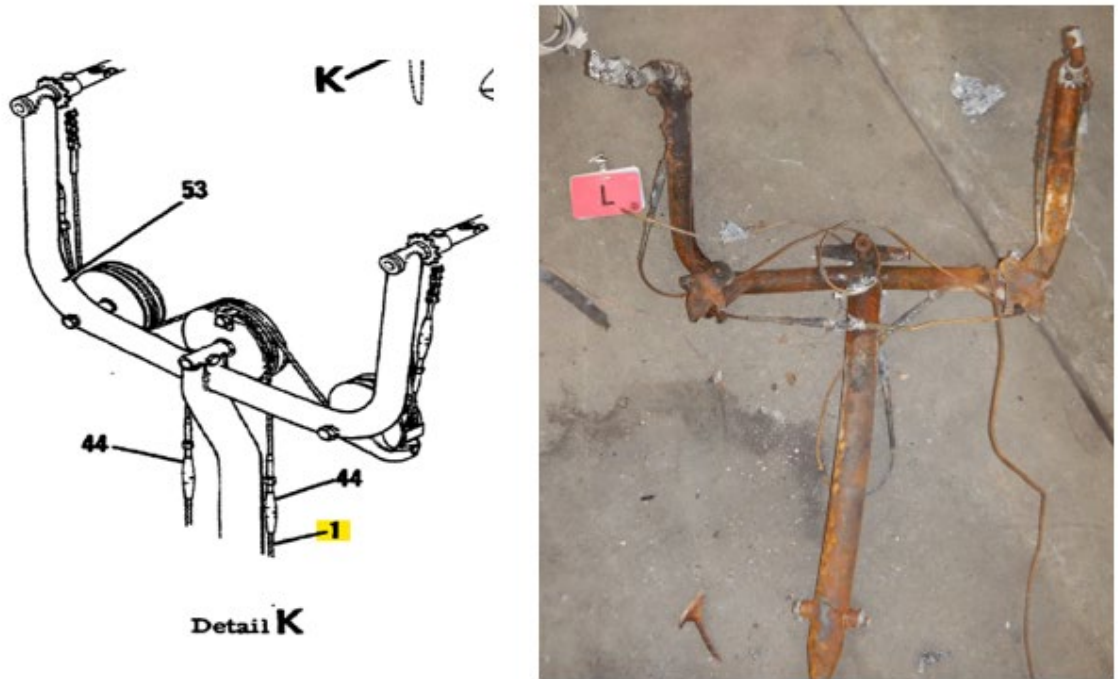
The control lock was not observed in the wreckage debris. The post impact fire destroyed all the pulleys in the cockpit area. The aileron control wheel interconnect system was observed with all cables attached to the chains and continuity was established. The aileron direct control cables were observed in the area, of the pulley, common to the aileron control wheel interconnect system. The left direct control cable was observed attached to the control yoke turnbuckle and continuous out to the recovery cut. The direct control cable was observed attached to the left aileron wing bellcrank and was observed with a recovery cut to the cable. The right direct aileron control cable was attached to the control yoke turnbuckle and was separated in the area near the lower to the control yoke pulleys under the cockpit floor, as shown in figure below as Figure 1. Both left and right aileron wing bellcranks push rods were observed attached.

Figure 1. Diagram of aileron system and location of cable separation in highlighted portion of figure.
