# National Transportation Safety Board

## **MATERIALS LABORATORY**

Factual Report 22-104

Location: Sparta, Tennessee  
Date: March 27, 2022  
Vehicle: Cessna 172F, N8431U  
Investigator: Millicent Hill

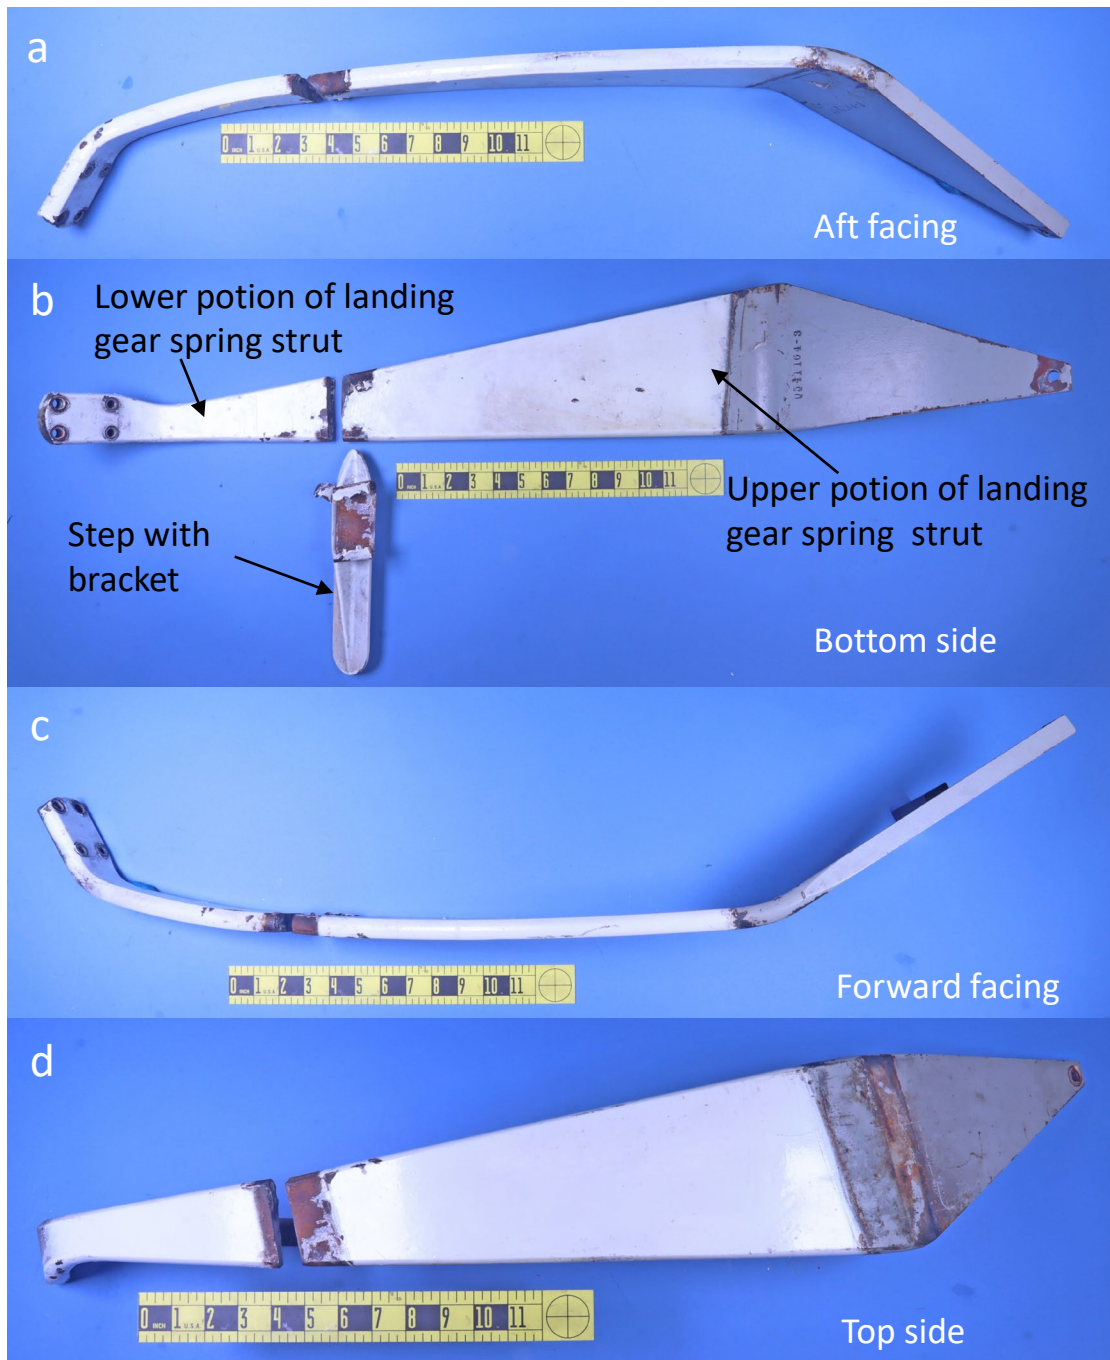
The submitted left main landing gear items are shown in in Figure 1 with key pieces identified. For reference, an image of the landing gear spring strut with step and bracket from the Cessna Model 172 Service Manual is shown in Figure 2<sup>1</sup>.

**Figure 1.** Image of the submitted items.

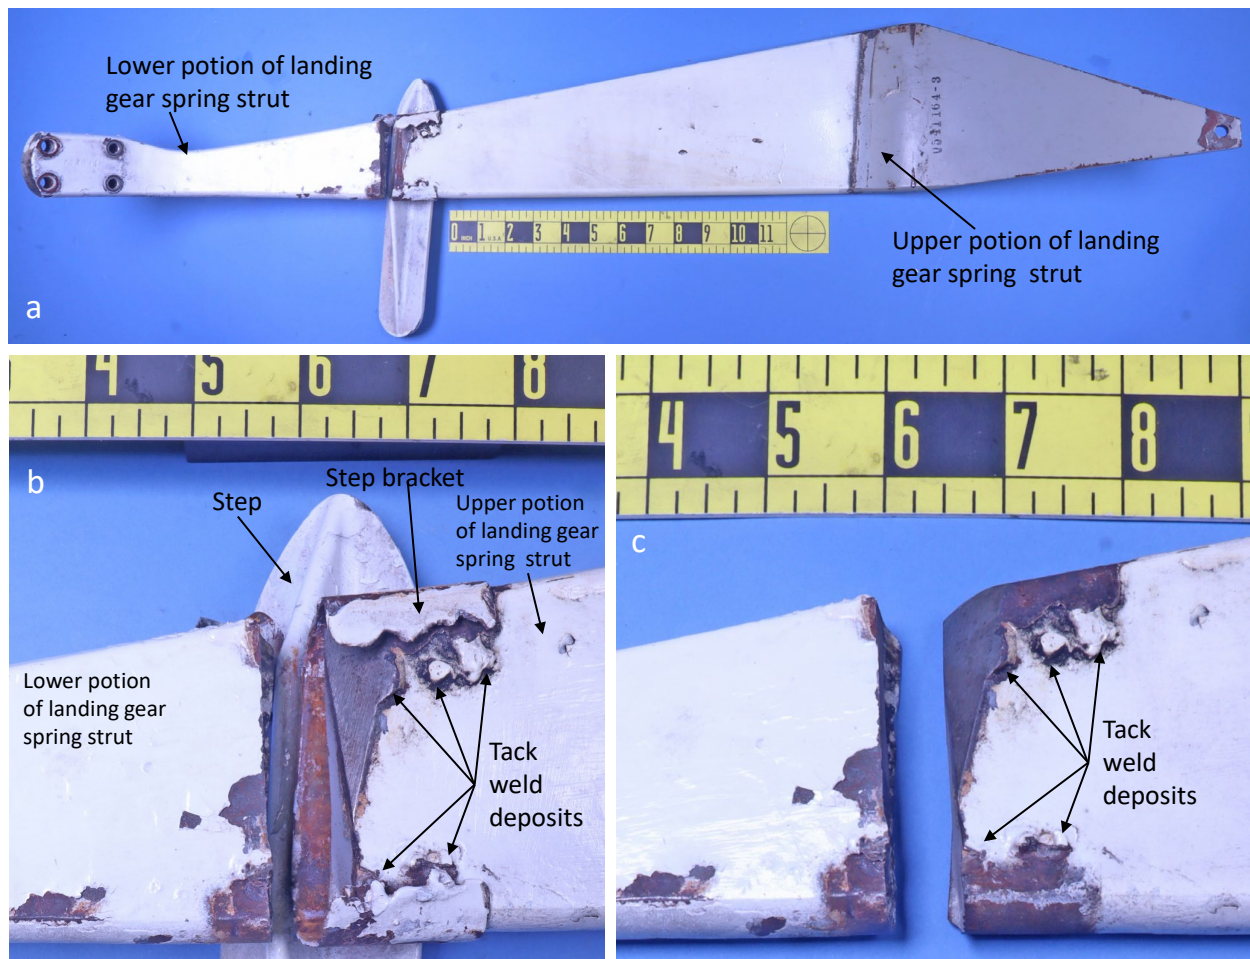
The left main landing gear spring strut fractured where the step is affixed to the spring strut. The step bracket was tack welded to the spring strut as indicated in Figures 3-6. Detailed images in Figures 5 and 6 reveal that a thumbnail-shaped semi-elliptical fatigue crack initiated at a tack weld between the step bracket and the spring strut and propagated to a length of about 0.2 inch; a size sufficient for overstress fracture during the accident flight<sup>2</sup>. The pre-existing fatigue crack exhibited dark coloration consistent with tight and adherent corrosion product.

**Figure 3.** Images of the upper and lower portions of the fractured spring strut pieces with the step and bracket positioned in its approximate pre-accident location. A tack weld between the step bracket and the bottom face of the spring strut is noted.

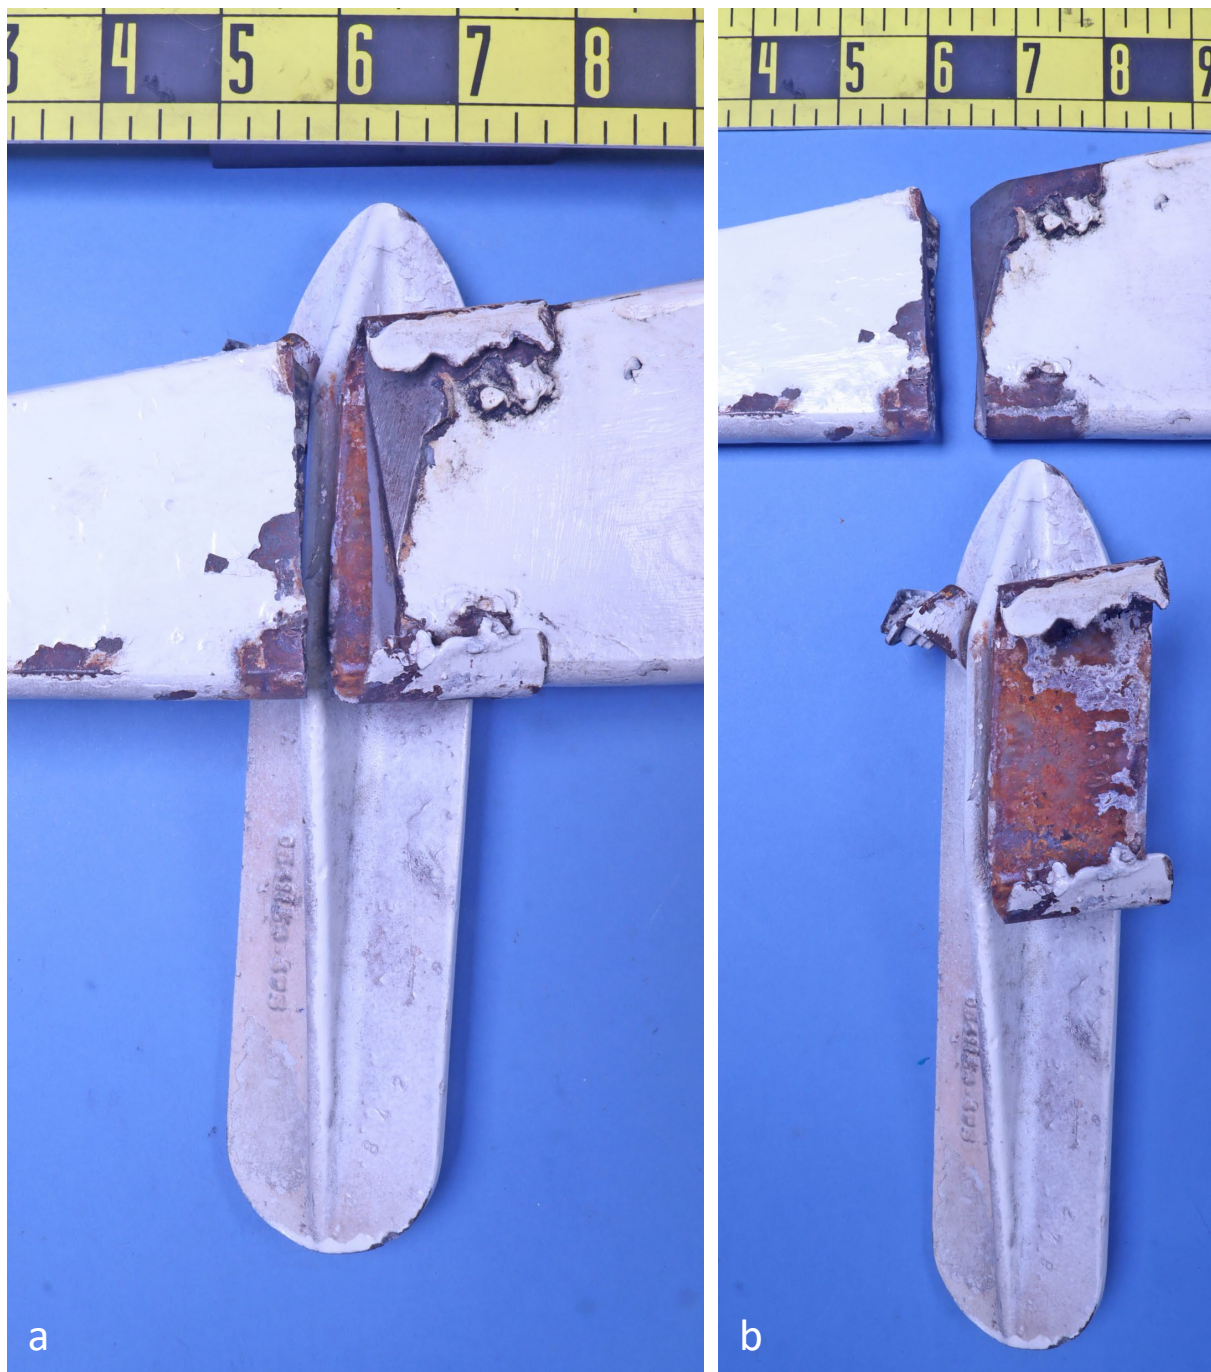
Figure 11 shows the top side surfaces of the spring strut pieces at the location of the fracture (under the step bracket). In this area, the surfaces exhibit corrosion product deposits and loose scale. The sides and bottom side surfaces also exhibit such corrosion product and scale. As shown in Figure 4b, the underside of the step bracket also exhibited corrosion product and loose scale. Based on visual inspection, there is no evidence of an epoxy adhesive present on the faying surfaces of the step bracket or spring strut. In accordance with the Service Manual, step brackets may only be affixed to the spring strut using an approved epoxy adhesive on abrasively blasted surfaces; welding on the spring strut is not permitted.

**Figure 4.** View a shows an image of the upper and lower portions of the fractured spring strut with the step and bracket positioned in its approximate pre-accident location. Tack welds between the step bracket and the bottom face of the spring strut are noted. In view b, the underside of the bracket exhibits corrosion product, loose scale, and paint stains from wicking paint

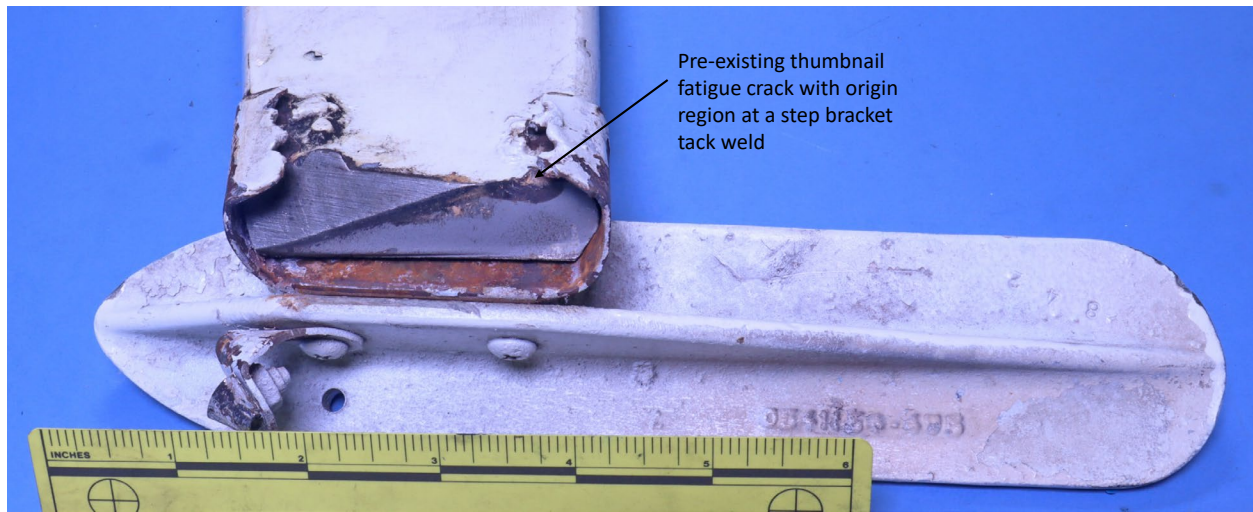
**Figure 5.** Image of the upper portion of the fractured spring strut piece with the step and bracket positioned in its approximate pre-accident location. A fractured tack weld between the step bracket and the bottom face of the spring strut is noted. A closer image is shown in Figure 6.

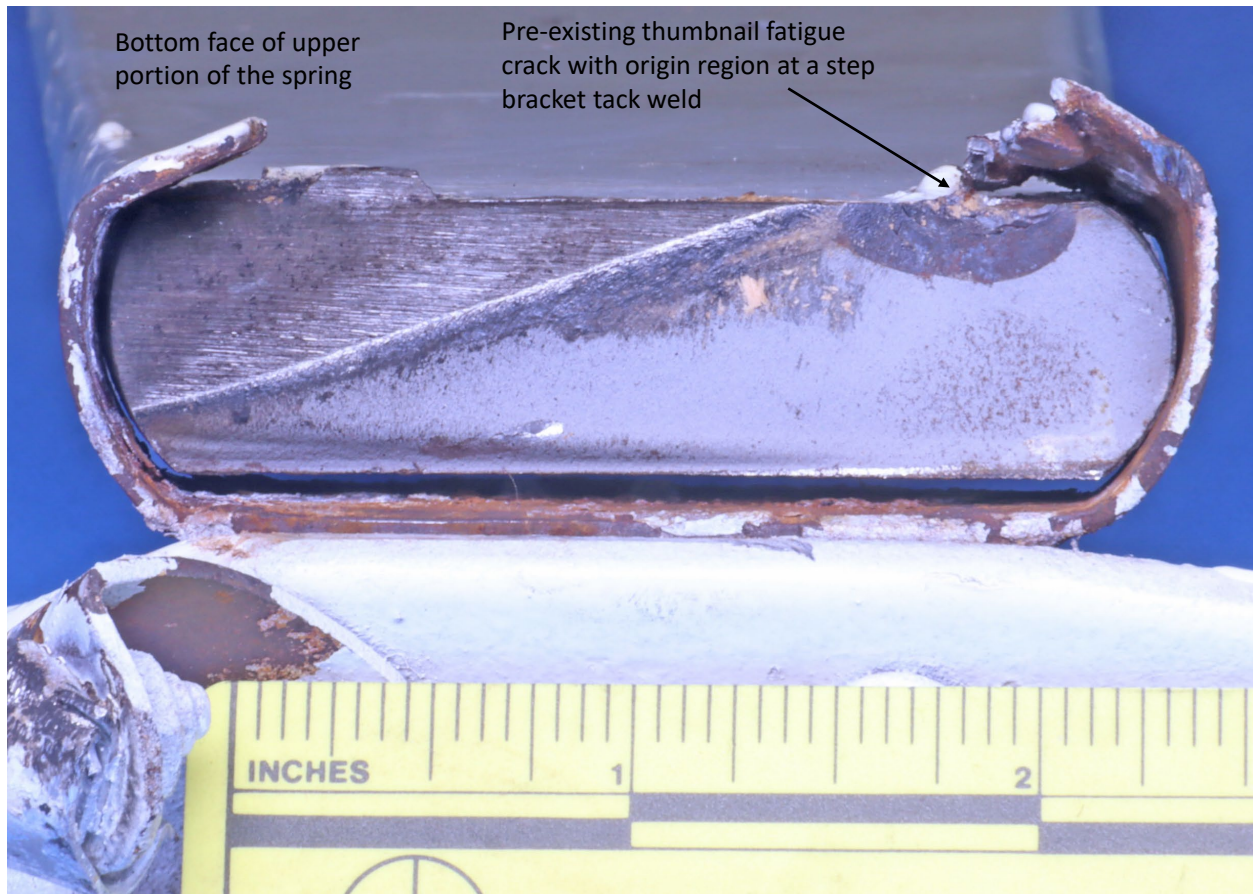
**Figure 6.** Closer image of the upper portion of the fractured spring strut piece with the step and bracket positioned in its approximate pre-accident location. A fractured tack weld between the step bracket and the bottom face of the spring strut is noted.

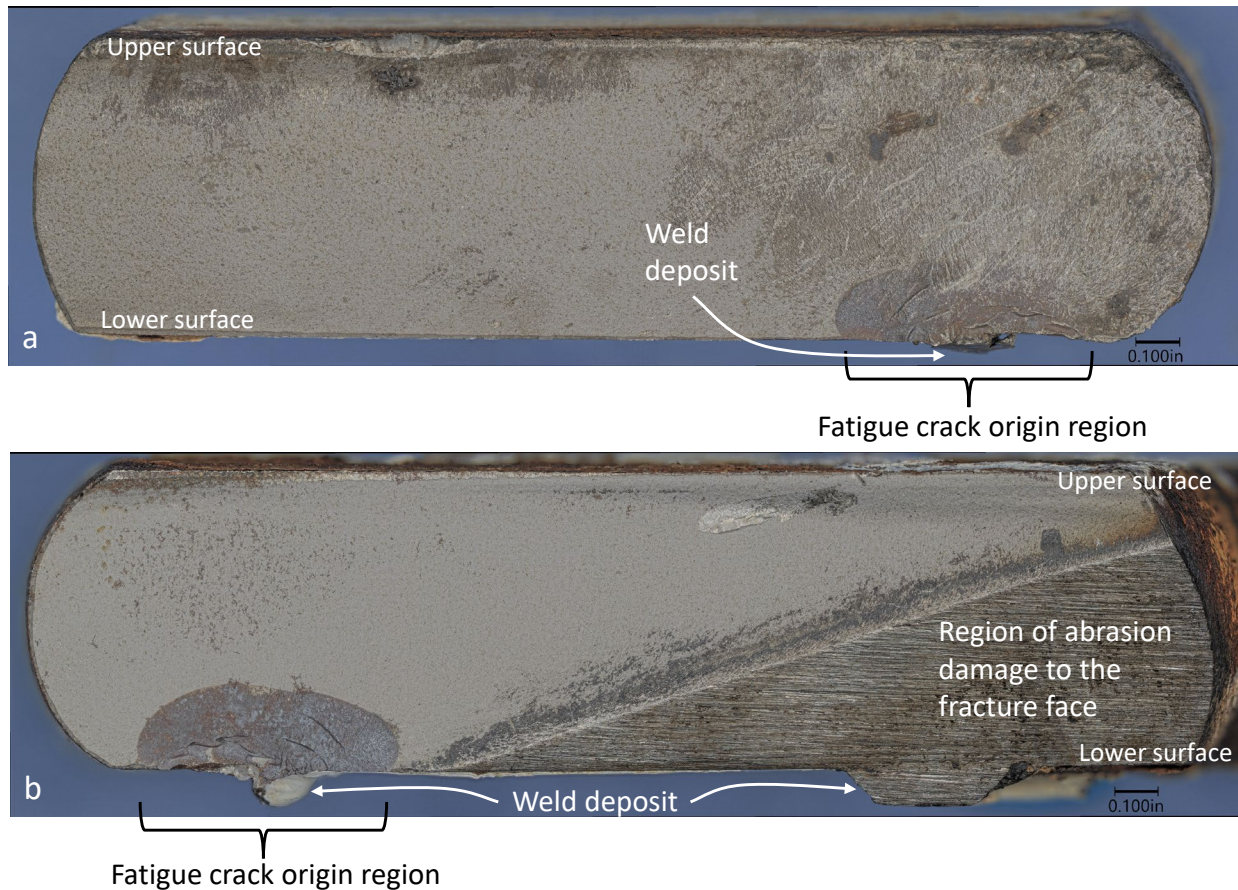
Digital microscope images of both halves of the spring strut fracture surfaces are shown in Figure 7. Higher magnification oblique views in Figure 8 reveal that a

**Figure 7.** Digital microscope images of the fracture faces of the upper and lower spring strut pieces. A semi-elliptical fatigue crack is noted at the fracture origin region.

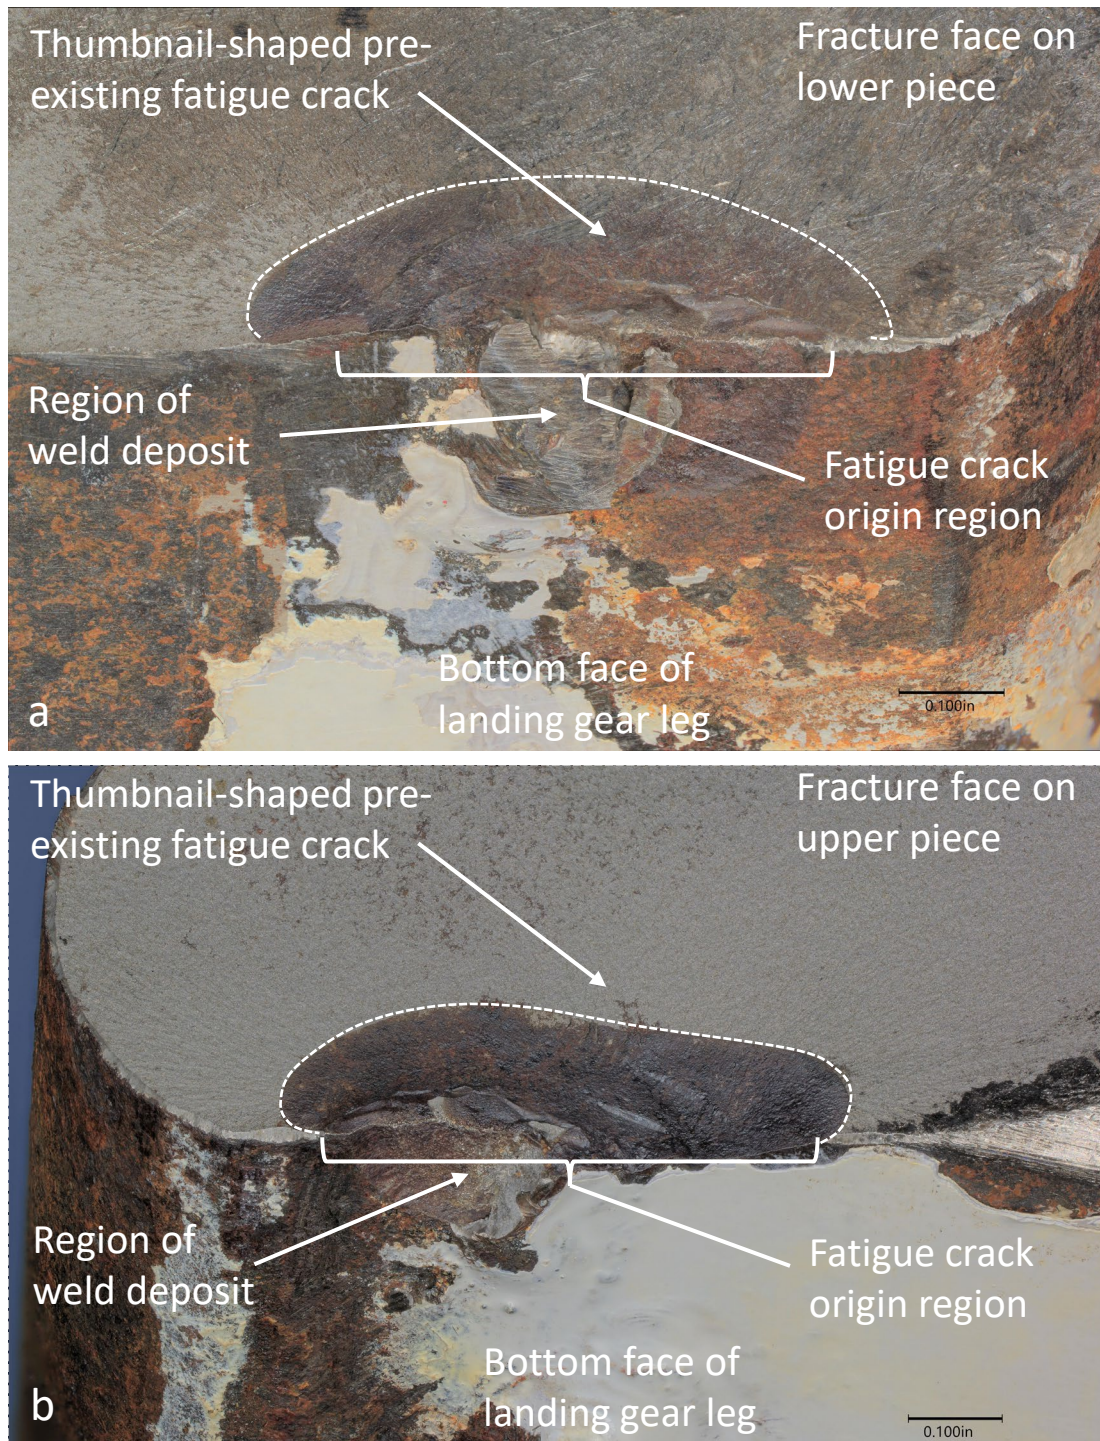
semi-elliptical fatigue crack initiated and propagated at a step bracket tack weld deposit on the underside of the spring strut.

**Figure 8.** Oblique digital microscope images of the fracture origin region on the upper and lower spring strut pieces. The fatigue crack origin region is located at a weld deposit between the step bracket and the underside of the spring strut.

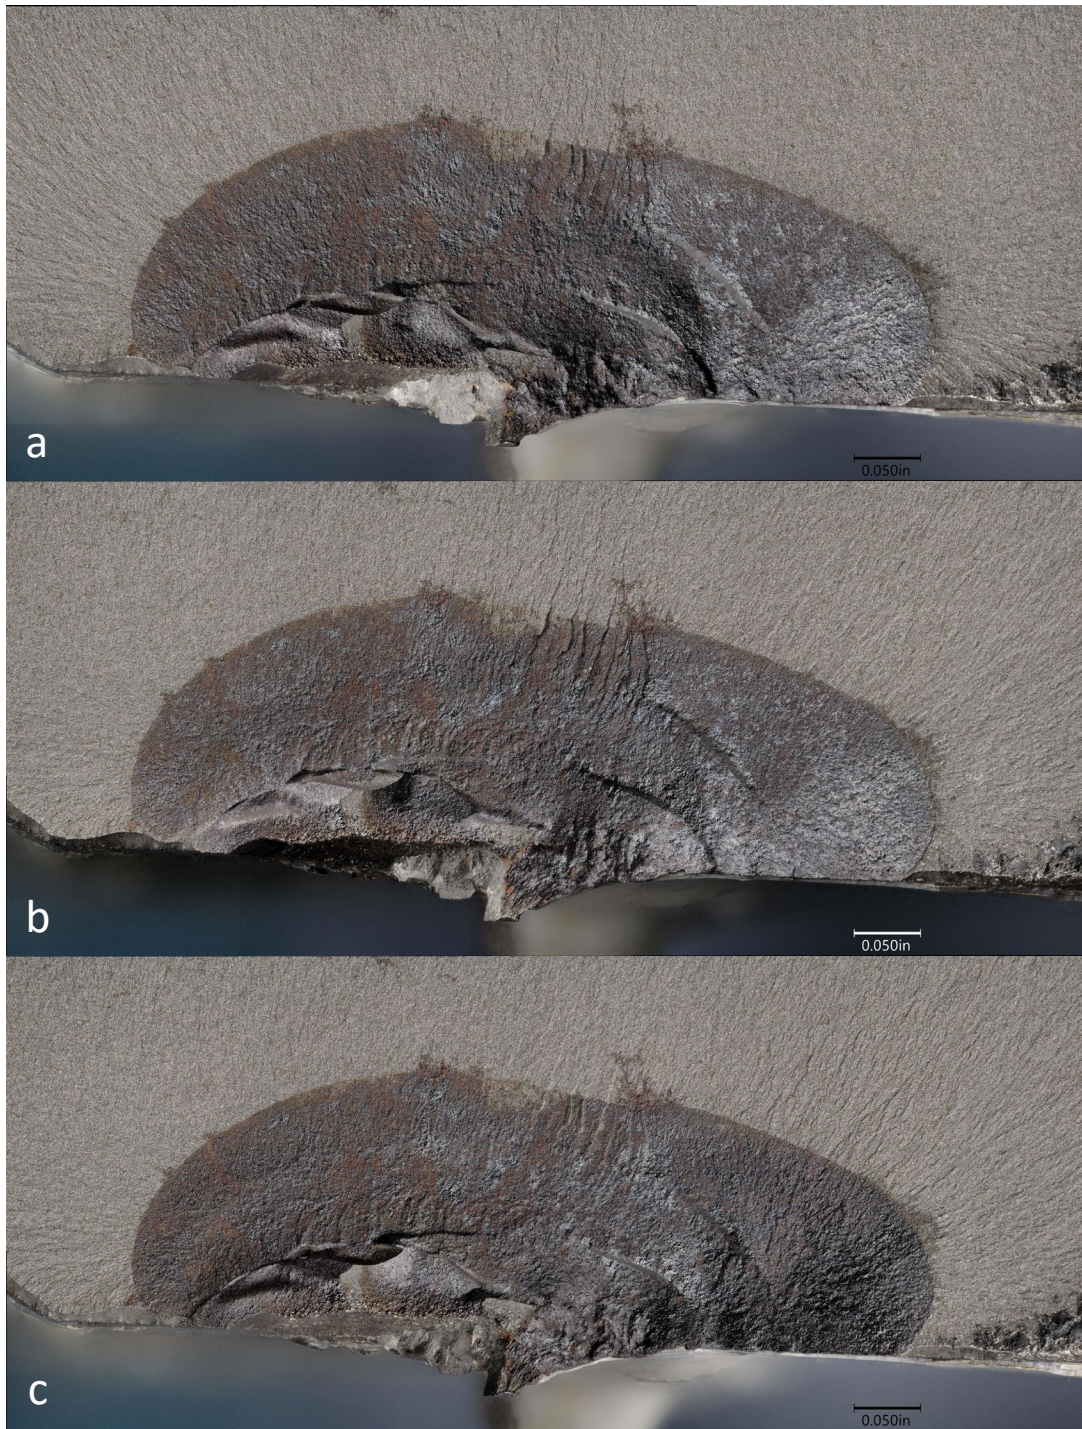
Close views using a digital microscope in Figures 9 and 10 document fine fractographic features of the semi-elliptical fatigue crack as well as the subsequent overstress crack that occurred during the accident flight.

**Figure 9.** Digital microscope images of a semi-elliptical fatigue crack (darker region) at the fracture origin region viewed under different oblique lighting conditions and high dynamic range color.

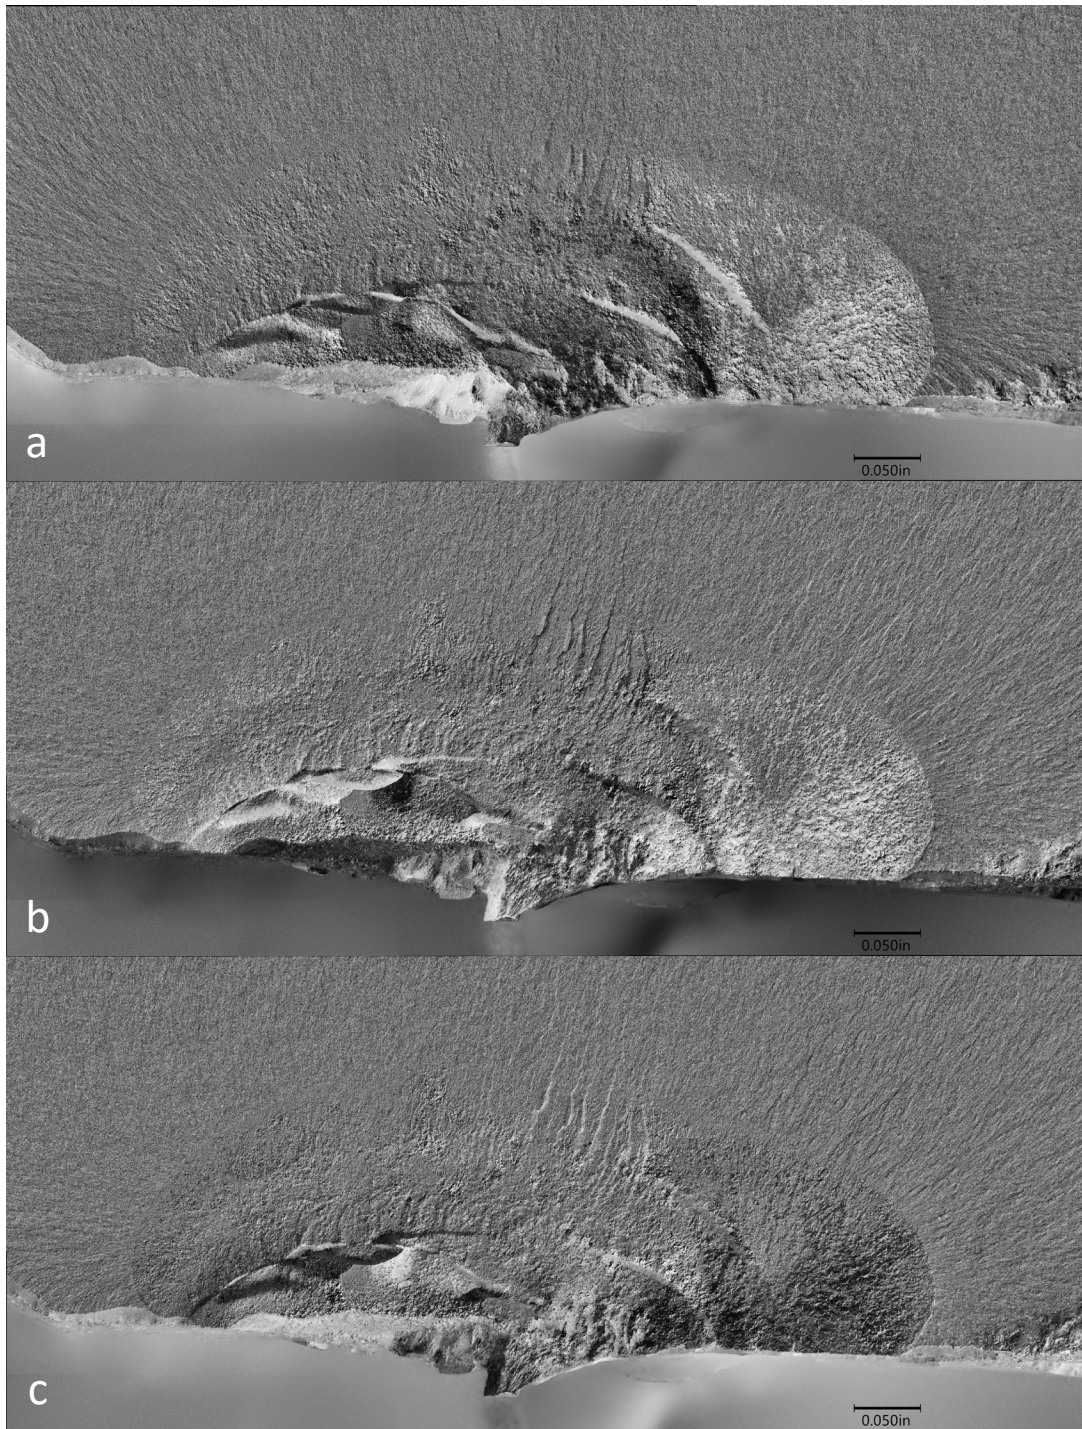
**Figure 10.** Monochromatic digital microscope images of a semi-elliptical fatigue crack at the fracture origin region viewed under different oblique lighting conditions (Same images as Figure 9, but monochromatic).

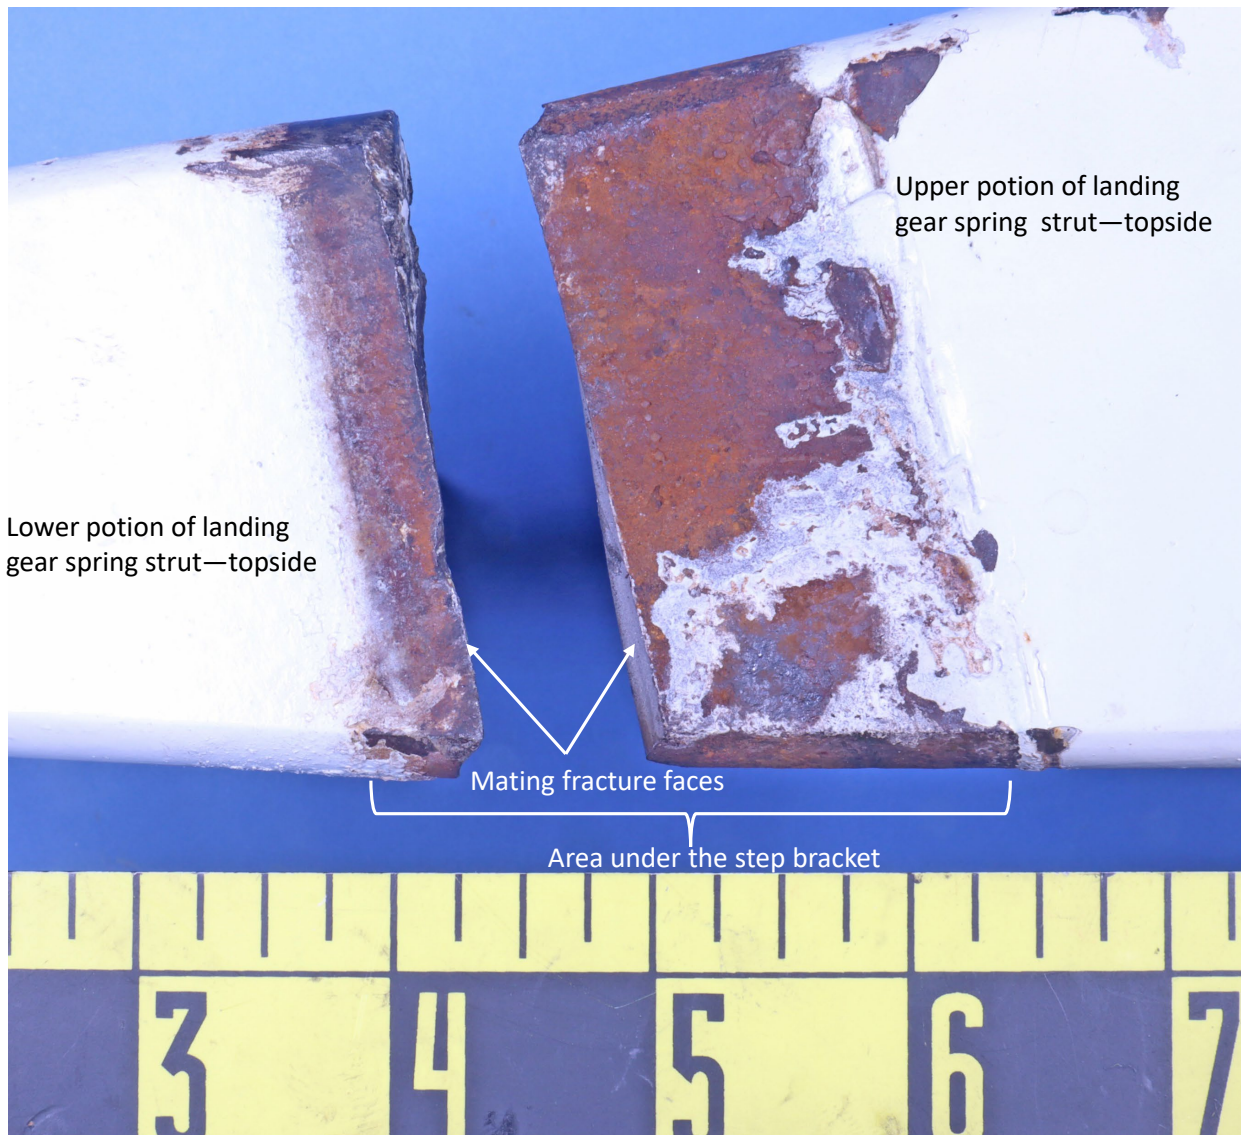
**Figure 11.** Portions of the upper and lower spring strut pieces showing the topsides in the vicinity of the fracture. The spring strut surfaces exhibit corrosion product and loose scale under the step bracket. Paint stains under the step bracket are consistent with paint wicking under the step bracket when the spring strut was painted (see Figure 4b for the faying surface of bracket). No evidence of an epoxy adhesive was noted.
