## **NATIONAL TRANSPORTATION SAFETY BOARD**

Office of Aviation Safety  
Eastern Region

**Photo Array**

**ERA22LA171**

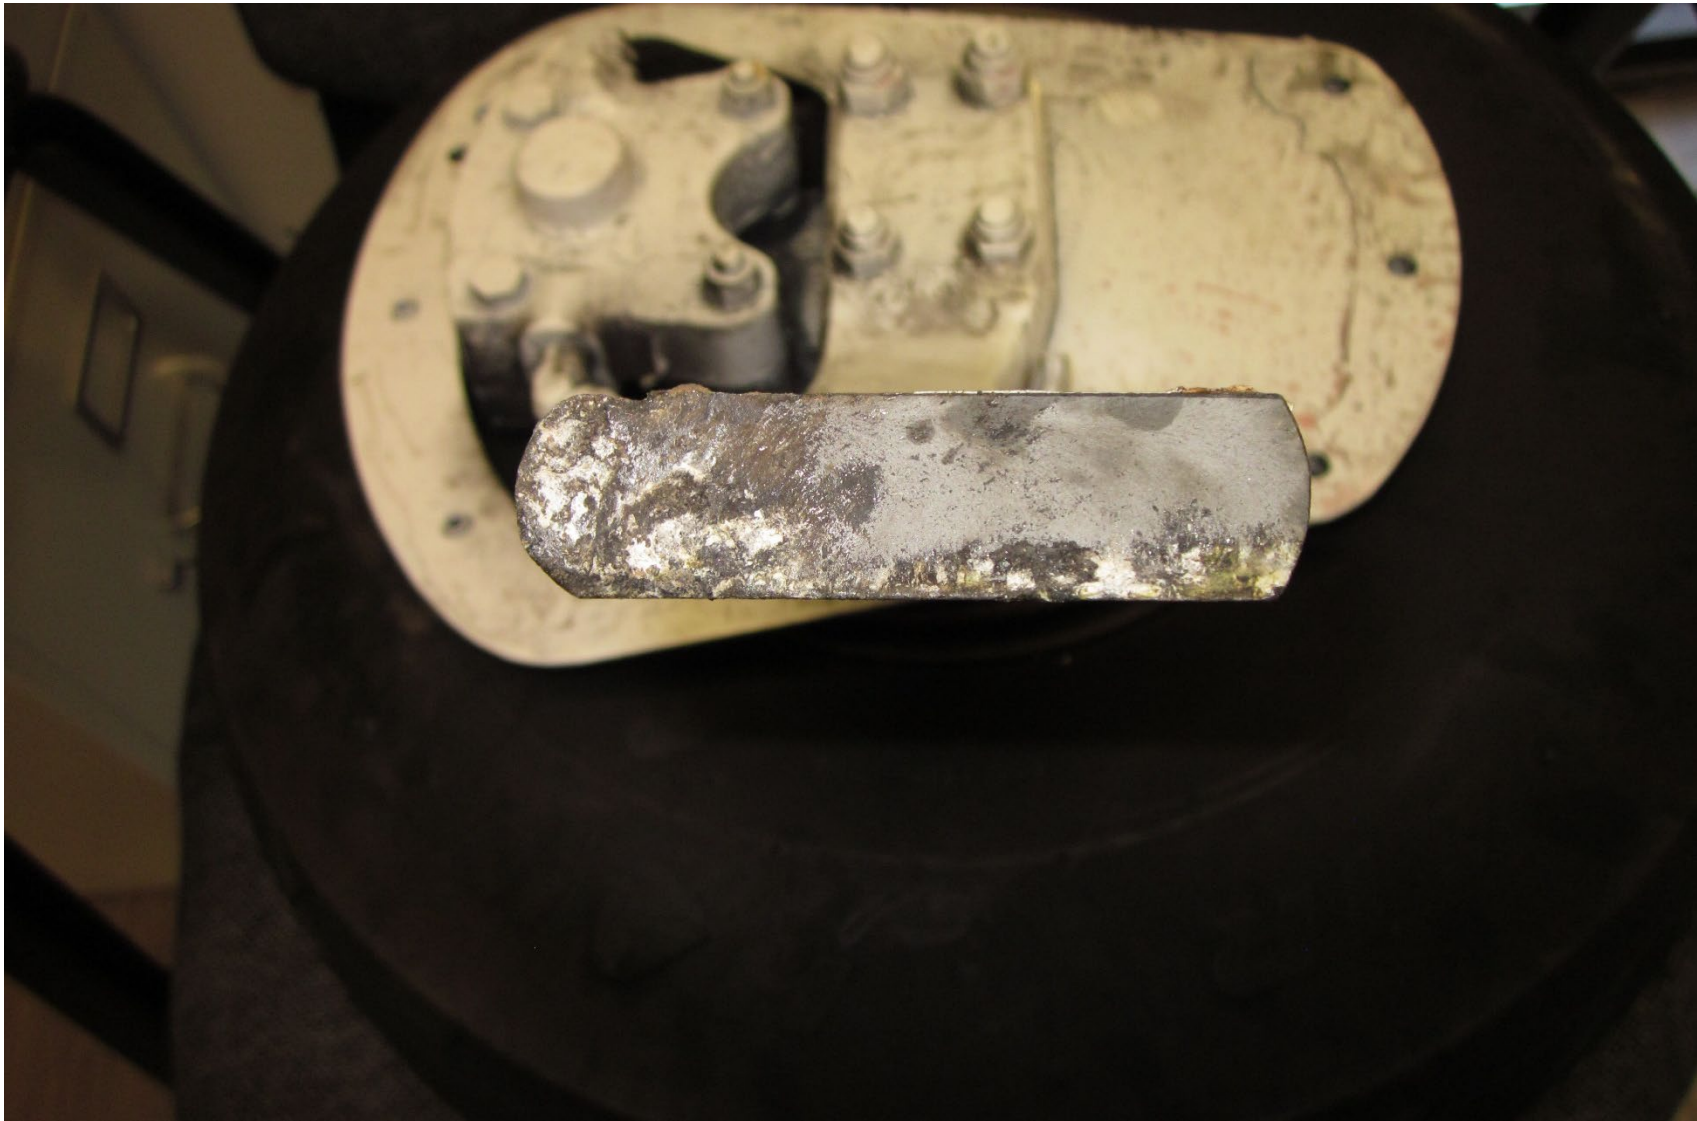
**Photo 1 – View of the fracture surface on the step (Photo courtesy of FAA)**

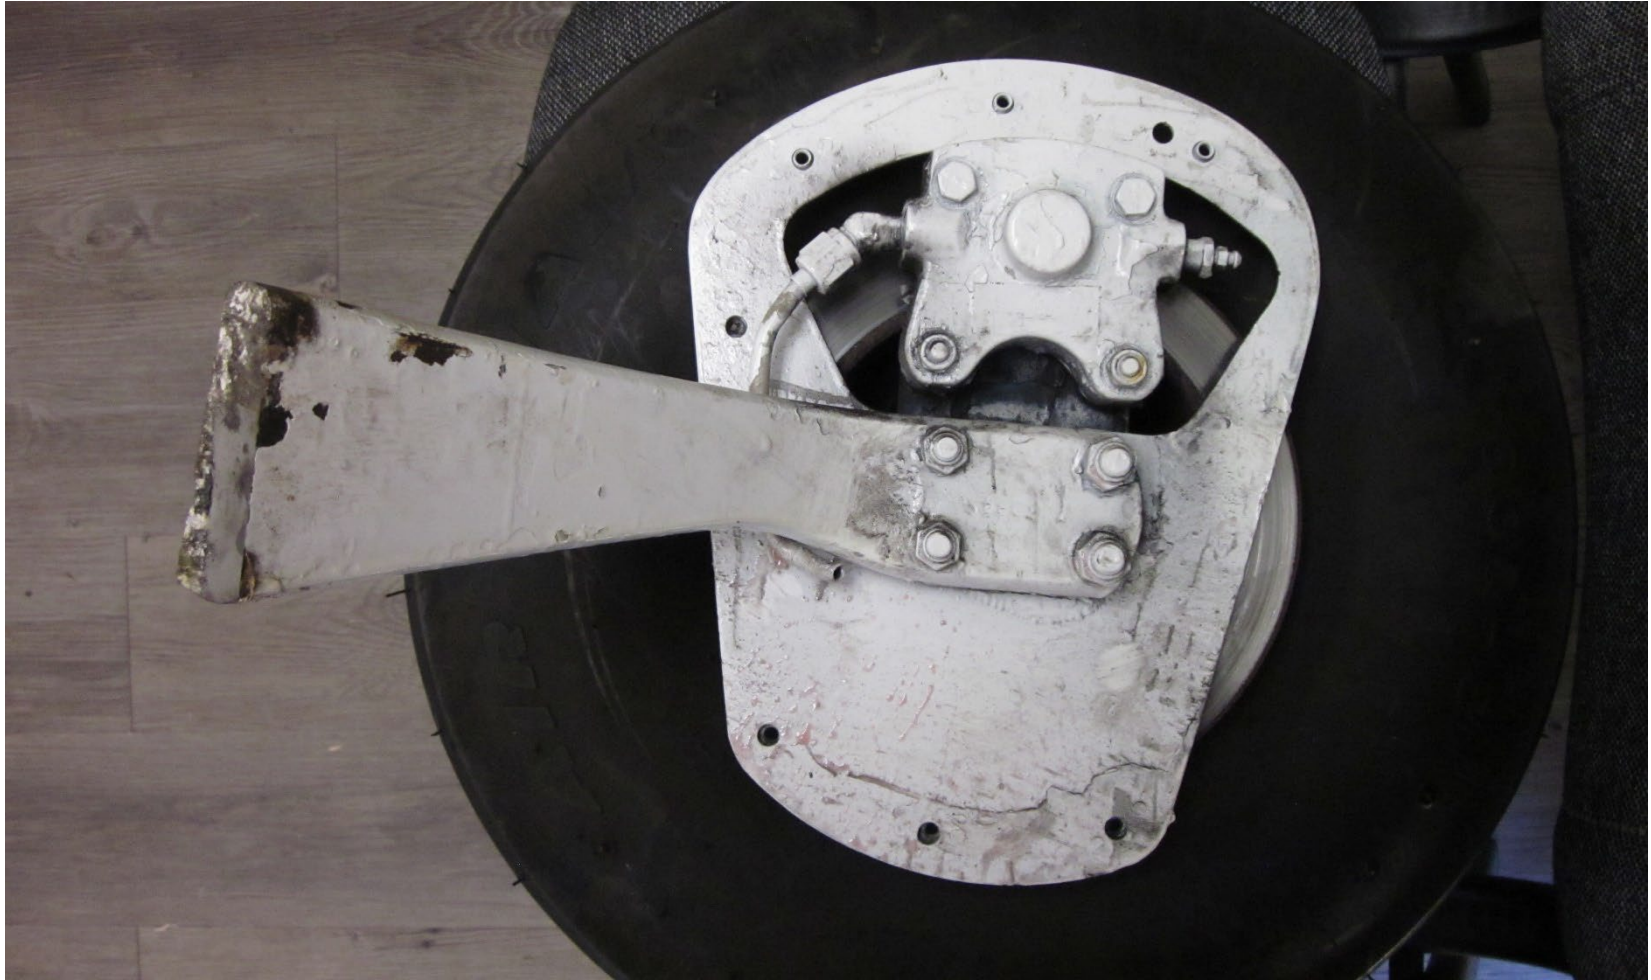
**Photo 2 – View of the separated left main landing gear (Photo courtesy of FAA)**
