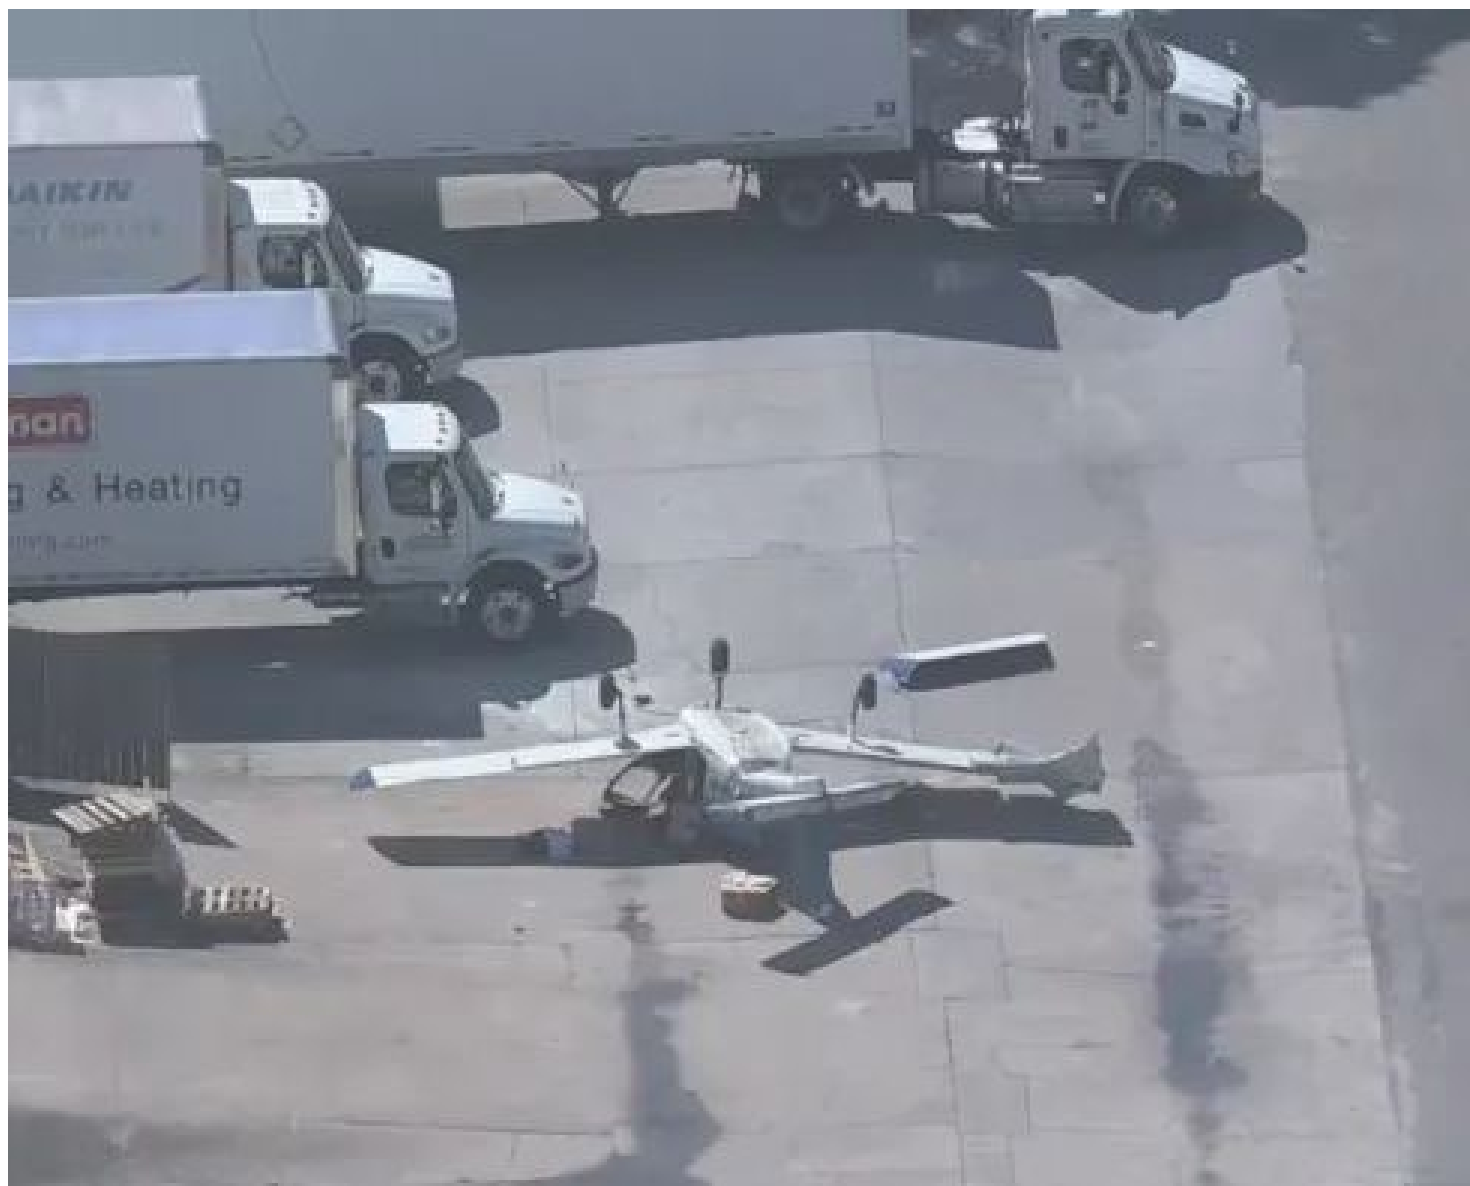
**Photo 1 – main wreckage, inverted (FAA)**

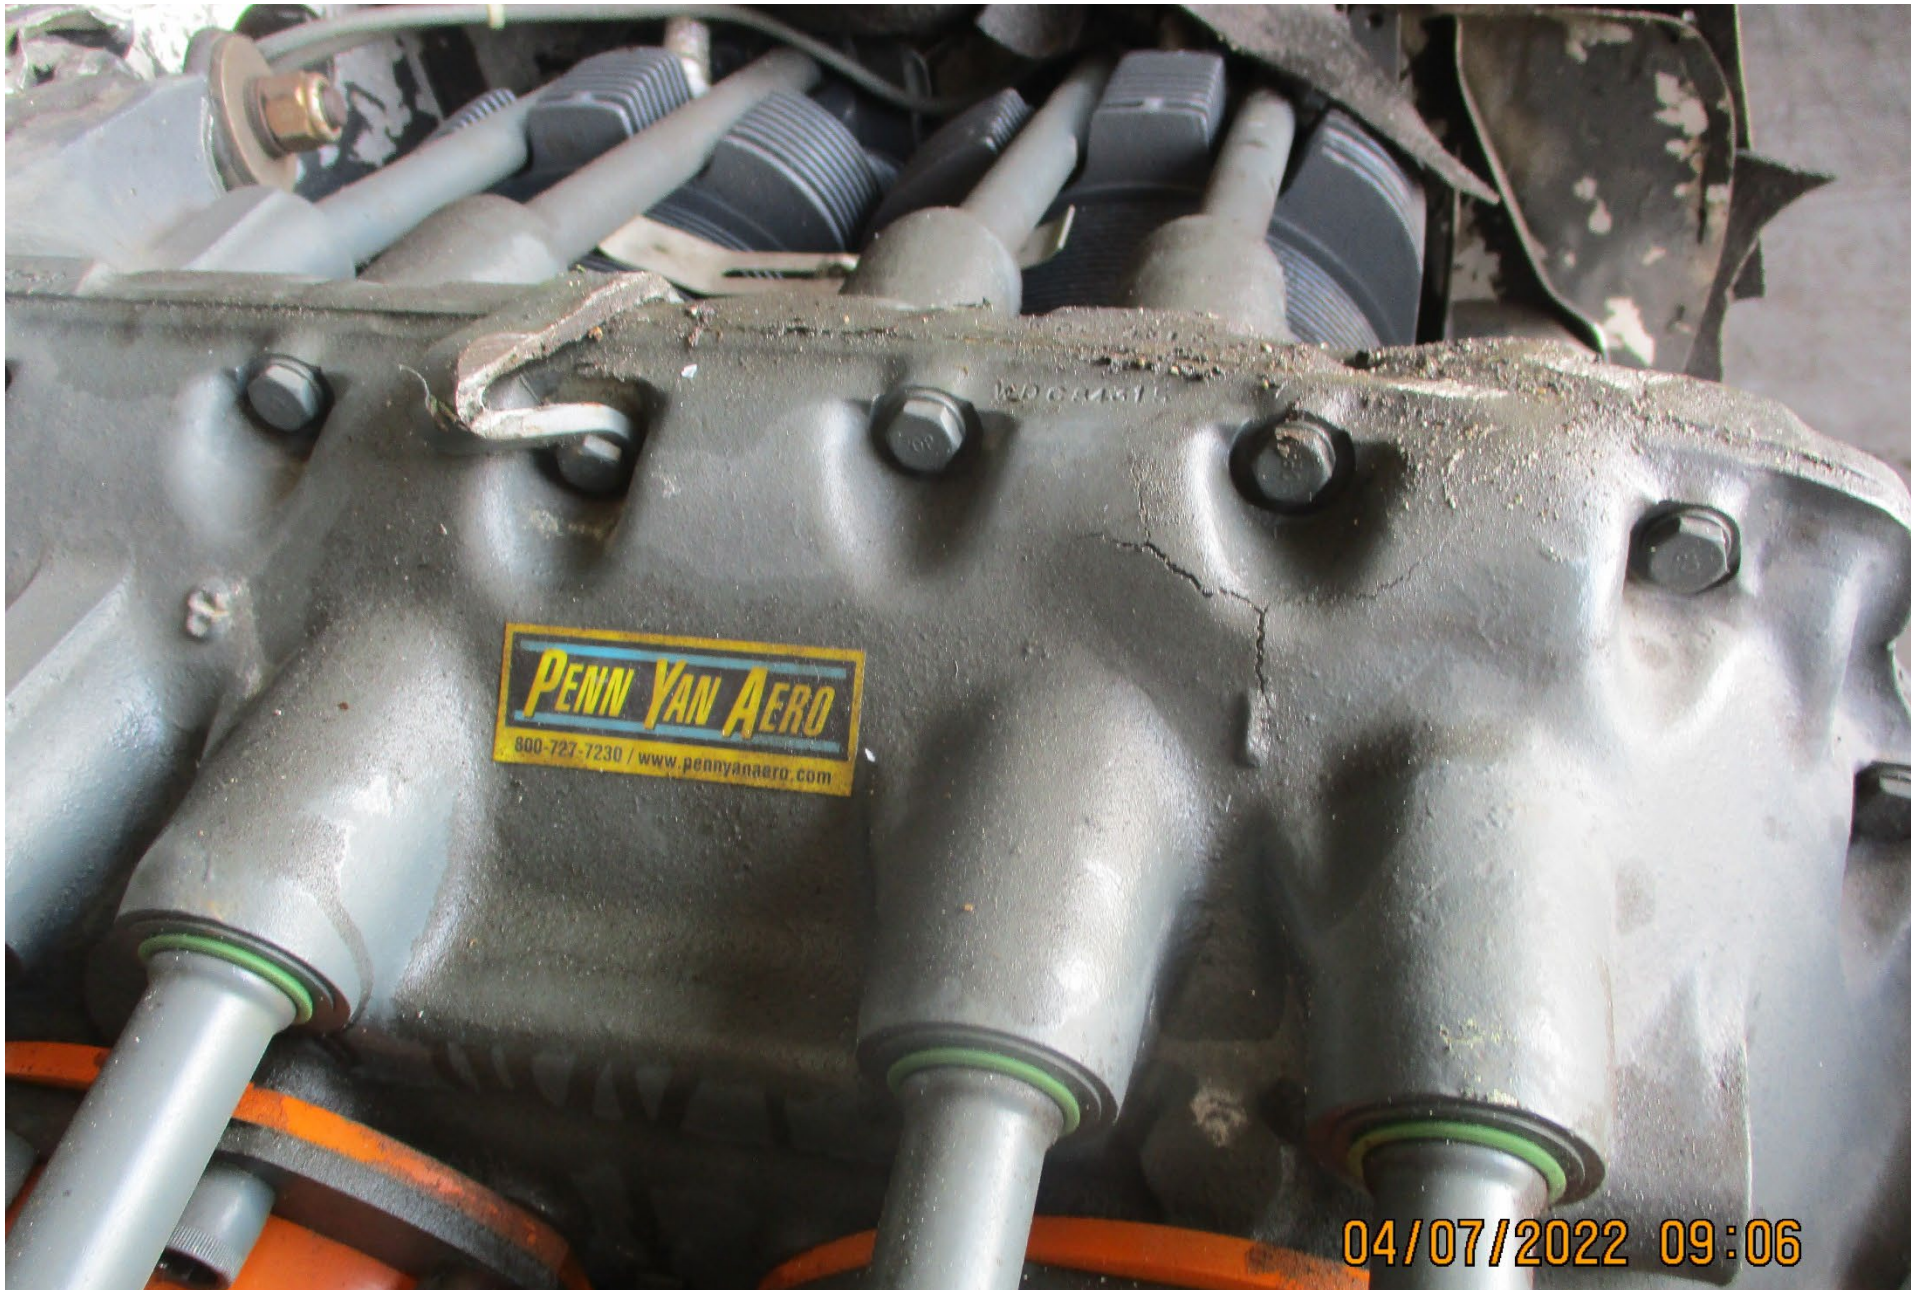
Photo 2 – case fractured

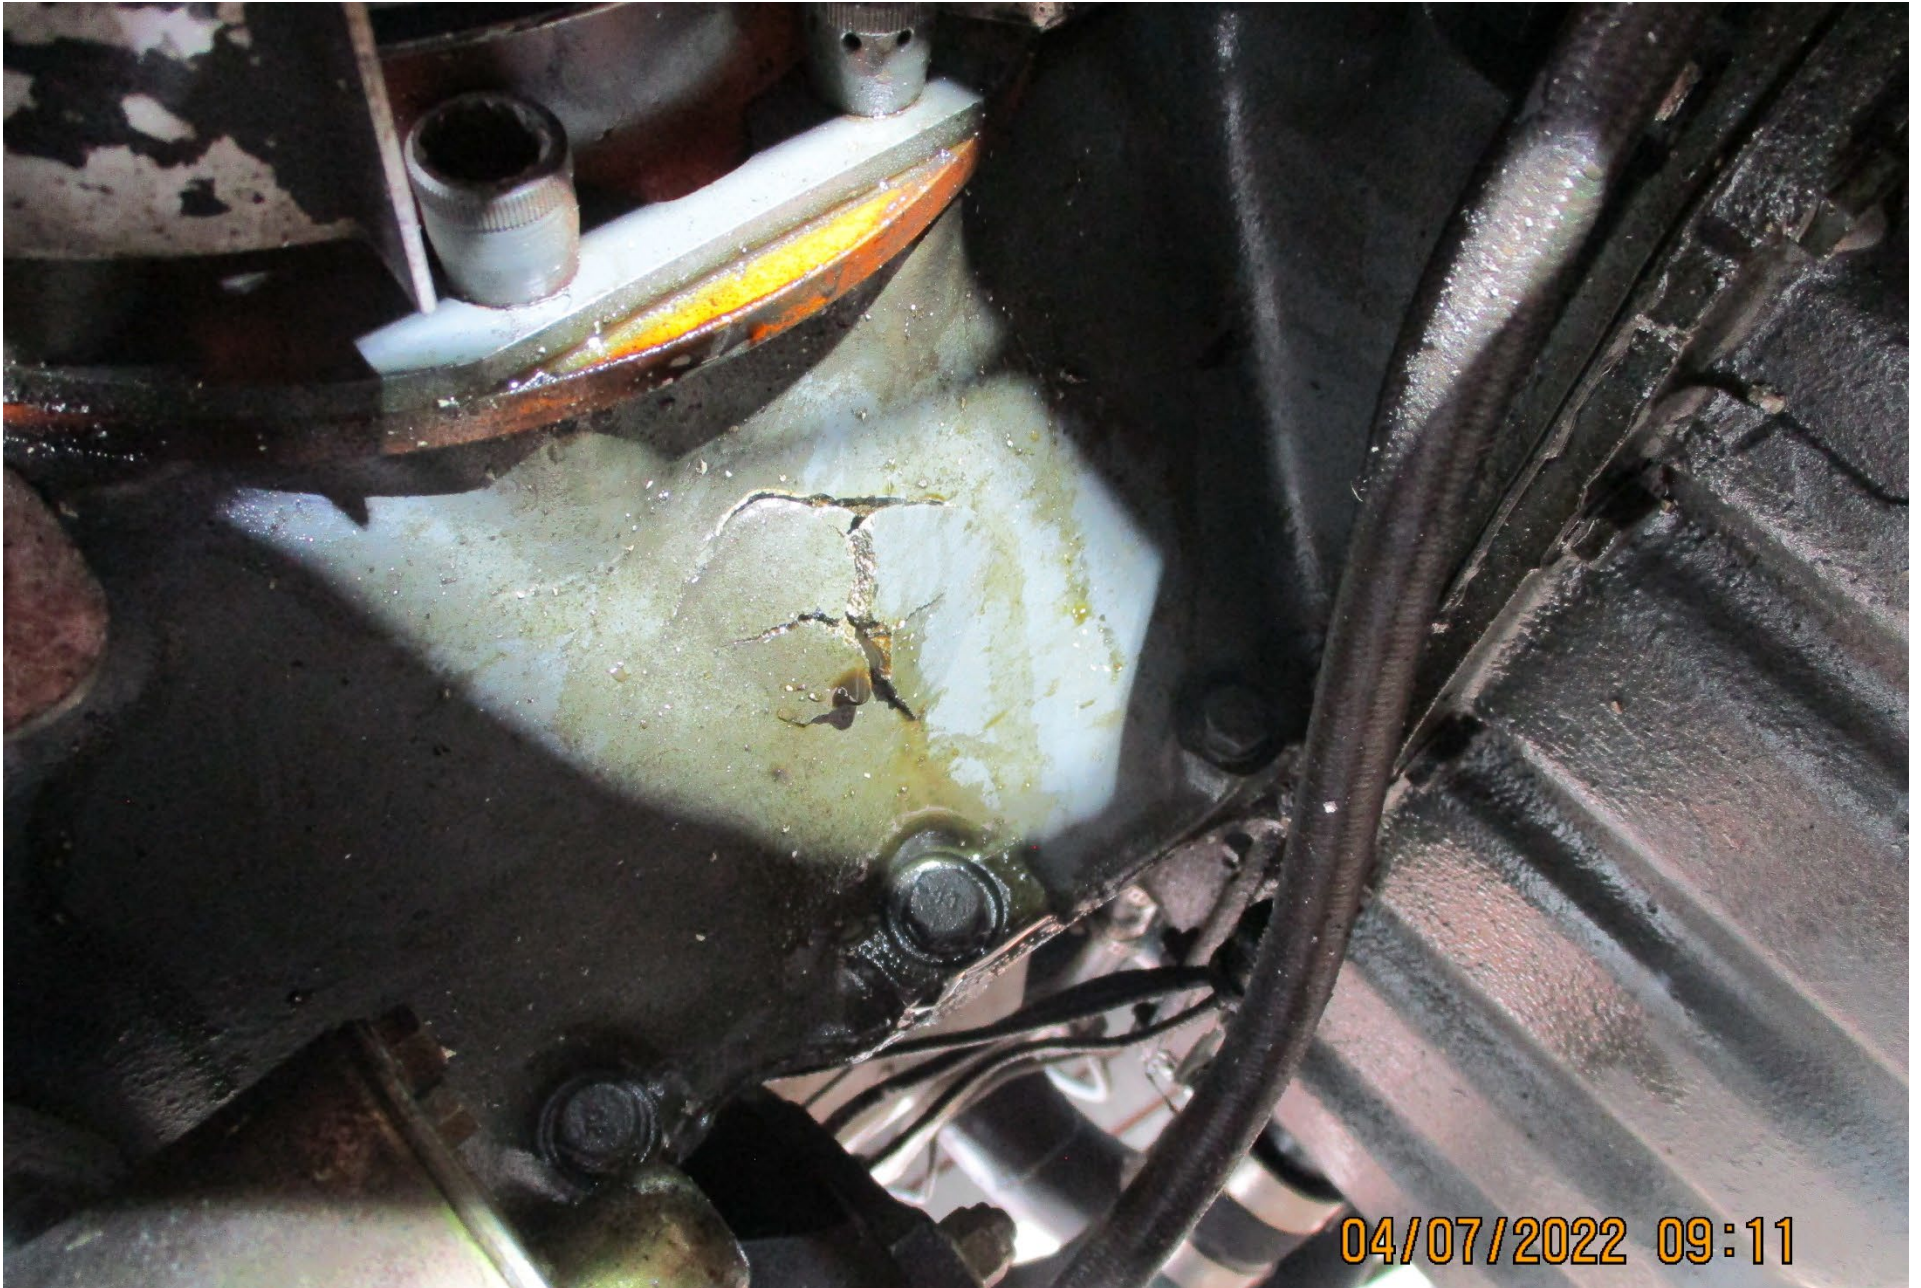
**Photo 3 – case fractured from inside**

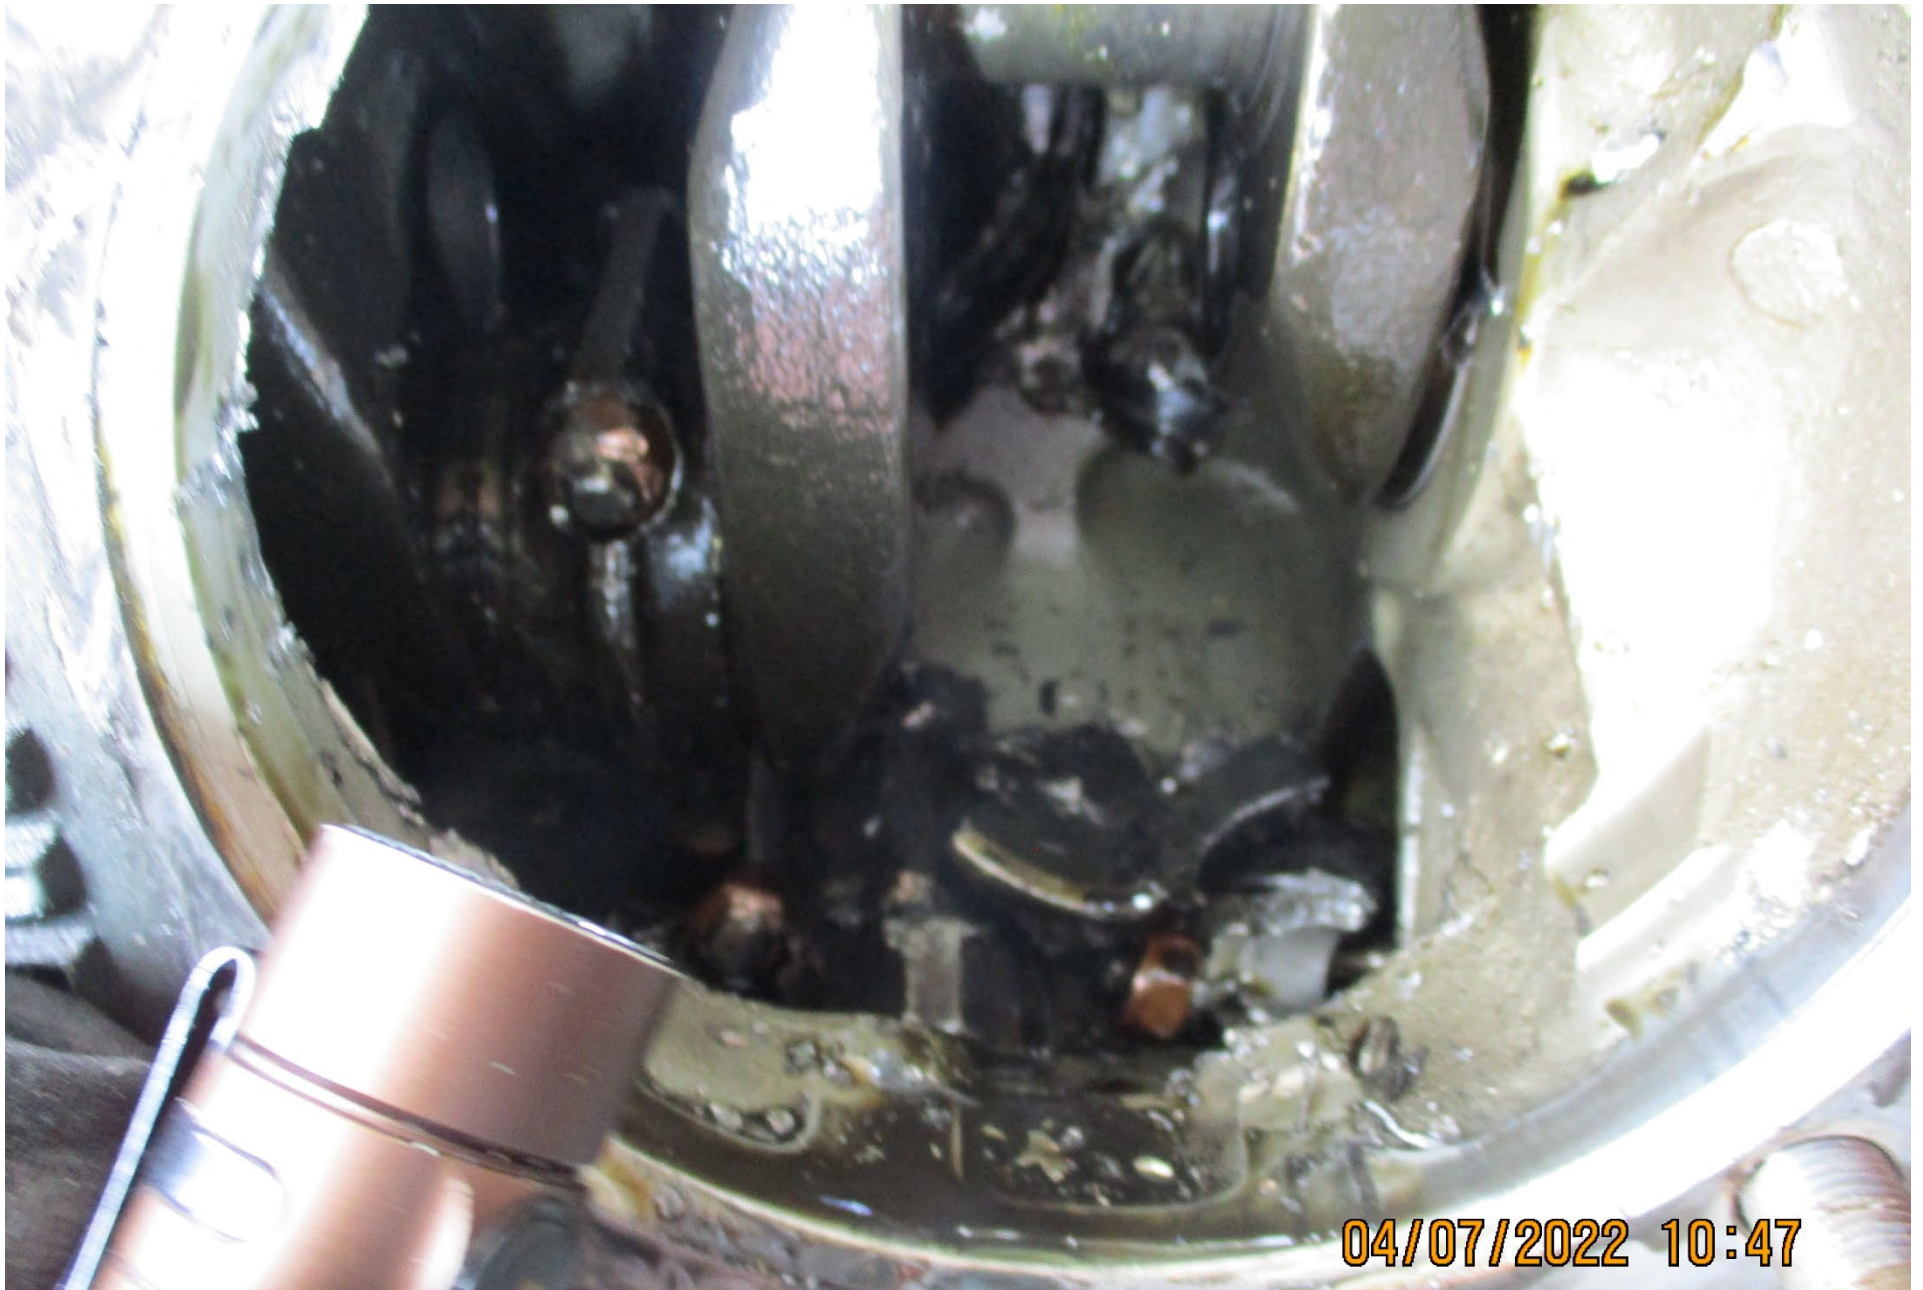
Photo 4 – metal parts at bottom of case half

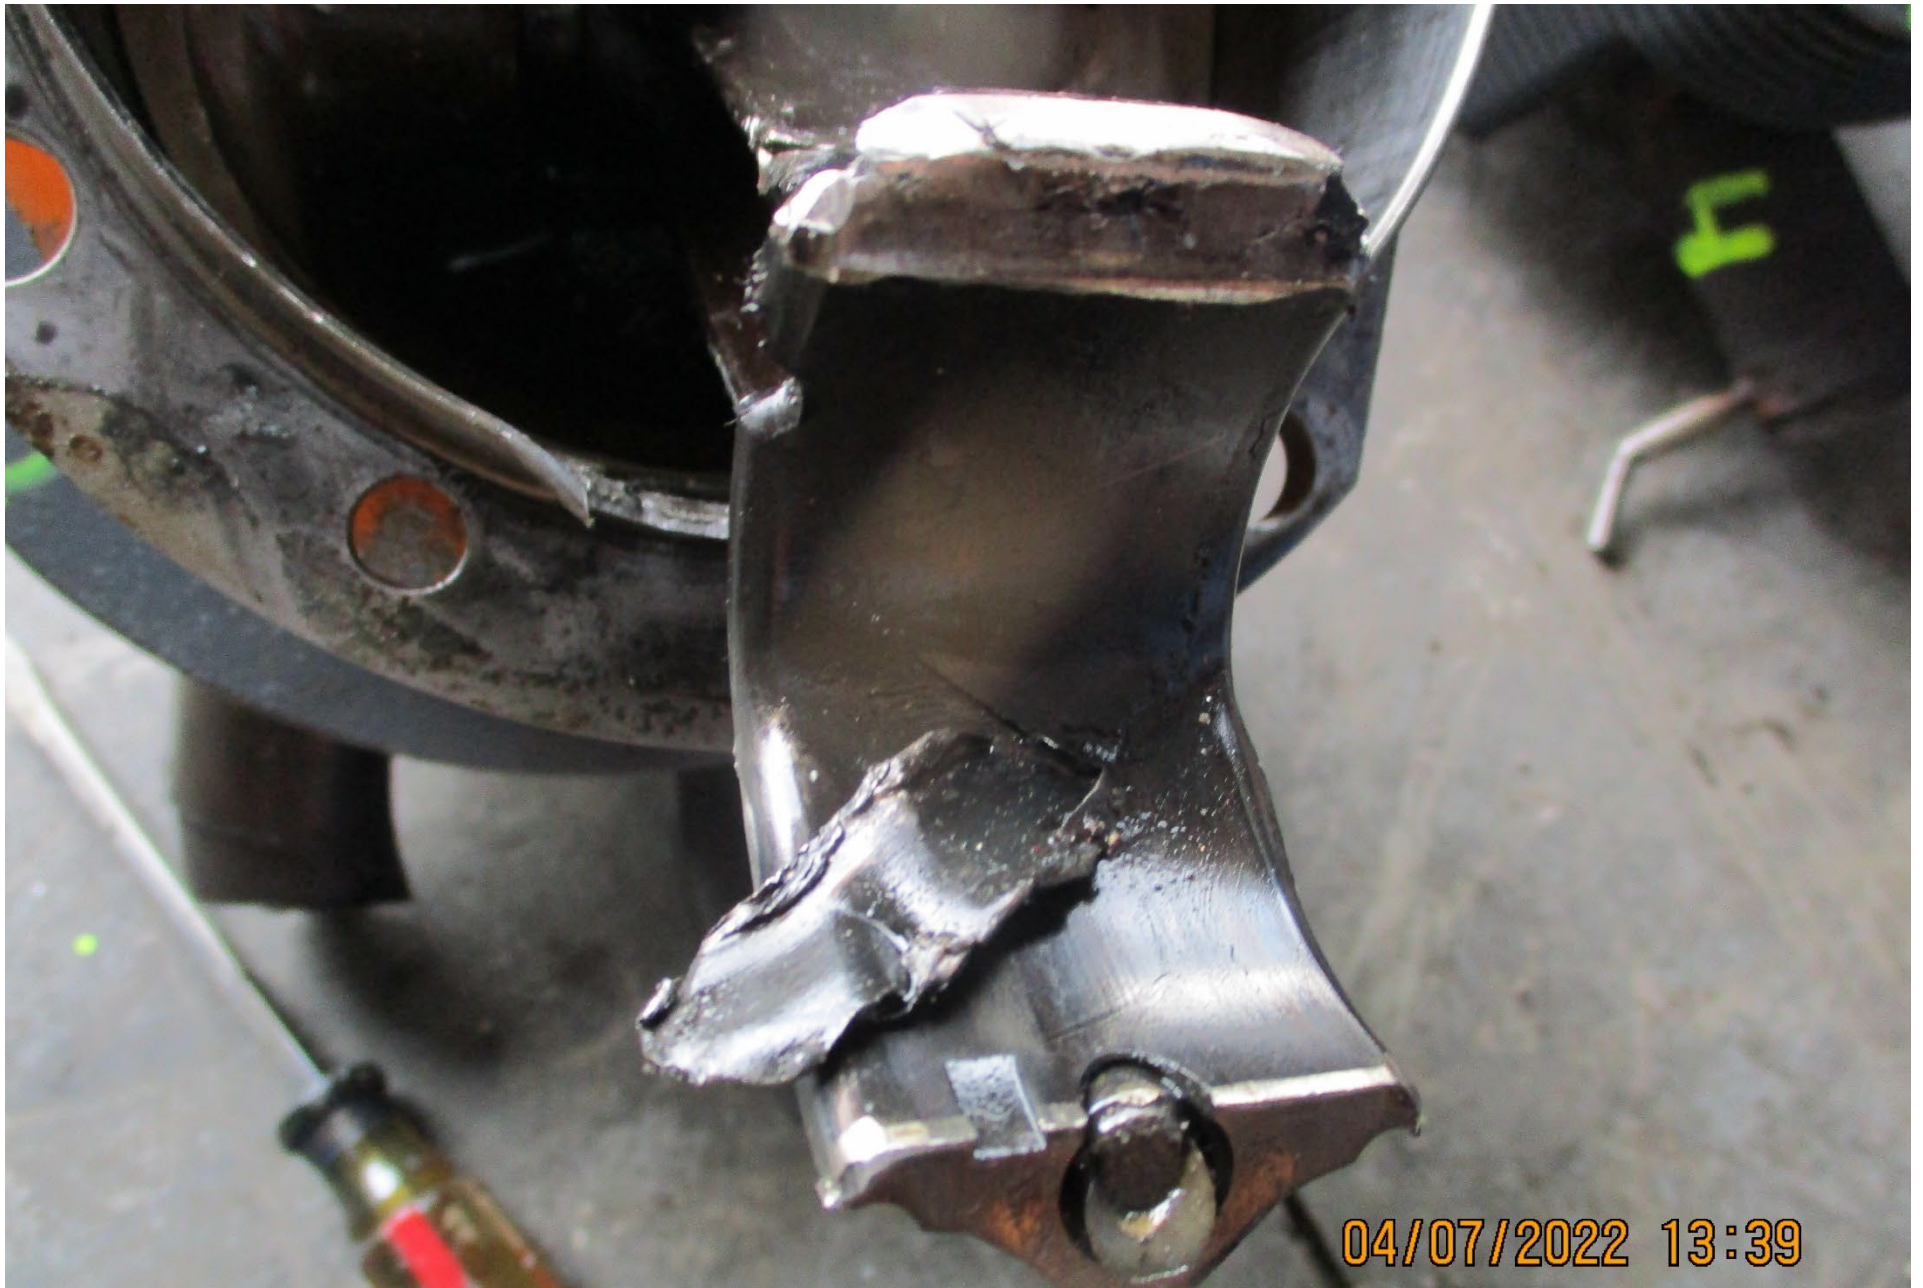
**Photo 5 – piston rod, fractured with bearing destroyed**

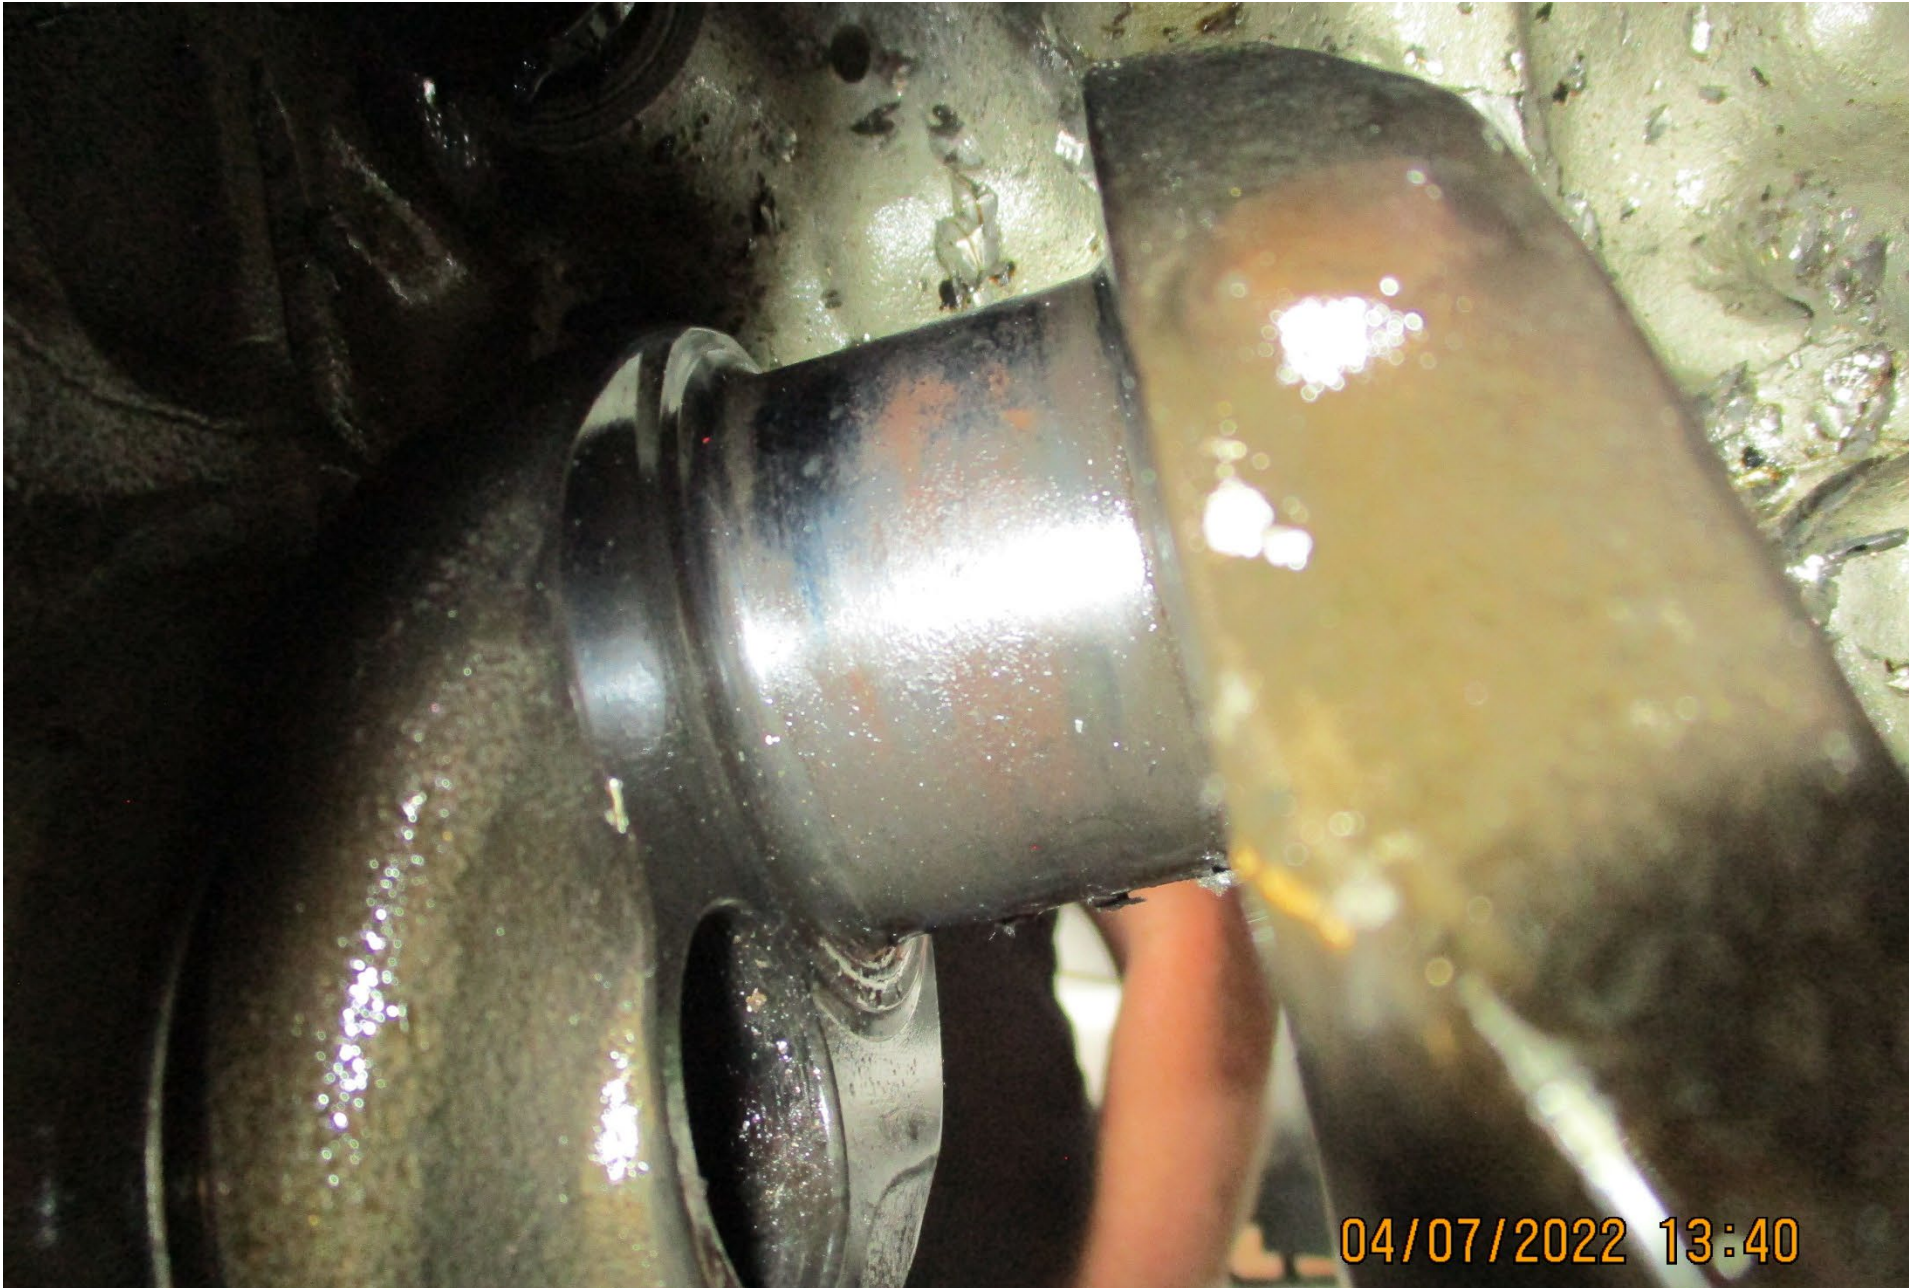
Photo 6 – crankshaft, pitted

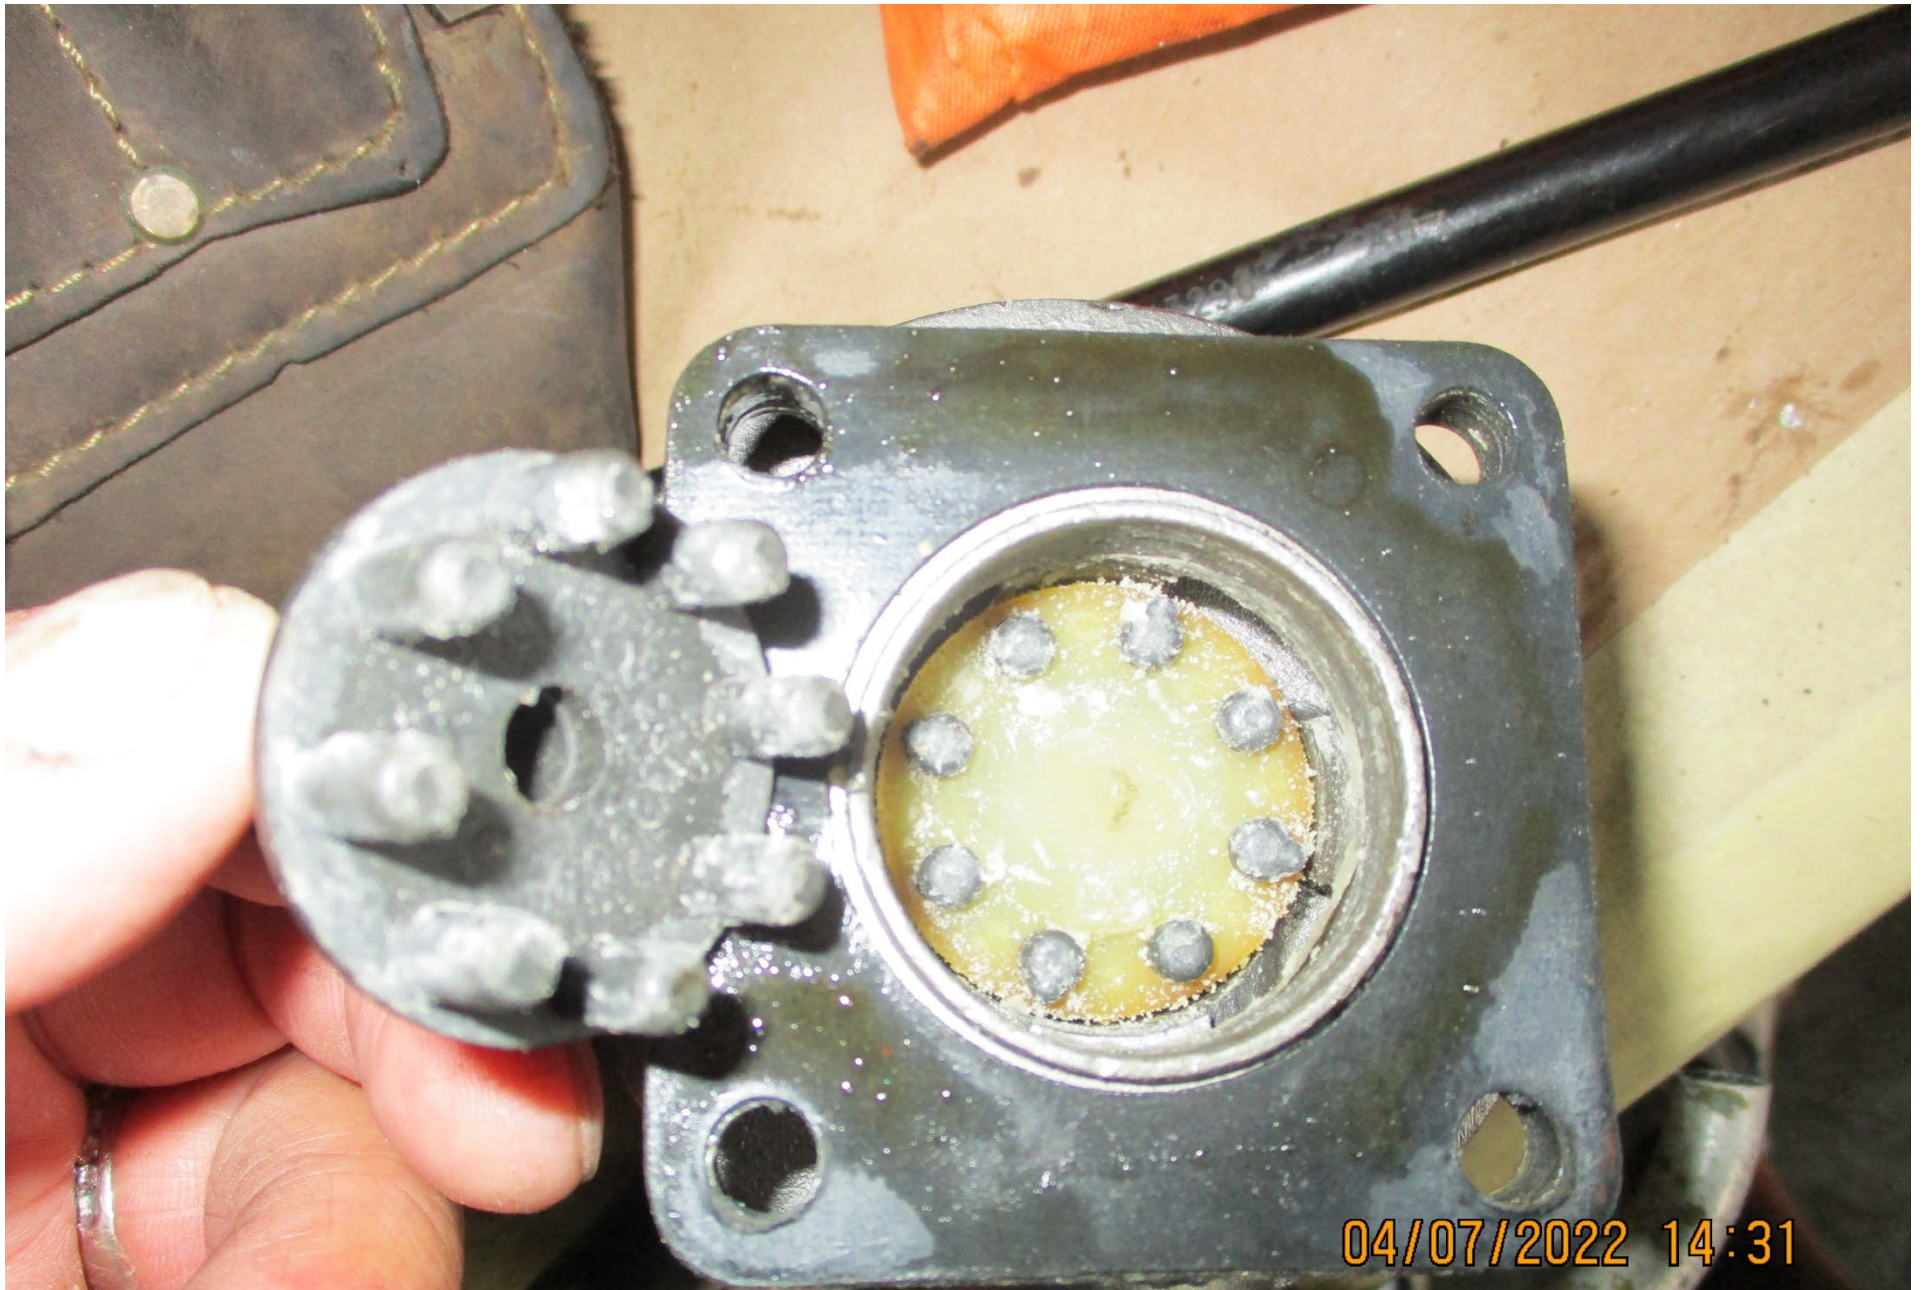
**Photo 7 – vacuum pump, coupling destroyed**
