ERA22LA191

## **AUTOMATIC DEPENDENT SURVEILLANCE- BROADCAST (ADS-B) STUDY**

Aircraft Performance Study

Location: Grantsville, Maryland  
Date: April 16, 2022  
Time: 1952 Eastern daylight time (EDT)  
2352 UTC  
Airplane: Piper PA-32-260, N3618W

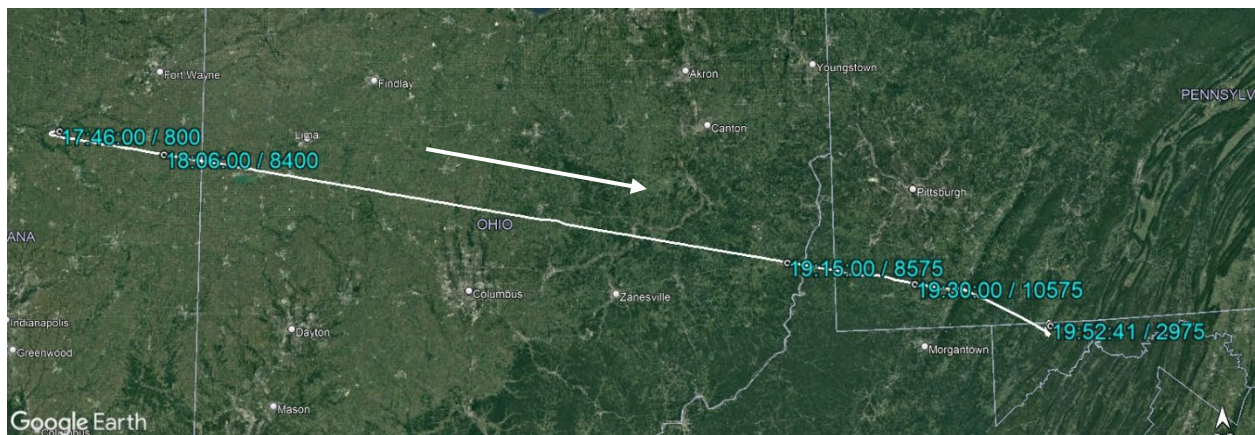
The airplane took off from Wabash Municipal Airport (KIWH) in Wabash, Indiana at 17:46 EDT (16:46 local time) (Figure 2). The airplane climbed to 8,500 ft above mean sea level (msl) by 18:05 and remained straight and level until 19:15 when it climbed to 10,500 ft msl.

**Figure 2.** ADS-B flight path with select times (EDT) and altitudes (msl) annotated.

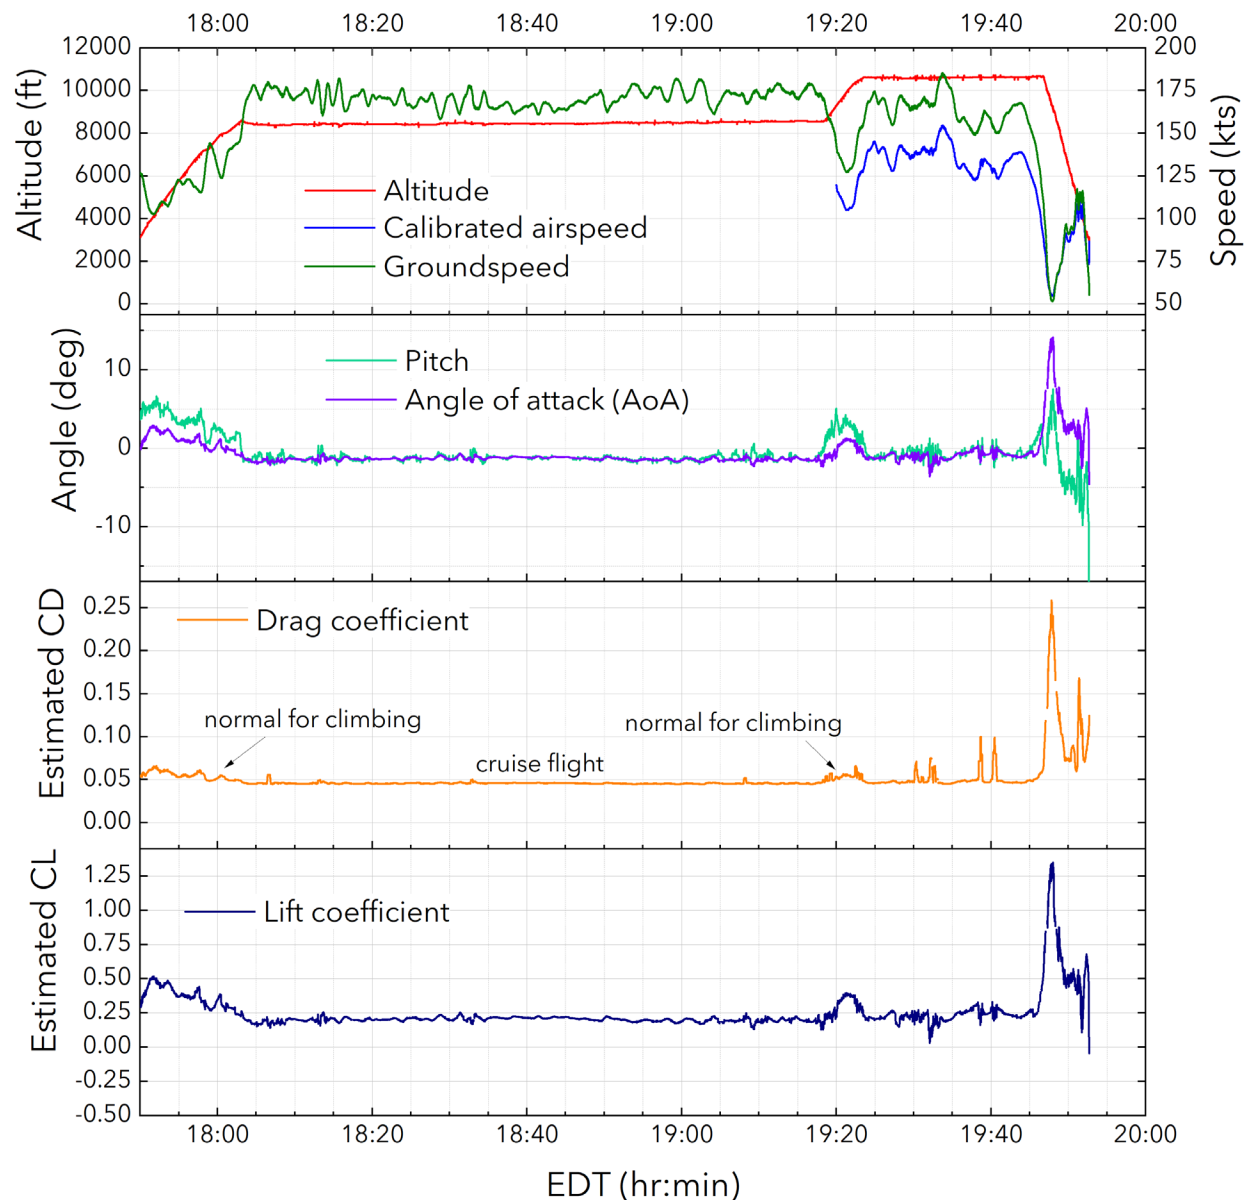
**Figure 3.** Flight altitude (msl), calculated groundspeed and calibrated airspeed, pitch and angle of attack, drag coefficient, and lift coefficient.

As would be expected, during the airplane's two climbs pitch and angle of attack increased as did the airplane's lift and drag. All parameters were mostly level during the cruise portion of flight. However, during the level flight above 10,000 ft, some unexplained increases in drag can be seen in addition to some significant increases in drag during the airplane's final descent.

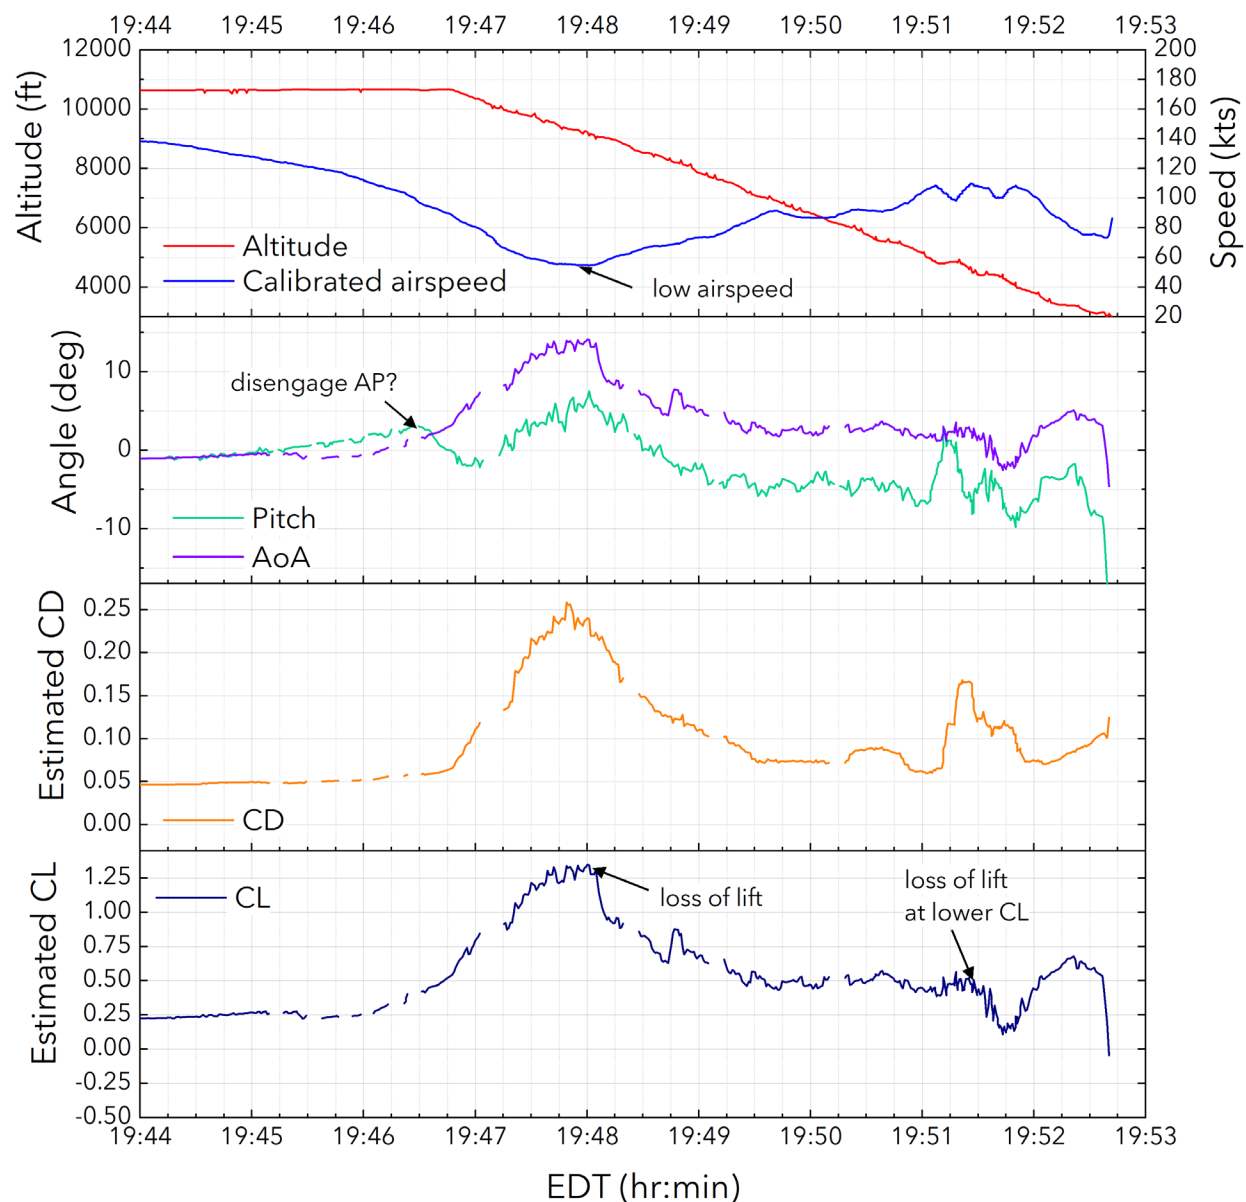
Figure 4 shows flight parameters from the final nine minutes of flight. Figure 5 shows the flight path for the final six minutes of flight. From 19:45, pitch was increasing as the airspeed dropped, which was consistent with the pilot's report that the autopilot was increasing pitch to maintain altitude, and by 19:46, lift and angle of attack were increasing. Just after 19:46:30, pitch was decreased, likely corresponding to the pilot's report that he disconnected the autopilot and decreased the pitch attitude. The airplane began to descend 15 seconds later and there was a marked increase in drag.

At 19:47 the airplane began a turn to the right, leaving the straight track it had been on for the prior ten minutes of flight. Pitch again increased, but the descent continued while lift and drag increased. Drag at this point in the flight was four times higher than at any point in the flight. The airplane's calculated airspeed slowed to near 54 kts. At 19:48, angle of attack, pitch, lift, and drag all dropped. This loss of lift was consistent with an aerodynamic stall. The airplane's angle of attack and lift had been increasing continuously as the airplane descended and slowed. The calculated 54 kts of calibrated airspeed at the time was below the listed power off, gross weight, wings level, no flaps stall speed of 57 kts [2].

At 19:51, drag again quickly increased but without an increase in lift. The airplane began a turn to the right. At 19:51:30, lift dropped sharply without having increased during the increase in drag. This sudden loss of lift occurred at a much lower lift coefficient and angle of attack than the previous event at 19:48 and at a speed well above the listed stall speeds.

**Figure 4.** Last ten minutes of flight altitude (msl), calibrated airspeed, pitch and angle of attack, drag coefficient, and lift coefficient.

However, the loss of lift at 19:51:30 occurred without an increase in the lift coefficient and a speed above 100 kts. Additionally, there was a marked increase in drag before the loss of lift. This would be consistent with an accumulation of ice on the wing increasing drag and reducing the amount of lift it could produce before stall.

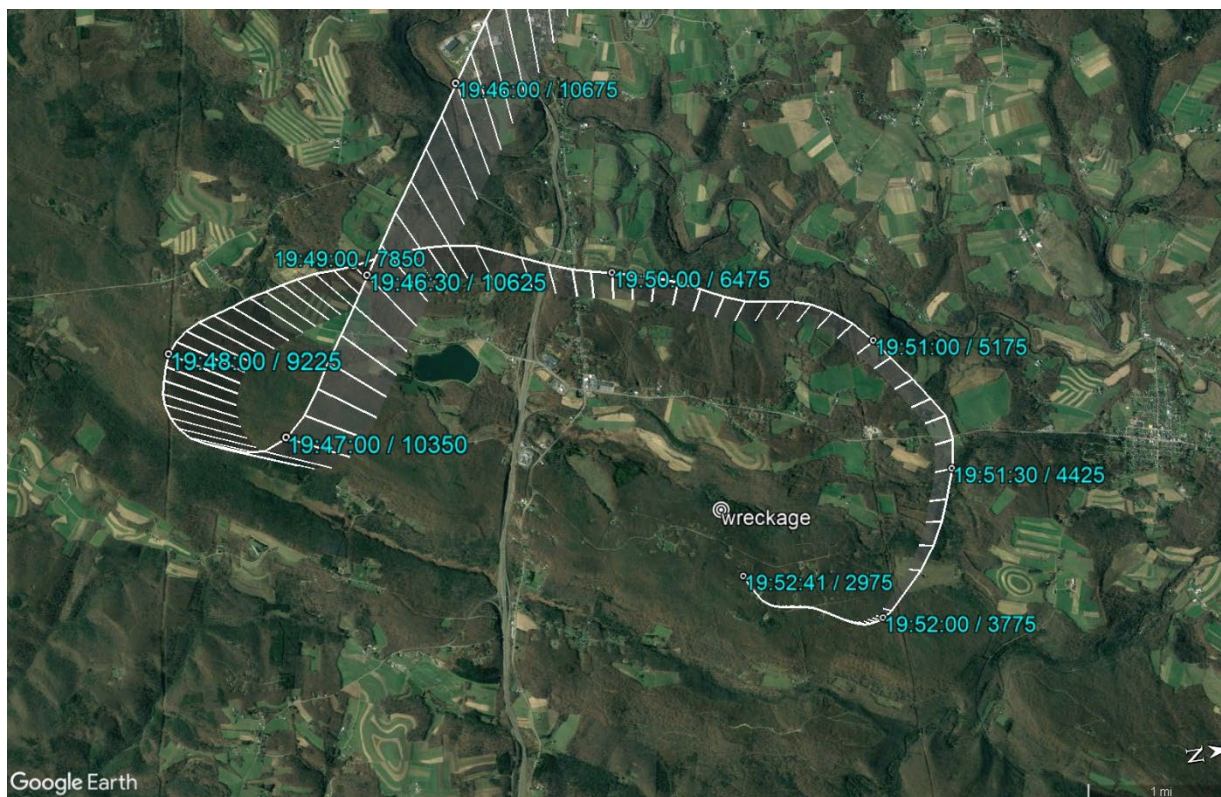
The nose was lowered and the airplane gained airspeed while continuing to descend. Lift and drag decreased, but not to pre-19:46 values. After 19:49 the airplane was on a mostly northerly track.

The airplane recovered briefly before drag again began to increase. The airplane was still descending and slowing. ADS-B data ended as the airplane descended below 150 ft above the terrain<sup>2</sup>. The wreckage was 2,500 ft farther into a valley, indicating that the airplane continued to be aloft for a few more seconds before impacting the ground.

**Figure 5.** End of flight with selected times (EDT) and altitudes (msl) annotated. North is to the right in the image.
