# National Transportation Safety Board

ERA22LA191

## **WRECKAGE EXAMINATION SUMMARY**

Location: Grantsville, Maryland  
Date: April 16, 2022  
Time: 1952 EDT  
Airplane: Piper PA-32-260, N3618W

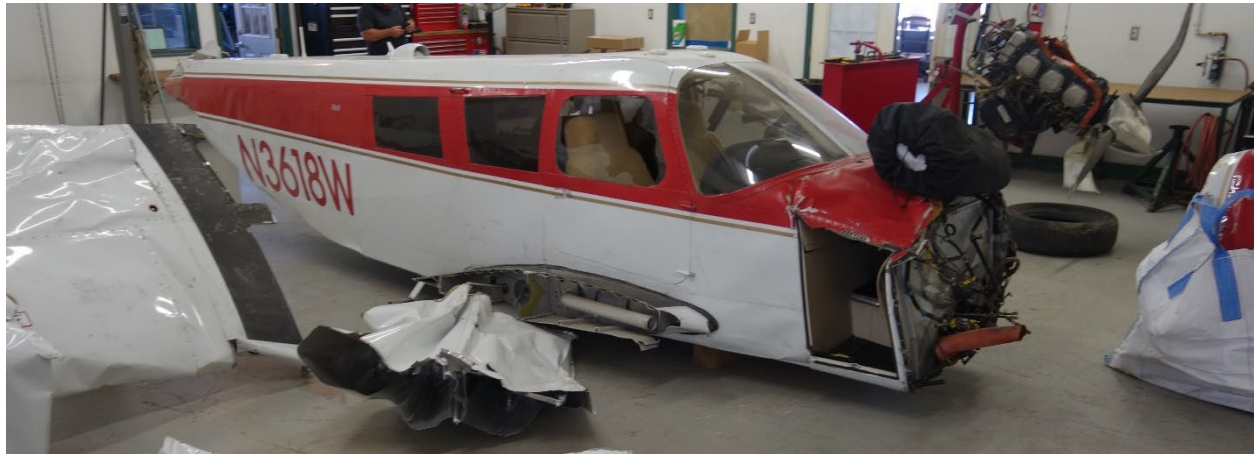
**Figure 1. View of fuselage.**

The fuselage remained intact and exhibited wrinkling on the left side. The wings and empennage were cut to facilitate recovery. Flight control cable continuity was confirmed from the flight controls in the cockpit to the flight control surfaces through multiple cuts made by recovery personnel and tensile overload fractures.

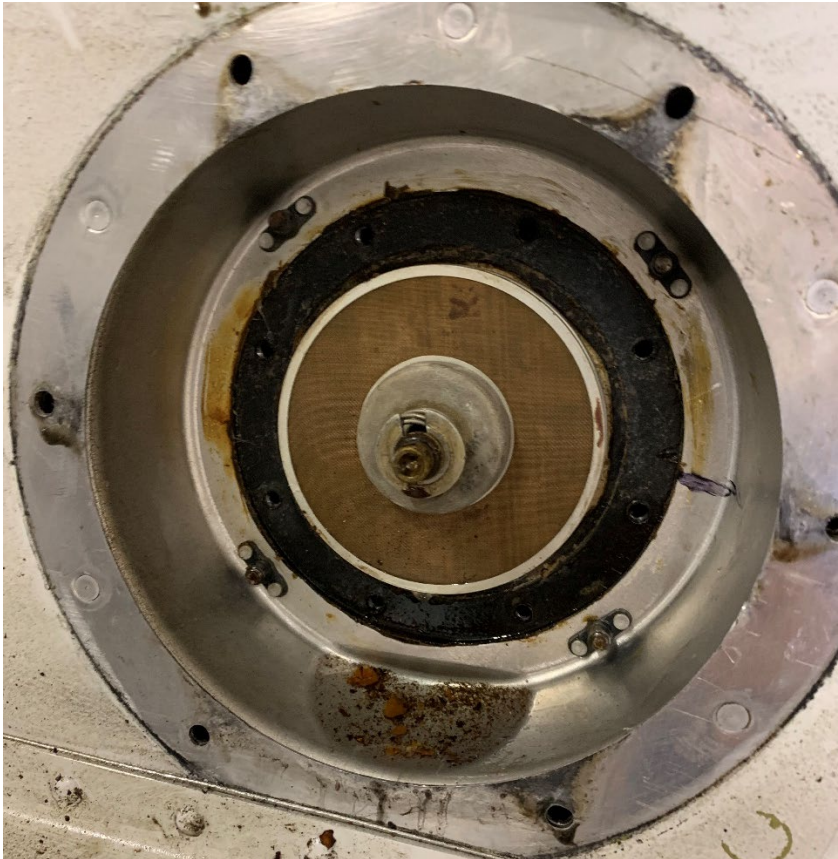
**Figure 2. Fuel strainer.**

The fuel strainer was removed from the fuselage. The screen did not contain debris. The strainer bowl contained unknown debris and fluid that smelled similar to 100LL aviation fuel. The fuel selector was noted between the right tip tank and the right main fuel tank. The fuel selector valve was noted in the right main fuel tank position.

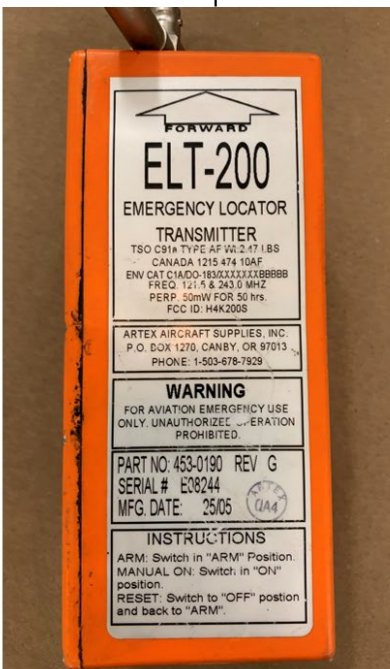
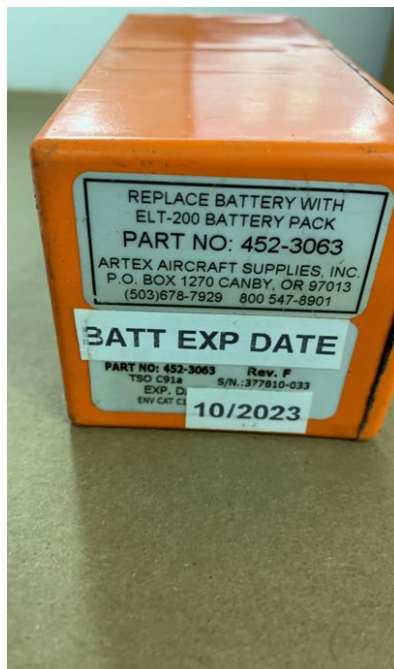
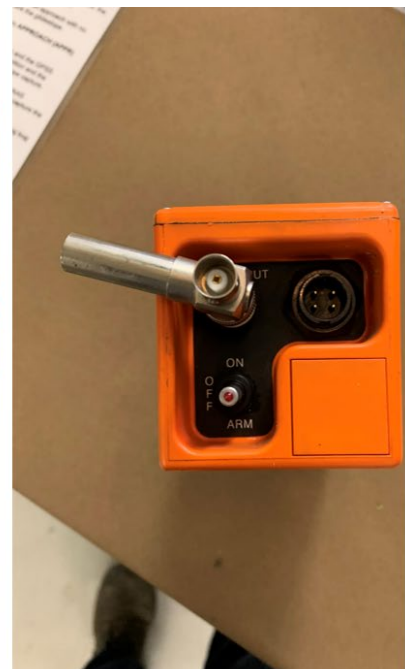
**Figure 3. View of ELT.**

The ELT remained inside the aft section of the fuselage. It was removed and it was in the OFF position.

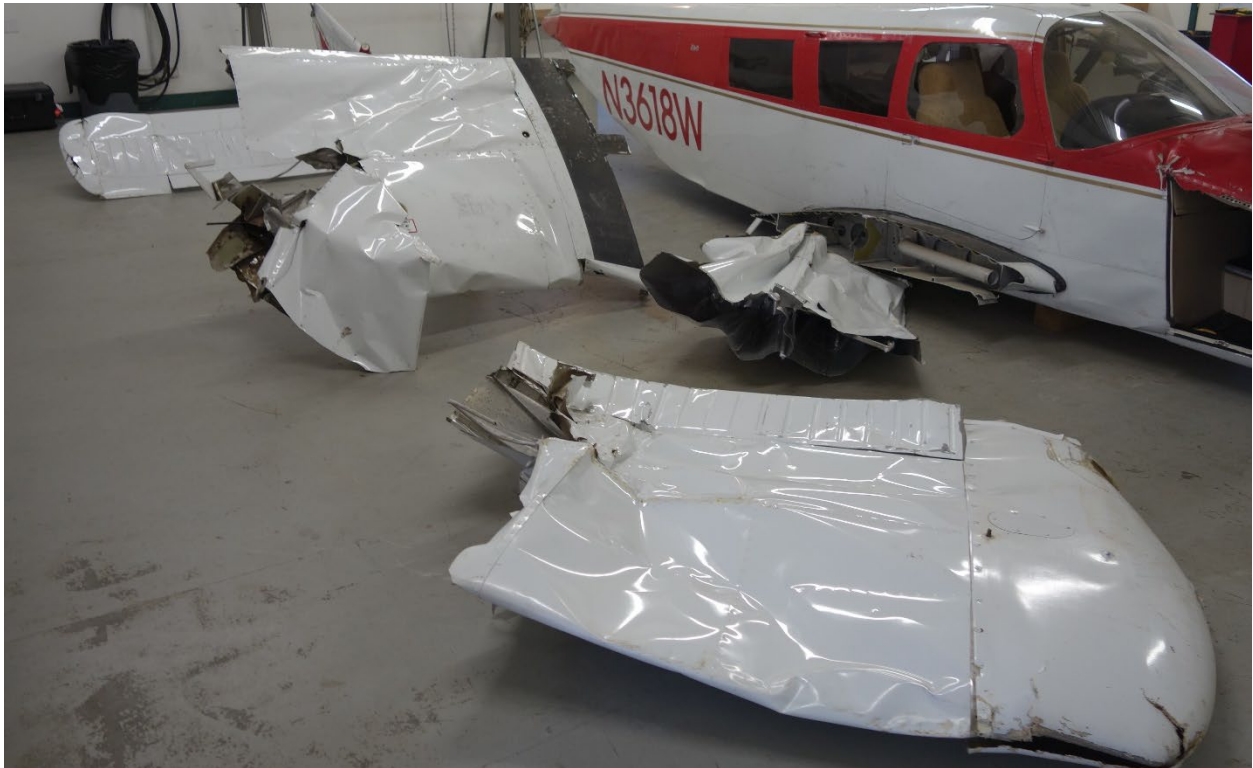
**Figure 4. View or right wing.**

The wings were cut from the fuselage for recovery. They were cut into multiple sections. All components of the wings were recovered. Both left and right wings exhibited leading edge impact damage. All fuel tanks were breeched and no fuel was present.

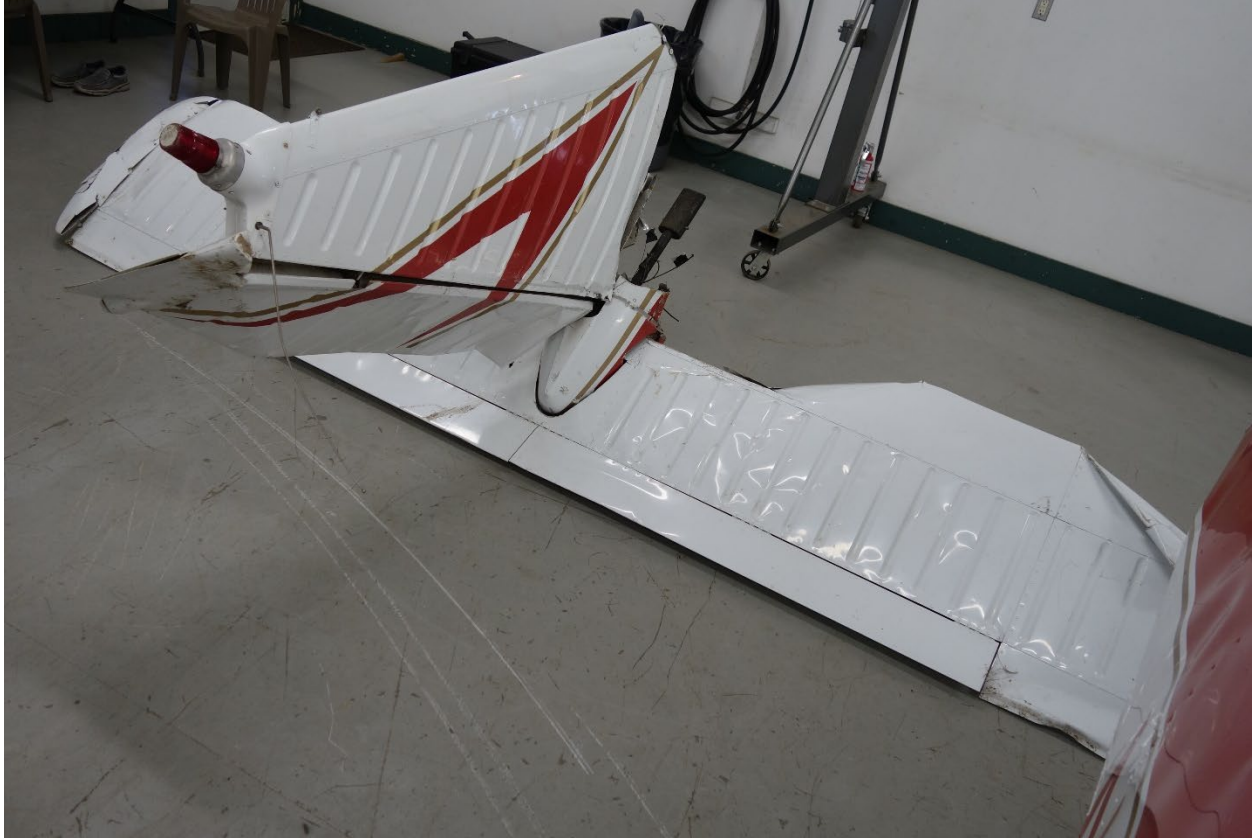
**Figure 6. View of Empennage.**

The empennage was separated from the fuselage to facilitate recovery. The stabilator balance weight remained attached. The stabilator trim tab remained attached to the stabilator. The vertical stabilizer remained attached to the empennage. The rudder remained attached to the vertical stabilizer.

A hornet's nest was located in the top of the rudder.

The pitch trim was measured and noted in the full nose up position.

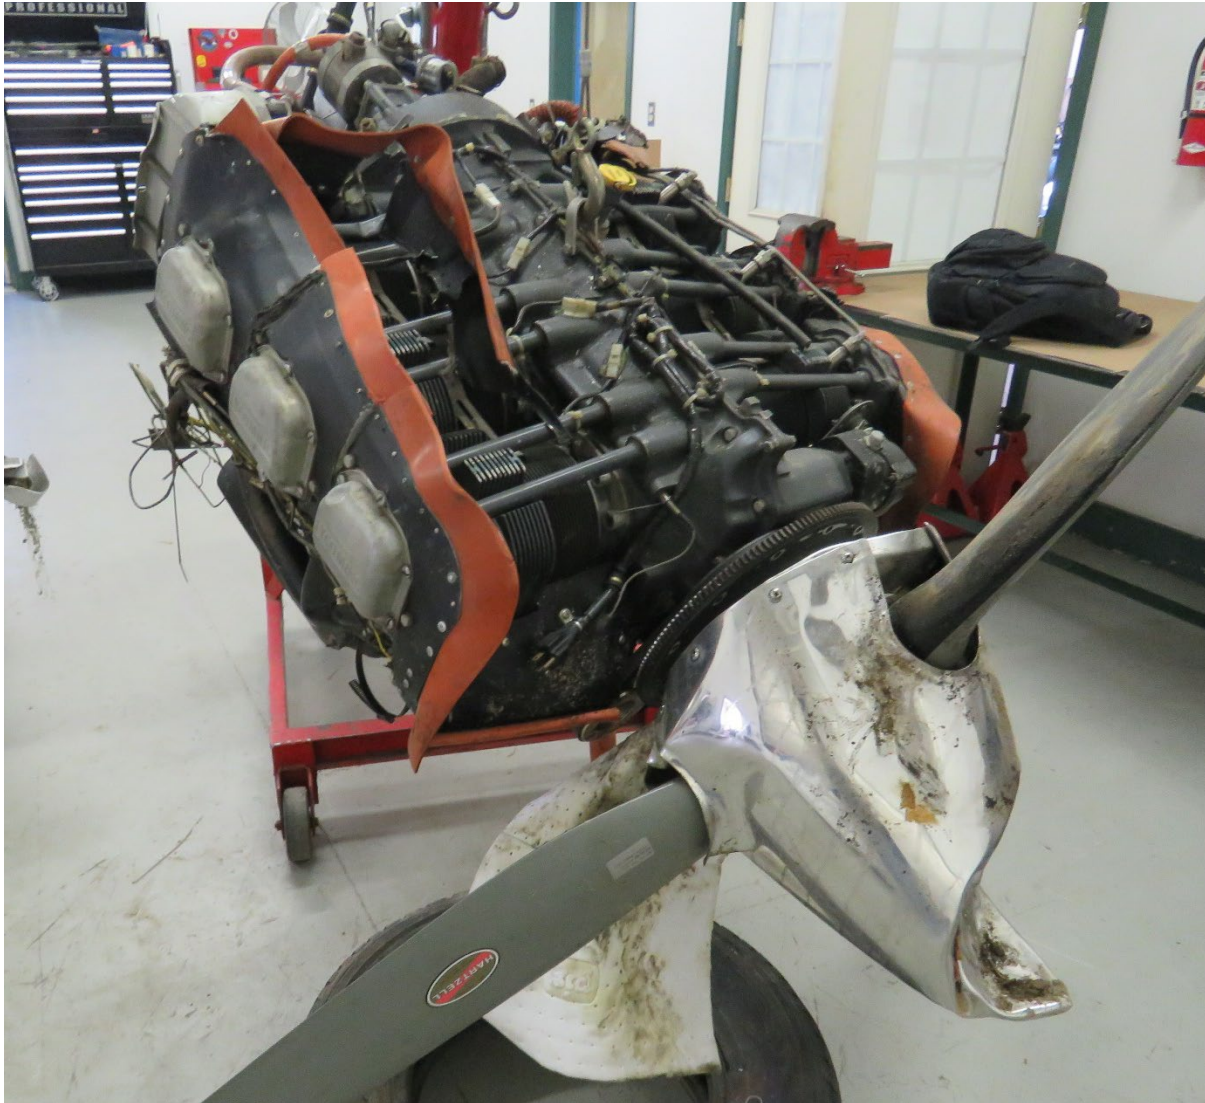
**Figure 7. View of engine.**

The engine was removed to facilitate examination. All cylinders remained attached to the crankcase and compression was observed on all cylinders. Crankshaft and valvetrain continuity were confirmed when the propeller was rotated by hand. The cylinders were examined with a lighted boroscope and no anomalies were noted.

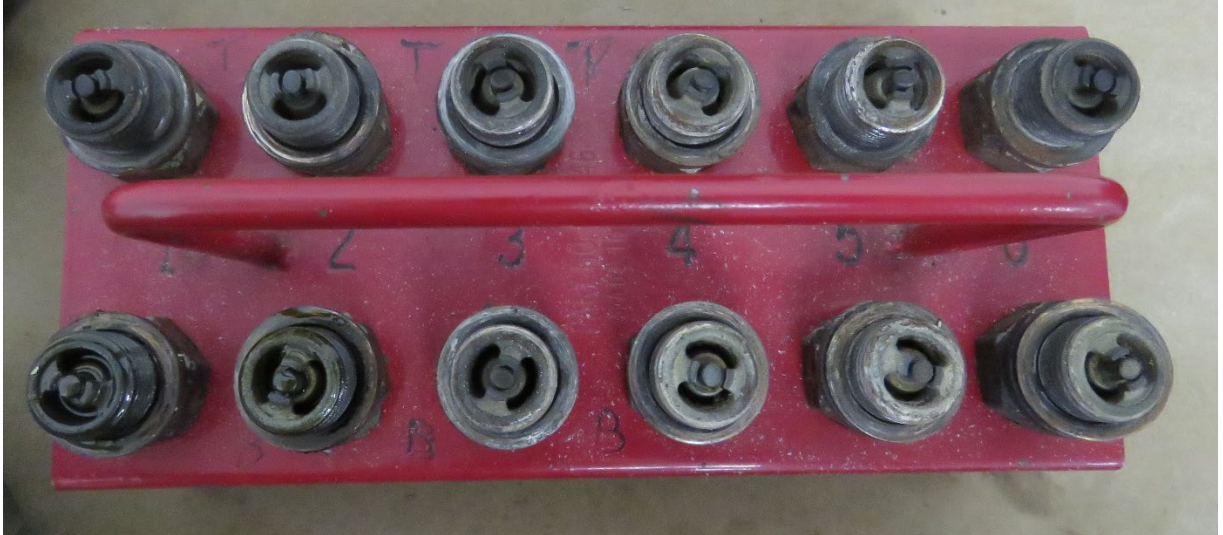
**Figure 8. View of spark plugs.**

The top and bottom spark plugs were removed. They all exhibited "worn out - normal" condition when compared to the Champion-Check-A-Plug Chart. The No. 5 bottom spark plug contained debris similar to carbon. The Nos. 1 & 2 bottom spark plugs were oil soaked.

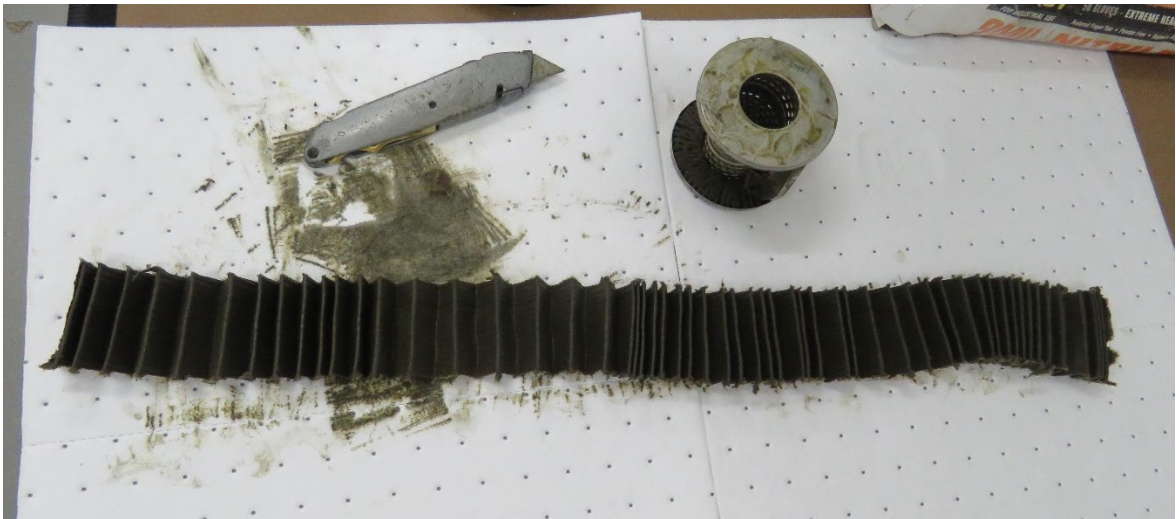
**Figure 9. View of oil filter element.**

The oil filter was removed and examined. No debris was noted in the filter element. Oil was present in the oil sump. When measured, the dipstick indicated about 3 quarts of oil. The oil suction screen was removed from the engine and no debris was noted. The oil cooler remained attached to the engine.

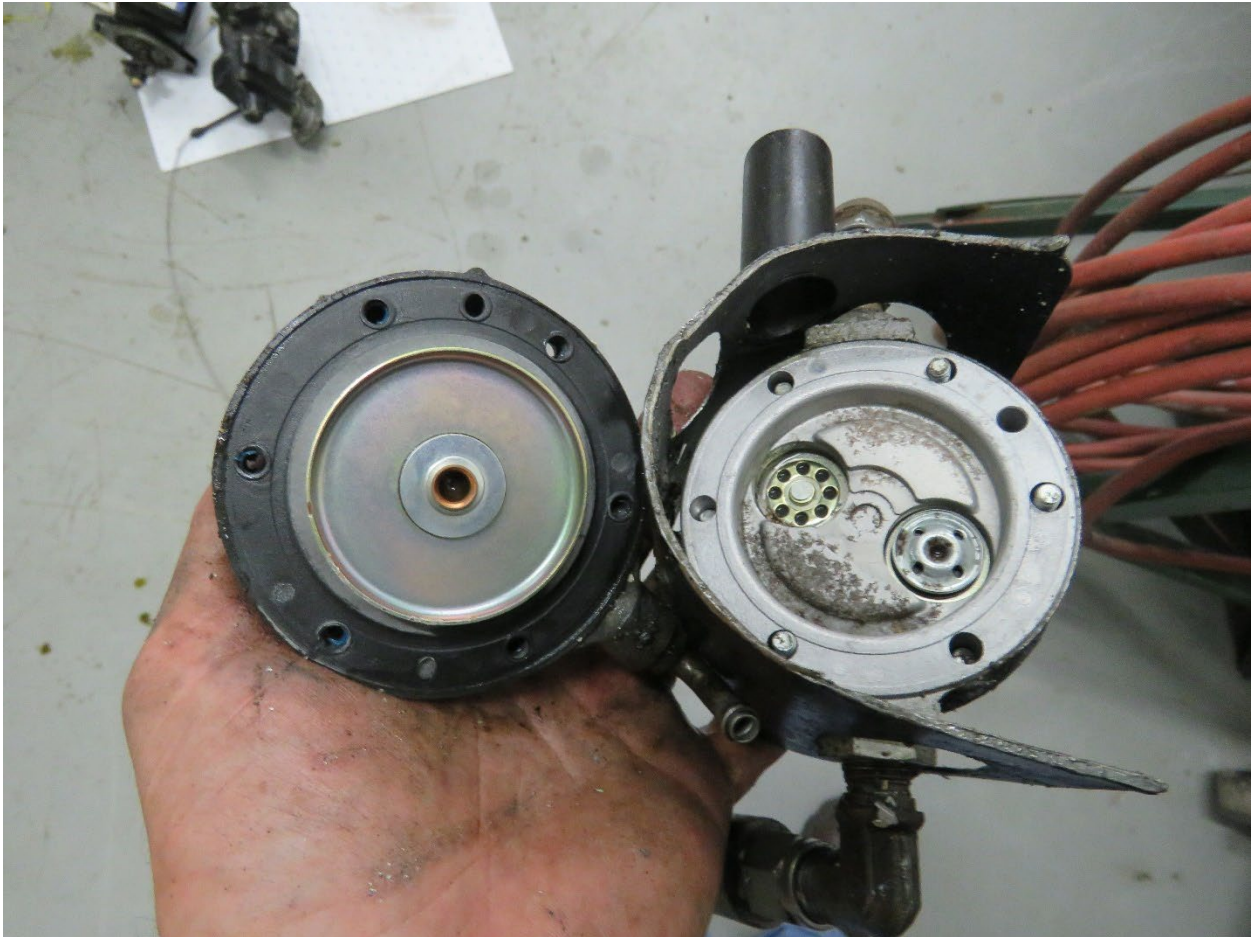
**Figure 10. View of disassembled fuel pump.**

The fuel pump remained attached to the engine firewall. The line from the airframe to the pump remained intact and the line from the fuel pump to the carburetor was impact separated. No fuel was noted in the line from the airframe to the fuel pump. The fuel pump was disassembled and fuel was noted in the fuel pump. Furthermore, the interior of the pump was corroded. The fuel pump diaphragm was examined and no anomalies were noted.

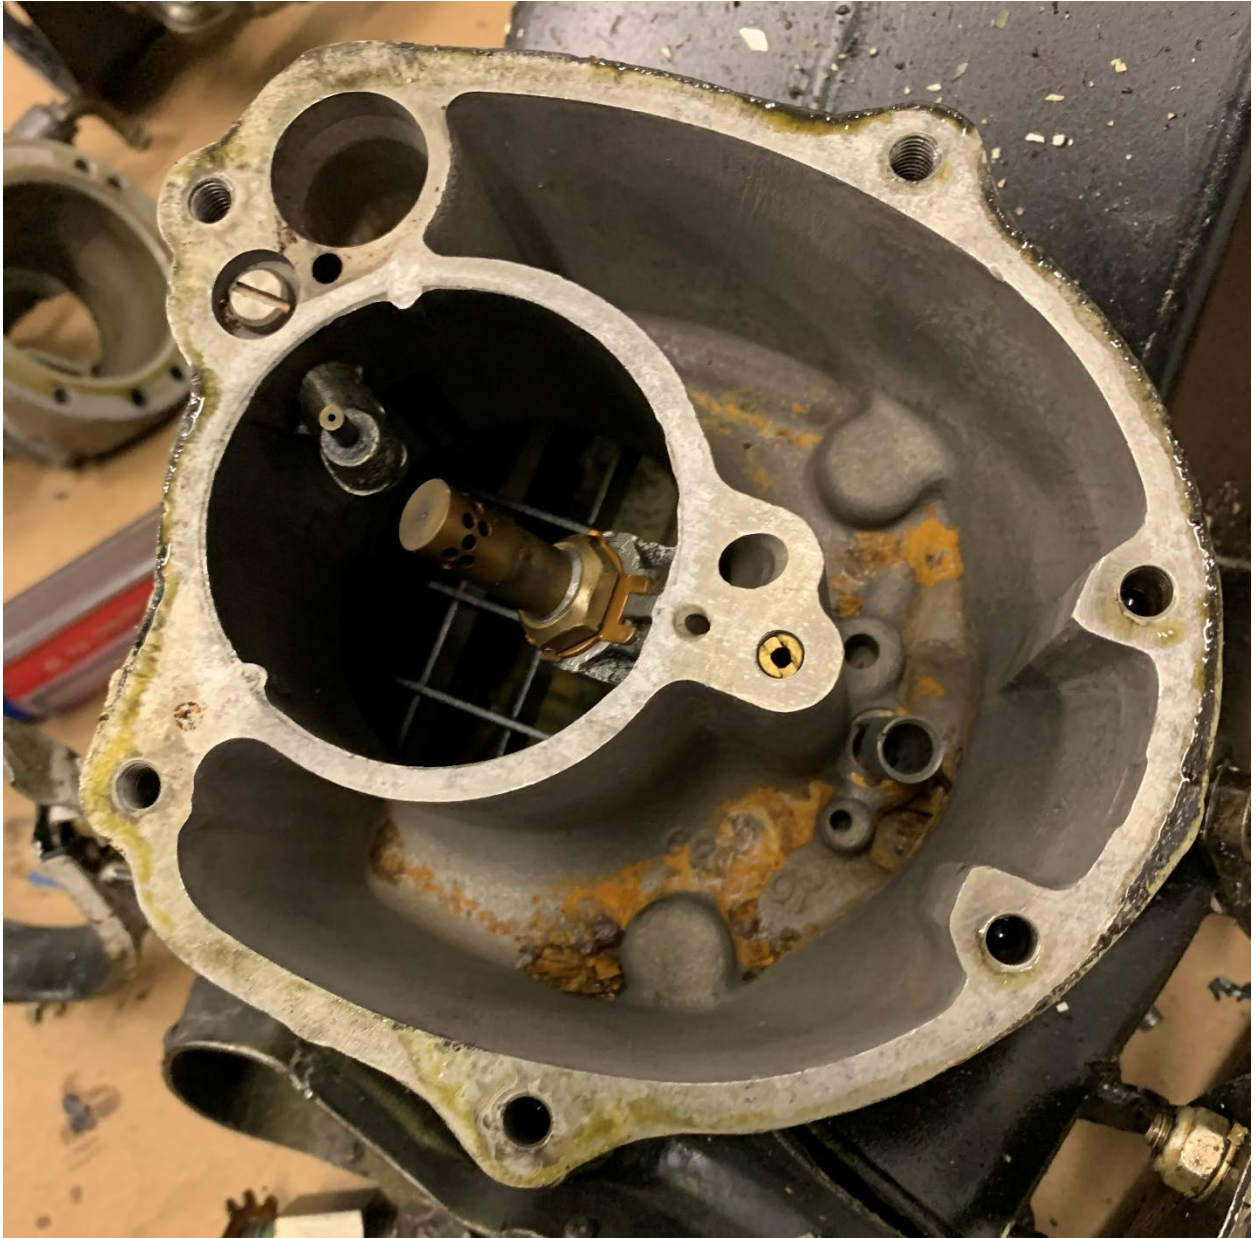
**Figure 11. View of Carburetor Bowl.**

The carburetor was removed from the engine and disassembled. The throttle and mixture control cables remained attached to their respective arms and could be operated by hand. The carburetor bowl was examined and corrosion was noted at the bottom of the bowl. No liquid was present in the bowl. The fuel screen was examined and no debris was noted. The accelerator pump actuated when moved by hand. The carburetor floats remained intact with no anomalies noted.

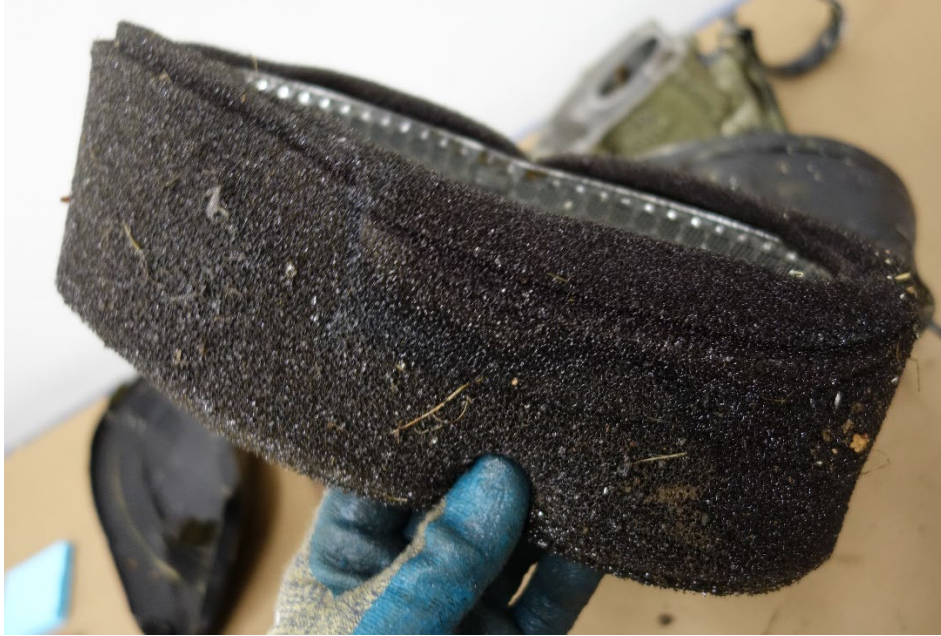
**Figure 12. View of air inlet filter.**

The air inlet box was impact damaged and remained attached to the carburetor. The filter was removed and not obstructed.

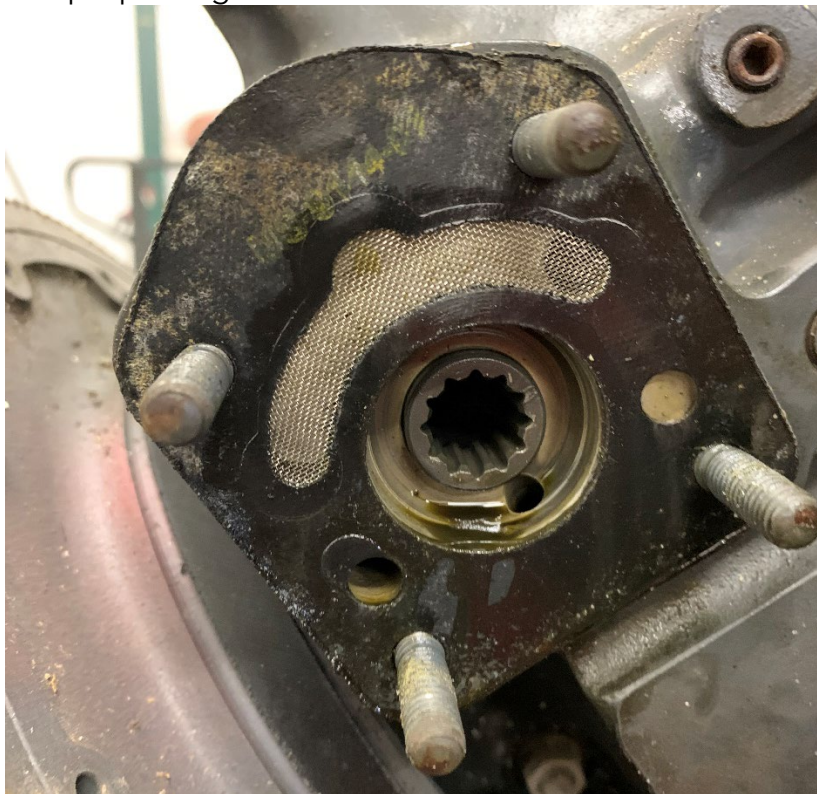
**Figure 13. View of propeller governor screen.**

The propeller governor was removed from the engine. The propeller governor control cable remained attached to the control arm but was cut to facilitate recovery. The propeller governor oil screen was examined and no debris was noted.

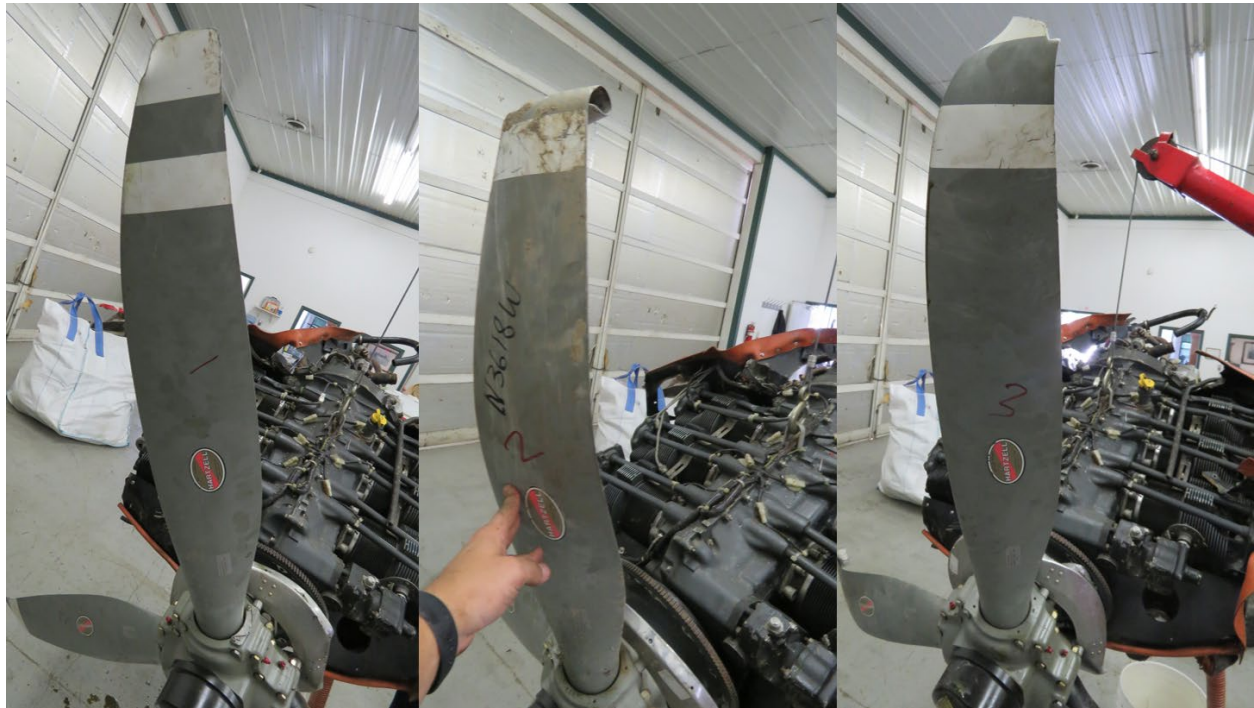
**Figure 14. View of propeller blades.**

The propeller remained attached to the engine. It could be rotated through 360° of motion. All three blades remained attached to the propeller.

Blade 1 exhibited tip damage and remained straight.

Blade 2 tip was curled, and the tip was torn.

Blade 3 remained straight and the tip was torn.
