## **NATIONAL TRANSPORTATION SAFETY BOARD**

# **EXAMINATION SUMMARY**

**ERA22LA213**

Location: Huntsville, Alabama  
Date: May 1, 2022  
Time: 1705 CDT  
Airplane: N1218B, RV7A

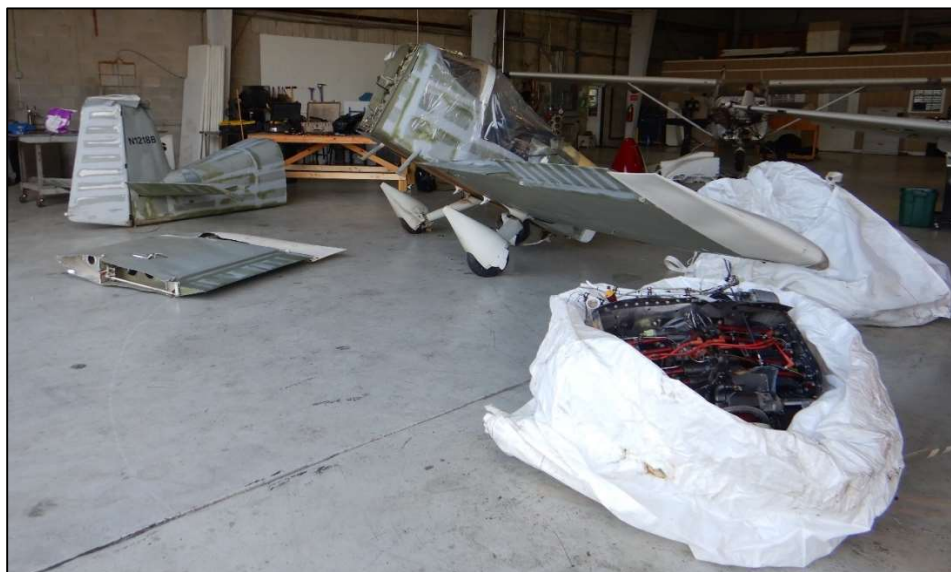
*Photo 1- Wreckage laid out for examination*

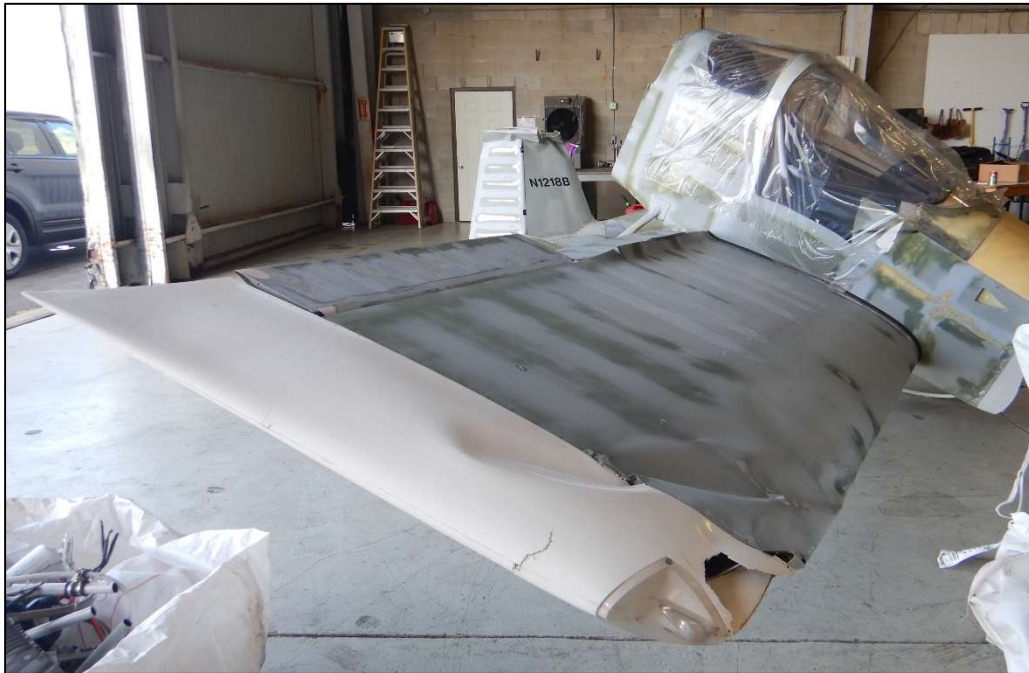
at its outermost 3 feet. The right wing with flap and aileron attached was intact and the outermost 3 feet of the leading edge was impact damaged. The flap was impact displaced forward and downward.

*Photo 2 - Right Wing*

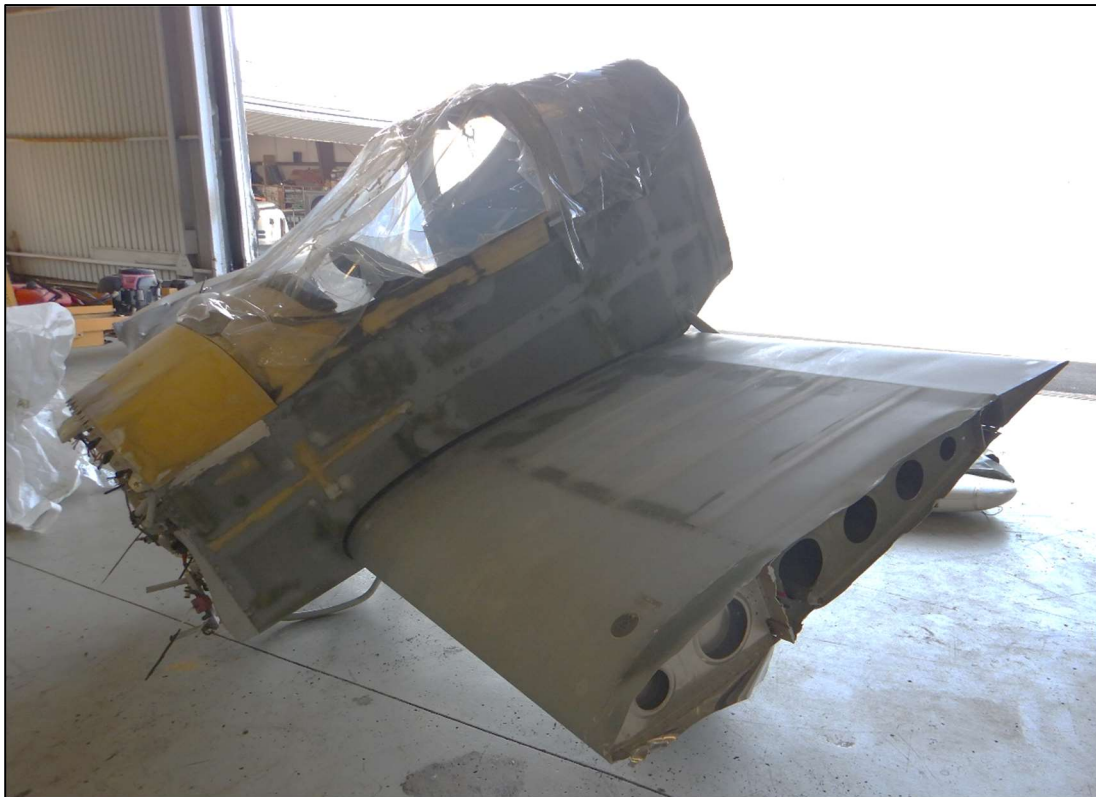
The fuselage was intact, and the canopy was in the closed and latched position; however, the plastic canopy was fractured with the pieces in a nearby wreckage bag. The left wing had been cut just outboard of the wing fuel tank for recovery and the flap was still attached. The outer section of the left wing with aileron attached displayed impact damage from the leading edge aft

*Photo 3 - Left wing cut for recovery*

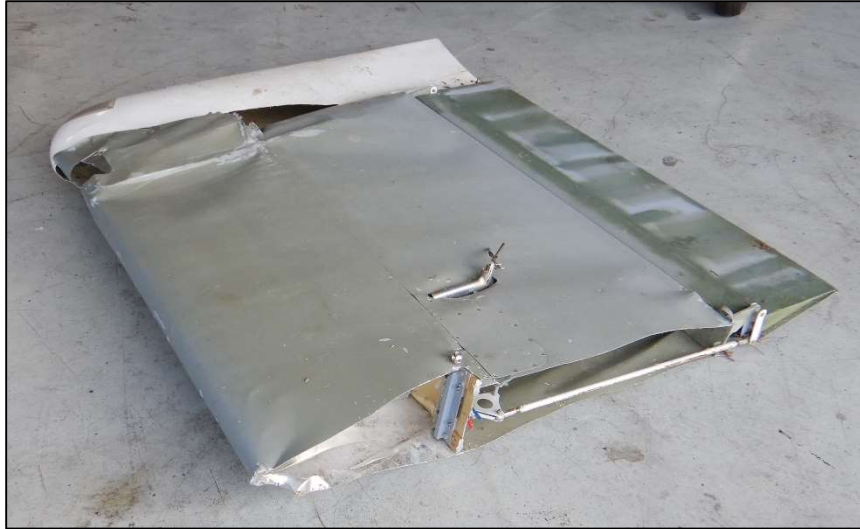
*Photo 4 - Outboard section of left wing with aileron attached*

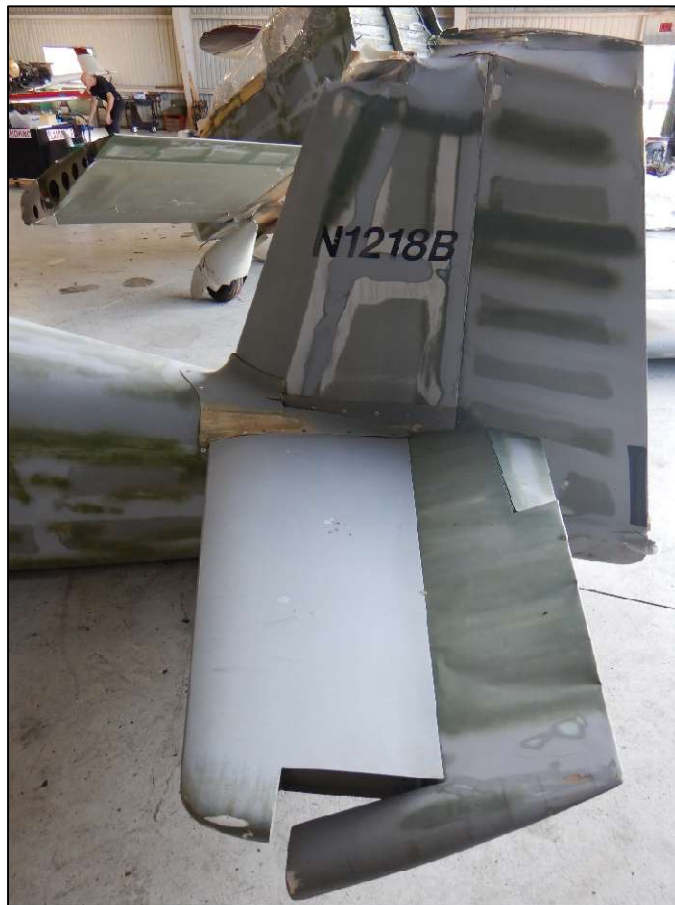
The fuselage and empennage had been separated for recovery. The fuselage and cockpit were intact except for the canopy plastic. The empennage was intact with the rudder attached to the vertical stabilizer and the elevators attached to the horizontal stabilizers. The top portion of the vertical stabilizer and rudder were impact damaged.

*Photo 5 - Empennage with elevators and rudder intact*

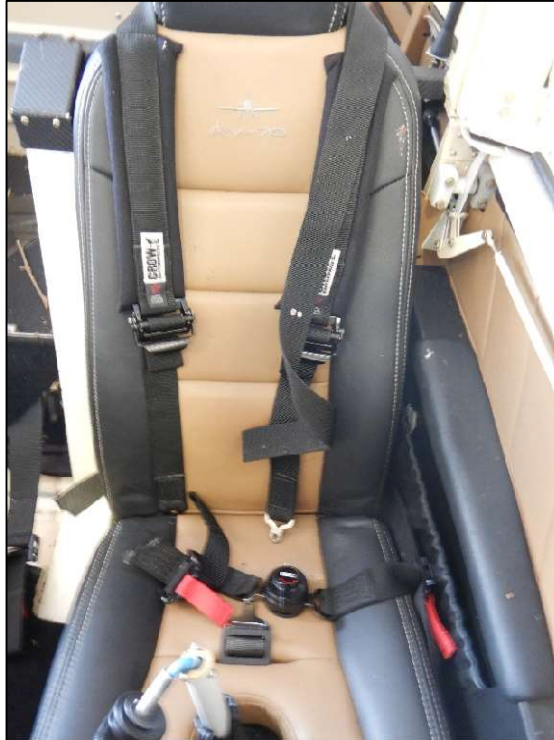
The right seat had been removed and the seat base was detached from the back, and the left seat was intact and attached to the fuselage. There was a 5-pt harness and seat belt for the left seat. The left and right lap belts were still connected to the center locking mechanism, and the right lap belt had been cut. The left and right shoulder harnesses were found attached to their attachment points in the empennage through cable cuts for recovery. The shoulder harness webbing and attachment latches appeared undamaged. The shoulder harness straps for the left seat were not attached to the center locking mechanism.

*Photo 6 - Left pilot seat with lap belts attached to locking mechanism*

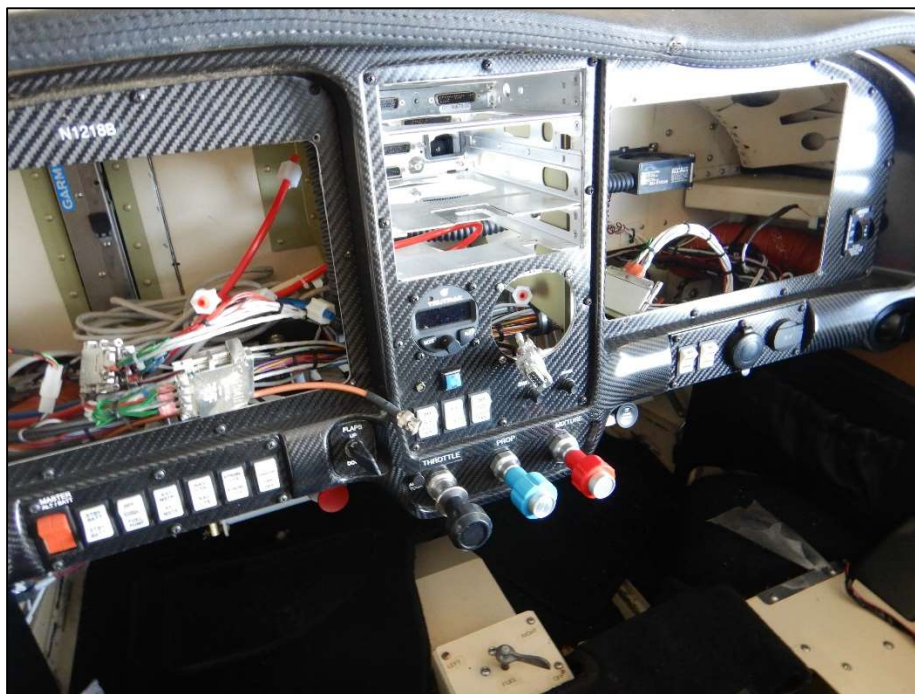
There was no fuel present in the left or right wing fuel tanks. The fuel selector handle was in the OFF position. The firewall fuel line fitting to the cockpit fuel selector dripped a liquid consistent with fuel.

The instrument panel was intact and undamaged with most instruments removed at recovery and available for inspection. The cockpit was observed and photographed. The Master Switch, Fuel Pump, Taxi light, Pitot Heat, and Defrost Fan switches were in the OFF positions, and the Standby battery, AVI Master, Nav Lights, Strobe lights and Autopilot were in the ON positions. The throttle, mixture and propeller controls knobs were in their full IN positions. The carburetor heat was in the OFF position.

*Photo 7 - Control panel and fuel selector with avionics removed*

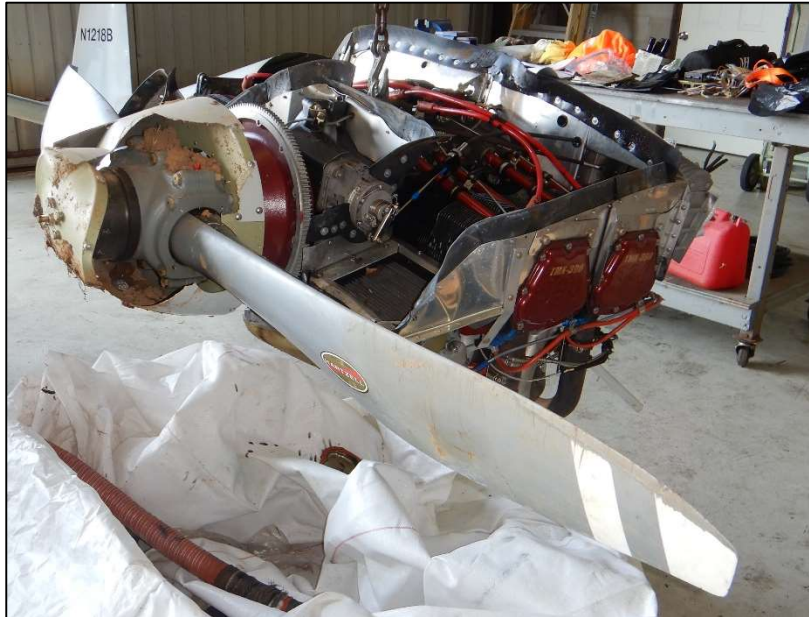
*Photo 8 - Engine and propeller before examination*

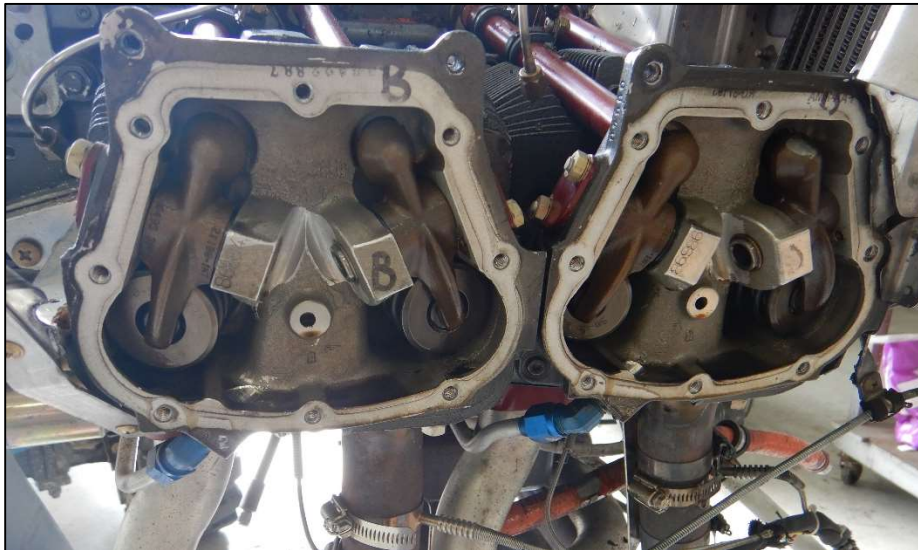
The rocker covers were removed, and the top and bottom spark plugs were removed. The upper and lower spark plugs were worn normal condition. The engine crankshaft was rotated by turning the propeller and continuity of the crankshaft to the rear gears and to the valve train confirmed. Compression and suction were observed from all cylinders. The interiors of the cylinders were observed using a lighted borescope with no anomalies noted.

*Photo 9 - Cylinders B and D with rocker covers removed*

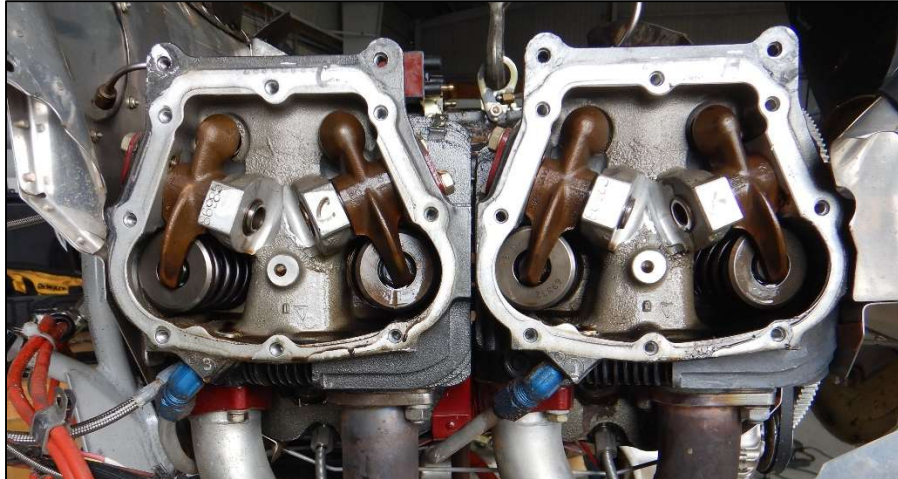
*Photo 10 - Cylinders C and A with rocker covers removed*

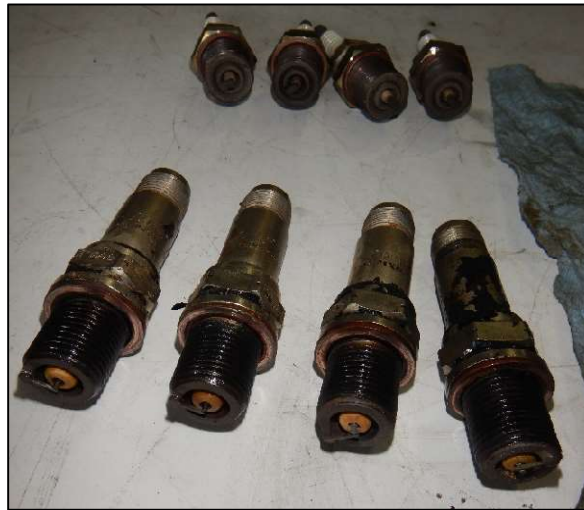
*Photo 11 - Spark plugs*

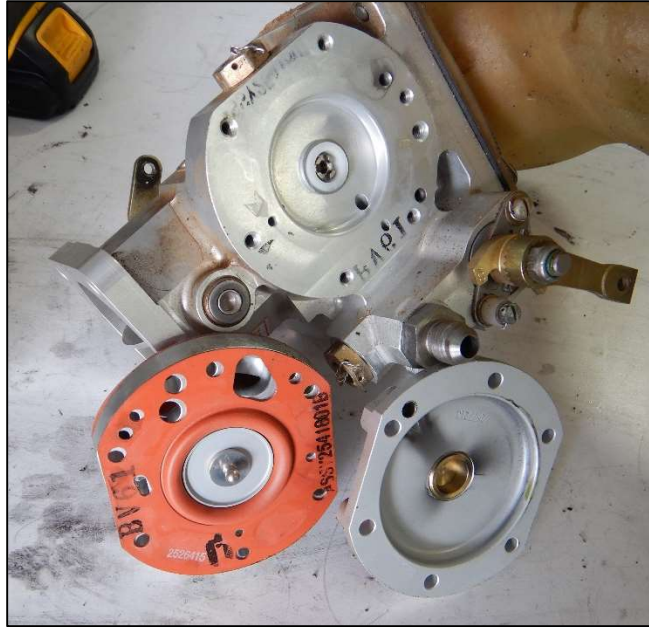
The fuel injector servo was removed with no damage noted. The throttle control arm remained attached and was in the full throttle position. The mixture arm remained attached and was in the full rich position. A few drops of liquid consistent with fuel were present when the servo was turned upside down. The diaphragms were undamaged, and the fuel inlet screen was unobstructed. The fuel flow divider remained attached to the engine with no damage noted. The fuel injector lines remained securely attached. It was partially disassembled with no damage noted to the rubber diaphragm. There was no fuel noted. The engine driven fuel pump was removed with no fuel noted. The fuel pump produced air at the outlet port when actuated by hand. It was partially disassembled with no damage to the rubber diaphragms or internal check valves and no fuel noted. Fuel injector nozzles were unobstructed. The left magneto remained attached to the engine and was removed. Sparks were produced on all leads when the magneto was rotated by hand. The right side ignition was electronic and was not tested; the upper high tension contacts for each coil were broken off. No fuel was noted in any fuel lines forward of the firewall. The oil suction screen was absent of debris. The oil filter was cut open and was absent of debris.

*Photo 13 - Disassembled fuel selector servo*

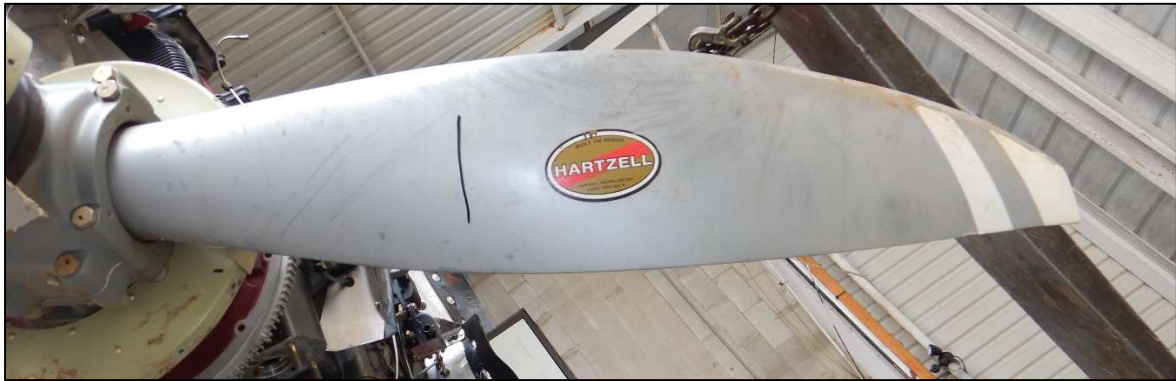
- Blade 1 – Aft bend; leading edge gouging and chordwise abrasion
- Blade 2 – Aft bend; leading edge gouging and chordwise abrasion

*Photo 14 - Propeller blade 1*

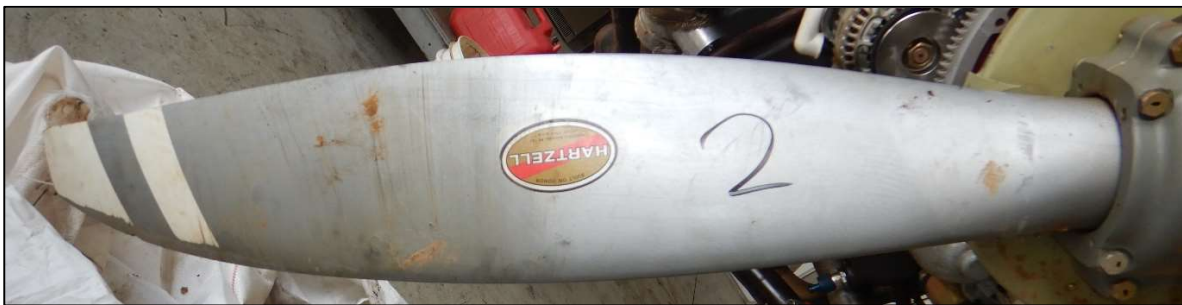
*Photo 15 - Propeller blade 2*

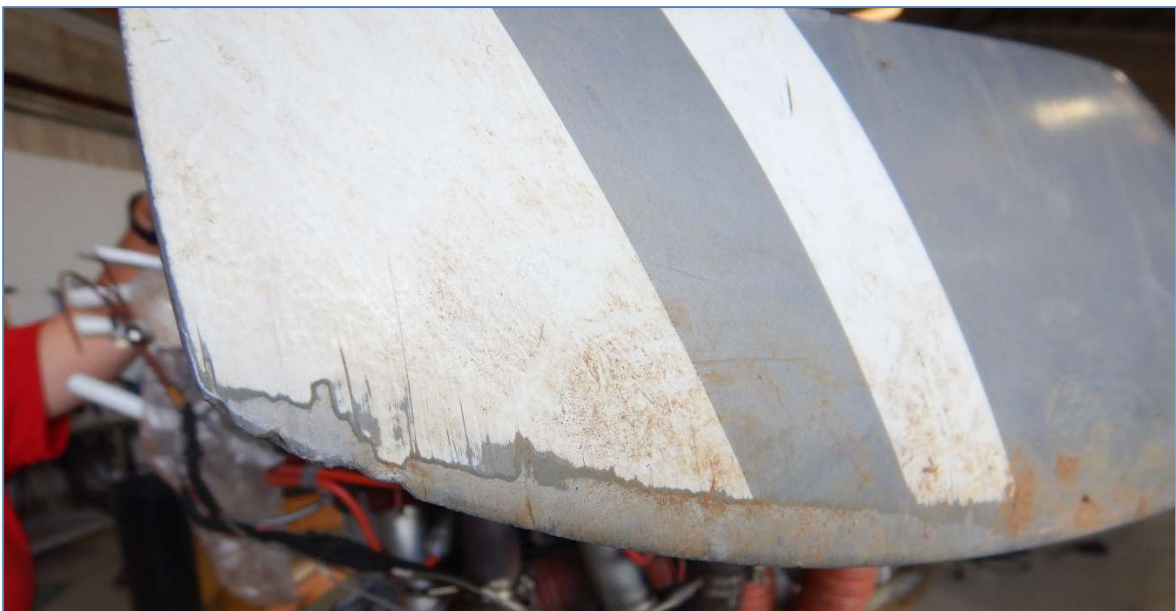
The propeller remained attached to the engine crankshaft flange. The propeller spinner was impact fragmented. Both propeller blades were curved aft about 10 degrees at about mid-span and exhibited chord-wise scratches and leading edge gouges.

*Photo 16 - Close-up view of leading edge gouging on blade 1*
