# NTSB ERA22LA215

N46TA, Cessna 414

Investigative Photographs

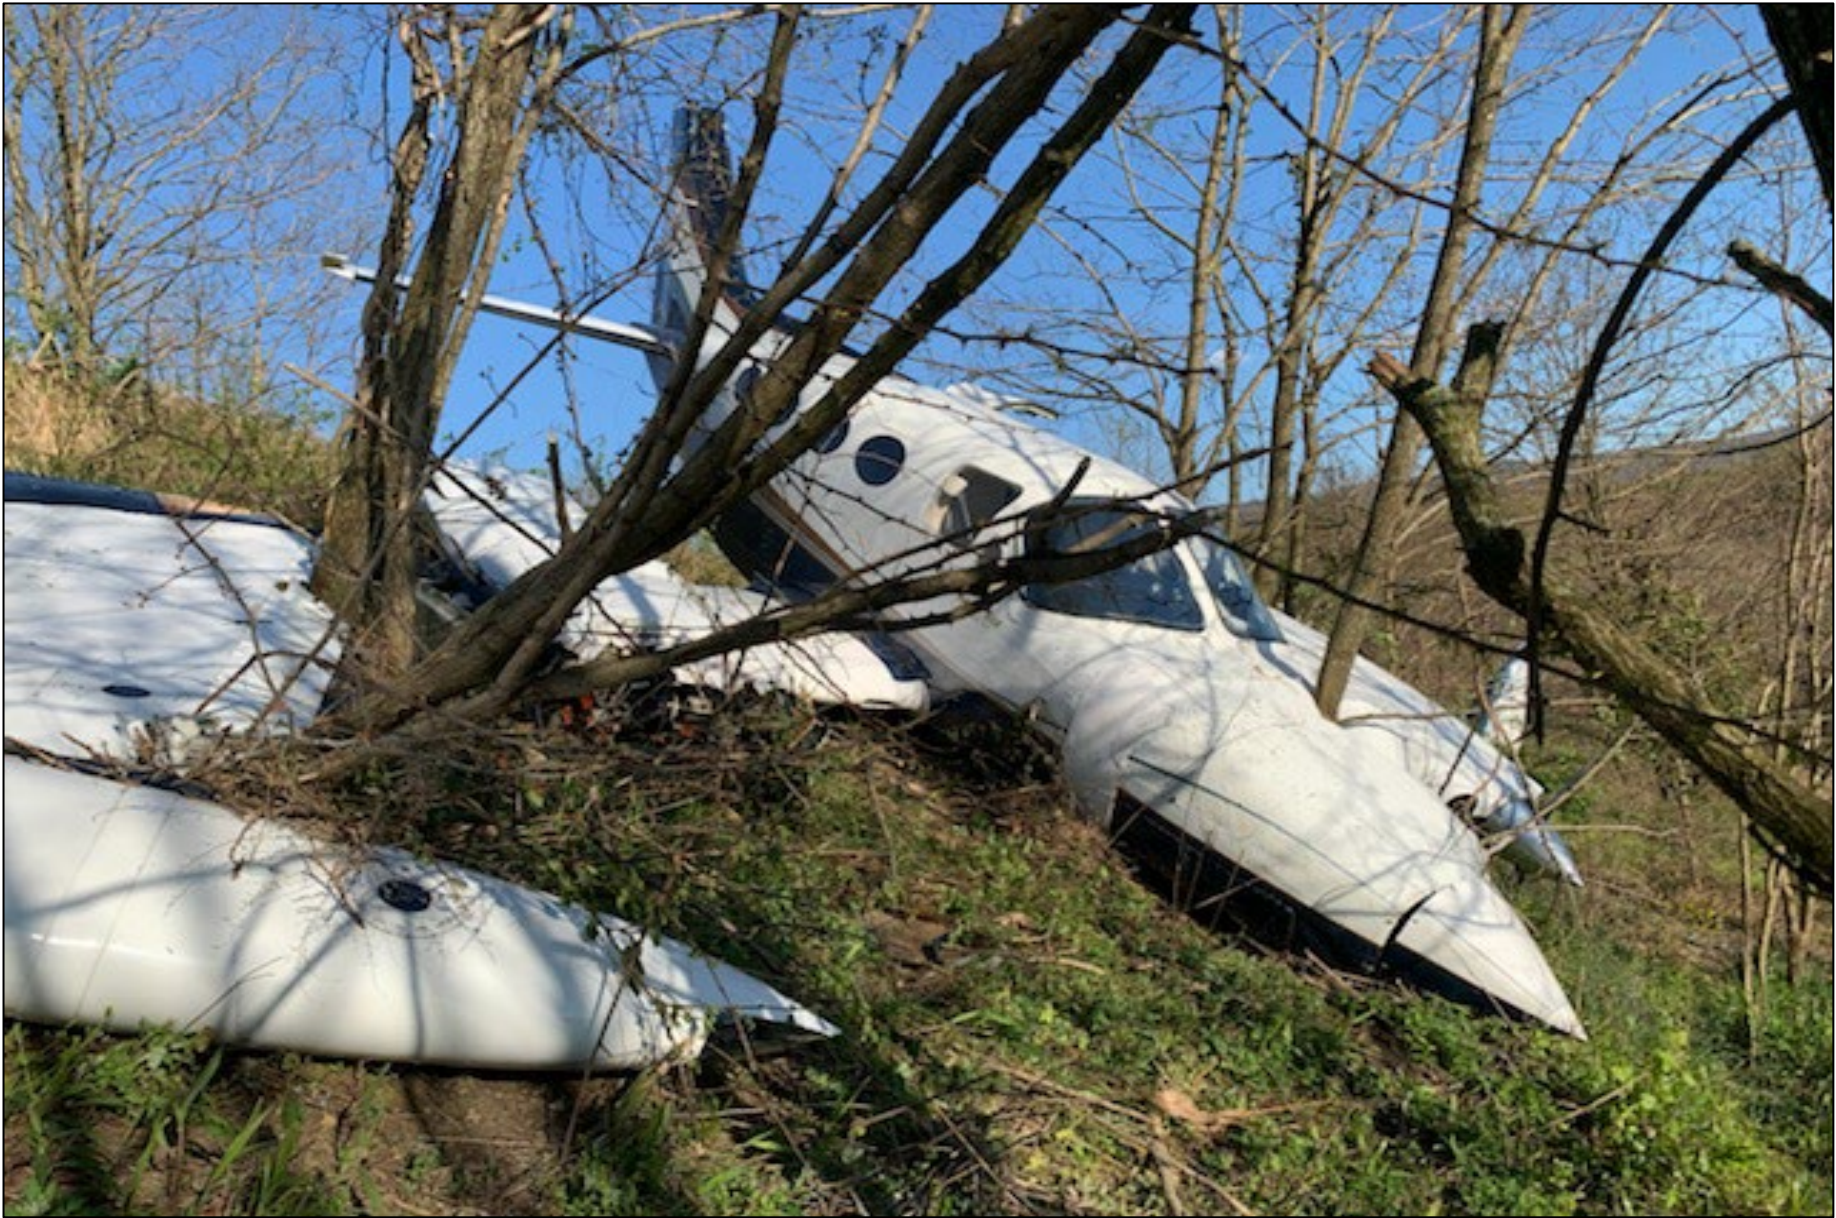
Photo 1: Overview of the substantial damage sustained to the airplane (Photo Courtesy of FAA)

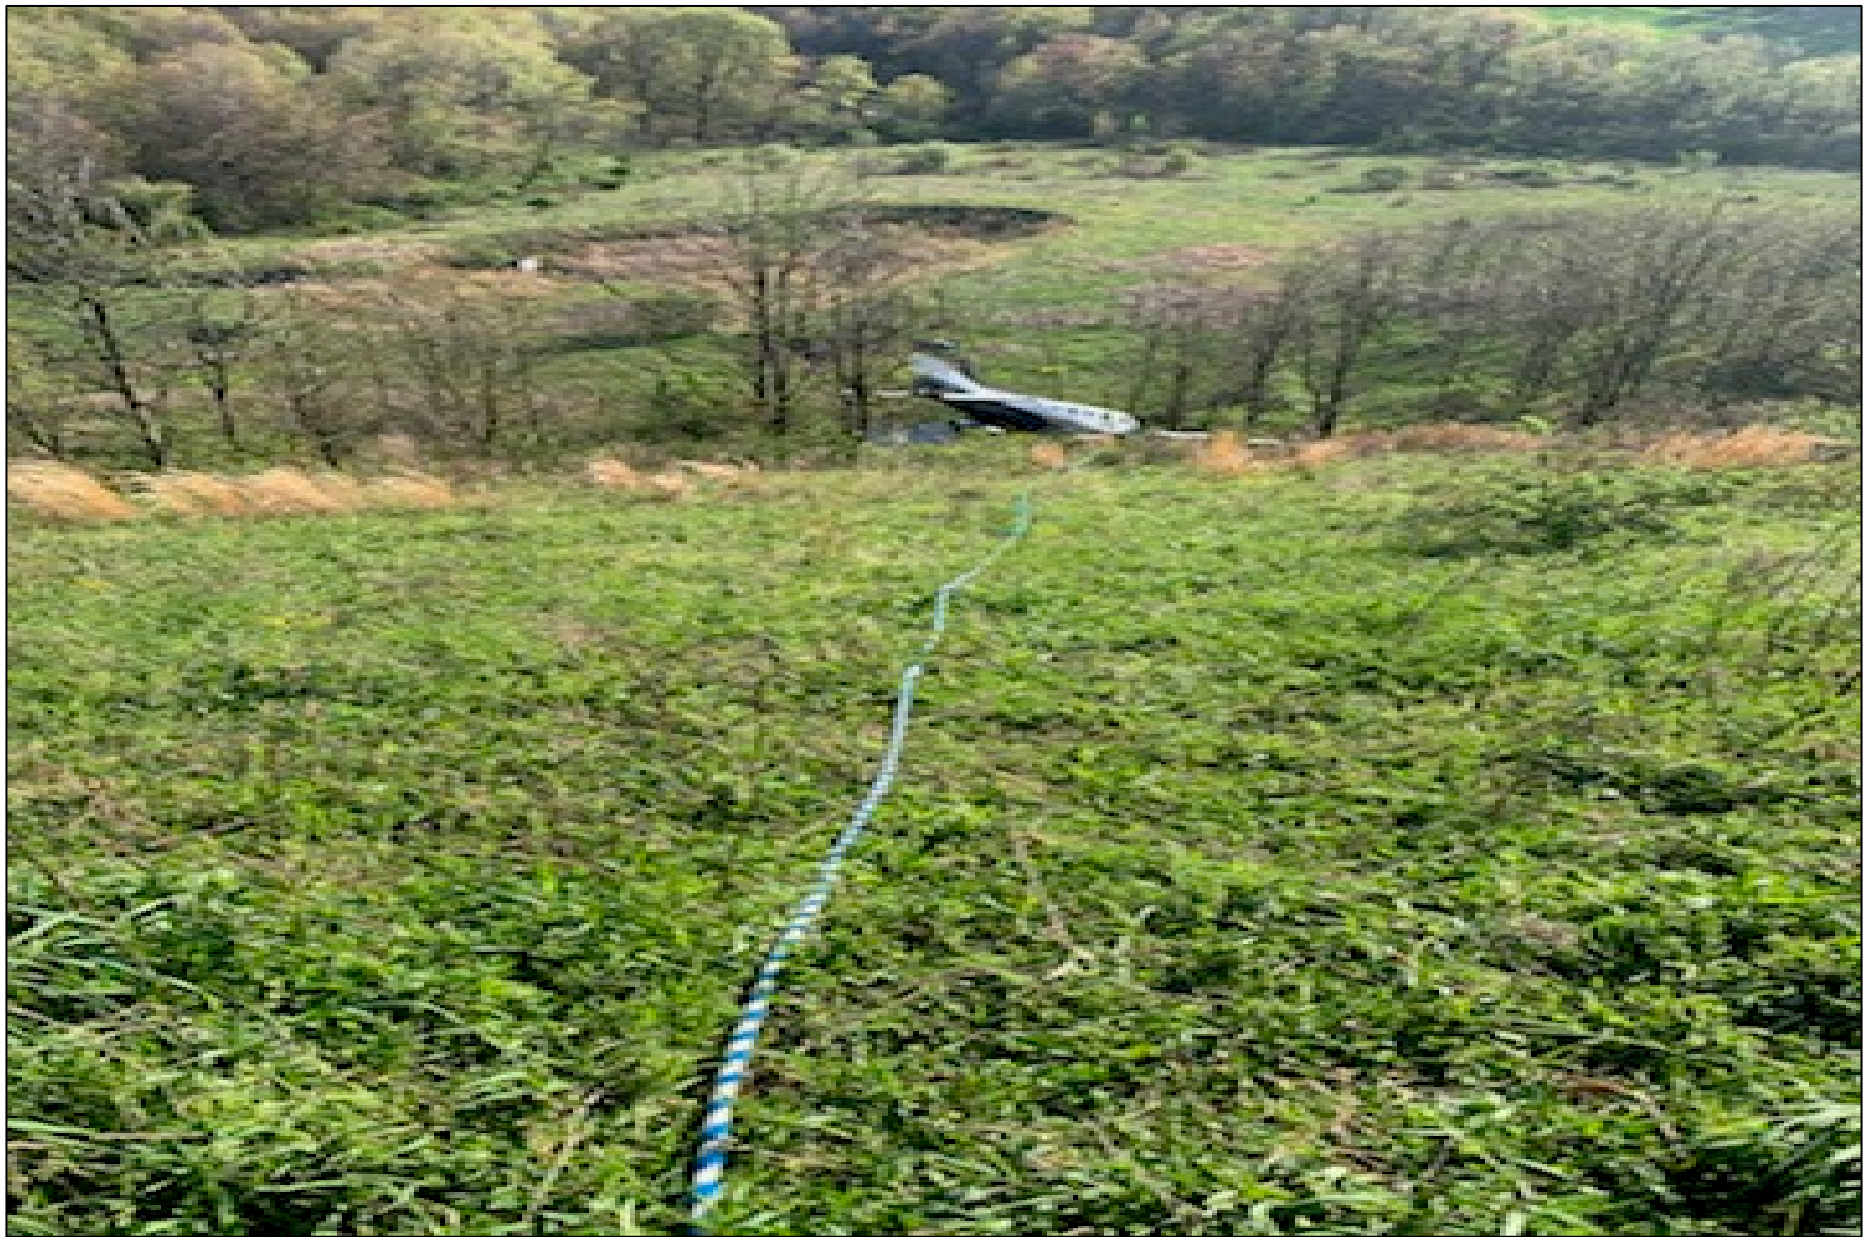
Photo 2: Overview of the ravine the airplane traveled down after departing the runway surface (Photo Courtesy of FAA)

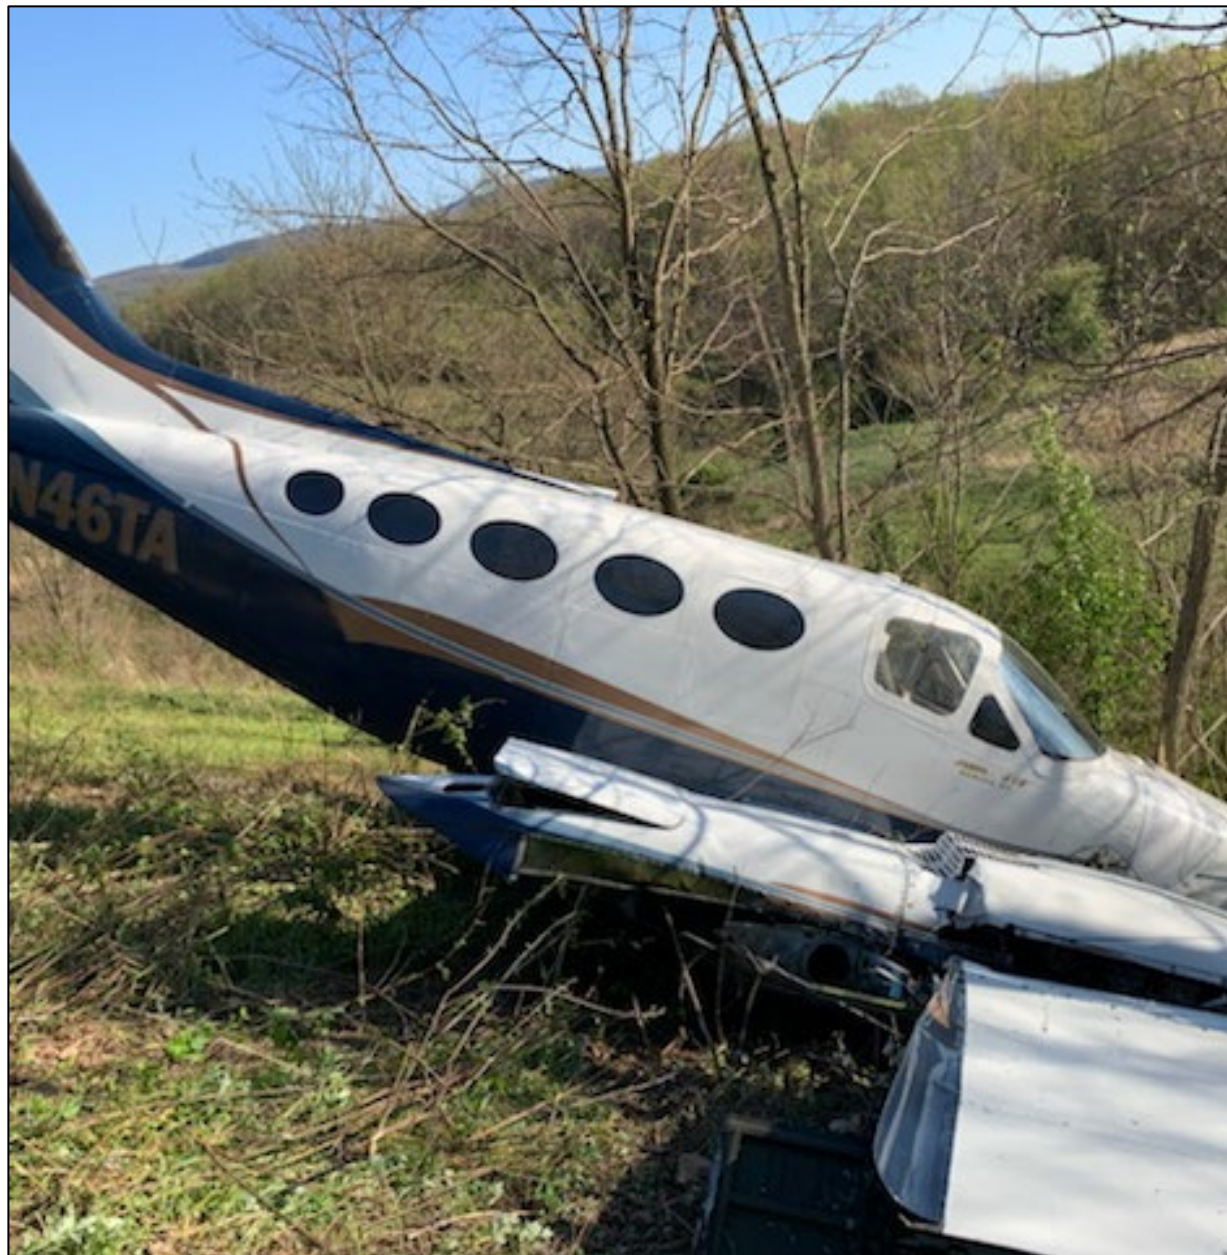
Photo 3: Overview of the substantial damage sustained to the airplane (Photo Courtesy of FAA)

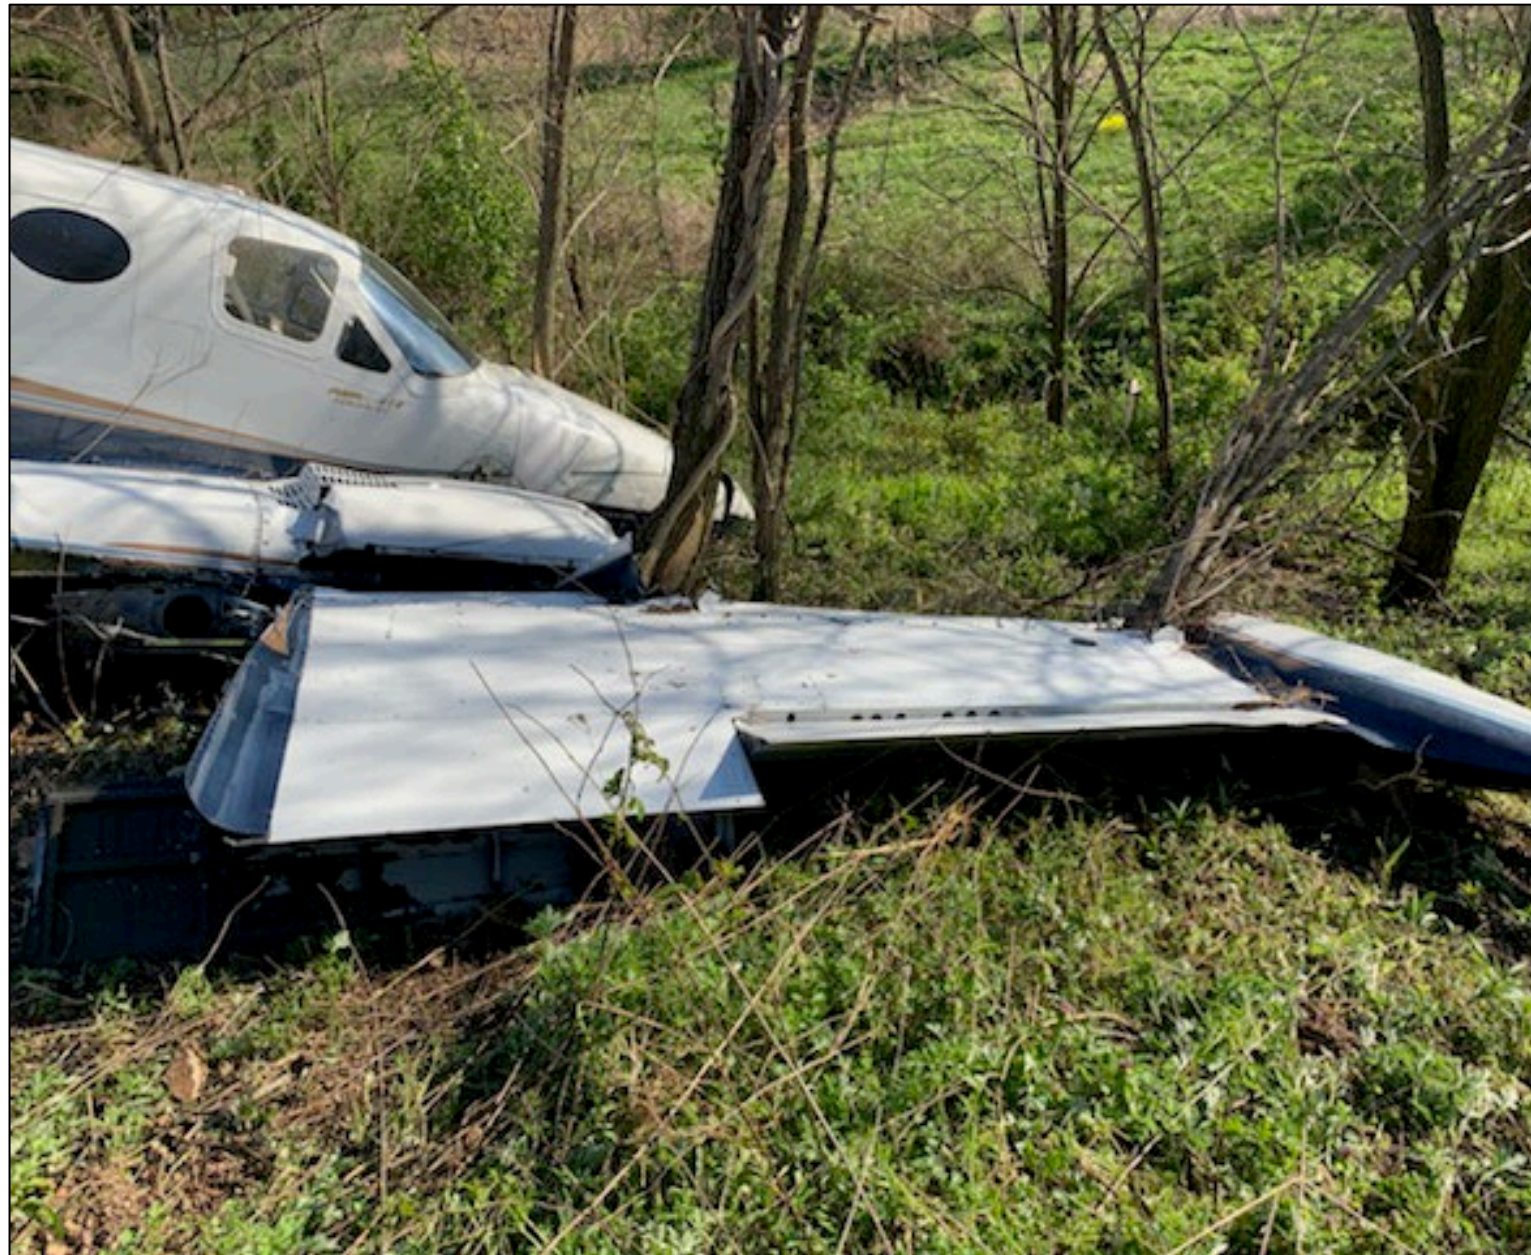
Photo 4: Overview of the substantial damage sustained to the airplane (Photo Courtesy of FAA)
