# NTSB MEMORANDUM FOR RECORD

**Date: 5/5/2022**  
**Person Contacted: GARY ANKNEY (FAA INSPECTOR)**  
**NTSB Accident Number: ERA22LA215**

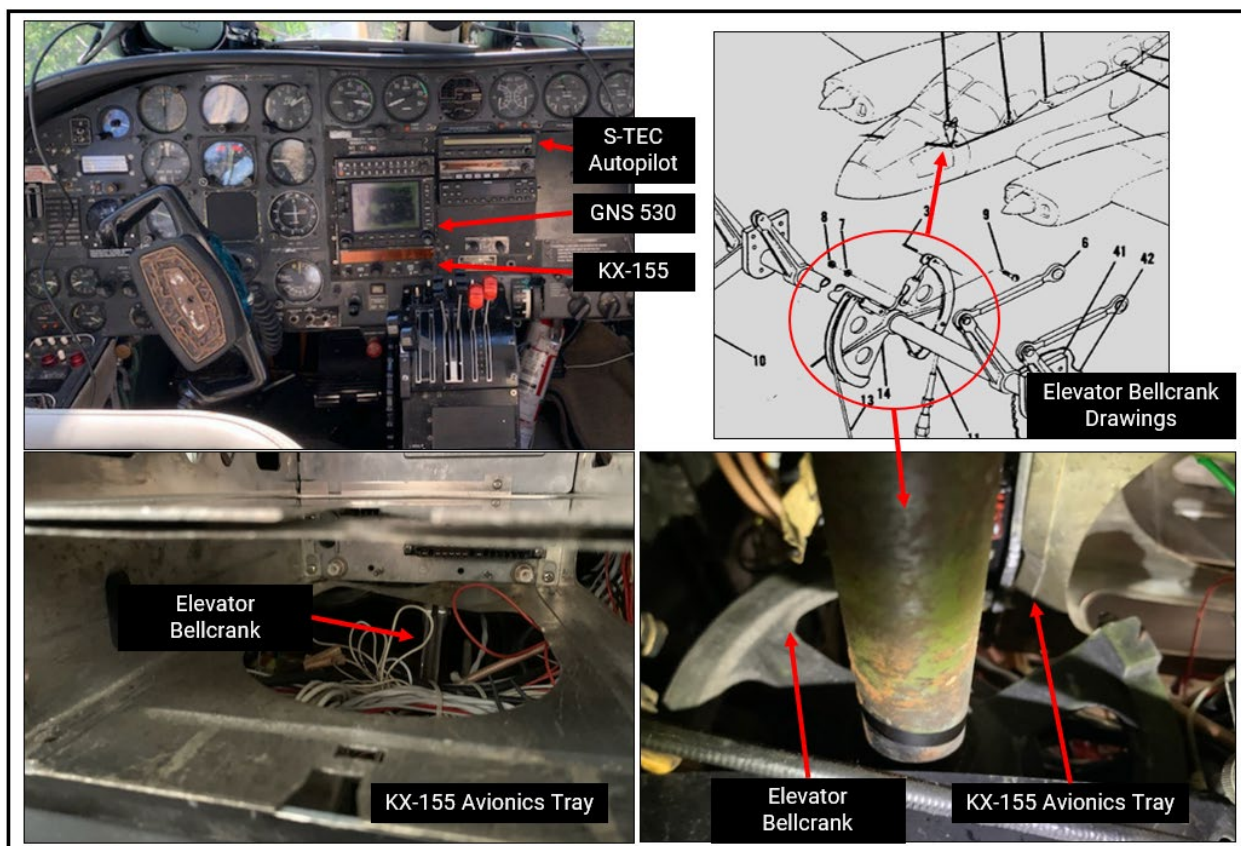
- The KX-155 avionics tray was found jammed in the elevator bell crank. This was the lowest avionics tray, within a stack of avionics. The left side stack. There was a Garmin 530 unit above the KX155 unit, and the trays were found sagging downward. They all moved downward when the face of the units were touched.

Figure 1: Annotated photographs of the avionics installed on the accident airplane and view of the elevator bell crank as found after the accident.

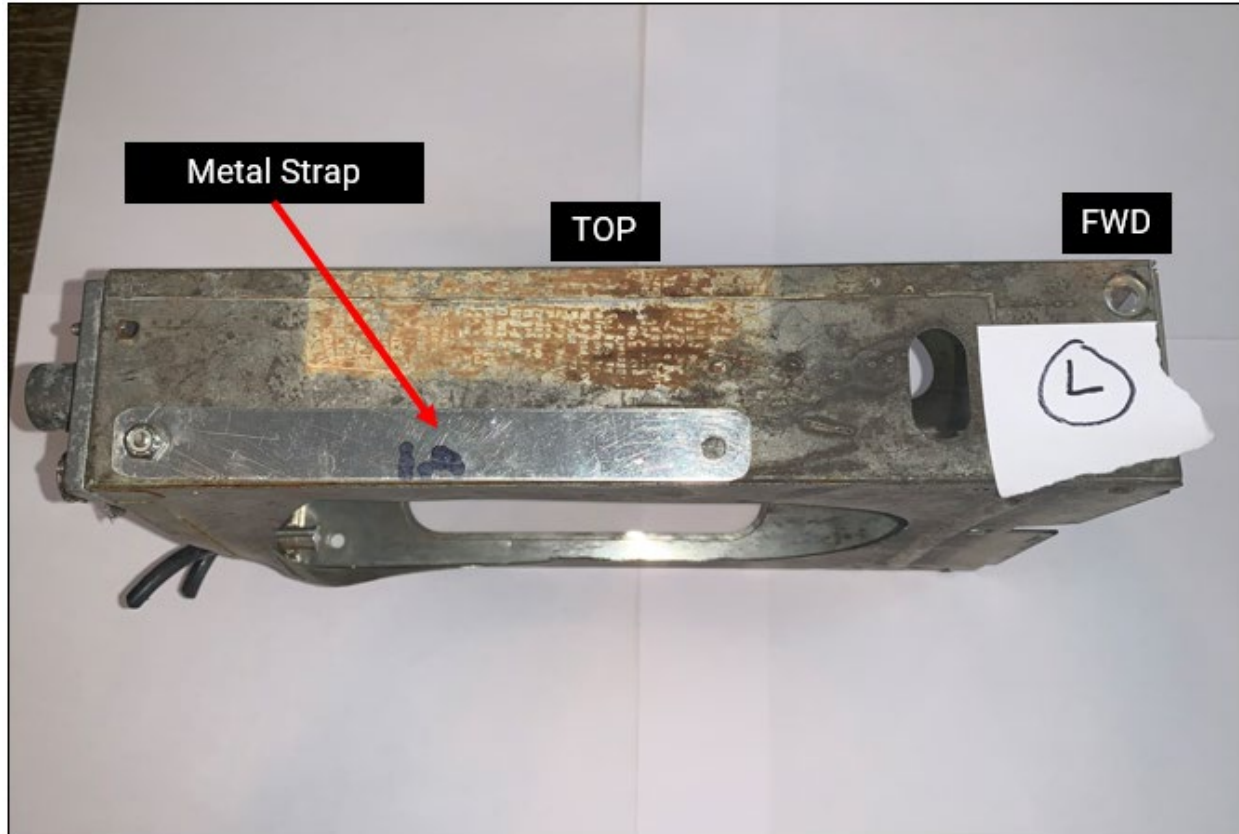
Figure 3: View of the left side of the KX-155 avionics tray. The metal strap remains installed on the unit's left side. The strap was connected to the tray; however, it was found not connected to any other components on the accident airplane. The "FWD" refers to where the face of the avionics unit would be located in the cockpit.

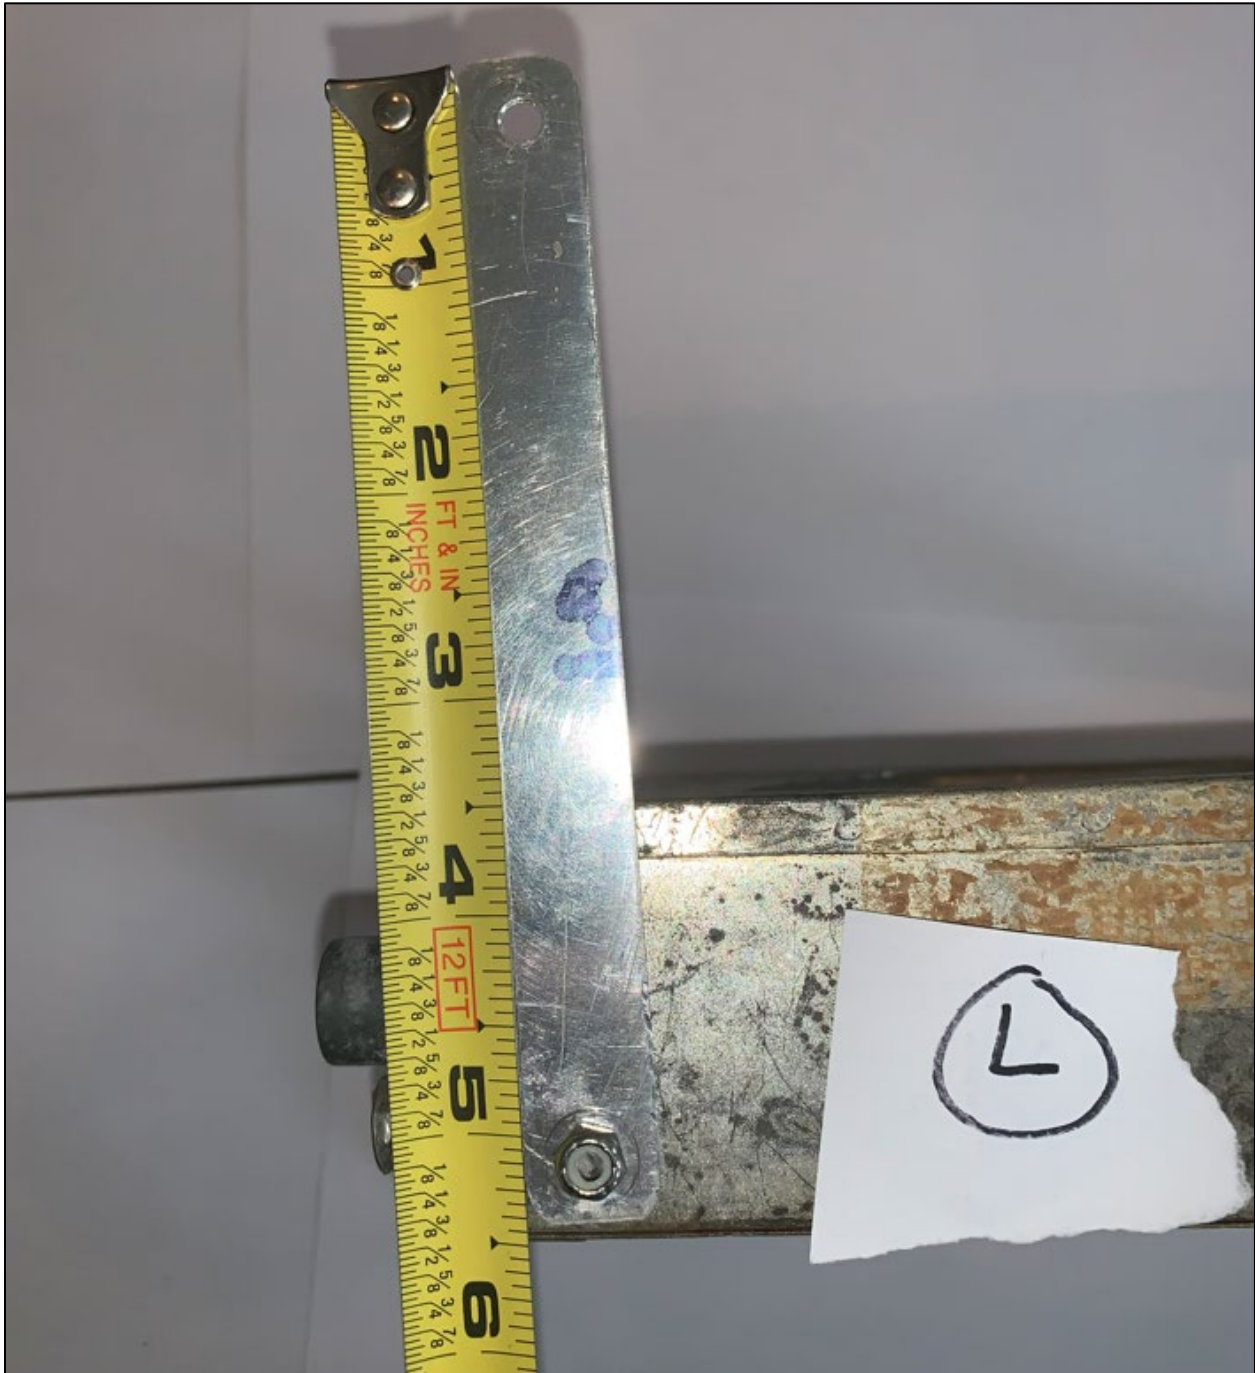
Figure 4: The metal strap on the KX-155 avionics tray measured about 5.5 inches in total length.

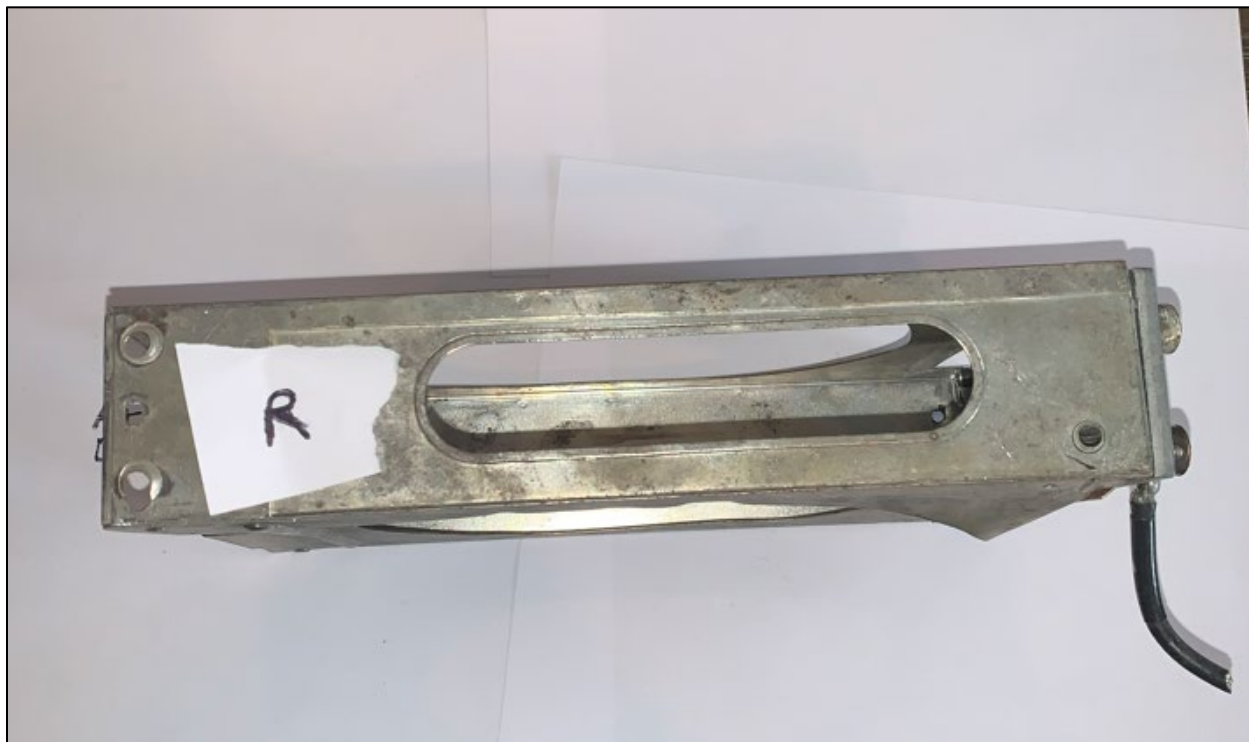
Figure 5: View of the right side of the KX-155 avionics tray. The right side did not possess a metal strap.

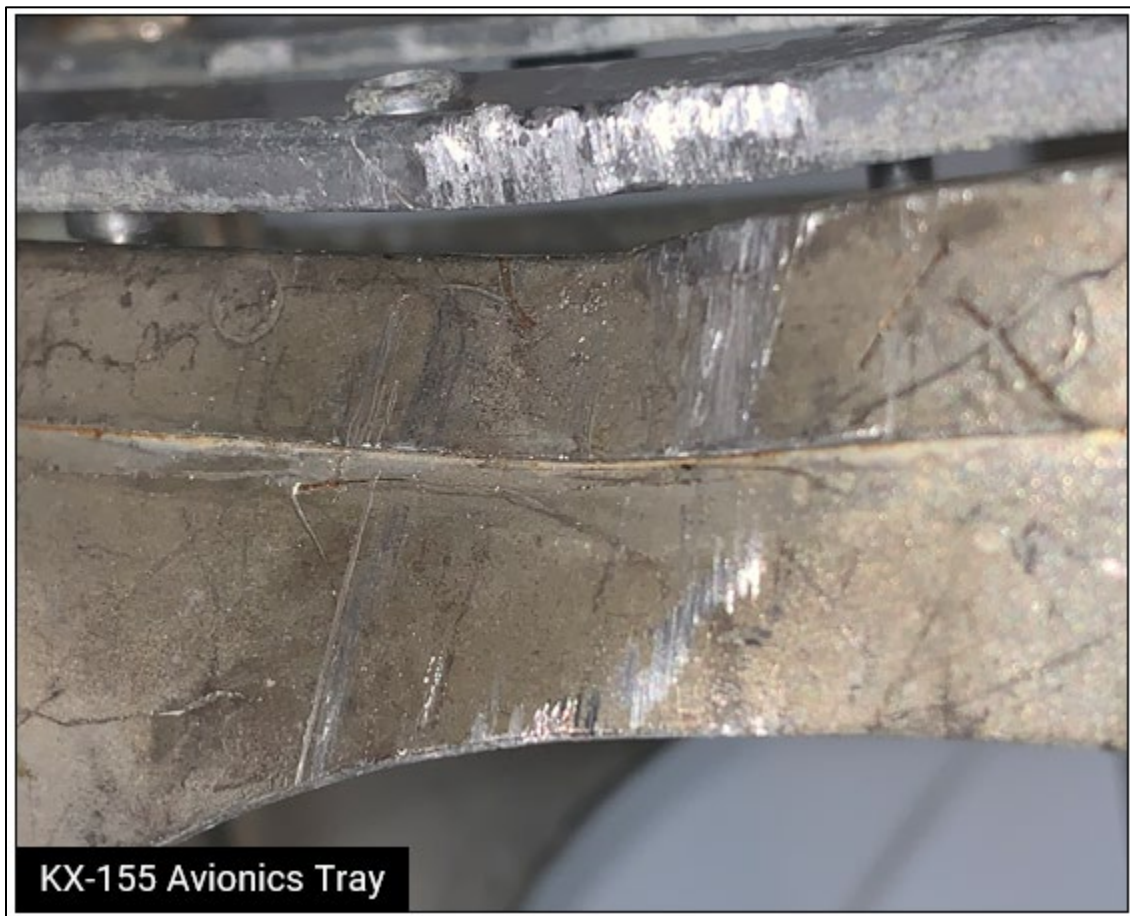
Figure 6: View of the KX-155 avionics tray and its bottom side. This side was the nearest surface to the elevator bell crank. Significant scrapping, metal polishing, and deformation of the tray was observed.

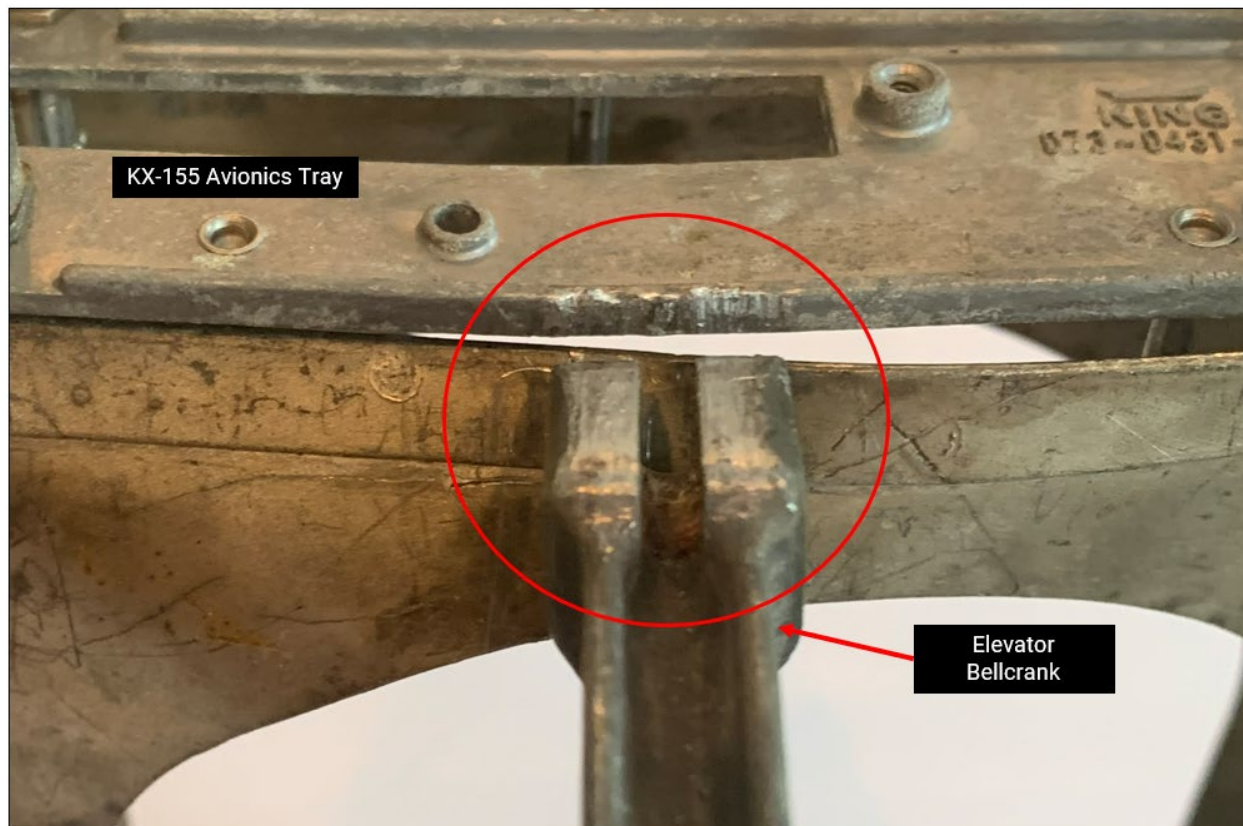
Figure 7: View of the elevator bell crank and avionics tray scraping.

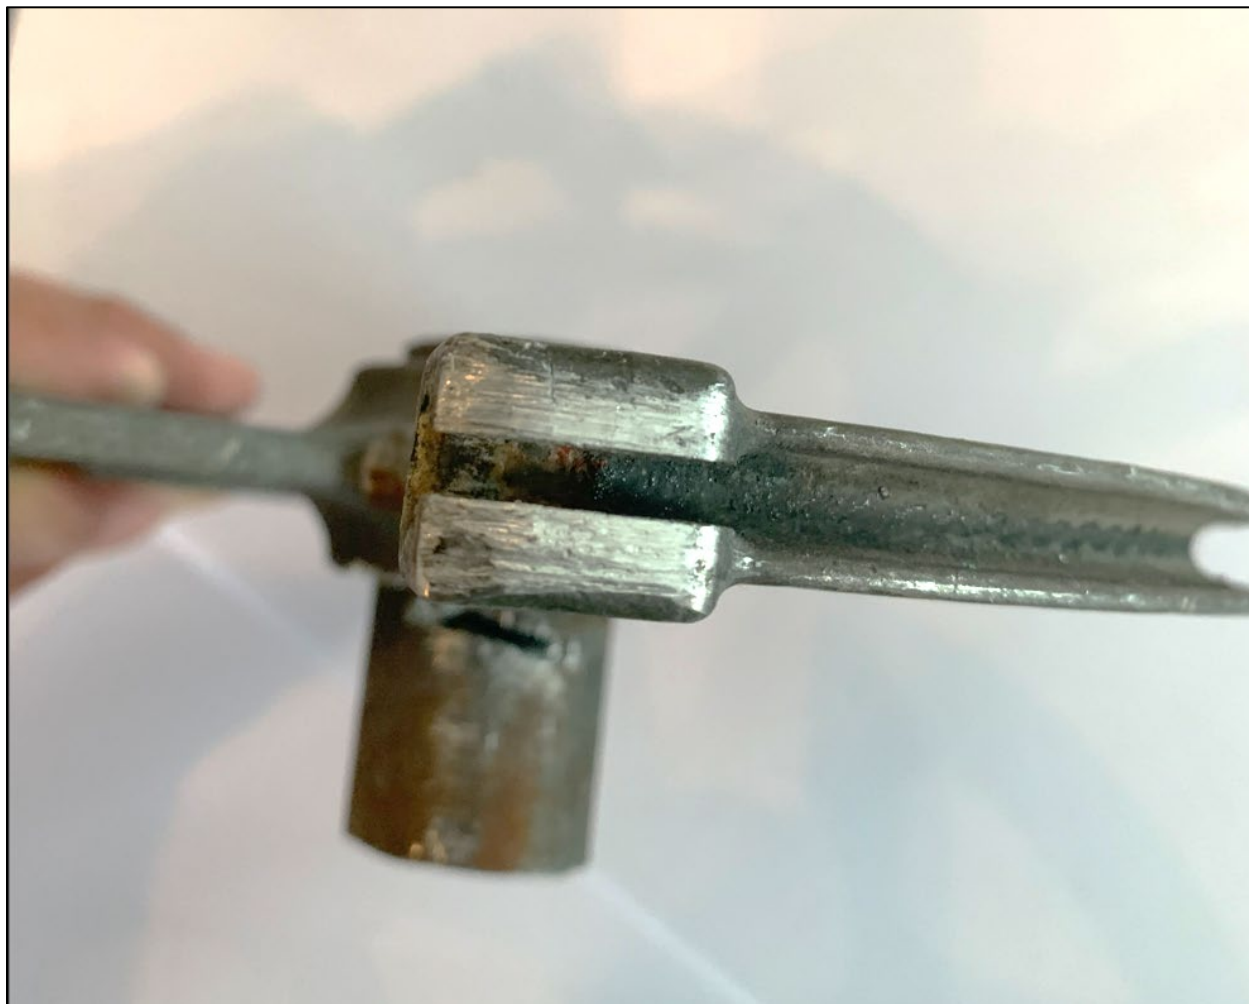
Figure 8: View of metal scraping and polishing as found on the elevator bell crank.

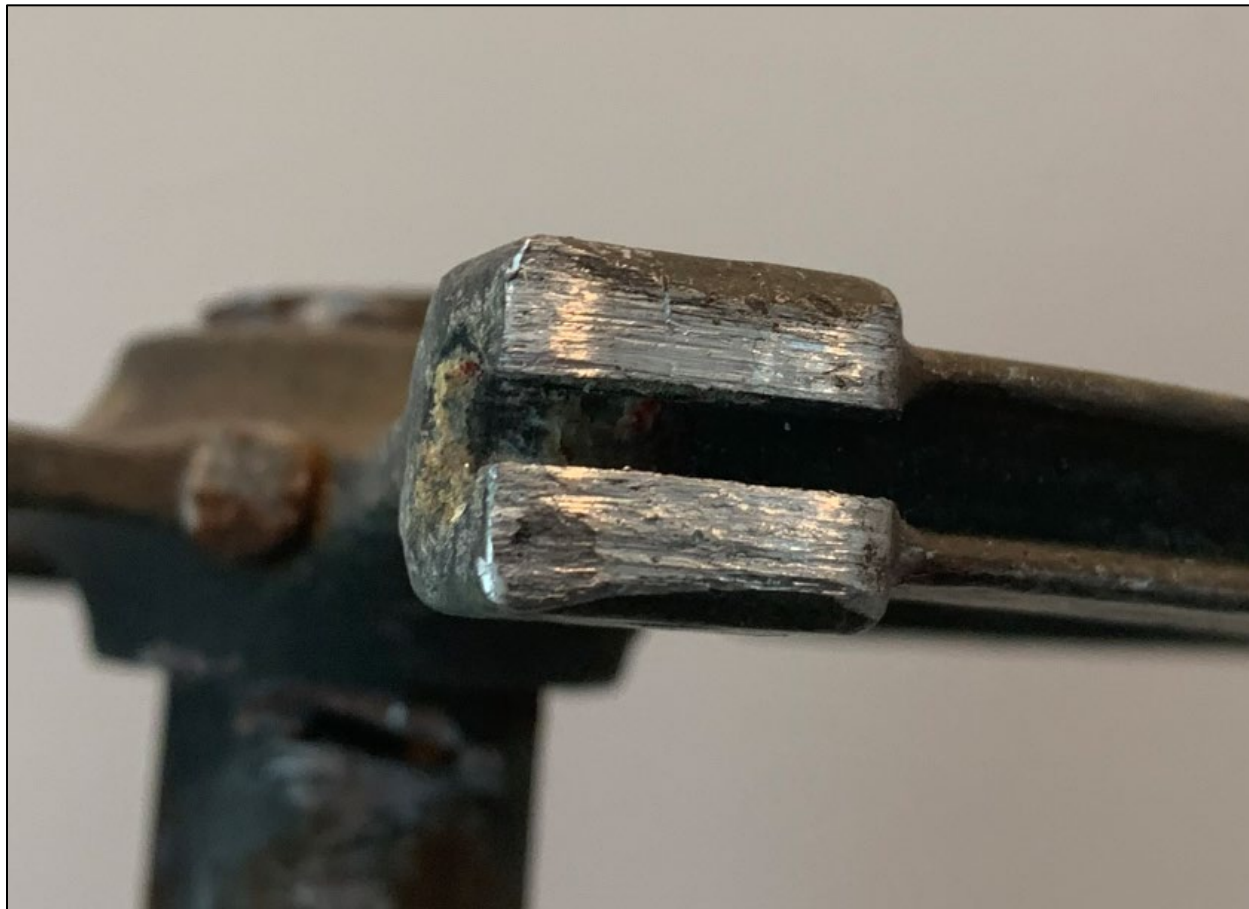
Figure 9: Additional view of metal scraping and polishing as found on the elevator bell crank.

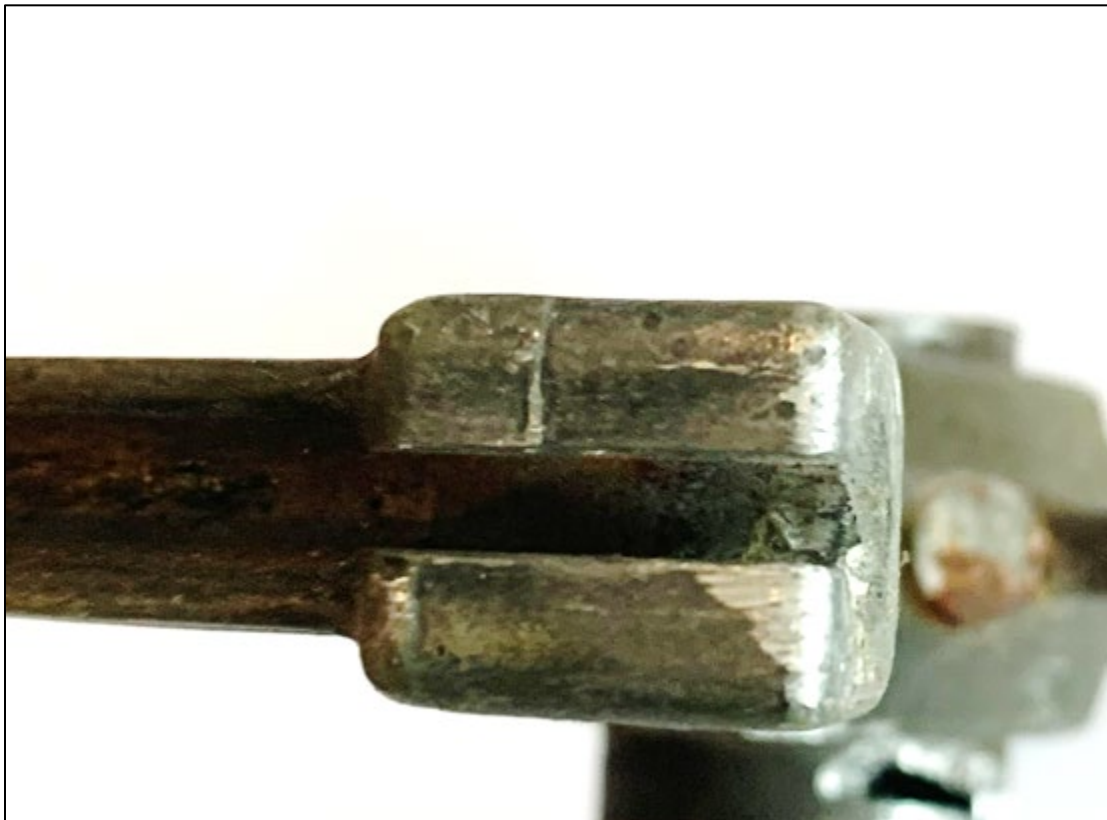
Figure 10: View of metal scraping and polishing as found on the other end of the elevator bell crank.
