# National Transportation Safety Board

ERA22LA239

## WRECKAGE EXAMINATION SUMMARY

Airplane: Thrush S2R-H80, N6216M

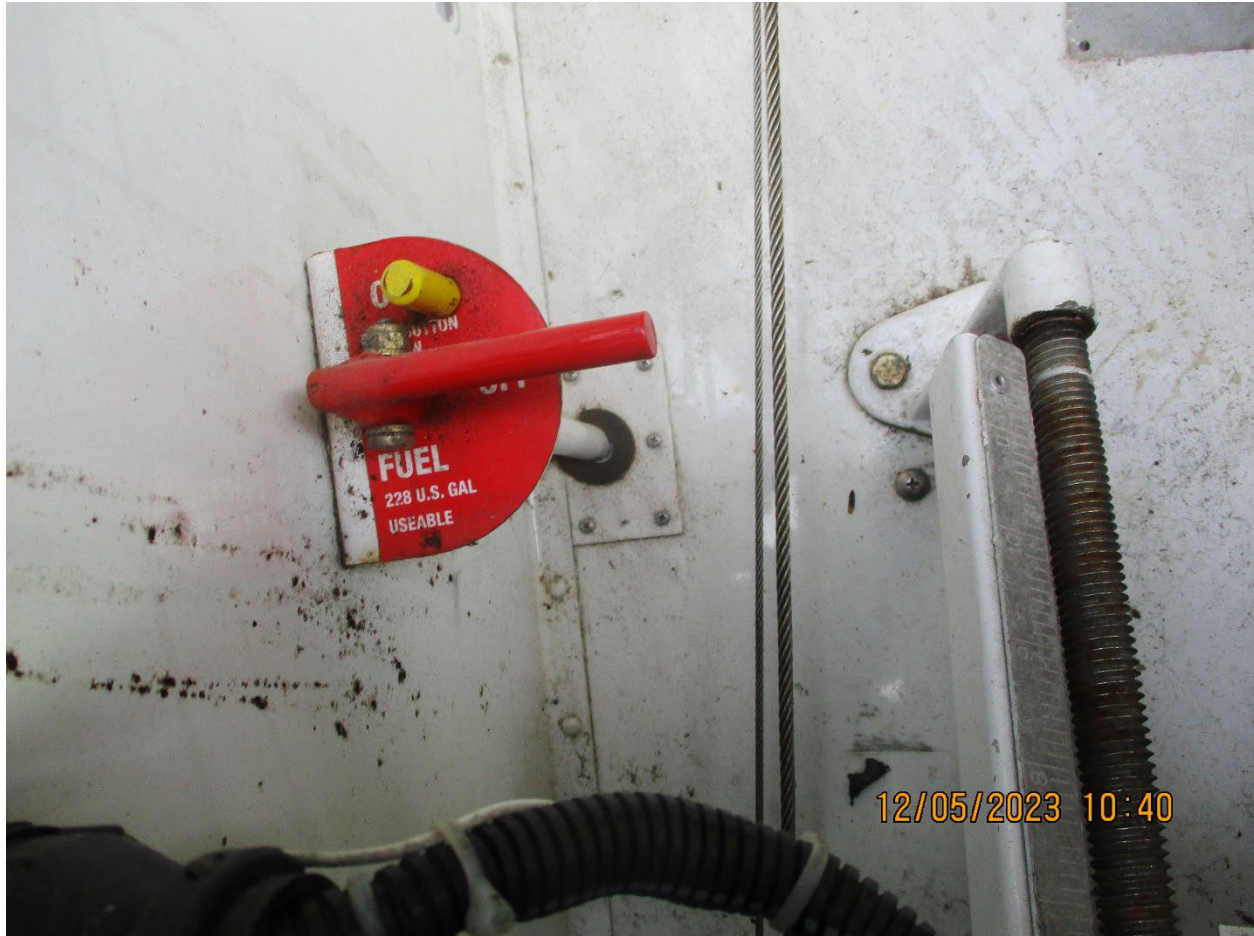
**Figure 1 - Fuel Shutoff Valve**

The airplane was first observed at the recovery company salvage yard. The wings had been removed and the elevator had been cut for transportation. The engine mounts were cut by recovery personnel and the engine was on a pallet. All of the instruments were removed and boxed up by the recovery personnel. All primary flight control surfaces were present and accounted for. The focus was on the fuel system. The fuel shut off valve was tested by blowing air through the valve. No anomalies noted.

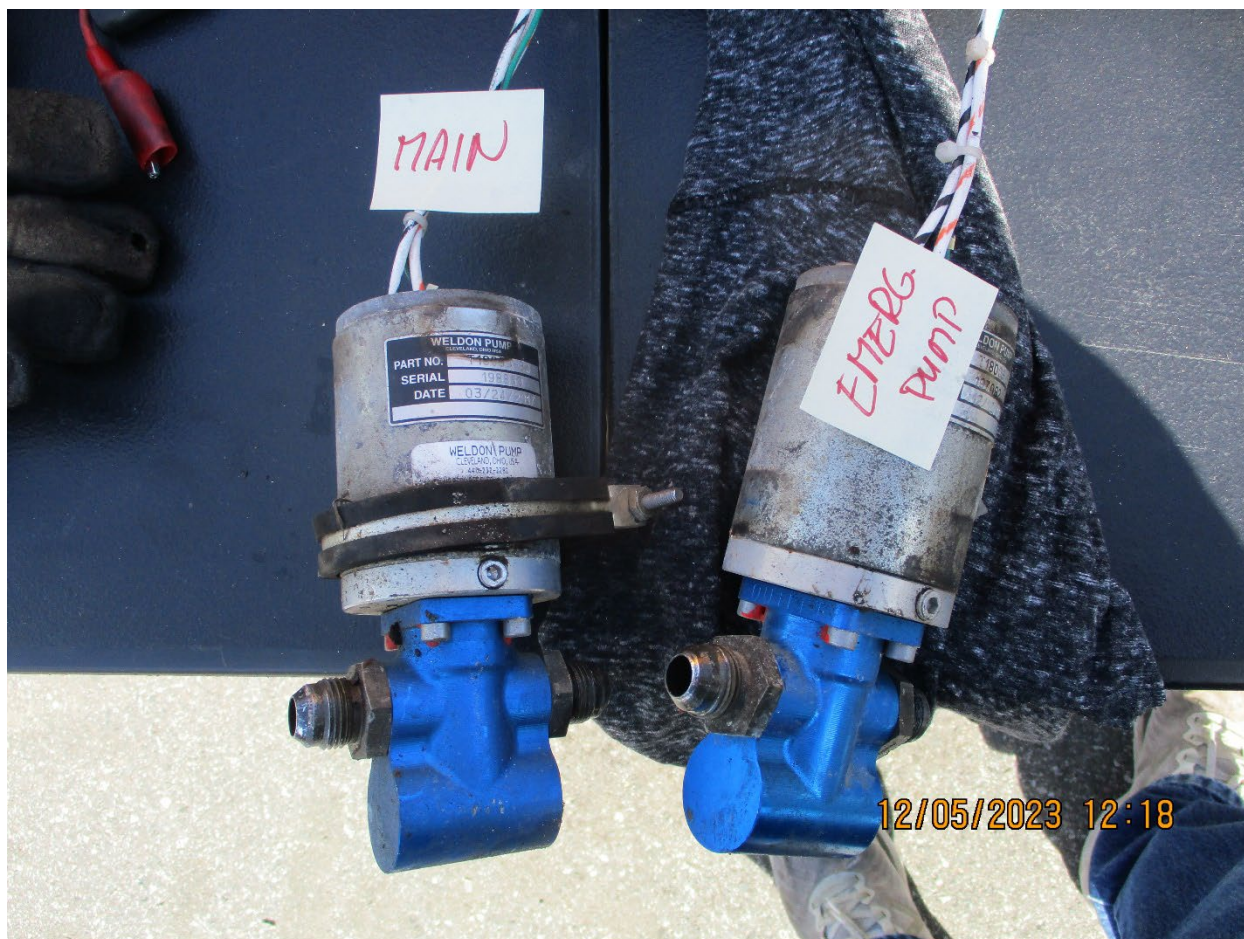
**Figure 3 - Fuel Pumps**

The main fuel pump and emergency fuel pump were tested by connecting 24 volt battery to the wiring. The main fuel pump did not rotate, the emergency fuel pump rotated when connected. The main fuel pump was disassembled, and large amounts of carbon were noted within the armature and housing of the pump. One carbon brush was completely worn down and the other brush was missing, as was the push block and spring. The connecting wire was hanging loose in the housing. The emergency fuel pump was disassembled and although it was working, there were also large amounts of carbon deposits in the armature. Both the carbon brushes in the emergency pump motor measured 3/16 inch long.

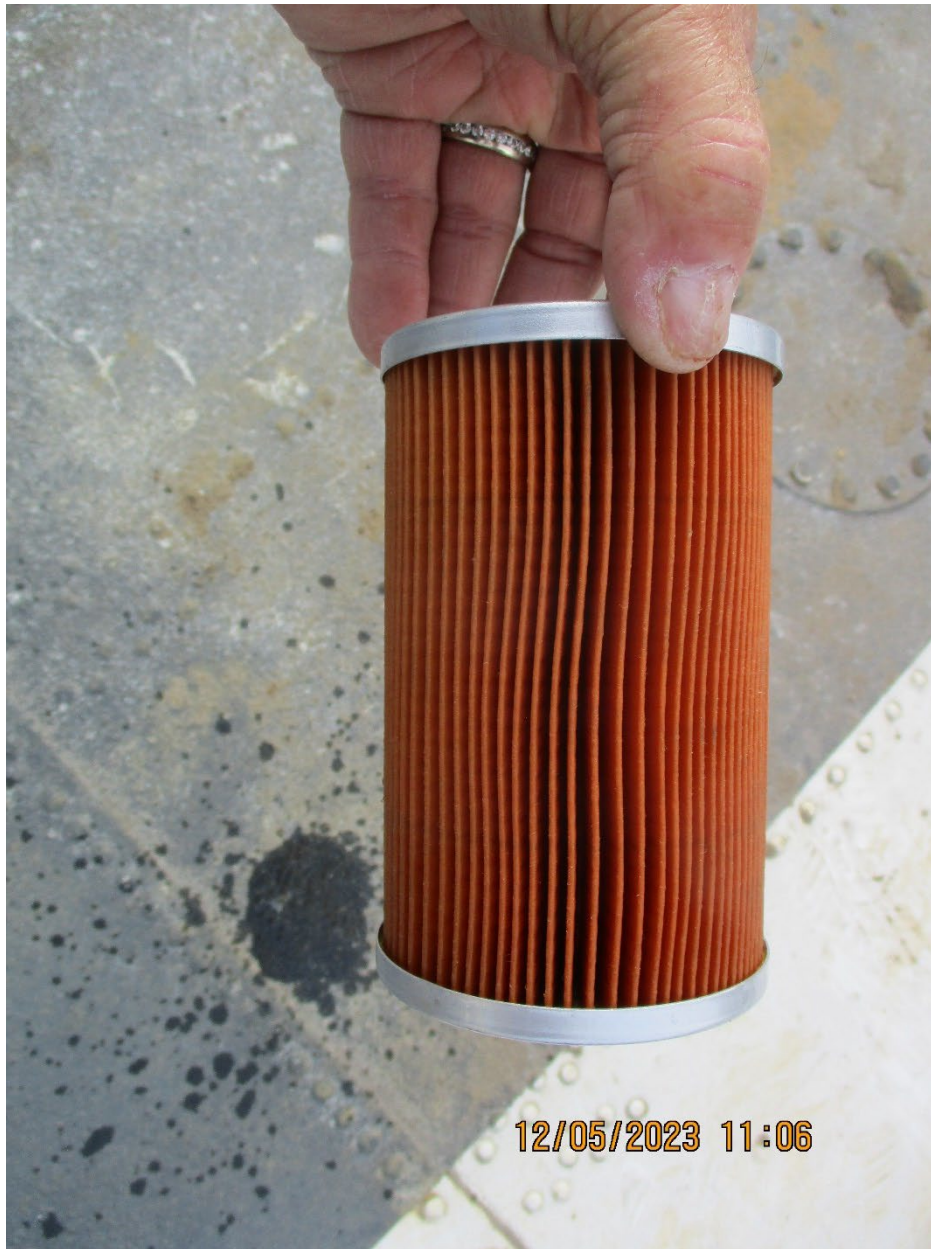
**Figure 9 - Airframe Fuel Filter**

The airframe mounted fuel filter was clean and no debris was found. The filter housing was full of fuel. The fuel pressure transducer was missing.

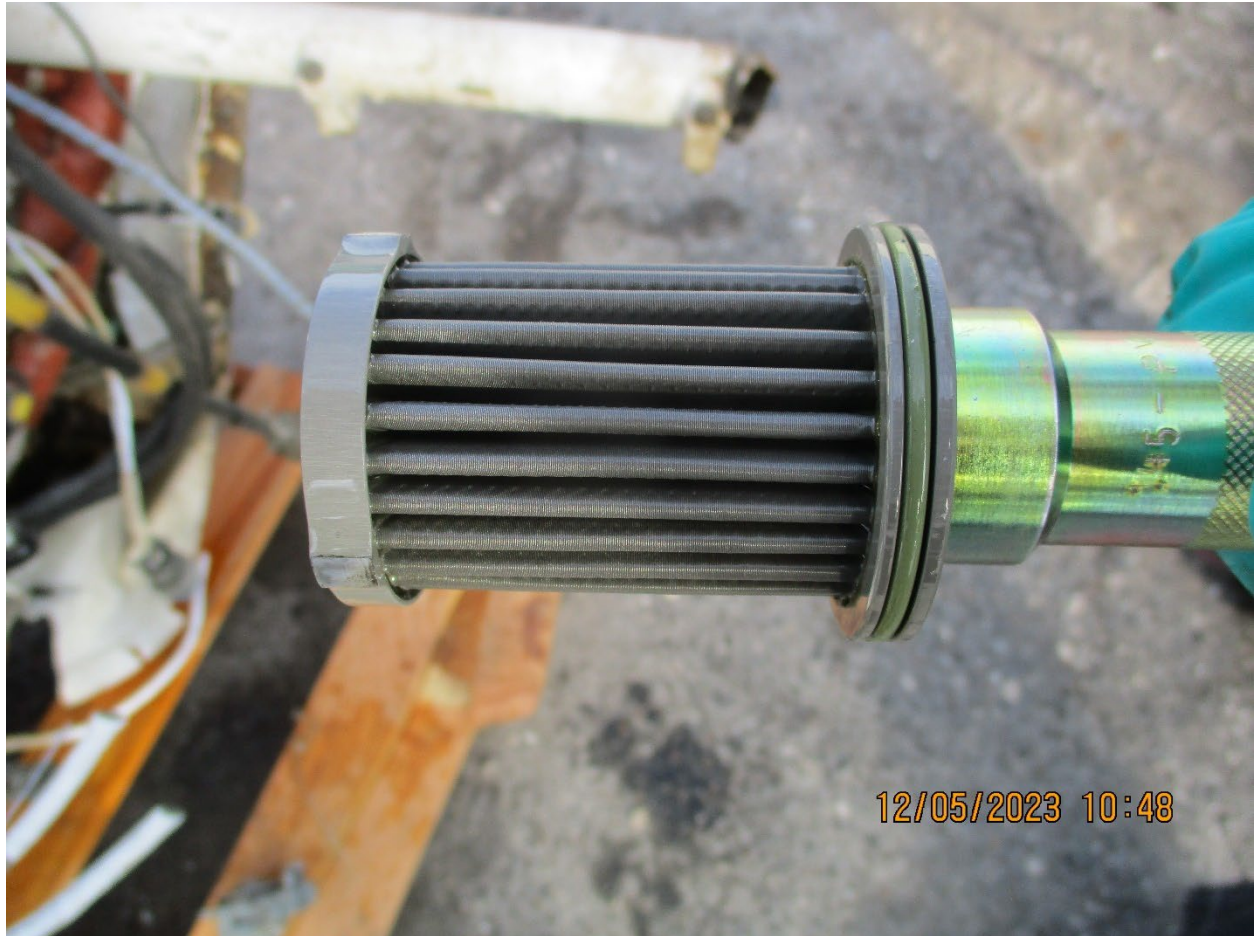
**Figure 11 - Engine Fuel Pump Filter**

The engine fuel control unit was removed, it was clean, and no debris was noted. The was fuel noted in the FCU. No anomalies noted. The engine fuel pump filter was clean, and fuel was present inside the chamber.

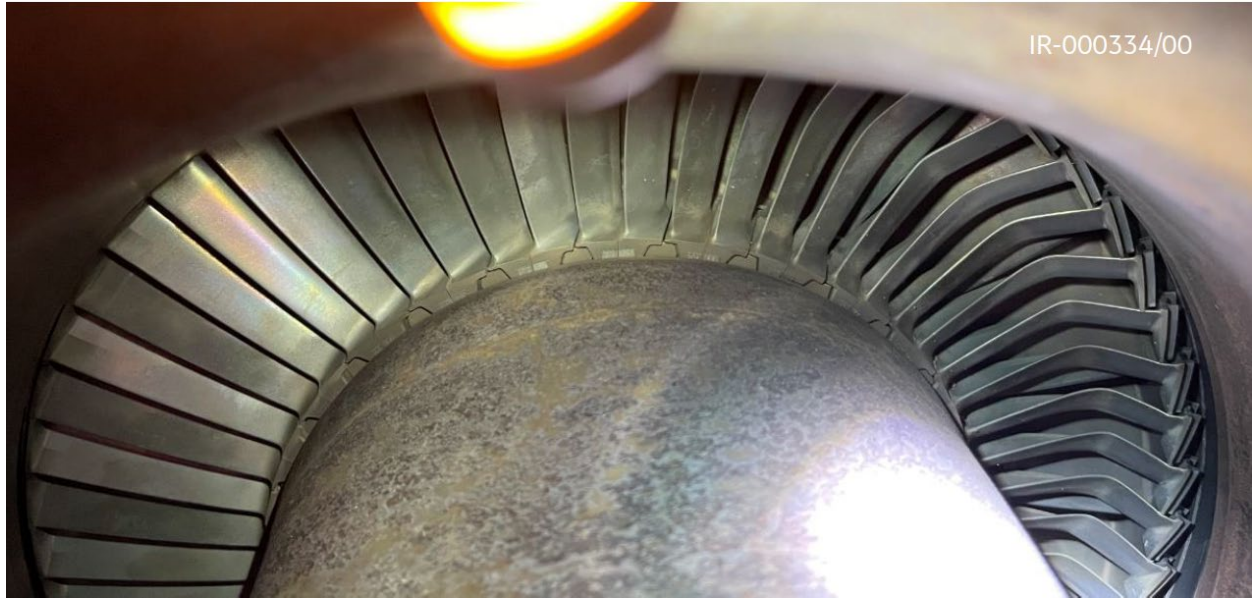
**Figure 12 - Power Turbine Blades**

The power turbine section could not be rotated by hand. All the power turbine blades were present, about half of them were bent slightly in the direction of rotation, consistent with impact damage.
