# National Transportation Safety Board

ERA22LA244

## **WRECKAGE EXAMINATION SUMMARY**

Location: Monongahela, Pennsylvania  
Date: May 27, 2022  
Time: 1900 EDT  
Airplane: Aeronca 7AC, N84583

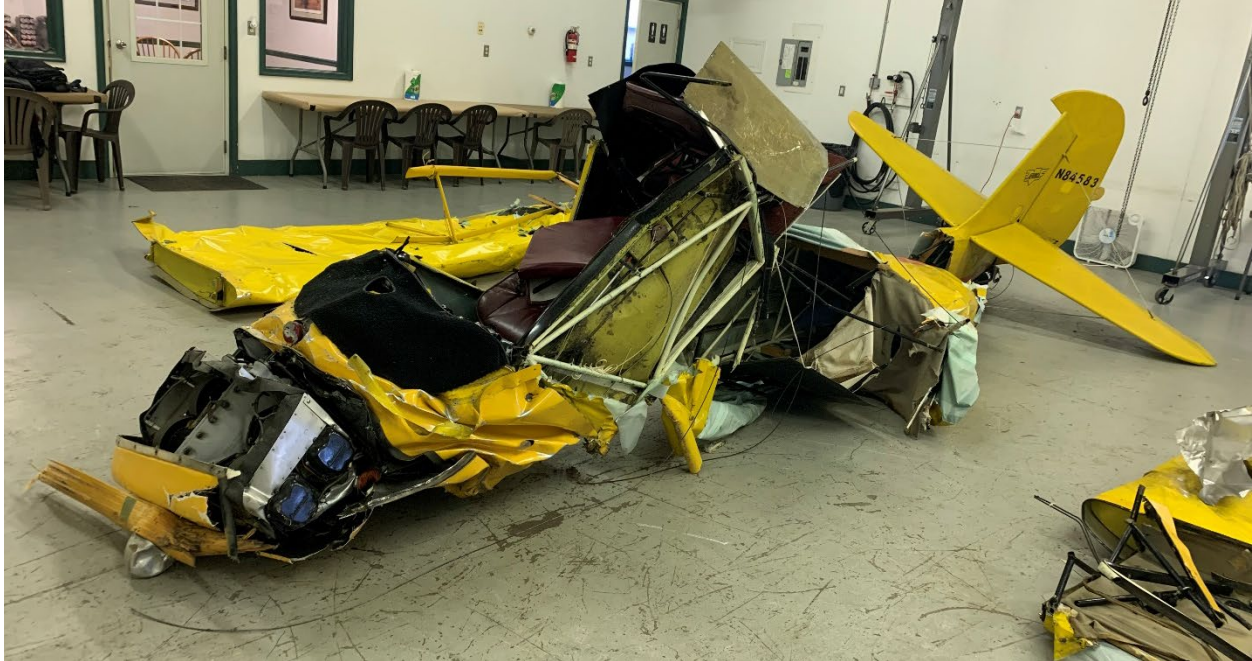
**Figure 1. View of Fuselage.**

The forward section of the fuselage was impact separated from the aft section but remained attached through fabric. The lower sections of the cabin seats remained attached to the airframe at all attach points. The front seat back was partially separated. The instrument panel was impact damaged. The tach indicated 1718.43 hrs. The ignition switch had an OFF-LEFT-RIGHT position and it was in the RIGHT position. The fuel was in the ON position. The throttle control was in the full forward position. Flight control cable continuity was established from the flight controls in the cockpit to the flight control surfaces through multiple cuts made by recovery personnel.

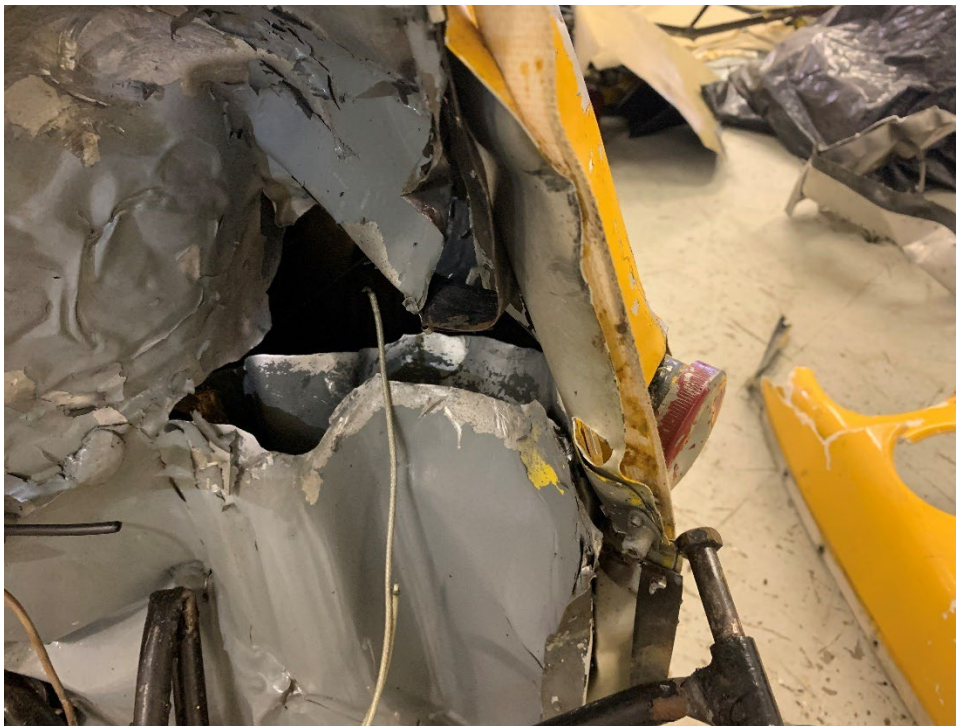
**Figure 2. View of breached fuel tank.**

The fuel tank was located forward of the instrument panel. The fuel cap remained seated. The fuel tank was breached and no fuel was noted in the tank.

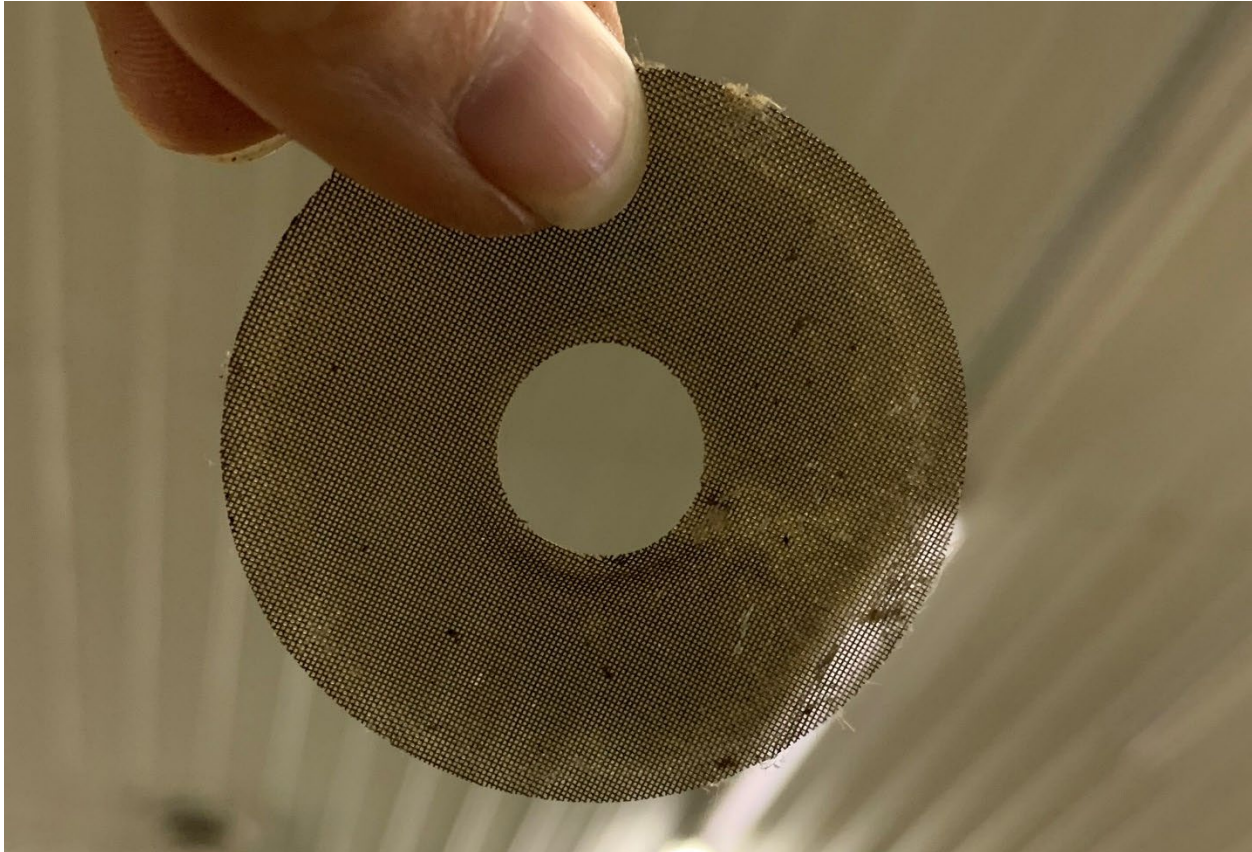
**Figure 3. View of gascolator screen.**

The gascolator was removed from the firewall and no fluid was in the bowl, however the valve was depressed. The gascolator screen was examined and no debris was noted.

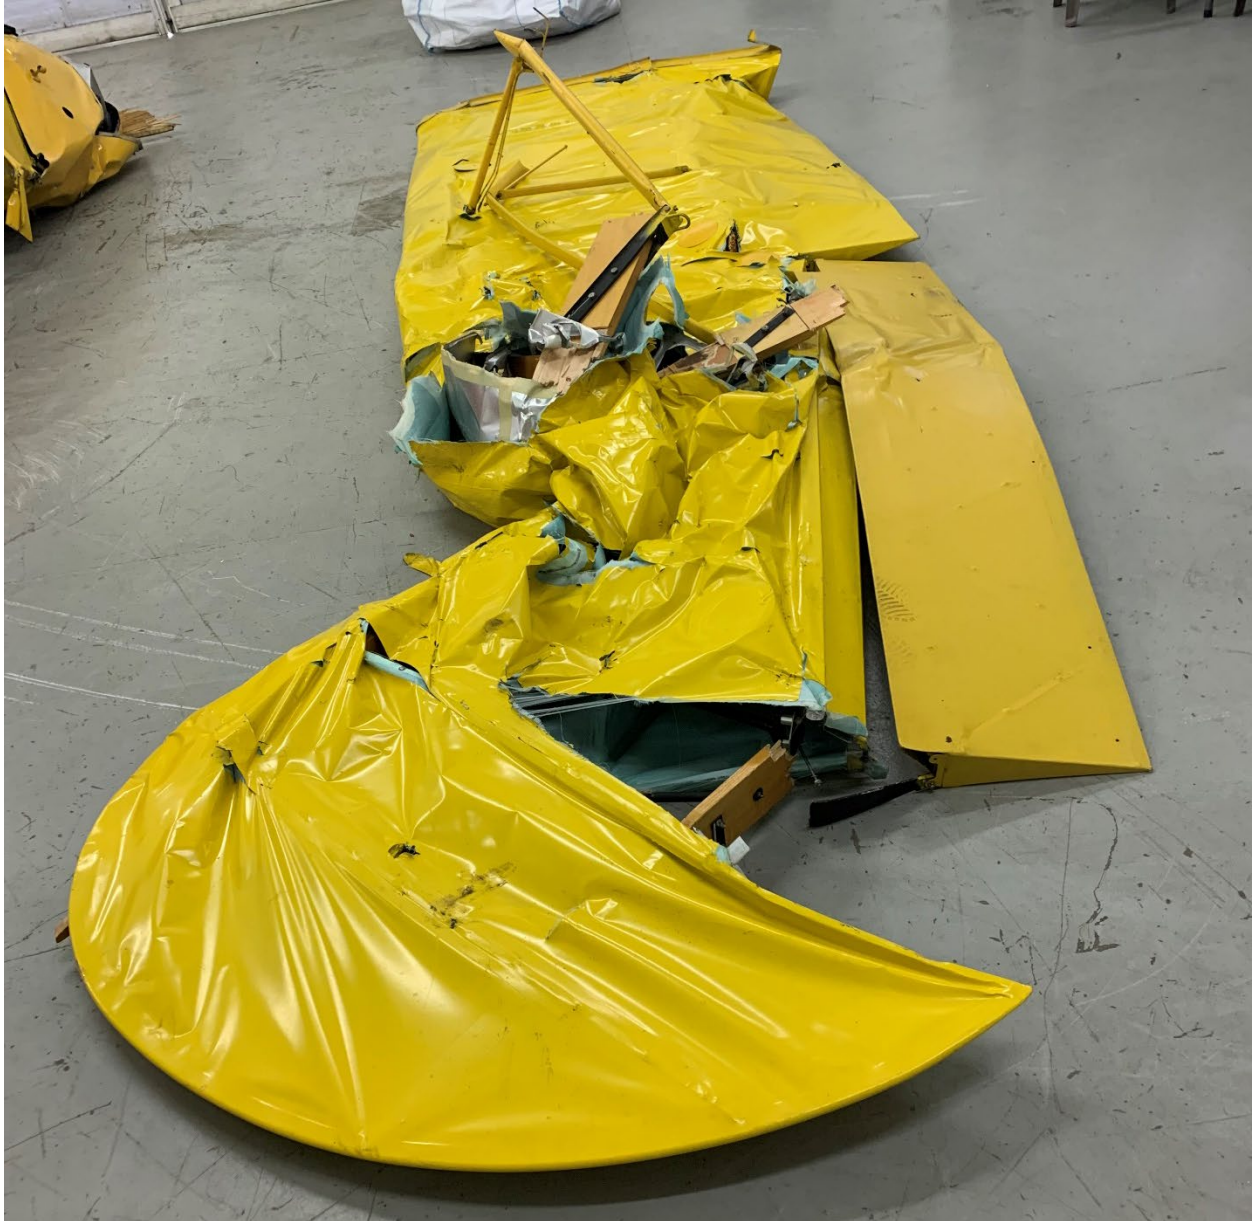
**Figure 4. View of Right Wing**

The right wing was separated to facilitate recovery. The struts remained attached to the wing. The right aileron remained attached to the right wing by the forward attach point. The aft attach point was impact separated. About 4 ft from the wing tip the leading edge exhibited impact damage.

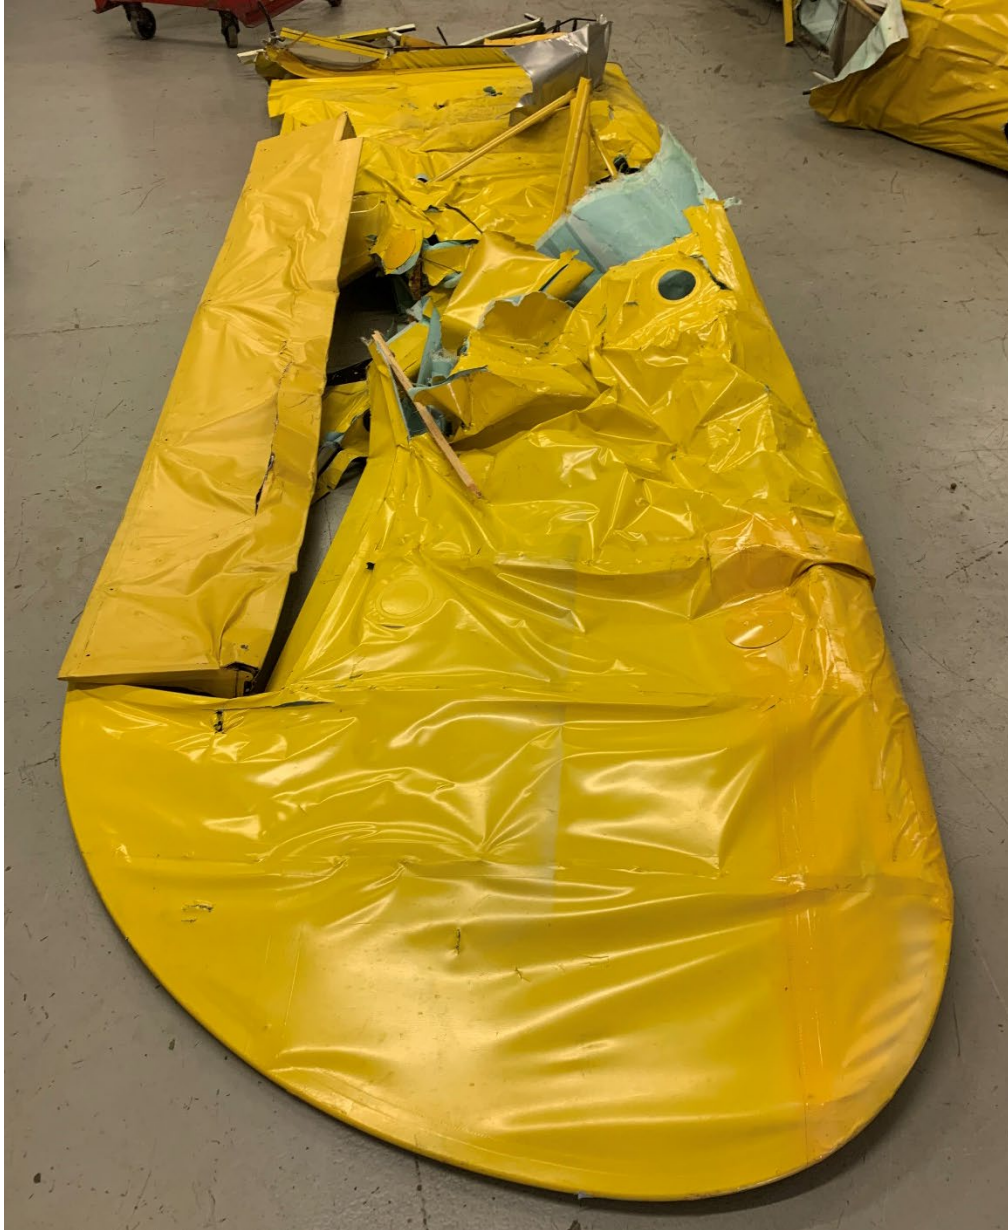
**Figure 5. View of Left Wing**

The left wing was separated from the fuselage but remained attached to the cabin roof. The left aileron was partially separated from the left wing but remained attached through the outboard attach point. The entire span of the leading edge was impact damaged.

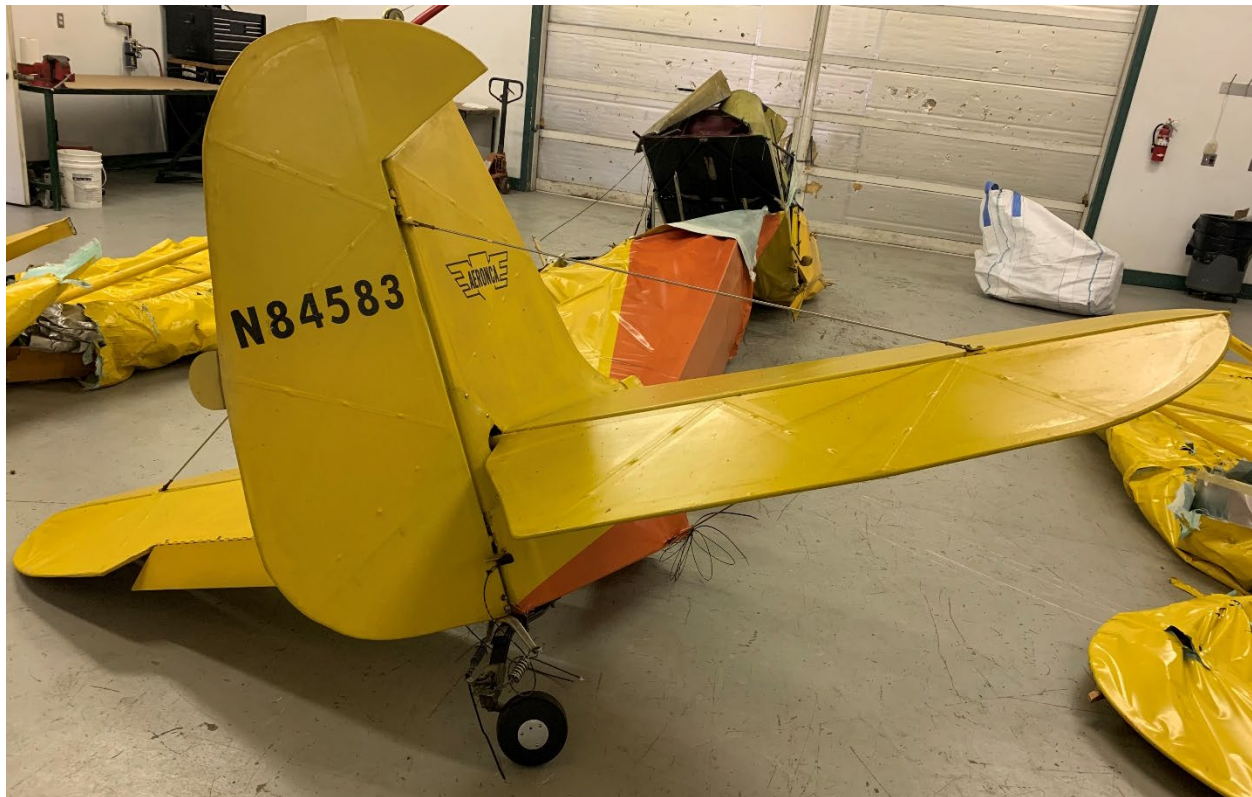
**Figure 6. View of Empennage**

The empennage was cut from the fuselage to facilitate recovery. The elevator remained attached to the horizontal stabilizer. The vertical stabilizer remained attached to the empennage and the rudder remained attached to the vertical stabilizer. The tailwheel remained attached to the empennage.

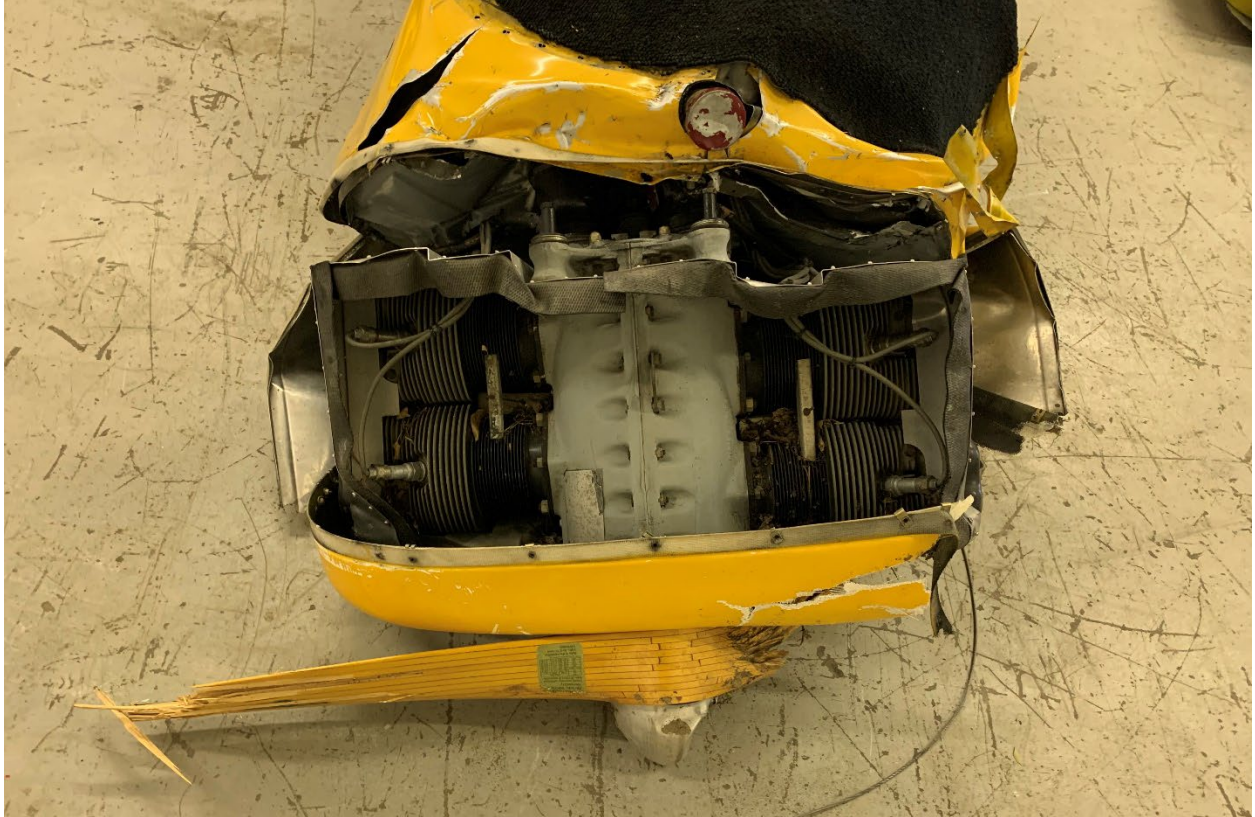
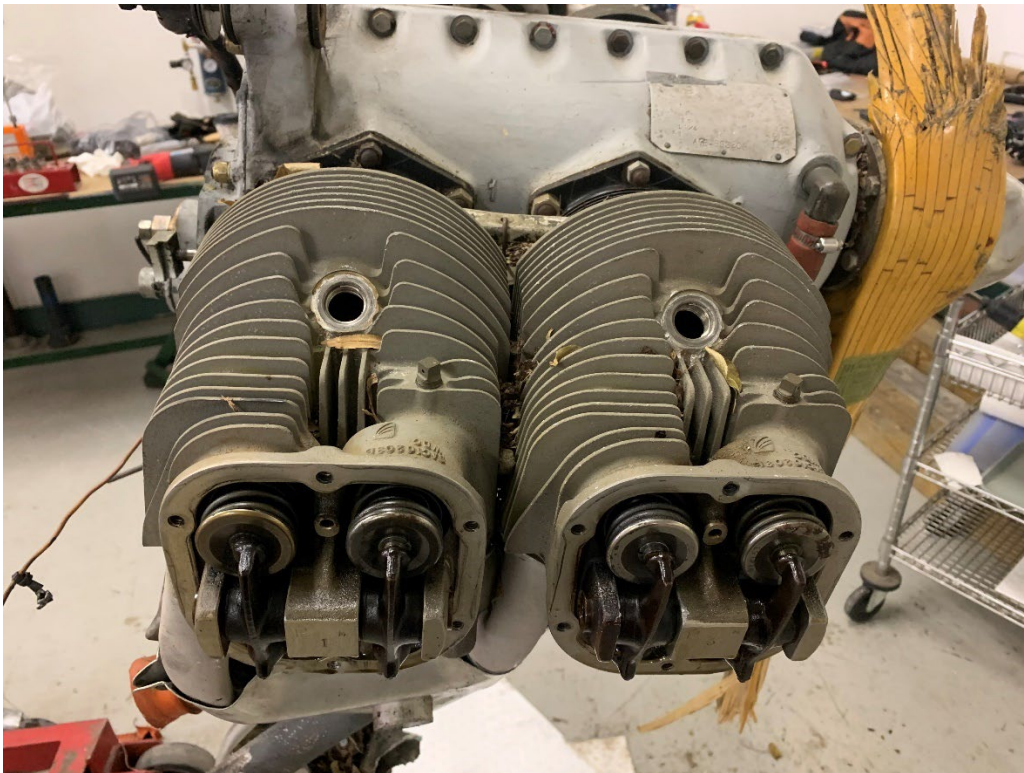
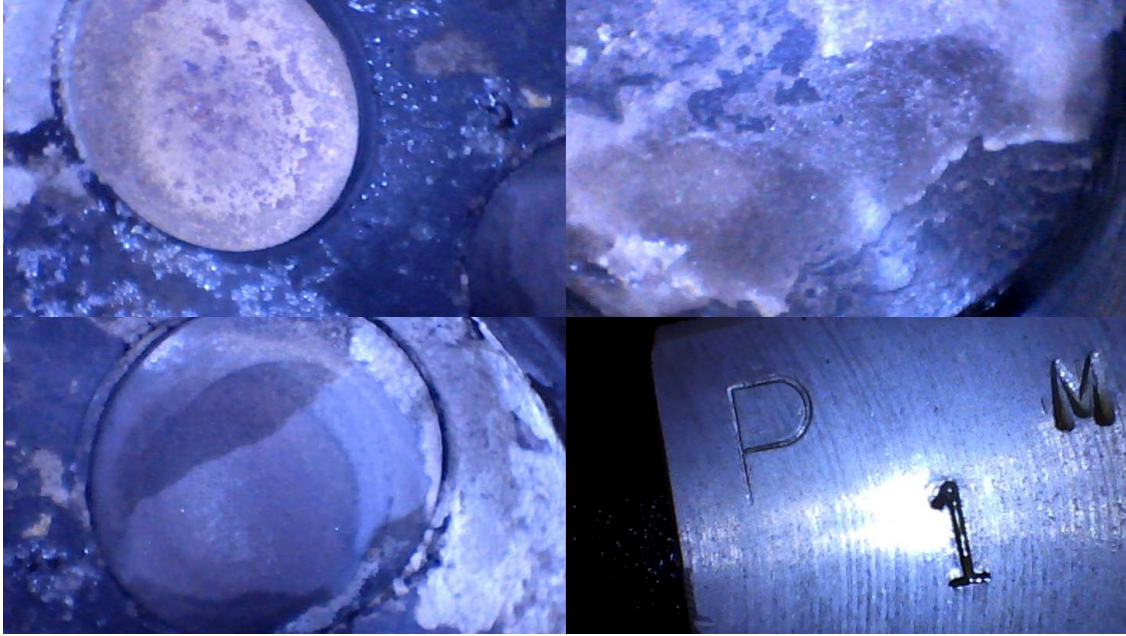
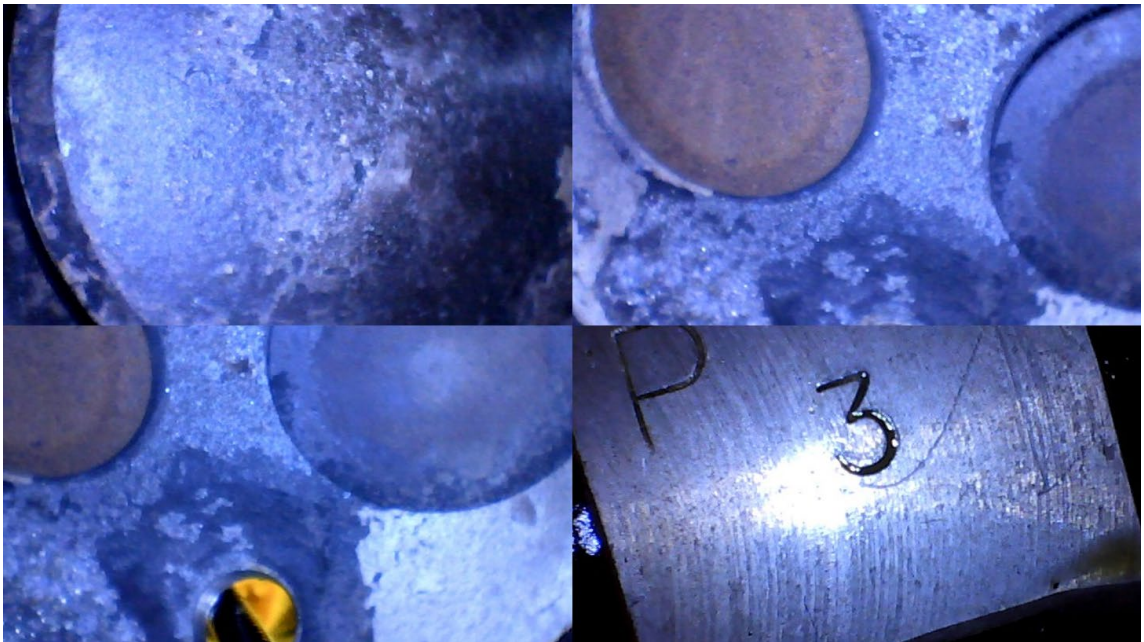
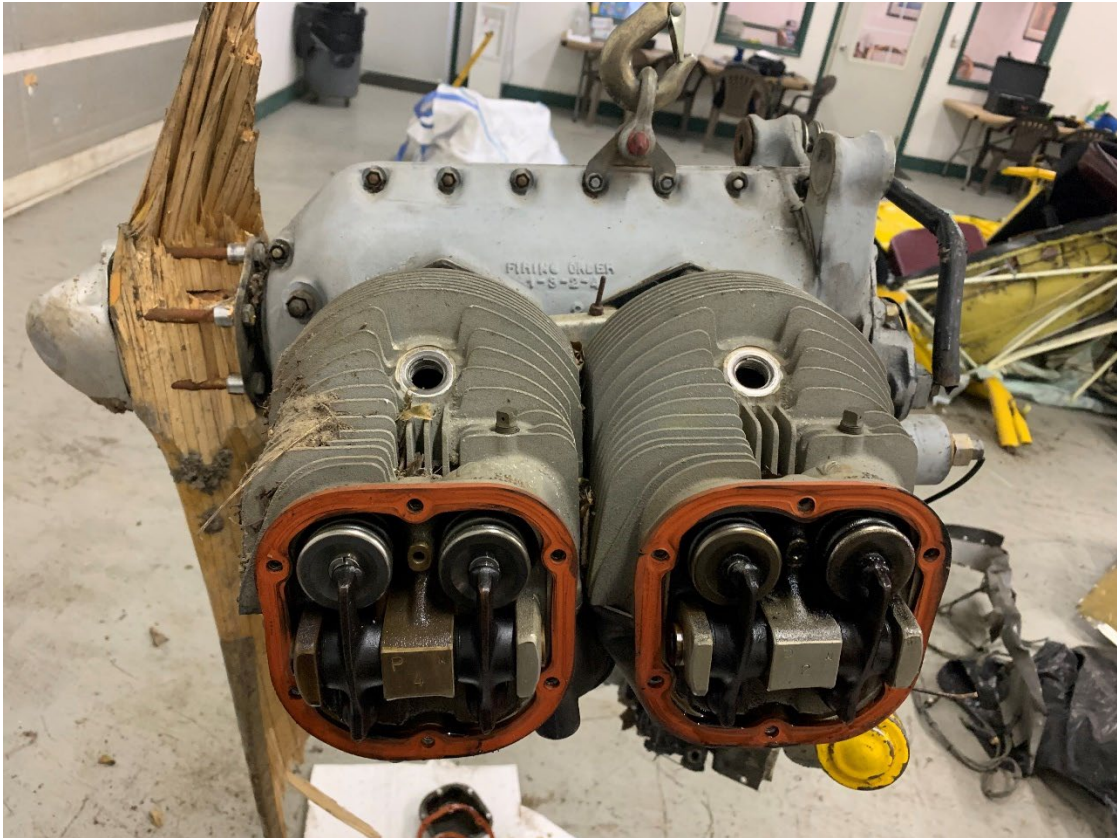
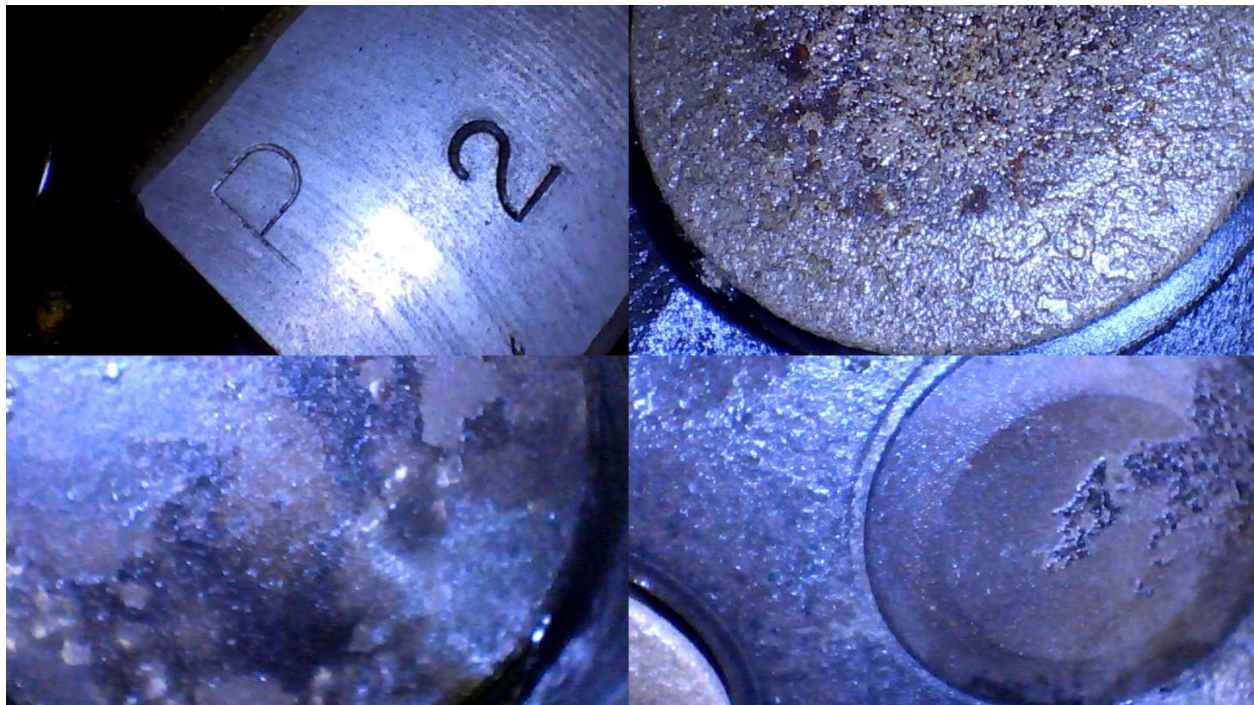
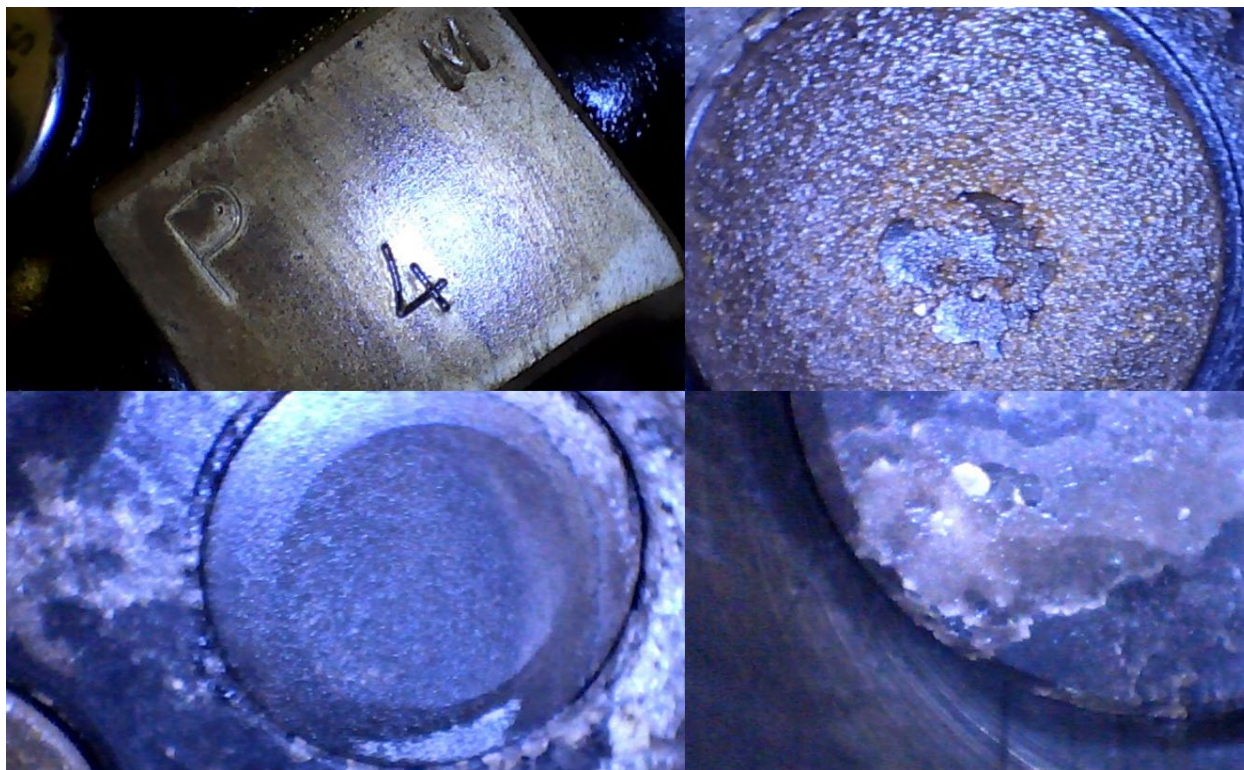
The engine was removed from the fuselage to facilitate examination. The top spark plugs were removed and compression and suction were observed on all cylinders. Crankshaft and valvetrain continuity were confirmed by rotating the propeller by hand. The cylinders were examined with a lighted boroscope and no anomalies were noted with the piston faces, cylinder walls, or valves.

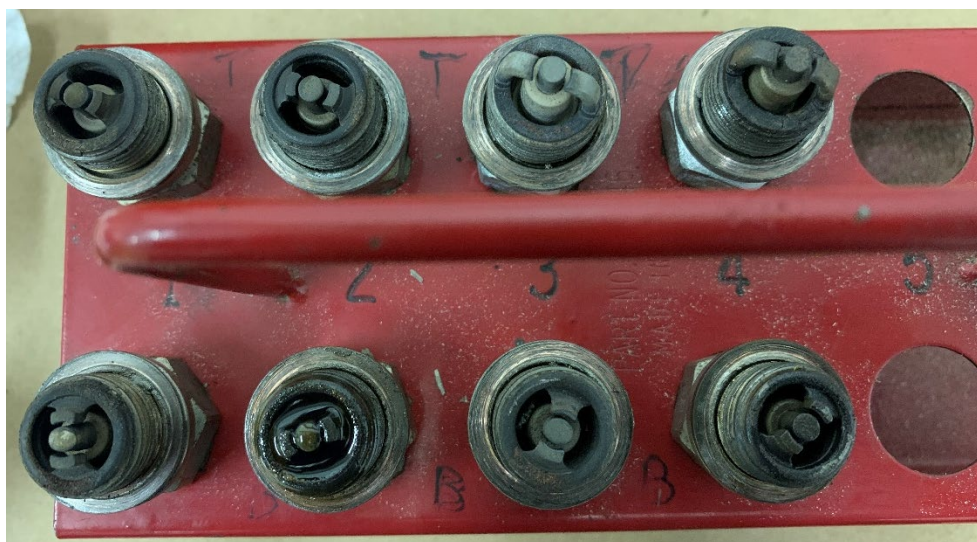
**Figure 14. View of Spark Plugs**

All spark plugs were removed and were light grey in color and in normal condition when compared to the Champion Check-A-Plug Chart. They were two different types of spark plugs.

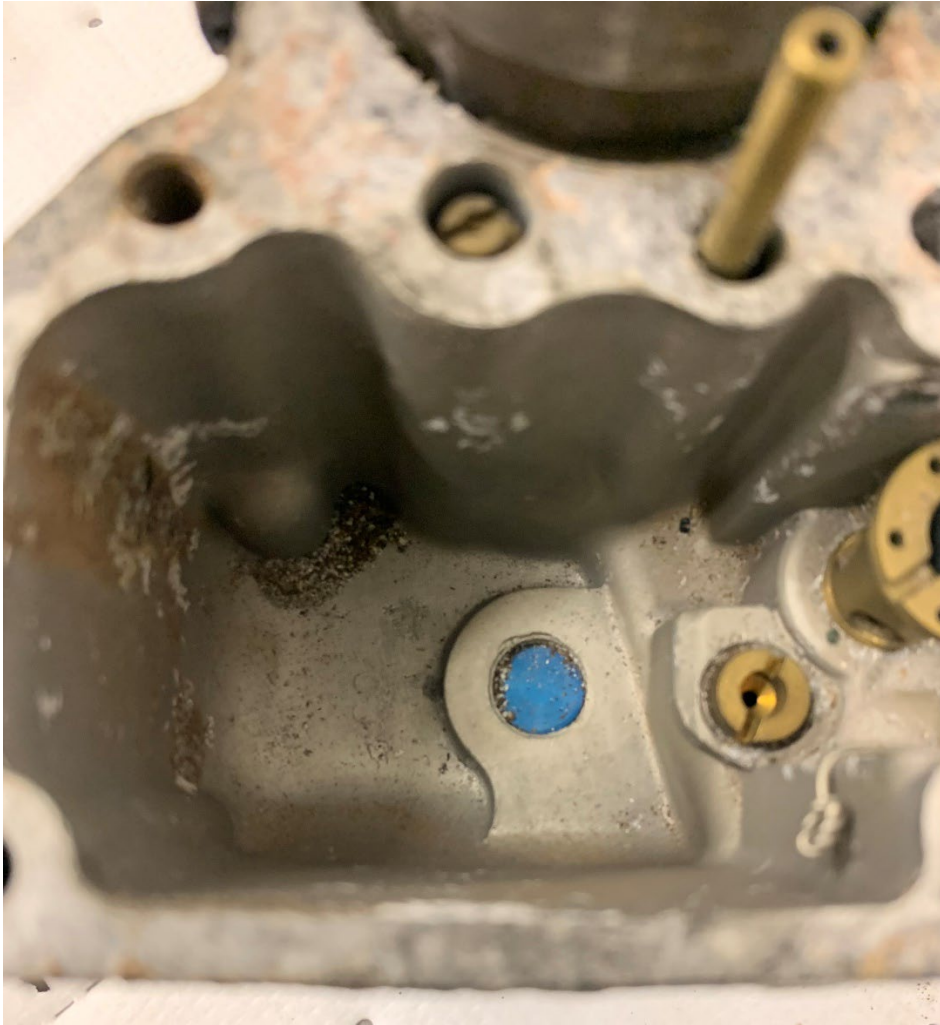
**Figure 15. View of Carburetor Bowl**

The throttle control cable remained attached to the carburetor and was cut to facilitate examination. The carburetor was removed from the engine and the throttle valve could be moved by the throttle arm. The fuel screen was removed, was not

obstructed, but contained a small amount of debris. The carburetor was disassembled and the float was intact, contained no holes. The needle valve was removed and no anomalies were noted. There was no fluid in the carburetor bowl, but a small amount of debris was noted.

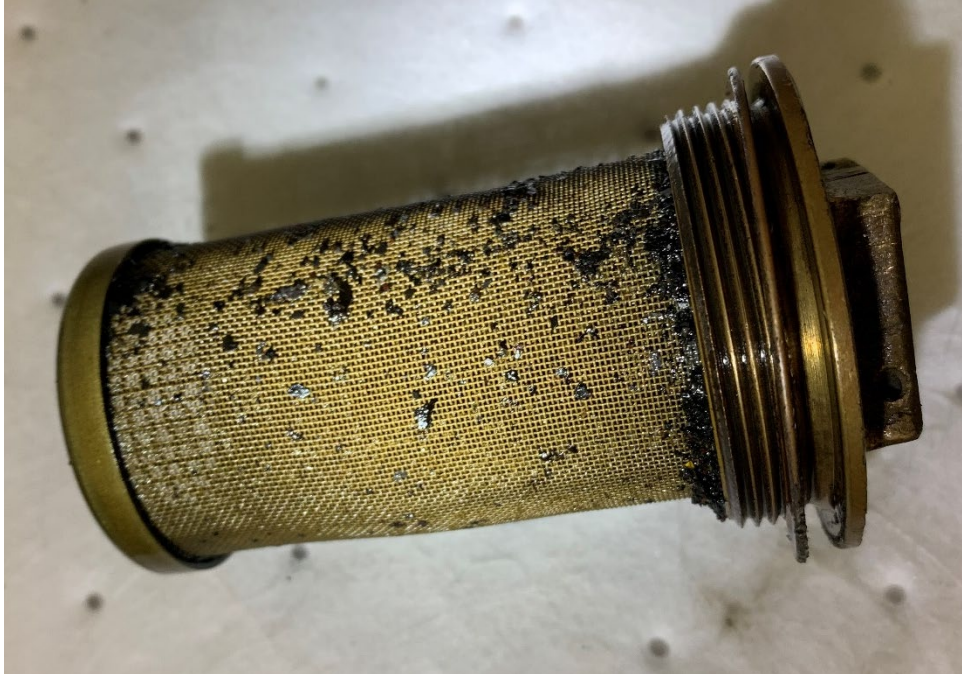
**Figure 16. View of oil suction screen.**

The oil tank was examined, and 3.5 quarts of oil was measured with the oil dipstick. The oil screen was removed and examined. It was not obstructed, but contained non-ferrous material.

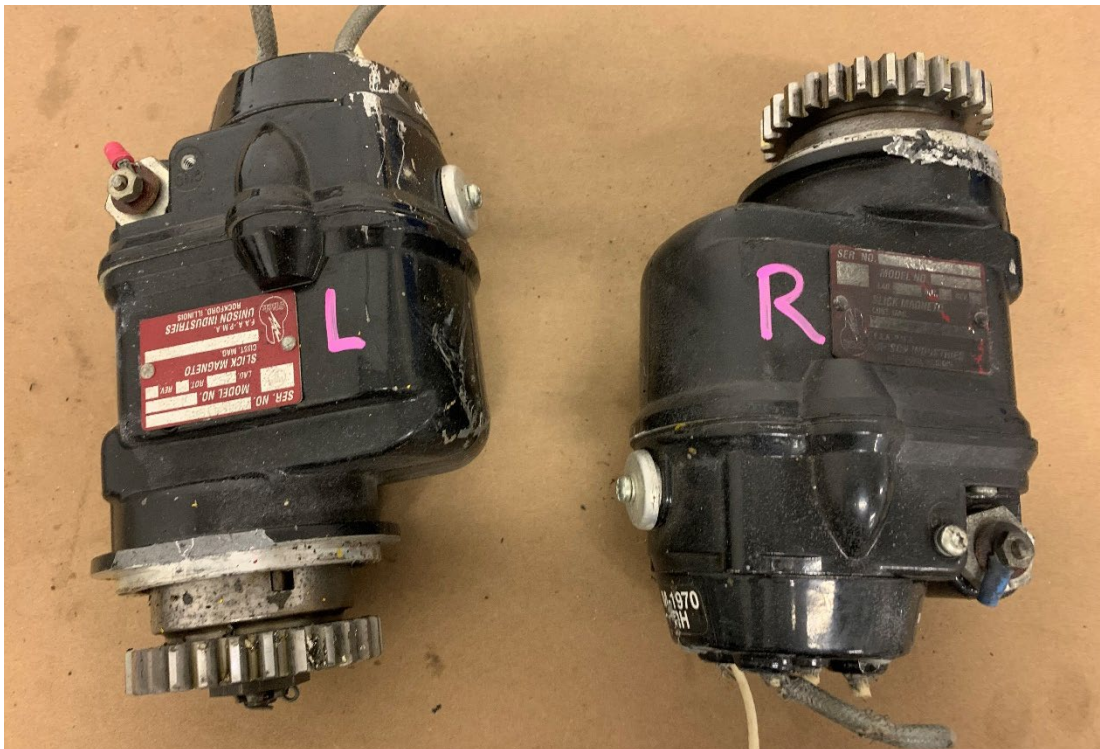
**Figure 17. View of Magnetos**

The left magneto was impact separated from the engine but remained attached through the ignition wires. The right magneto remained attached to the engine. They were removed, examined, and each produced spark on all towers.

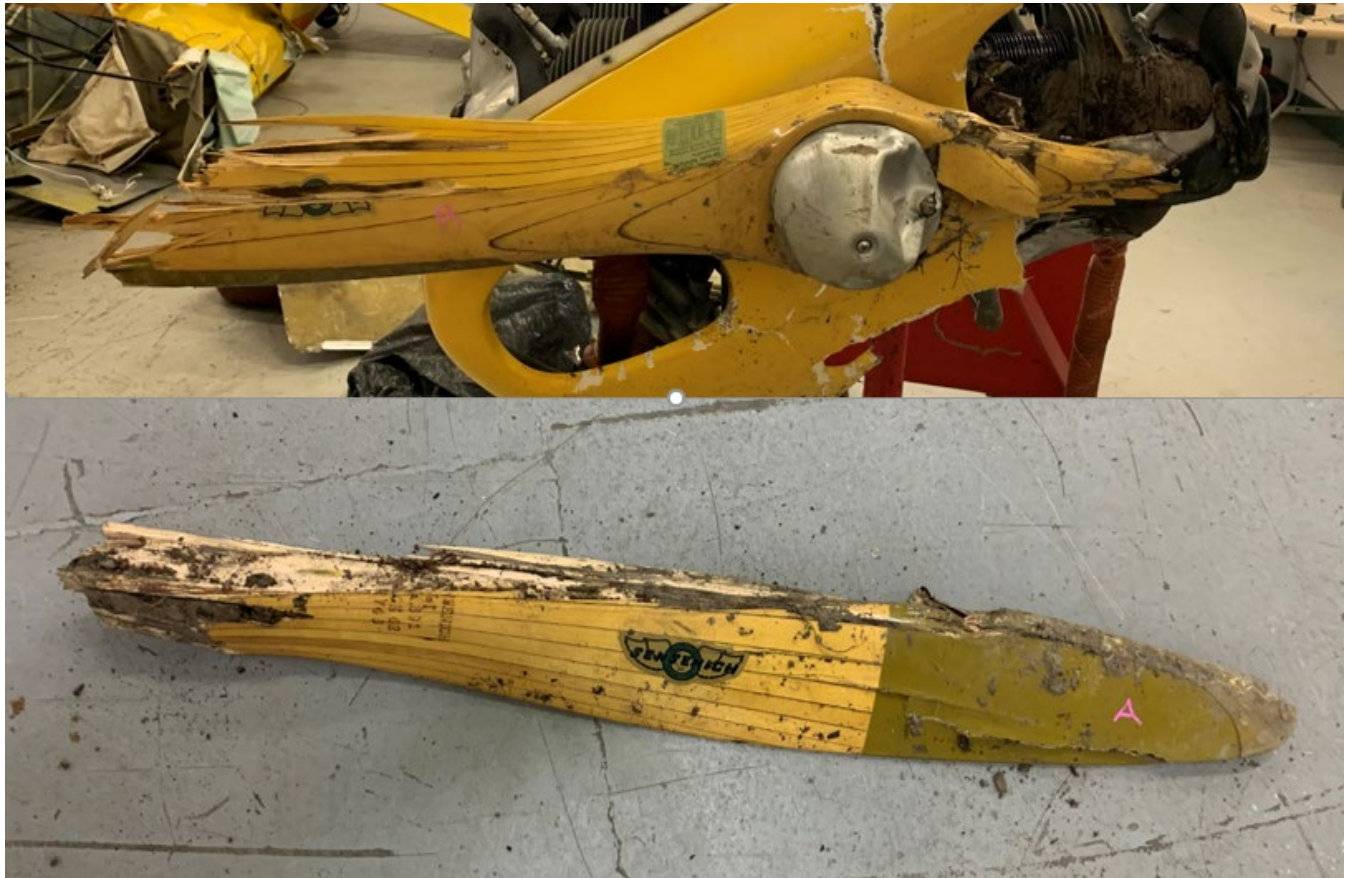
**Figure 18. View of propeller blades.**

The wooden propeller remained attached to the hub. Both blades were splintered. Blade A exhibited leading edge gouging and was fractured about 3 inches from the hub. Blade B was fractured about 22 inches from the hub. The propeller could be rotated through 360° of motion.
