## **NATIONAL TRANSPORTATION SAFETY BOARD**

**Photo Array**

**ERA22LA245**

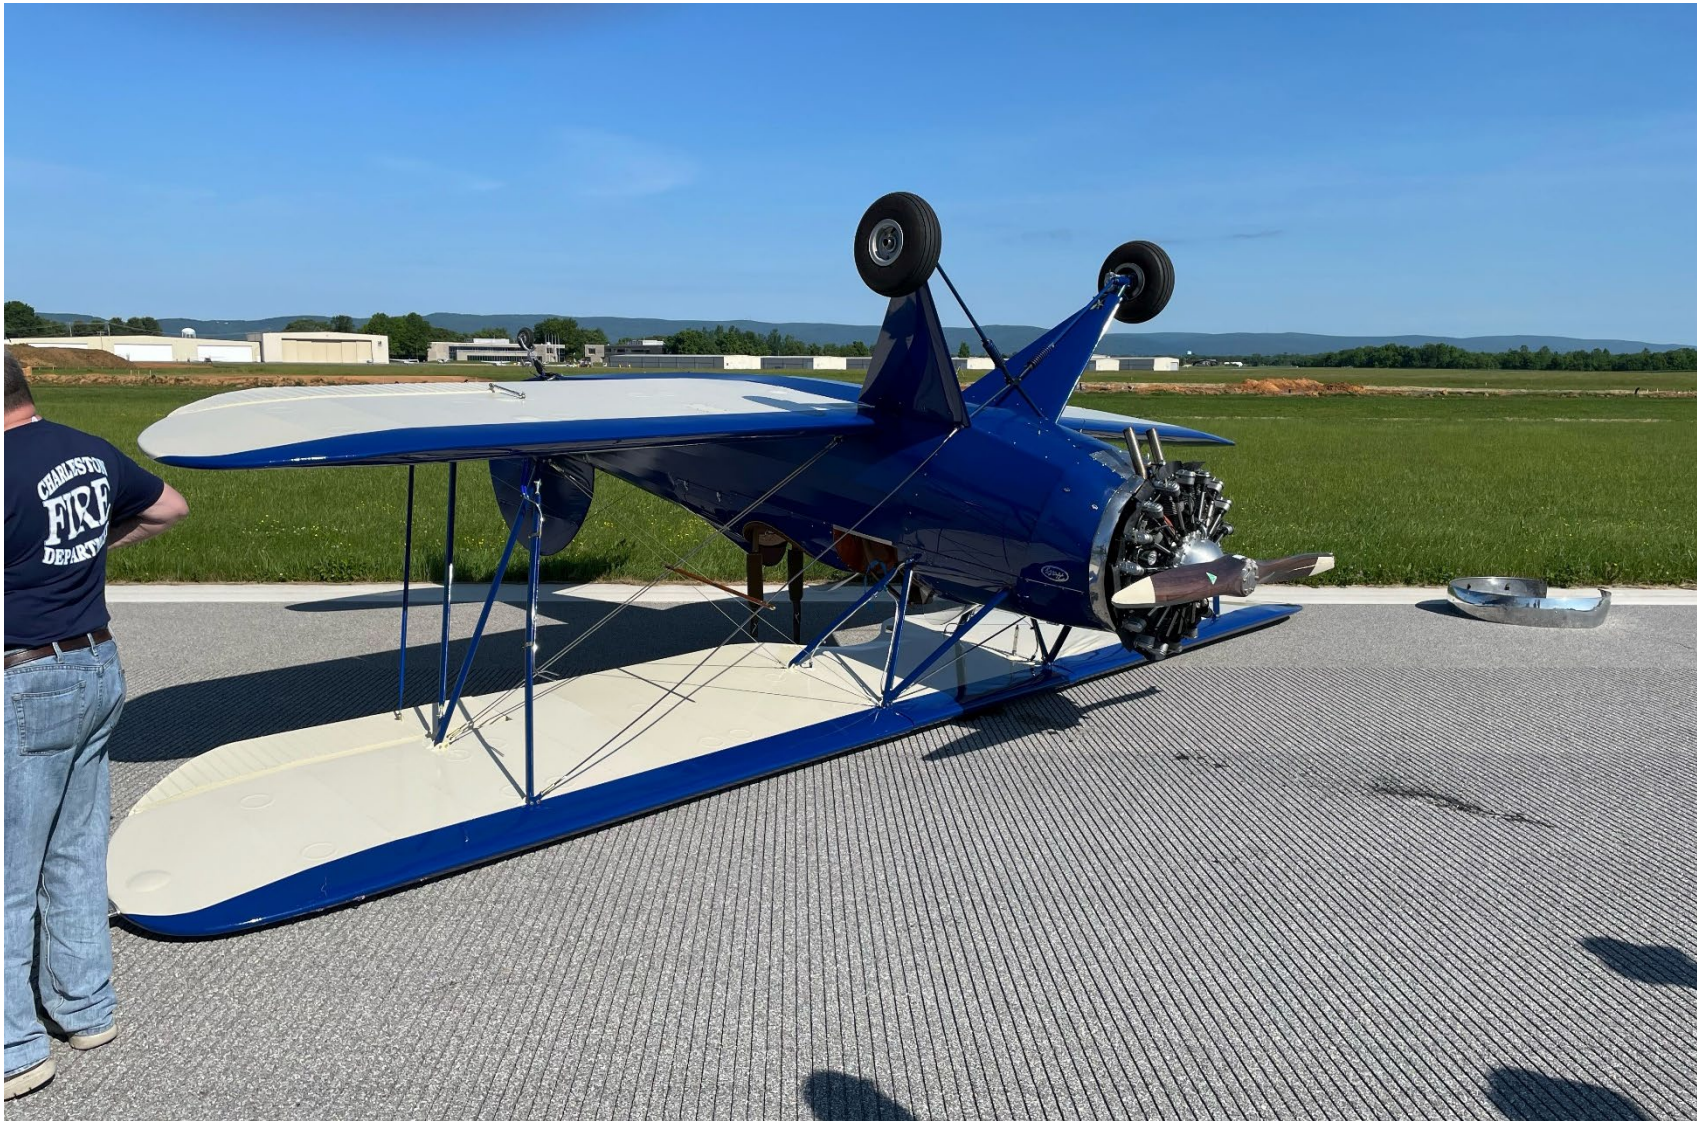
**Photo 1 – View of Inverted Airplane from Left Side (Courtesy of FDK Airport Manager)**

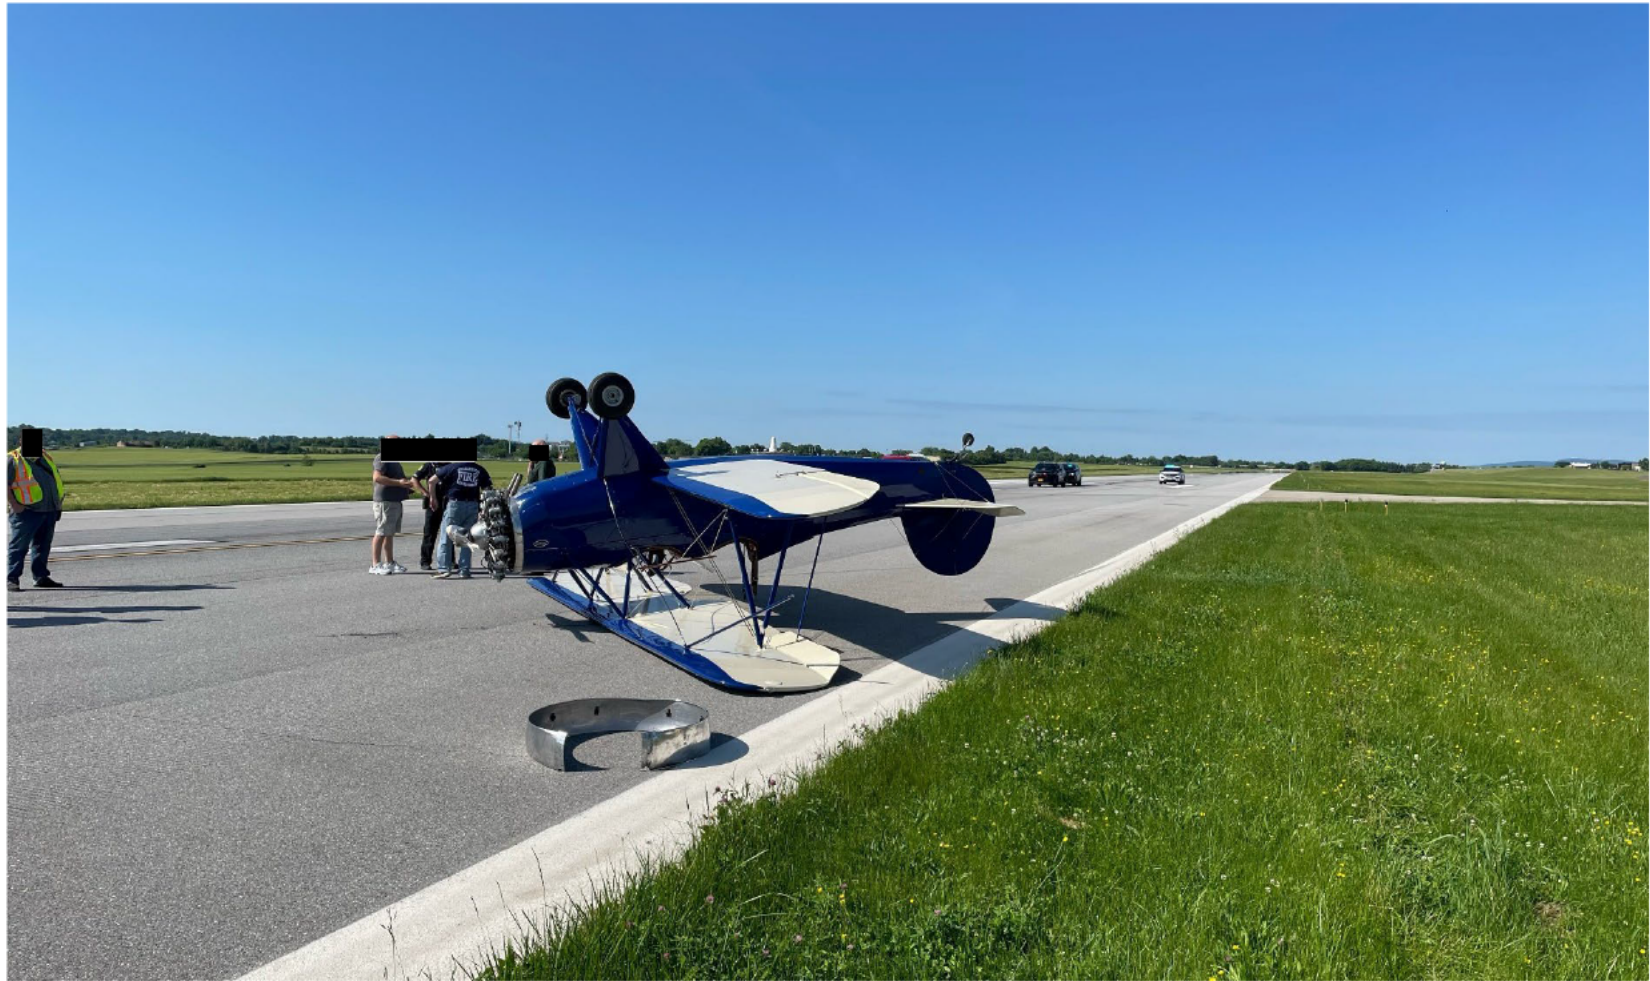
**Photo 2 – View of Inverted Airplane from Right Side – Note Damage to Upper Wing (Courtesy of FDK Airport Manager)**

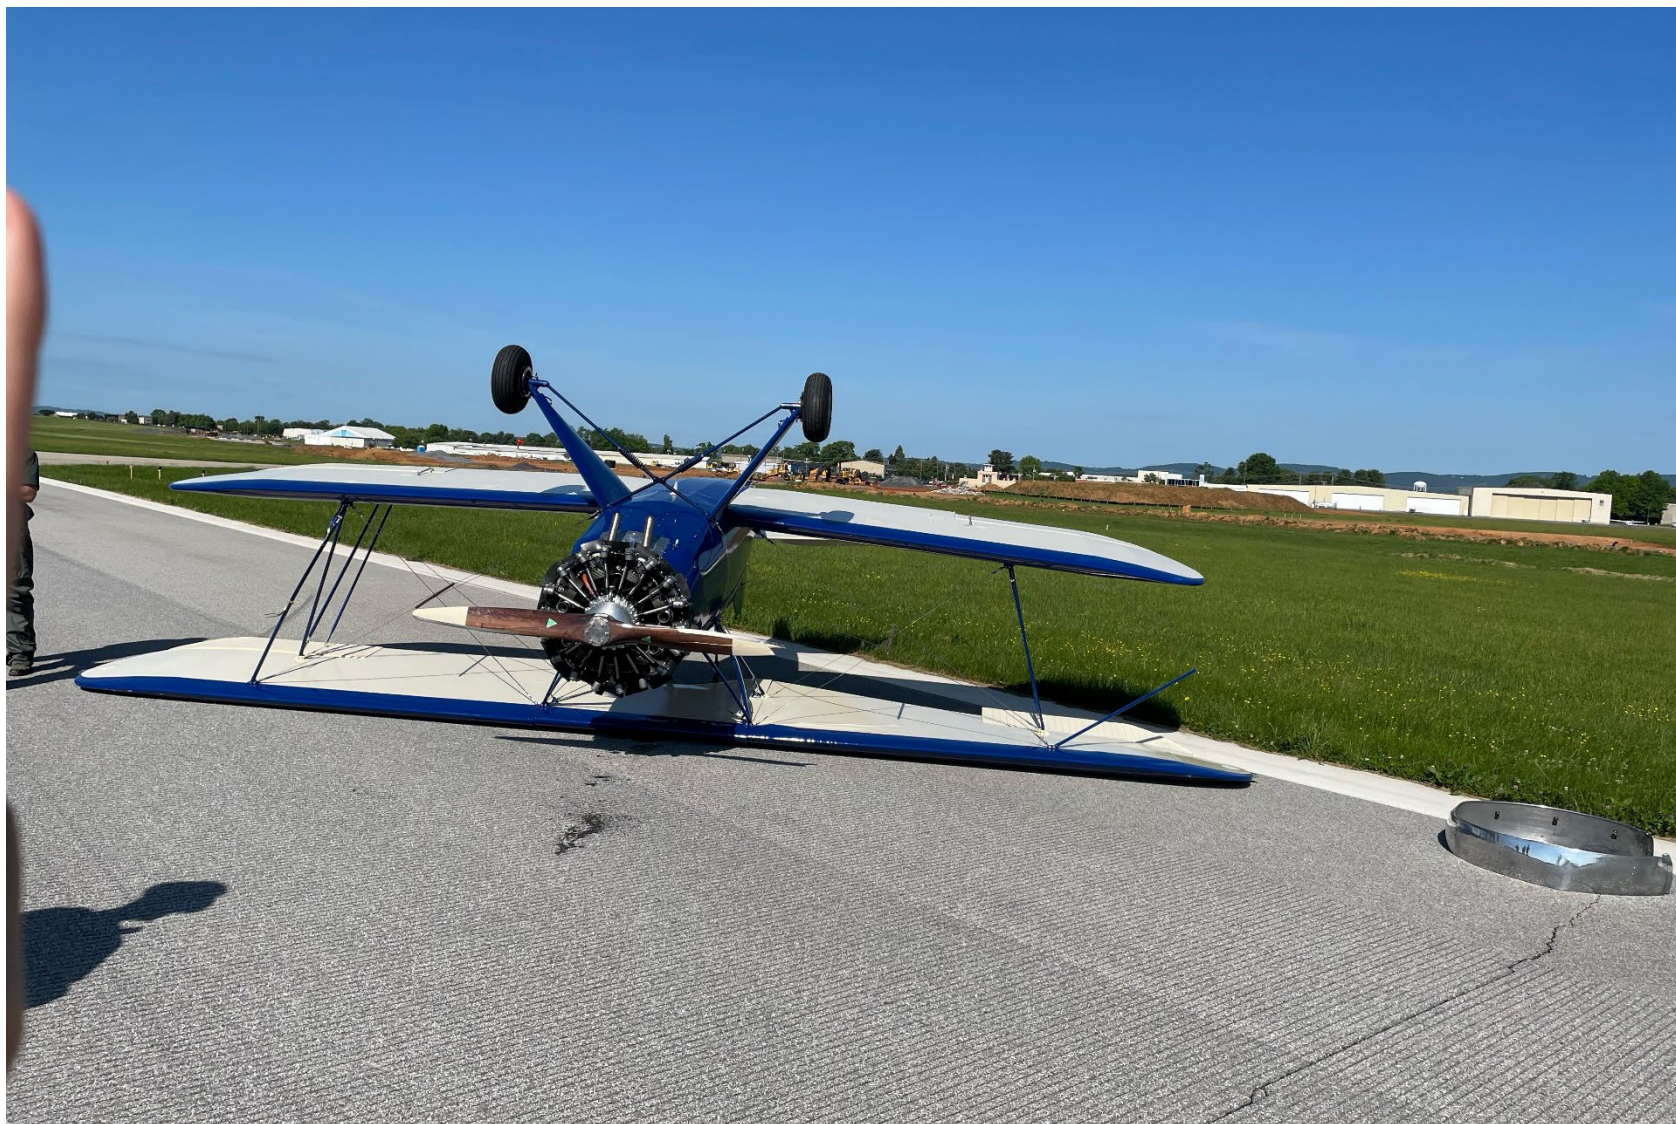
**Photo 3 – View of Inverted Airplane from Front (Courtesy of FDK Airport Manager)**
