**NTSB ERA22LA247**

**C150F, N8919S**

**Investigative Photographs**

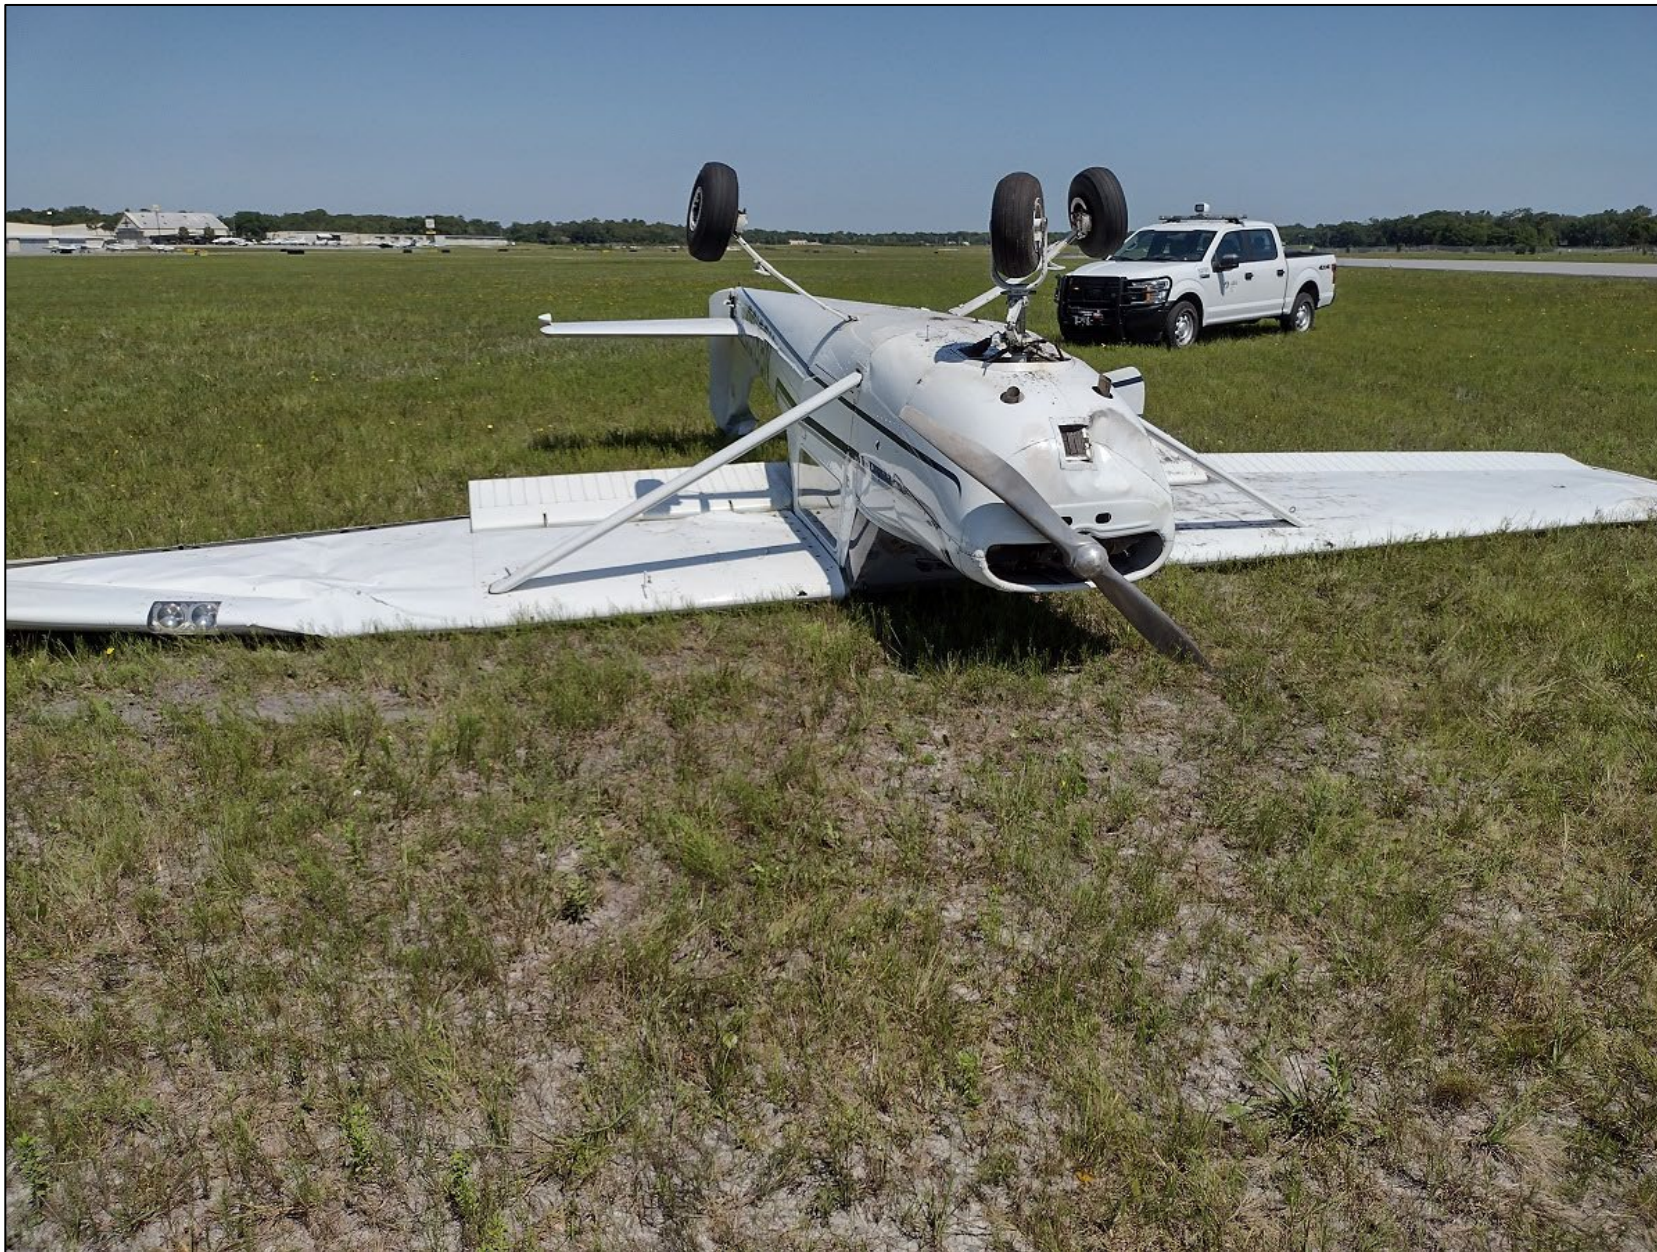
Photo 1: Overview of the substantial damage sustained to the airplane's right wing (Photo Courtesy of FAA)

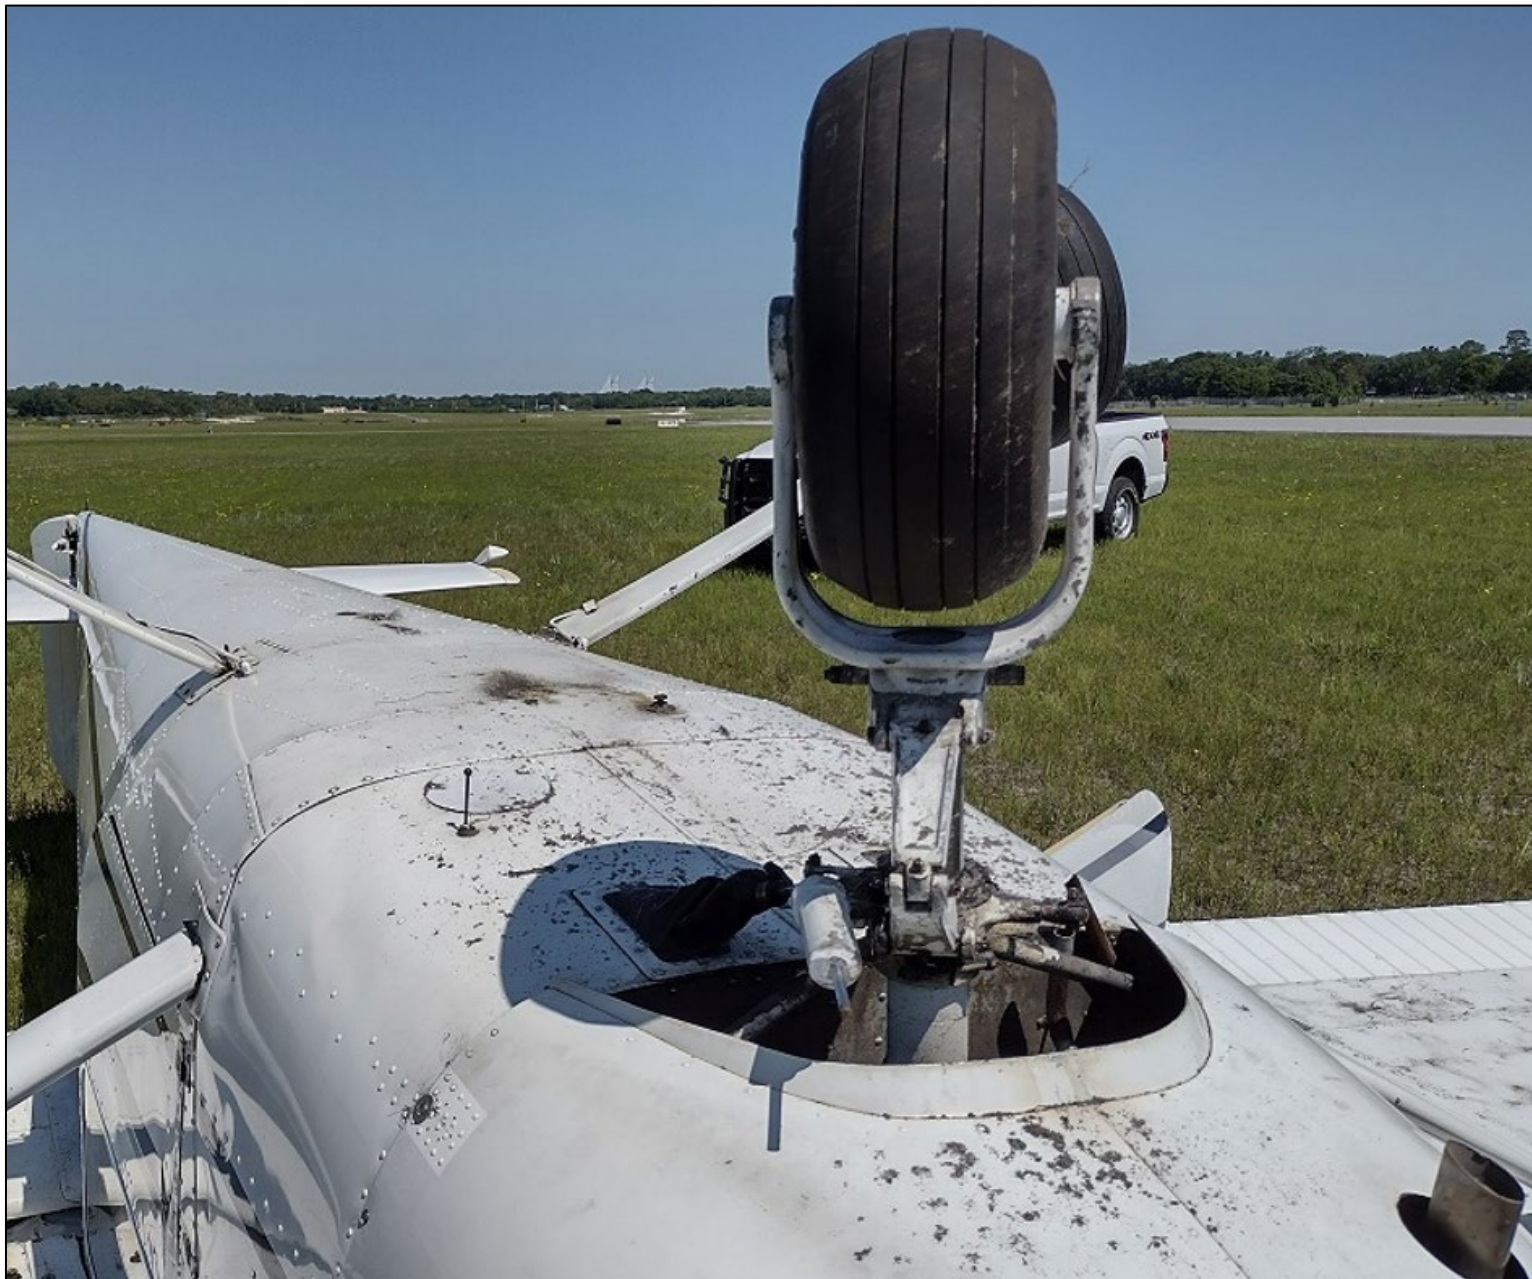
Photo 2: Overview of the nose gear postaccident (Photo Courtesy of FAA)

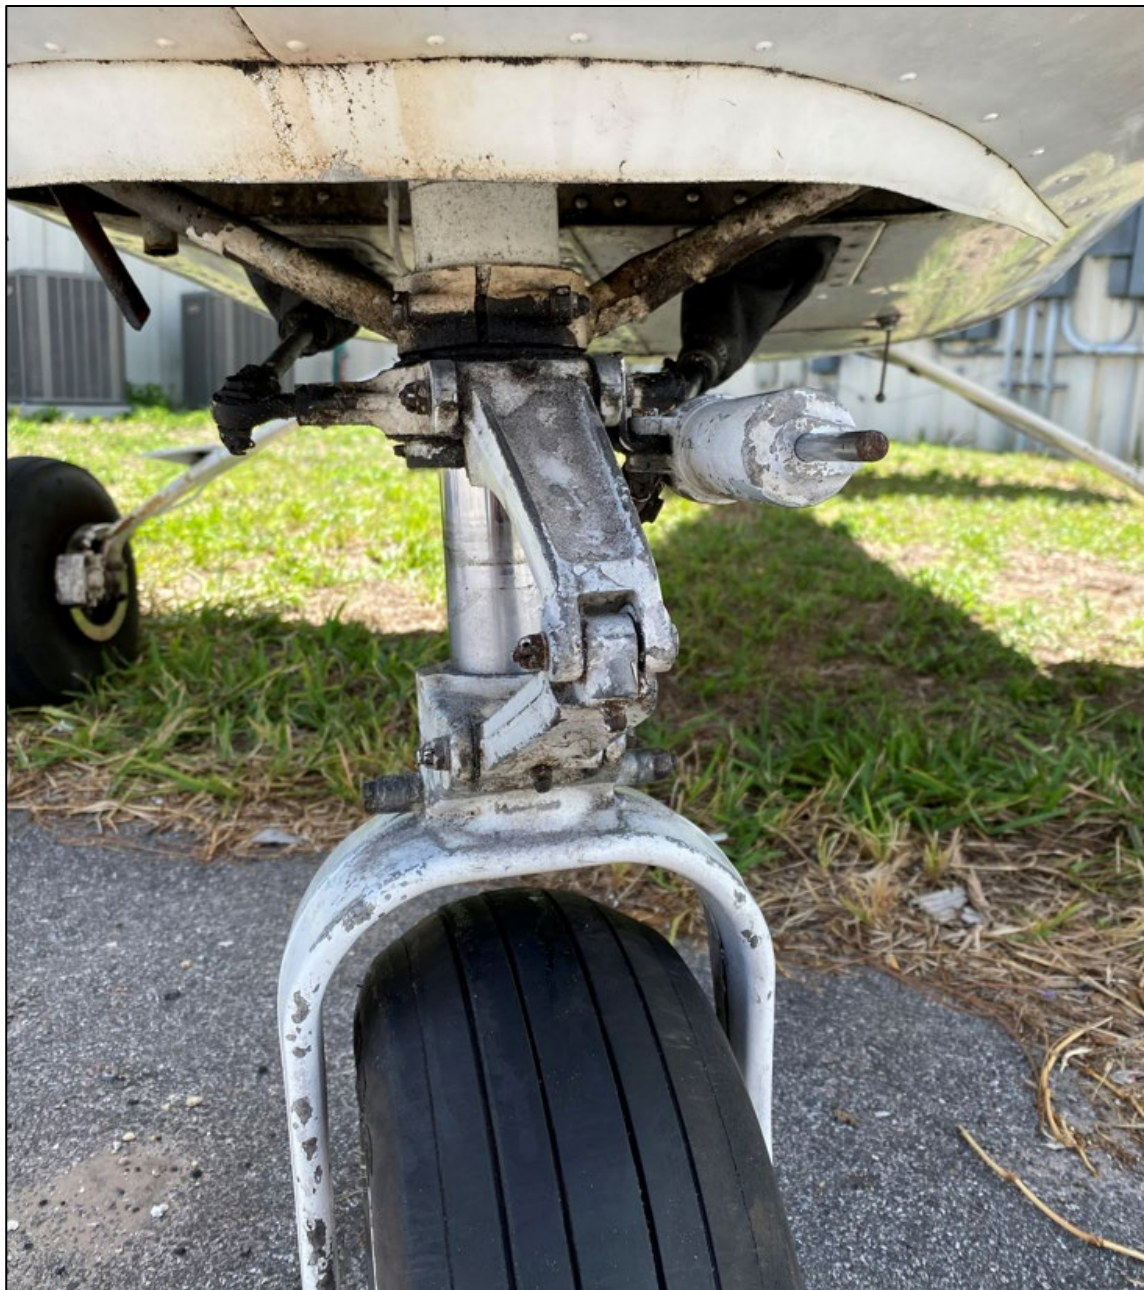
Photo 3: Forward view of the nose landing gear (Photo Courtesy of FAA)

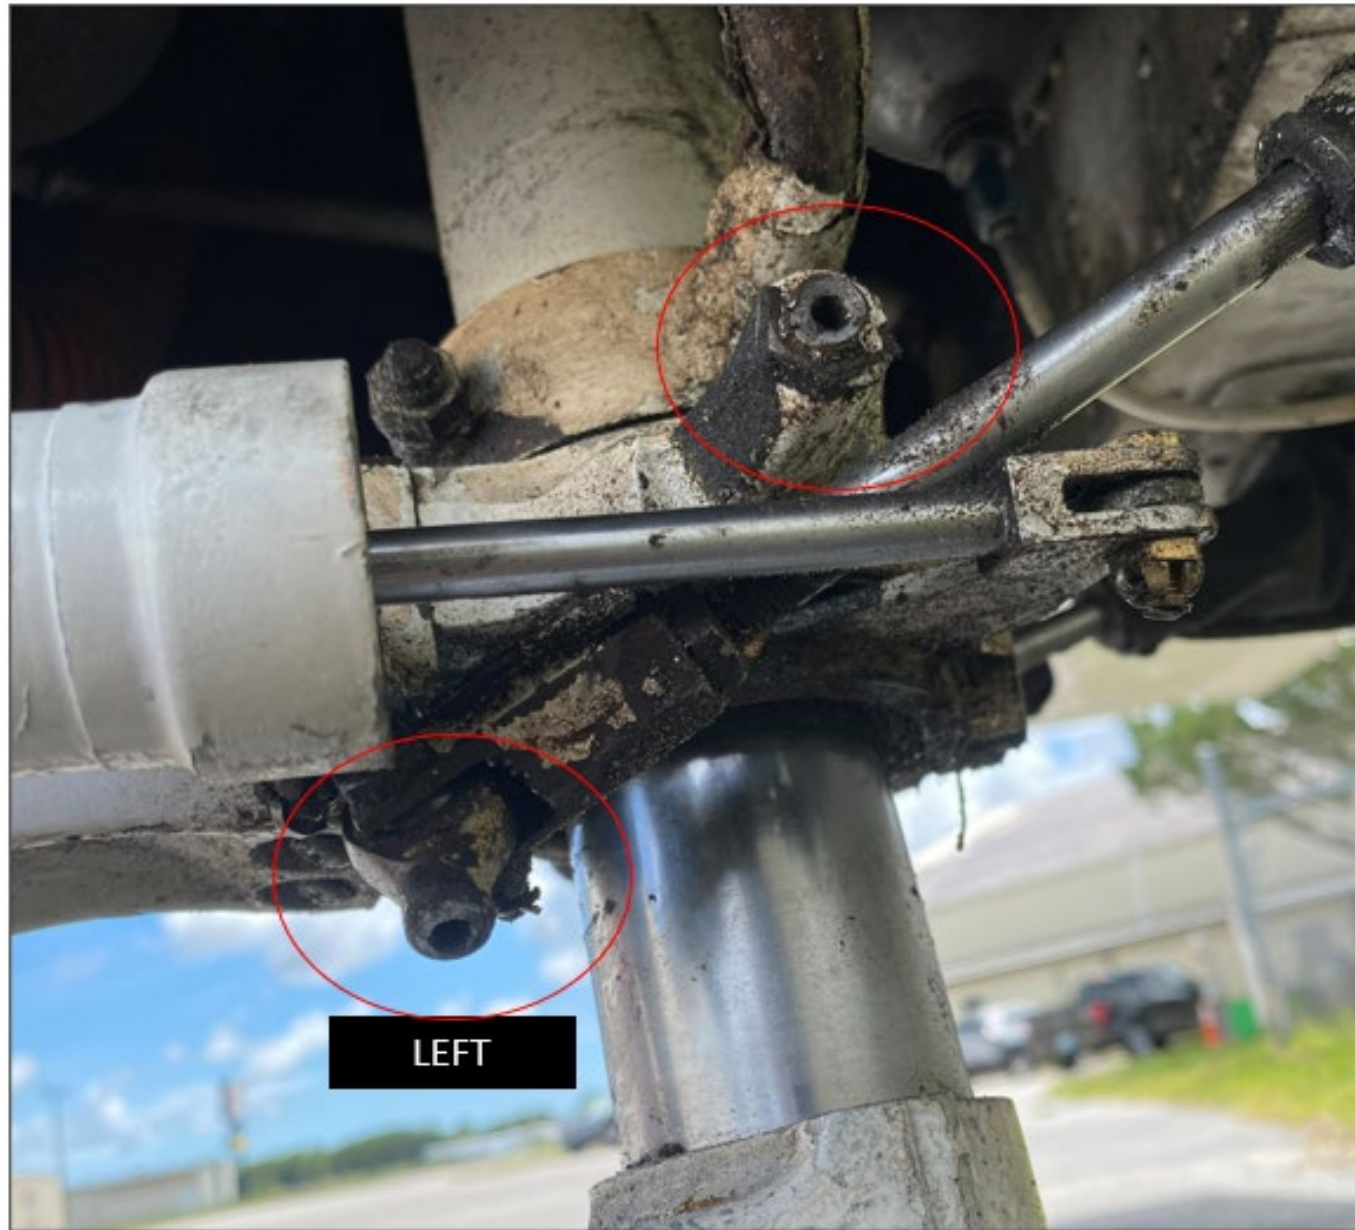
Photo 4: Overview of the left steering connecting rod (Photo Courtesy of FAA)

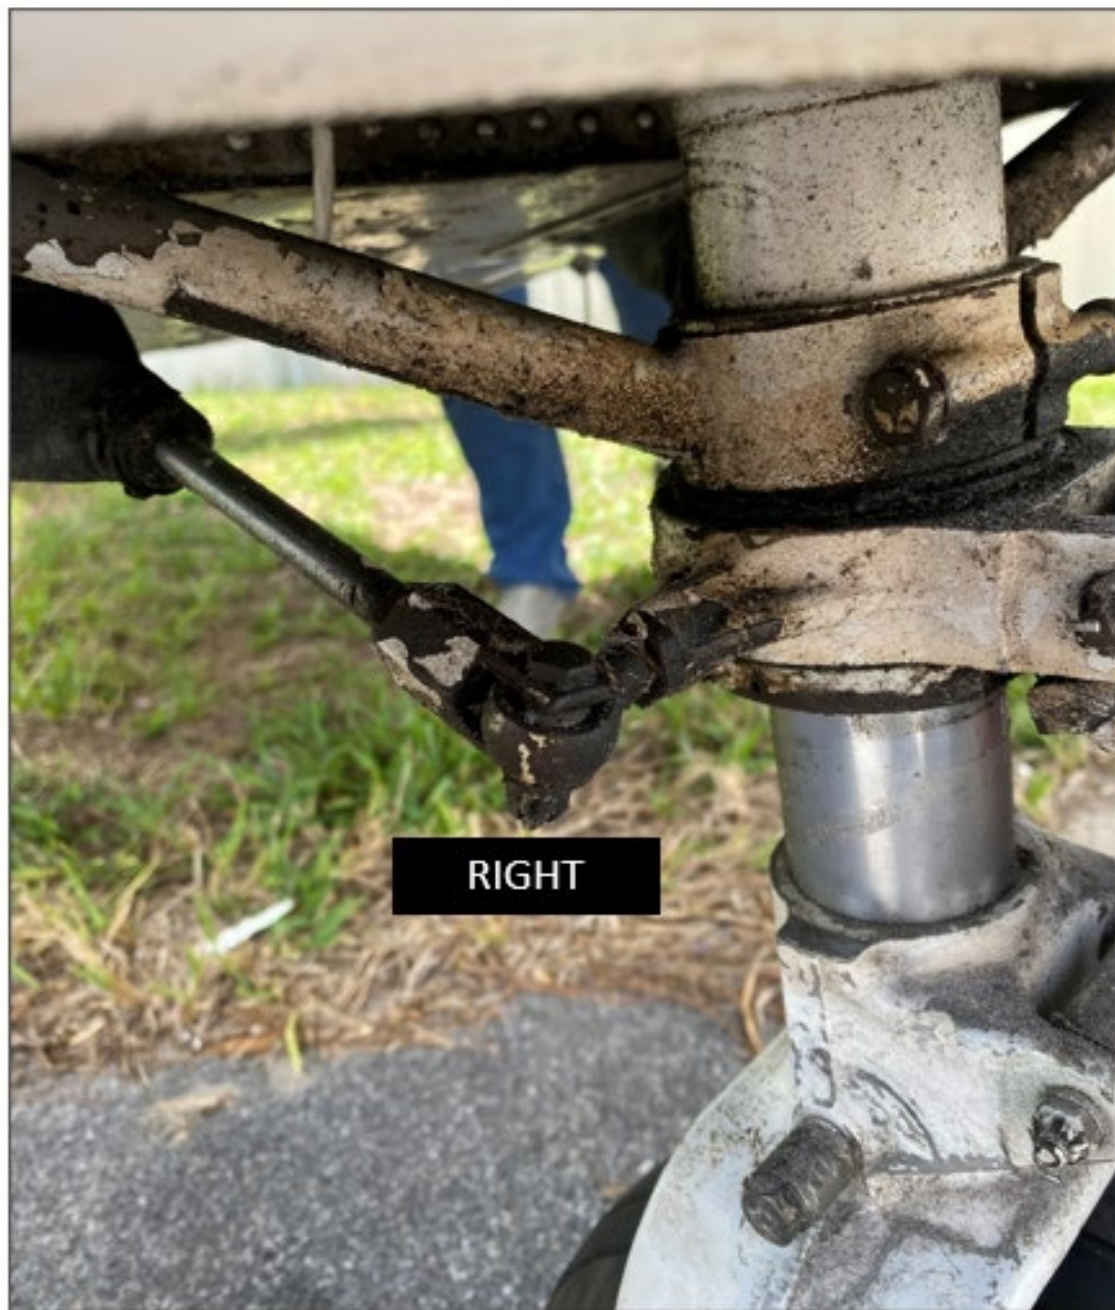
Photo 5: Overview of the right steering connecting rod remaining connected (Photo Courtesy of FAA)

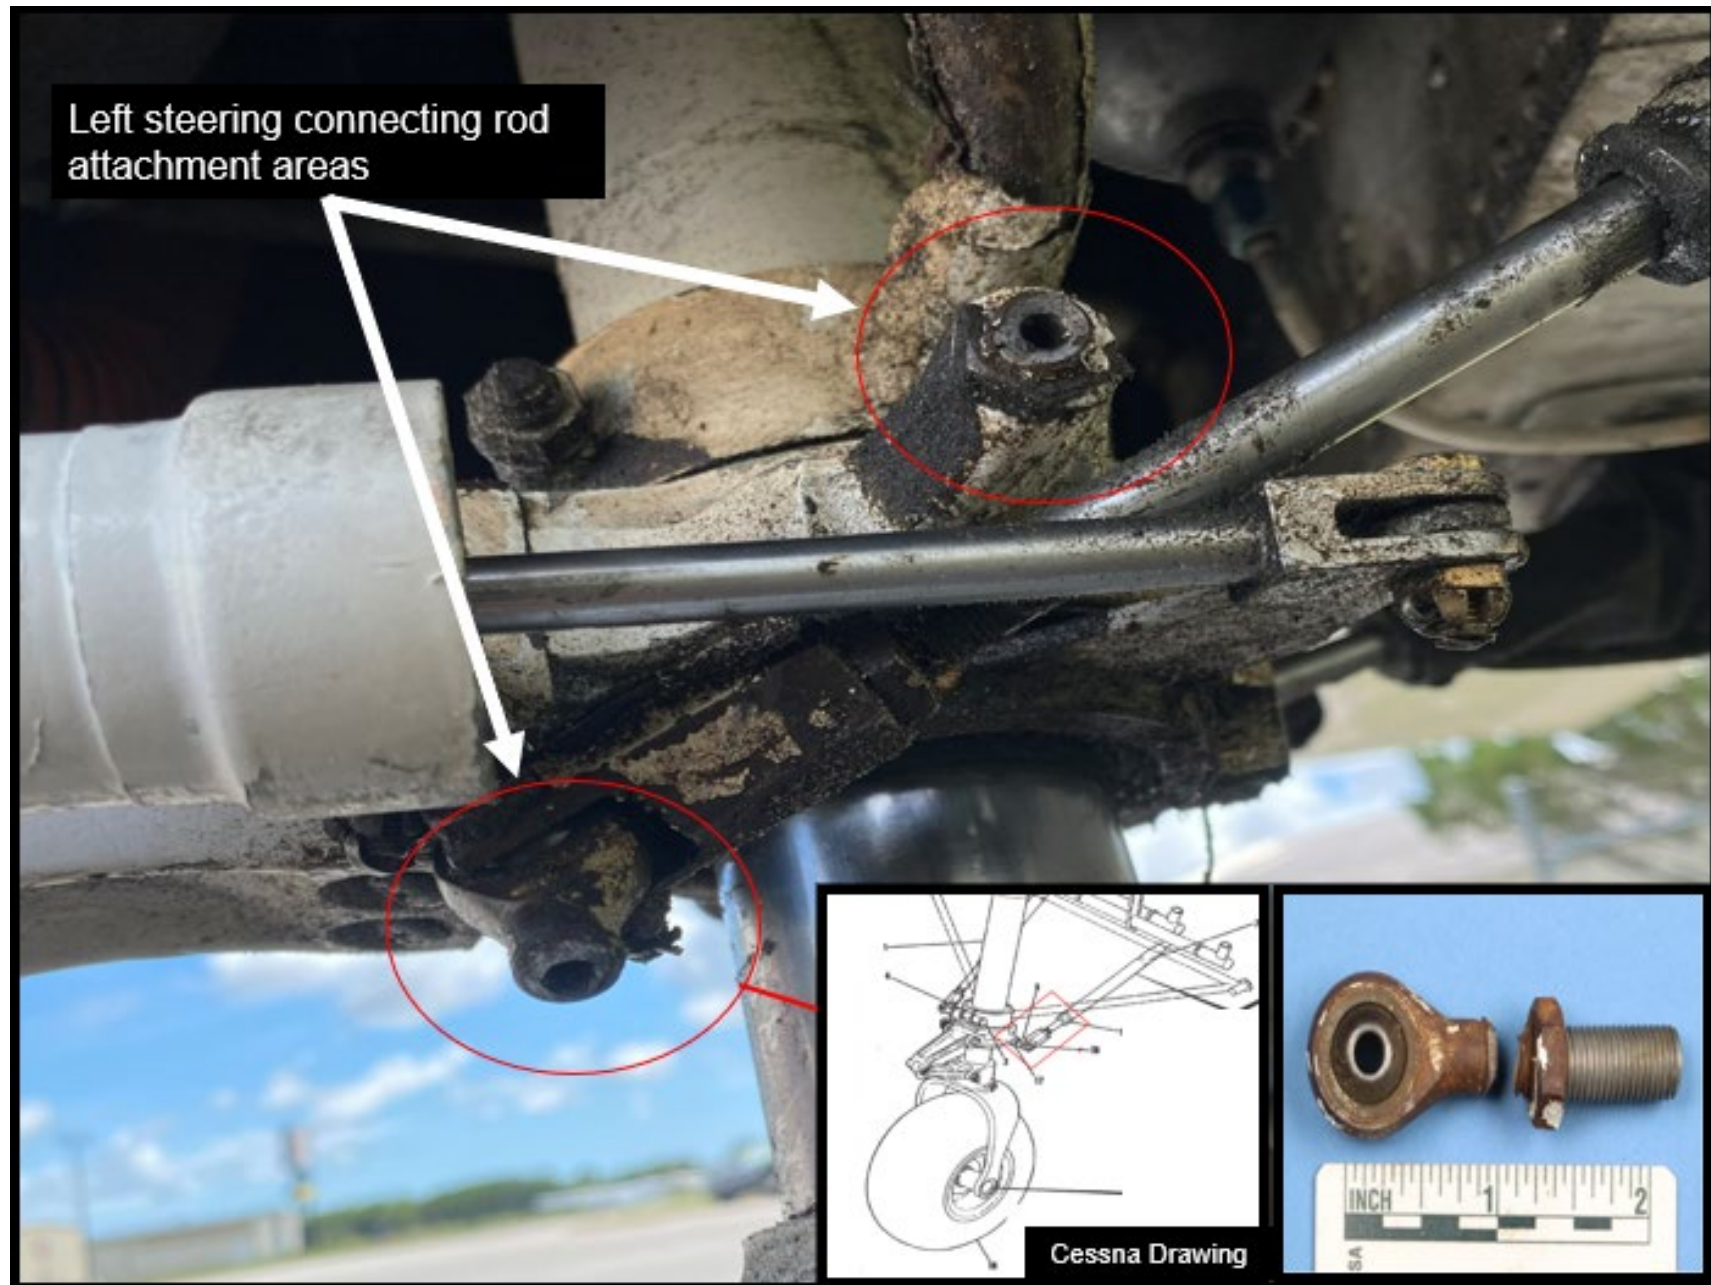
Photo 6: Overview of the left steering connecting rod (Figure from report)
