# National Transportation Safety Board

ERA22LA247

## **MATERIALS LABORATORY**

Factual Report 22-076

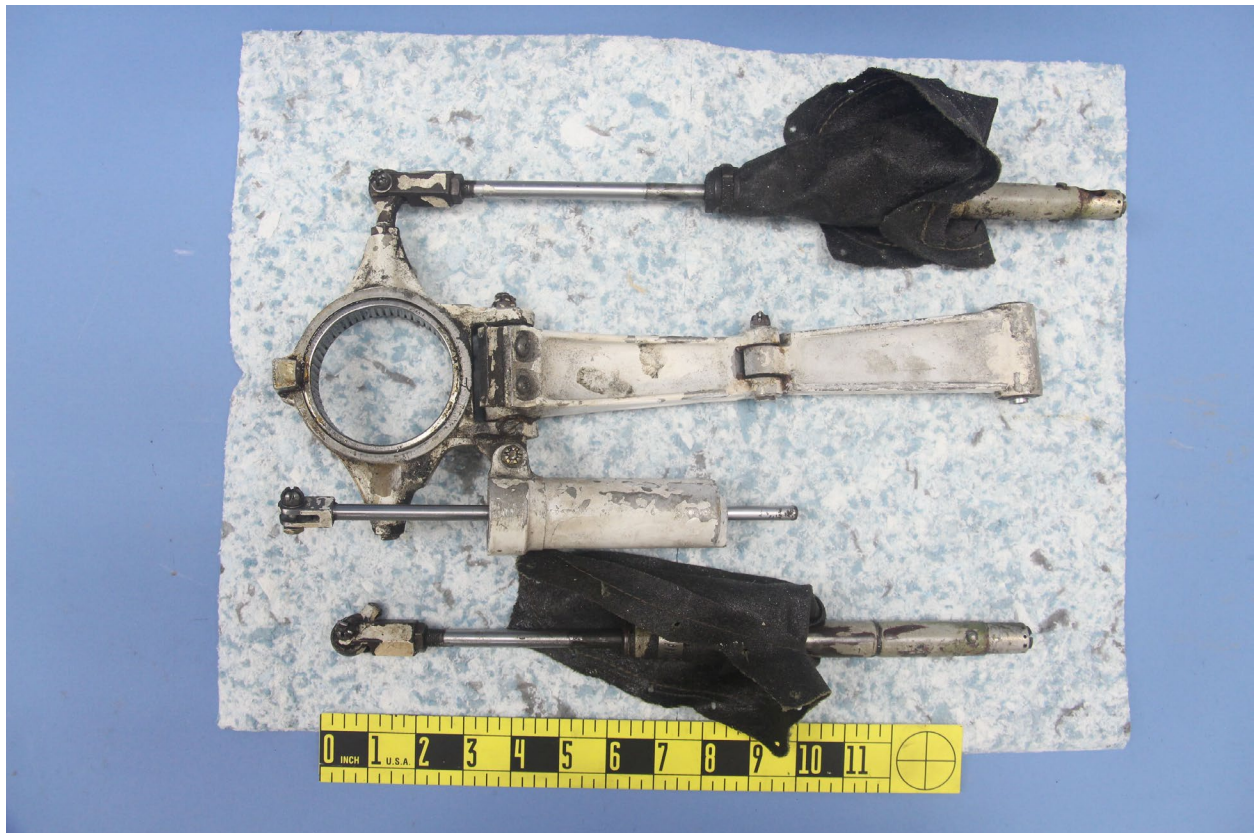
Left and right steering connecting rod assembly for C150 (Figure 1).

**Figure 1.** Left and right steering connecting rod assembly as received.

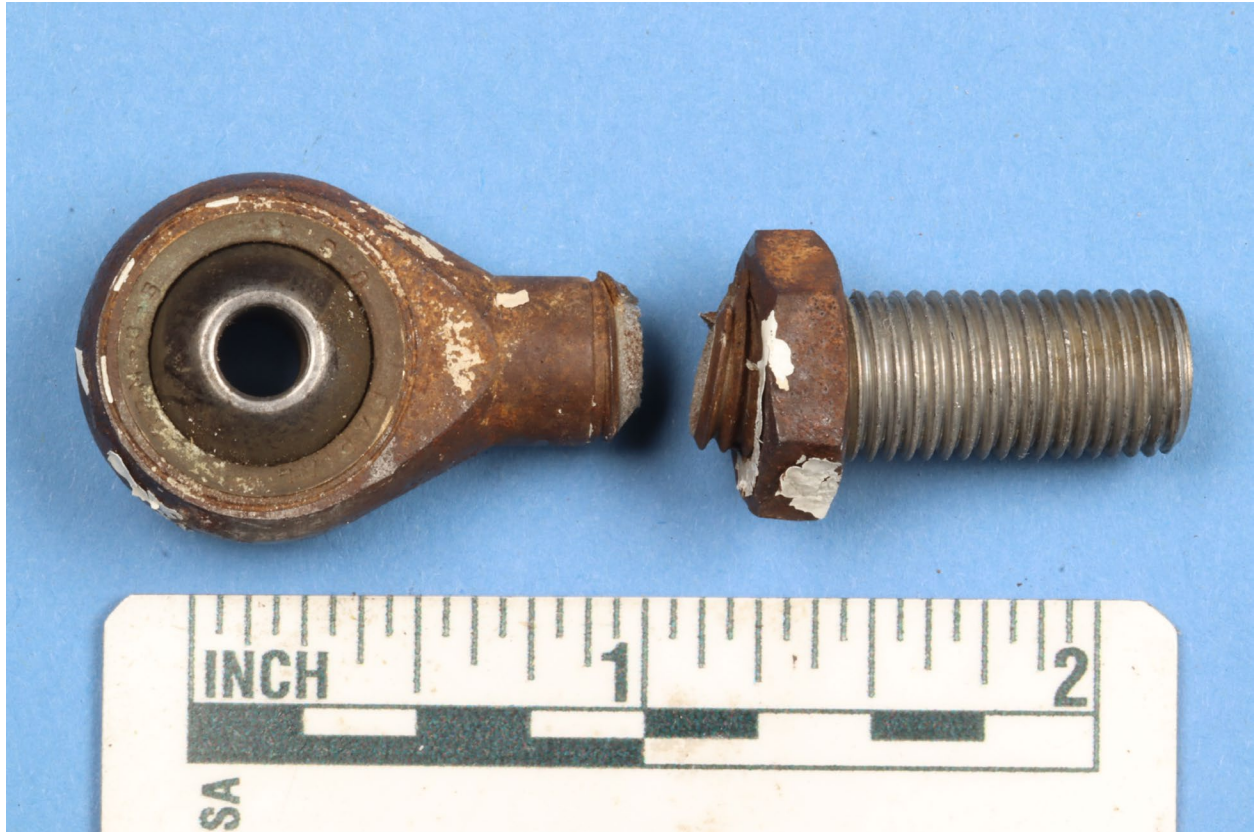
The steering connecting rod assembly exhibited a fractured rod end fitting (Figure 2). Examination of the fractured rod end fitting revealed that the threaded shank portion of the rod end fitting above the stop nut exhibited plastic deformation. Examination of the fracture surfaces of the rod end fitting revealed slant fractures consistent with overstress (Figure 3). The plastic deformation along with the slant fracture features are consistent with bending overstress.

**Figure 2.** Two portions of connecting rod end fitting exhibiting plastic deformation above the stop nut.

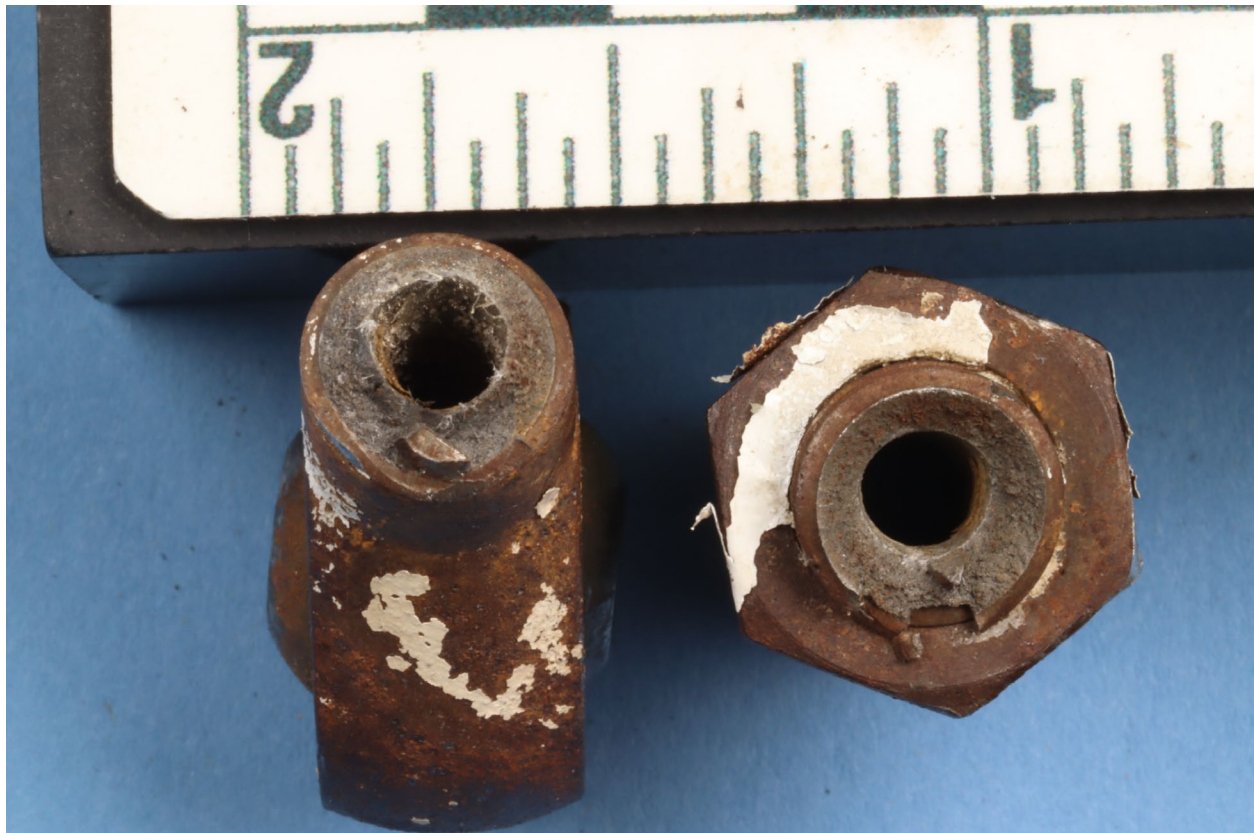
**Figure 3.** Slant fractures on fracture faces of connecting rod end fitting.
