## Inspector Statement for N1294E Accident in Maryville, TN

On May 30, 2022, at approximately 2100 local time, N1294E, a Aeronca, 7AC, serial number 7AC-4855 crashed at coordinates +035.756385° / -083.830545°. This area belongs to the University of Tennessee Agricultural Department for research. The pilot of the aircraft was Mr. Wayne Anthony Lequire, Private Pilot certificate number [REDACTED]. There was also a passenger in the aircraft, Mrs. [REDACTED]. Both occupants suffered minor injuries.

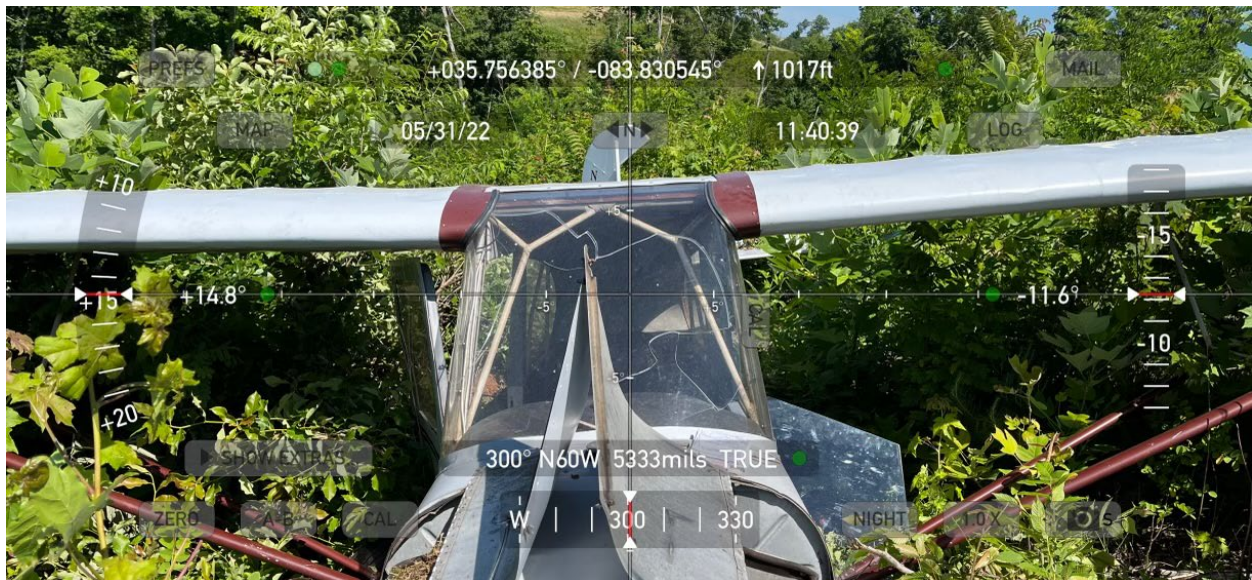
Aircraft Final Rest.

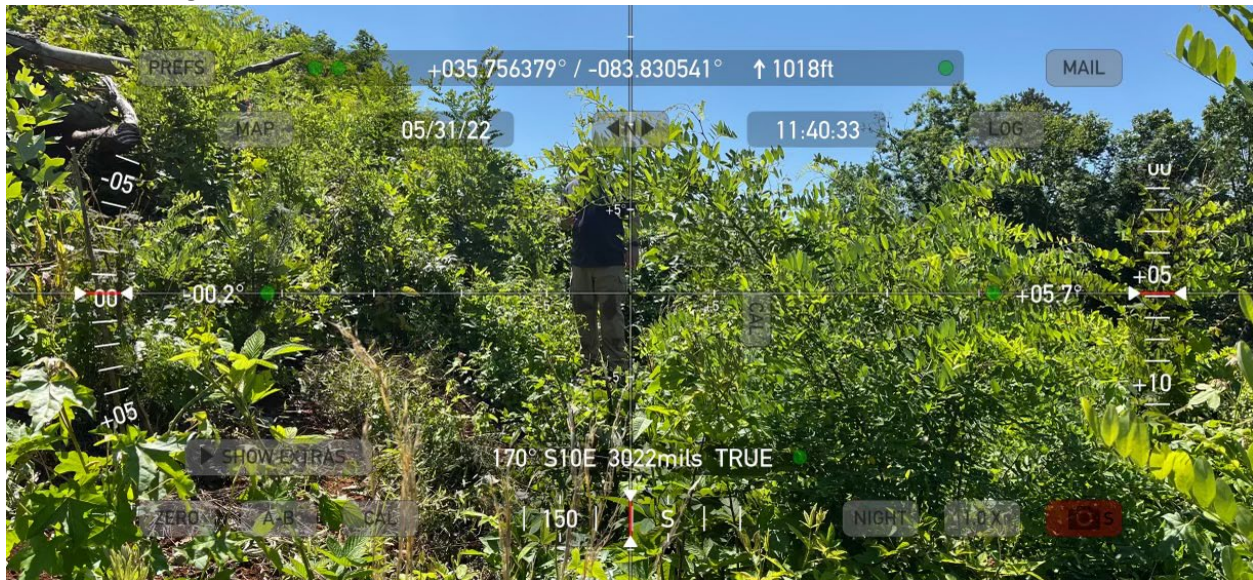
Aircraft heading at final rest.

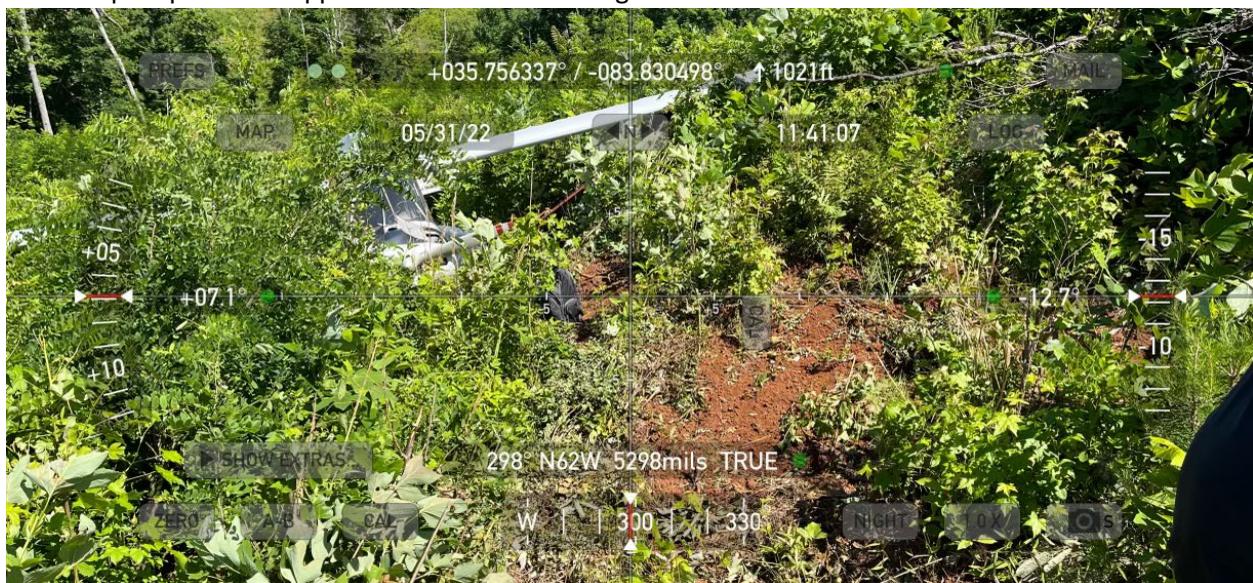
Initial impact point and approximate direction of flight.

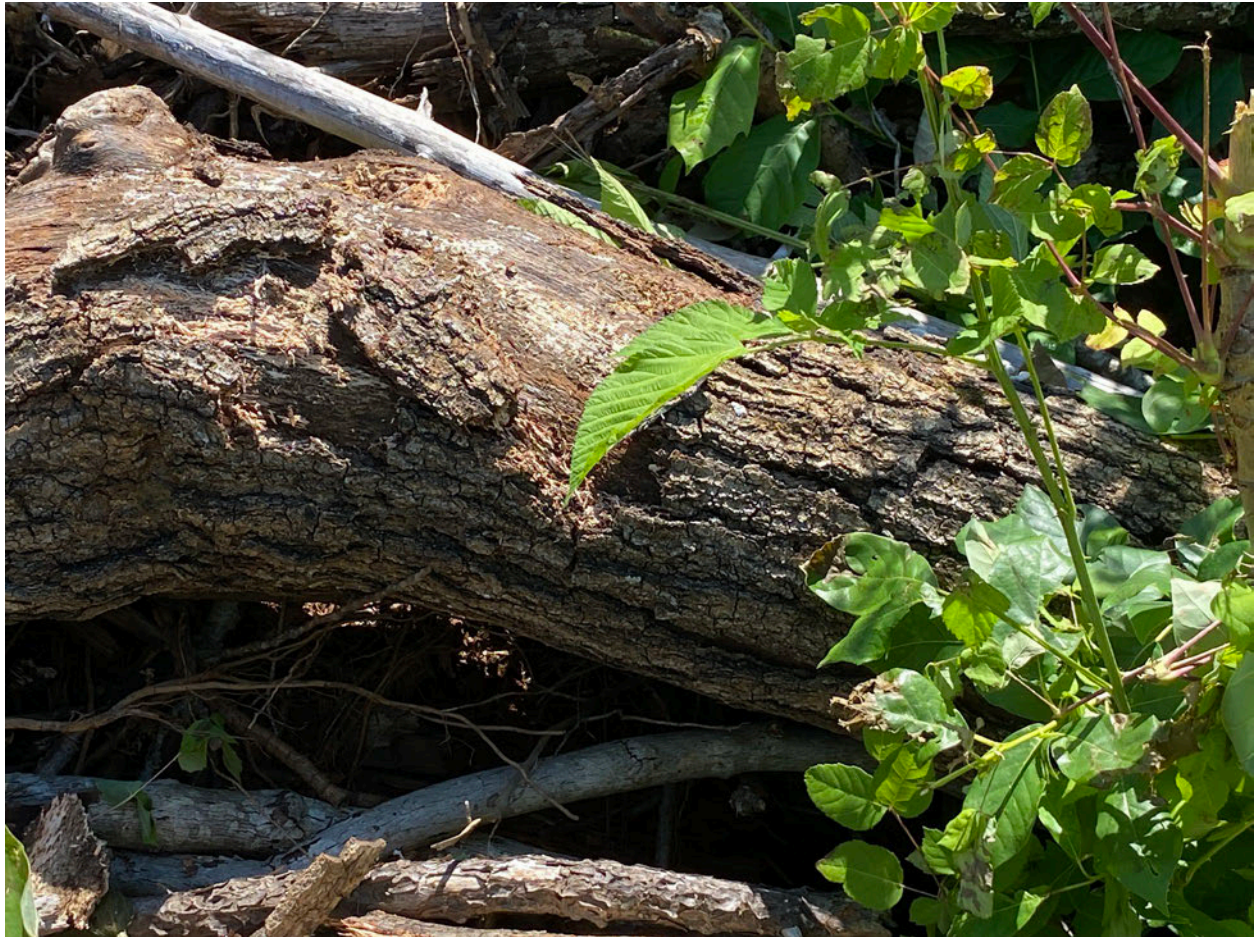
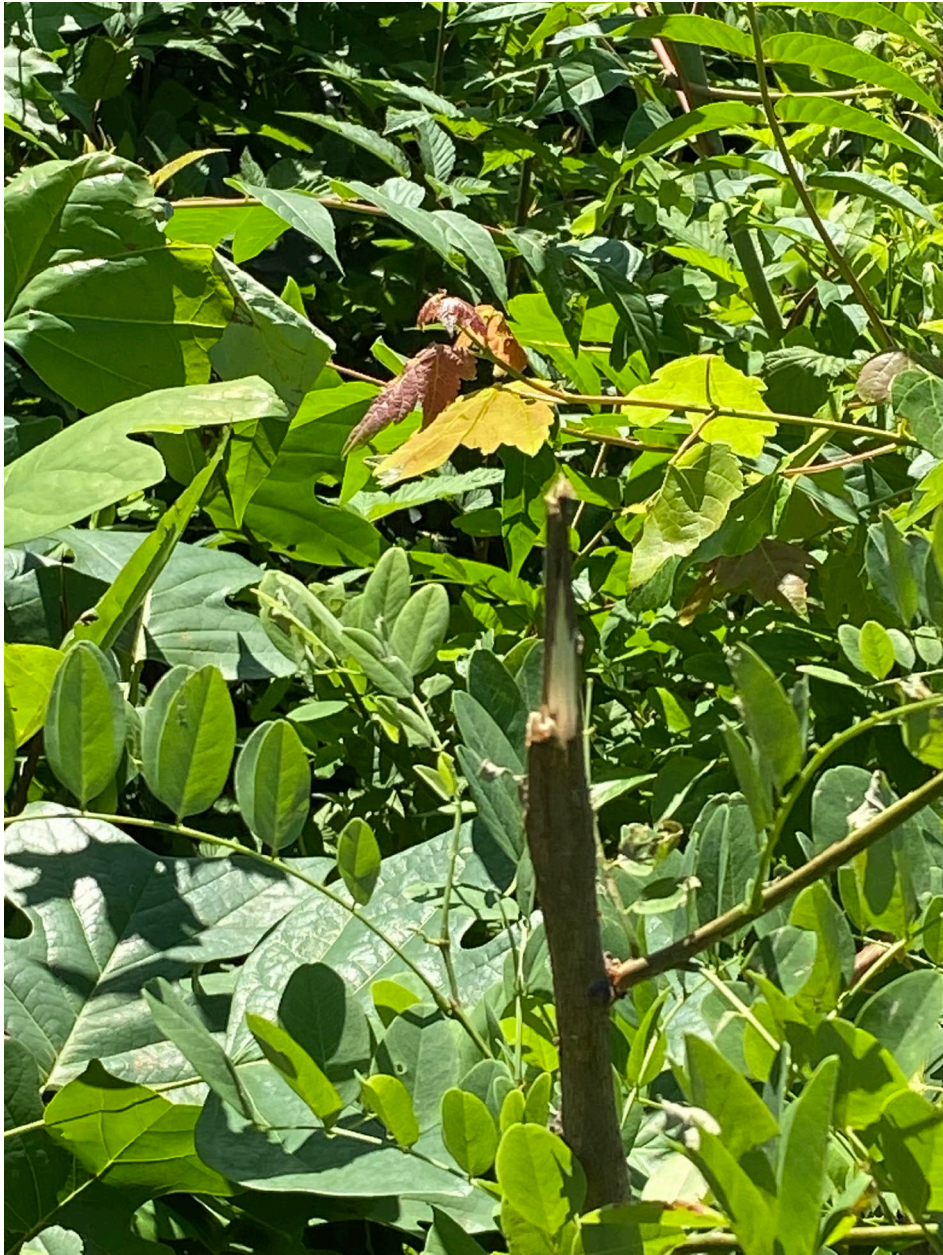
The following pictures show broken vegetation indicating direction of flight.

Impact marks from right wing.

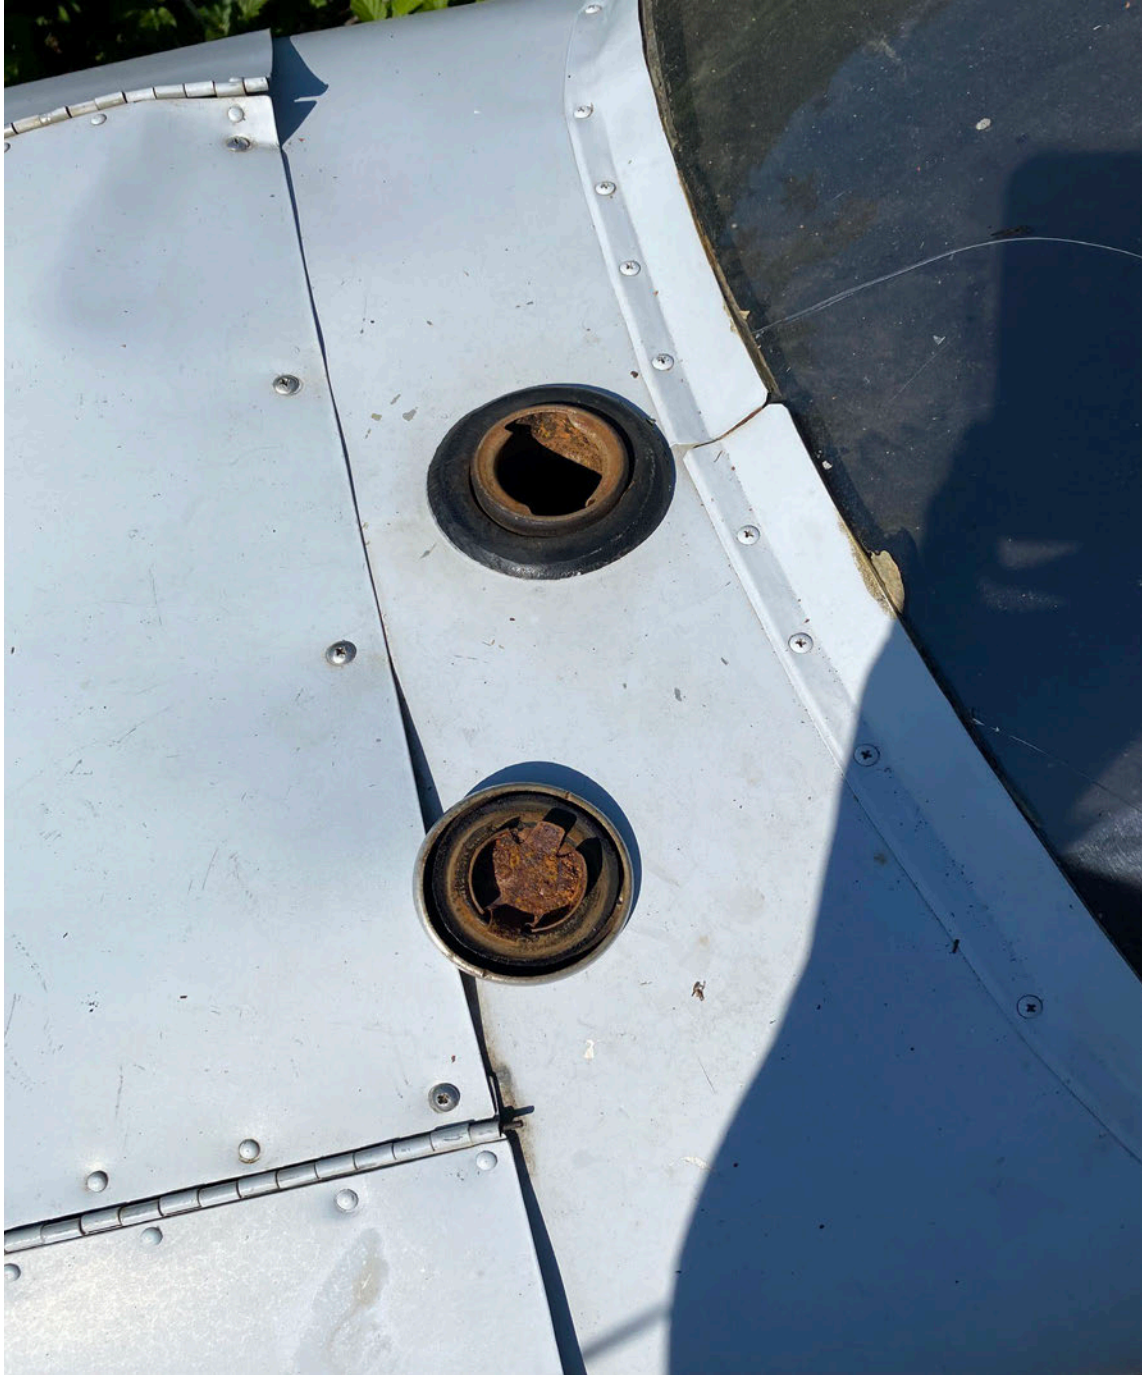
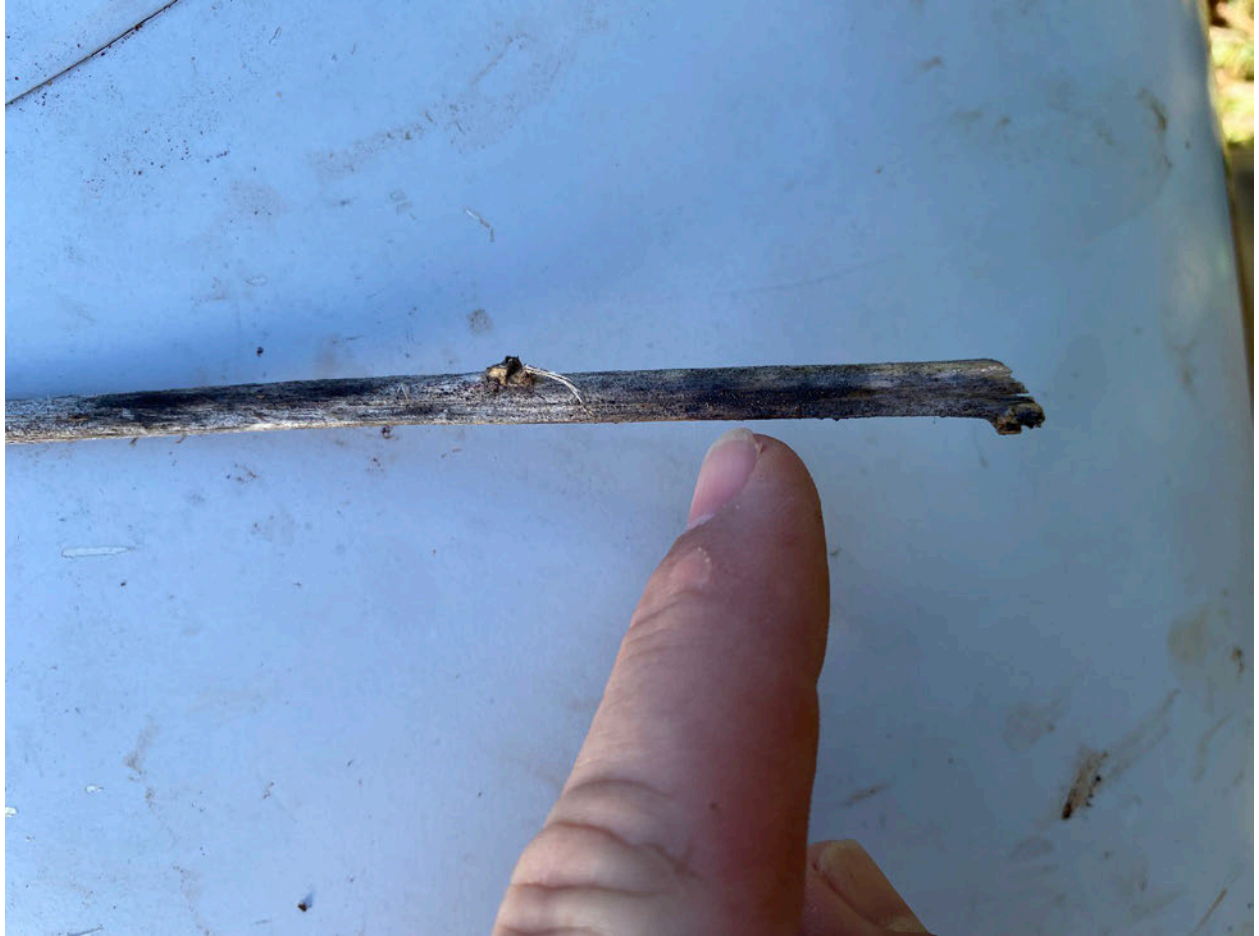
There was no indication of a fuel smell or fuel leak when approaching the aircraft. Inspector Lewis removed the fuel cap as soon as we arrived at the aircraft. The fuel cap and the fuel port showed excessive rust. A fuel sample was not taken due to inaccessibility to gascolator. A wooden stick was used to check fuel level.

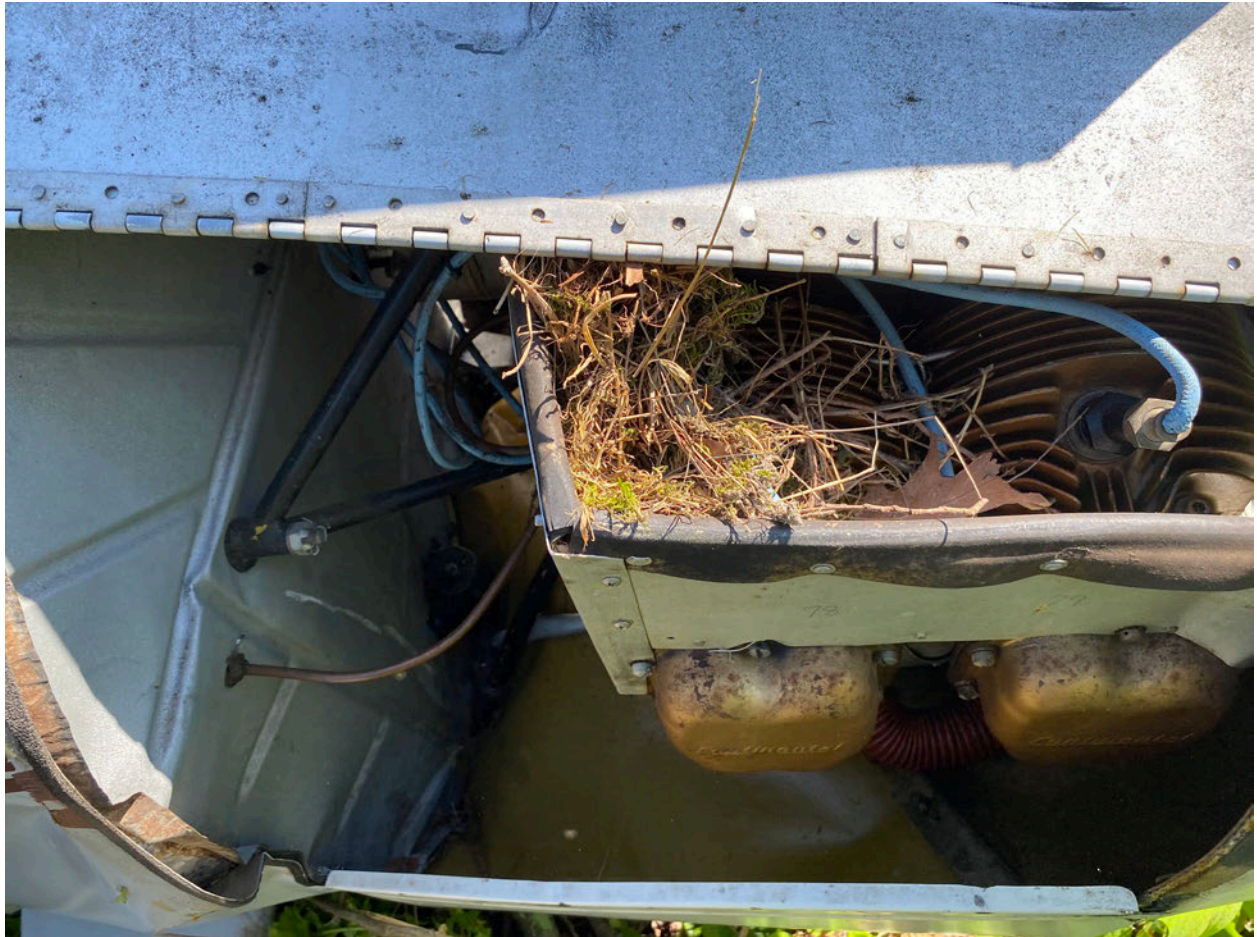
A bird's nest was found on the aft cylinder.

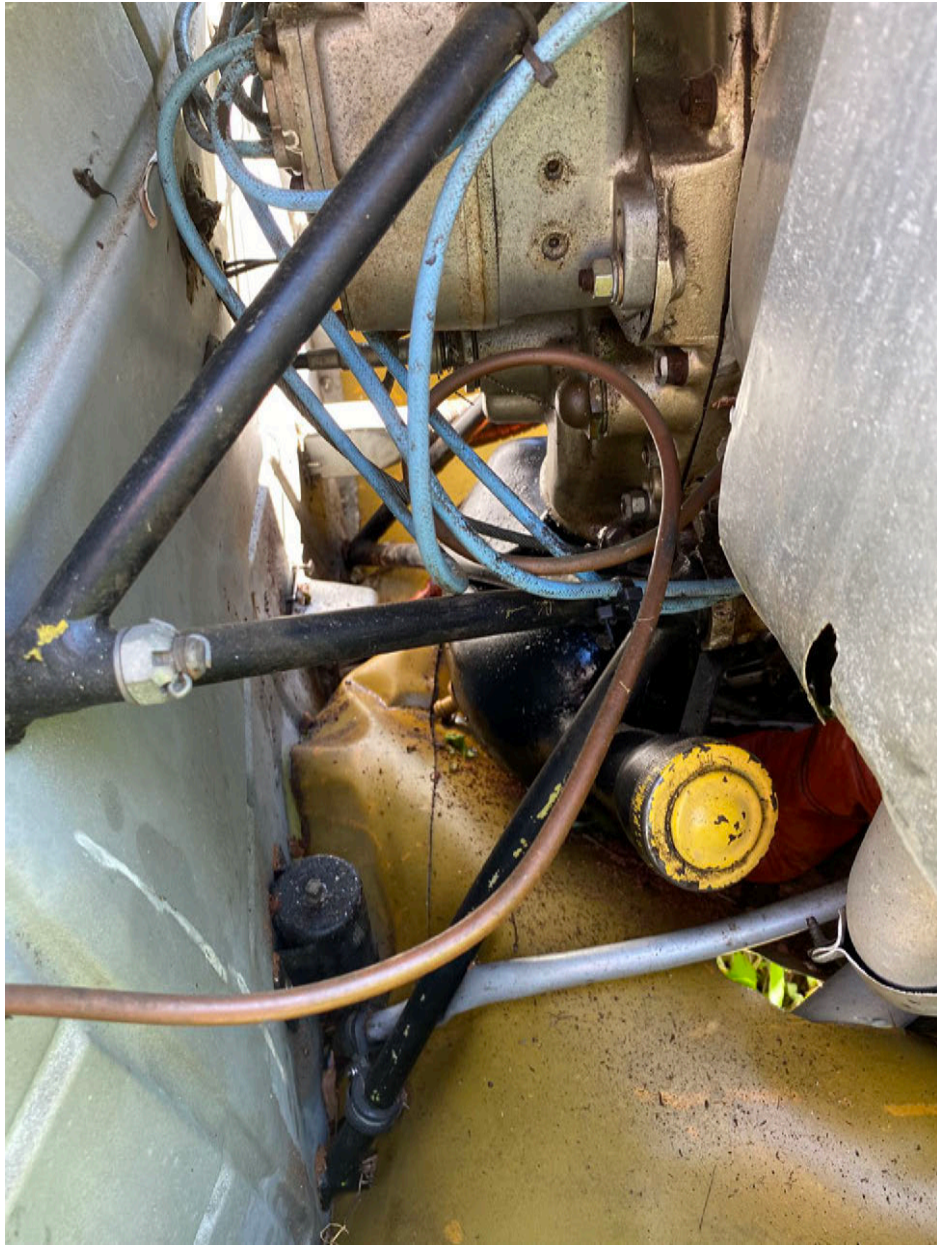
Firewall damage.

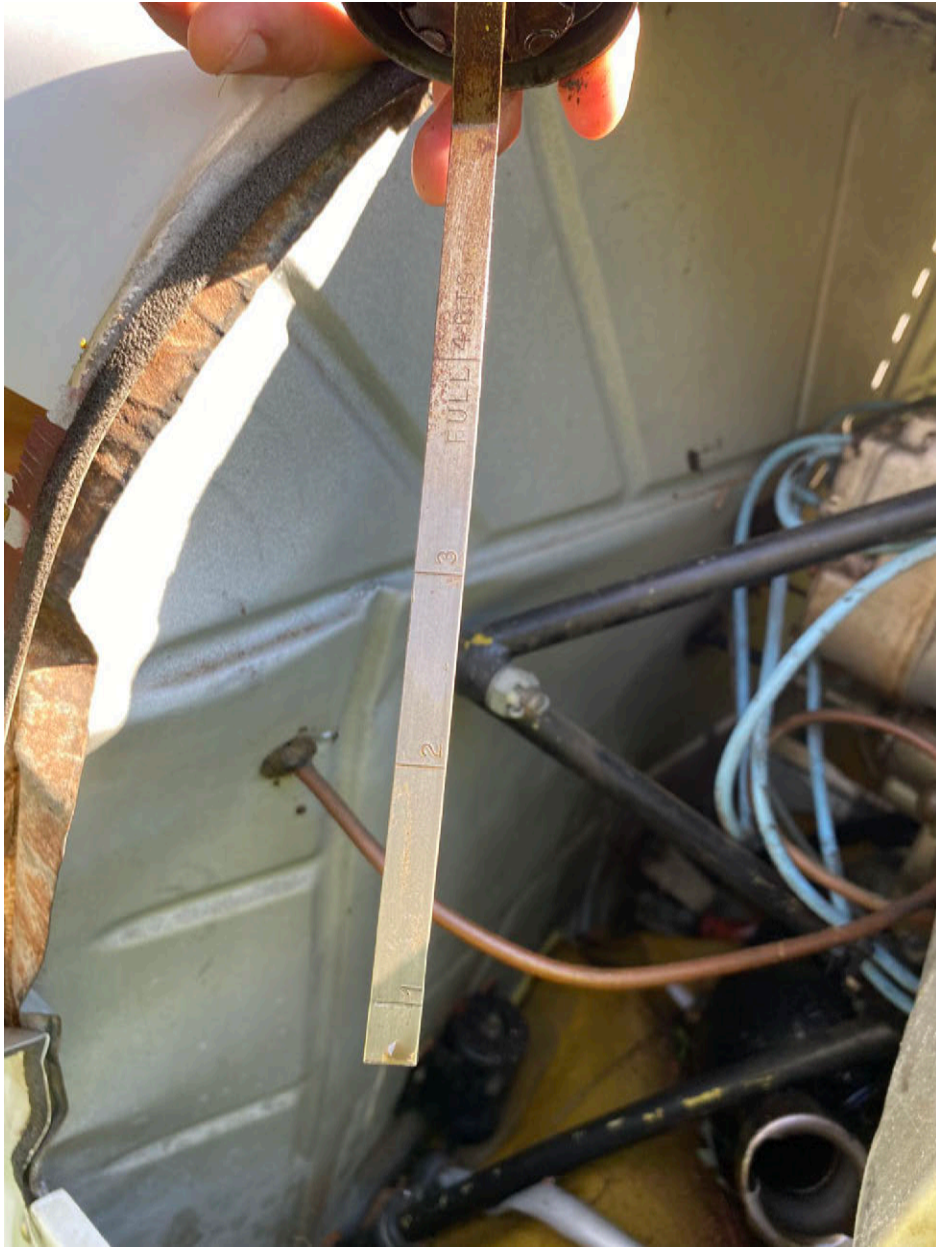
The oil level indicated zero oil.

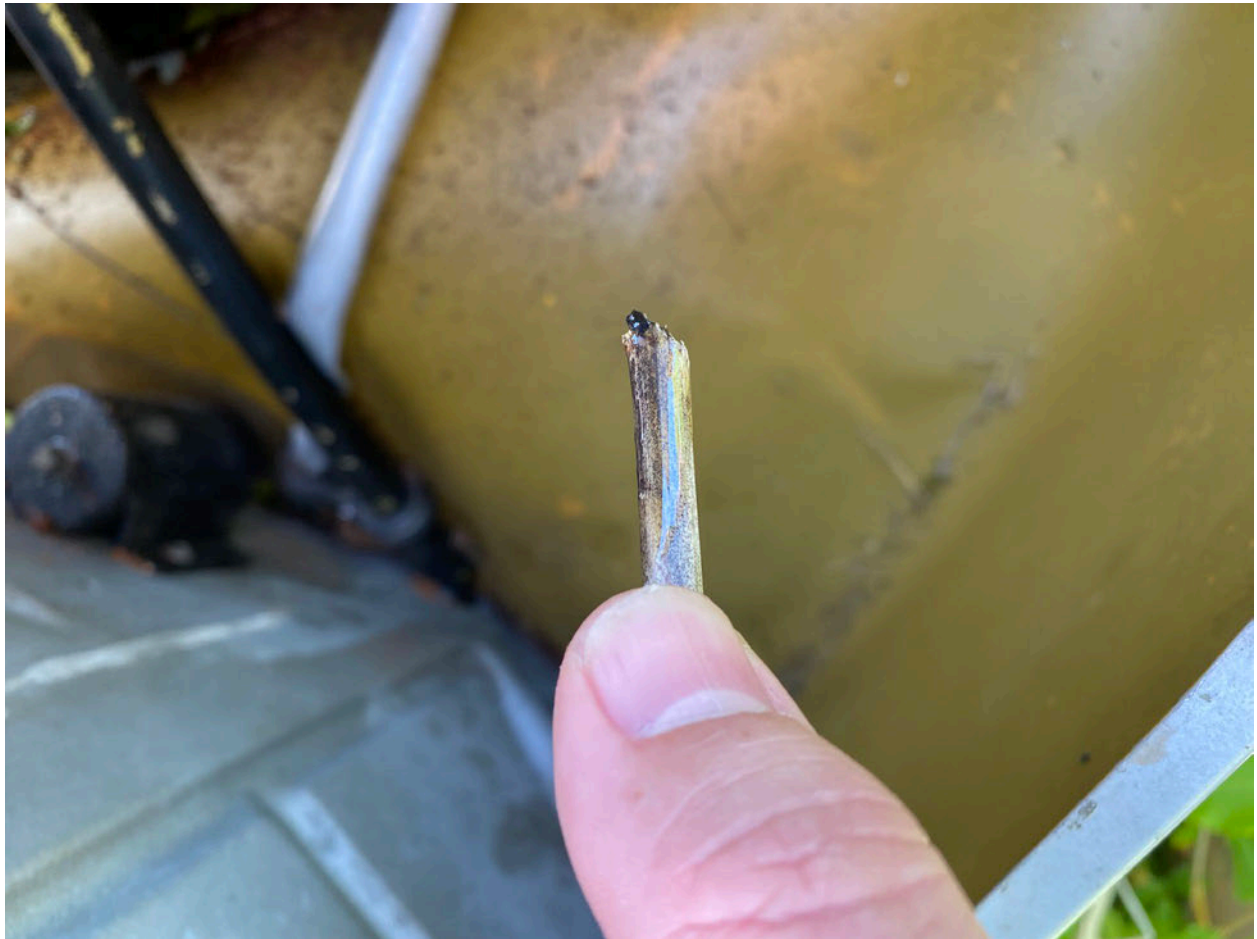
A wooden stick was used to check the bottom part of the tank. There was little indication of oil.

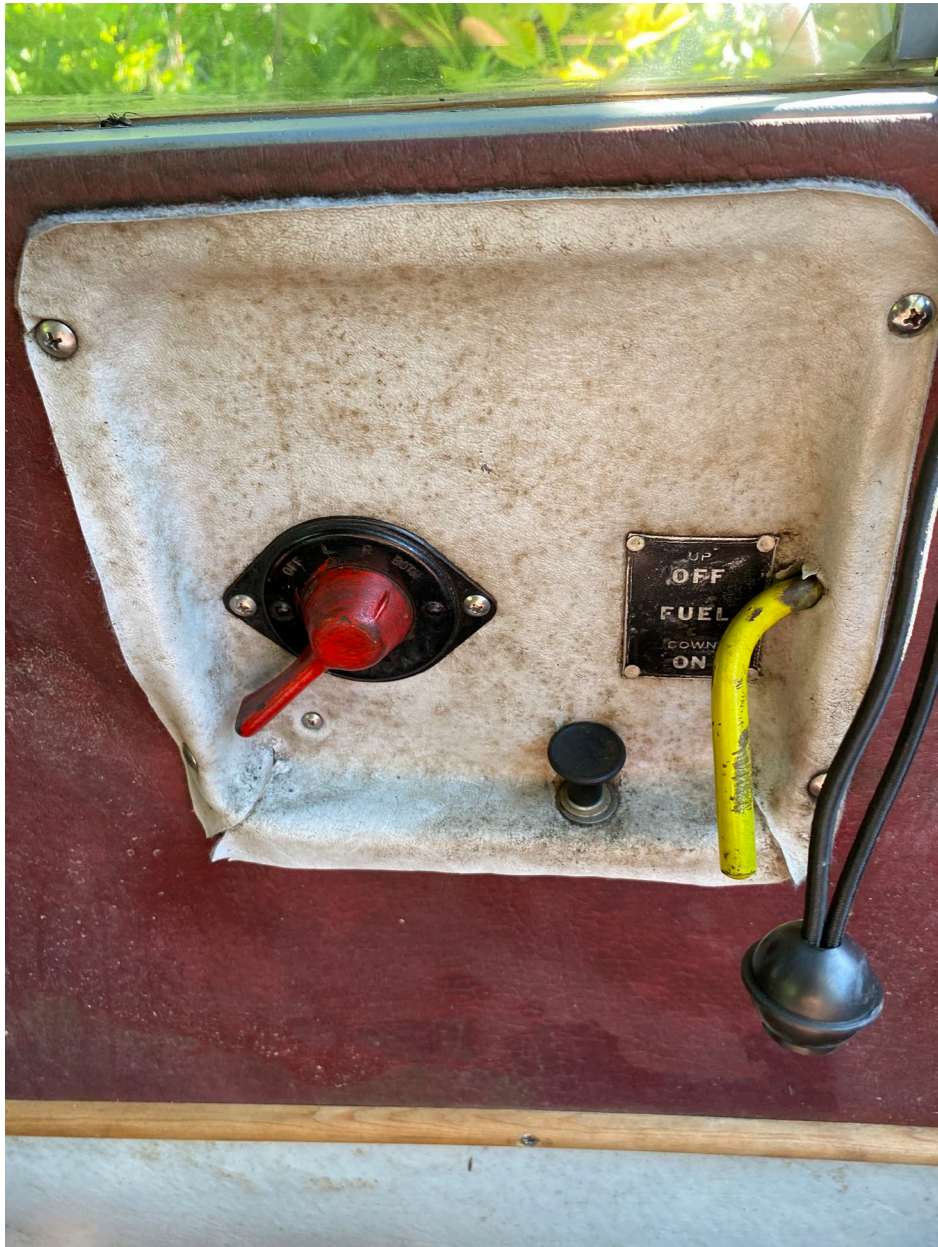
The magneto selector was on both and a fuel selector was down. The fuel lever feels disconnected.

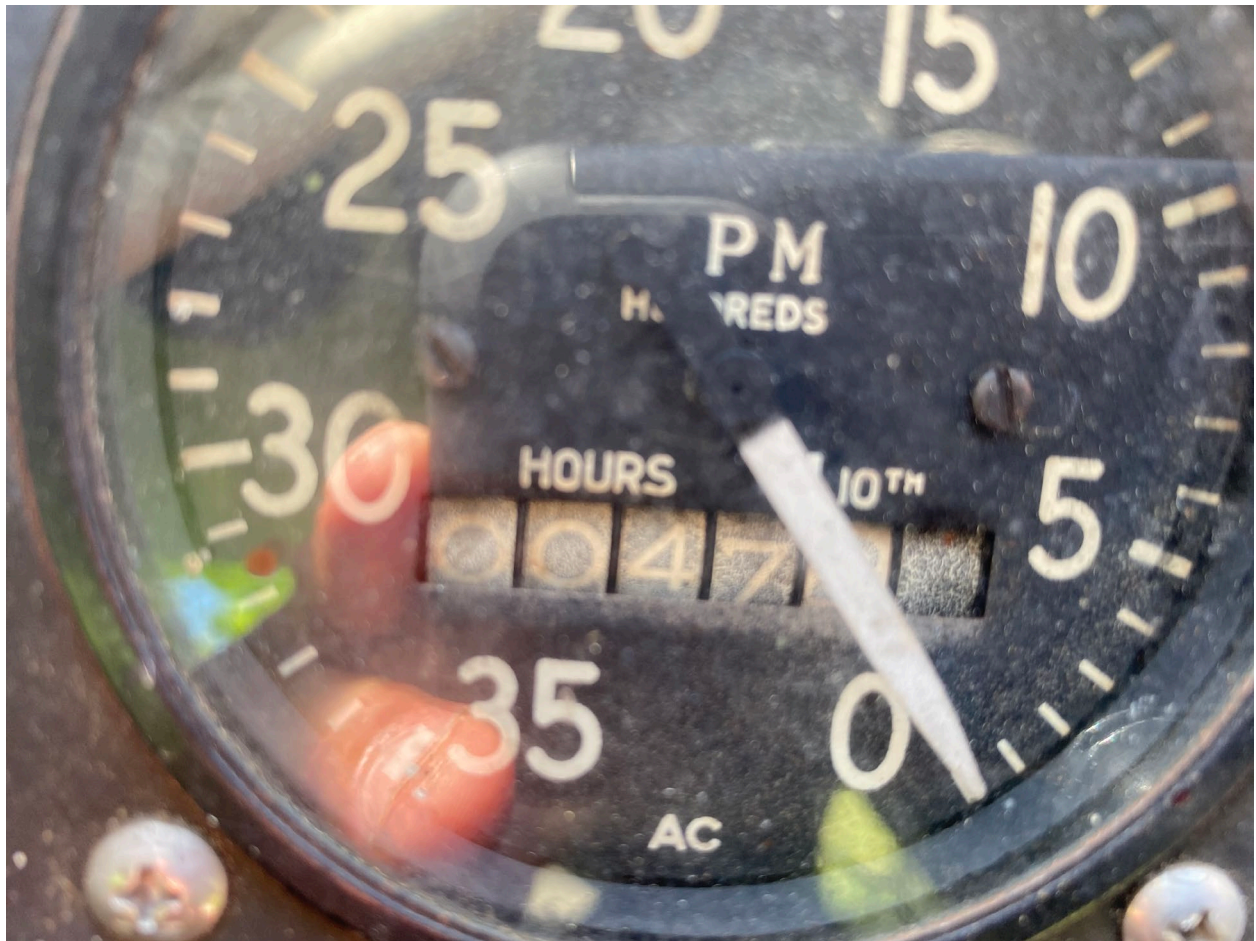
The tachometer showed 0047.2 Hours

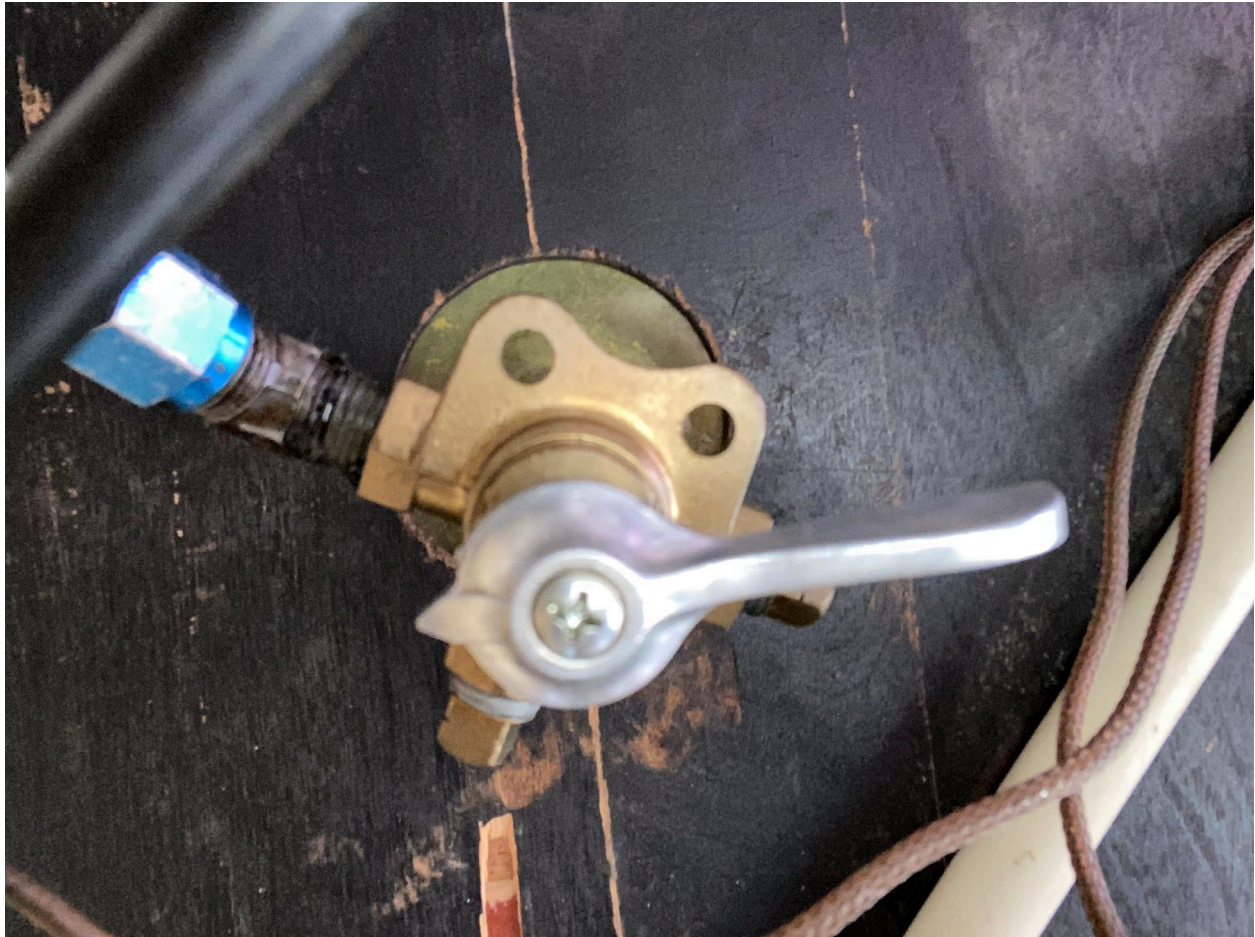
There is a fuel selector valve under the instrument panel by the pilot's knees. It is not labeled. The valve was able to be turned 360 degrees.

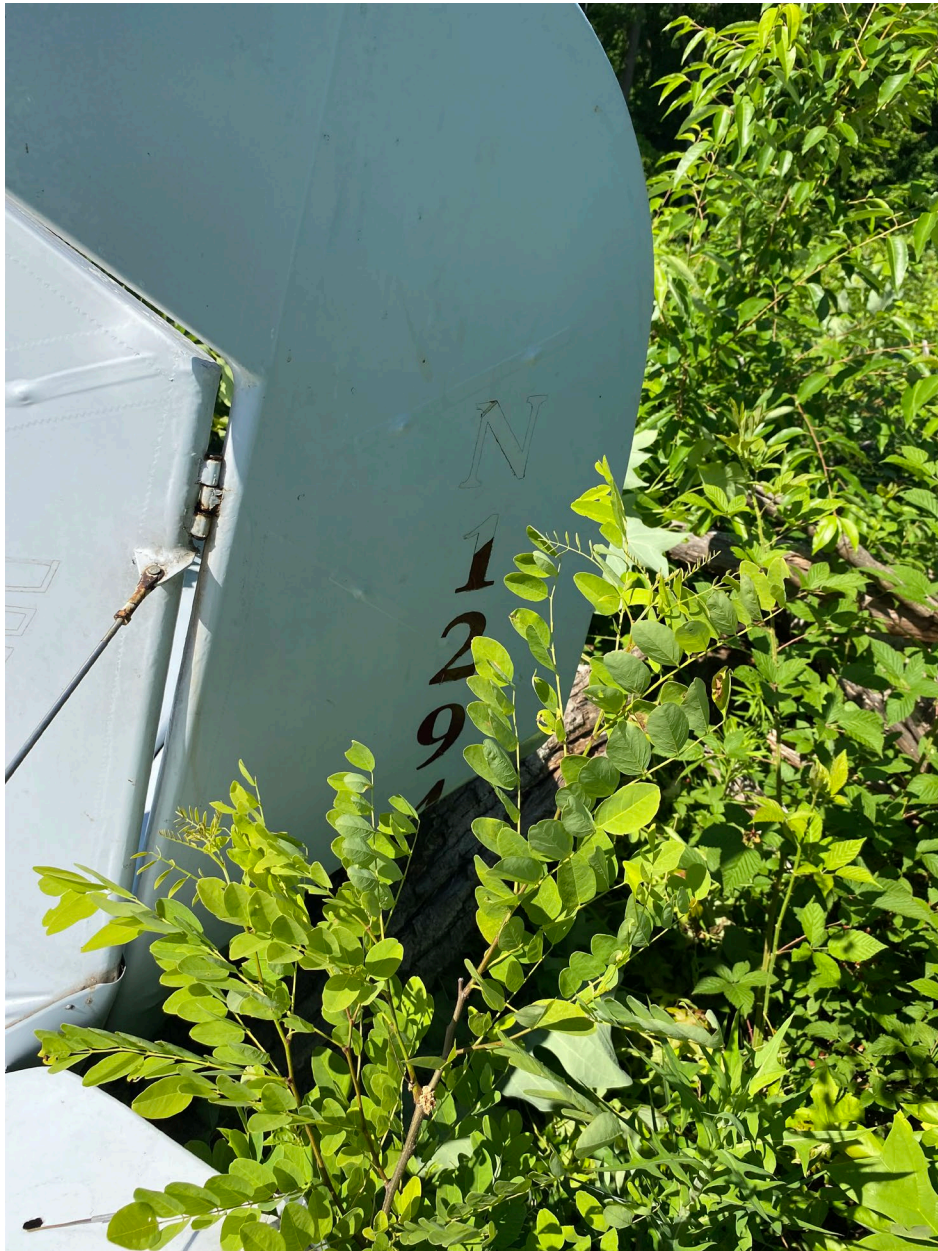
The bottom portion of the rudder contacted a piece of wood and was bent to the right.

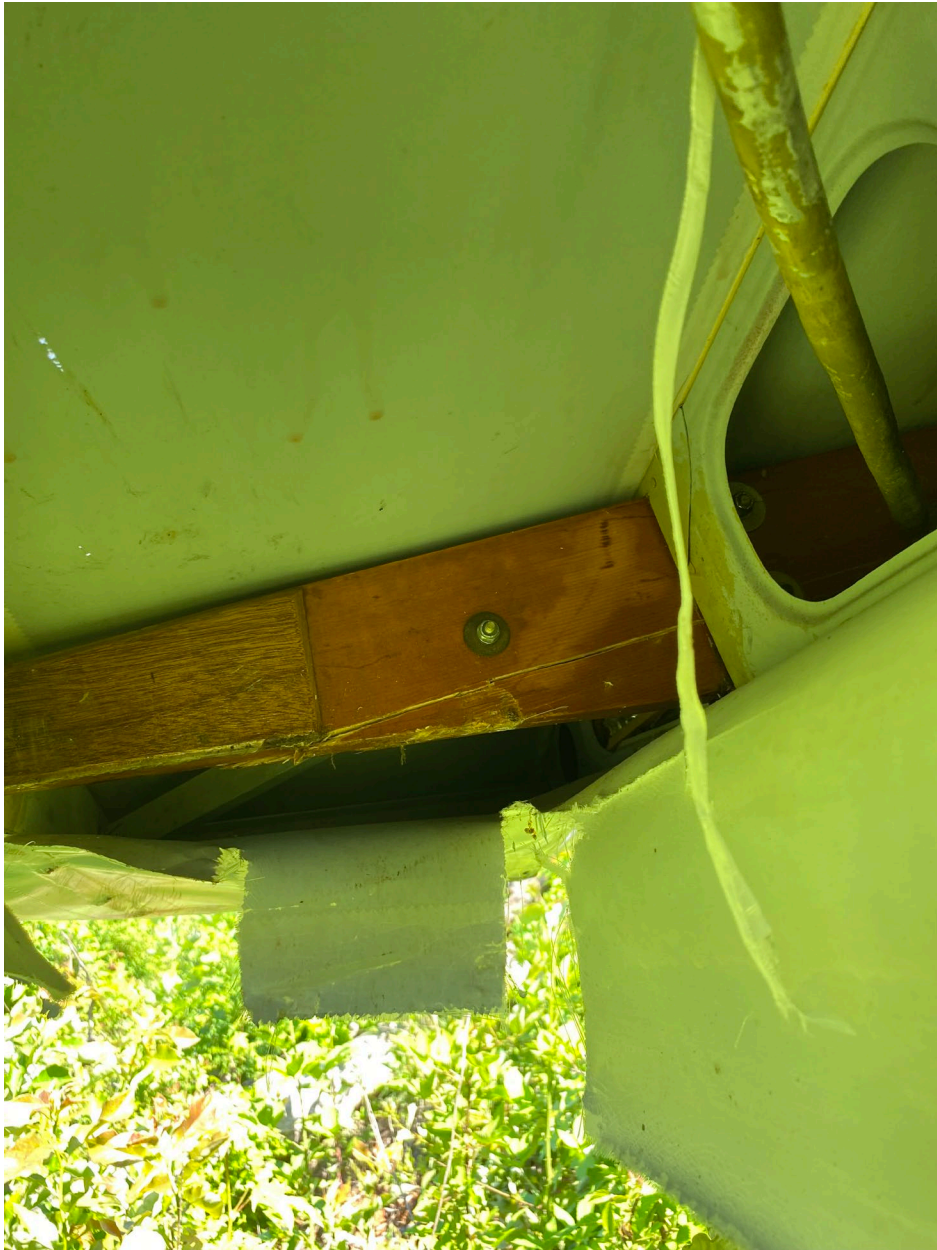
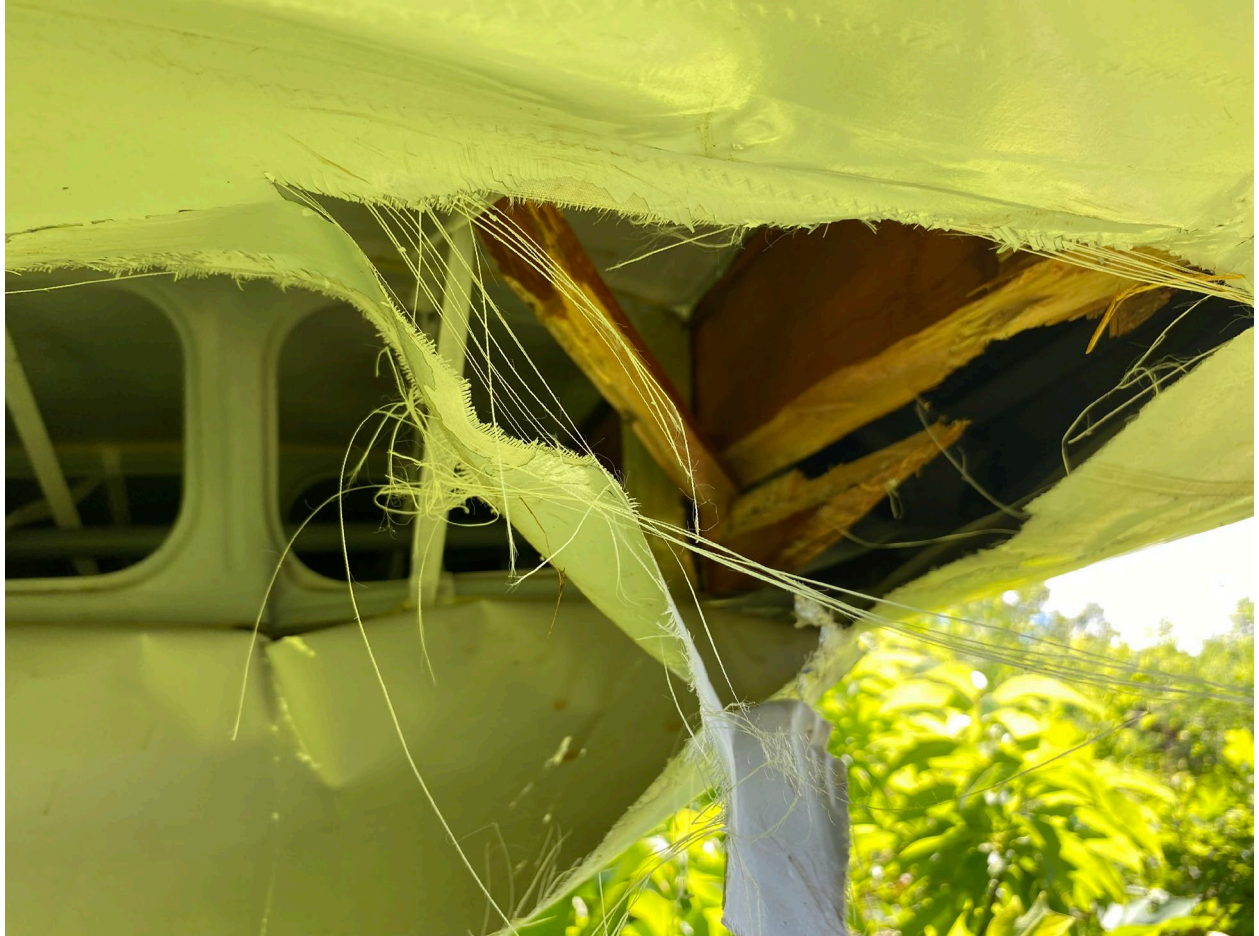
The right wing tip forward and aft spar are damaged.

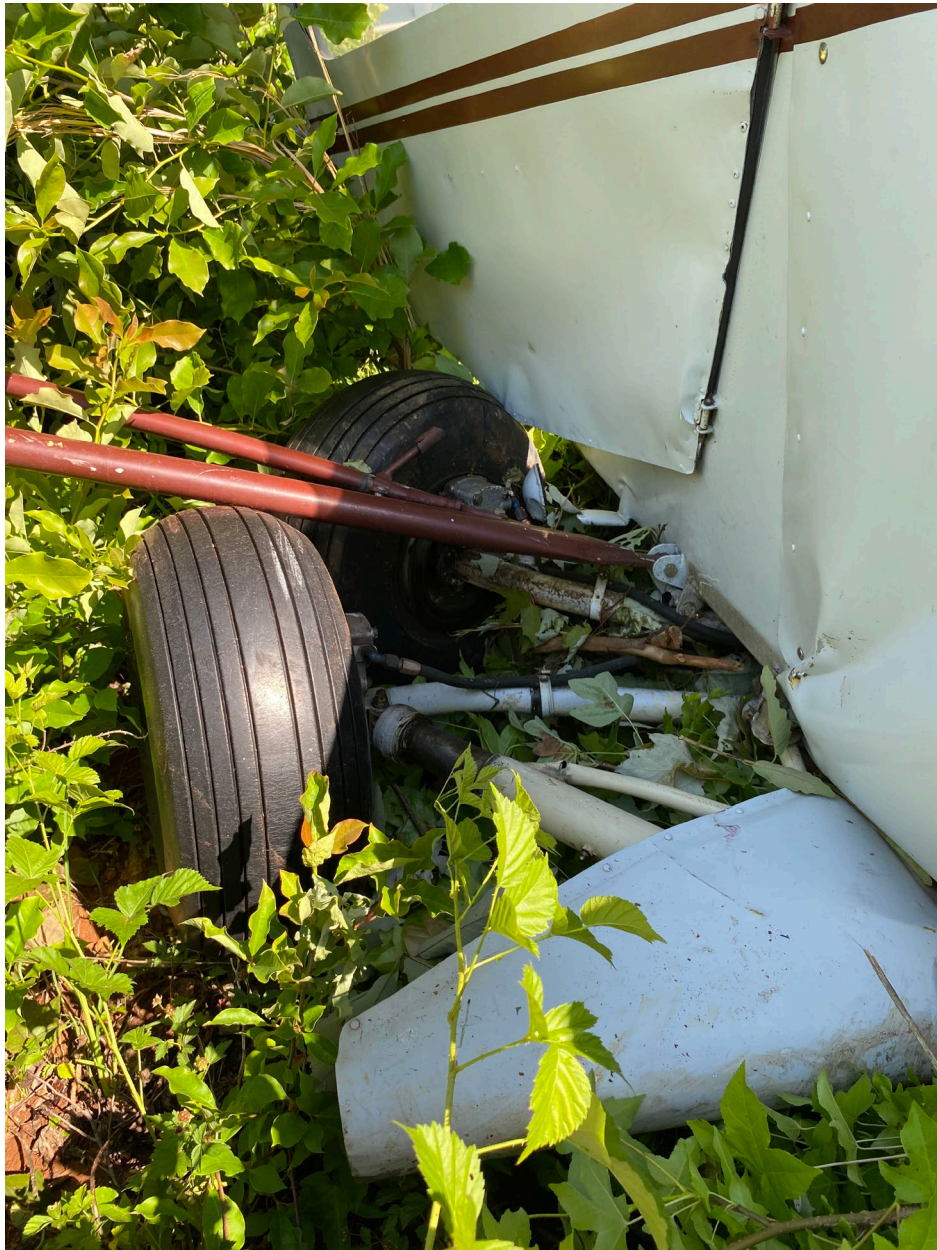
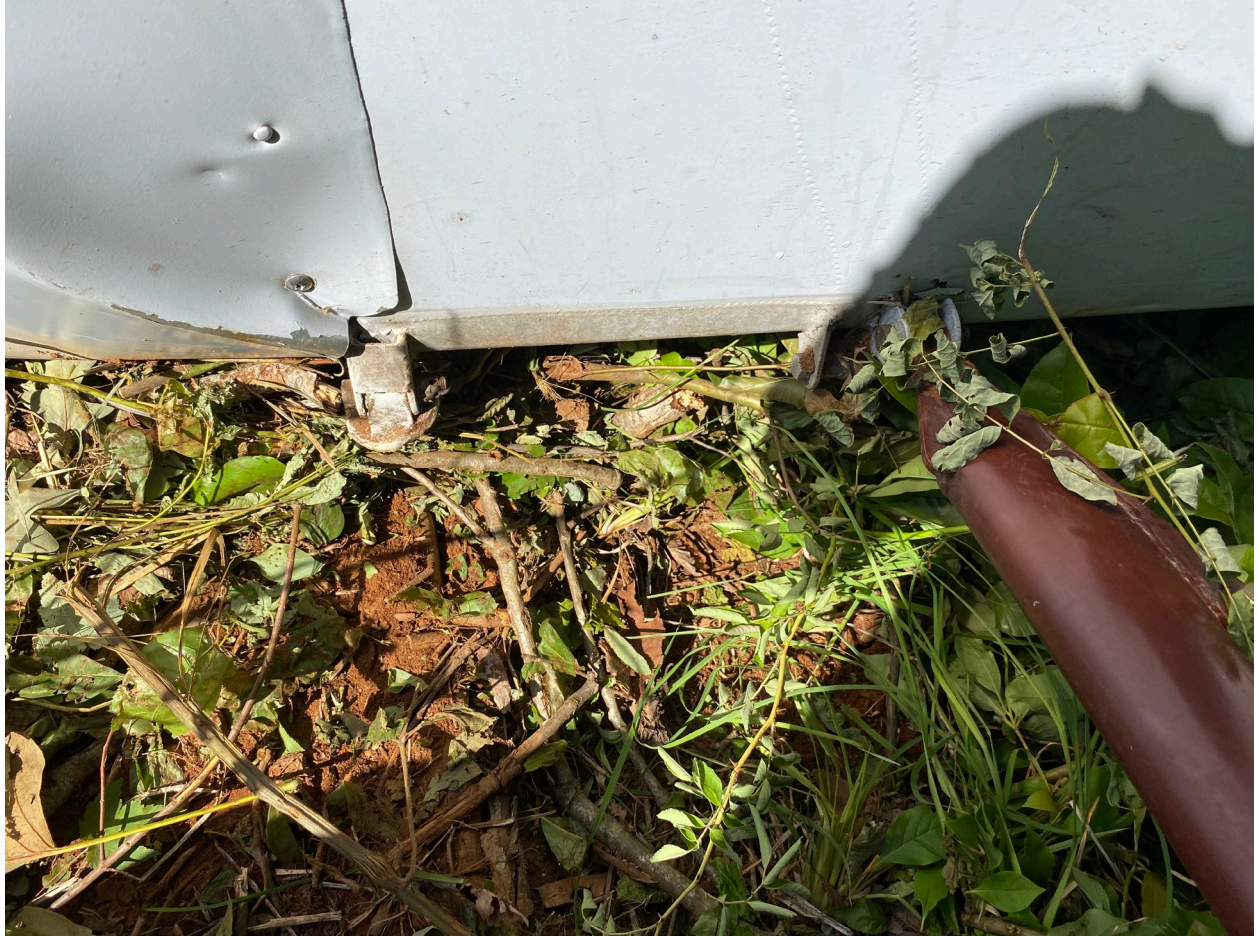
Both right and left landing gear were on the right side of the aircraft.
