## Inspector Statement for N1294E Accident in Maryville, TN

On May 30, 2022, at approximately 2100 local time, N1294E, a Aeronca, 7AC, serial number 7AC-4855 crashed at coordinates +035.756385° / -083.830545°. This area belongs to the University of Tennessee Agricultural Department for research. The pilot of the aircraft was Mr. Wayne Anthony Lequire, Private Pilot certificate number [REDACTED]. There was also a passenger in the aircraft, Mrs. [REDACTED]. Both occupants suffered minor injuries.

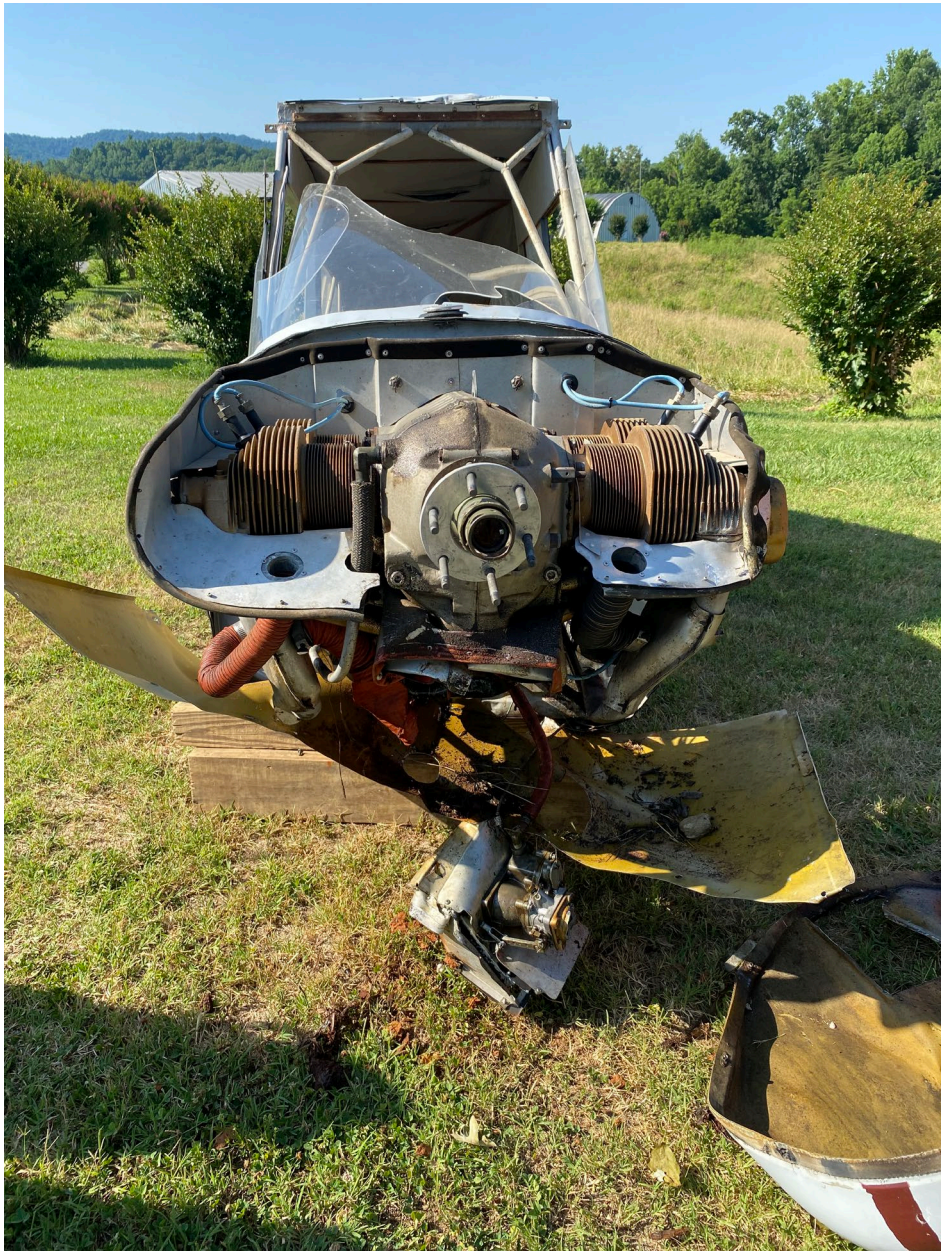
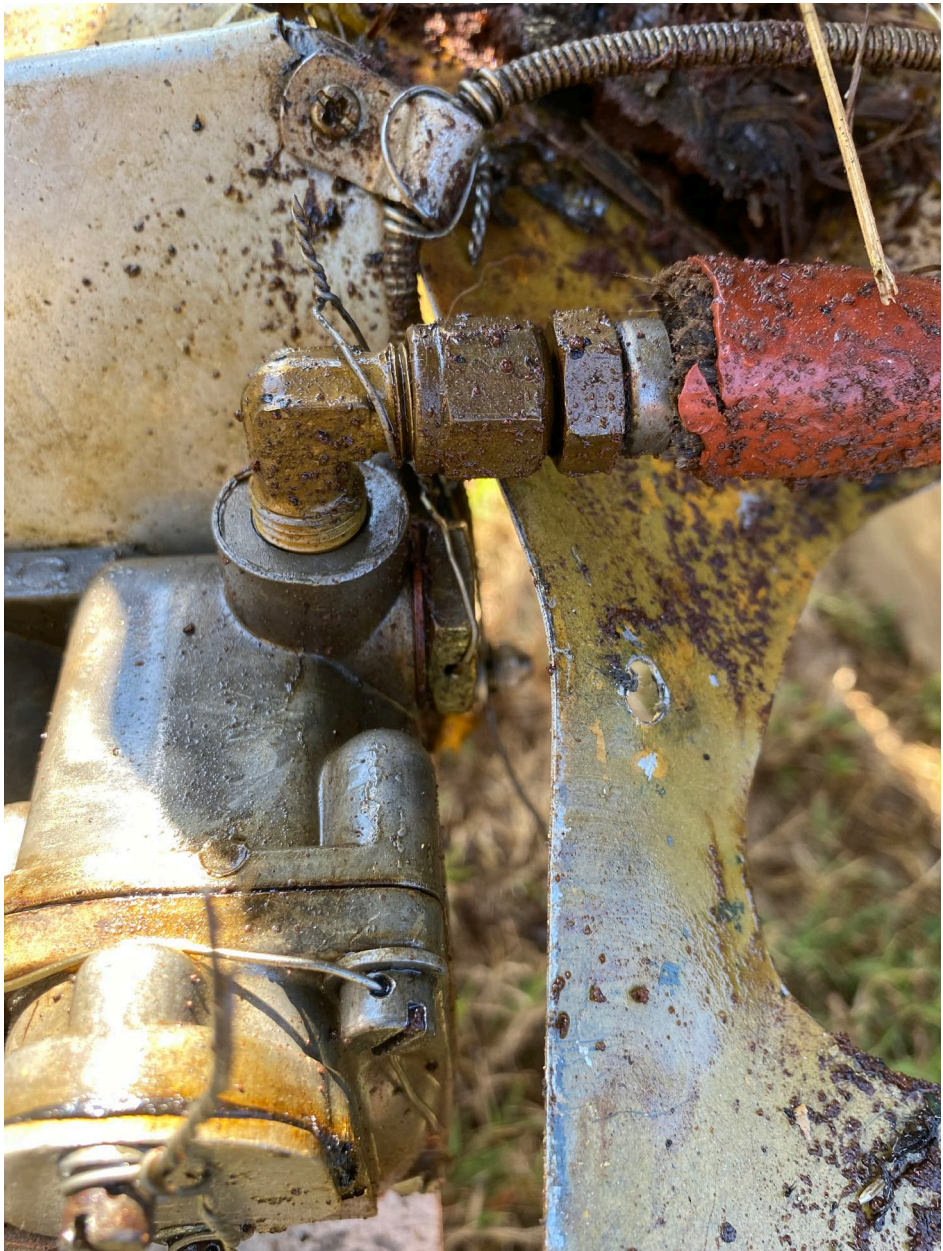
Inspector deVogel removed the front cowling. The propeller was previously removed by owner. Initial visual inspection noted the carburetor was broken at the neck and separated from the engine. It was attached to the airframe by the carb heat cable and fuel line from the gascolator. The intake box and fuel line was disconnected from the carburetor. No fuel noted in line.

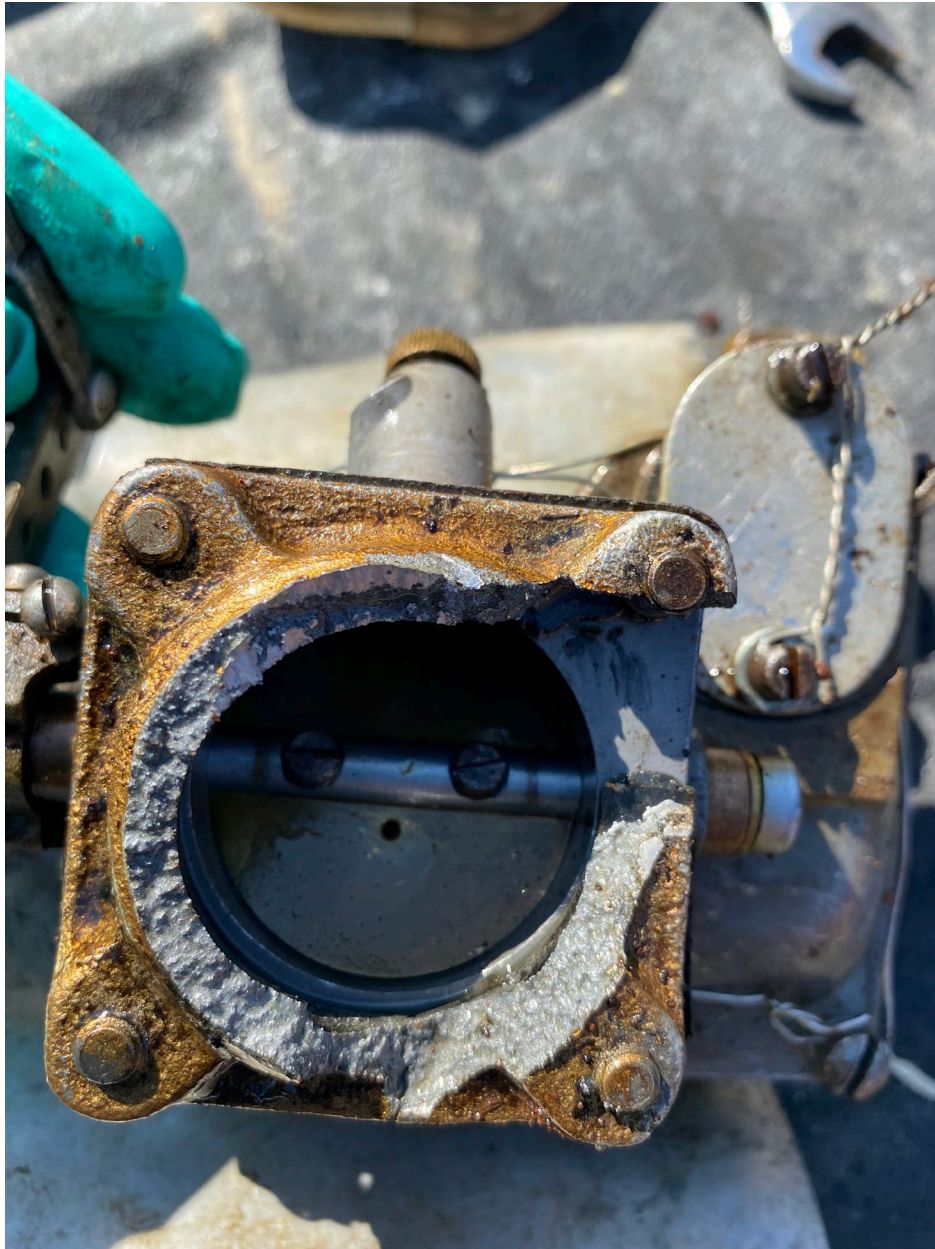
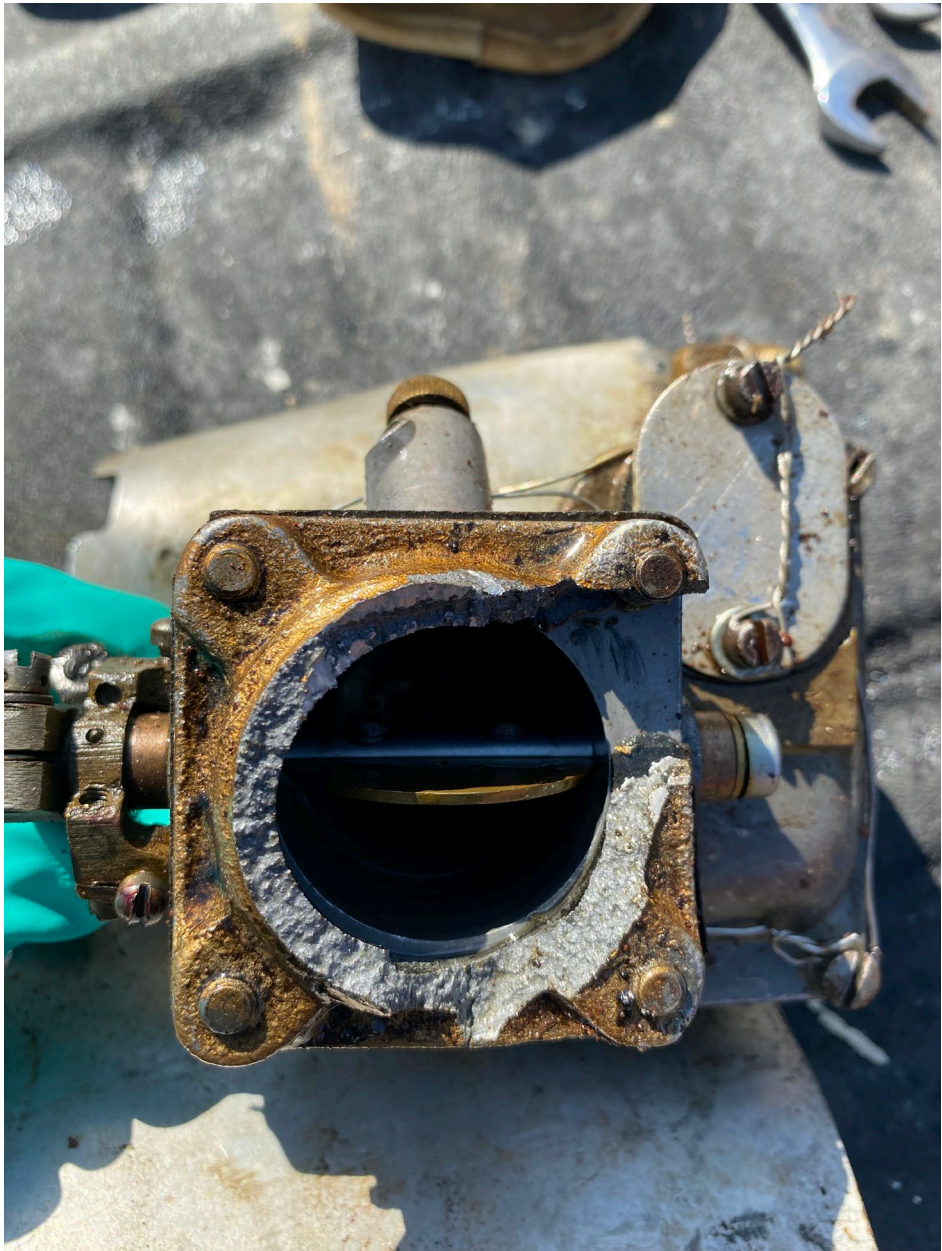
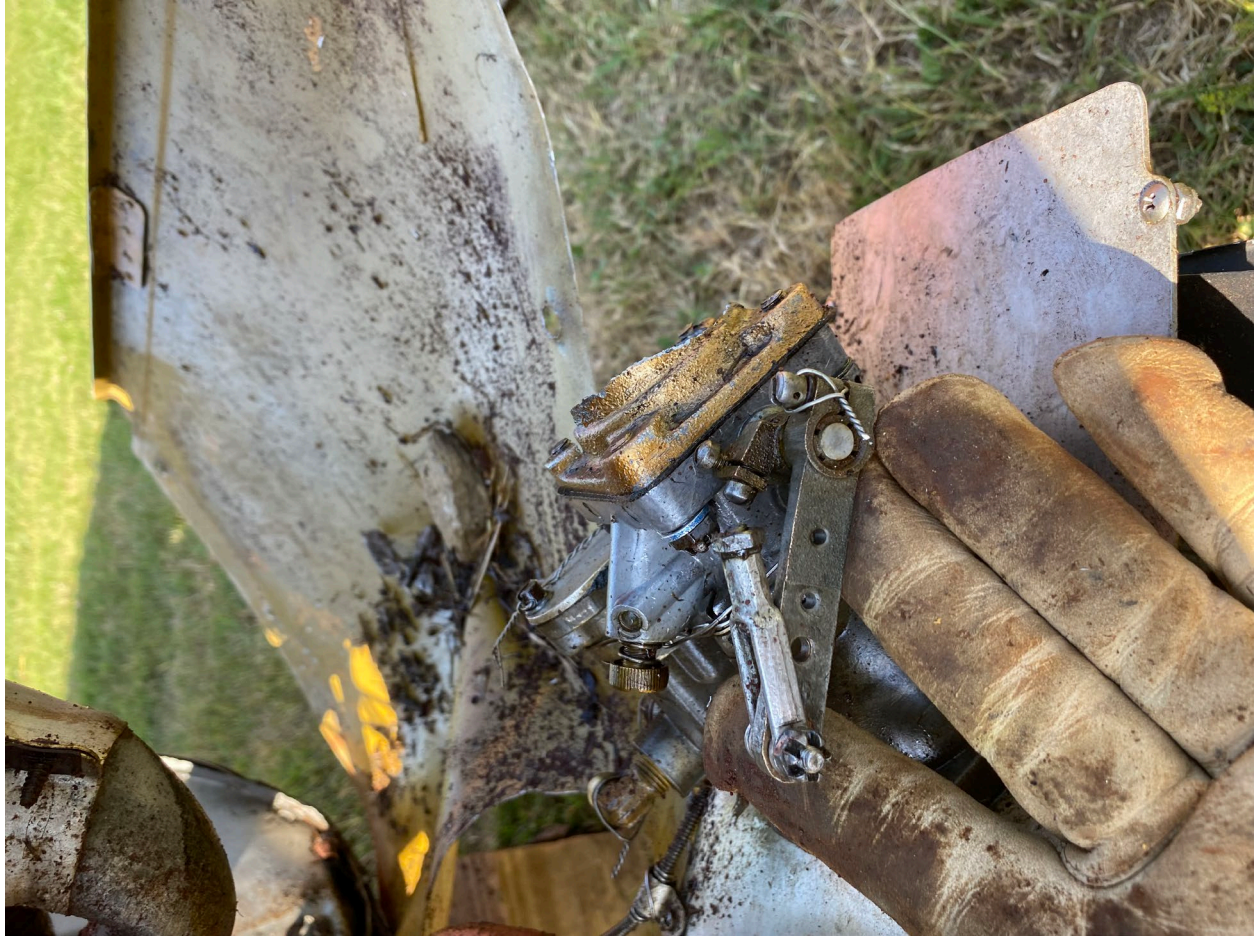
Inspector deVogel disassembled the carburetor. The choke plate moved freely. The throttle cable was broken at the throttle arm on the carburetor.

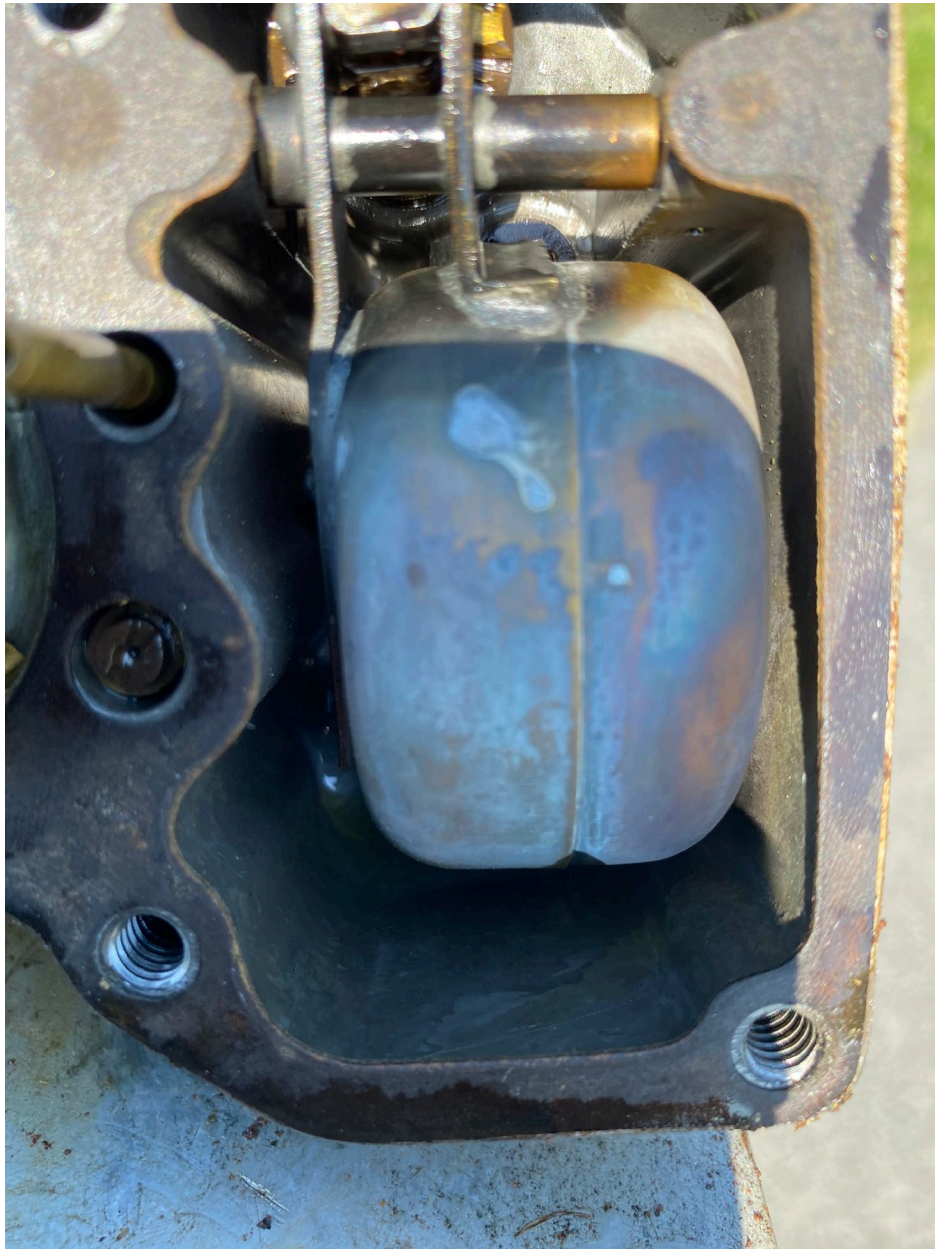
The float bowl was disassembled. There was a little fuel in the float bowl. Unable to measure quantity. The float moved freely.

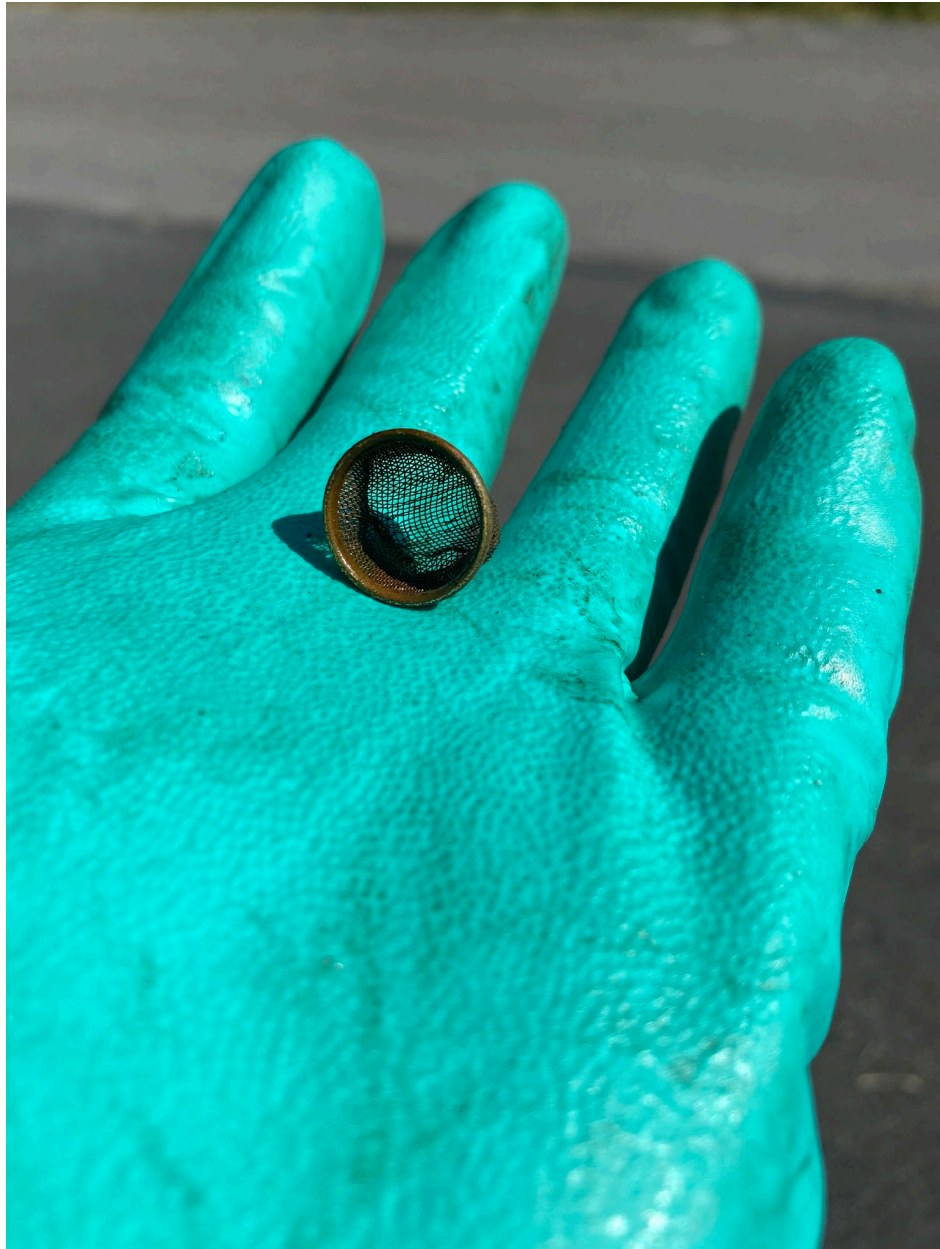
The fuel screen was removed from the carburetor. The screen was clean of any debris.

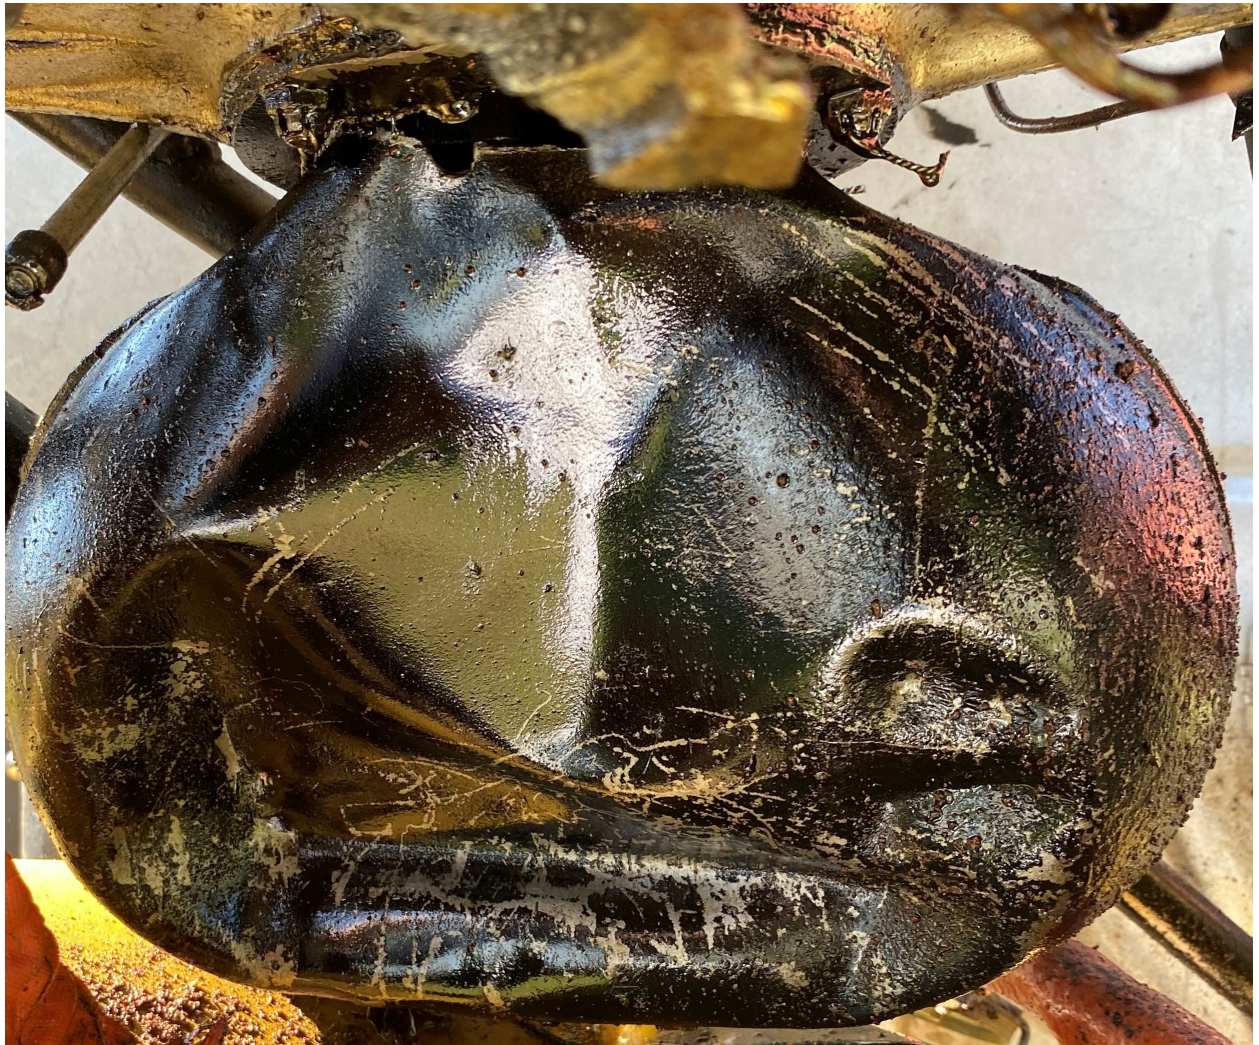
The oil tank had ruptured near the neck of the engine.

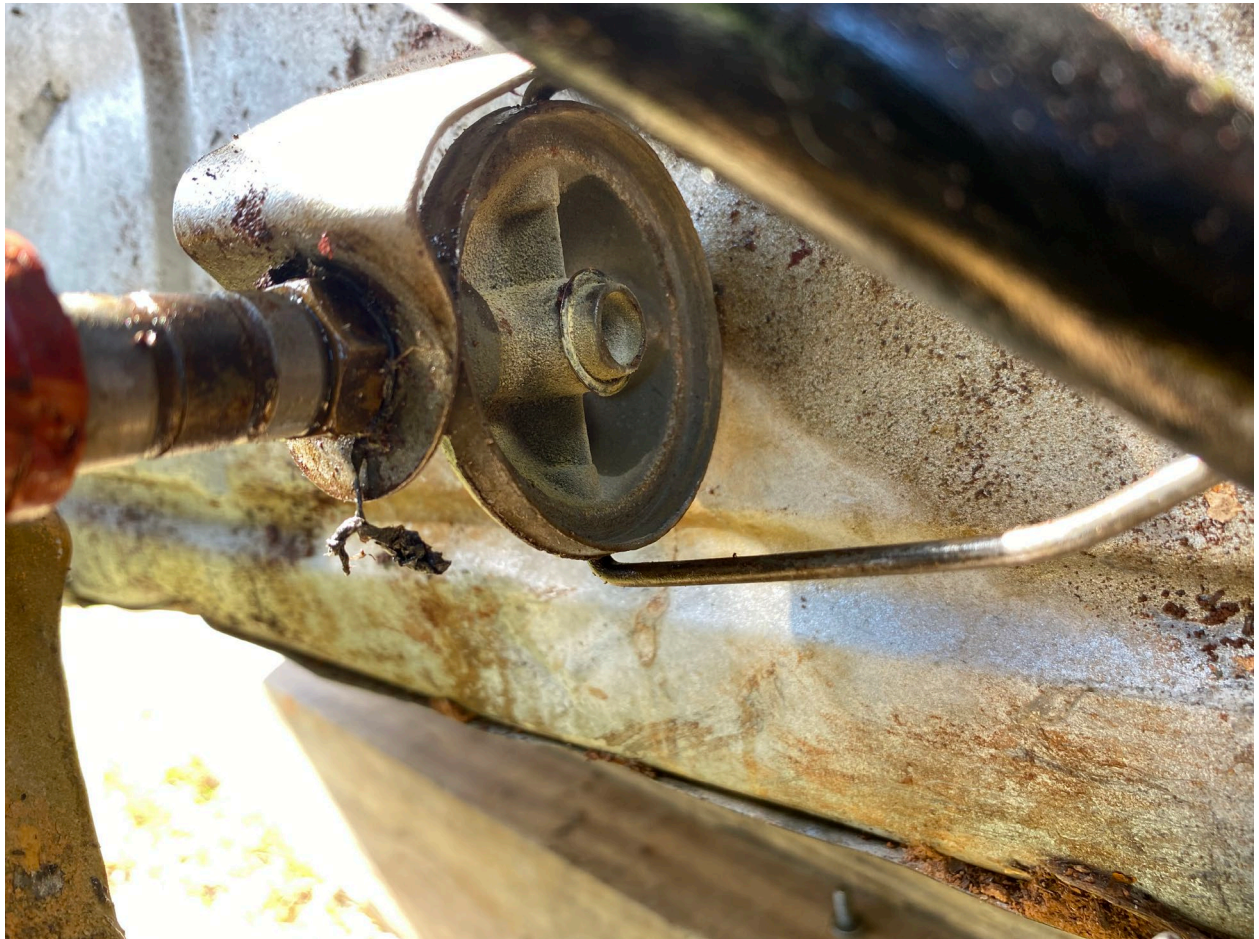
The gascolator bowl was missing from the aircraft.

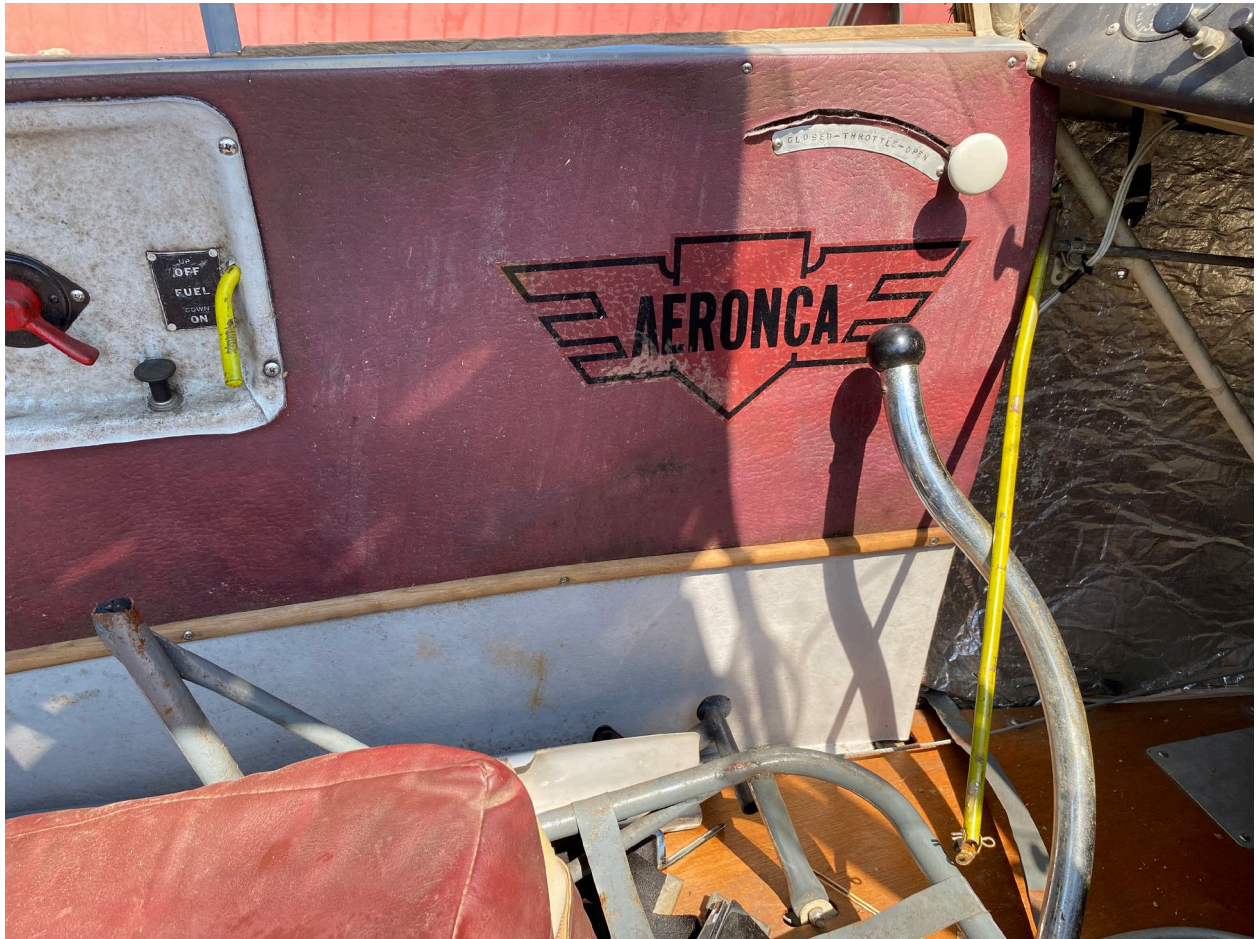
The fuel shutoff on the left side of the cockpit was found disconnected.

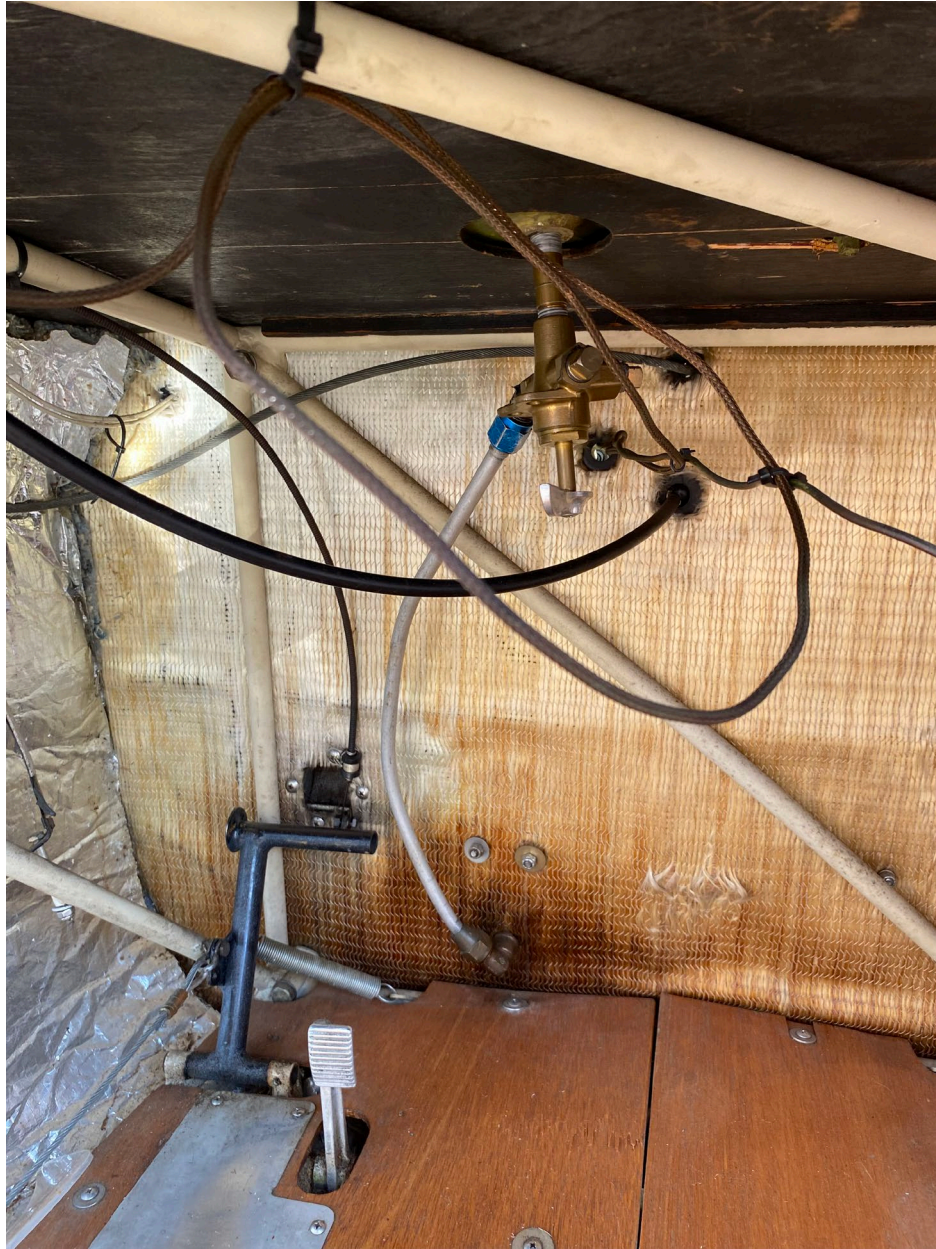
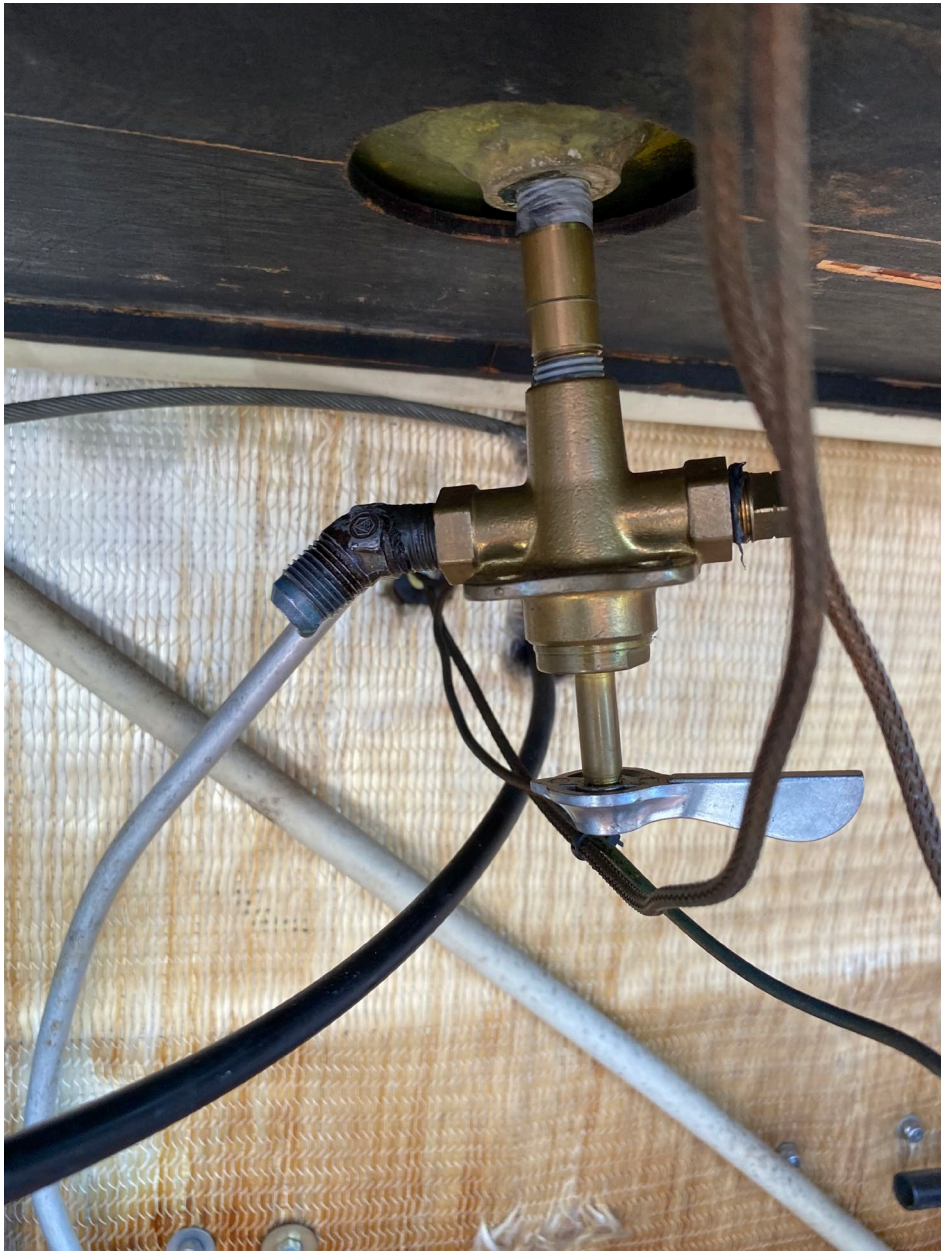
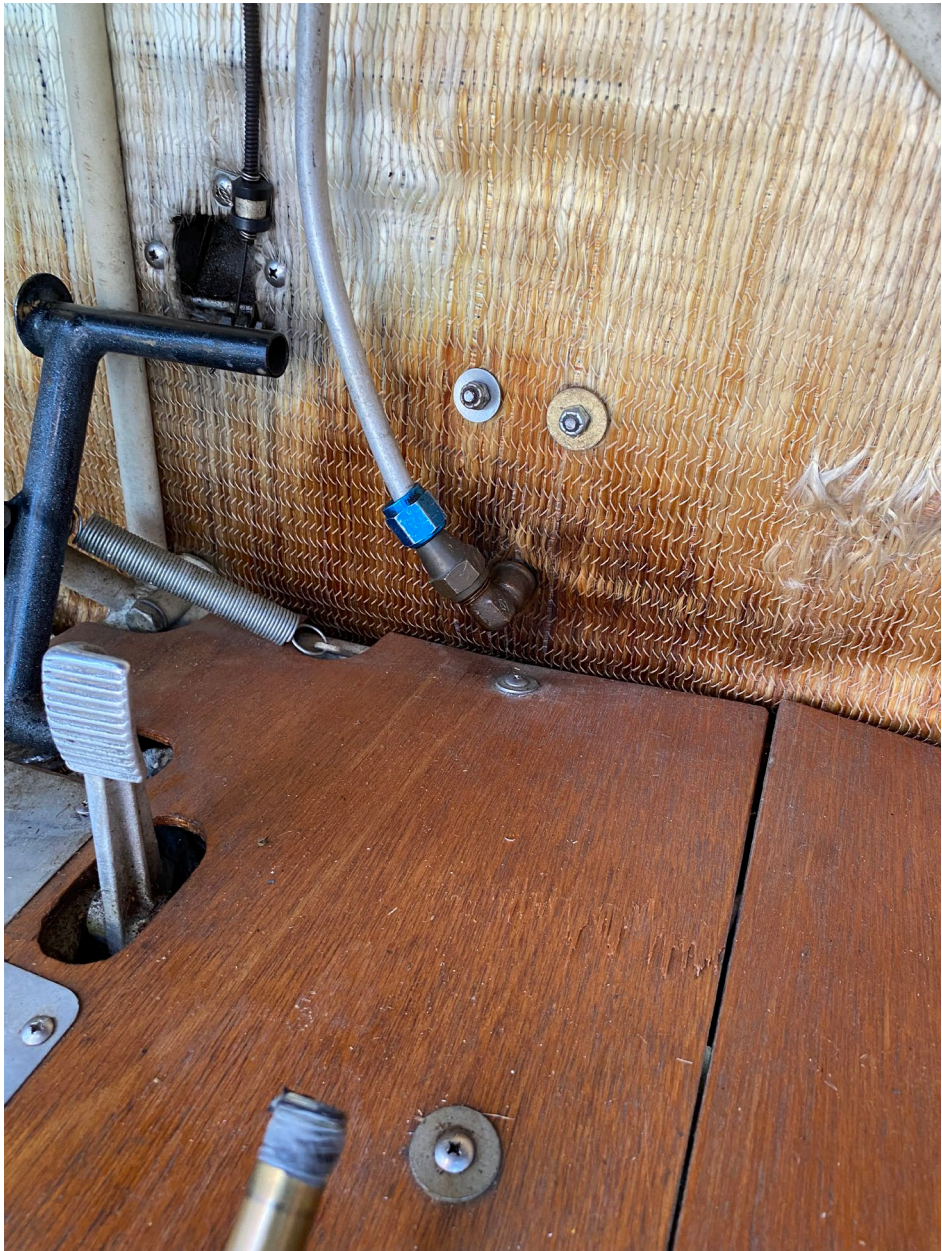
There was a fuel shutoff on the bottom of the fuel tank. After disconnecting the fuel line from the shutoff valve Inspector deVogel was able to turn the valve. Fuel trickled out and stopped as he rotated the valve. The valve was able to be turned 360 with ease. The valve was not labeled with on and off locations. The fabric on the firewall where the fuel line connects to the gascolator was discolored. The fuel line was properly connected. No cracks were noted on the union between the fuel line and the gascolator.

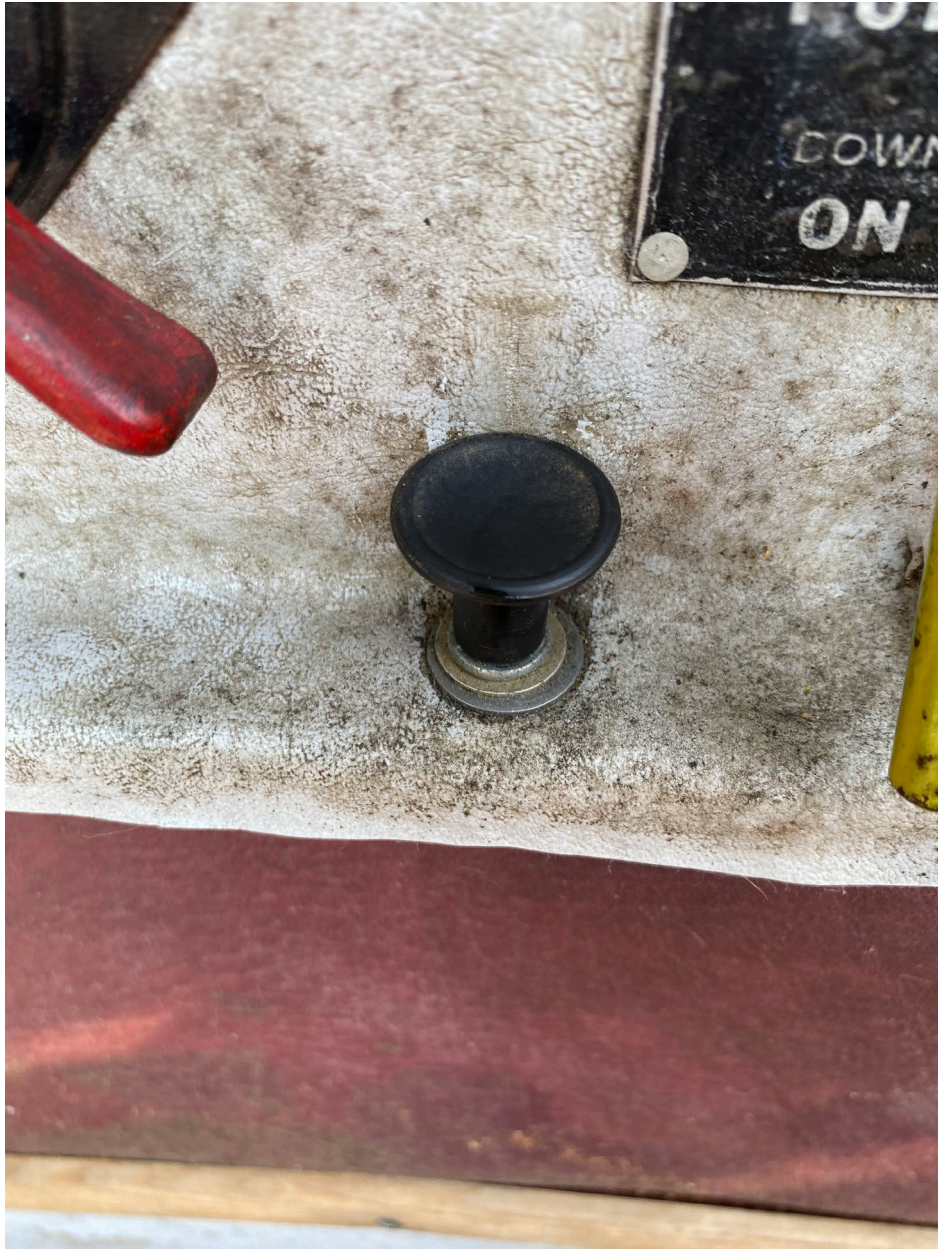
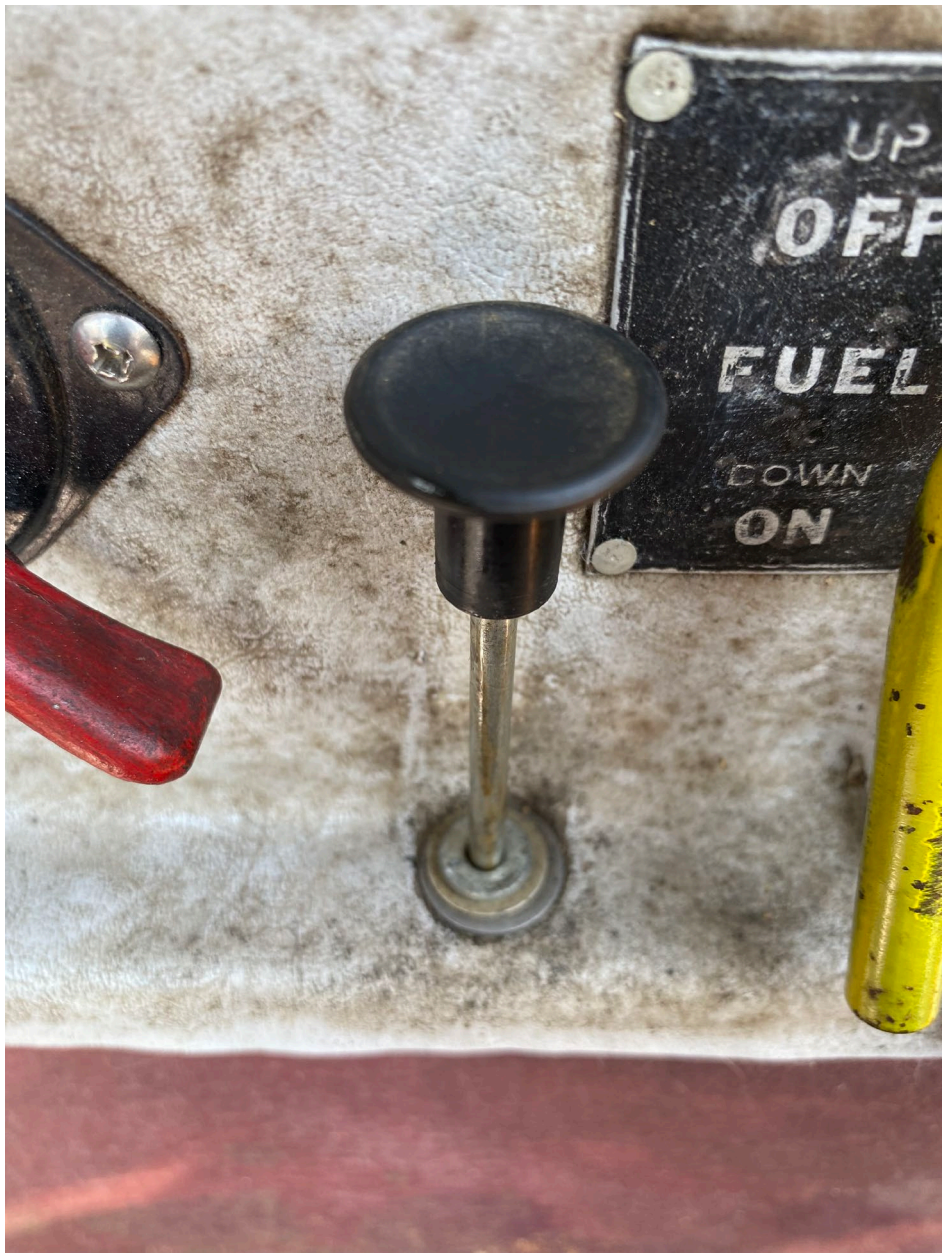
The carb heat cable moved freely after it was disconnected from the intake.

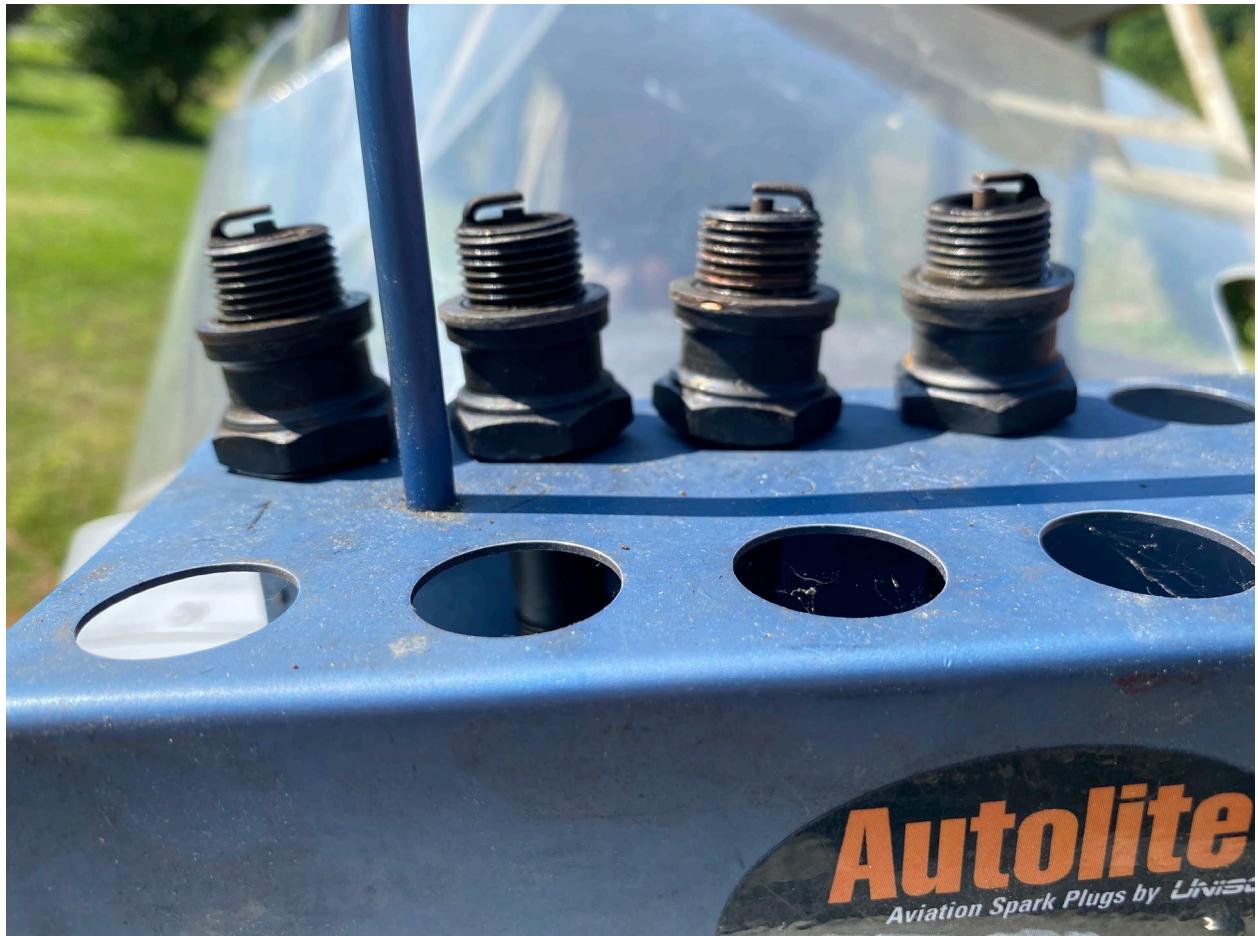
The top spark plugs were removed and inspected. No fouling was noted. Compression was checked by rotating the crankshaft and placing a thumb of the spark plug hole. Compression checked normal.

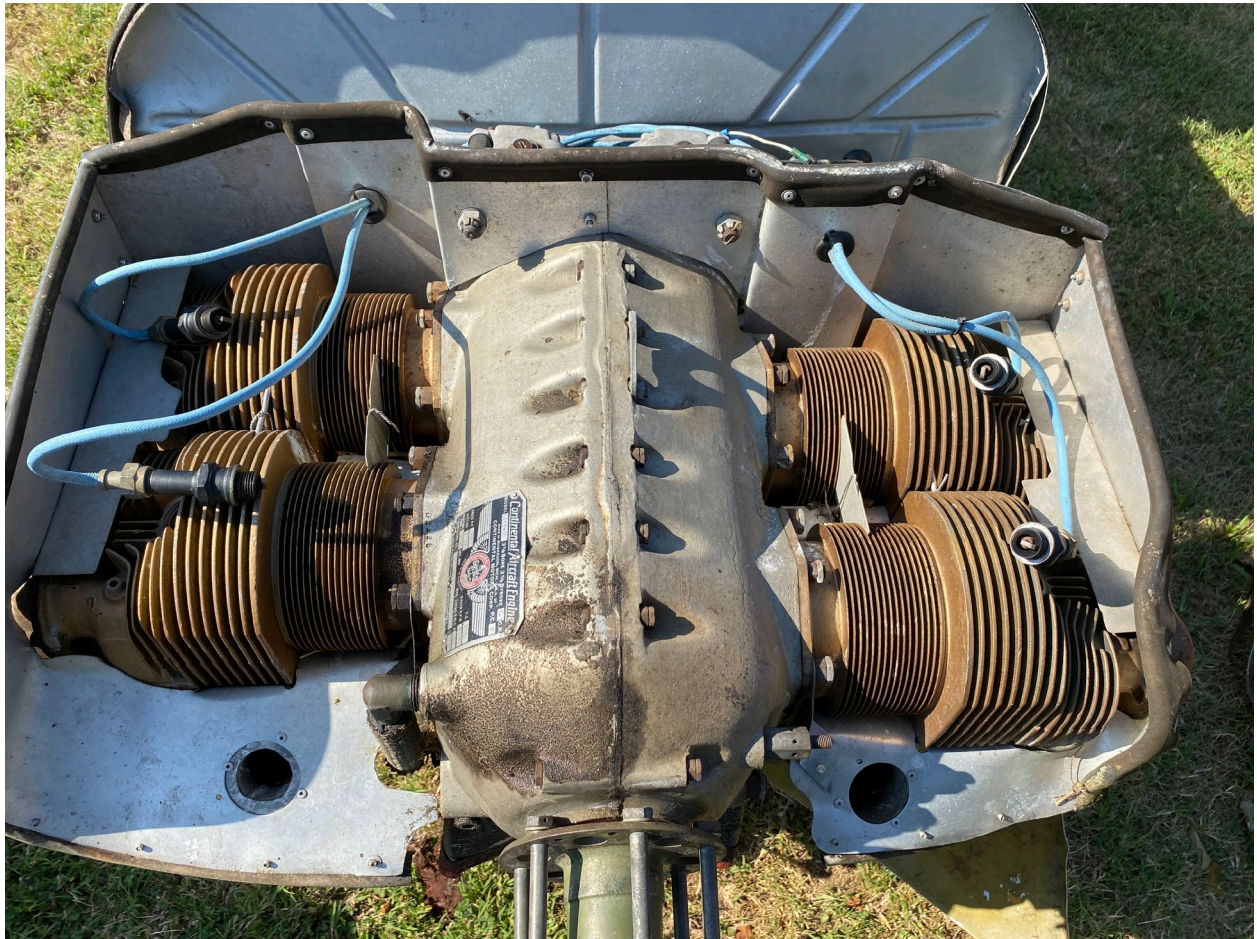
The "P" Leads on the magnetos were disconnected. The spark plugs leads were screwed back into the sparkplugs to their corresponding cylinders and placed on the engine. All spark plugs showed a spark as the crankshaft was rotated.

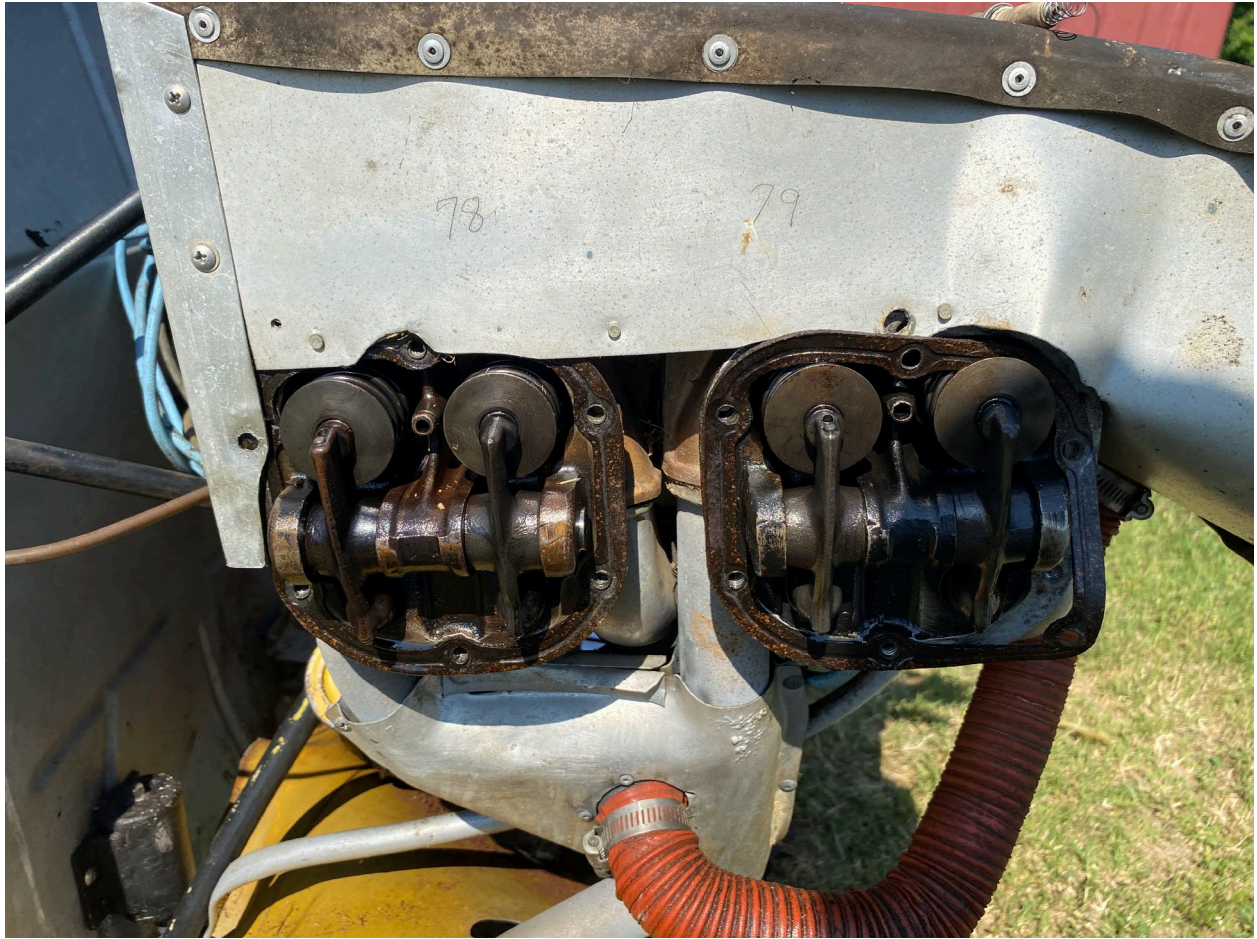
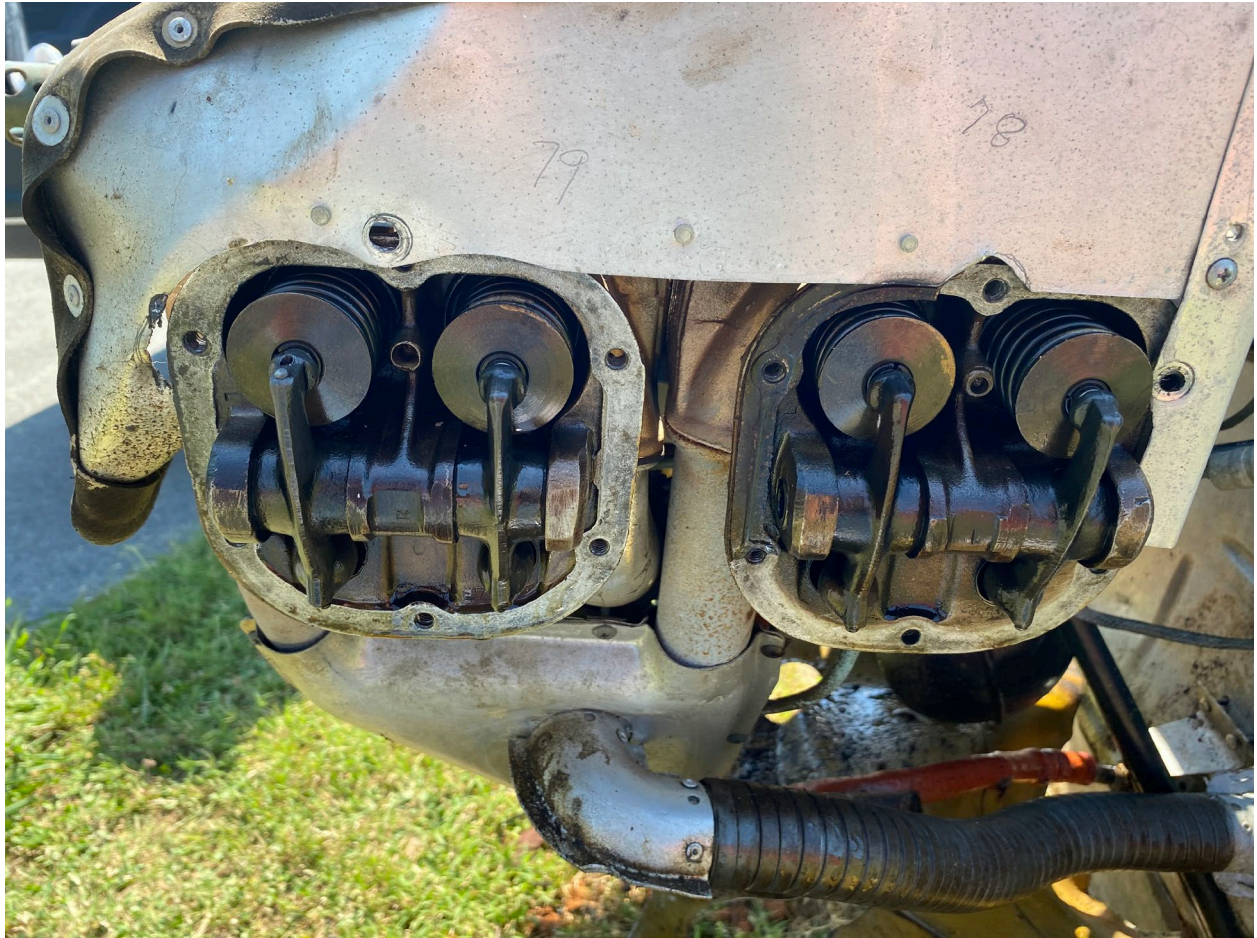
The rocker box covers were removed from all 4 cylinders. The crankshaft was rotated and all valves moved freely.
