ERA22LA249

## INVESTIGATION PHOTOGRAPHS

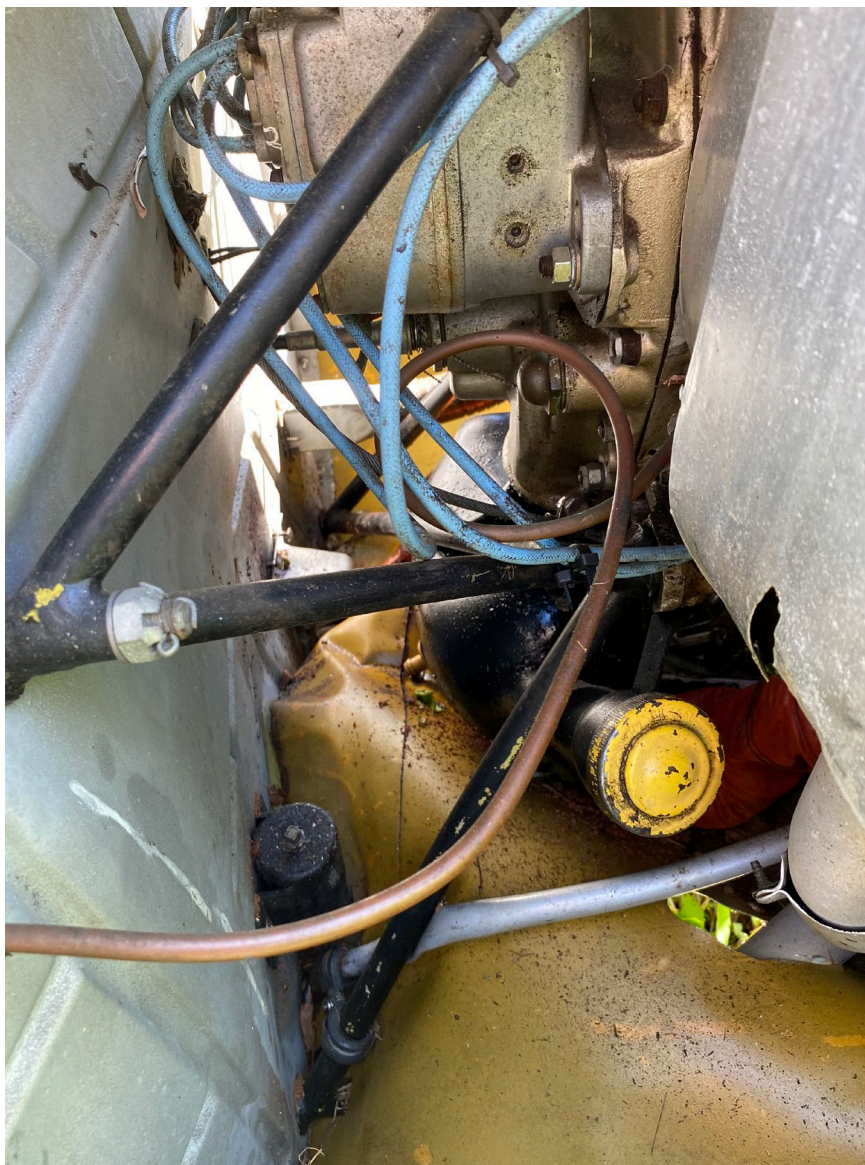
**Photograph 1 - Firewall damage (Courtesy of FAA)**

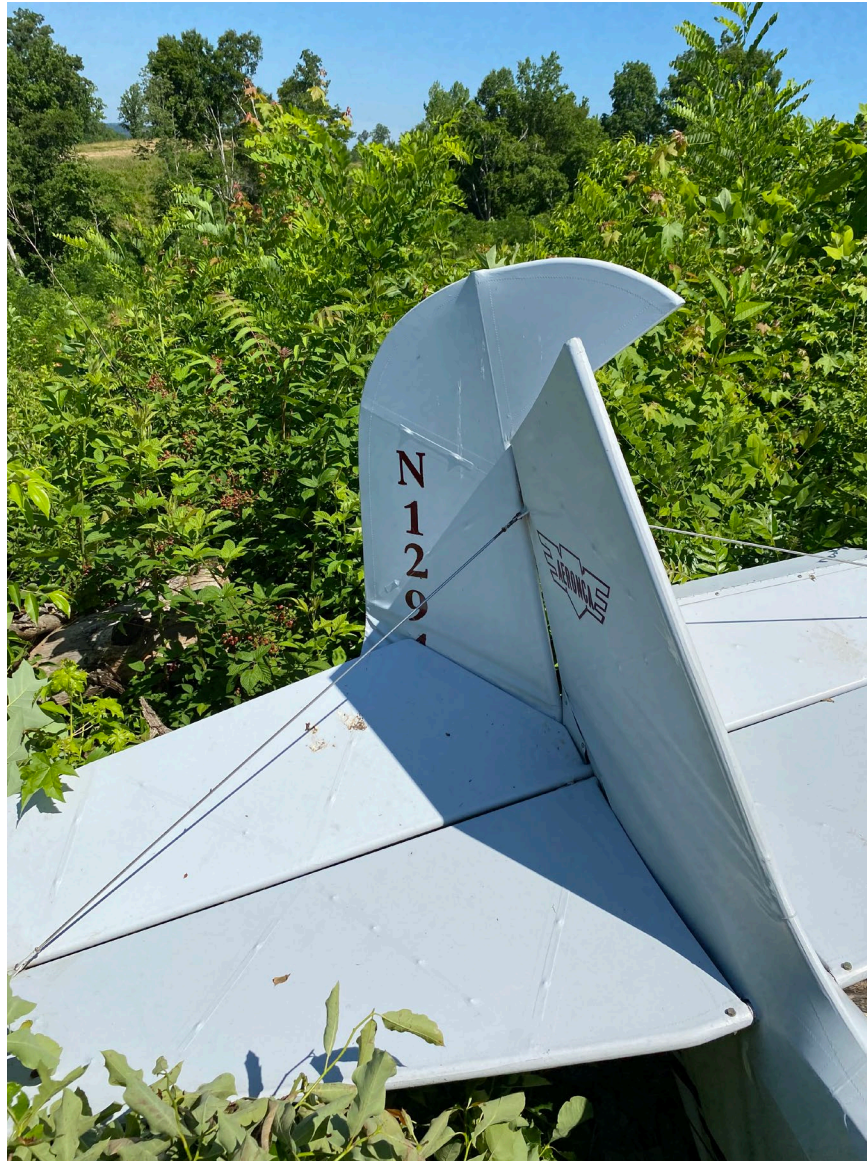
**Photograph 2 - Rudder damage (Courtesy of FAA)**

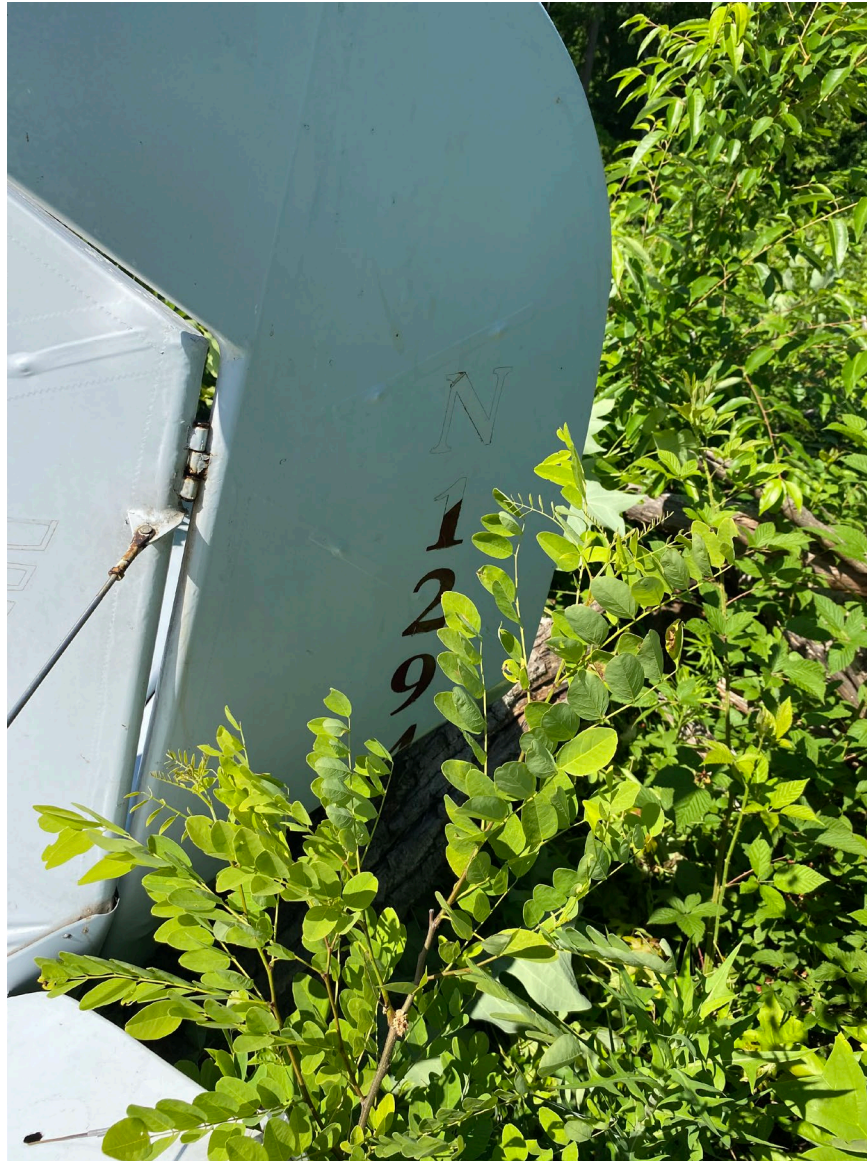
**Photograph 3 - Rudder damage (Courtesy of FAA)**

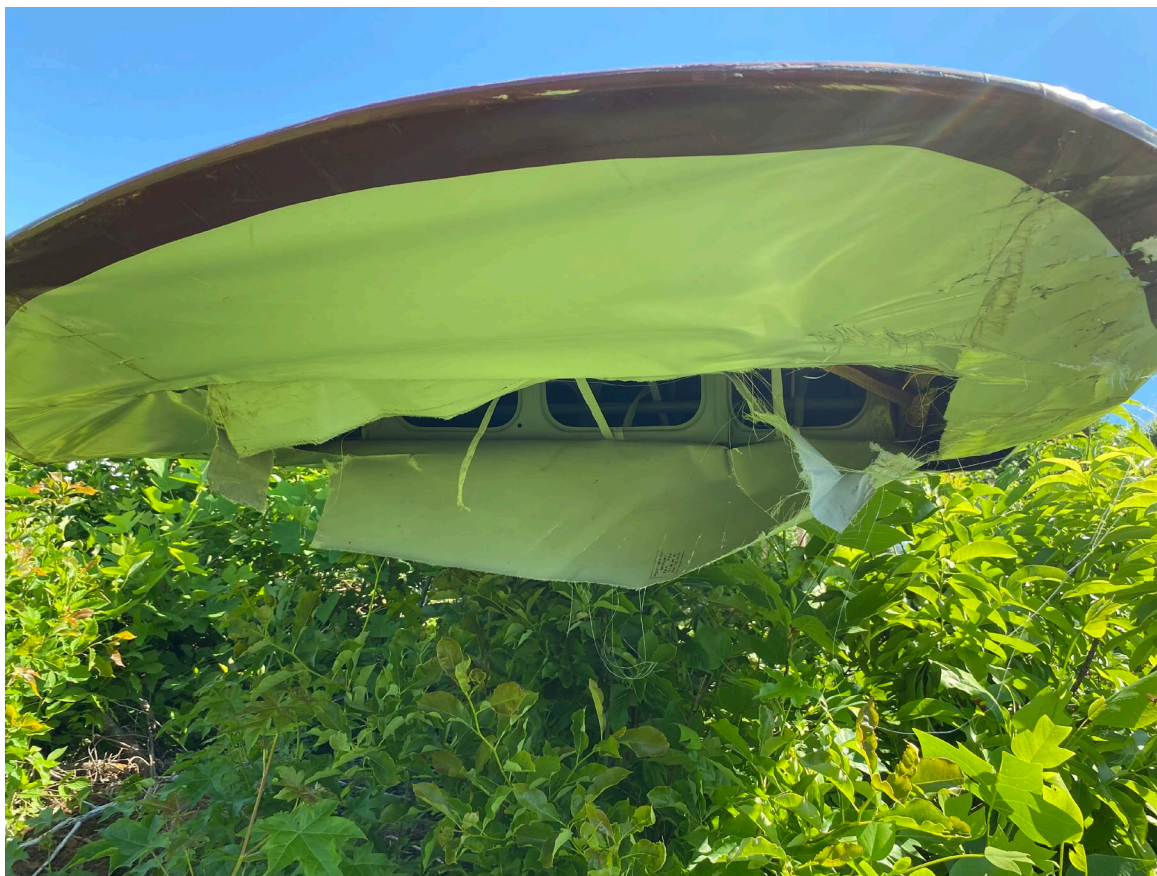
**Photograph 4 - Right wing damage (Courtesy of FAA)**

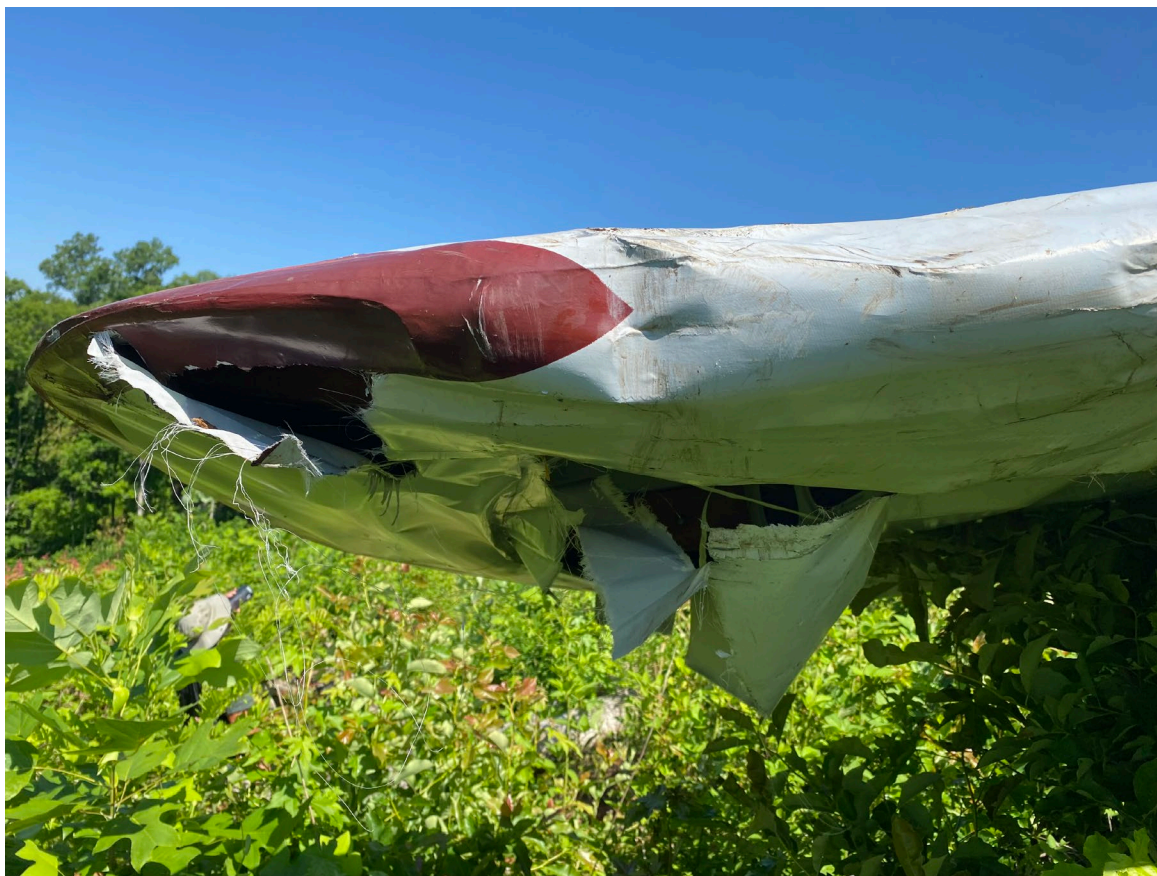
**Photograph 5 - Right wing damage (Courtesy of FAA)**

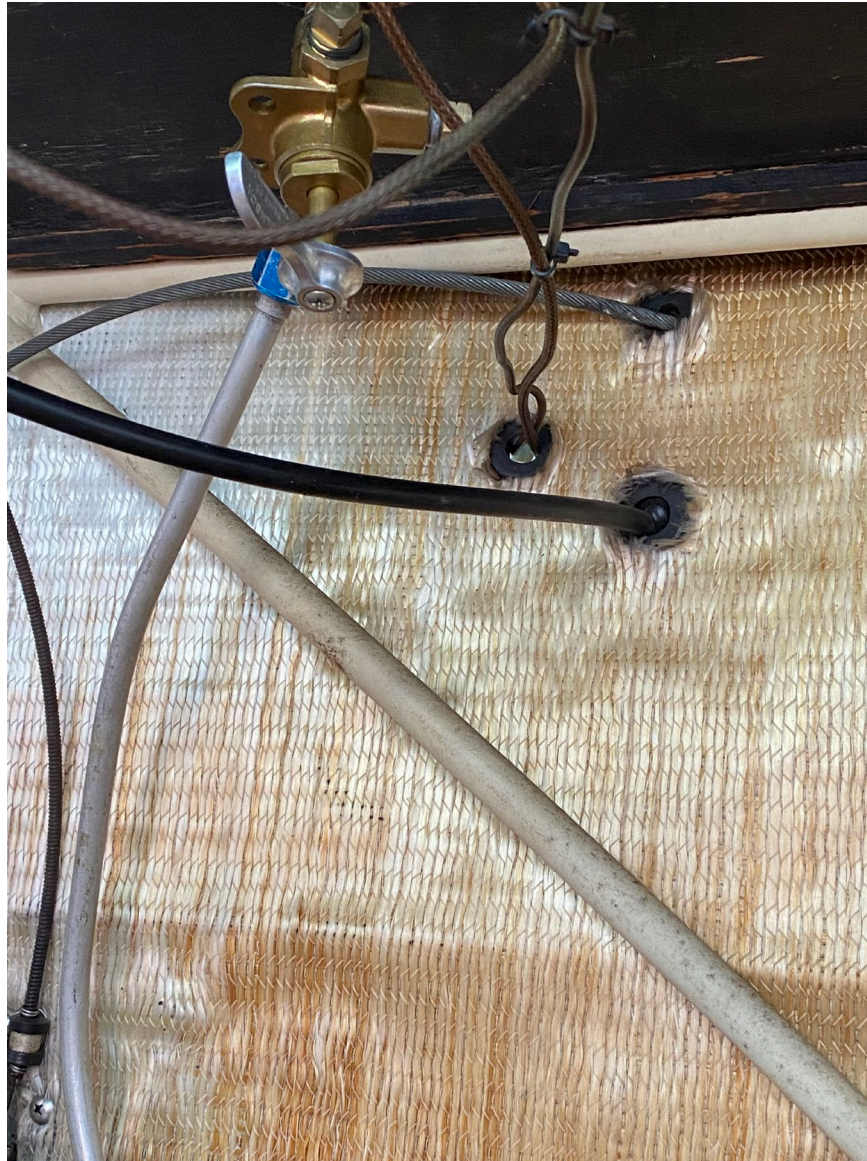
**Photograph 6 - Header tank fuel shutoff valve (Courtesy of FAA)**
