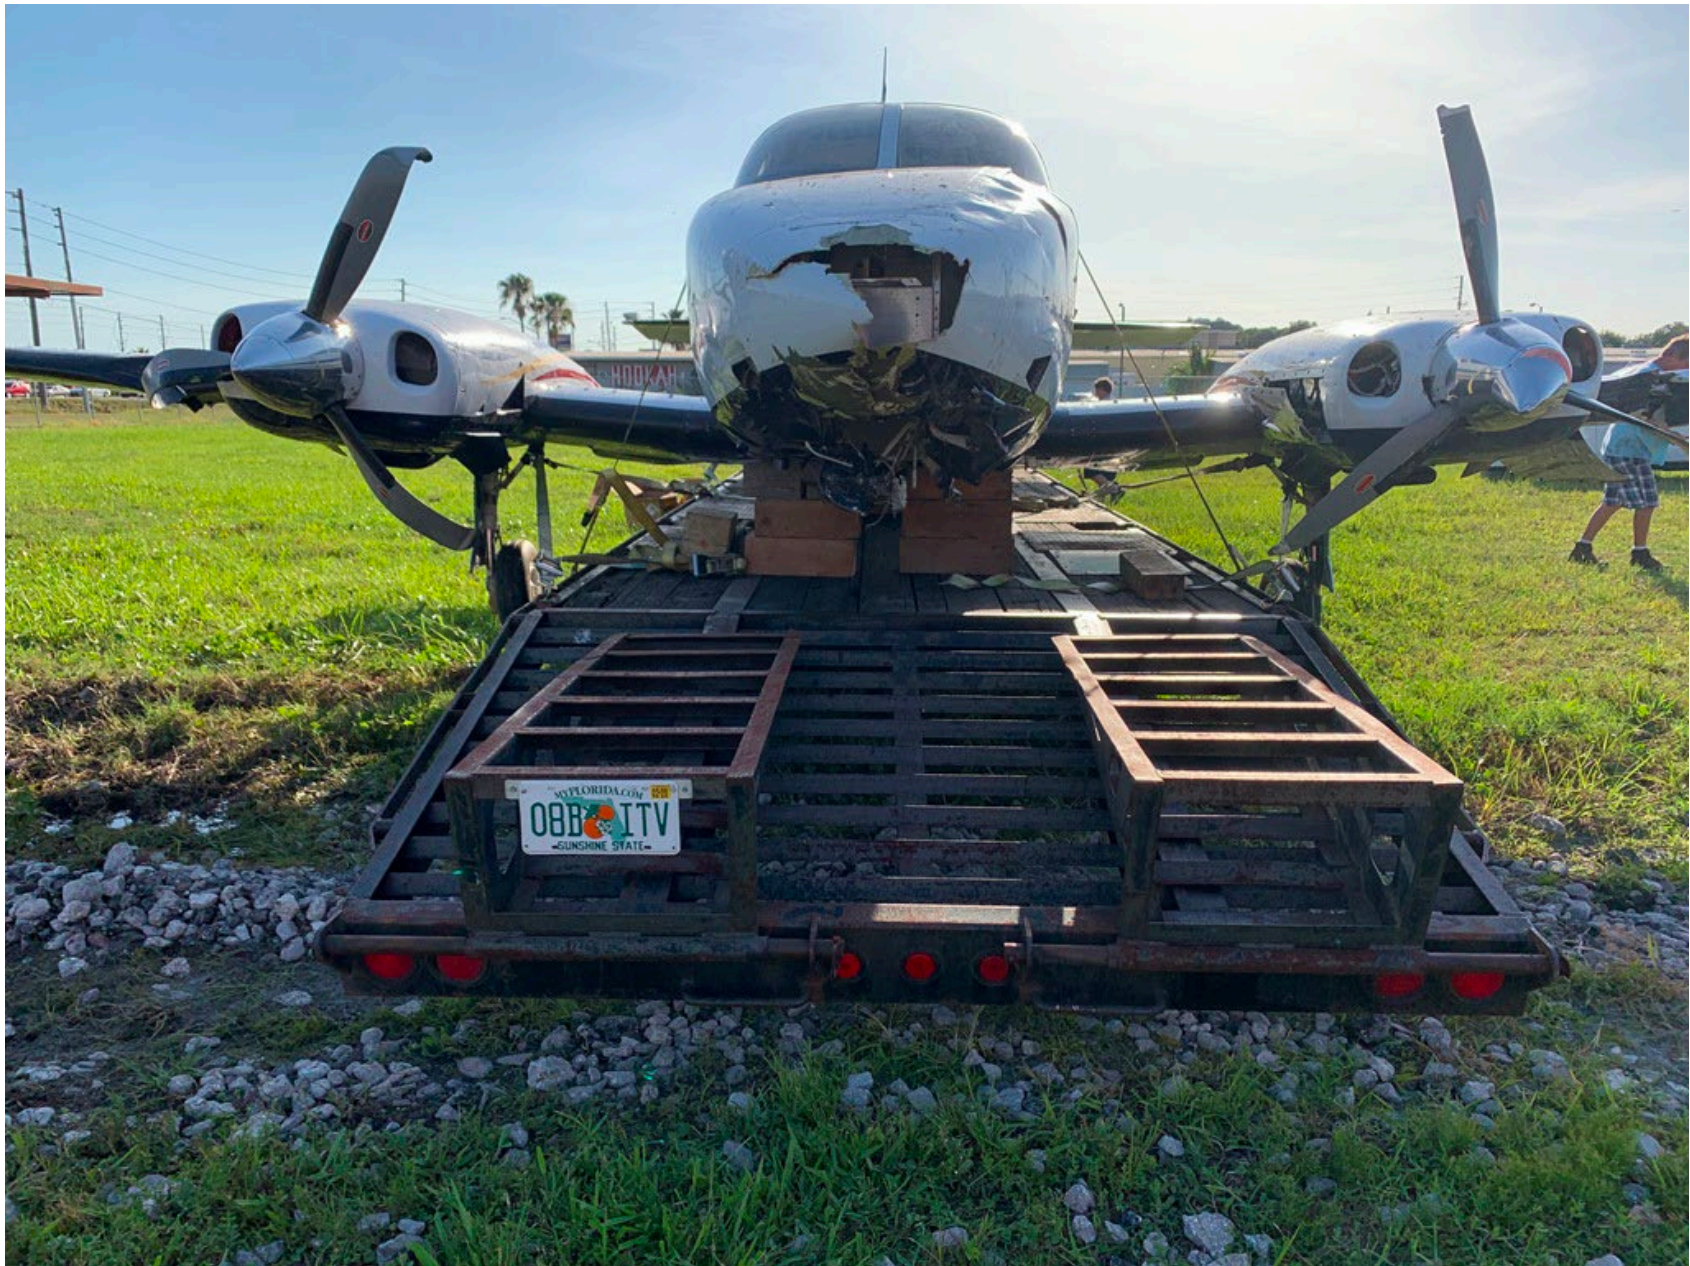
**Photo 1 – Front View of Airplane on Trailer (credit FAA).**

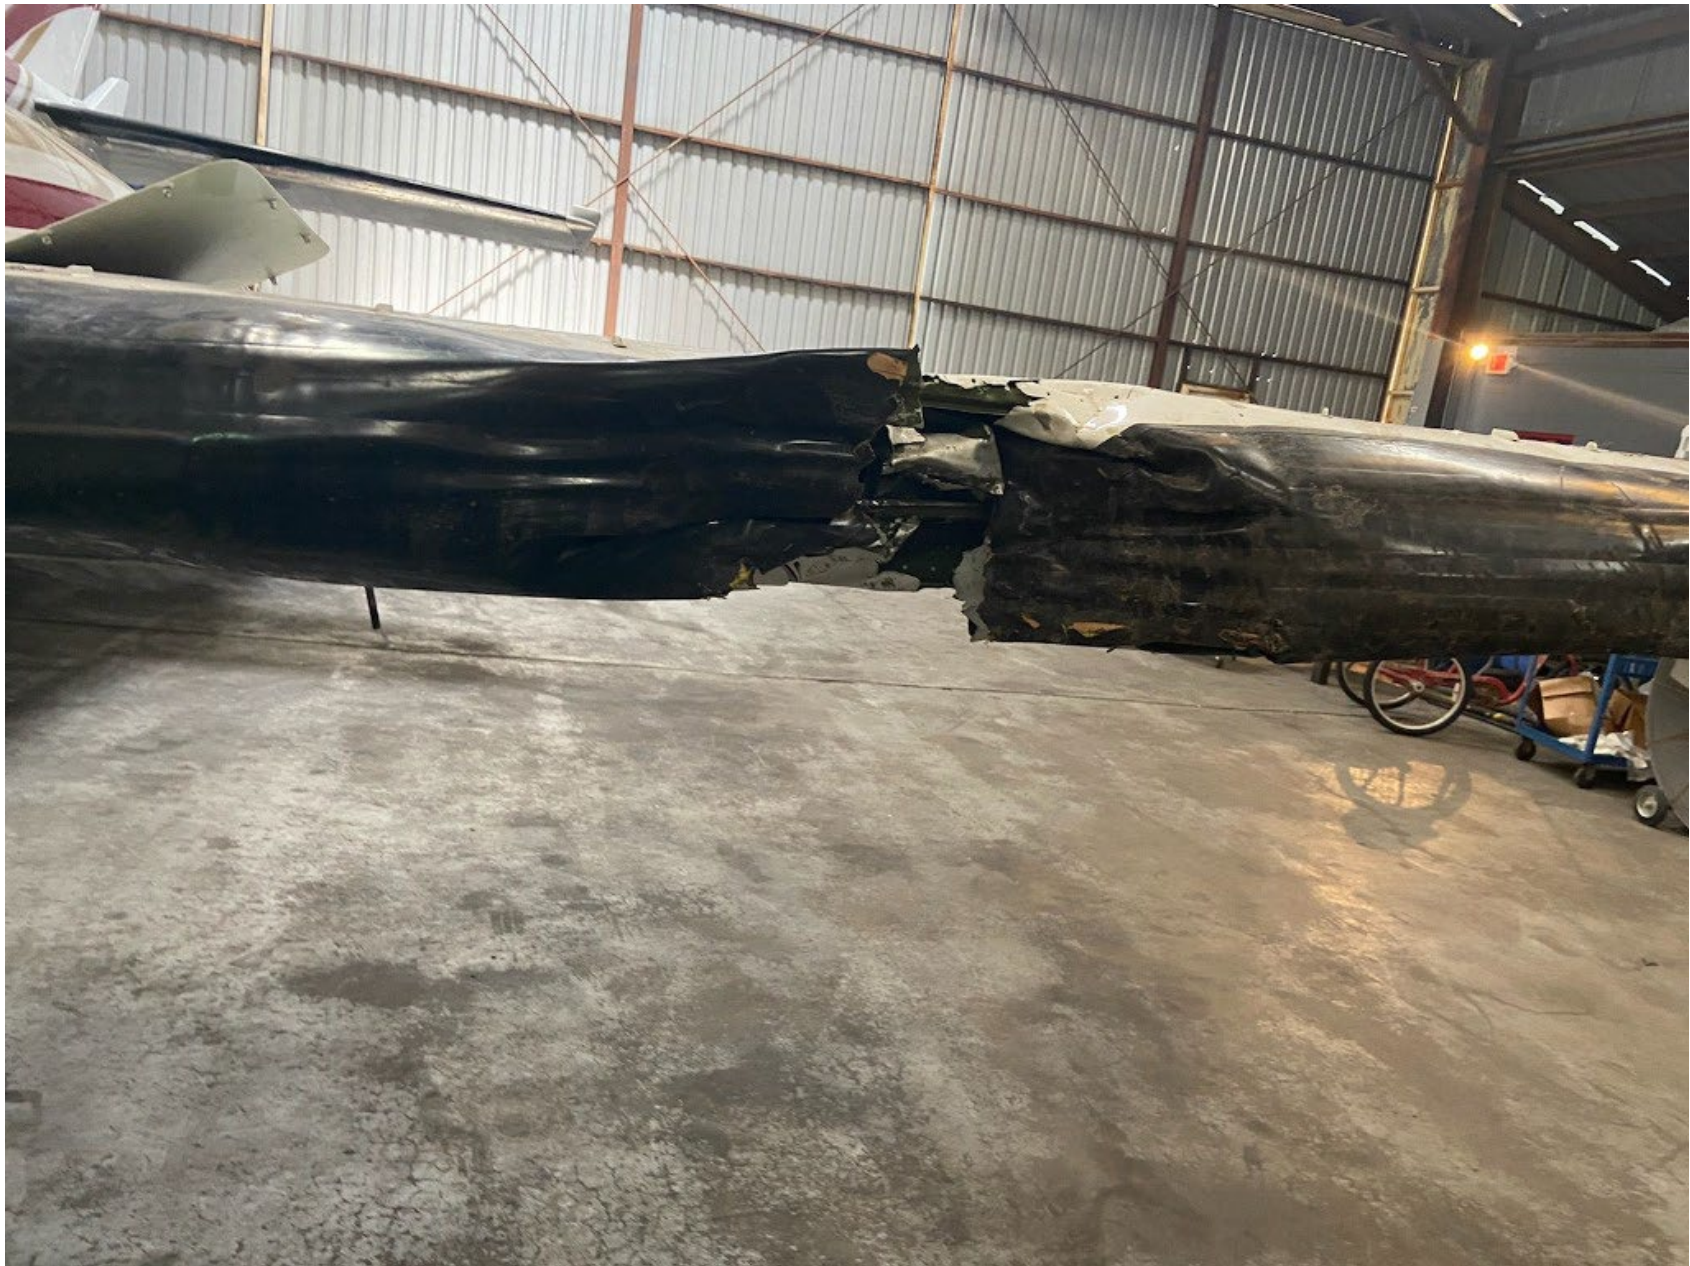
**Photo 2 – Damage to the Leading Edge of the Left Wing (credit FAA)**
