# National Transportation Safety Board

ERA22LA254

## **AUTOMATIC DEPENDENT SURVEILLANCE- BROADCAST (ADS-B) STUDY**

Location: Tredyffin, Pennsylvania  
Date: June 1, 2022  
Time: 1527 eastern daylight time (EDT)  
1927 UTC  
Airplane: Cirrus Design Corporation SR22, N432CP

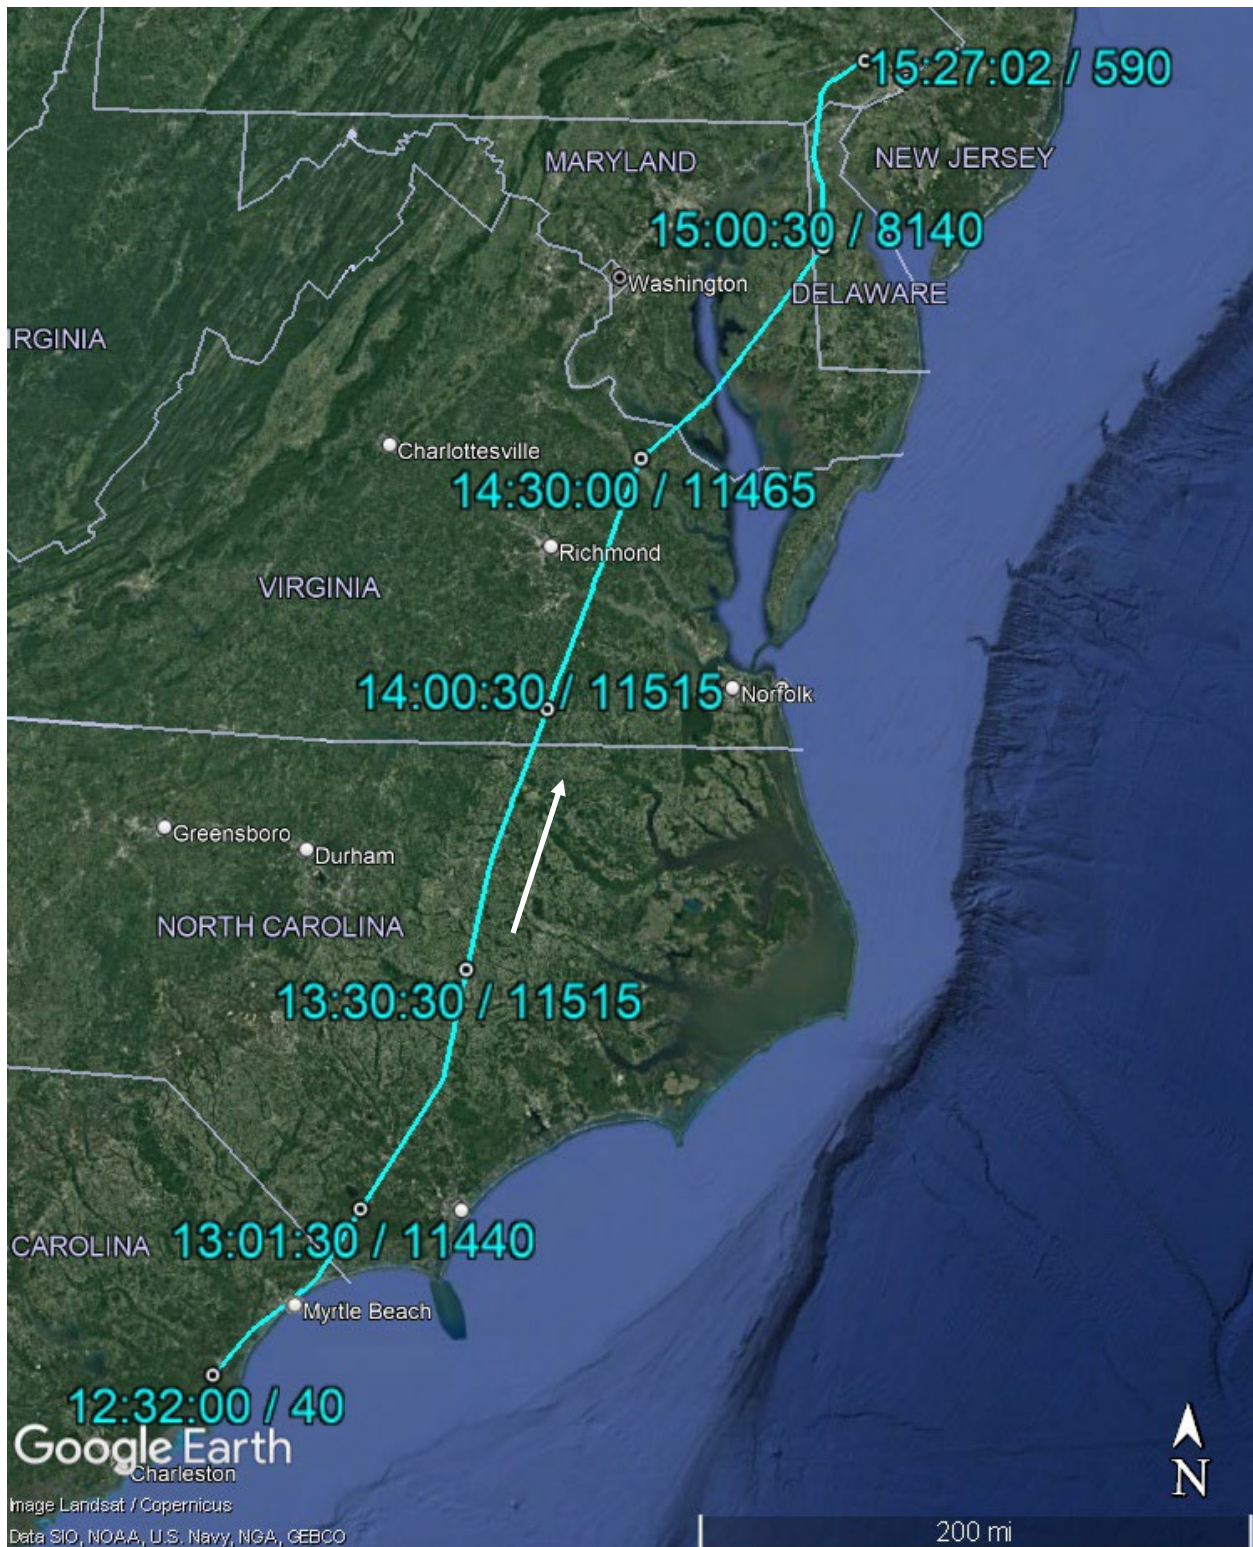
The airplane took off from Georgetown County Airport (KGGE) about 12:32 EDT (Figure 2). The airplane climbed to 11,500 ft above mean sea level (msl) (Figure 3) and flew north-northeast towards its intended destination of Wings Field Airport (KLOM) outside of Philadelphia, Pennsylvania. The airplane began a series of descents after 14:43.

**Figure 2.** Flightpath with selected times and altitudes (msl) noted.

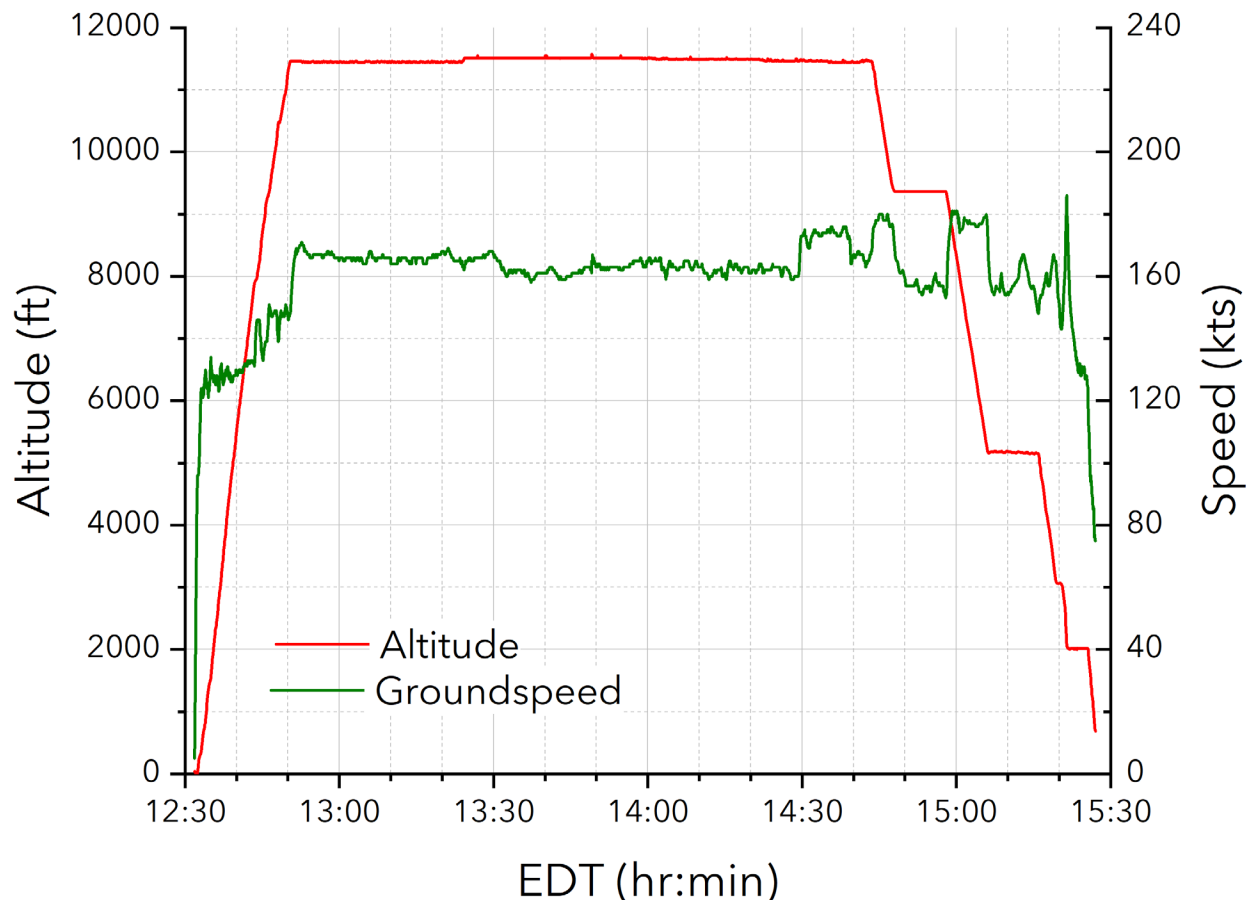
**Figure 3.** Recorded altitude (msl) and groundspeed from ADS-B data for whole flight.

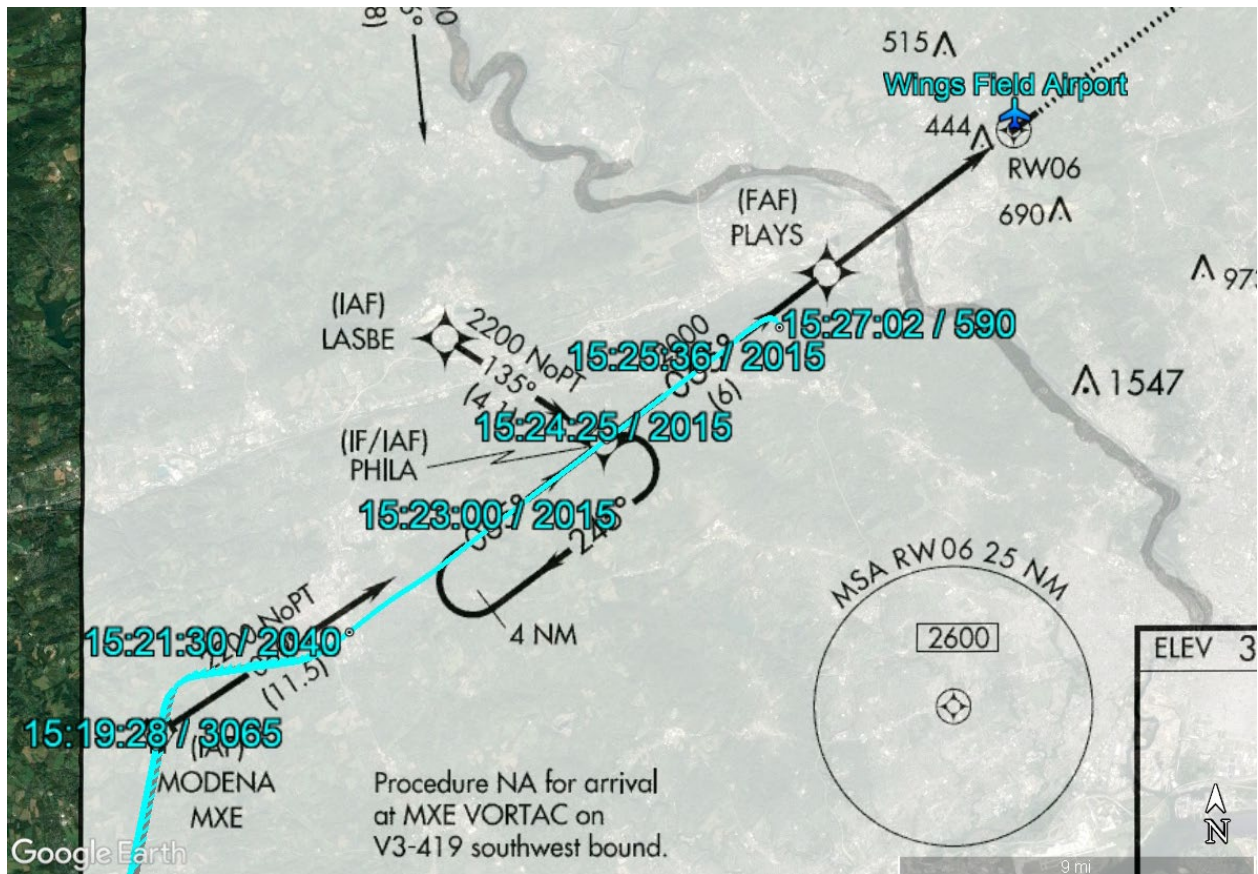
The pilot requested vectors for the area navigation (RNAV) approach for runway 6 at KLOM at 1512. The pilot was instructed to proceed to MODENA (MXE) and to begin the approach from there. The airplane crossed MXE at 15:19:28 (Figure 4), but did not initially turn onto the runway heading until the controller contacted the pilot at 15:21. By 15:21:30 the airplane was aligning with runway 6, had descended to about 2,000 ft, and was slowing to a groundspeed of about 130 kts (Figure 5) (assuming the KLOM weather conditions were representative, the calibrated airspeed was approximately 125 kts). The RNAV approach for runway 6 shows the minimum altitude at PHILA as 2,200 ft decreasing to 2,000 ft at PLAYS, and continuing to descend from there to runway 6, with an airport elevation of 302 ft. The pilot canceled the IFR (instrument flight rules) approach at 15:23 and crossed PHILA at 2,000 ft. The airplane maintained 2,000 ft until 15:25:36, about 3.5 NM before PLAYS (8.6 NM before the runway threshold).

**Figure 4.** Flightpath with selected times and altitudes (msl) shown overlaid on a portion of the RNAV (GPS) RWY 6 chart for LOM.

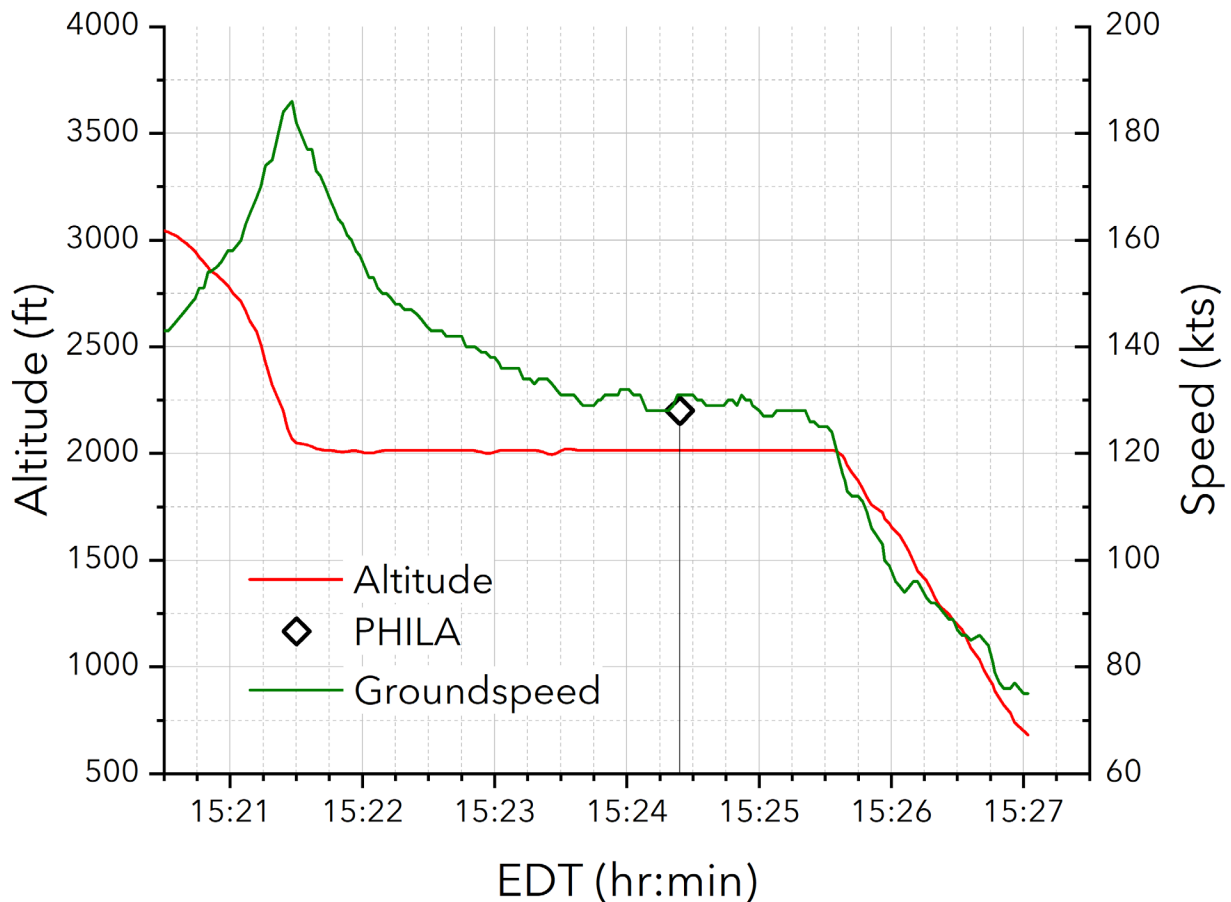
After 15:25:36, the airplane then began descending and slowing, losing altitude at a rate of 610 ft per nautical mile traveled, very close to the maximum glide performance specified for the airplane<sup>1</sup>. After the accident, the pilot reported a loss of engine power during flight and the decision to land.

**Figure 5.** Recorded altitude (msl) and groundspeed from ADS-B data for whole flight. The height of navigation aid PHILA and when it was passed is noted.

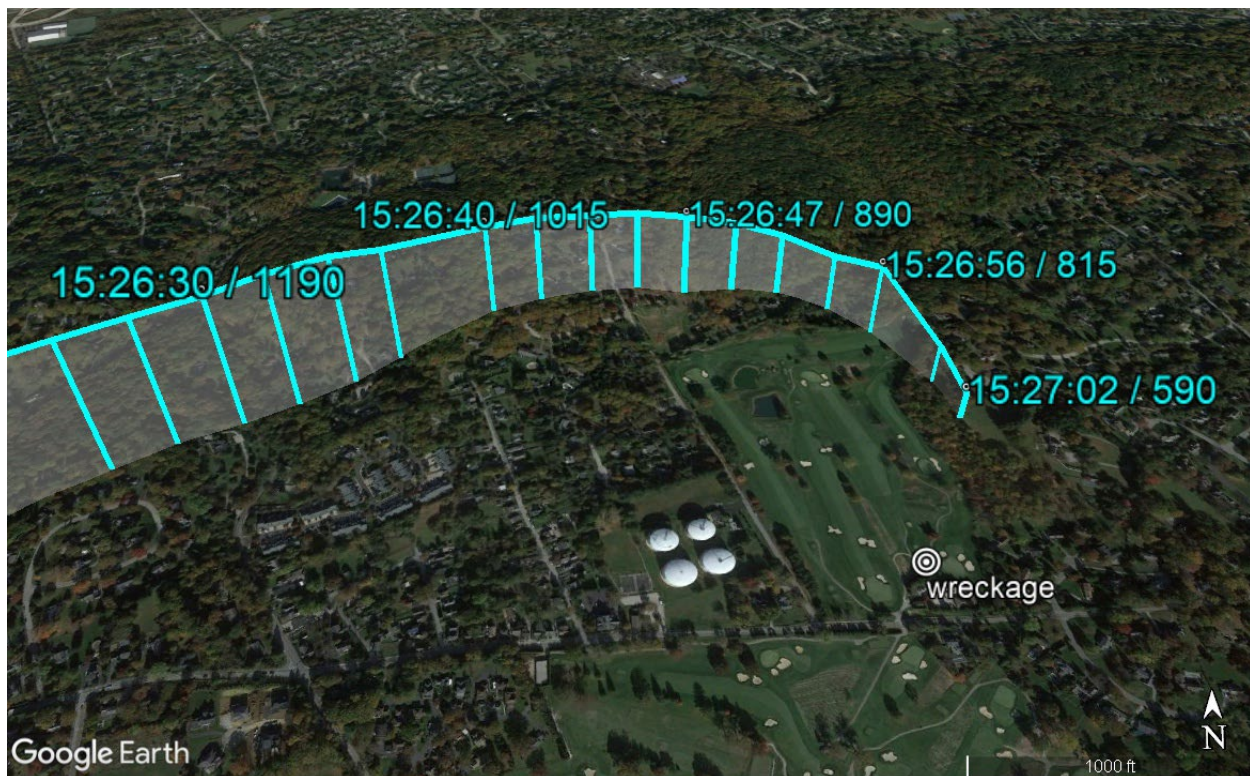
The airplane descended steadily and by 15:26:30 was about 700 ft above the terrain and approaching a golf course (Figure 6). The airport was still over 7 NM away. The airplane made a right turn towards the golf course which rapidly increased the descent rate and further slowed the airplane. The airplane impacted the golf course before coming to rest near some trees.

**Figure 6.** Airplane flight path with selected times and altitudes (msl) noted. The final wreckage location is marked and was at an elevation of approximately 480 ft.
