# NATIONAL TRANSPORTATION SAFETY BOARD

## MATERIALS LABORATORY FACTUAL REPORT

Report No. 22-050

Place : North Myrtle Beach, South Carolina  
Date : 05/26/2022  
Vehicle : Robinson Helicopters R44  
NTSB No. : ERA22LA256  
Investigator : Brian Rayner

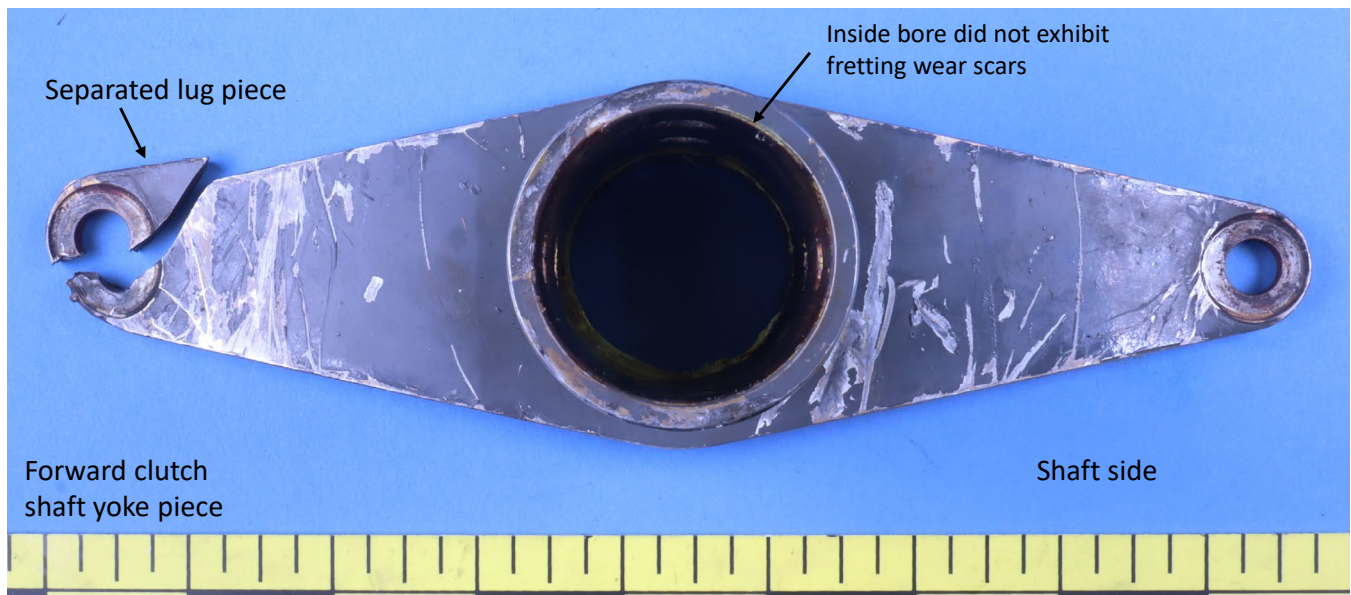
Details of the forward clutch shaft yoke pieces are shown in Figures 3-5. In the figures, a separated piece of the lug at the bolt hole is identified and has been placed in close proximity to its pre-separation location. The forward and aft faces of the lugs exhibit scratches and gouges whereas the separated piece is free from such damage. As identified in Figure 4, the main inside bore (the bore that fits over the clutch shaft) did not exhibit any fretting wear scars. No paint deposits or fretting wear scars were observed under the yoke mounting block pads, although a thin clear organic layer was present on the faying surfaces of the mounting block pads consistent with an adhesive. No fretting wear scars were observed on the bore walls of the mounting bolt holes.

Figure 3 Macroscopic view of the of the clutch shaft side of the forward clutch shaft yoke piece with a separated lug piece positioned close to its pre-incident location. The shaft-side face of the lugs are scratched and gouged. The separated piece is free from scratches and gouges.

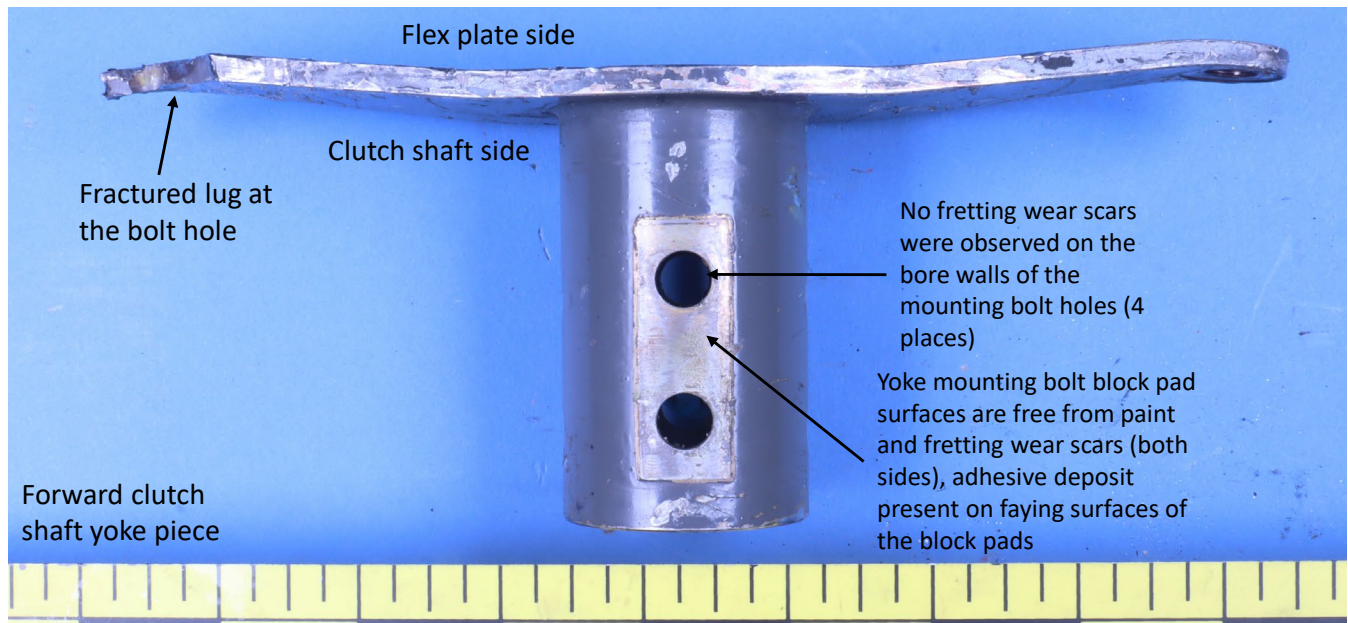
Figure 4 Macroscopic profile view of the forward clutch shaft yoke piece.

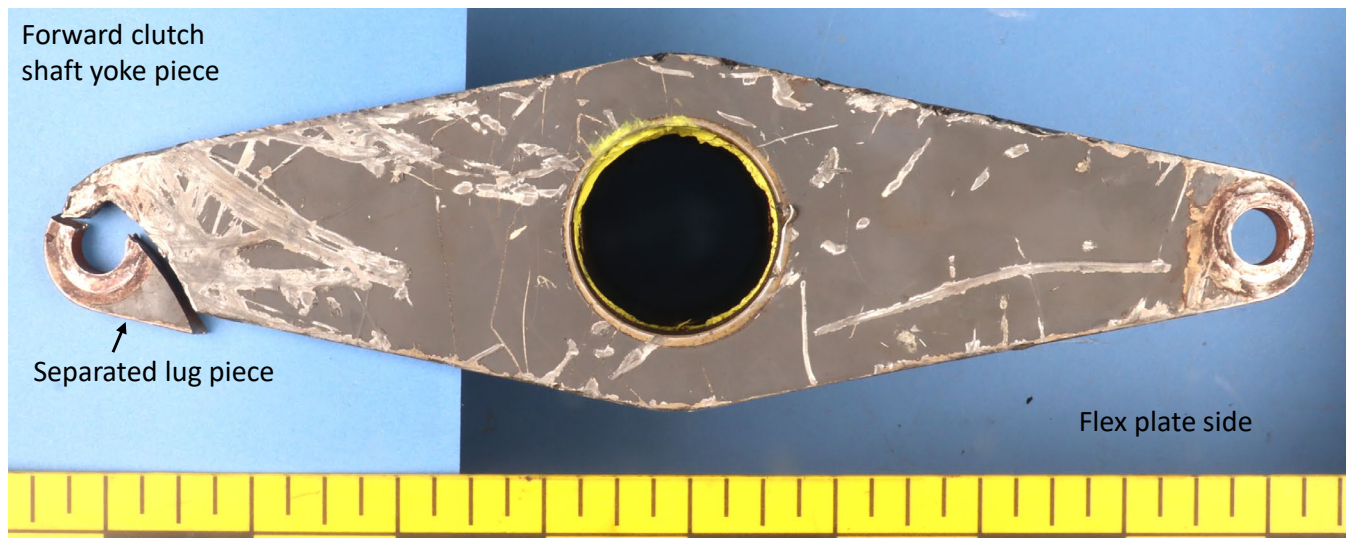
Figure 5 Macroscopic view of the of the flex plate side of the forward clutch shaft yoke piece with a separated lug piece positioned close to its pre-incident location. The shaft-side face of the lugs are scratched and gouged. The separated piece is free from scratches and gouges.

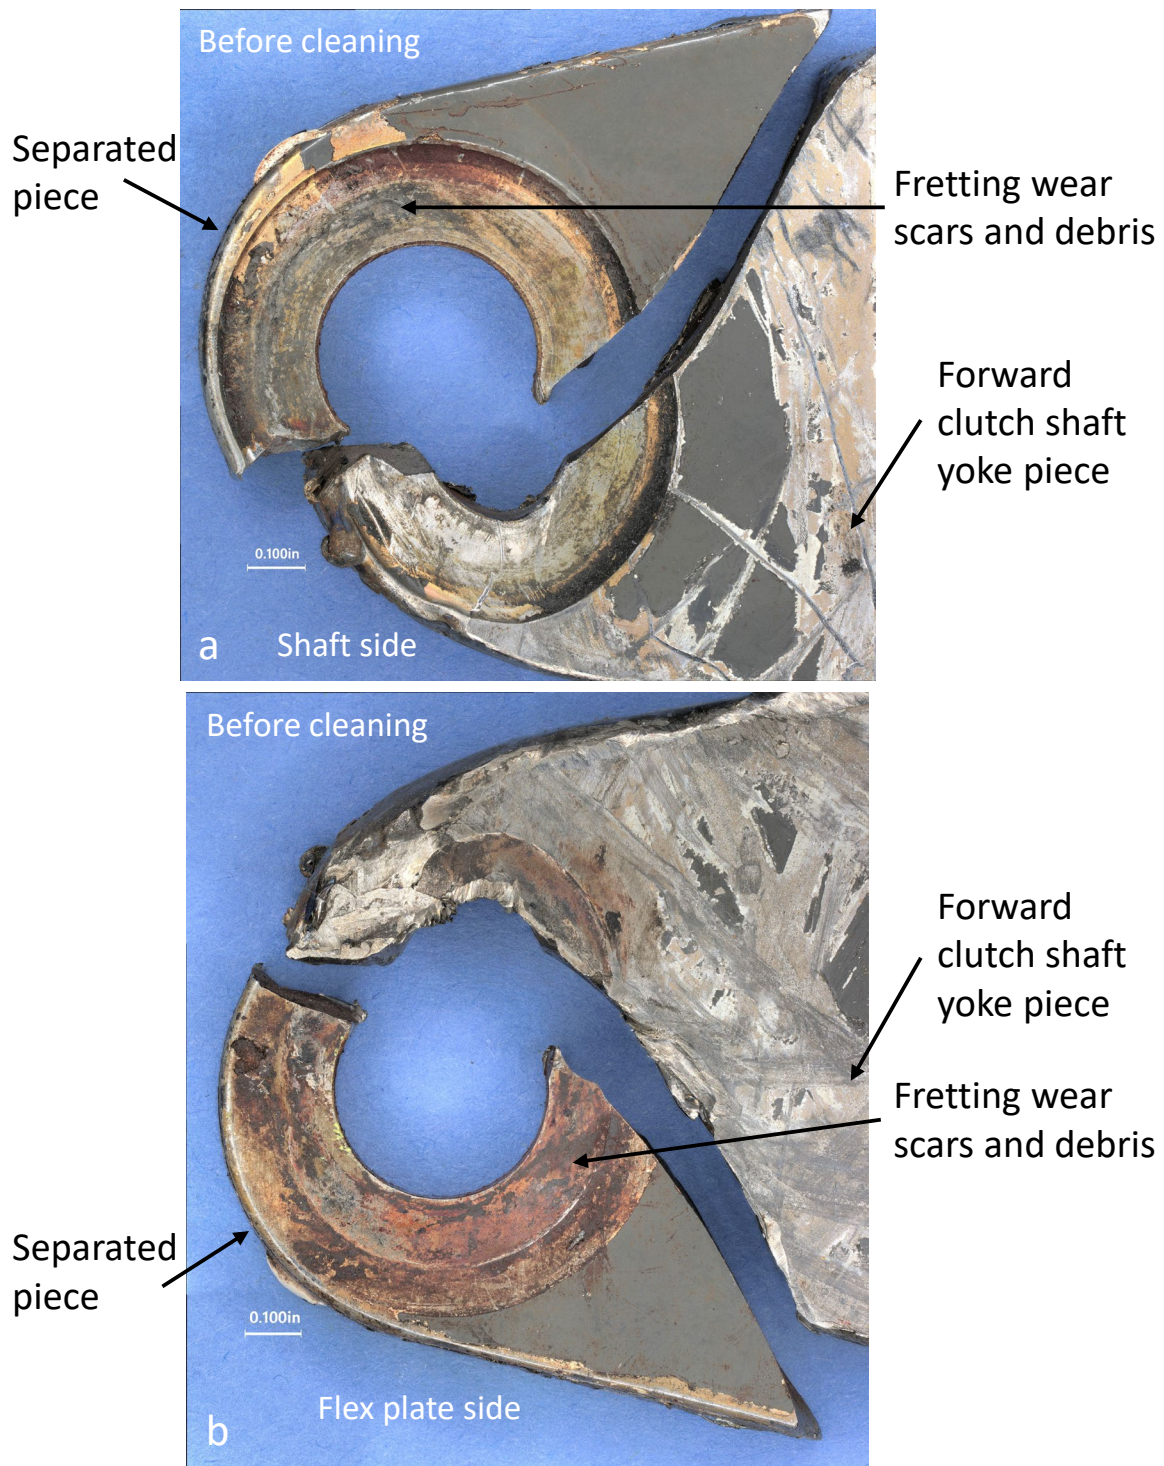
Closer views of the separated forward clutch shaft yoke lug piece are shown in Figures 6 and 7 in the as-received and acetone-cleaned condition, respectively. The fracture faces on the separated piece and the lug were examined using a digital microscope under various lighting conditions to reveal the fracture features. The fracture surfaces from both halves of the fractured lug are shown in Figures 8-11 in the as-received and acetone-cleaned condition. The fracture faces exhibited contact damage and gross mechanical distortion; however, two fatigue cracks were observed. One fatigue crack nucleated at the bolt hole bore chamfer at the outer periphery on the flex plate side

Figure 6 Close views of the fractured lug on the forward clutch shaft yoke piece with the separated lug piece positioned close to its pre-incident location (before cleaning). Indications of fretting wear are noted in the images.

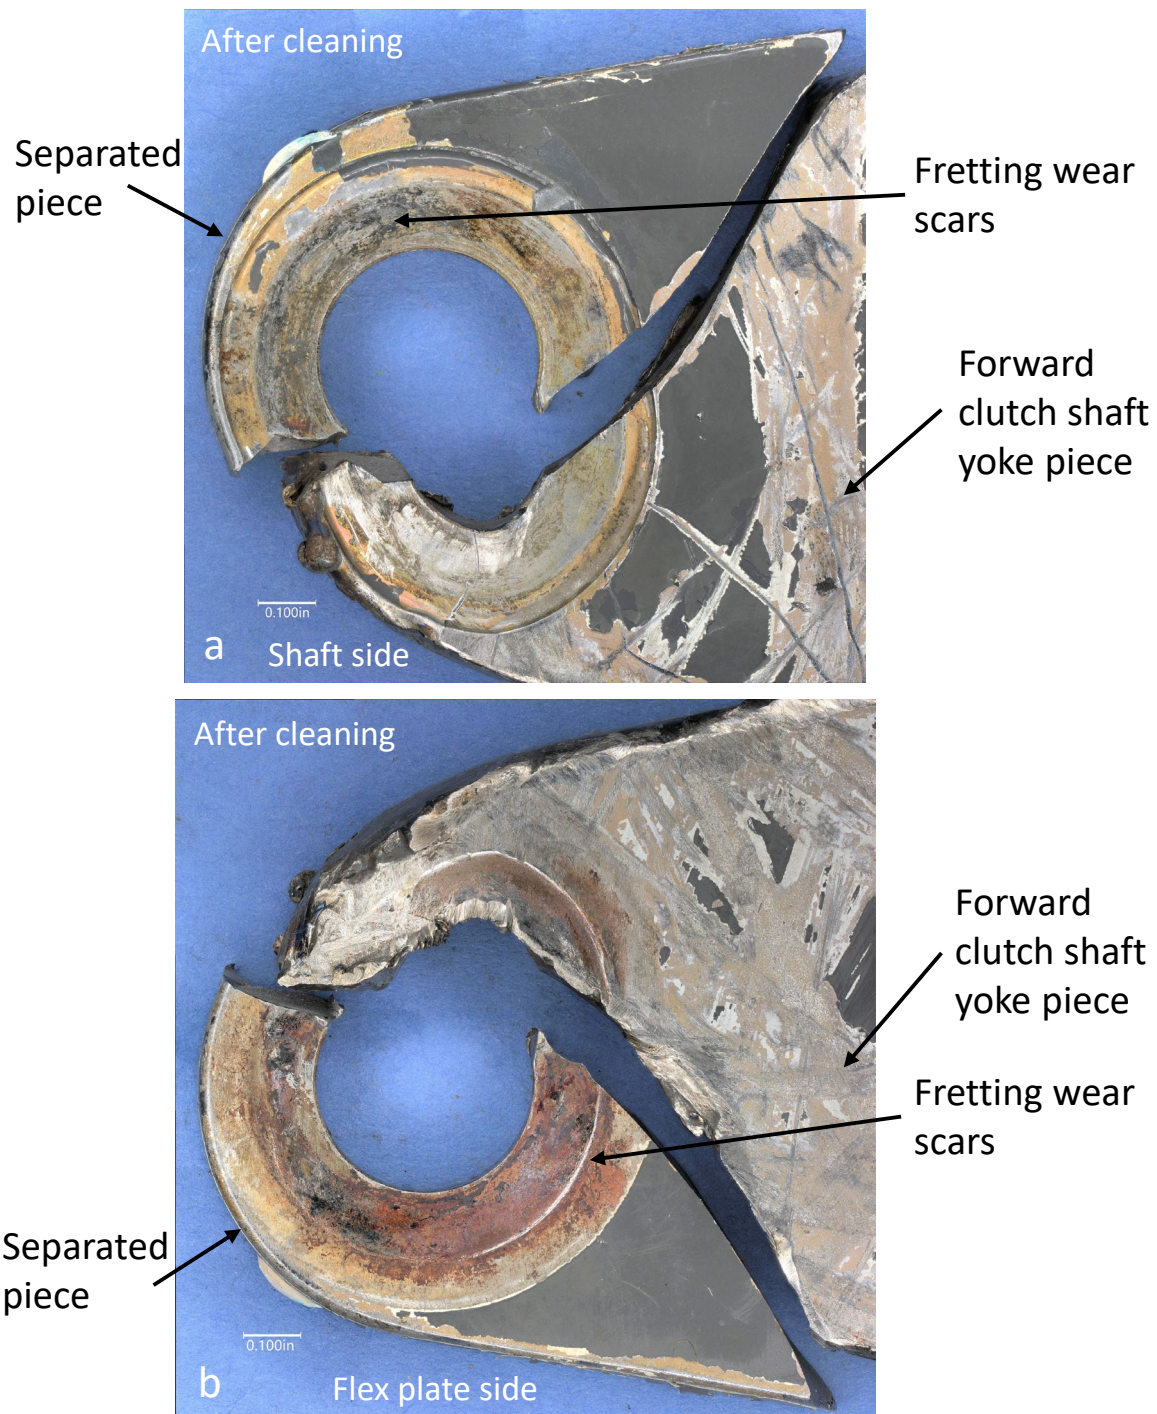
Figure 7 Close views of the fractured lug on the forward clutch shaft yoke piece with the separated lug piece positioned close to its pre-incident location (after acetone cleaning). Indications of fretting wear are noted in the images.

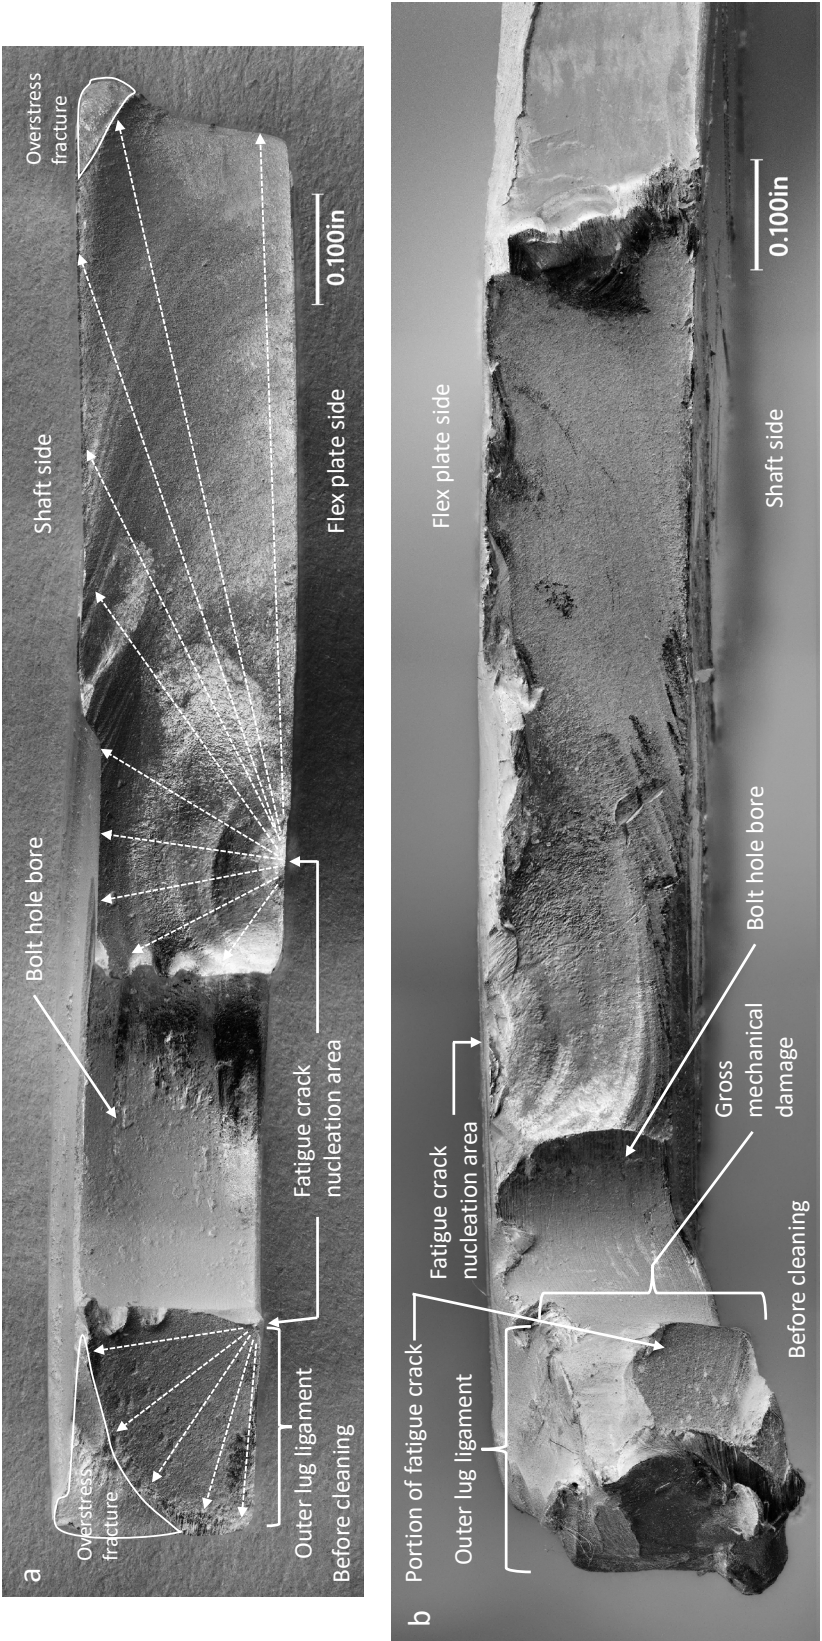
and progressed towards the shaft side of the lug. Fatigue crack progression marks were observed over about 80% of the fracture surface. A second fatigue crack nucleated under the washer of the mounting bolt on the flex plate side of the lug. The crack progressed through the lug thickness towards the shaft side of the lug and outwards towards the free surface of the lug. Fatigue crack progression marks were present over about 90% of the fracture surface. The specific locations of the two fatigue crack nucleation sites are identified on the separated lug piece in Figures 12 and 13.

Figure 8 As-received monochromatic digital microscope images of the fracture surfaces on the fractured lug of the forward clutch shaft yoke with key features annotated. View a shows the fracture surfaces on the separated lug piece with origin areas and direction a crack propagation (dashed arrows) annotated. View b shows the fracture surfaces on the main lug with origin area annotated.

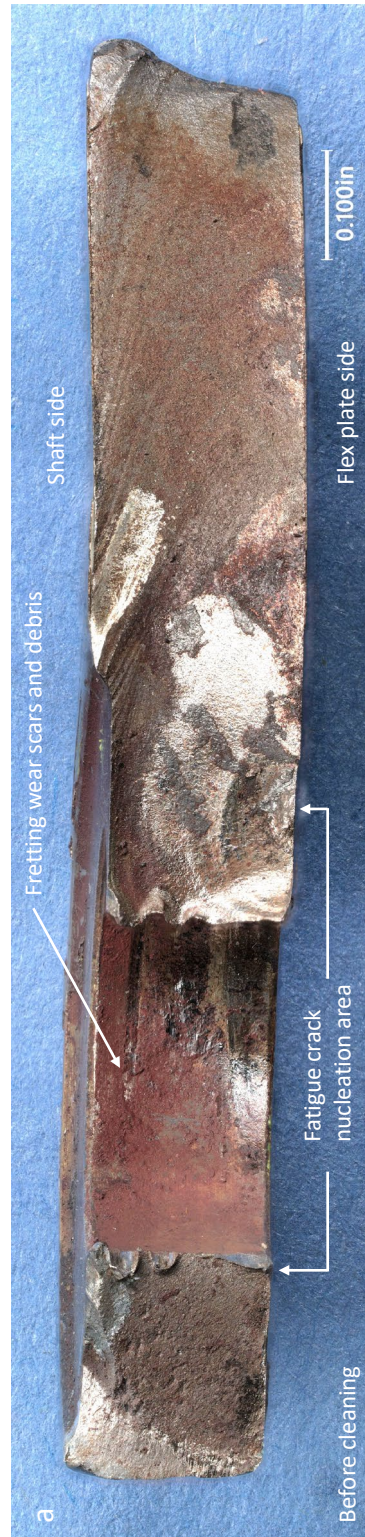
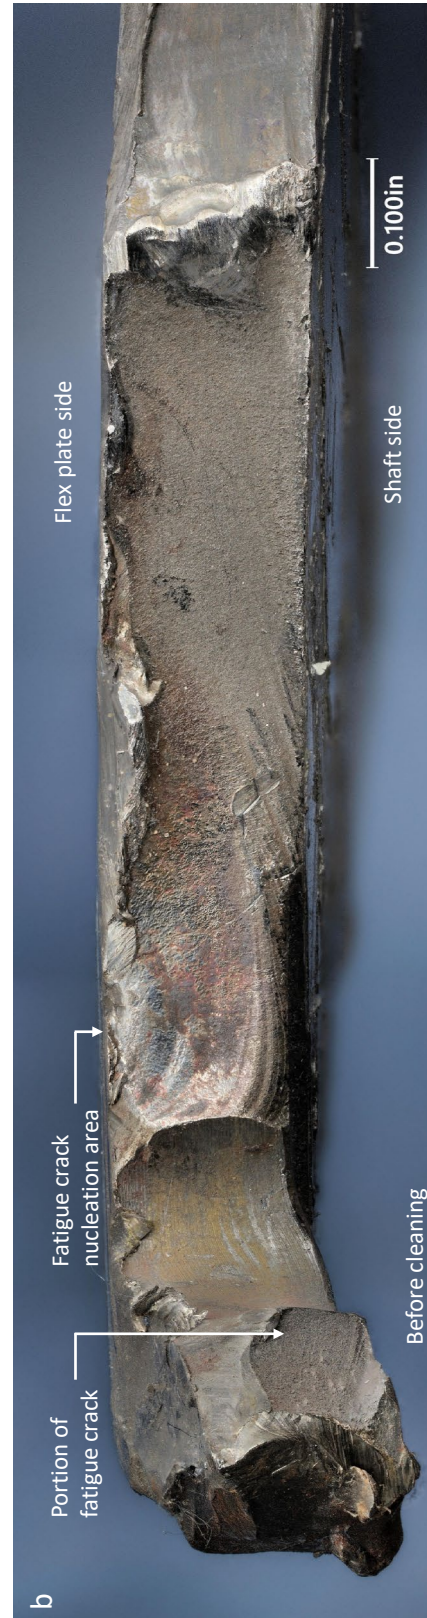
Figure 9 As-received high-dynamic range digital microscope images of the fracture surfaces on the fractured lug of the forward clutch shaft yoke with key features annotated. View a shows the fracture surfaces on the separated lug piece with origin areas annotated. View b shows the fracture surfaces on the main lug with origin area annotated.

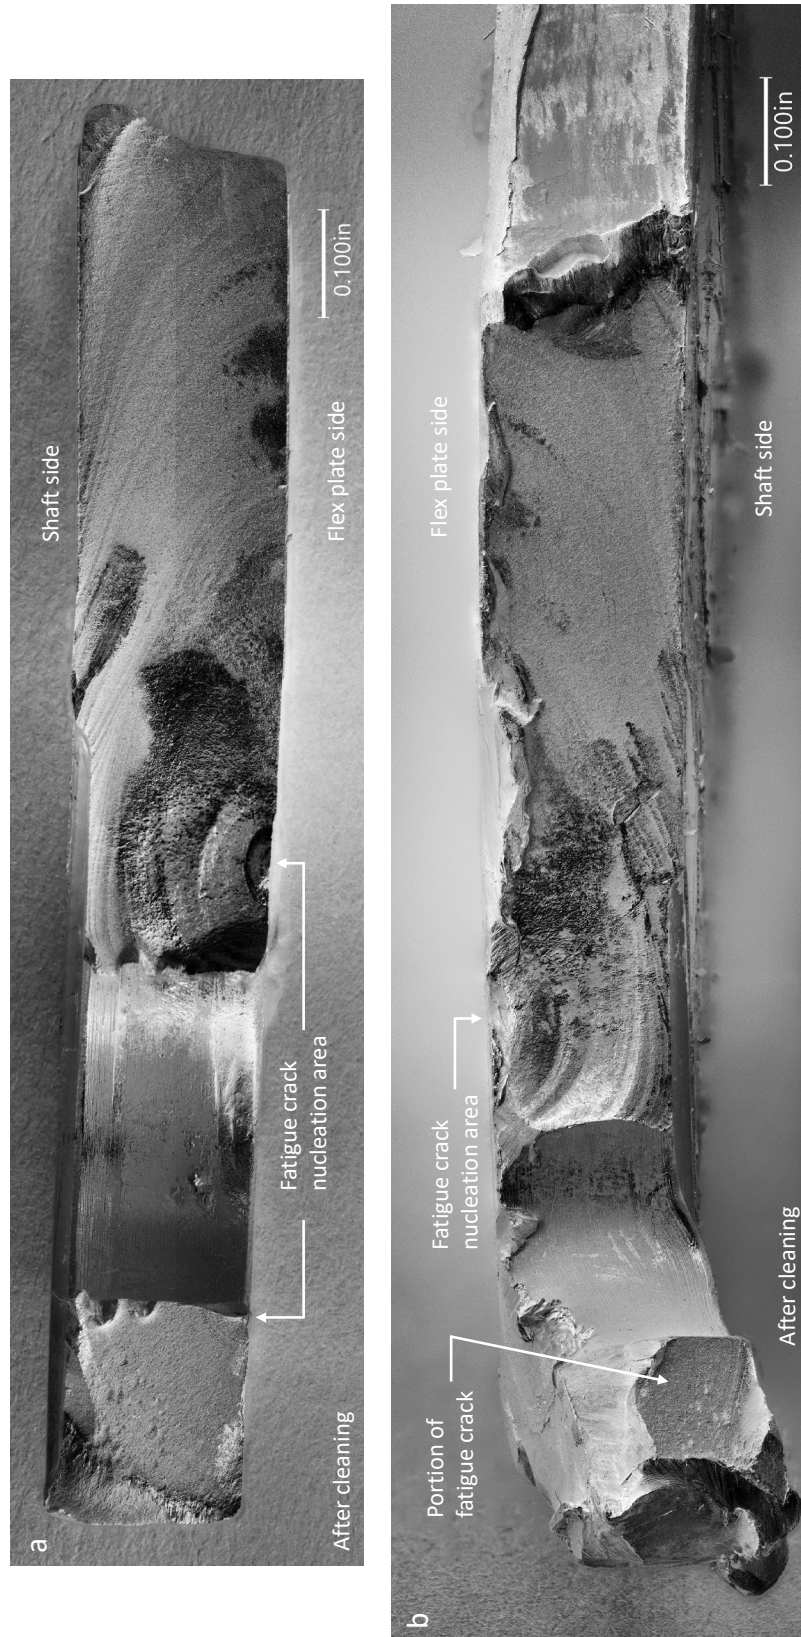
Figure 10 Acetone-cleaned monochromatic digital microscope images of the fracture surfaces on the fractured lug of the forward clutch shaft yoke with key features annotated. View a shows the fracture surfaces on the separated lug piece with origin areas annotated. View b shows the fracture surfaces on the main lug with origin area annotated.

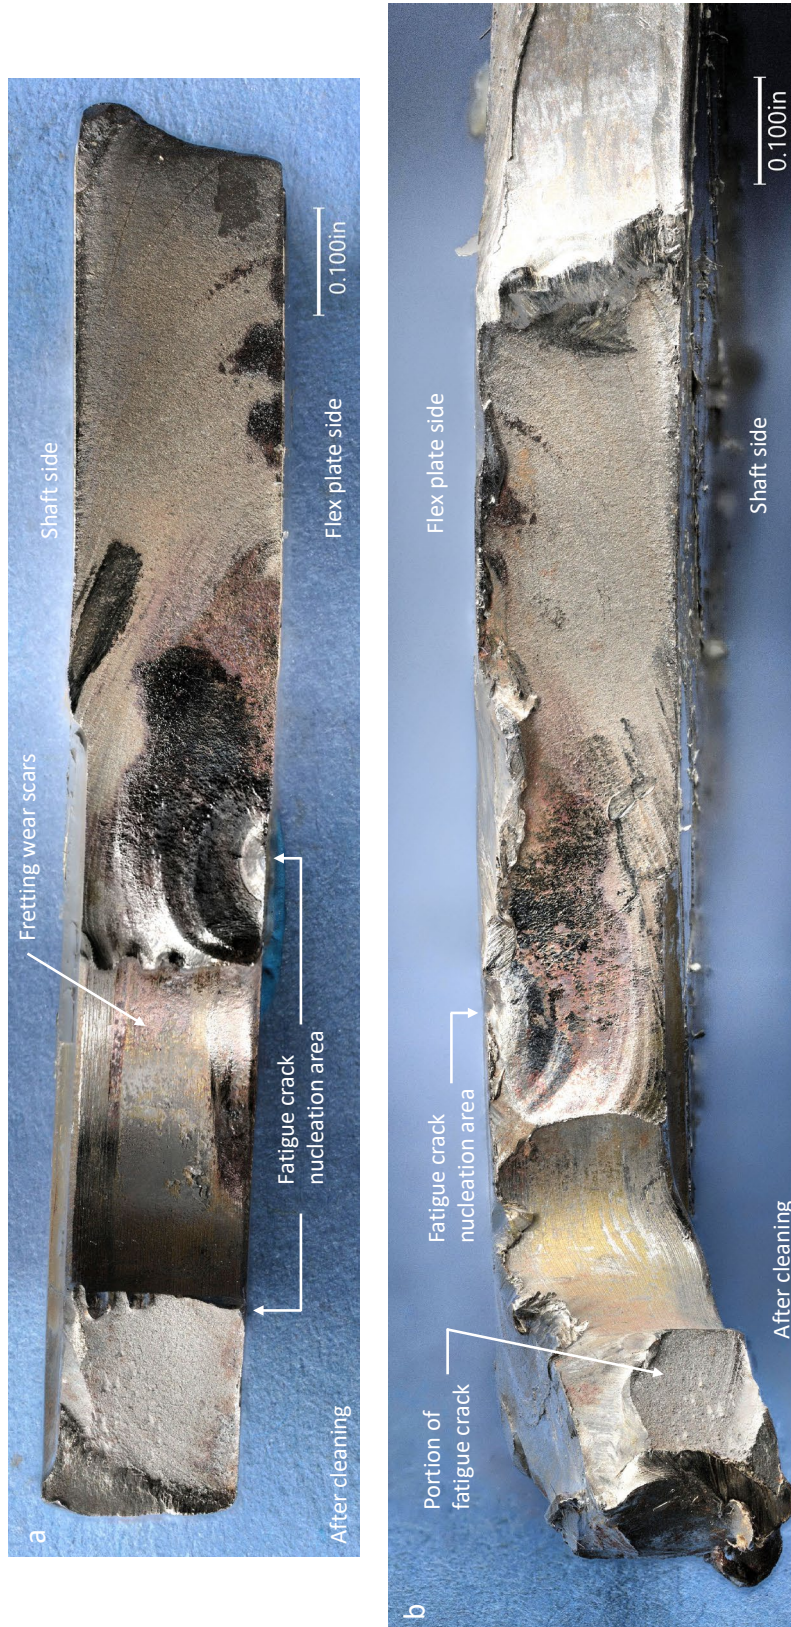
Figure 11 Acetone-cleaned high-dynamic range digital microscope images of the fracture surfaces on the fractured lug of the forward clutch shaft yoke with key features annotated. View a shows the fracture surfaces on the separated lug piece with origin areas annotated. View b shows the fracture surfaces on the main lug with origin area annotated.

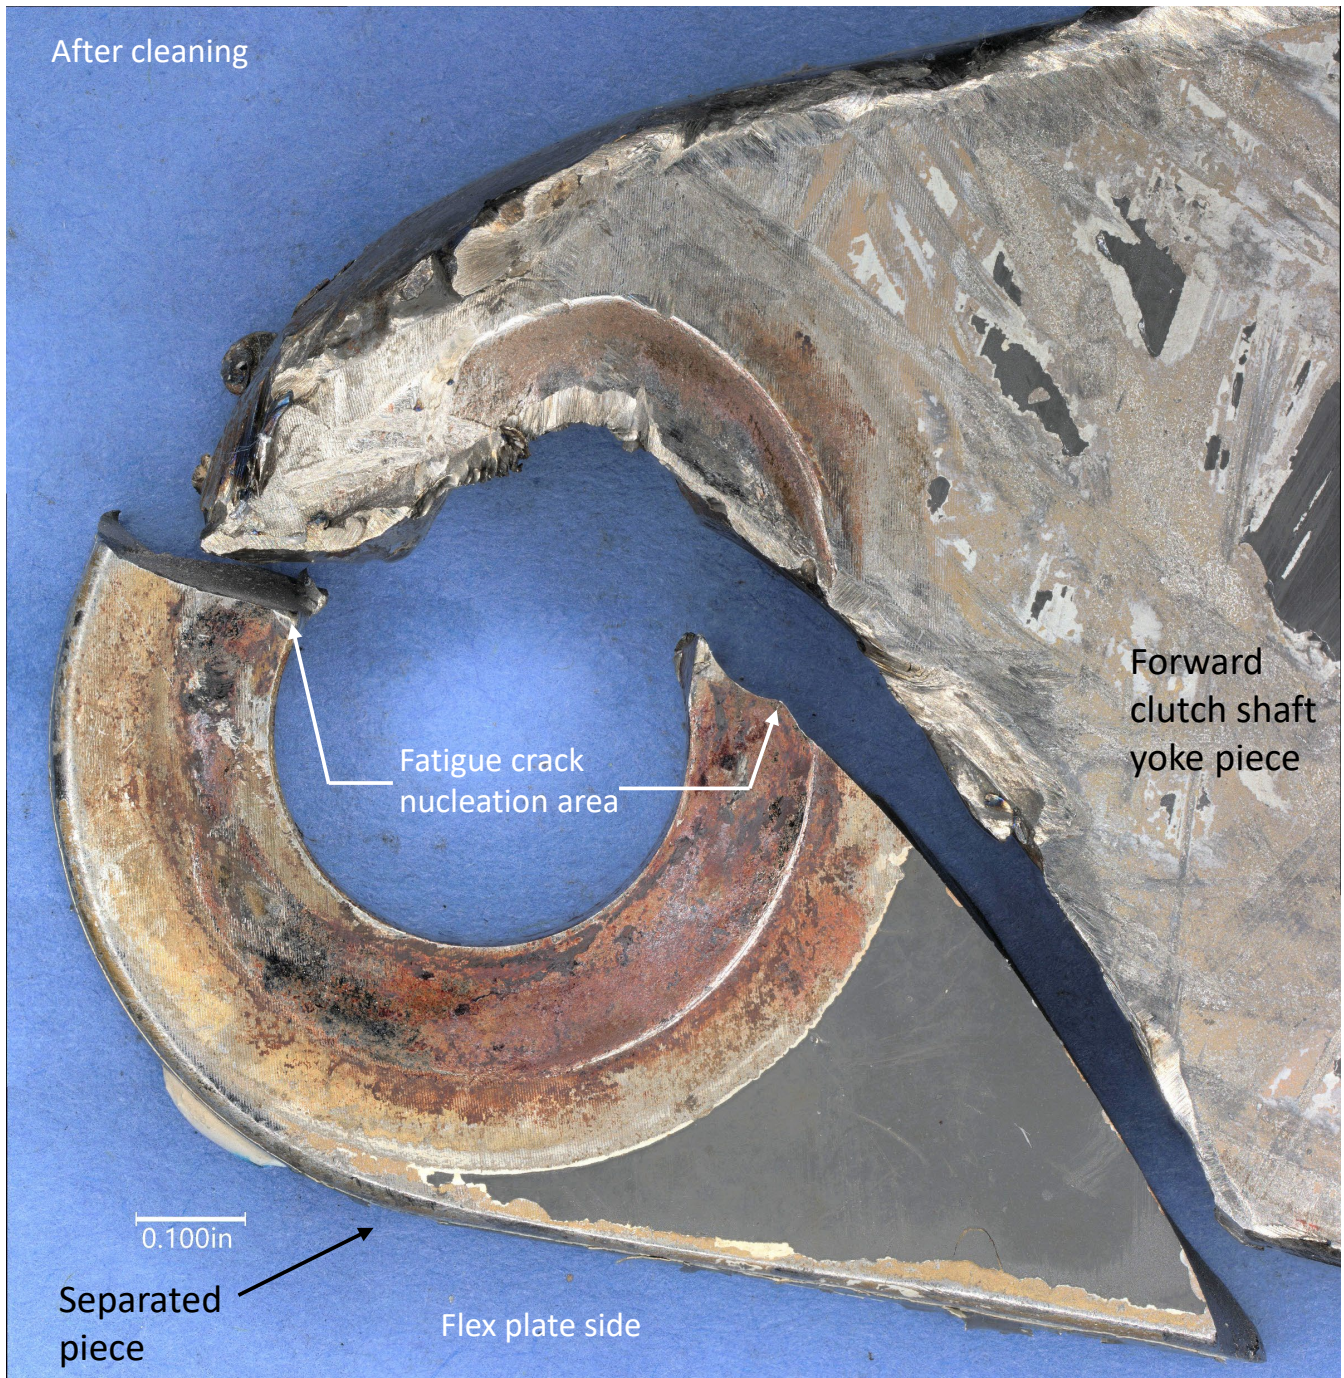
Figure 12 Close view of the fractured lug on the forward clutch shaft yoke with the fatigue crack nucleation areas annotated.

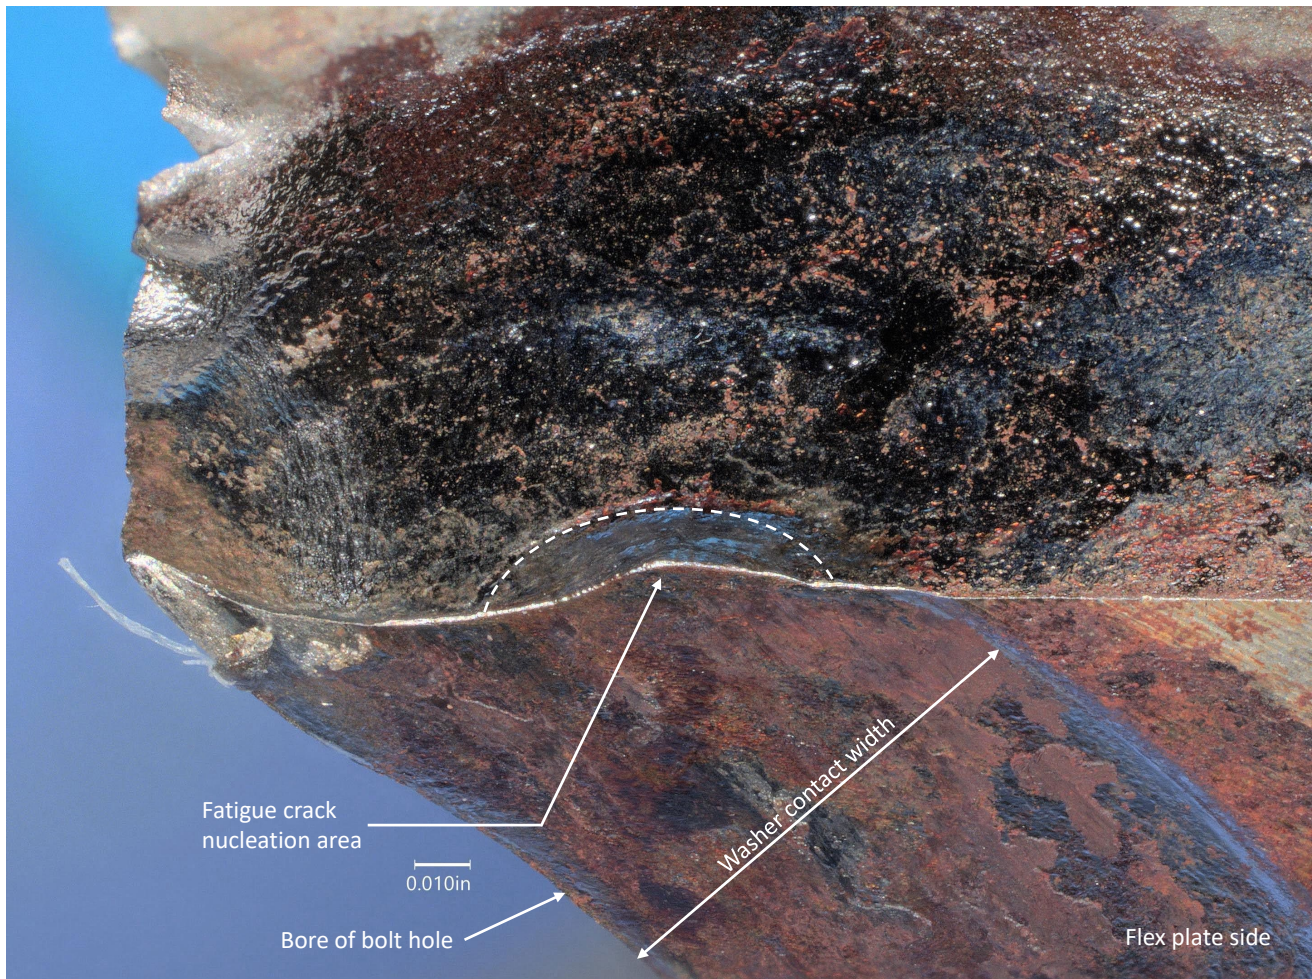
Figure 13 Oblique close view of the fracture surface on the separated piece of lug on the forward clutch shaft yoke with the fatigue crack nucleation area annotated.

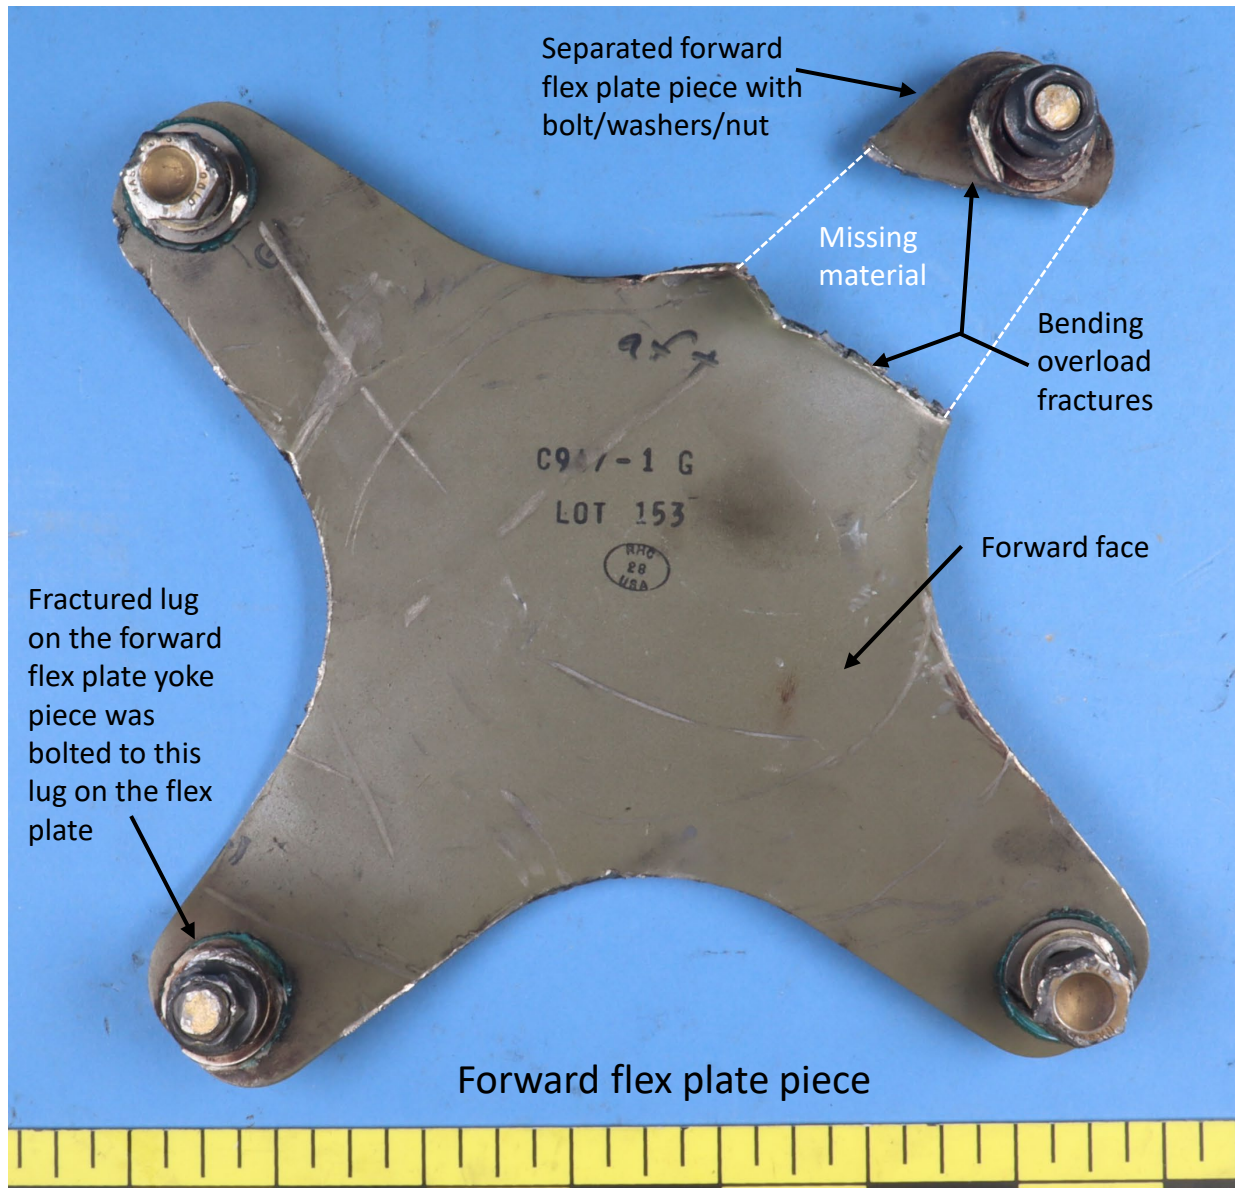
Details of the damage on the flex plate are annotated in Figure 14. Identified in the figure, one of the lugs was separated from the flex plate and additional unrecovered material was also separated. The fracture surfaces at the points of separation reveal features consistent with bending overstress fracture. The bolt, nut, and washers used at the fractured end of the lug on the forward clutch shaft yoke are identified in the figure. The washers and nut exhibited battering damage. The nut was tight on the bolt, consistent with being in the as-assembled (pre-incident) condition. Due to the damage to the bolt/washers/nut assembly, no indications of fretting wear were noted. Overall, the flex plate exhibited bending and twisting deformation at the lugs.

Figure 14 Image of the forward flex plate pieces with key observations annotated.
