ERA22LA258

## INVESTIGATION PHOTOGRAPHS

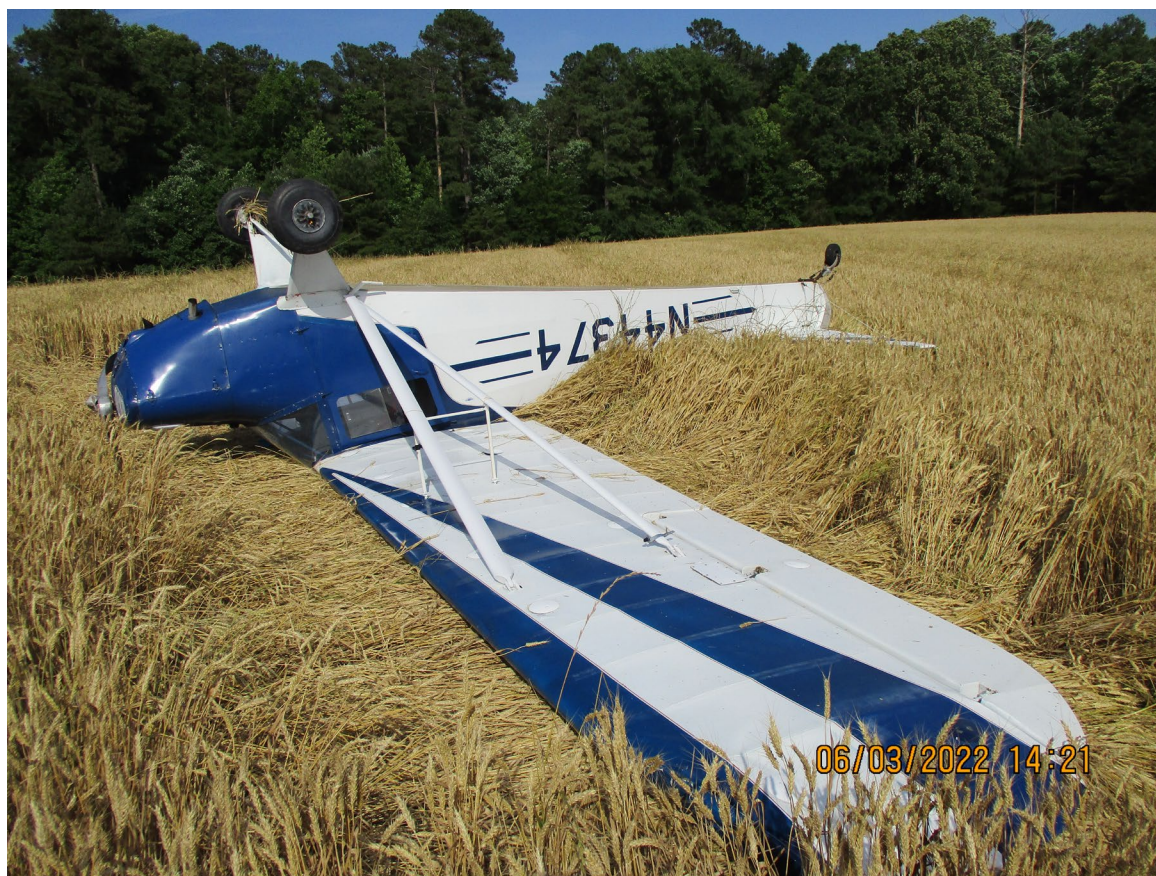
**Photograph 1 - View of the airplane inverted where it came to rest. (Courtesy of FAA)**

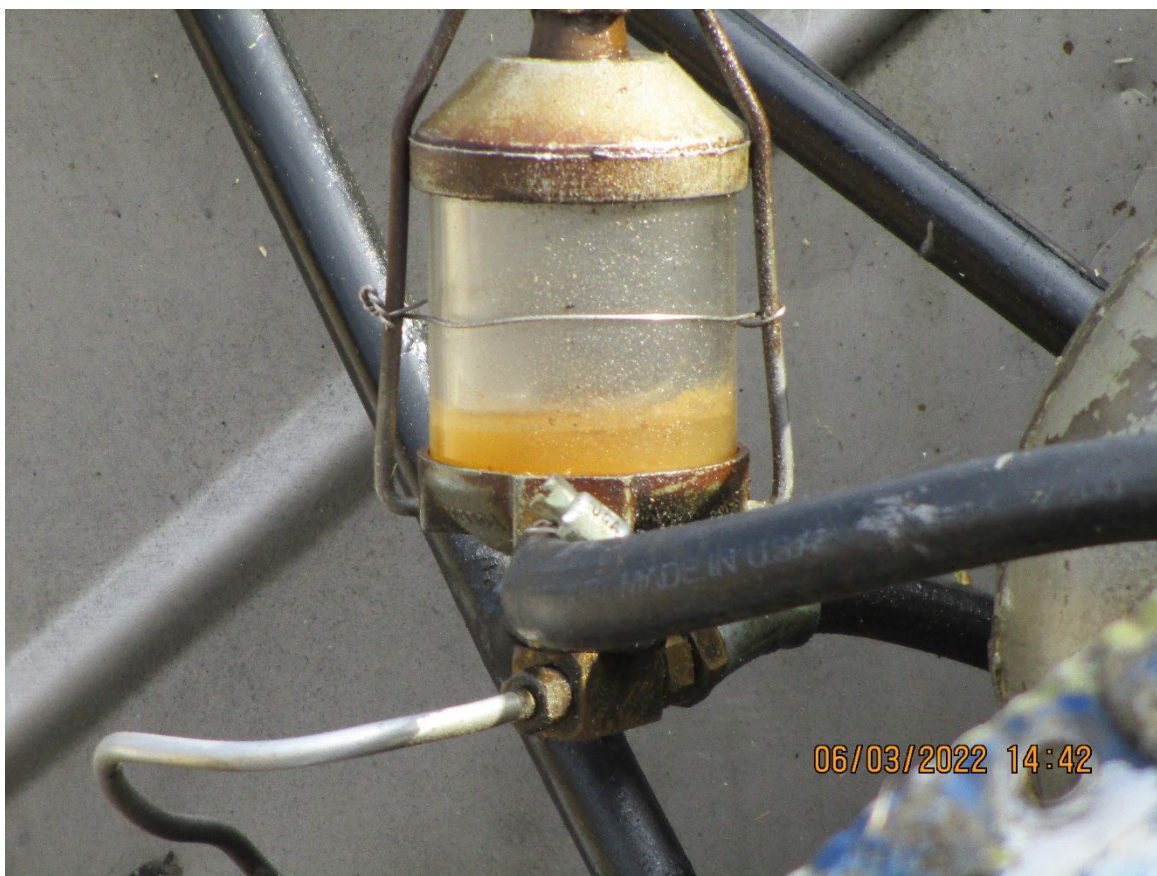
**Photograph 2 - View of the gascolator. (Courtesy of FAA)**

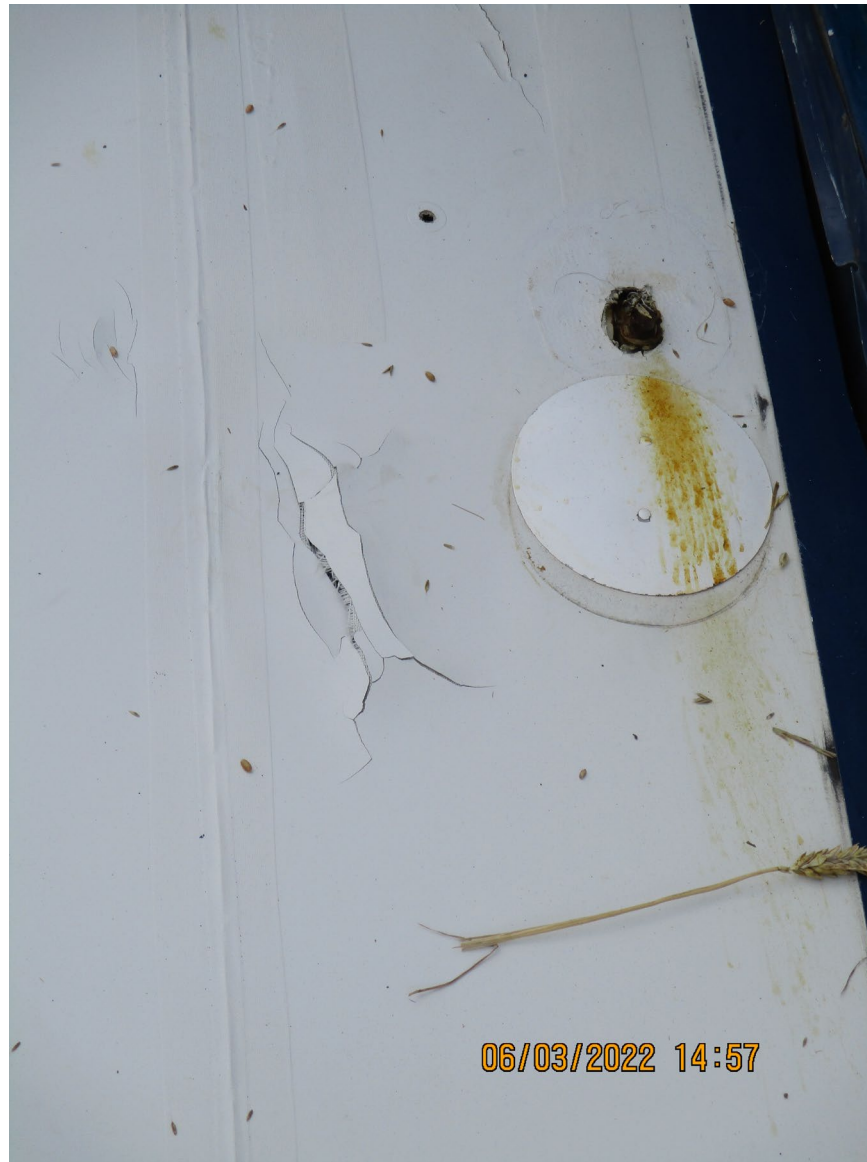
**Photograph 3 - View of staining aft of right wing fuel sump. (Courtesy of FAA)**
