## AIRFRAME AND ENGINE EXAMINATION REPORT

NTSB ACCIDENT NUMBER: ERA22LA266

AIRCRAFT REGISTRATION: N9577L

ACCIDENT LOCATION: Sarasota, FL

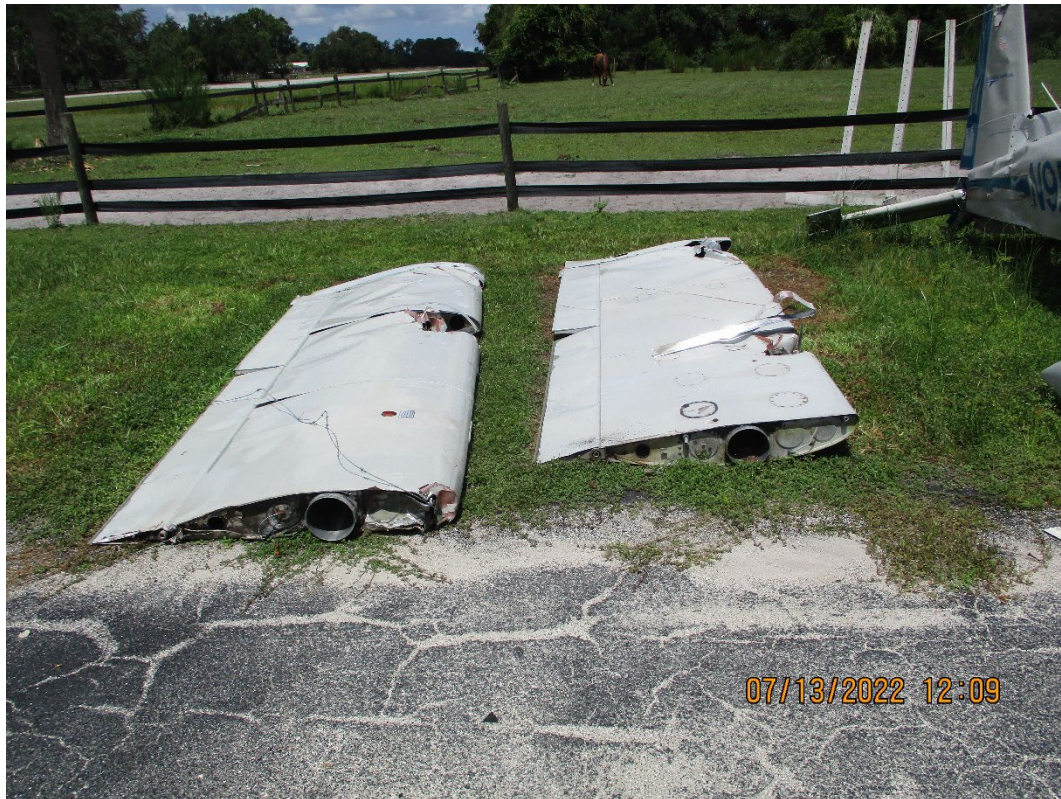
The initial examination revealed that the aircraft wings were removed and laying on the ground beside the fuselage, both wings had impact damage from possible fence post. The flaps and ailerons remained attached to the wings and were not damaged.

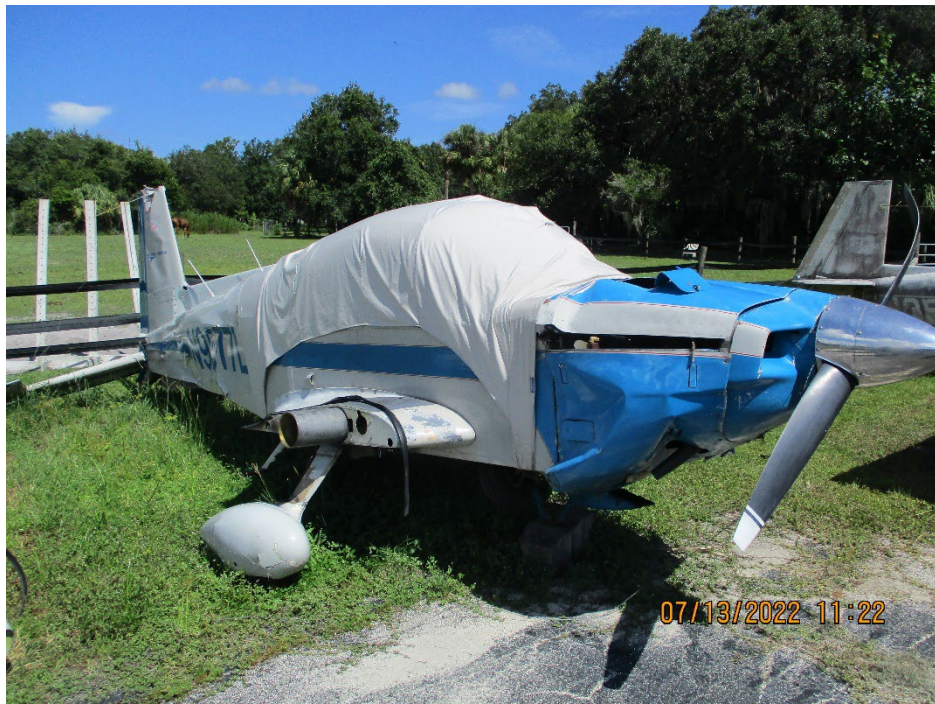
The tail section was wrinkled, and the elevator was partially fractured off. The nose gear was bent backwards, and one propeller blade was bent aft.

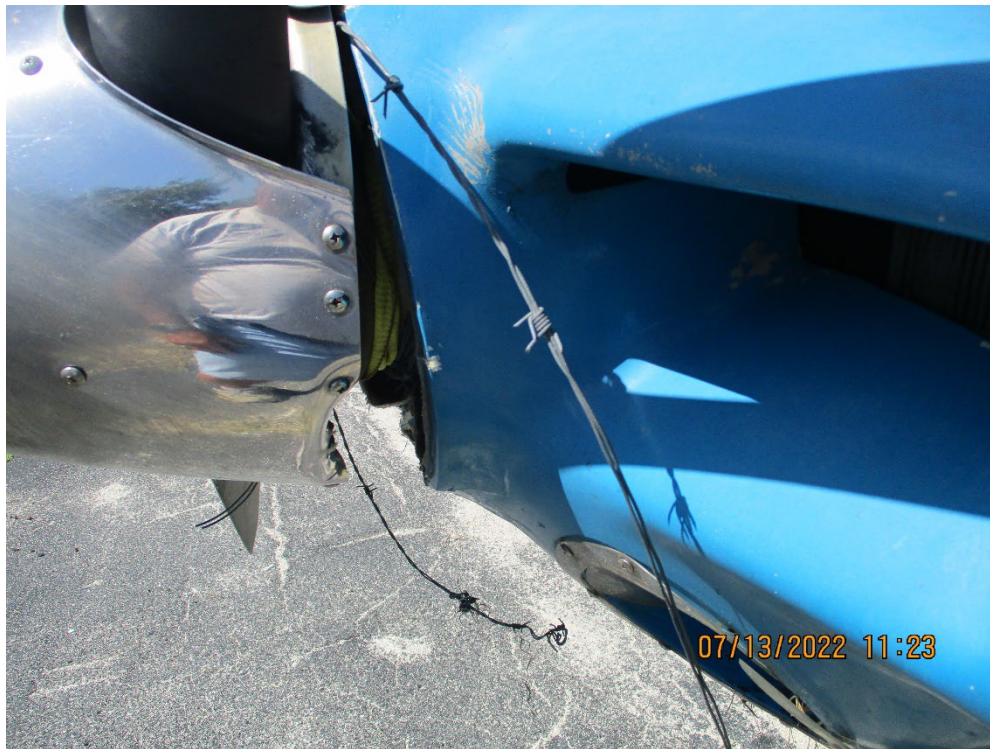
There was barbed wire wrapped around the propeller flange.

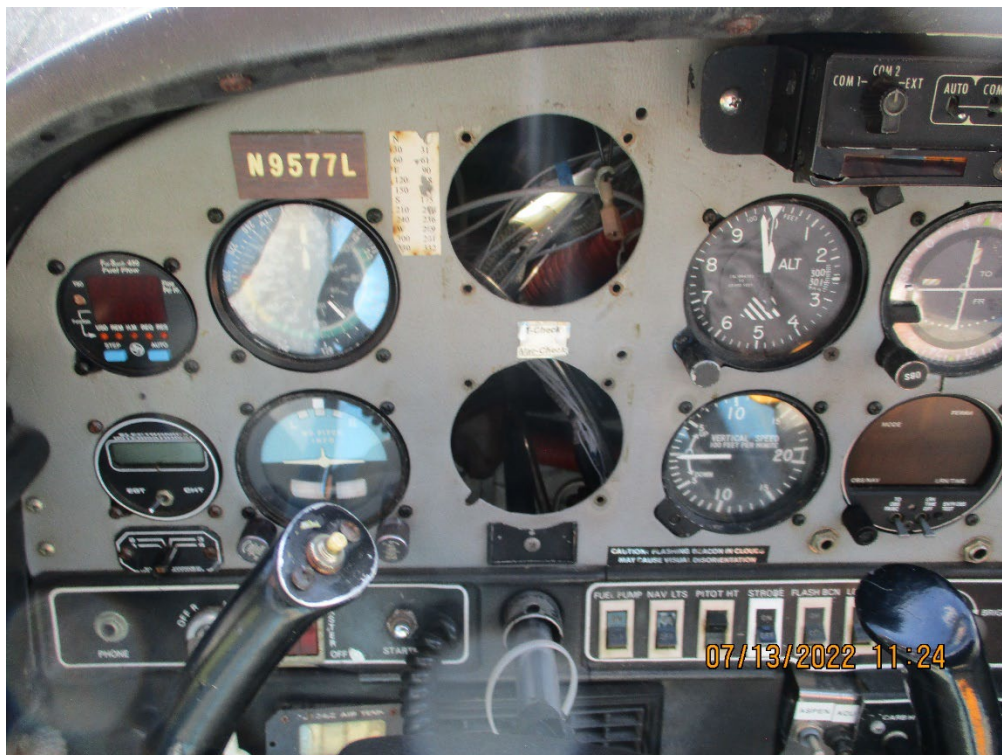
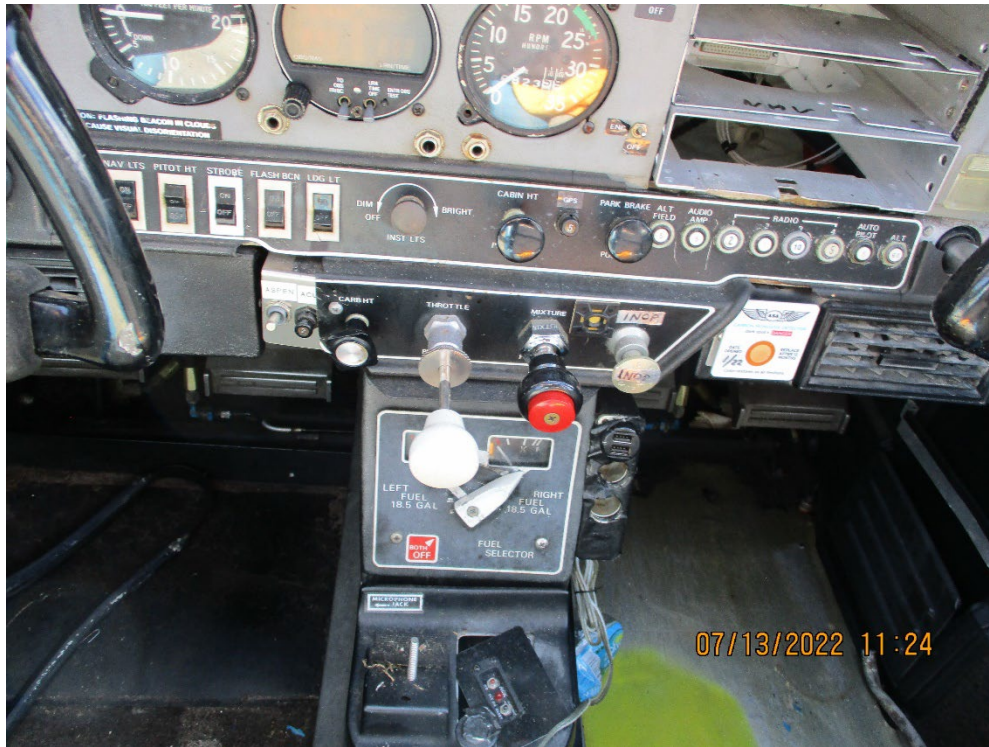
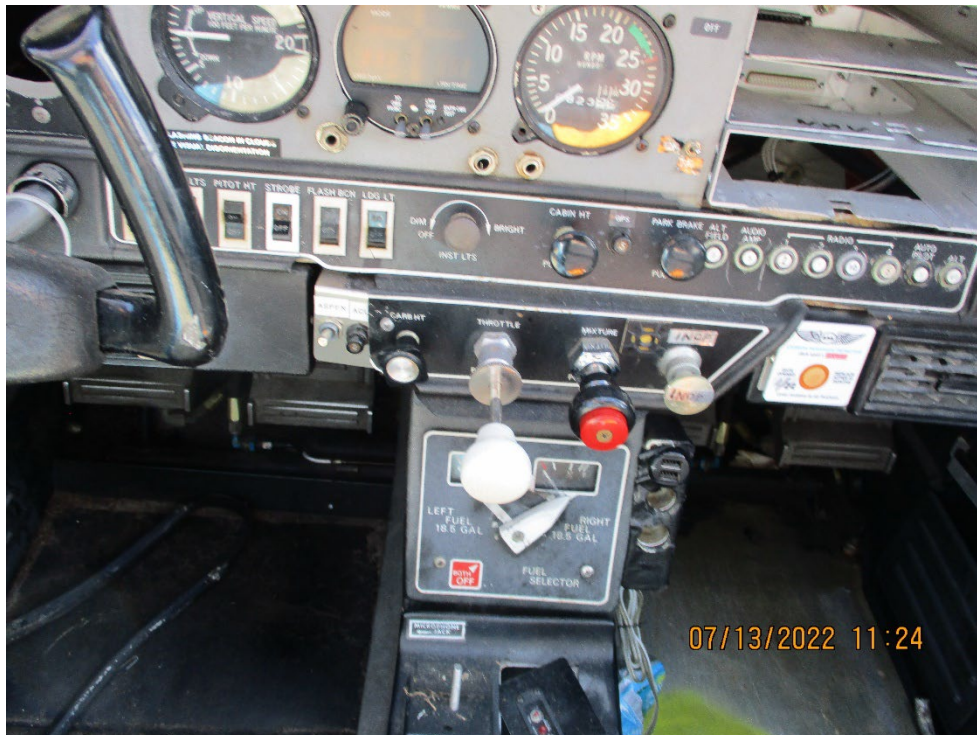
The instrument panel was missing several instruments and radios.

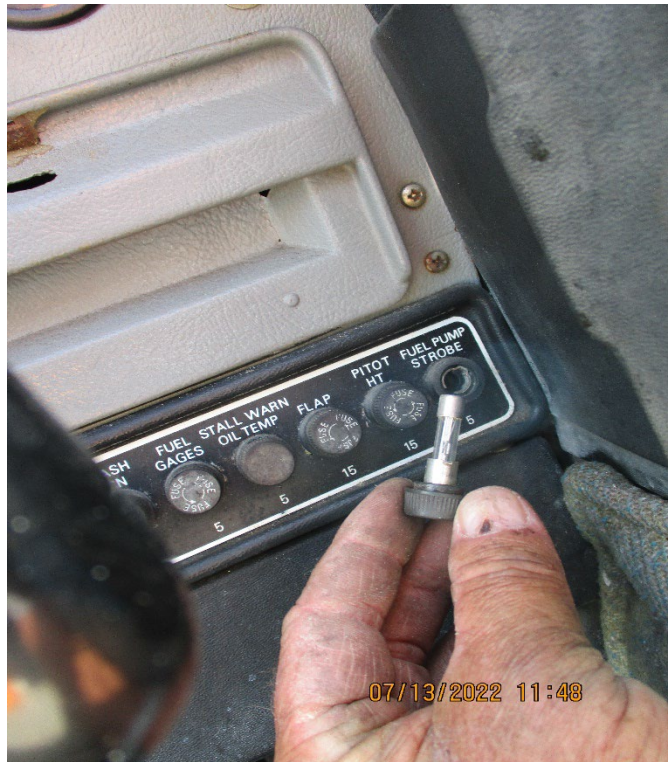
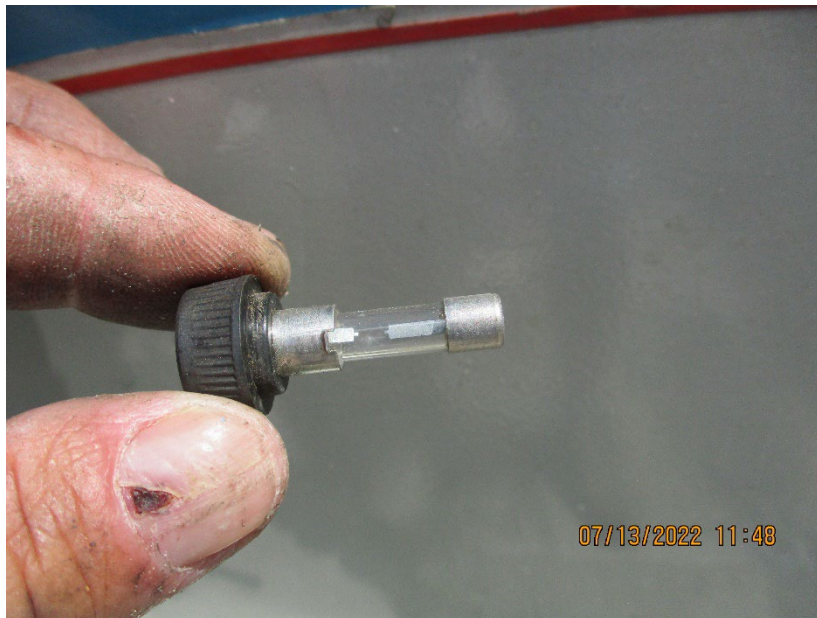
The battery and avionics switch was turned on. When the electric fuel pump was turned on, it did not operate. Troubleshooting of the fuel pump revealed that the 5 amp fuse was blown. The fuse was replaced and the fuel pump worked normally.

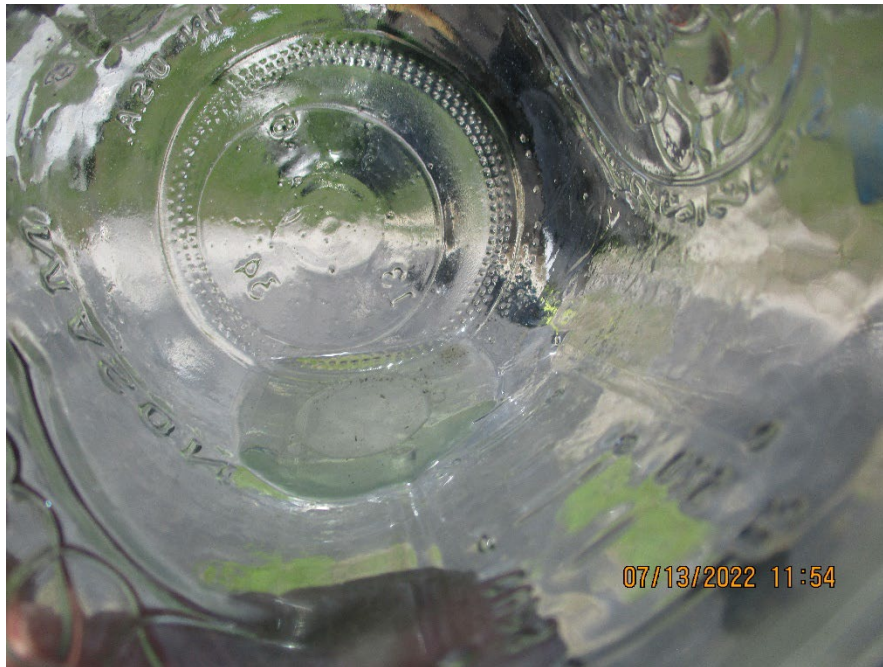
Fuel was drained from the carburetor, about two tablespoons of liquid came out of the drain plug. One tablespoon looked like auto fuel, and one tablespoon was water.

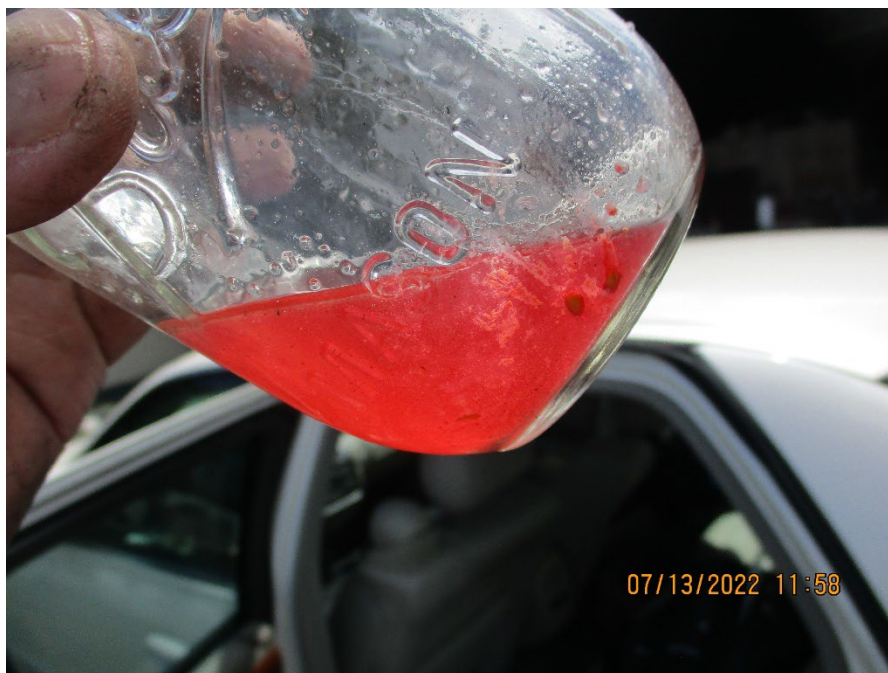
Fuel was drained from the right wing fuel tank. It appeared to be mostly water in the fuel tank. When Kolor Kut water paste was used to test for water, the entire jar turned red indicating all water. The left wing fuel tank was empty and dry.
