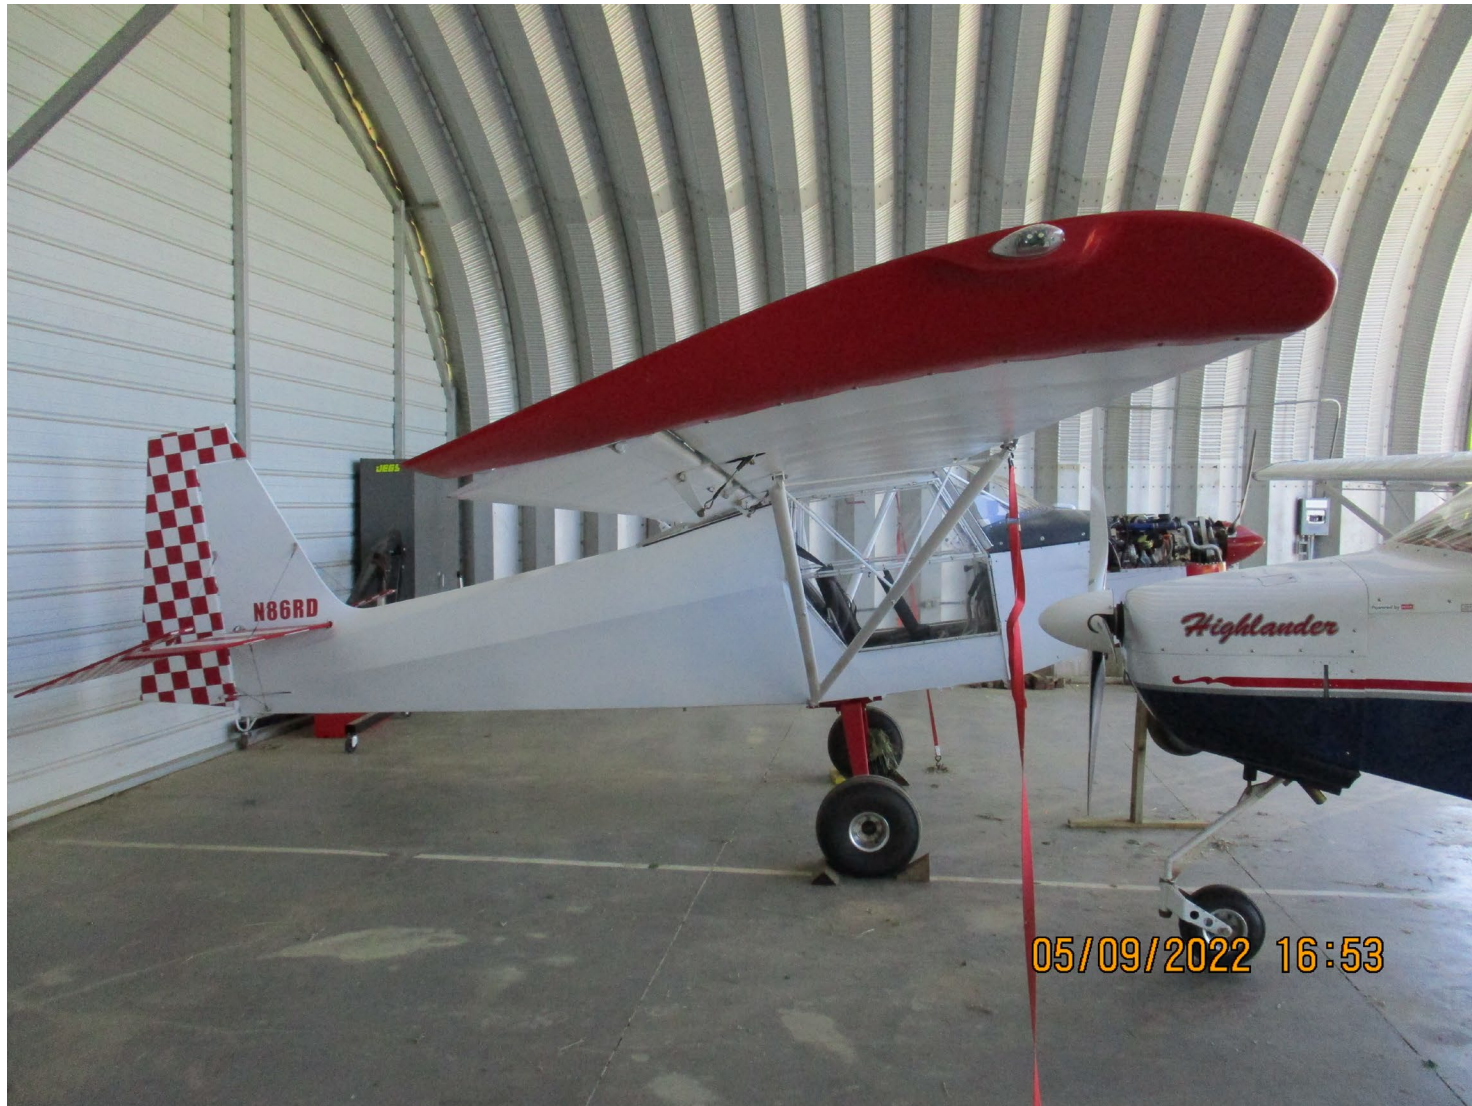
**Photo 1 – Right profile view of airplane. (Courtesy of FAA)**

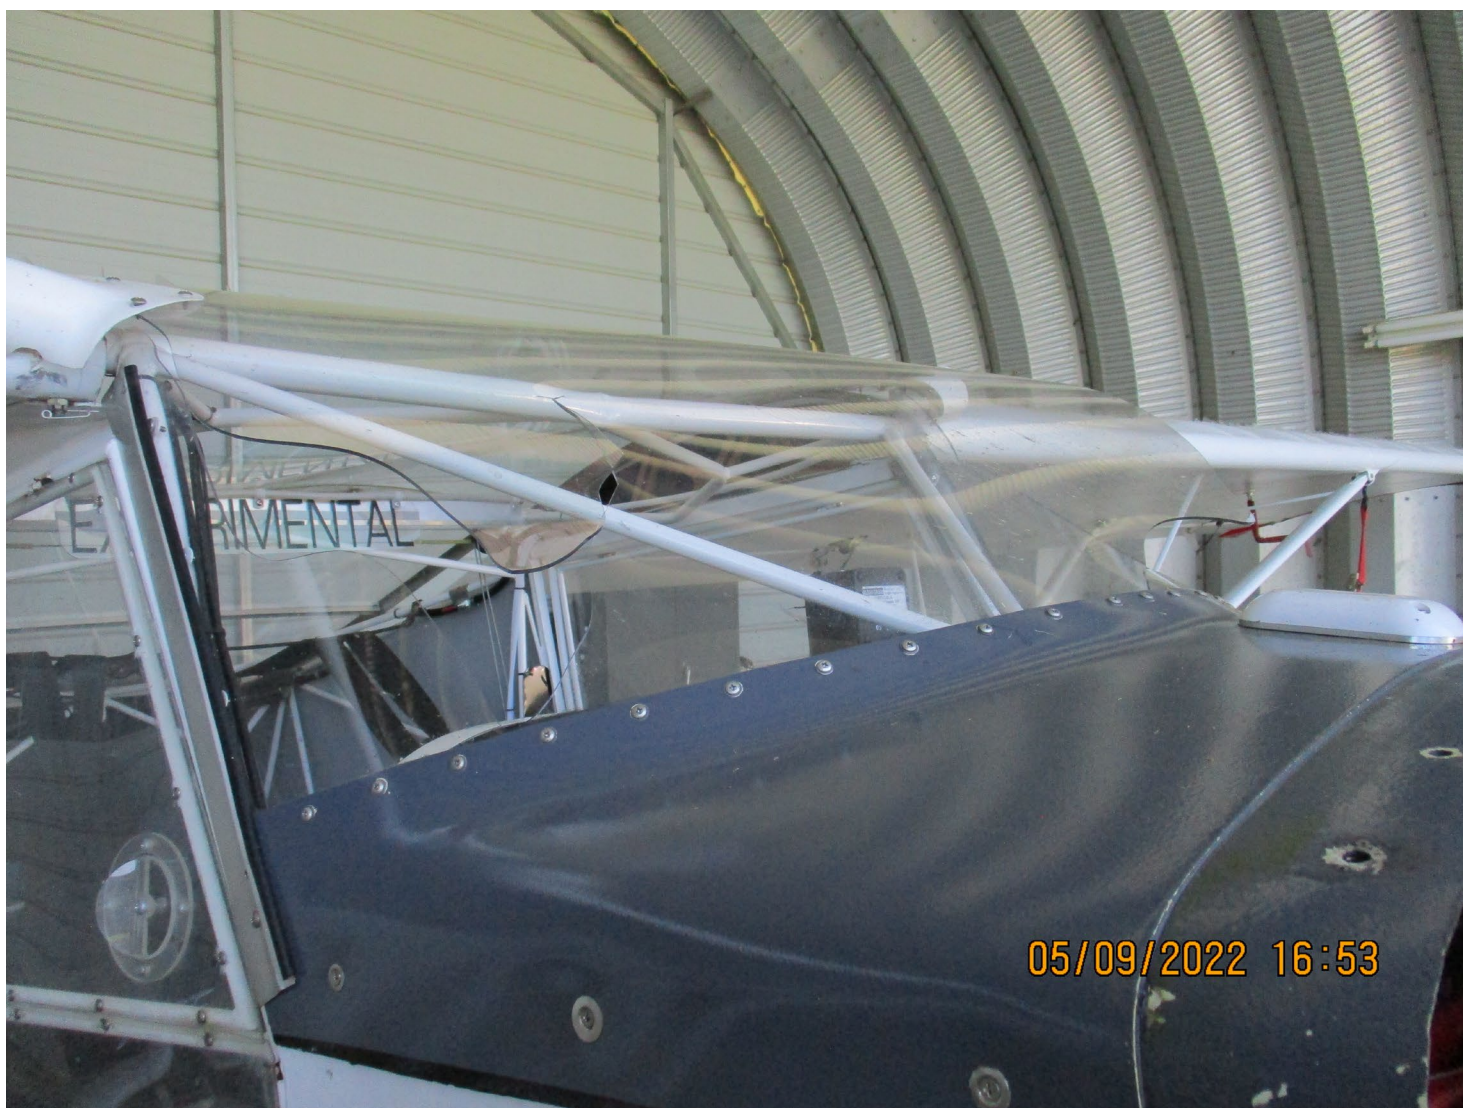
**Photo 2 – Front windscreen and airframe damage (Courtesy of FAA)**

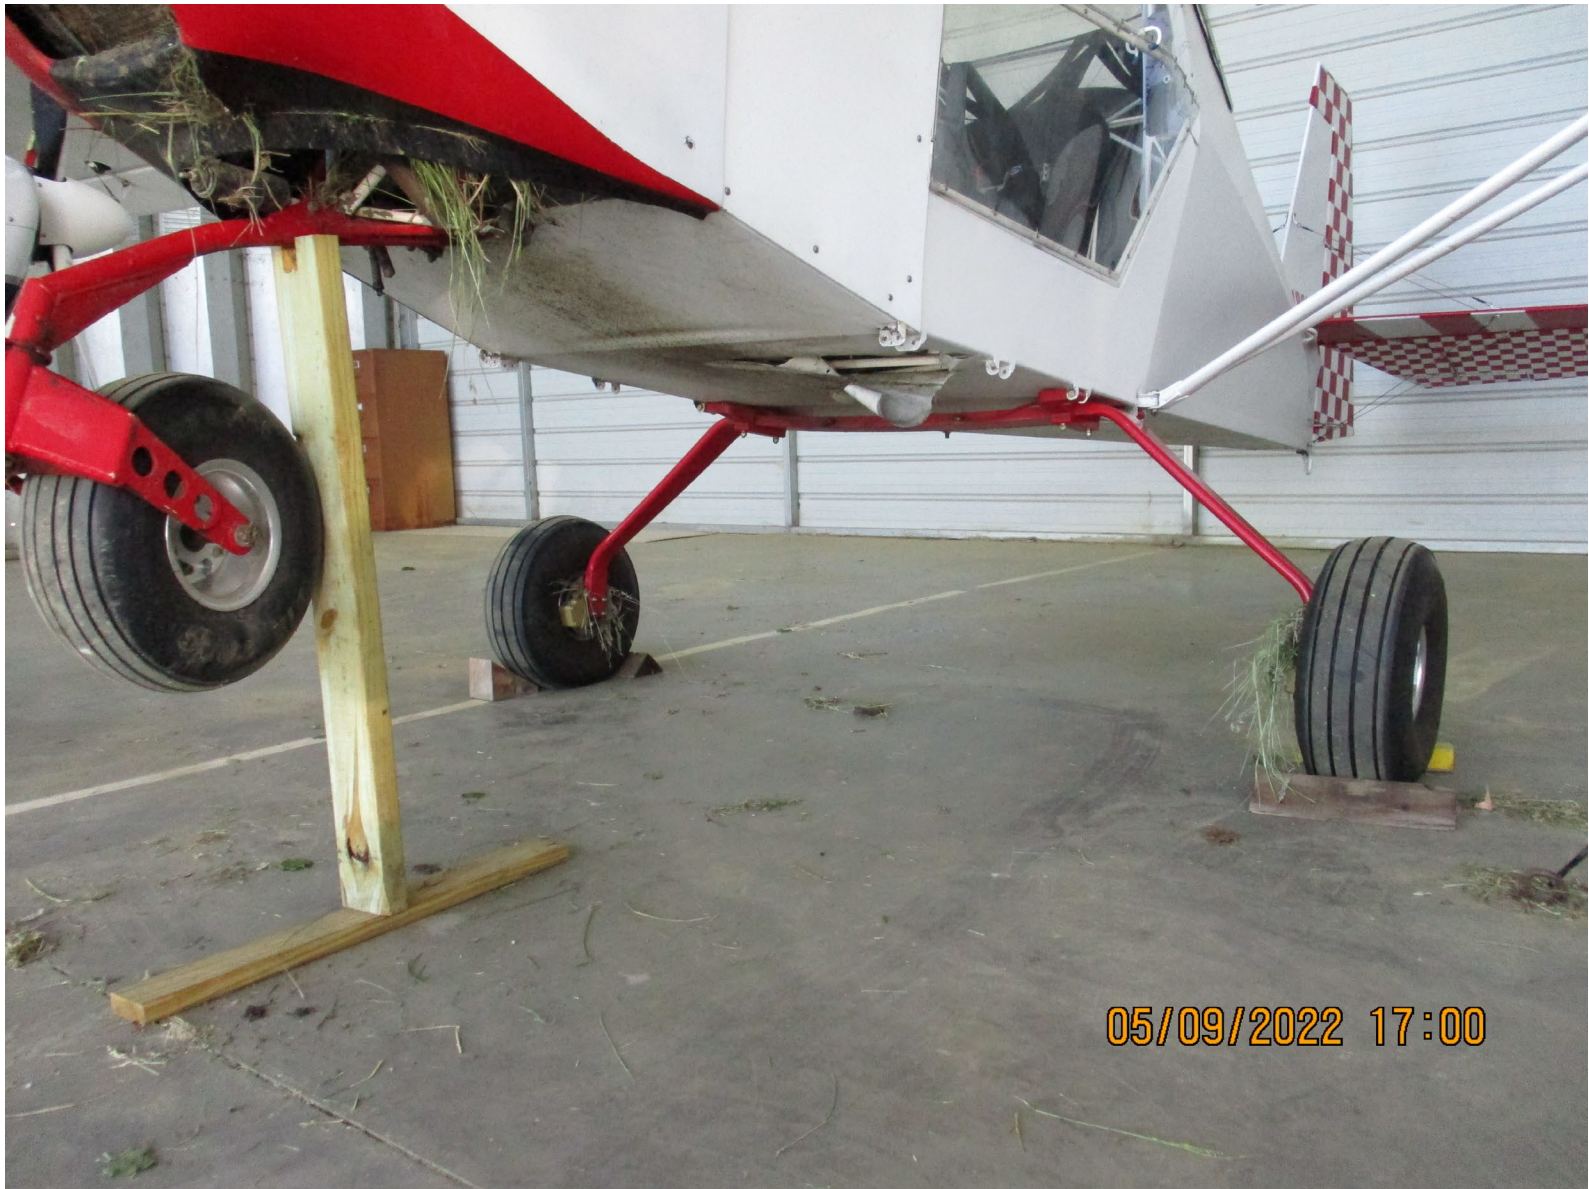
**Photo 3 – View of nose landing gear and fuselage damage. (Courtesy of FAA)**

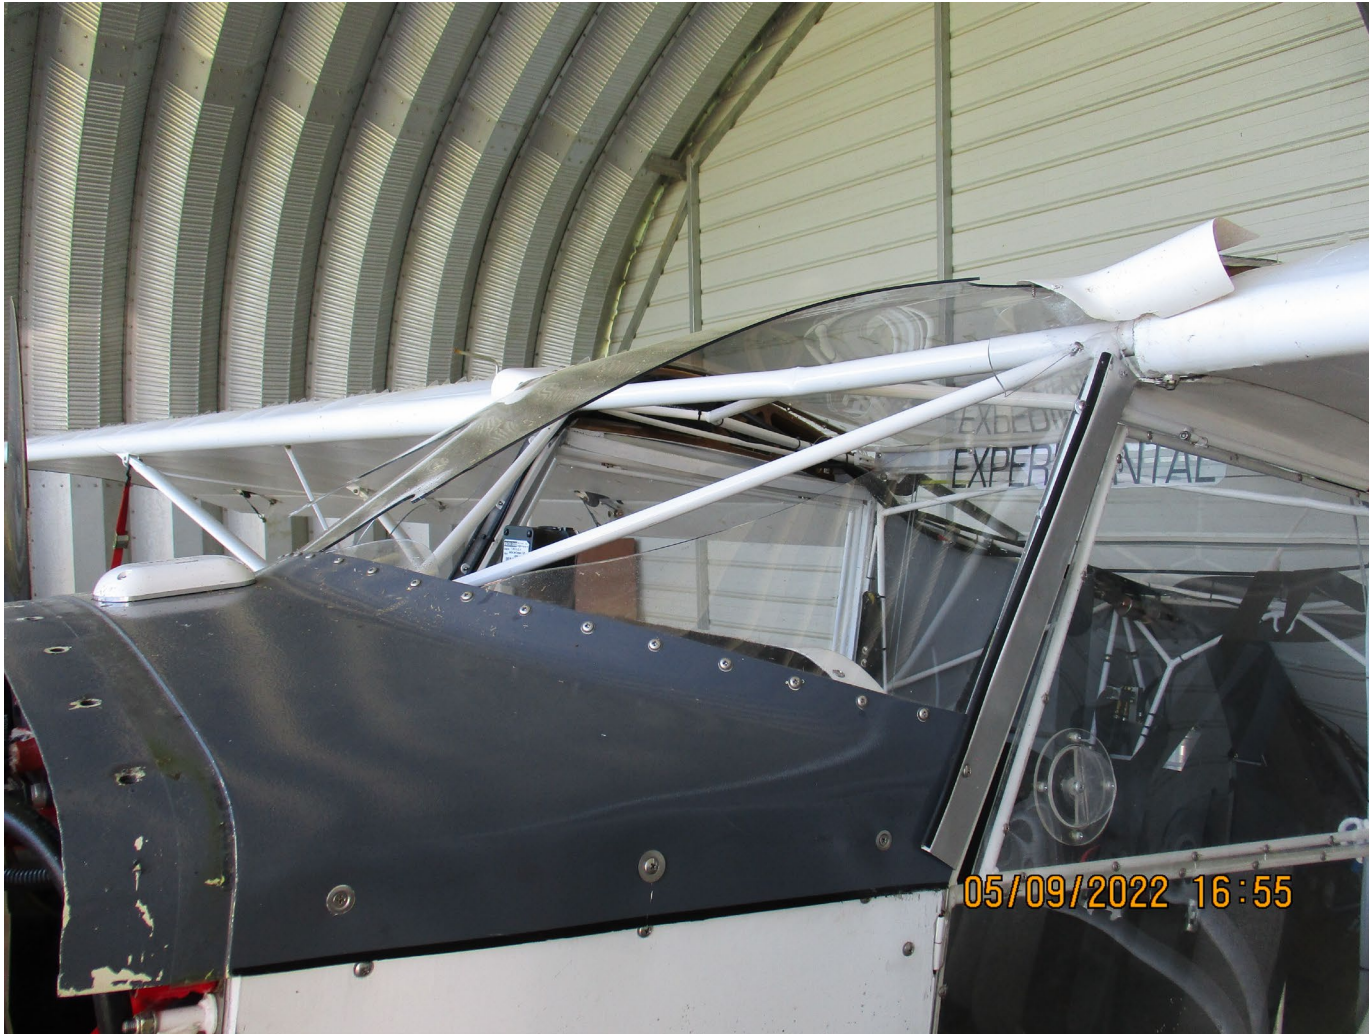
**Photo 4 – Interior cockpit damage to the “head-rack” airframe structure between the wings. (Courtesy of FAA)**

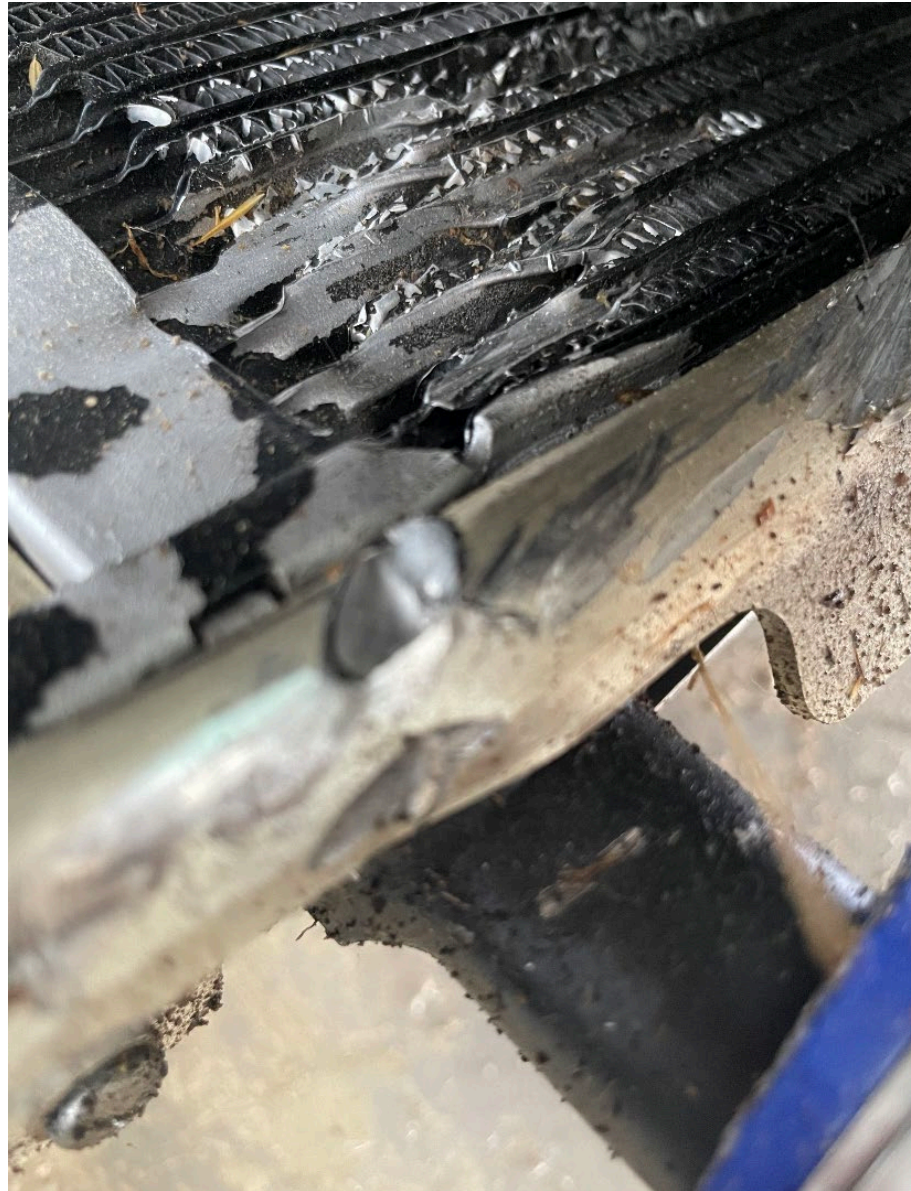
**Photo 5 – Damaged radiator. Impact damage from drive flange parts. (Courtesy of FAA)**

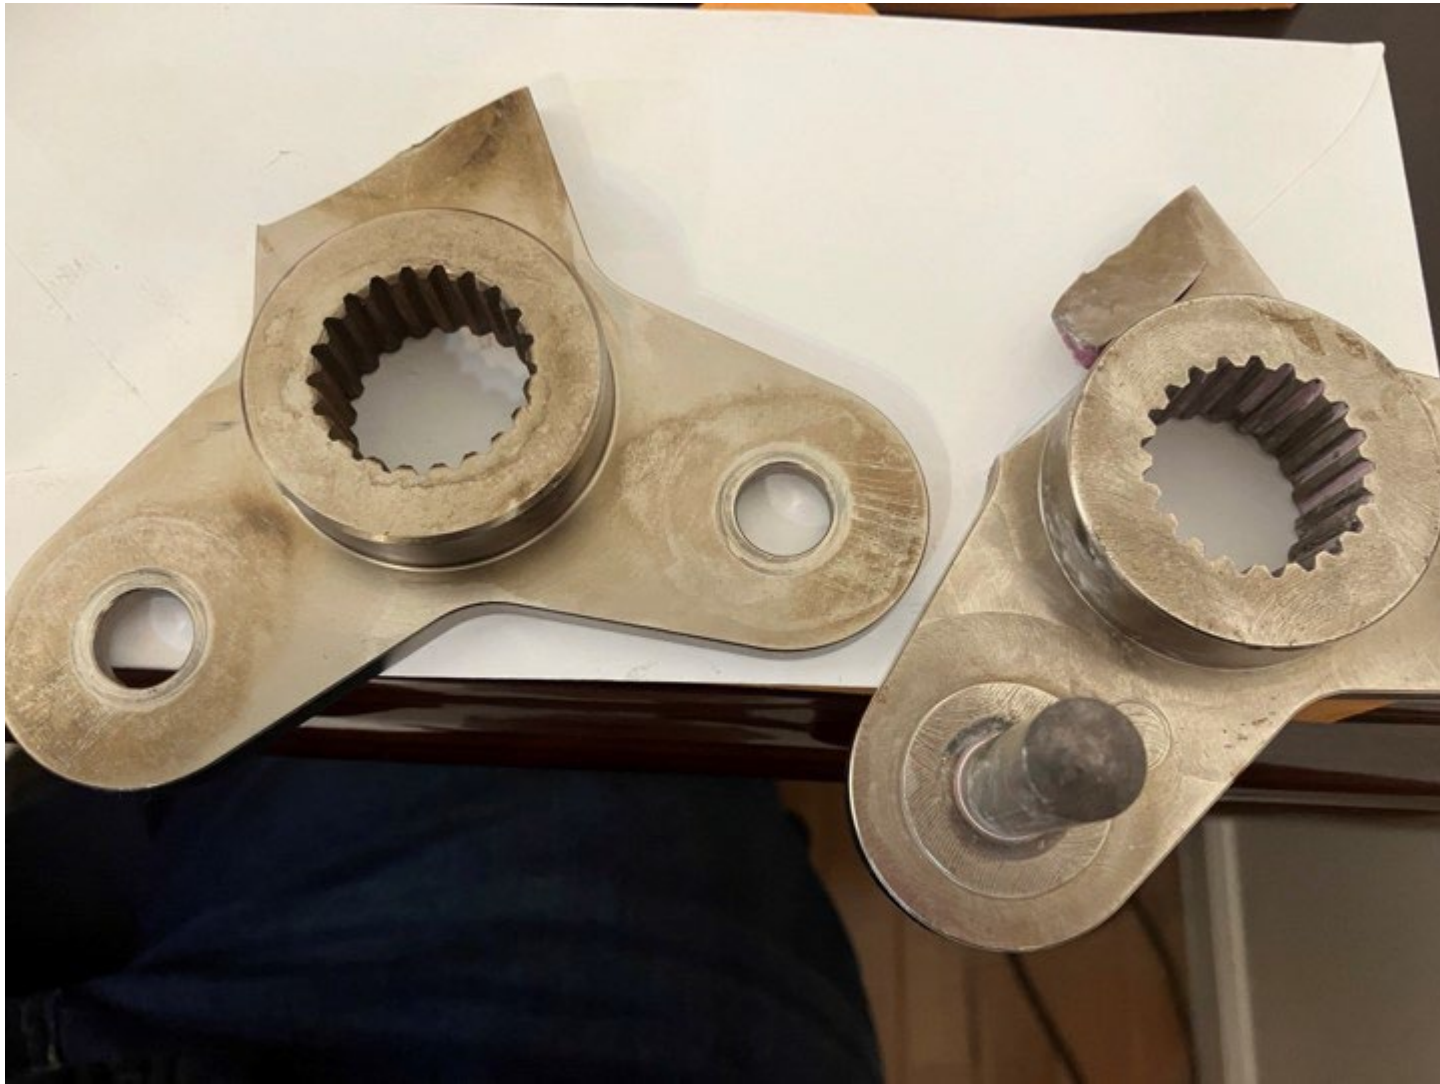
**Photo 6 – View of drive flange. The accident airplane drive flange is on the right. (Courtesy of Keith Olivier)**

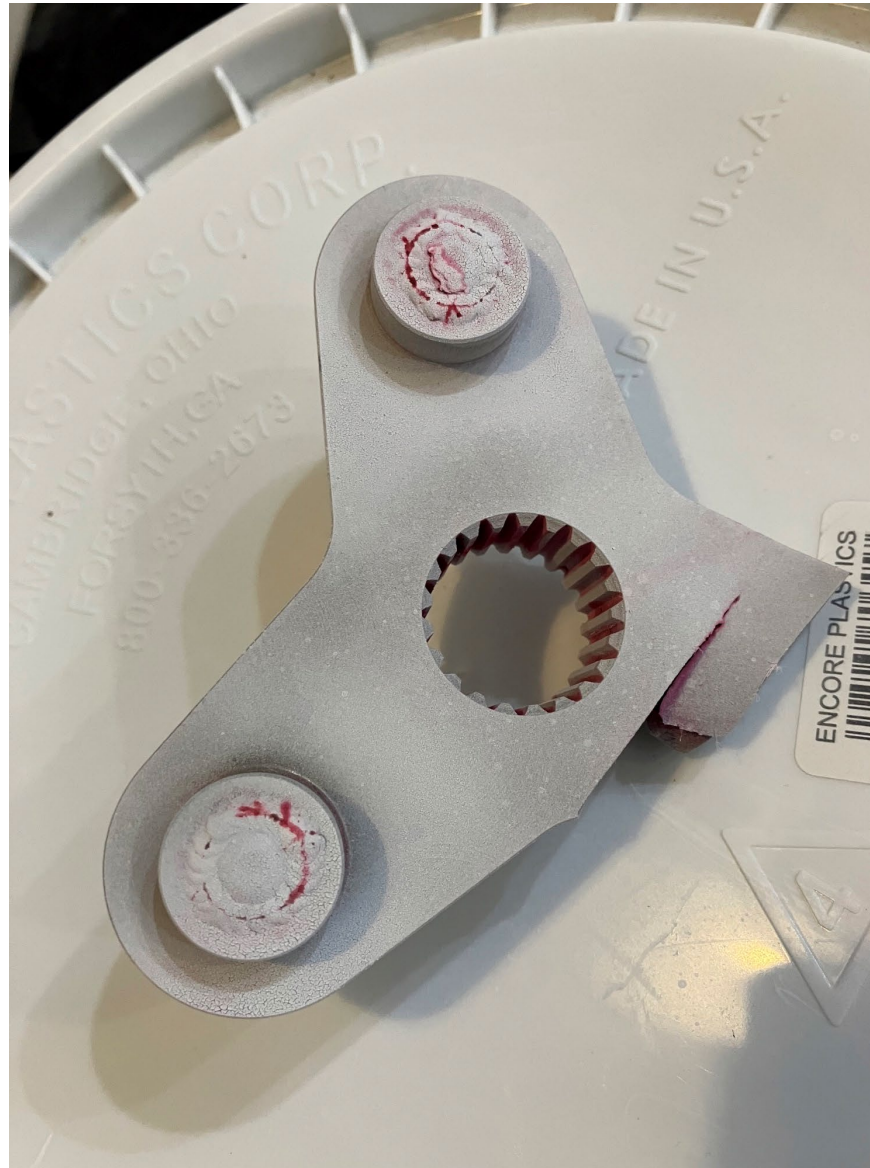
**Photo 7 – View of damaged drive flange after dye penetrant treatment. (Courtesy of Keith Olivier)**

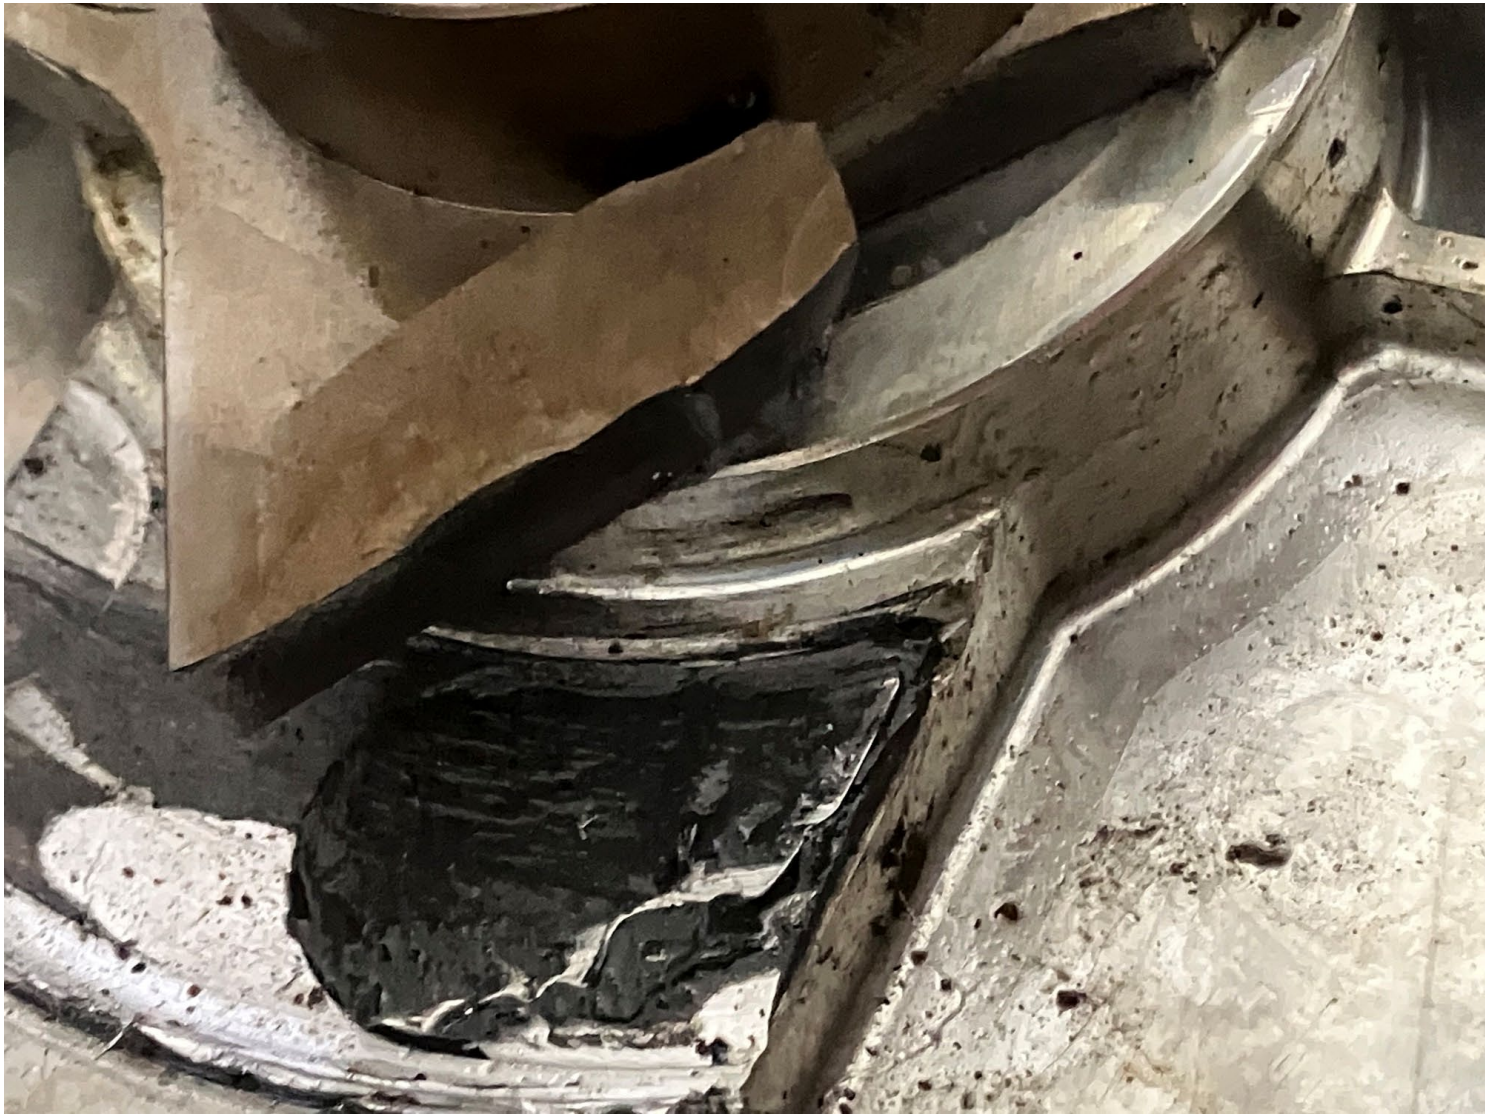
**Photo 8 – View of drive flange as installed on gearbox prior to removal. (Courtesy of Pilot/Owner)**
