## RECORD OF CONVERSATION

**Timothy W. Monville**  
**Sr. Air Safety Investigator**  
**Eastern Region**

**Date: July 8, 2022**  
**Person Contacted: Steven Burrill**  
**NTSB Accident Number: ERA22LA270**

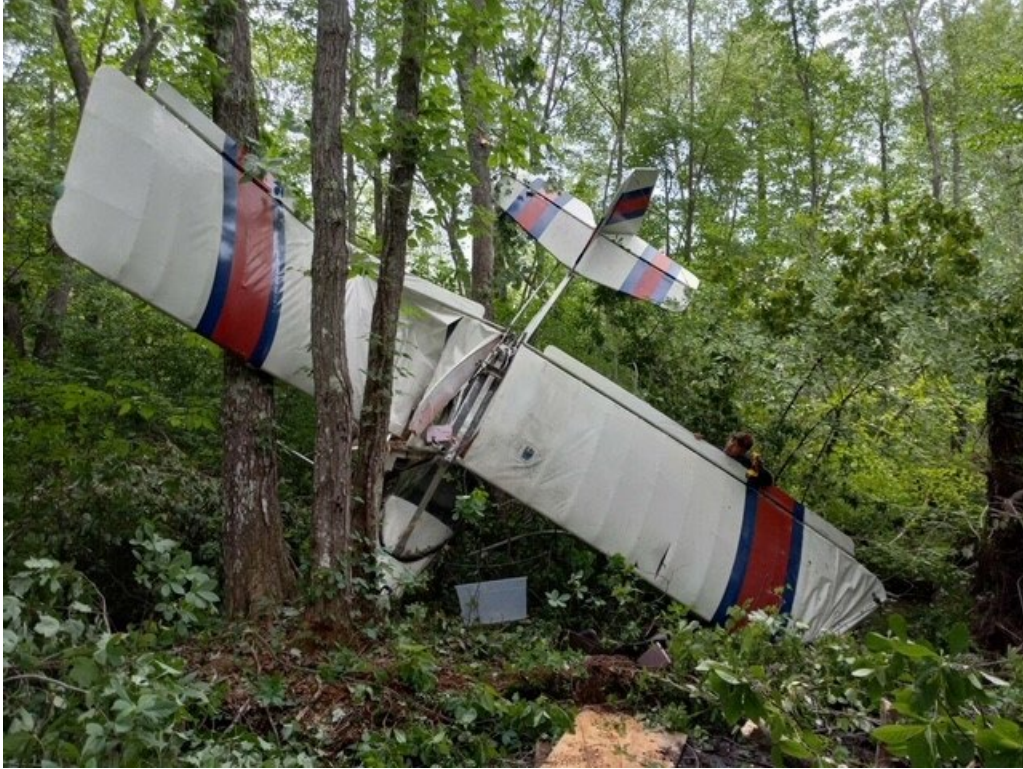
Figure 1: Digital Photograph From Owner. View of the airplane at the accident Site.

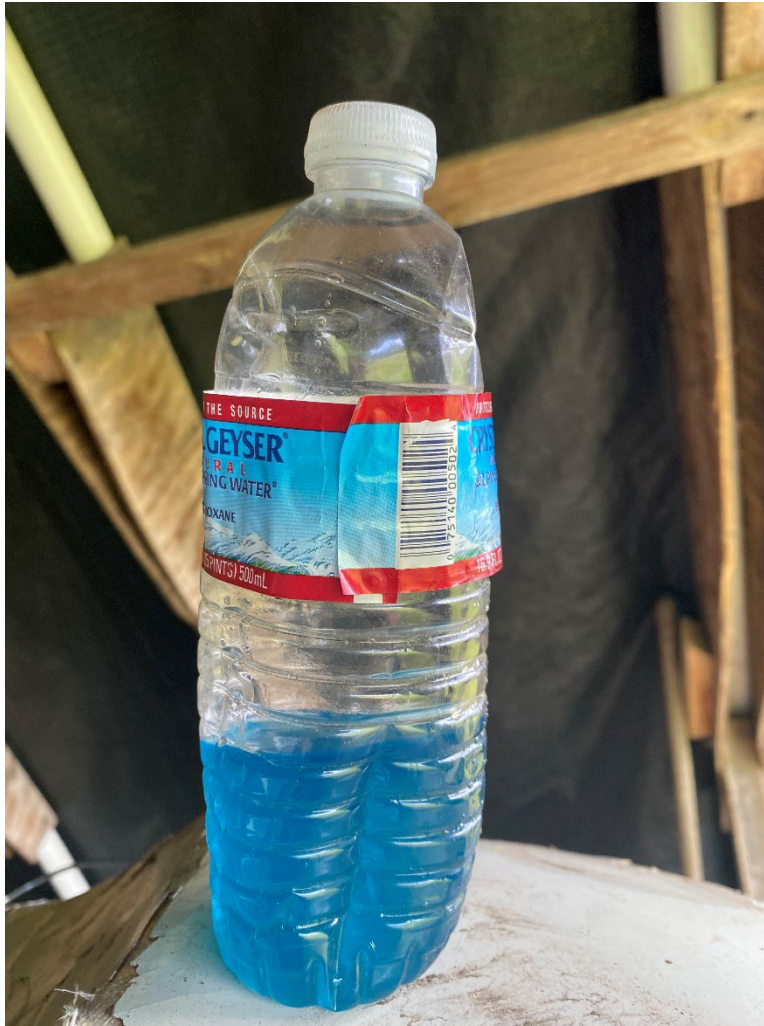
Possibly water. During the inspection they drained fuel from one of the fuel tanks into a plastic bottle (Figure 2). At first it appeared ok but after settling there were a few drops of water in it.

Figure 2: FAA Digital Photograph. View of Fuel Sample From Wing Fuel Tank Taken During Postaccident Examination.

He indicated that he did receive my typed interview notes and the only change is that the pulse fuel pump is located under the plate beneath the engine. He indicated that the fuel sample depicted in the photograph contained in the interview summary of July 6, 2022, was the sample that had drops of water days later. He did receive the NTSB report and his wife sent it the other day.

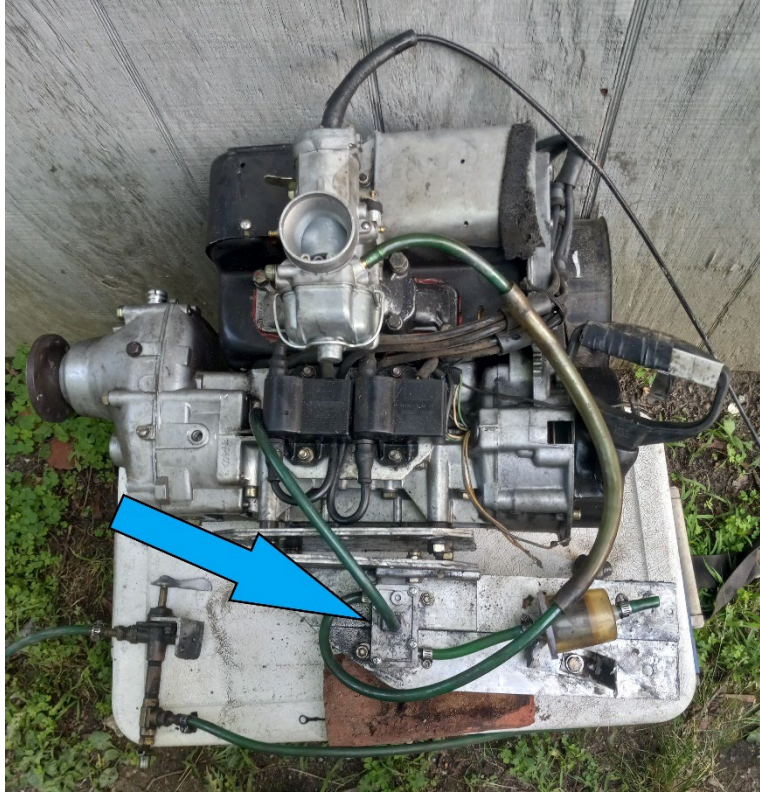
It is a pulse type pump installed on a plate beneath the engine (Figure 3).

Figure 3: Digital Photograph From Owner. Arrow Points to Pulse Fuel Pump.

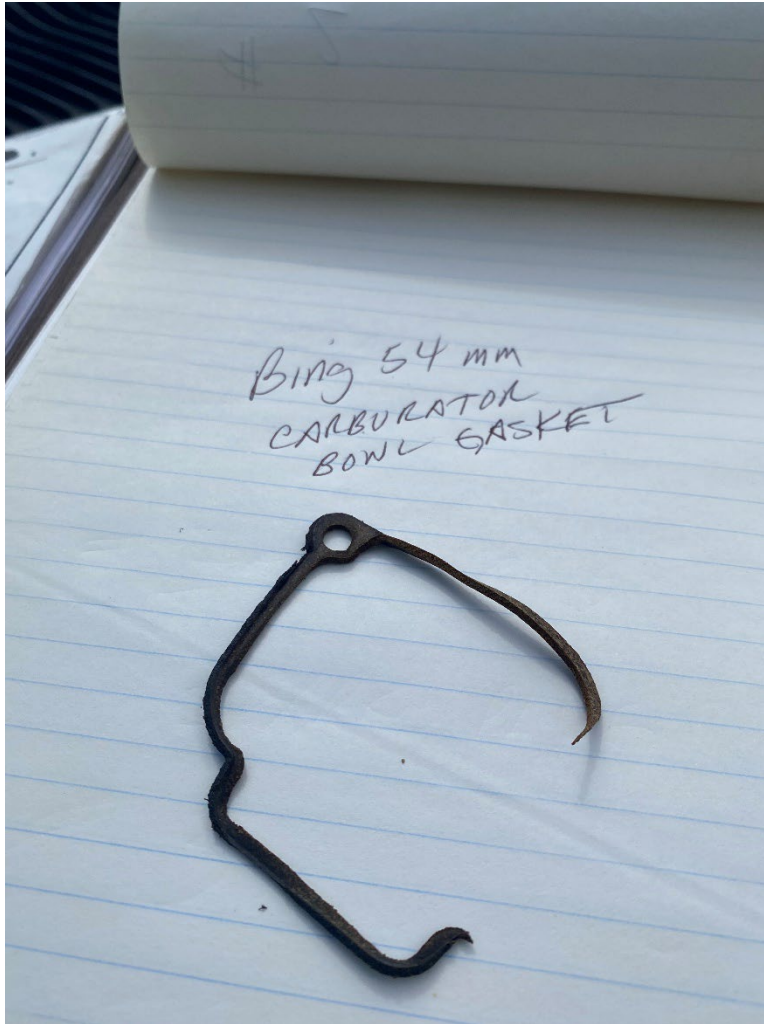
He did indicate that during the postaccident engine examination, when they took the carburetor bowl cover off they noted the gasket was broken (Figure 4), though he never saw any associated fuel leaks from the carburetor.

Figure 4: FAA Digital Photograph. View of the Damaged Carburetor Bowl Gasket. Note the Missing section.
