**WRECKAGE EXAMINATION**  
**NTSB Accident Number**  
**ERA22LA274**

Location: Brevard, NC  
Date: June 16, 2022  
Time: 1745 EDT  
Aircraft: Cessna 172M  
Registration: N5064H

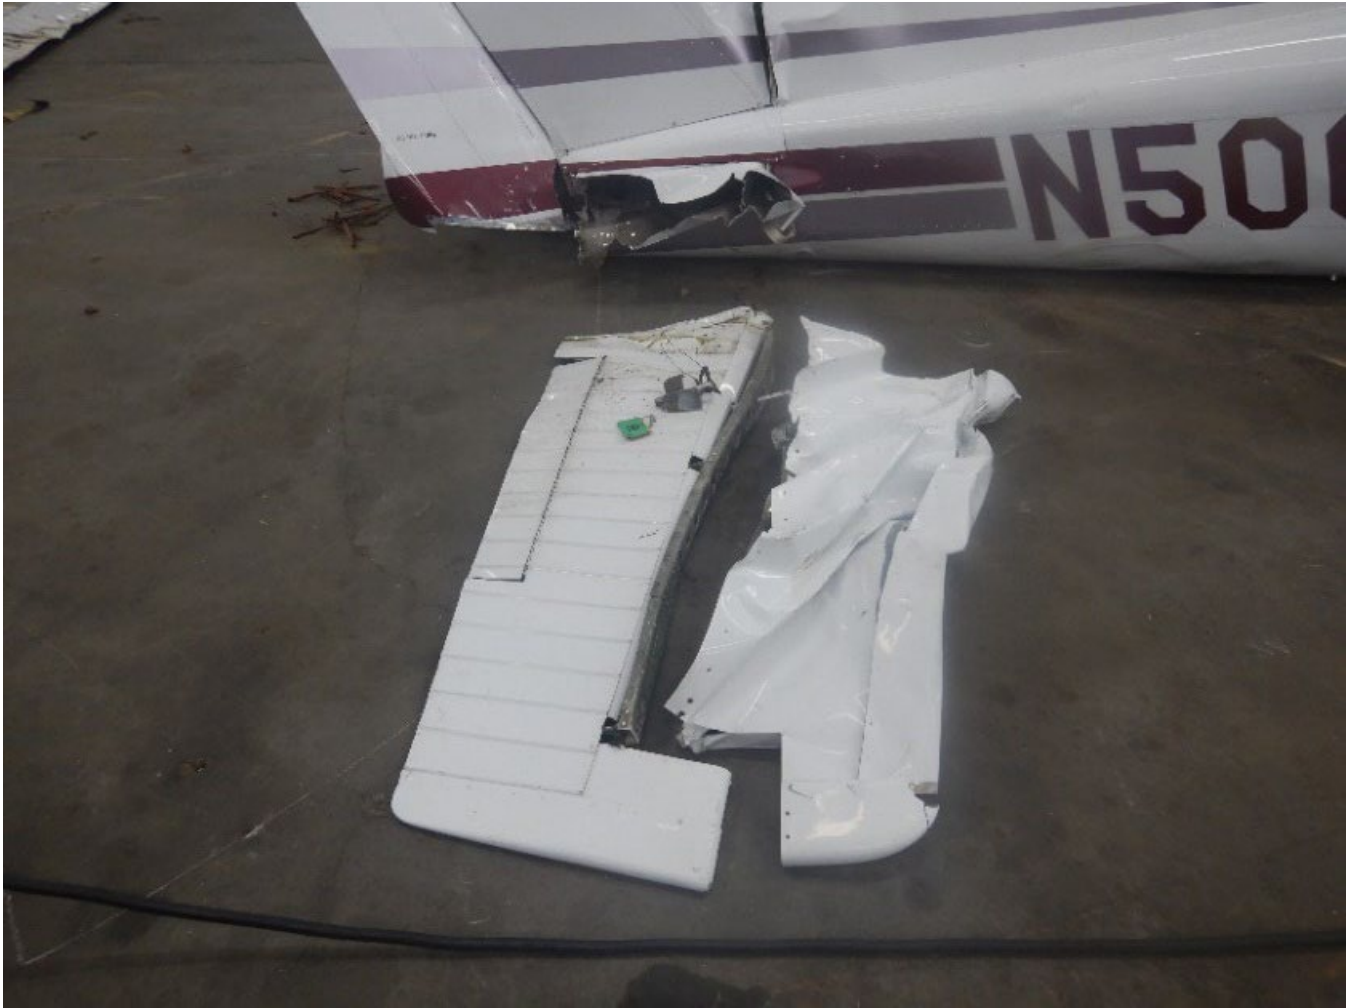
The left wing remained attached to its attachment points to the fuselage. The leading edge exhibited an aft diagonal buckling/crushing from the wing root to the pitot tube. Just inboard of the pitot tube, the leading edge exhibited approximately an 8" diameter tree impact mark. The leading edge approximately mid-span exhibited about a 1 ½" diameter tree impact mark.

The right wing remained attached to its attachment points to the fuselage. The leading edge exhibited approximately a 4" diameter tree impact mark about 3' 5" from the wing tip.

The RH horizontal stabilizer was separated approximately 6" outboard from its attachment points. The elevator with attached trim tab remained attached to the horizontal stabilizer rear spar which separated from the rest of the horizontal stabilizer.

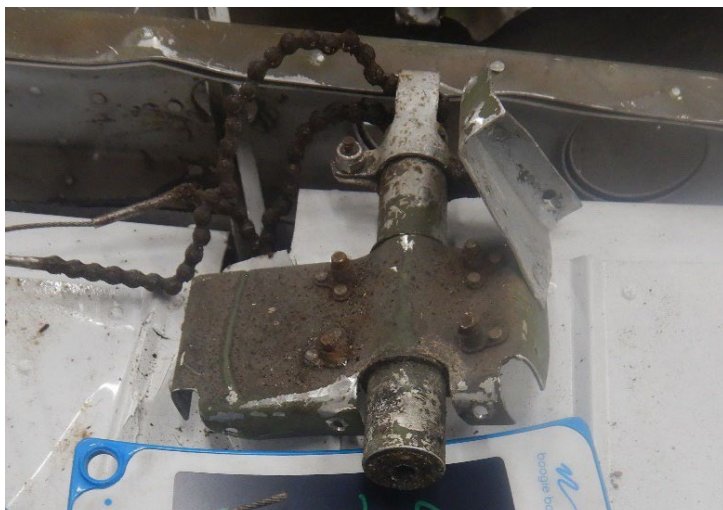
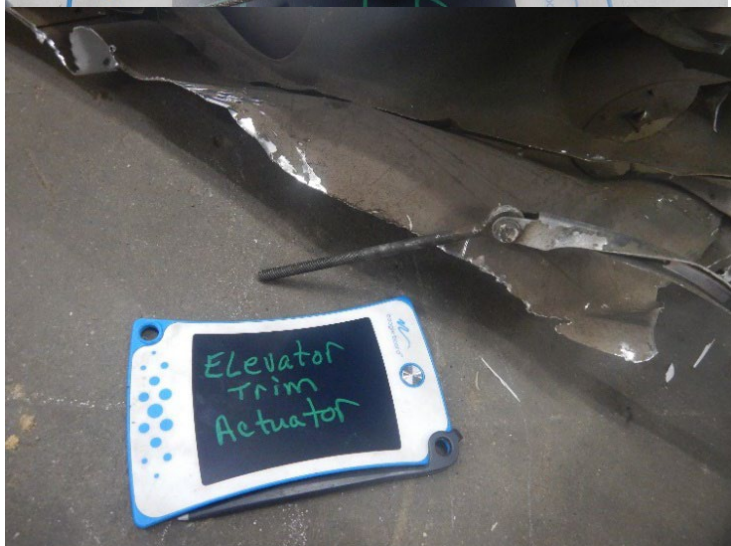
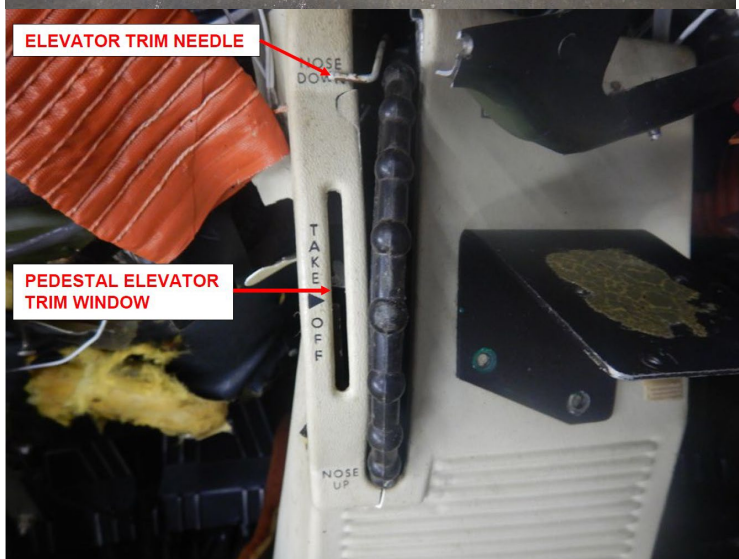
The 3-position flap switch mounted in the instrument panel was found in the middle position.

The flaps remained attached to their respect wing and bellcrank. The flap motor/actuator remained attached to the RH wing. The flap motor/actuator extension was measured and found to be approximately 5", which corresponds to approximately 30° flap position.

The elevator trim actuator exhibited impact damage. The actuator trim extension rod was separated from the trim actuator body. The chain remained attached to the actuator sprocket/gear. The cockpit elevator trim indicator, the needle was found outside the pedestal trim indicator window.

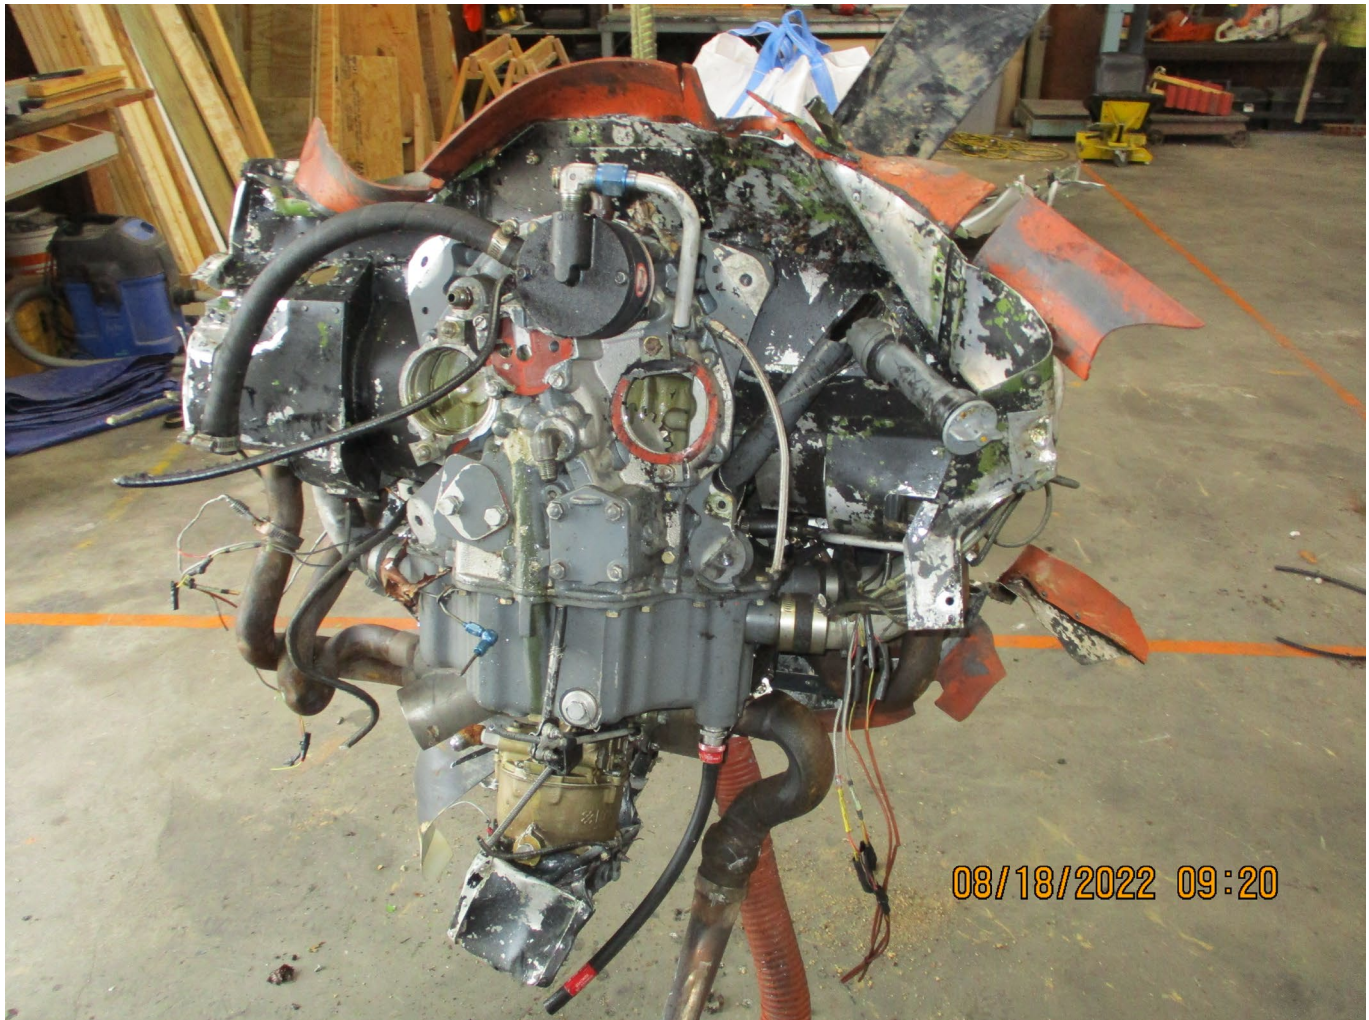
The engine remained attached to the firewall and front section of the fuselage. The engine was removed and hung from a forklift for examination. The propeller remained attached to the engine and tree bark was noted in the bent spinner dome. Both blades exhibited bent tips and one blade had "S" bending. Both magnetos were separated from the engine. The magnetos were spun with an electric drill and produced sparks on all leads. The top spark plugs were removed and exhibited normal wear. Thumb compression was established on all cylinders when the propeller was rotated by hand. Engine continuity was established through the engine and accessory case. A lighted boroscope was used to examine the cylinders, pistons, and valves. The carburetor was disassembled, and no anomalies noted. No preimpact anomalies were noted that would have precluded normal operation.
