# National Transportation Safety Board

ERA22LA274

## **ONBOARD IMAGE RECORDER**

Location: Brevard, NC  
Date: June 16, 2022  
Time: 17:45 EDT  
Airplane: Cessna 172M, N5064H

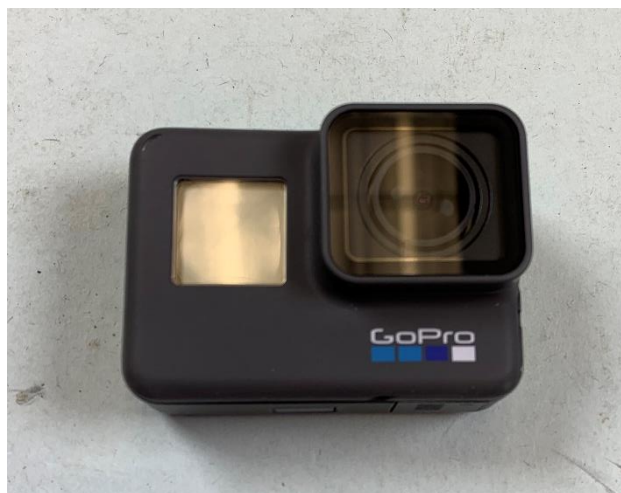
The device was in good condition and the data were downloaded using a USB adapter to read out the associated microSD card.

**Figure 1.** Device as received by the lab.

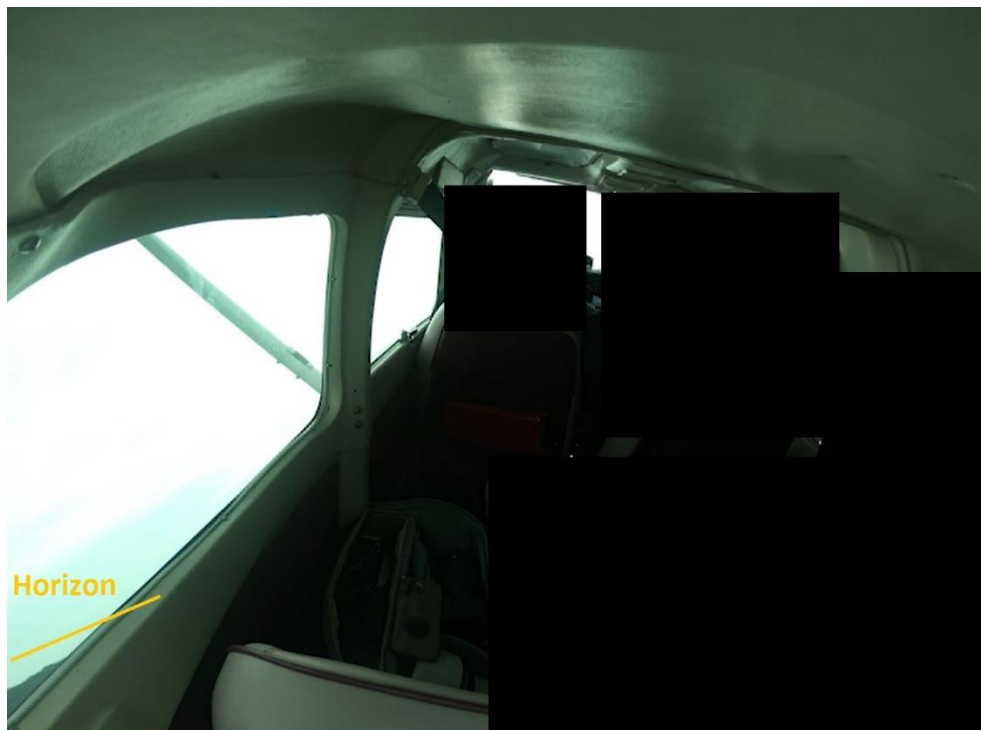
The recording began at 00:00, the rear seat occupant was facing backward and turned on the camera. The aircraft at this time was in a steep left bank, with the tree canopy visible below the aircraft. Shortly thereafter, the aircraft made a low pass over a clearing and performed a right bank turn. Figure 3 is a redacted screenshot at this time, the horizon is annotated for clarity.

**Figure 3.** Image showing an example of the aircraft's bank angle at 00:16 elapsed. The horizon is annotated.

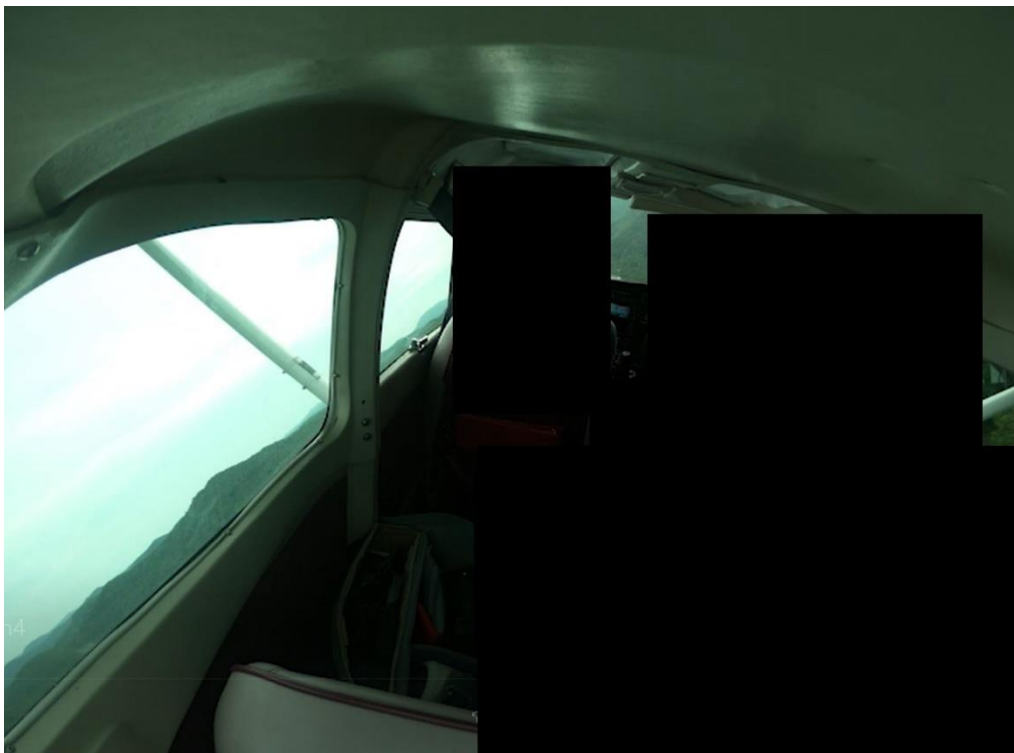
Figure 4 is a screenshot taken at 00:49 which shows the aircraft's bank angle and relative height to the tree canopy at this time.

**Figure 4.** Image showing the aircraft's bank angle at 00:49 elapsed.

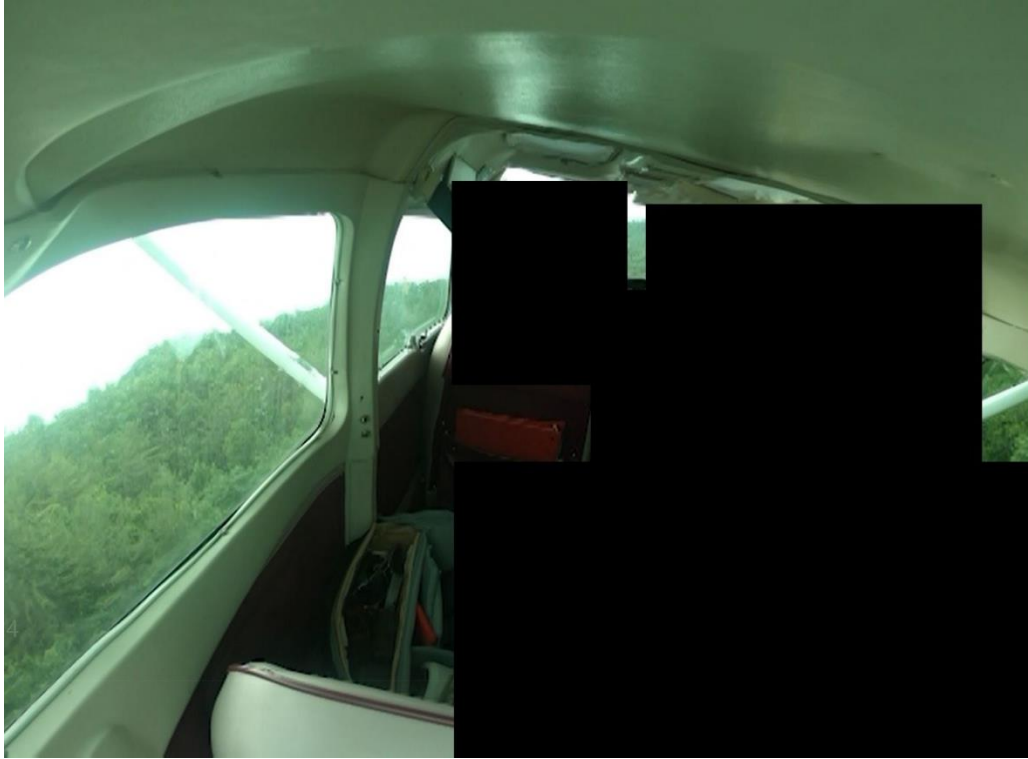
Figure 5 is a screenshot taken at 01:00 which shows the aircraft maneuvering close to the level of the tree canopy. The front right seat passenger opened the right window and made a motion with his hand consistent with tossing objects out of the aircraft.

**Figure 5.** Image showing the aircraft maneuvering at 01:00 elapsed.

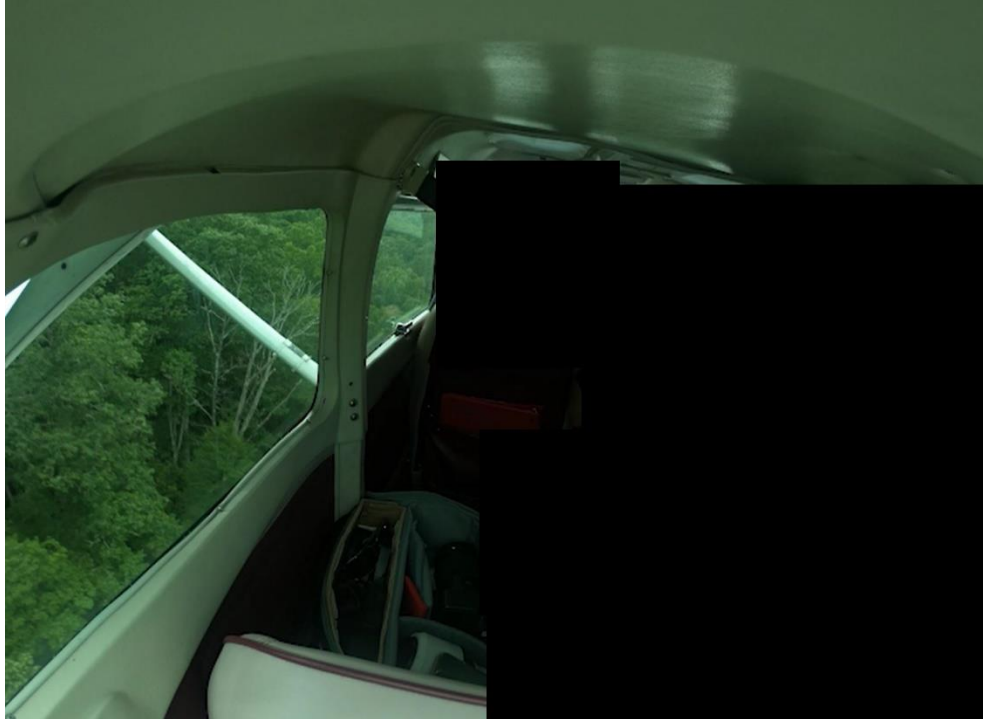
Around 08:00 the pilot began to make a pass over the clearing which resulted in the accident sequence. The aircraft appeared to be a lower level than previously noted earlier in the recording. Around 08:11, the right front passenger and the rear passenger made a motion with their heads consistent with looking at the small clearing in the tree canopy which the aircraft just passed. Moments after, the pilot appeared to increase the pitch of the aircraft briefly. In the next few seconds, the pitch angle became lower, and more level. The right passenger and the rear passenger then diverted their attention forward. The aircraft continued traveling near the tree canopy level at a more level attitude, but still slightly positive pitch angle. The rear passenger grabbed the right front seat back in a brace-like manner. The aircraft continued to travel forward at a low level over the tree canopy. Around 08:33, the pilot banked the aircraft right, the tree canopy level appeared to be level with the aircraft. In the next few seconds, the aircraft made an abrupt nose down pitching motion. It is possible this negative pitching motion was related to the aircraft striking trees, however, evidence of a tree strike was not visible on the recorded images. The rear passenger then braced with both hands on the right front seat back. Figure 6 is a screenshot at this time. The next few frames showed the aircraft impacting trees, the angle of the camera abruptly changed and only the baggage area was visible. The

subsequent images suggested the aircraft continued impacting trees and terrain for the next few seconds. The camera images suggested the aircraft came to rest around 08:41. The image sequence constructed for the review of the accident sequence ended at 8:45.

**Figure 6.** Image showing the aircraft's position around the time of impact with trees.
