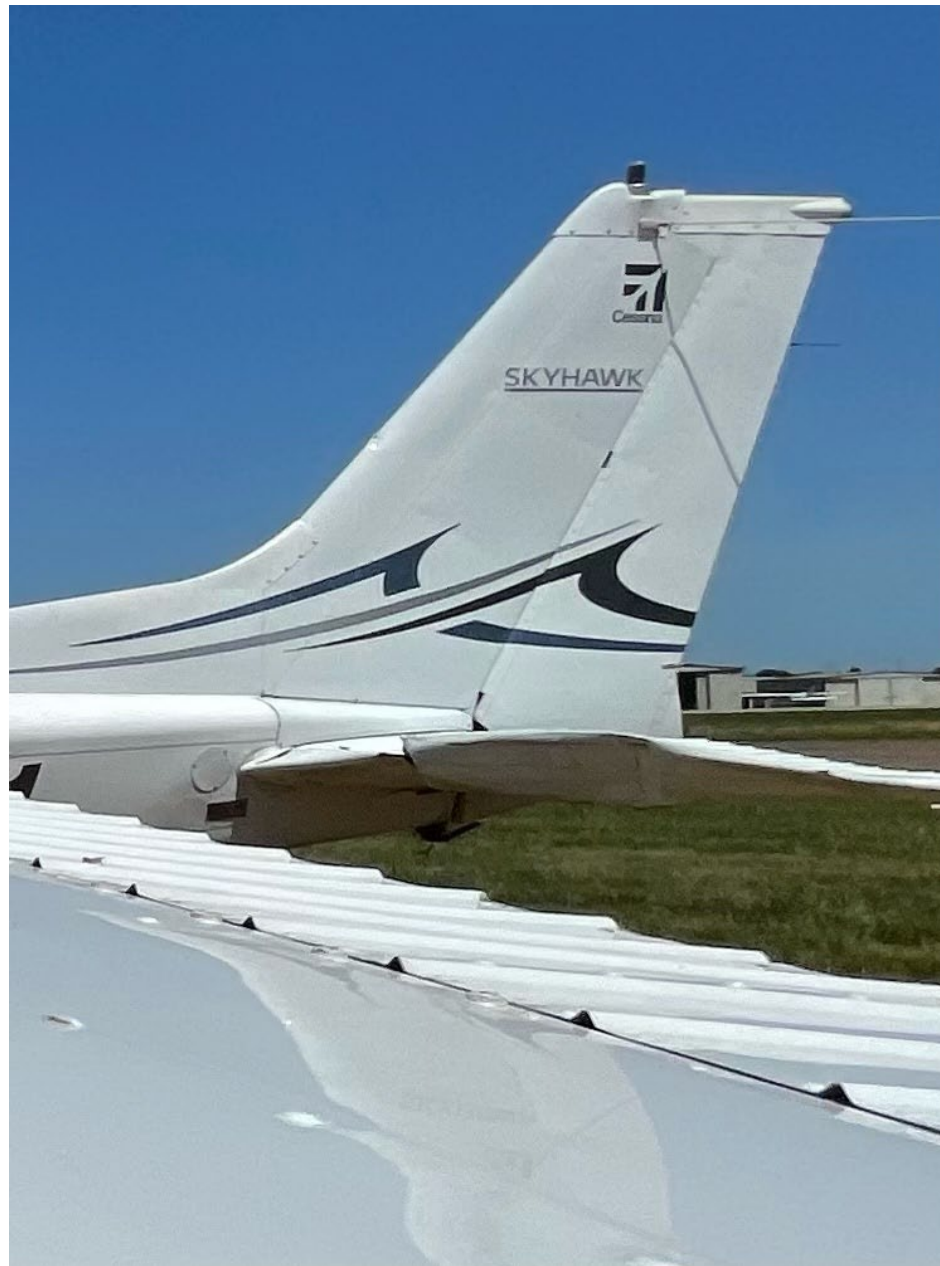
**Photo 1 – View of right horizontal stabilizer damaged**

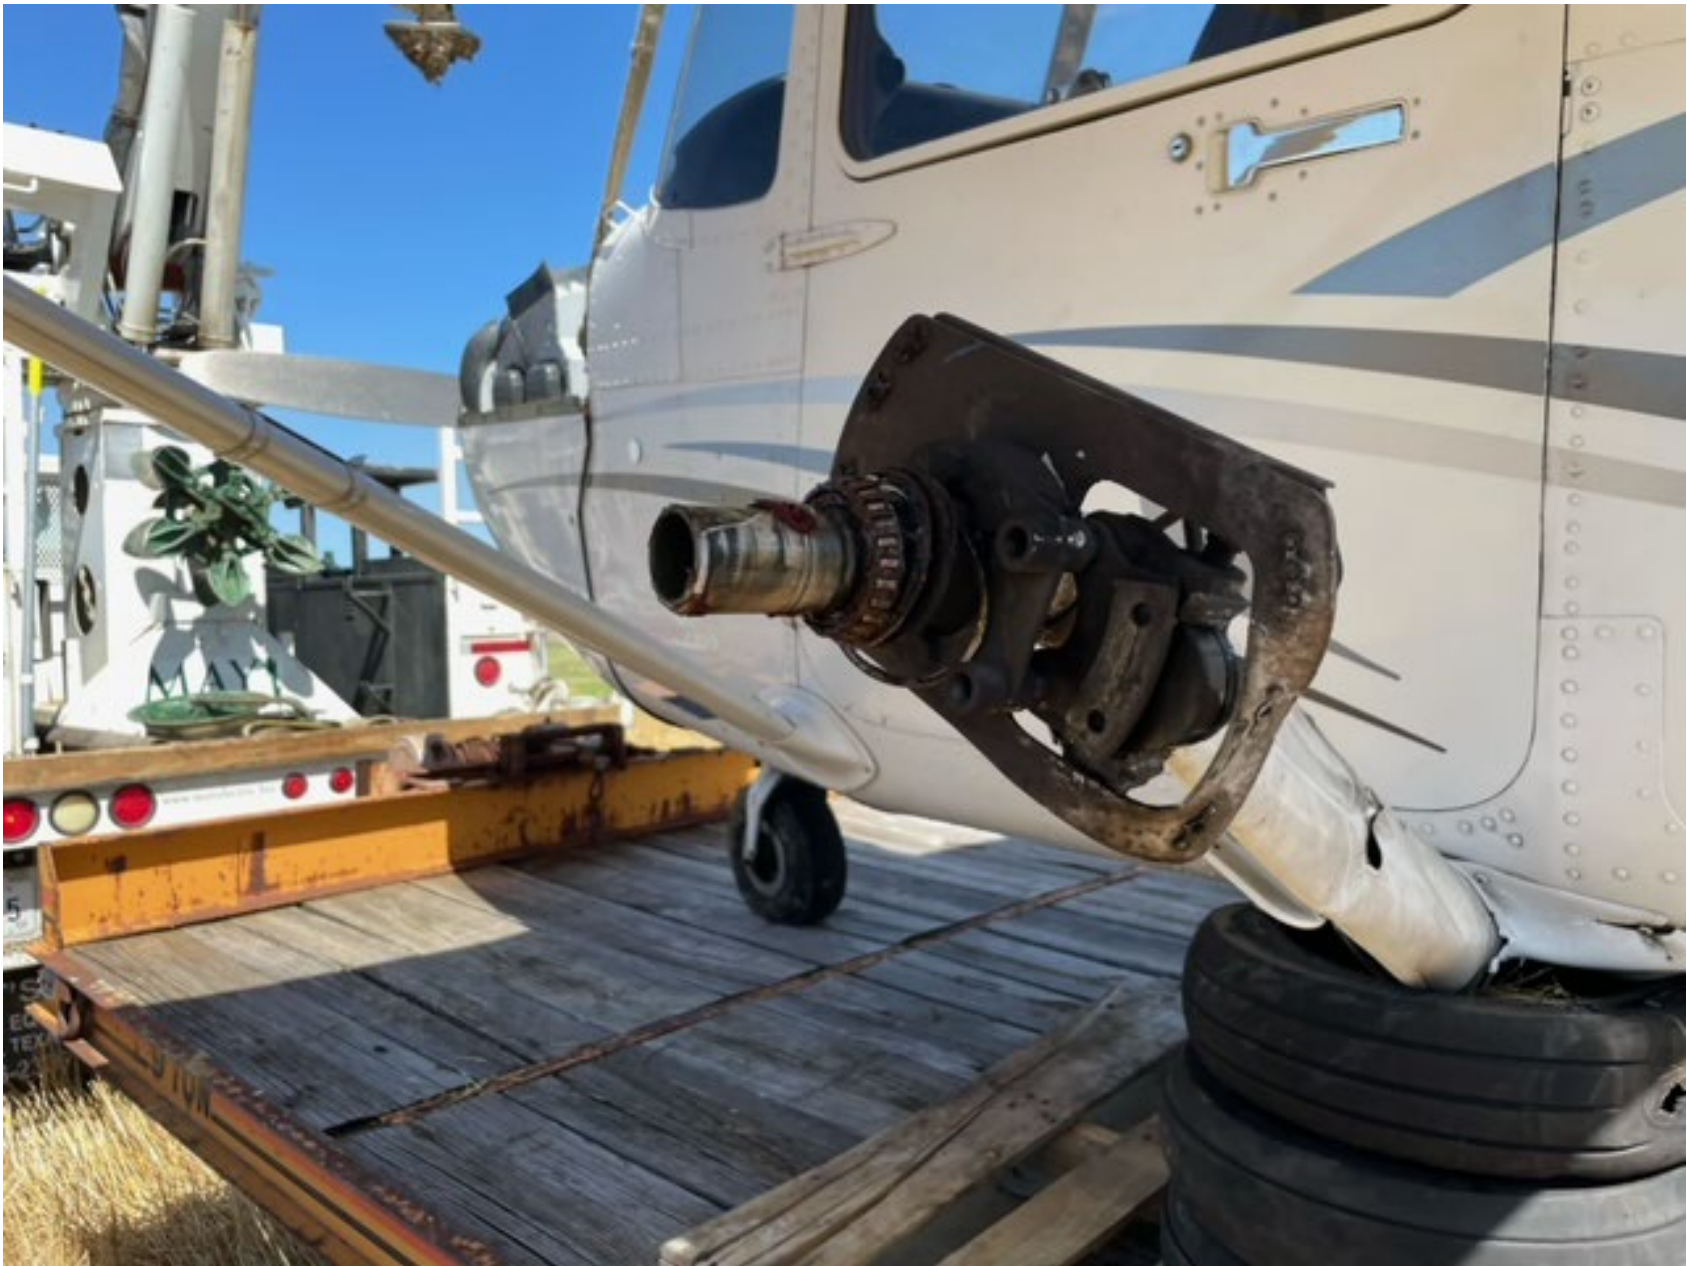
**Photo 2 – View of the damaged left main landing gear.**
