# National Transportation Safety Board

## **MATERIALS LABORATORY**

Factual Report 22-094

Location: Jasper, Georgia  
Date: June 18, 2022  
Time: 17:30 eastern daylight time  
21:30 coordinated universal time  
Vehicle: Cessna 414, N414HF  
Investigator: Ralph Hicks, AS-ERA

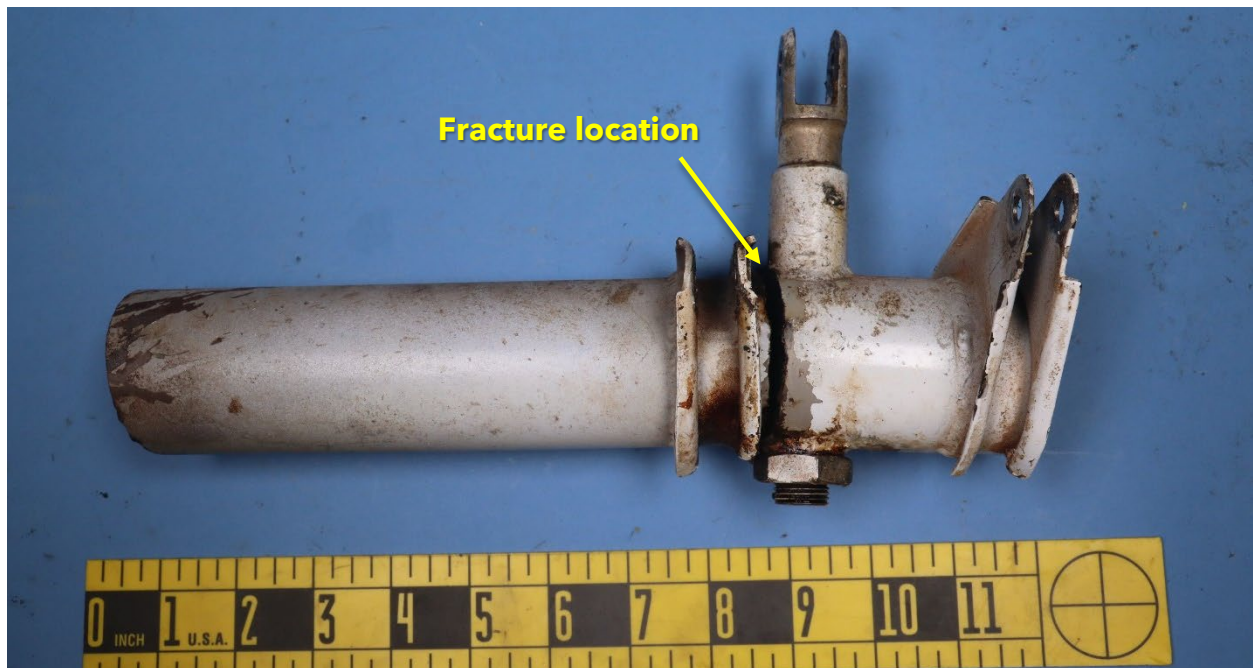
Figure 1 and Figure 2 show the torque tube as received. Of note was the crack or fracture along the right one-third of the figure, which exhibited longitudinal, circumferential, and angled alignments. The circumferential area of the crack was located near the flange welded to the tube, illustrated primarily in Figure 1. The circumferential crack portion measured 5.5 inches long. The longitudinal part of the crack was 1.63 inches long, with the angled portion that had advanced to the welded end measuring 2 inches (shown in Figure 2).

**Figure 1.** The torque tube, as received. The fracture location on the tube is annotated.

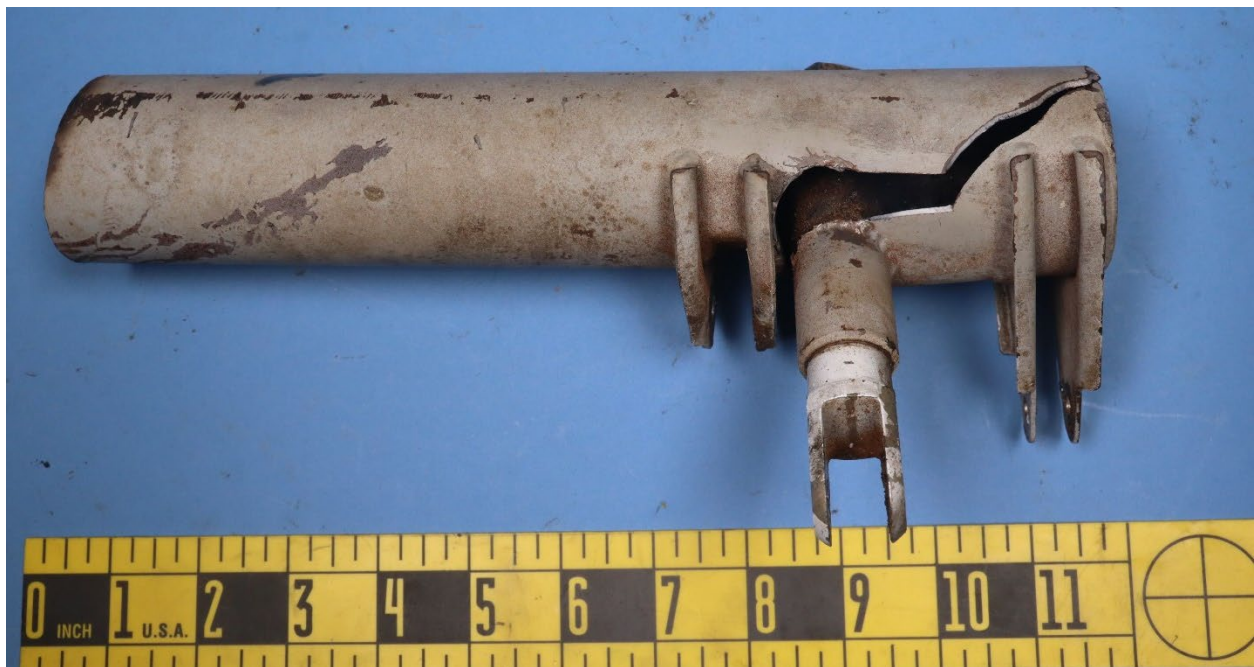
**Figure 2.** View of the torque tube, rotated 180° from Figure 1.

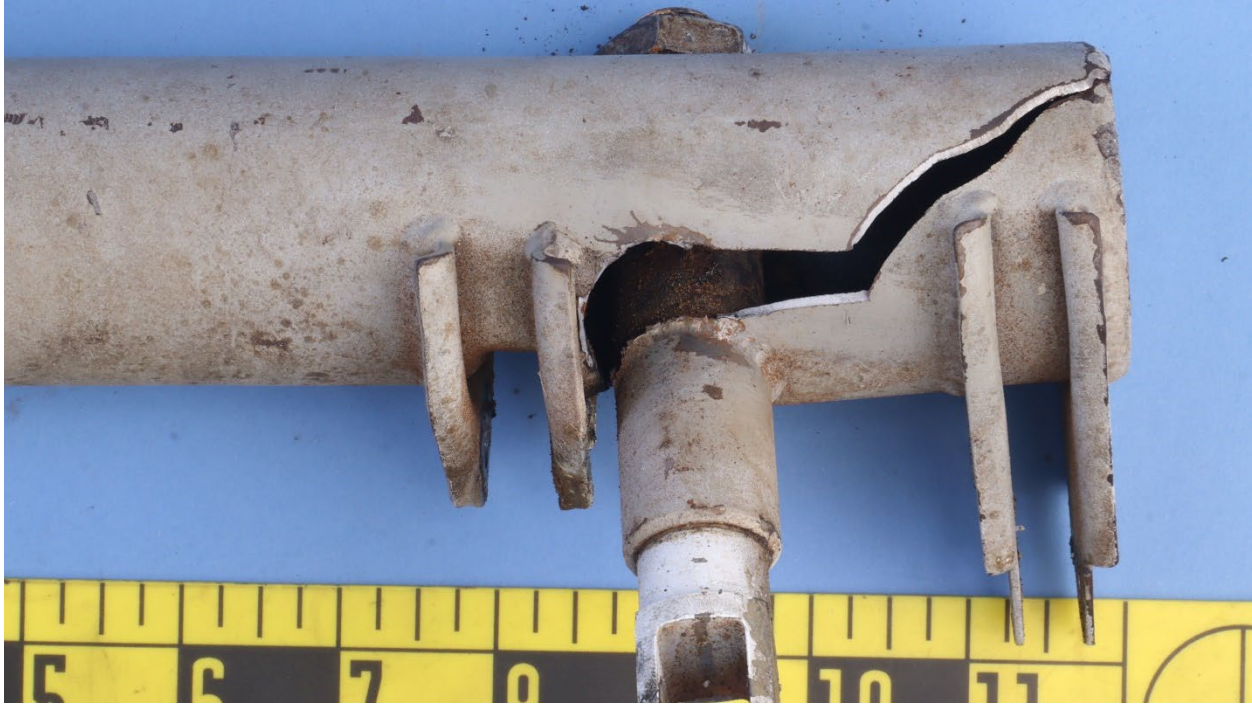
Examination of most crack faces (or fracture surfaces) revealed a slanted orientation with a rough fibrous texture and dull luster. These areas often exhibited chevron, or V-shaped, marks. These marks emanated from an area of the crack located in Figure 3. This figure shows a closer view of the longitudinal cracking around the weld with the boss arm. This area was generally flatter than the rest of the crack faces on the torque tube.

**Figure 3.** Closer view of the fracture near the weld along the boss of the torque tube.

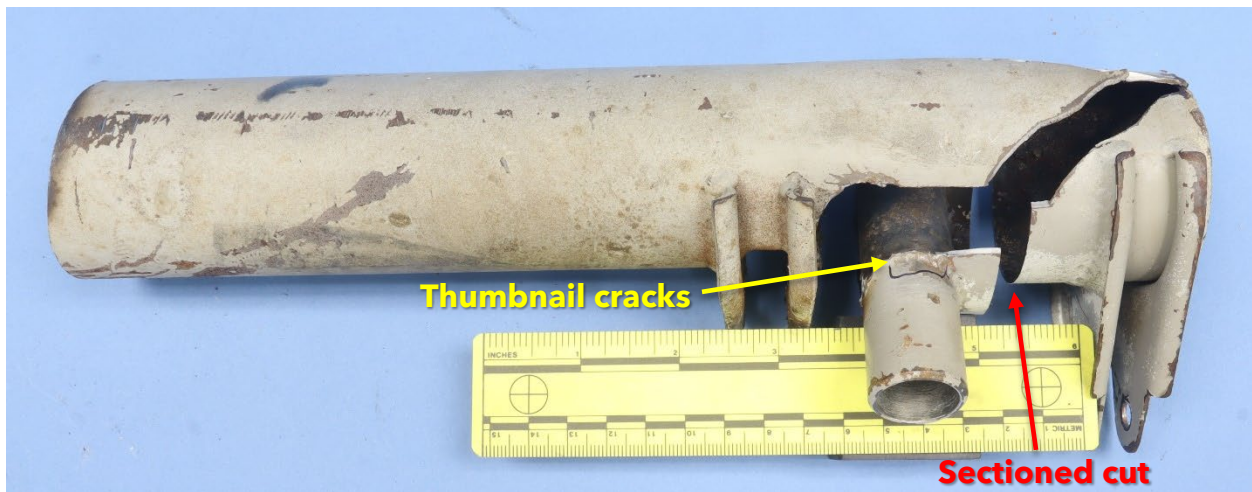
The tube was sectioned strategically to open and examine the crack faces. Figure 4 shows one of the sections and its location relative to the flat area of the tube crack. Figure 5 shows these sectioned fragments separated to reveal the interiors of the tube. The area of interest was the flat-oriented but highly tortuous fracture, as annotated in Figure 5 and highlighted in Figure 6. This portion of the fracture surface was located along the circumferential weld between the tube and the boss.

**Figure 4.** View of the torque tube after sectioning to reveal the crack faces. The location of the thumbnail cracks and sections are annotated in the figure.

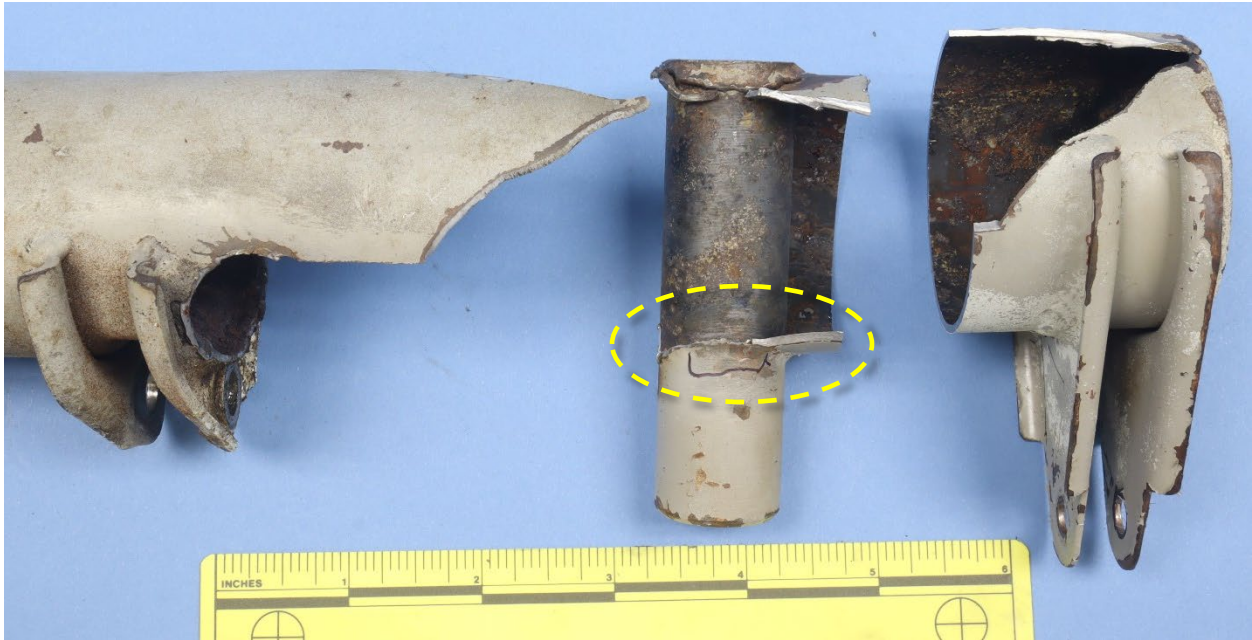
**Figure 5.** The sectioned portions of the torque tube, with the different sections separated to expose the tube interior.

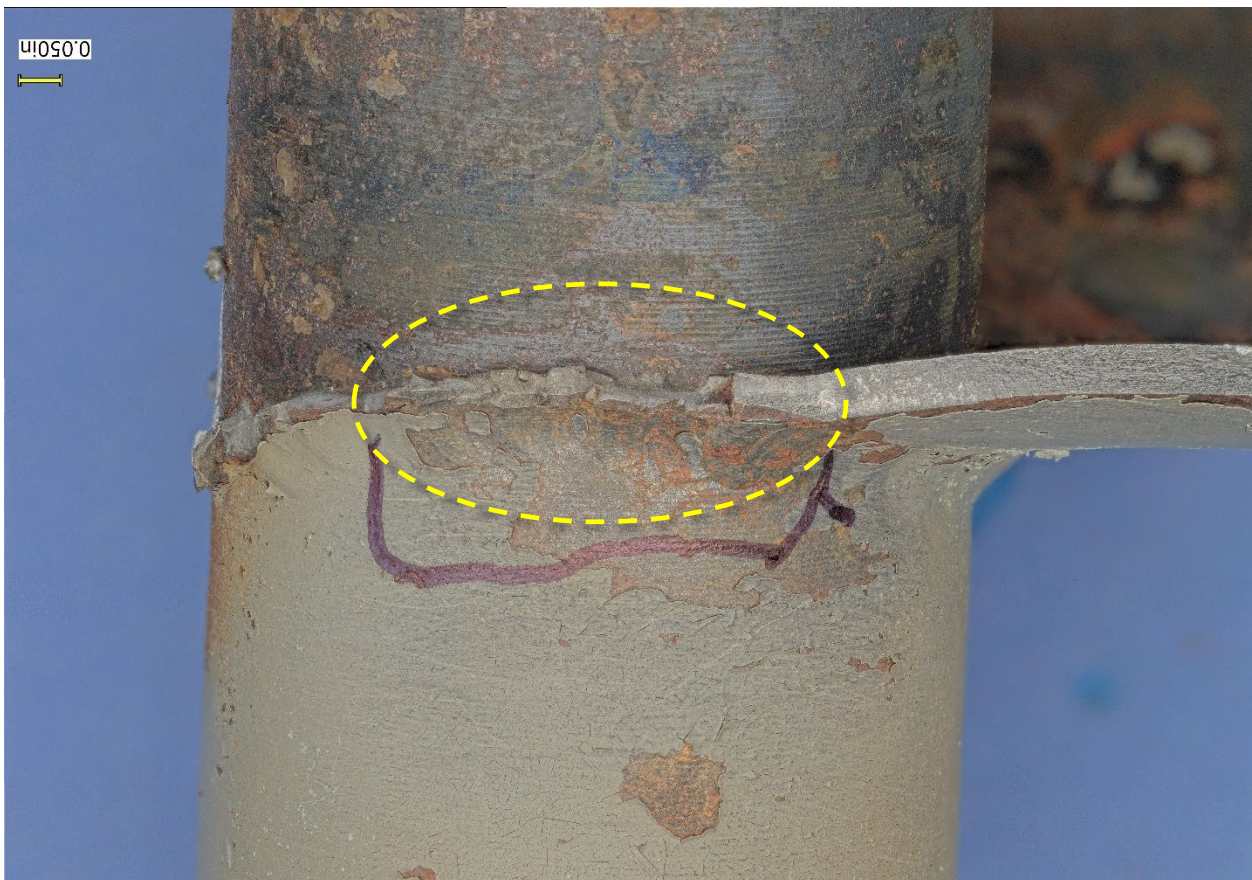
**Figure 6.** Closer view of the circled area in Figure 5, showing small thumbnail cracks.

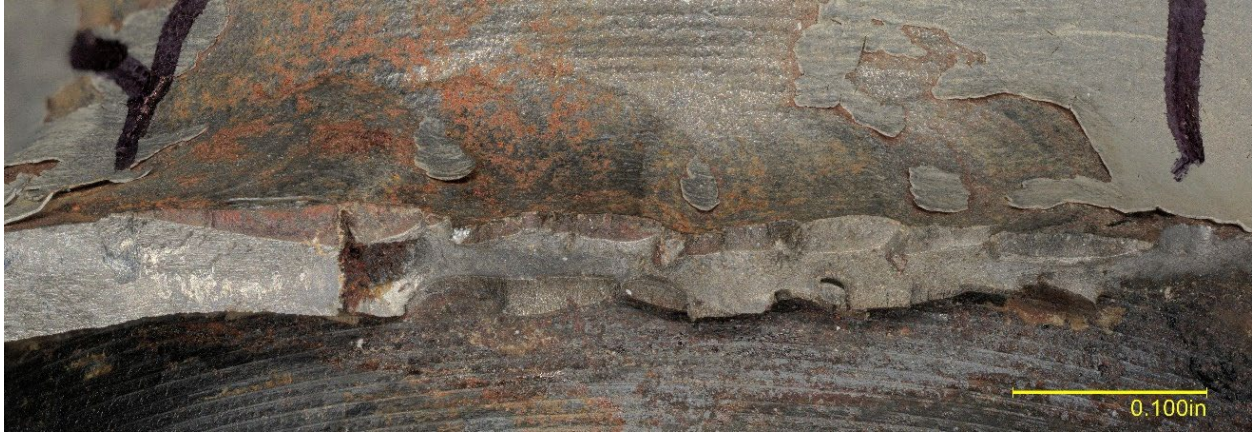
Figure 7 shows a closer view of this area, revealing at least ten thumbnail-shaped cracks along the edge of the crack. The length of the fracture surface with these thumbnail cracks was measured as 0.527 inches long. These cracks exhibited a different maroon color from the remaining metallic fracture surface. The thumbnails also exhibited radiating river patterns with concentric crack arrest marks. The upper thumbnail crack in Figure 8 exhibited vertically-oriented ratchet marks, consistent with smaller cracks having initiated and coalesced during propagation.

**Figure 7.** Closer view of the thumbnail cracks on the torque tube fracture location circled in Figure 6.

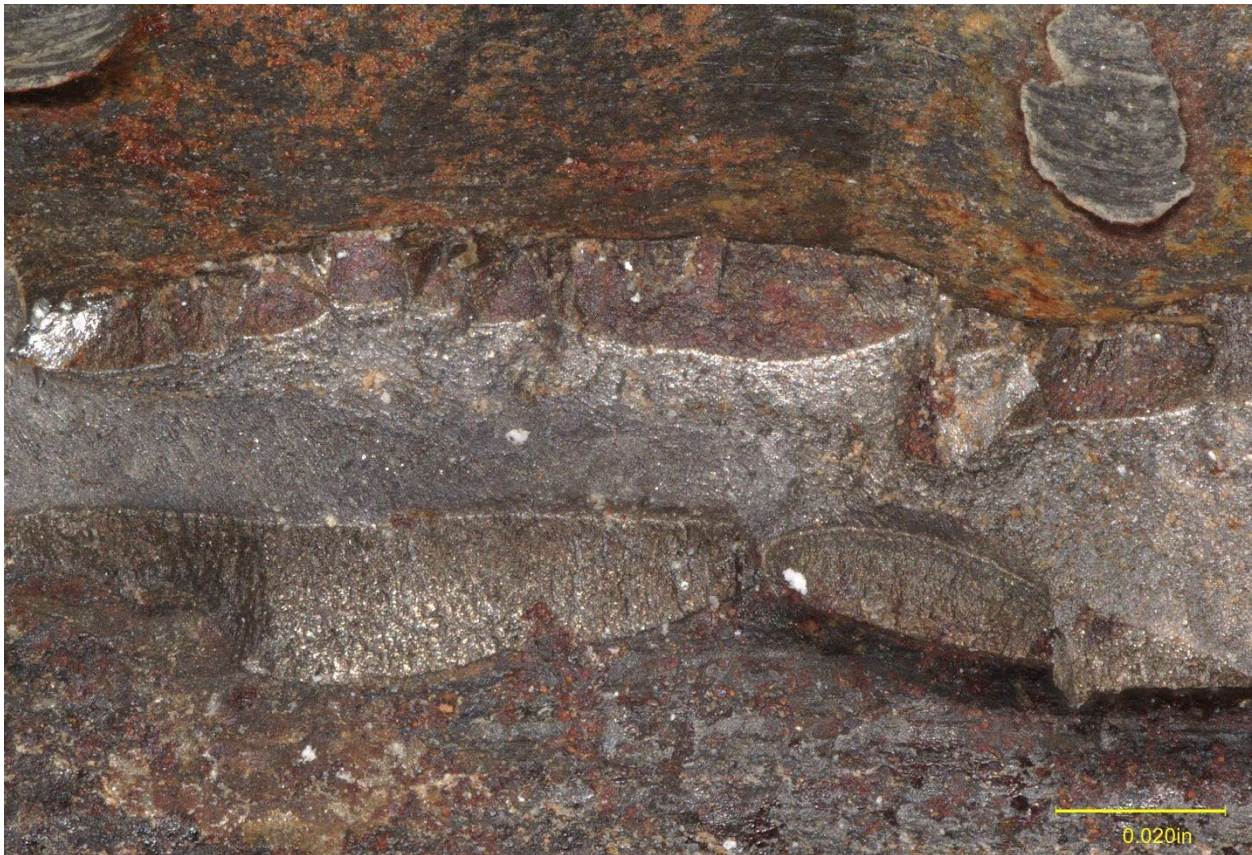
**Figure 8.** Closer view of some of the thumbnail cracks in the middle of the fracture in Figure 7.

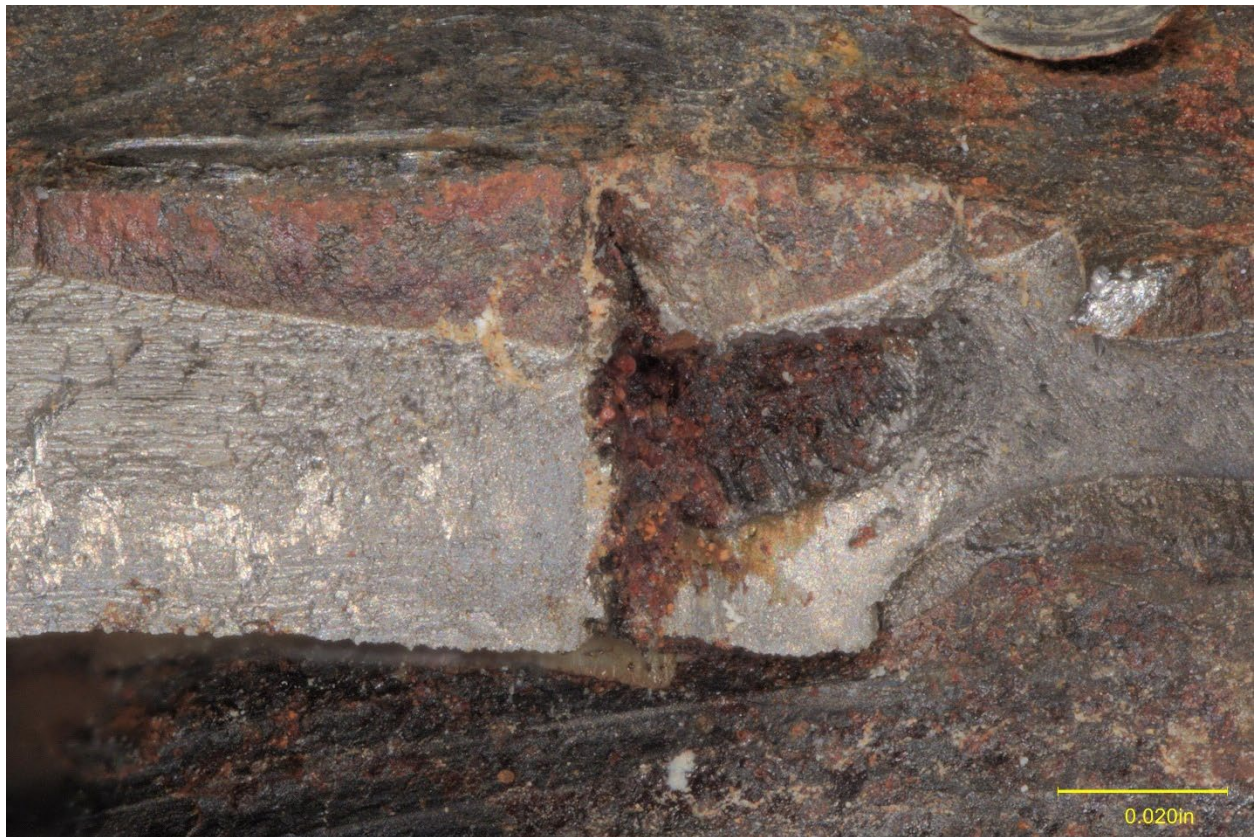
**Figure 9.** View of the largest thumbnail crack from the left side of Figure 7.

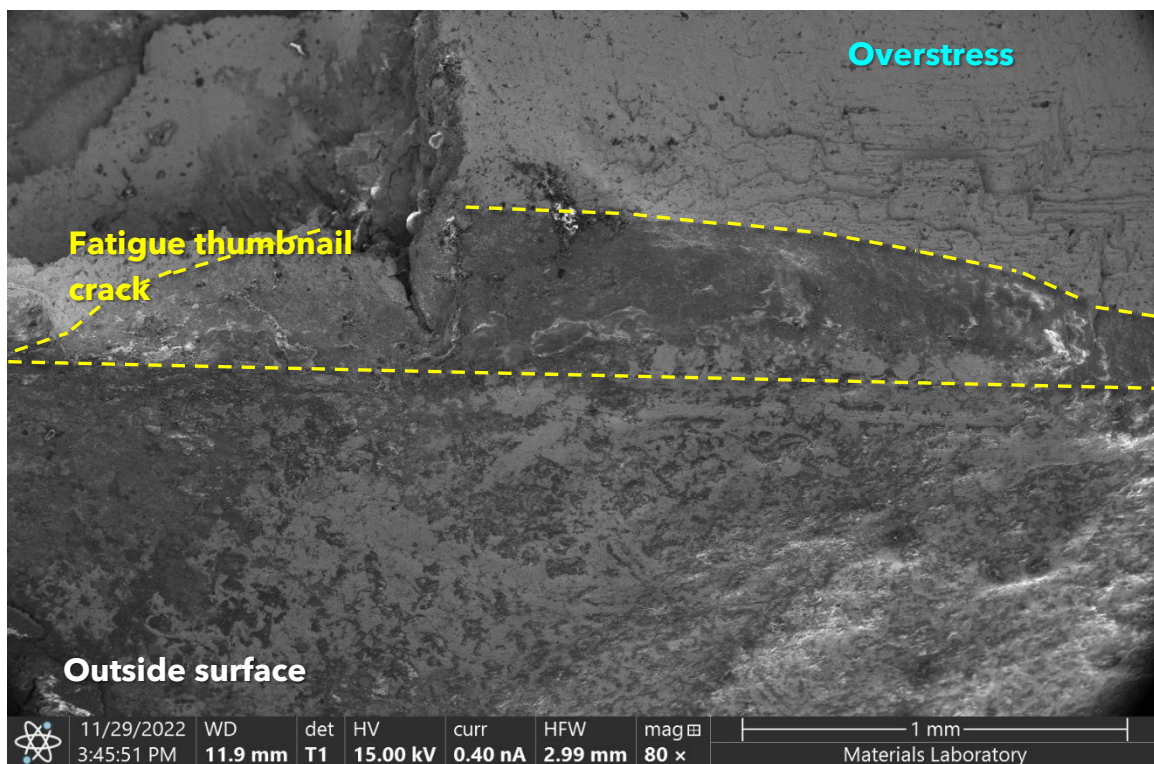
This fracture surface area was excised and examined using a field emission scanning electron microscope (SEM). Figure 10 shows the largest thumbnail crack, annotated to show its outline against the fracture edge and the rest of the surface. A closer view of the thumbnail revealed parallel, concentric features, typically underneath an undulating layer of dissimilar surface compounds. These features were consistent with fatigue striations from fatigue crack propagation.

**Figure 10.** Backscattered electron (BE) micrograph of the crack in Figure 9.

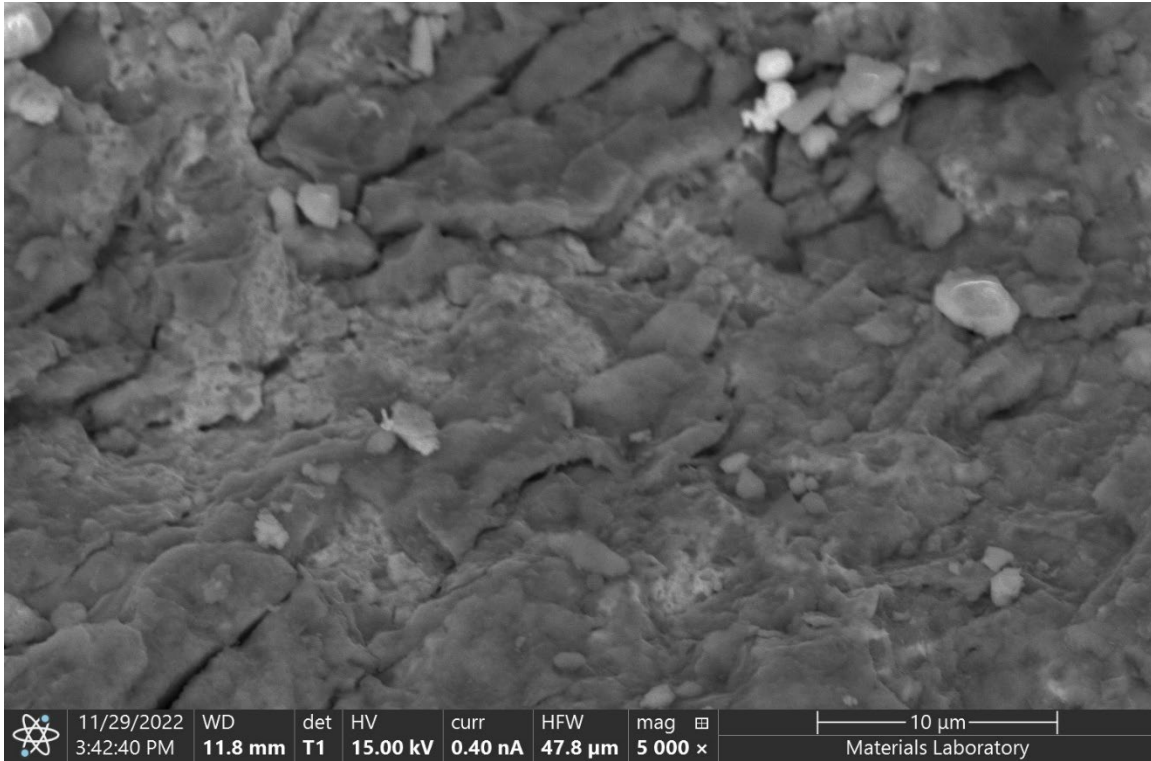
**Figure 11.** BE micrograph of the end of the fatigue crack in Figure 10.

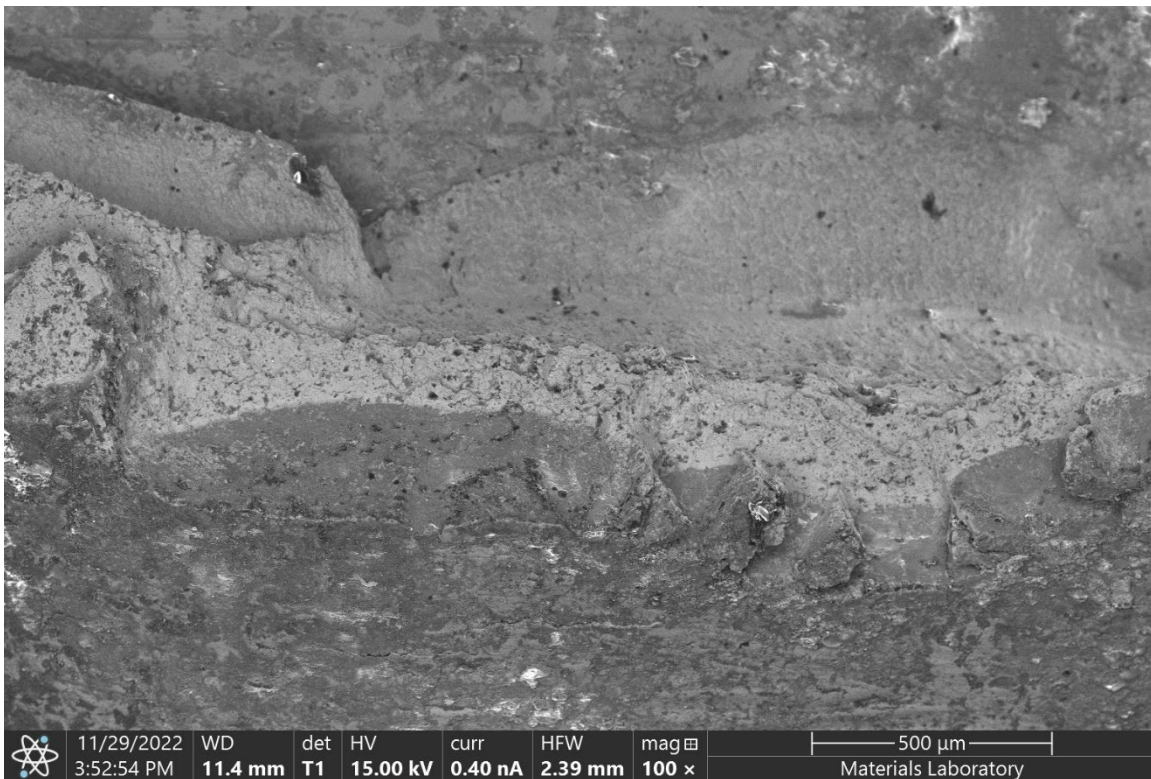
Figure 12 shows more thumbnail-shaped fatigue cracks on the tube fracture surface. These features exhibited a darker contrast in backscattered mode, consistent with more surface oxidation, as illustrated in Figure 11.<sup>1</sup> Examination of the lighter areas of the fracture using energy dispersive x-ray spectroscopy (EDS) found the material to be consistent with alloy steel. The fatigue crack exhibited higher amounts of oxygen, sulfur, and elements typical of salt compounds, consistent with prolonged exposure to the atmosphere during crack propagation. EDS examination of the cracks also detected cadmium, indicating the part had been coated with cadmium.

**Figure 12.** BE micrograph of more thumbnail cracks on the tube.

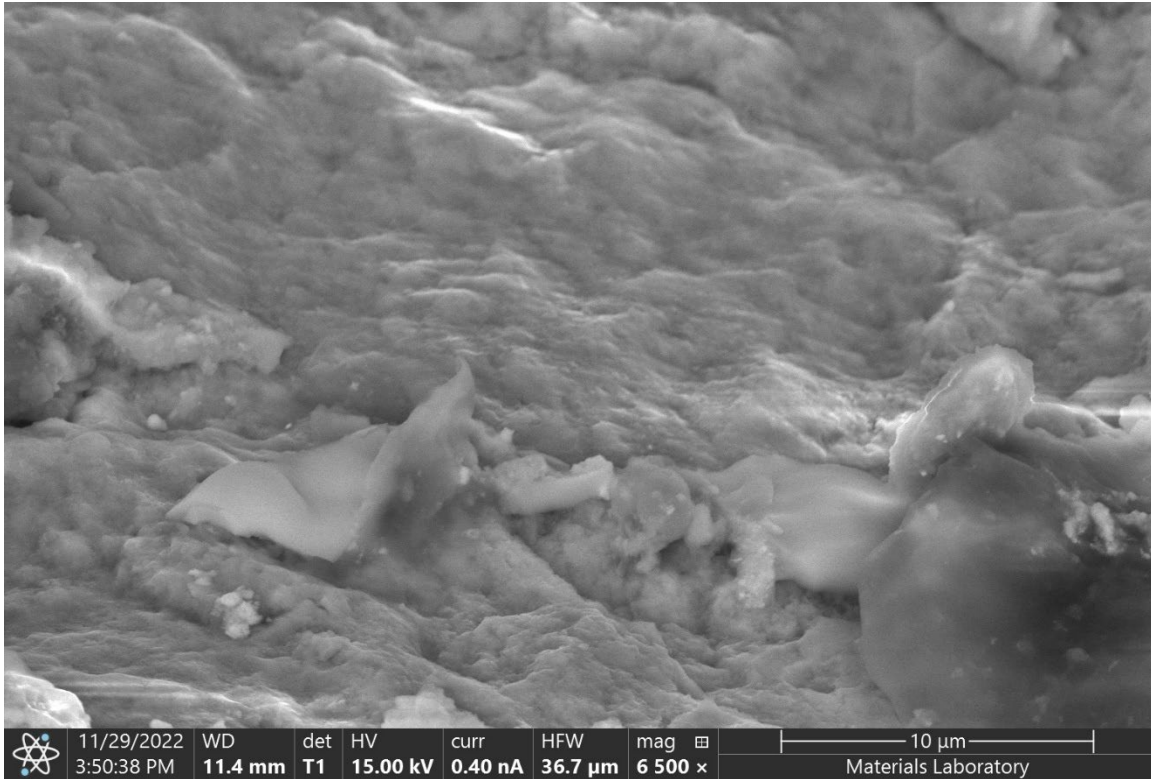
The fatigue cracks in Figure 12 exhibited striations, as typified in Figure 13. The edges of the fatigue cracks were examined to assess the nature of the initiation sites. Figure 15 shows a typical area of crack initiation site along the fracture edge. The undulations in the surface oxide were consistent with underlying fatigue striations. Though oxidized, the initiation site itself did not exhibit any geometric anomalies such as pits, scratches, or wear marks.

**Figure 13.** BE micrograph of fatigue striations in the fatigue crack in Figure 12.

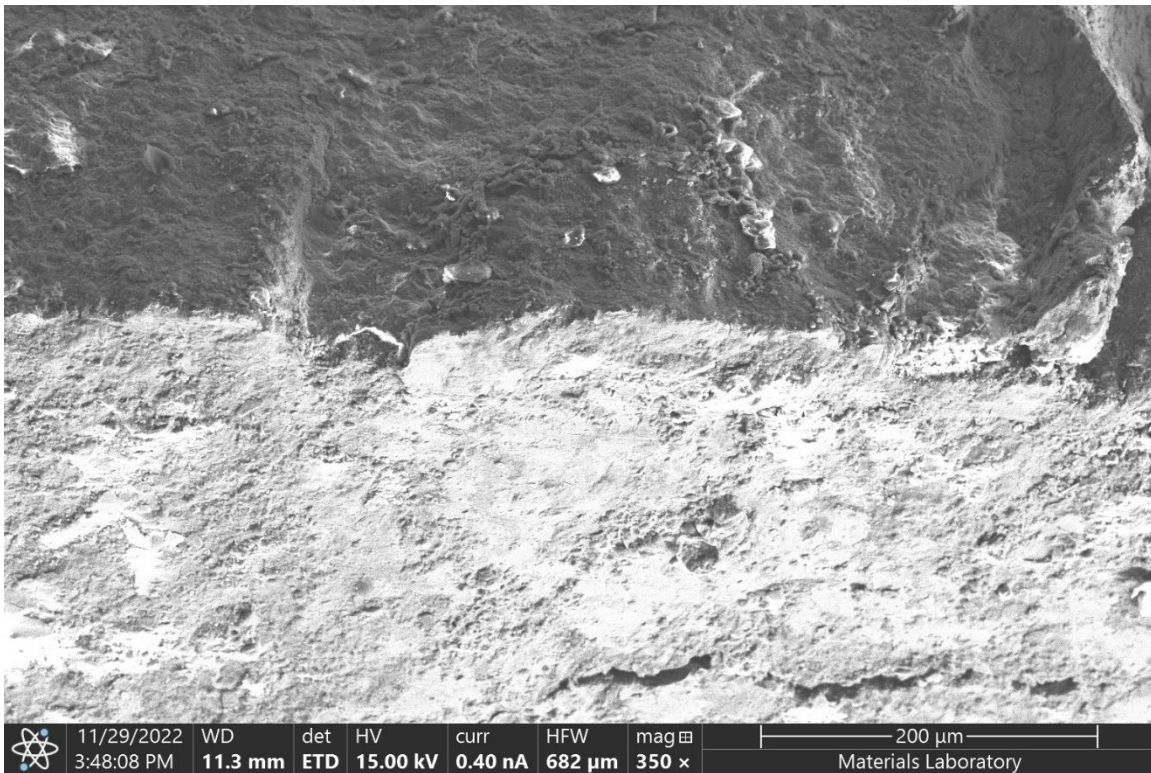
**Figure 14.** Secondary electron (SE) micrograph of the outer edge of one of the fatigue thumbnail cracks.

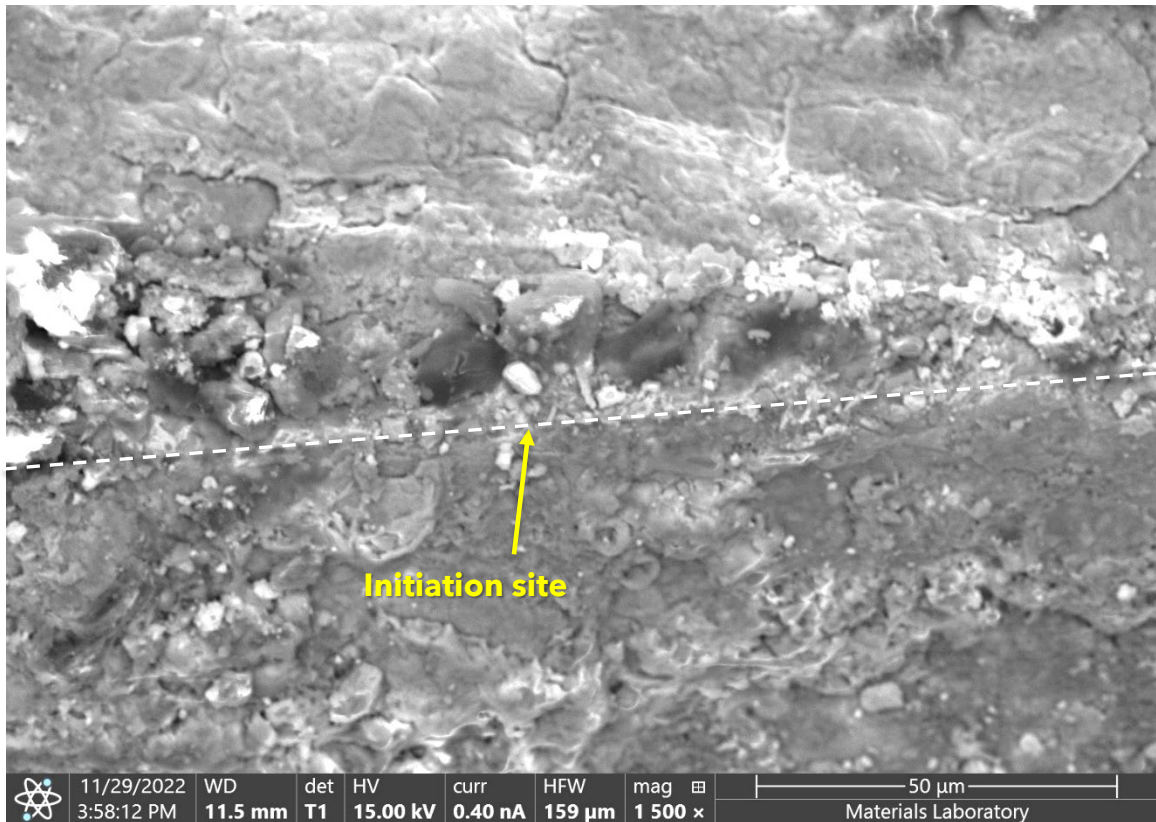
These features were consistent with fatigue cracking of the weld at multiple crack initiation sites. The presence of opposite-facing fatigue cracks having propagated

inward from the outer and inner surface was consistent with reverse bending at this location.

**Figure 15.** BE micrograph of a closer view of the edge of the crack in Figure 4, with the edge annotated and the fatigue crack initiation site labeled.

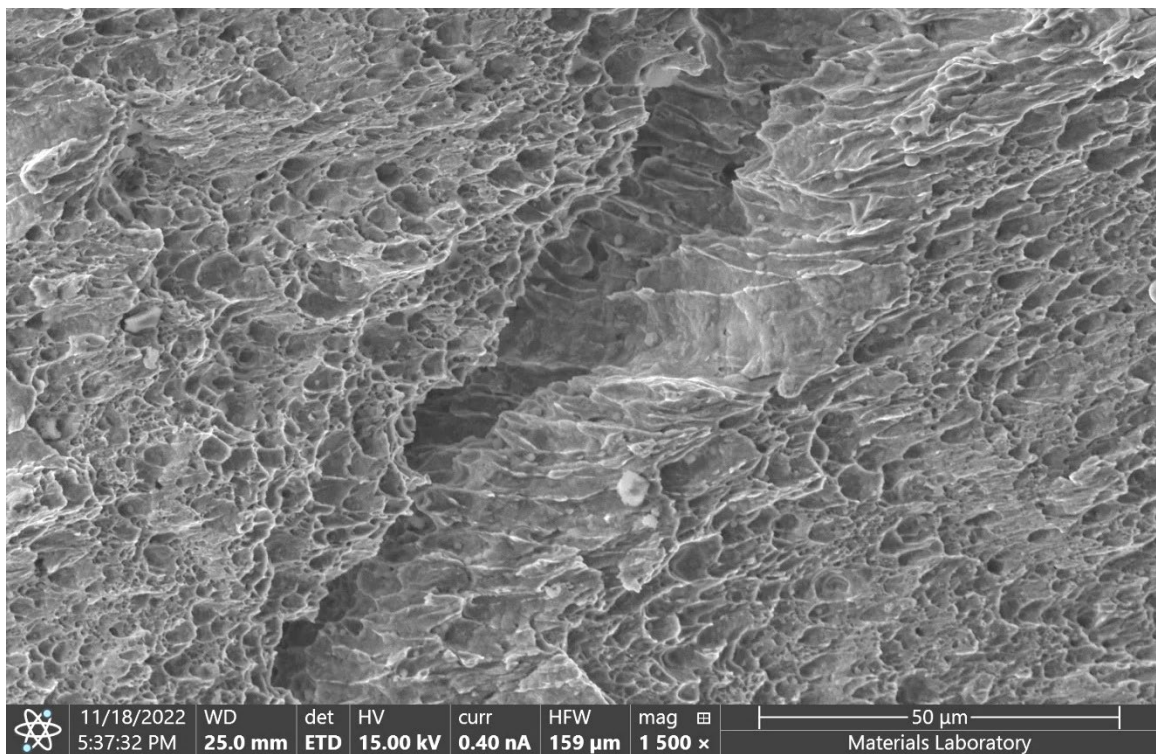
**Figure 16.** SE micrograph of dimpled rupture and tearing outside the fatigue cracks.
