## Service Bulletin

MEB09-2

MAIN LANDING GEAR TORQUE TUBE LIFE LIMIT

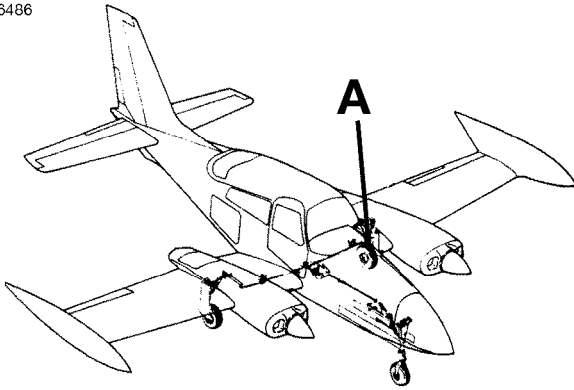
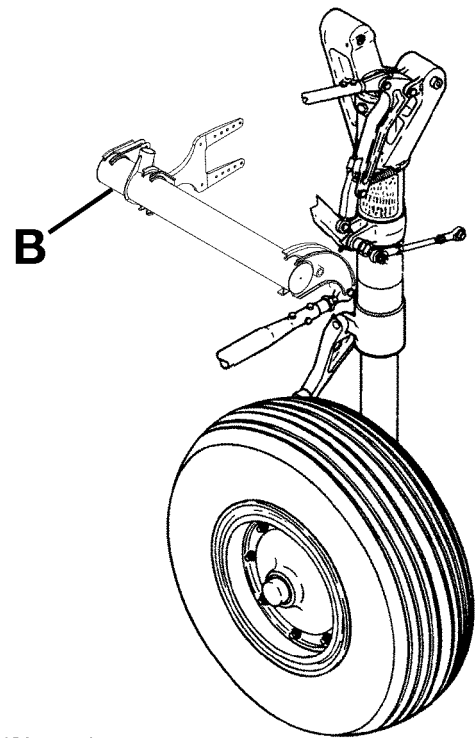
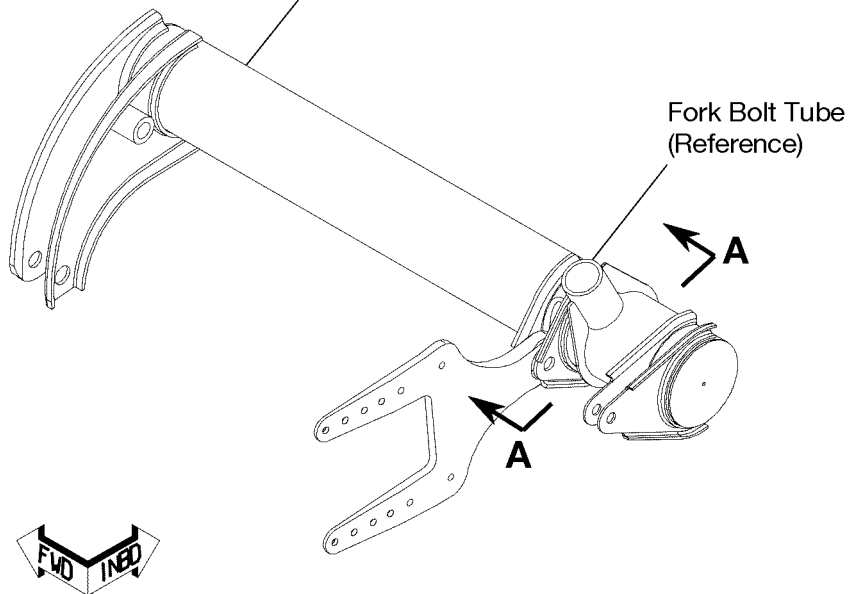
Figure 1. MLG Torque Tube Replacement (Sheet 1)

- B. (Refer to Figure 1, View A-A.) Examine the brace on the fork bolt tube.
    - (1) If there are no braces on the tube, the torque tube assembly installed on your airplane is not a 5045010-32 Right Torque Tube Assembly or a 5045010-33 Left Torque Tube Assembly. Go to Step 5.

- (3) If there are two braces on the tube, go to Step 4C.
  - C. Measure the outer diameter of the fork bolt tube:
    - (1) If the outer diameter of the tube is approximately 0.91 inch, the torque tube assembly installed on your airplane is a 5045010-32 Right Torque Tube Assembly or a 5045010-33 Left Torque Tube Assembly. Go to Step 9.

- (2) If the outer diameter of the tube is approximately 0.68 inch, the torque tube assembly installed on your airplane is not a 5045010-32 Right Torque Tube Assembly or a 5045010-33 Left Torque Tube Assembly. Go to Step 5.

5. Return the airplane to service as follows:
- A. Put the airplane on jacks. (Refer to the applicable section of the service/maintenance manual.)
  - B. (Refer to Figure 1, Detail A and Detail B.) Remove the 5045010 Torque Tube Assembly from the airplane. Keep the attachment hardware, but discard the nuts and the cotter pins. (Refer to the applicable section of the service/maintenance Manual.)

6. Install the 5045010-32 Right Torque Tube Assembly (5045010-33 Left Torque Tube Assembly) with the kept attachment hardware.
  - A. Do a visual inspection of the kept hardware that attaches the torque tube assembly to the outboard push-pull tube, uplock push-pull tube, support, 5027002-5 Support Bracket Assembly, and outboard drive tube.
